FLOODS OF NOVEMBER 11-13, 1974, IN ST. CROIX, U.S. VIRGIN ISLANDS

WRI-77-136

by
W.J. Haire and K.G. Johnson
1979

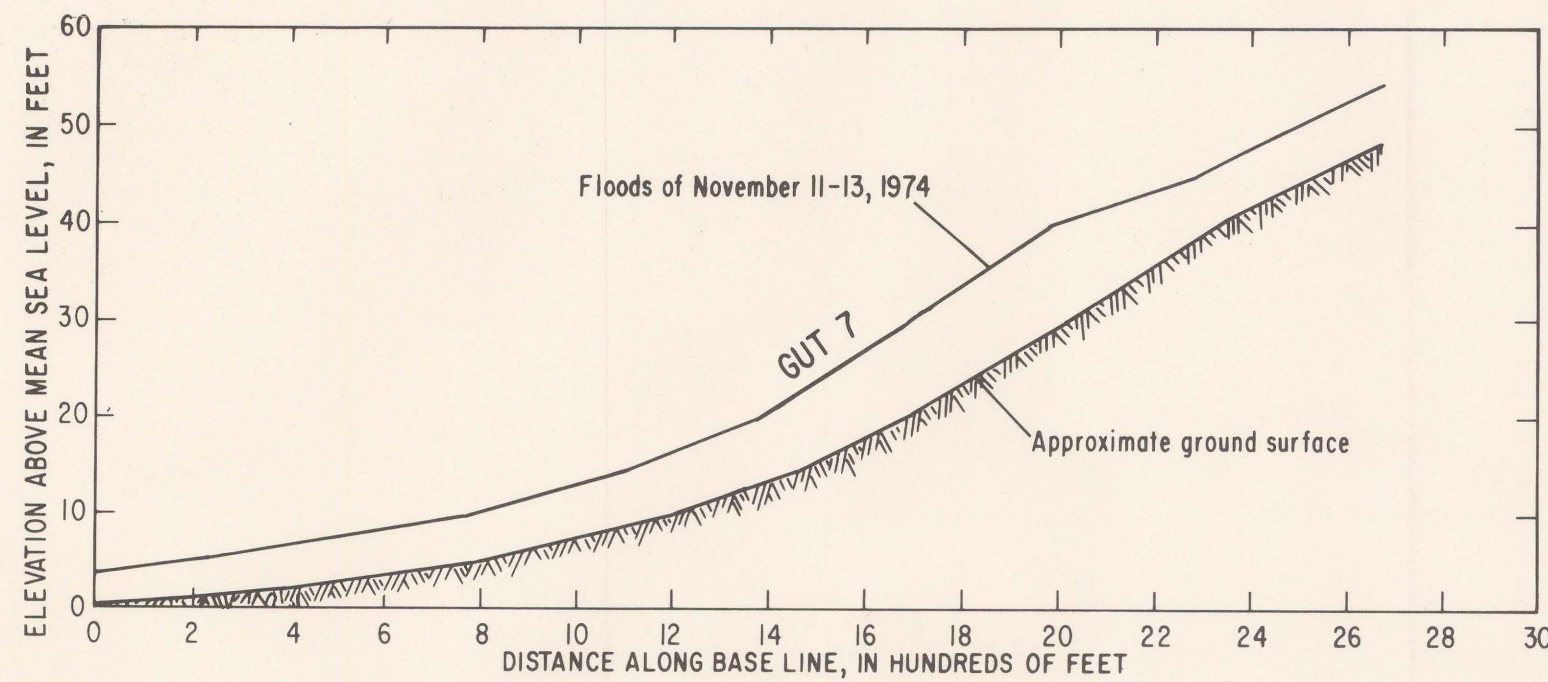
FIGURE 9.—Profile of November 11-13, 1974 flood at Christiansted near Richmond, Gut 7. See map E on plate 9 for location of base line.

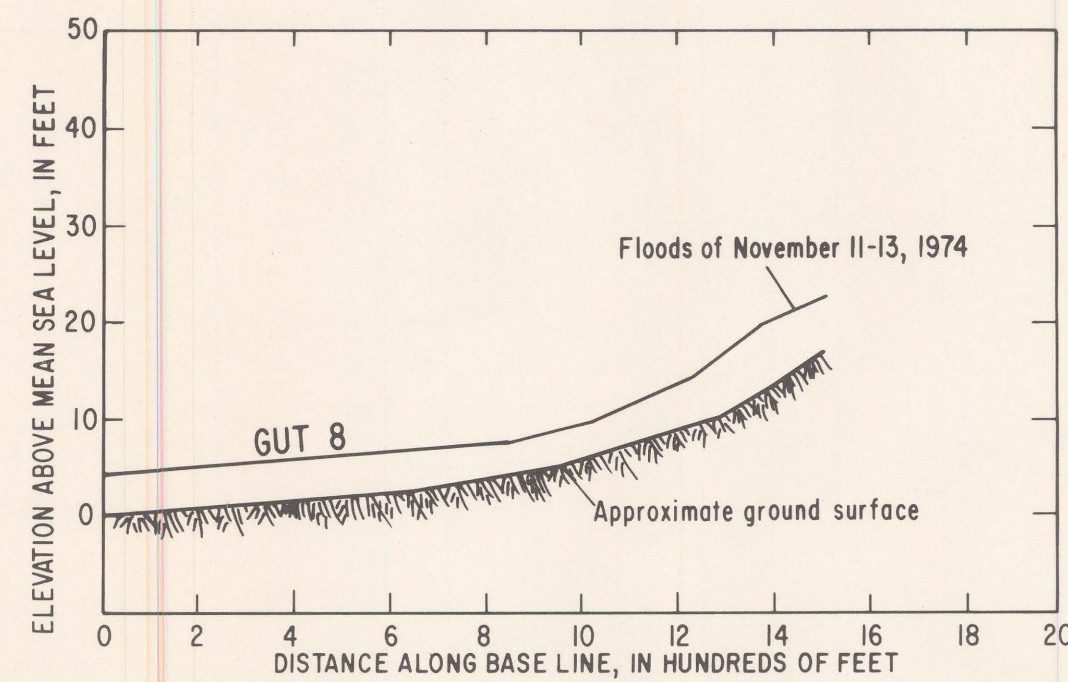
FIGURE 10.—Profile of November 11-13, 1974 flood at Christiansted, Gut 8. See map E on plate 9 for location of base line.

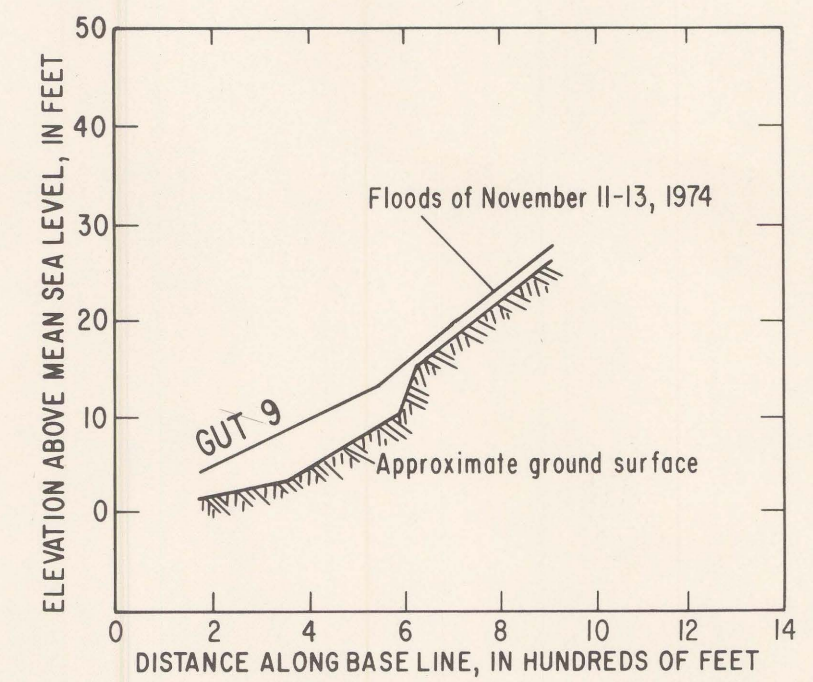
FIGURE 11.—Profile of November 11-13, 1974, flood at Christiansted near Altona, Gut 9. See map E on plate 9 for location of base line.

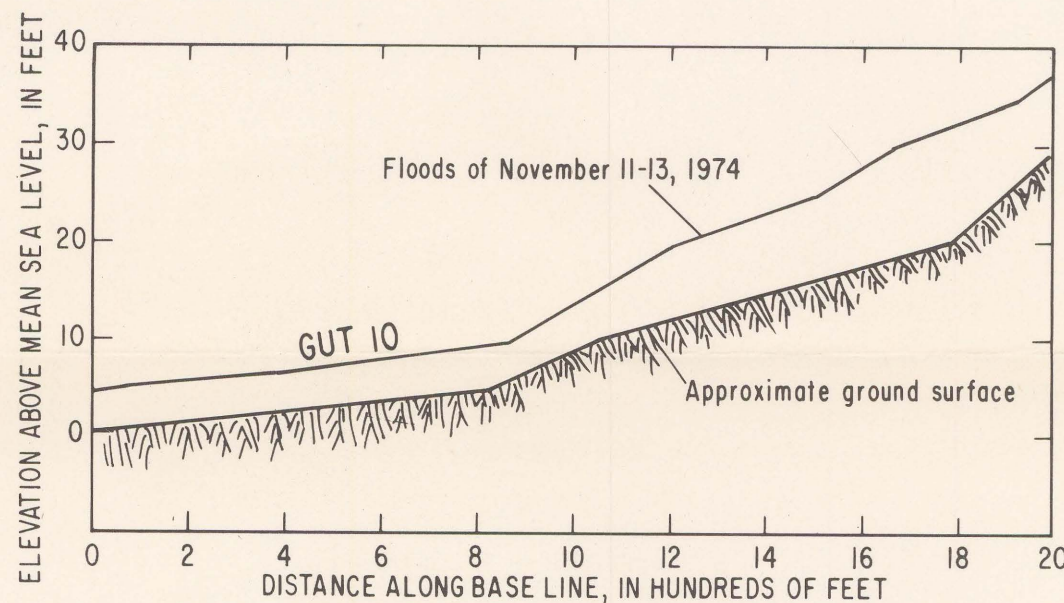
FIGURE 12.—Profile of November 11-13, 1974 flood at Tide Village near Altona, Gut 10. See map E on plate 10, for location of base line.

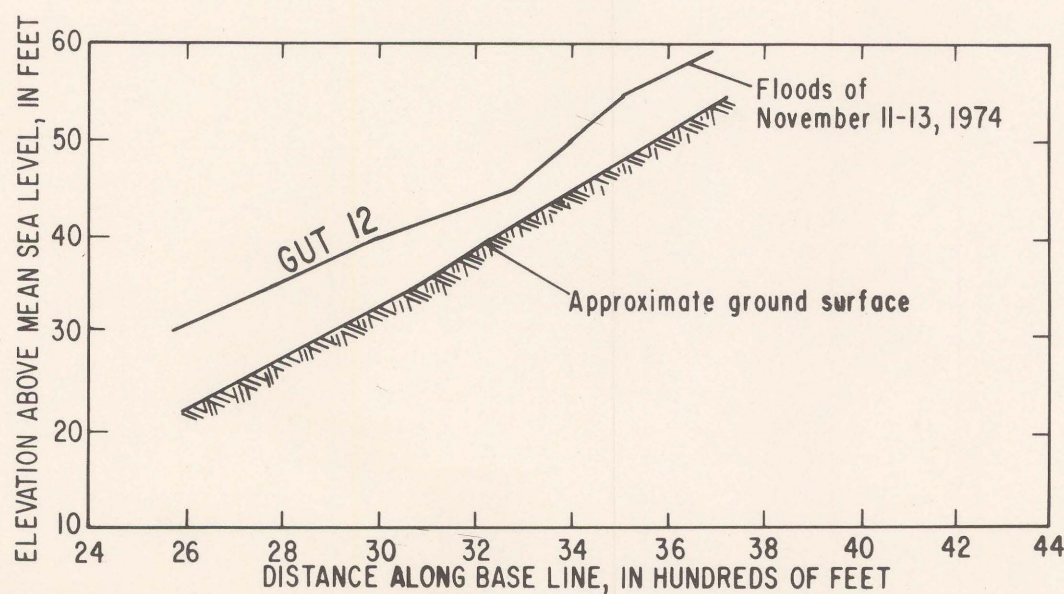
FIGURE 14.—Profile of November 11-13, 1974, flood at Tide Village near Altona, Gut 12. See map F on plate 11 for location of base line.

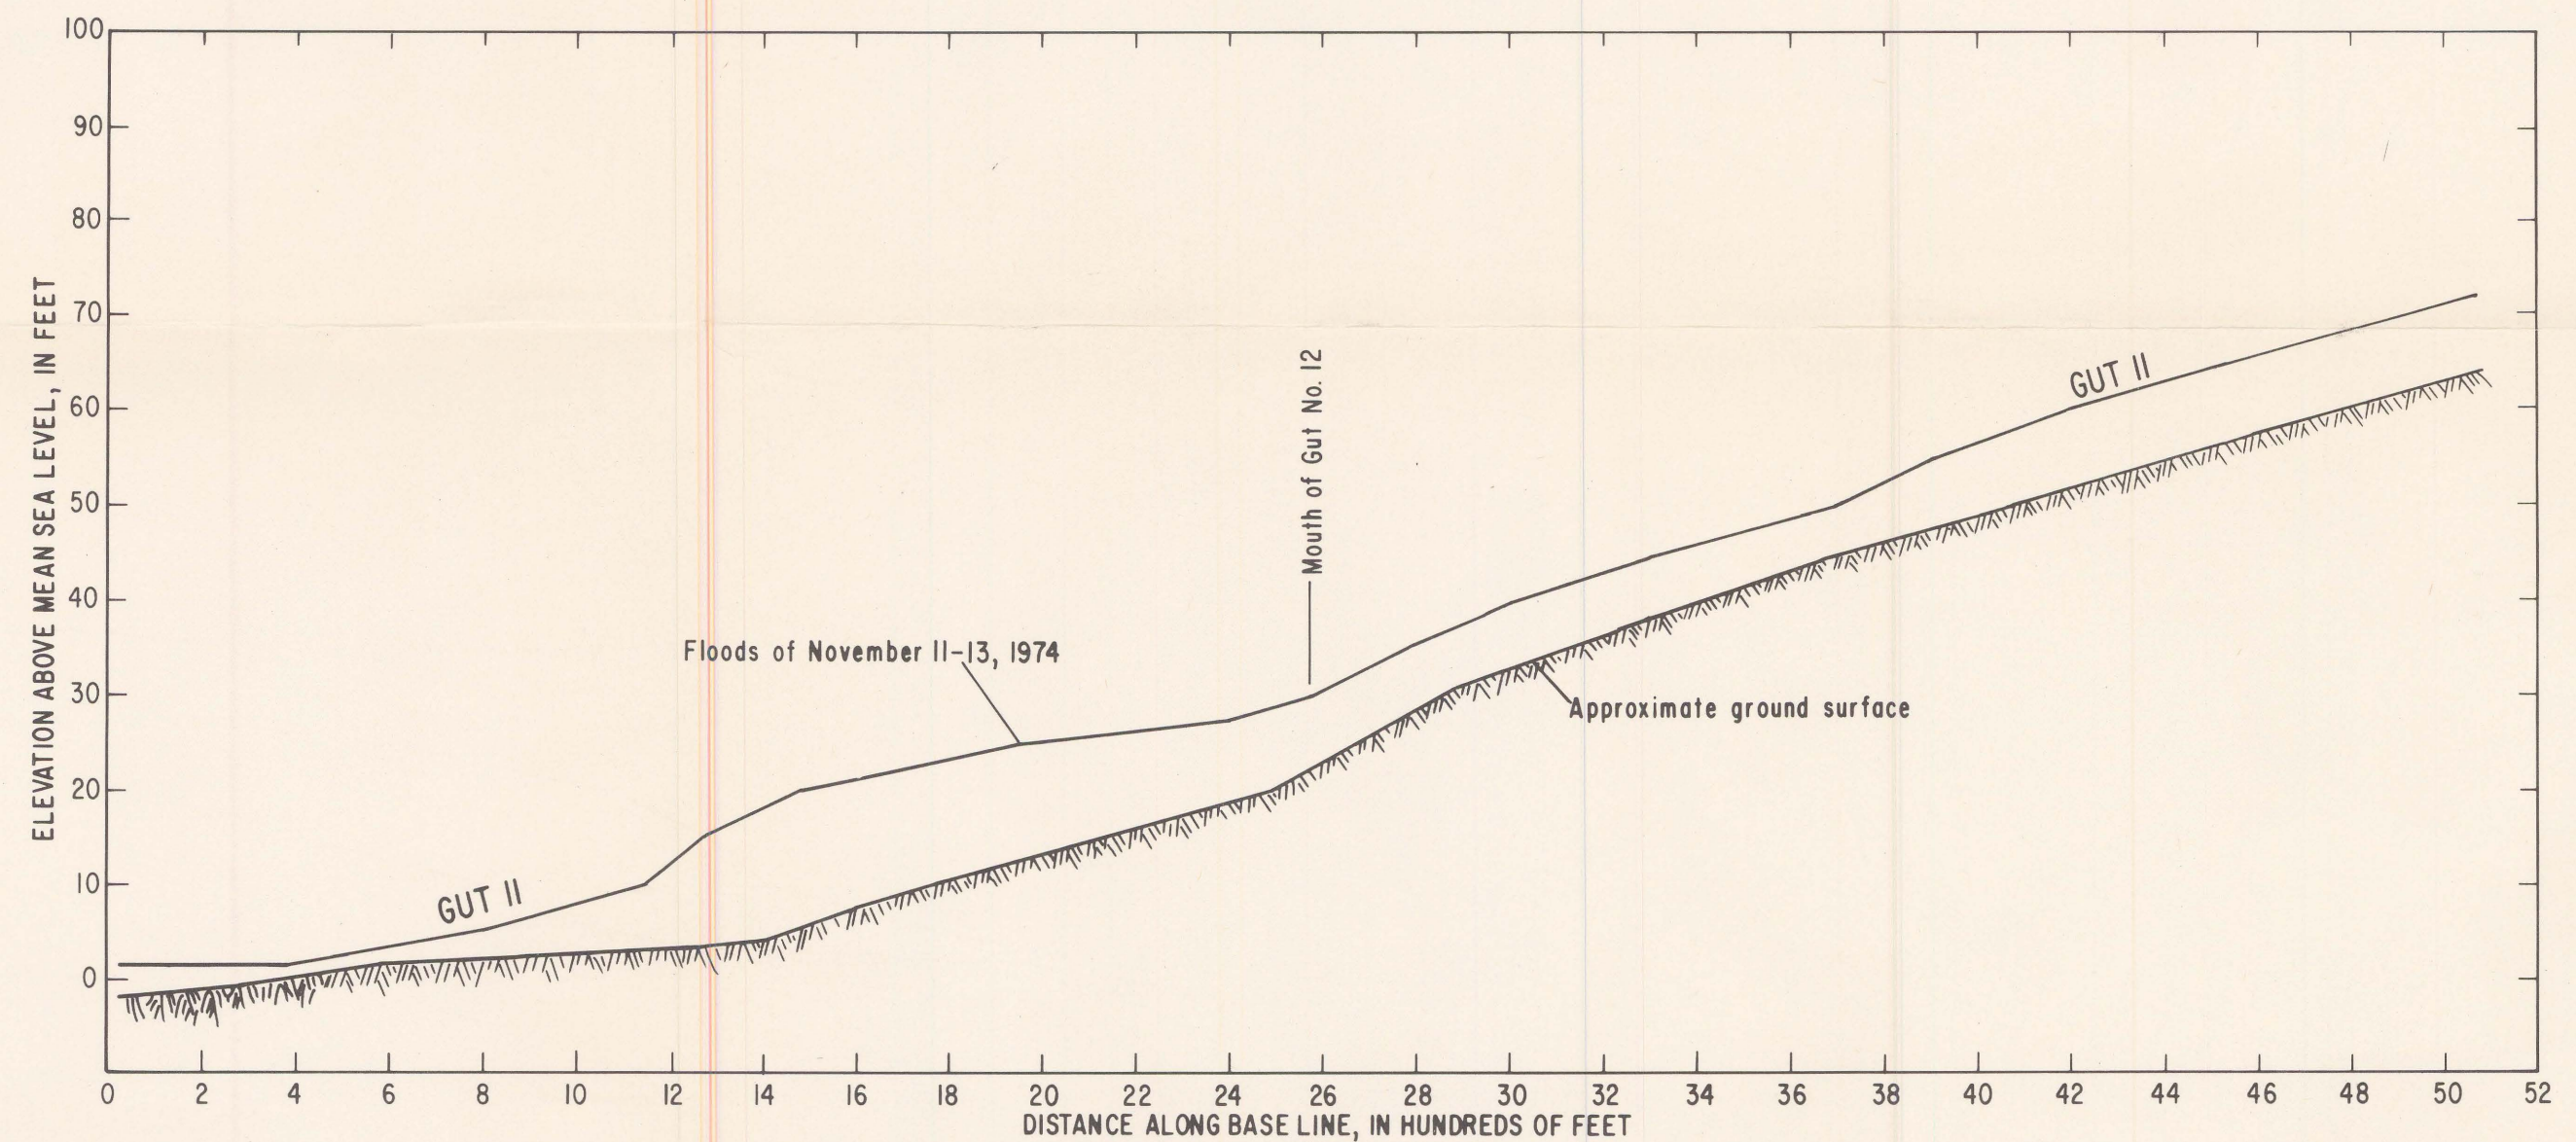
FIGURE 13.—Profile of November 11-13, 1974, flood at Tide Village near Altona, Gut 11. See map F on plate 11 for location of base line.
