C.1
FLOODS IN KANSAS CITY, MISSOURI AND KANSAS, SEPTEMBER 12-13, 1977

U.S. GEOLOGICAL SURVEY

Water-Resources Investigations 78-63

Floods in Kansas City, Missouri and Kansas,
September 12-13, 1977

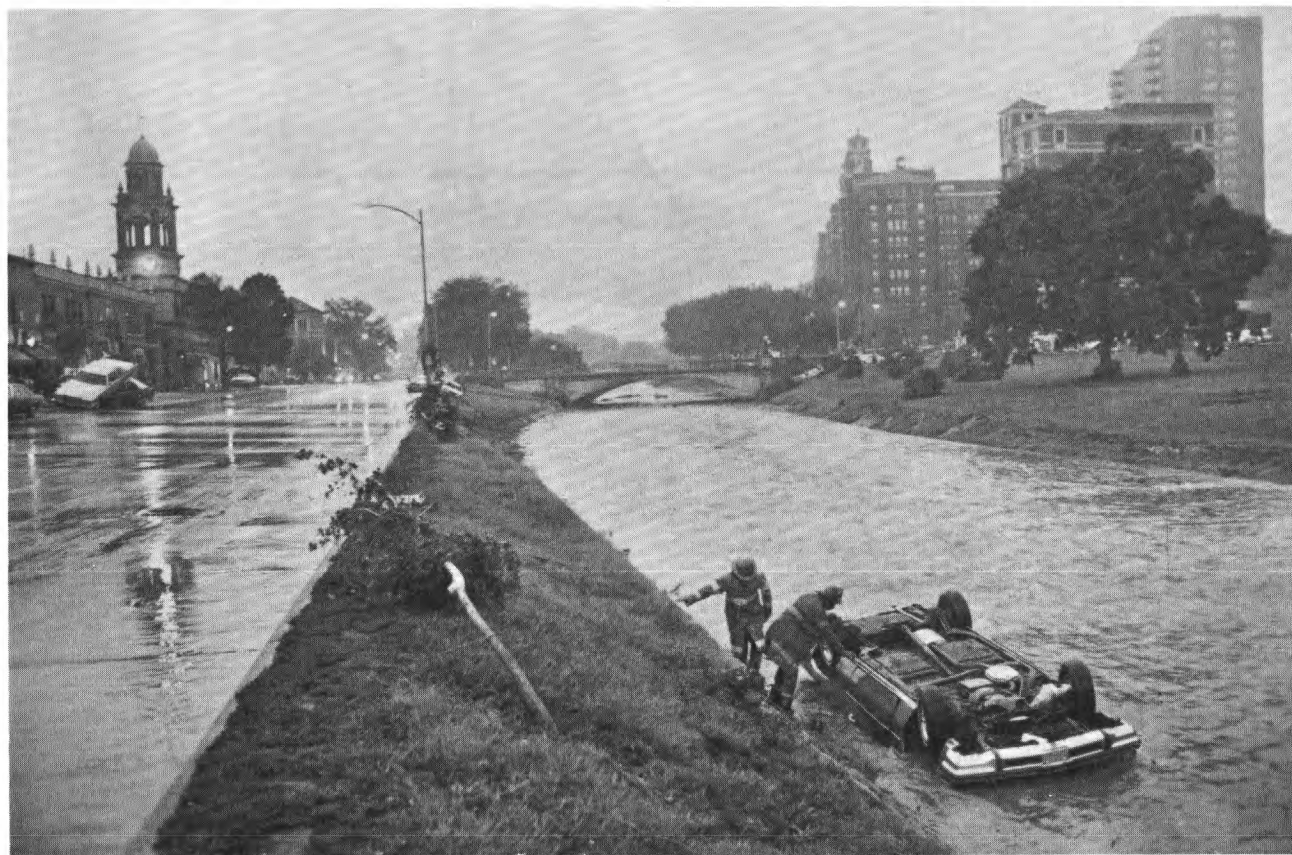
Figure 2.--View of Brush Creek after flood crest, looking east along Ward Parkway,
at Wornall Road at Country Club Plaza, Kansas City, Missouri.

Flood of
9-12-77,
high-water
mark.

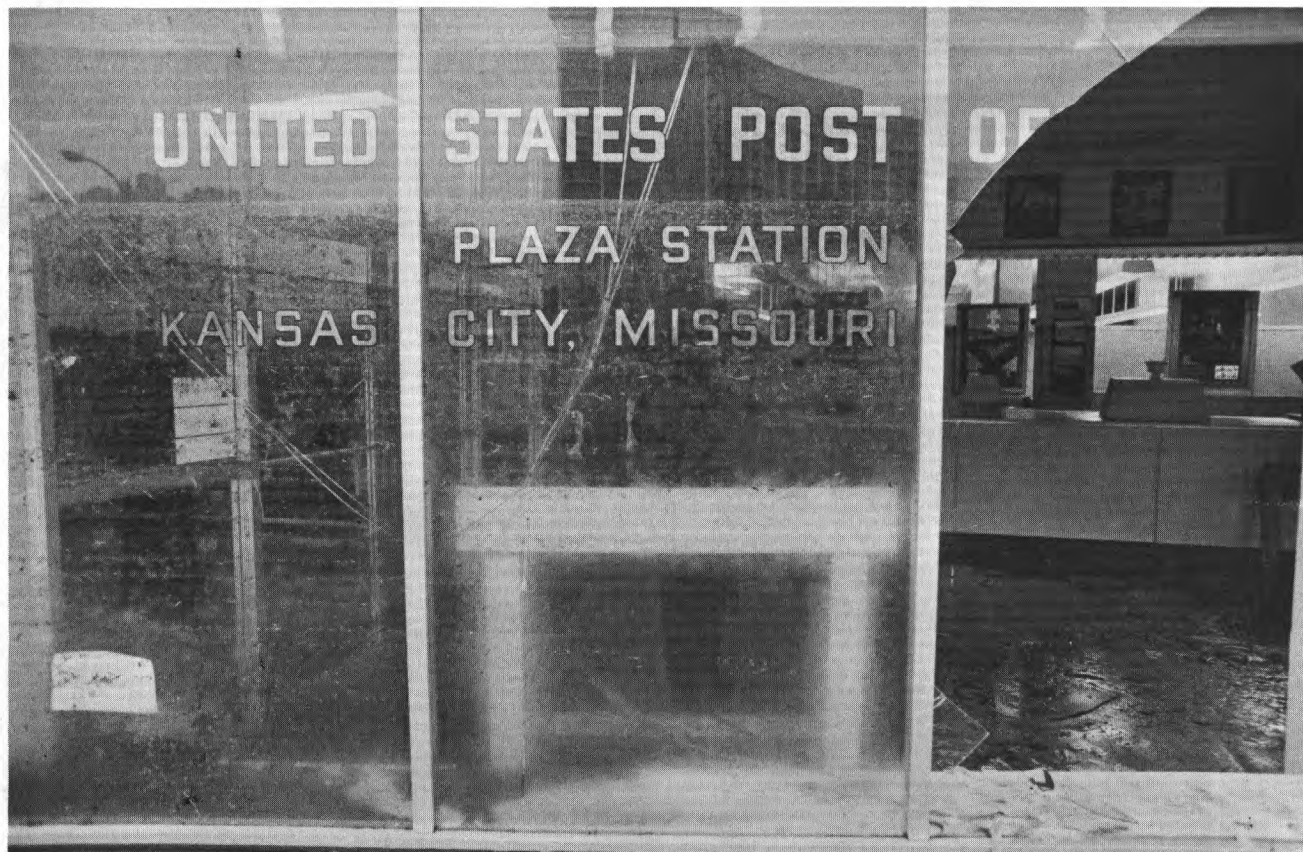
The greatest damage to commercial property occurred in the Brush Creek basin and lower Blue River. Most commercial business and development in the flood-affected area is centered along Brush Creek in Missouri and Kansas. Shops and stores in the Country Club Plaza of Kansas City, Mo., just upstream from the U.S. Geological Survey Brush Creek gaging-station at Main Street received as much as 6 ft of water as evidenced by figures 2-5. Marks left by the flood can be seen in the window of the U.S. Post Office at Plaza Center (fig. 3).

Figure 3.--United States Post Office, after Brush Creek flood crest, on Ward Parkway at Country Club Plaza, Kansas City, Missouri.

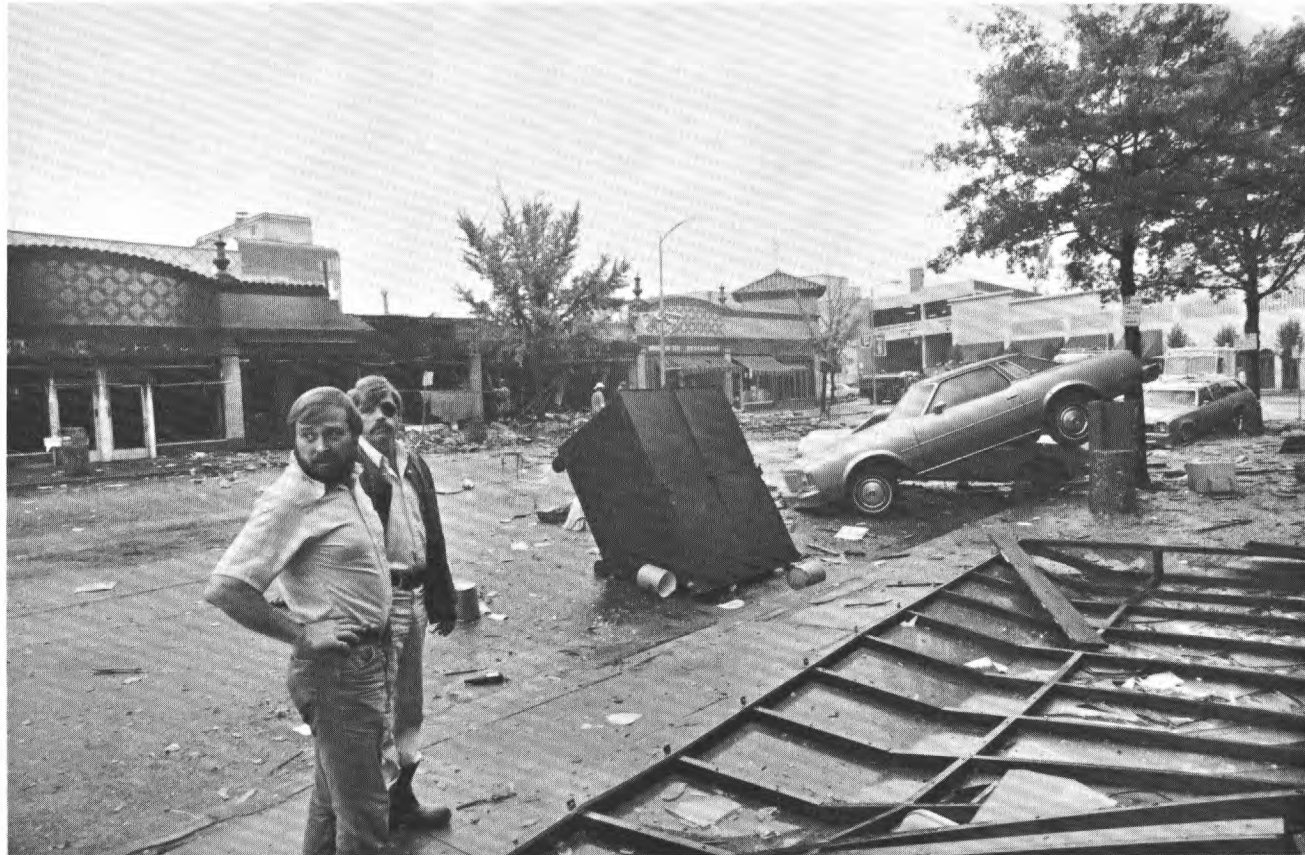
Figure 4.--View of 600 block of West 48th Street, after Brush Creek flood crest,
at Country Club Plaza, Kansas City, Missouri.

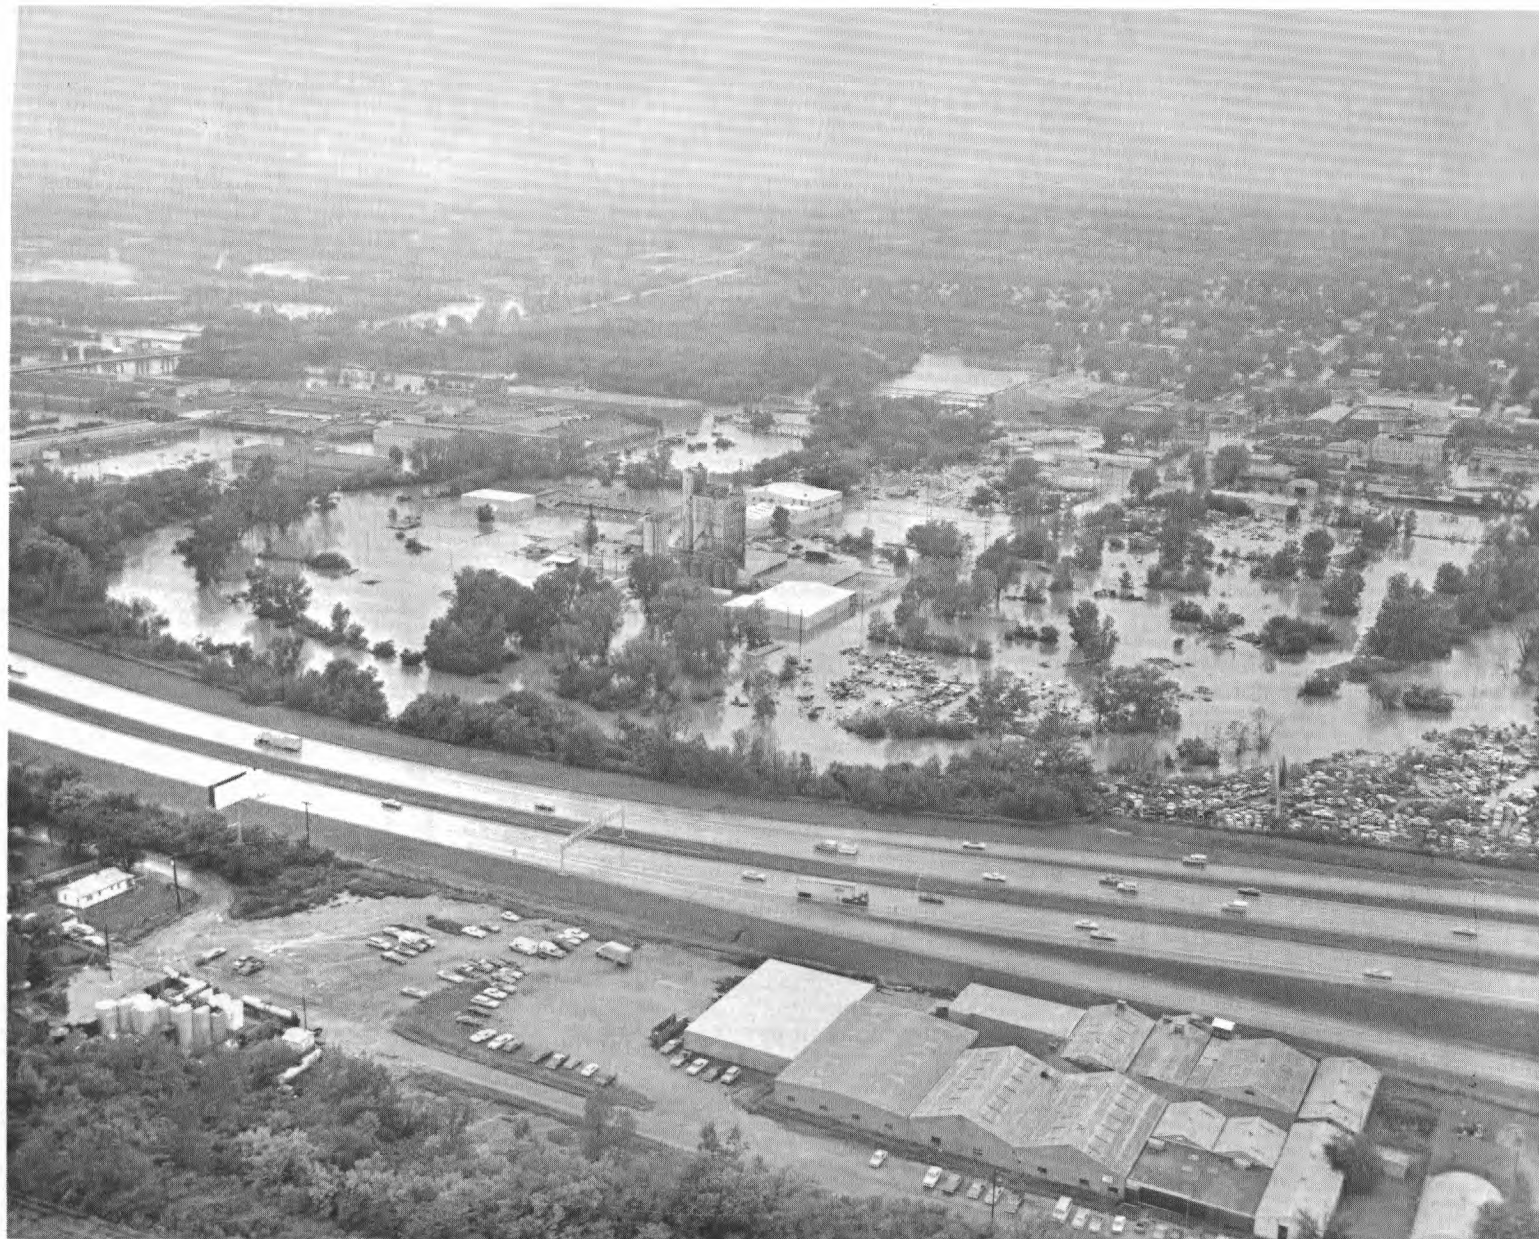
The industrialized lower Blue River flood plain also received its share of damage. Railroad tracks were undermined as much as 3 to 4 ft along bridge approaches. Figure 5 shows the general flooding in the industrial area in the Blue River basin between 23rd Street and Truman Road. In the Brush Creek basin, many shoppers had parked their cars in underground sections of multi-level parking lots and along streets that were inundated during the flood.

Figure 5.--Areal view after flood crest, looking west along Blue River between 23rd Street and Truman Road at Kansas City, Missouri. (U.S. Corps of Engineers.)

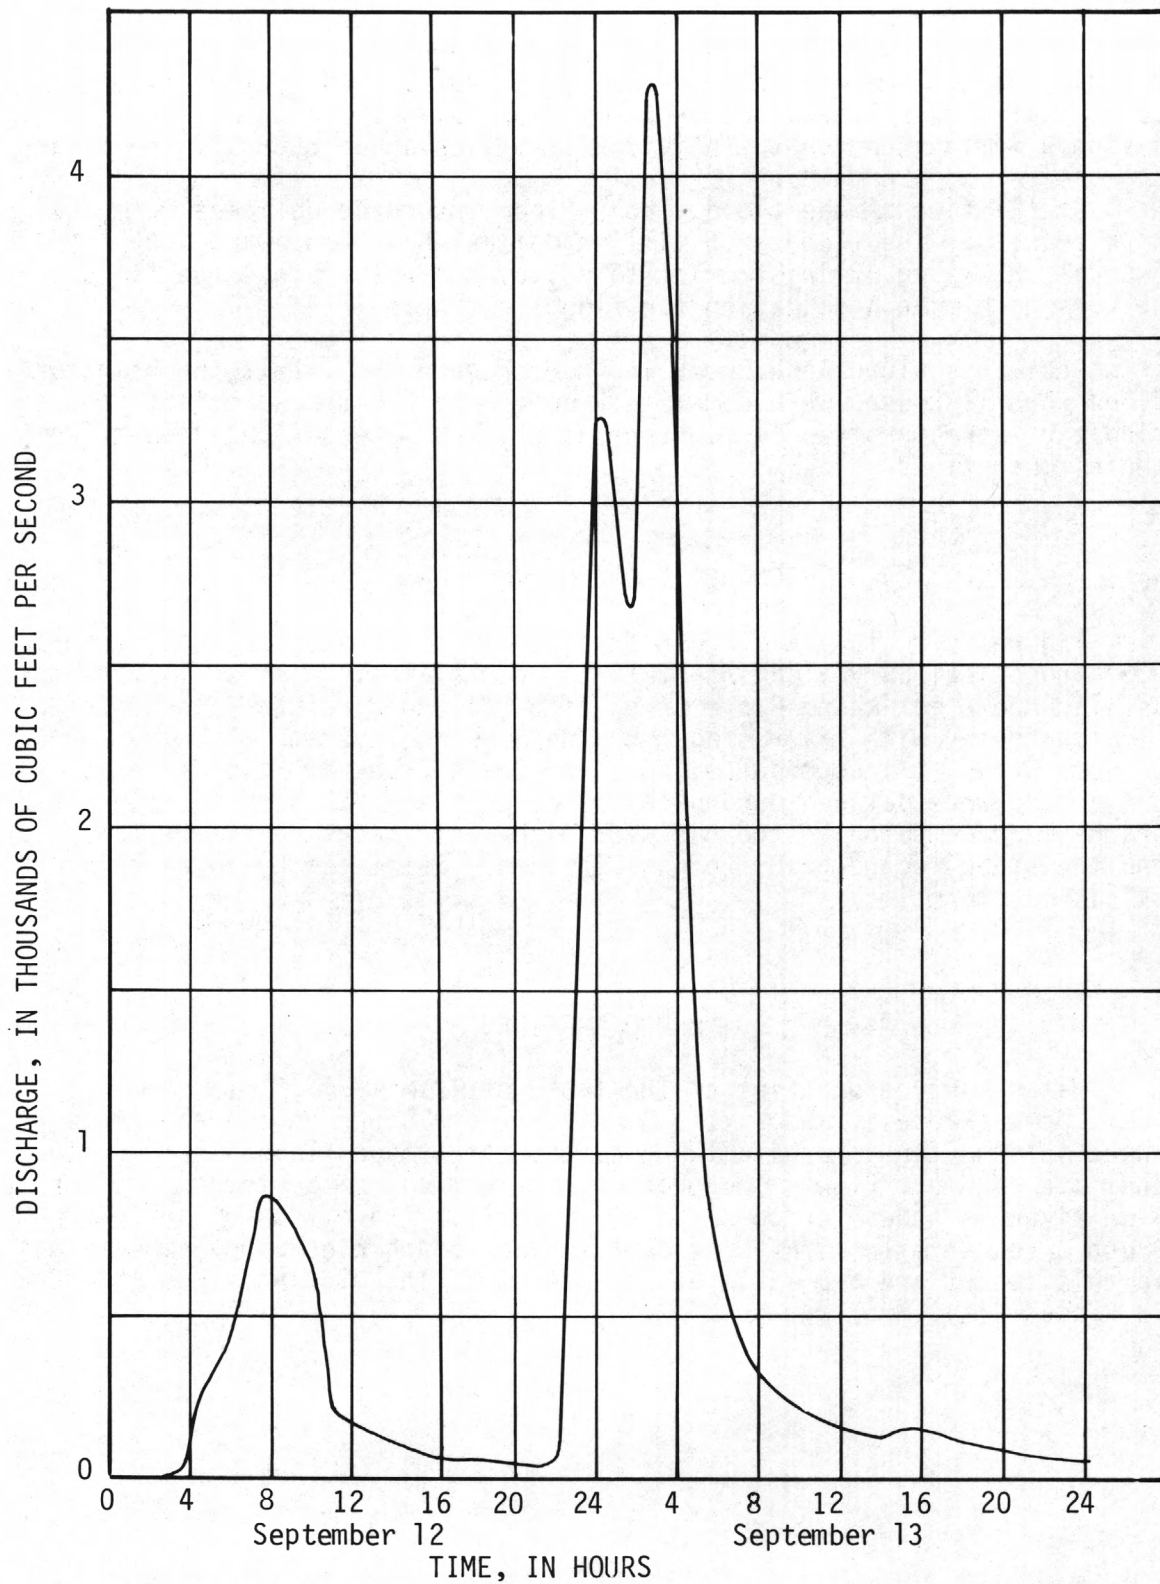
Figures 6 to 10 are flood hydrographs for the storm period at selected U.S. Geological Survey gaging-stations in the area. A rainfall mass curve is also shown for Round Grove Creek (fig. 9) where rainfall is recorded simultaneously with river stage in a dual gaging system. The gage structures on Rock Creek at Independence, Mo., and Brush Creek at Main Street at Kansas City, Mo., were damaged during the flood peak and parts of the flood hydrographs were computed on the basis of high-water marks, earlier flow records, and the stage record prior to gage failure. Estimated hydrographs are shown as dashed lines.

Figure 6.--Flood hydrograph at U.S. Geological Survey gaging-station, on Tomahawk Creek at Overland Park, Kansas, flood of September 12-13, 1977.

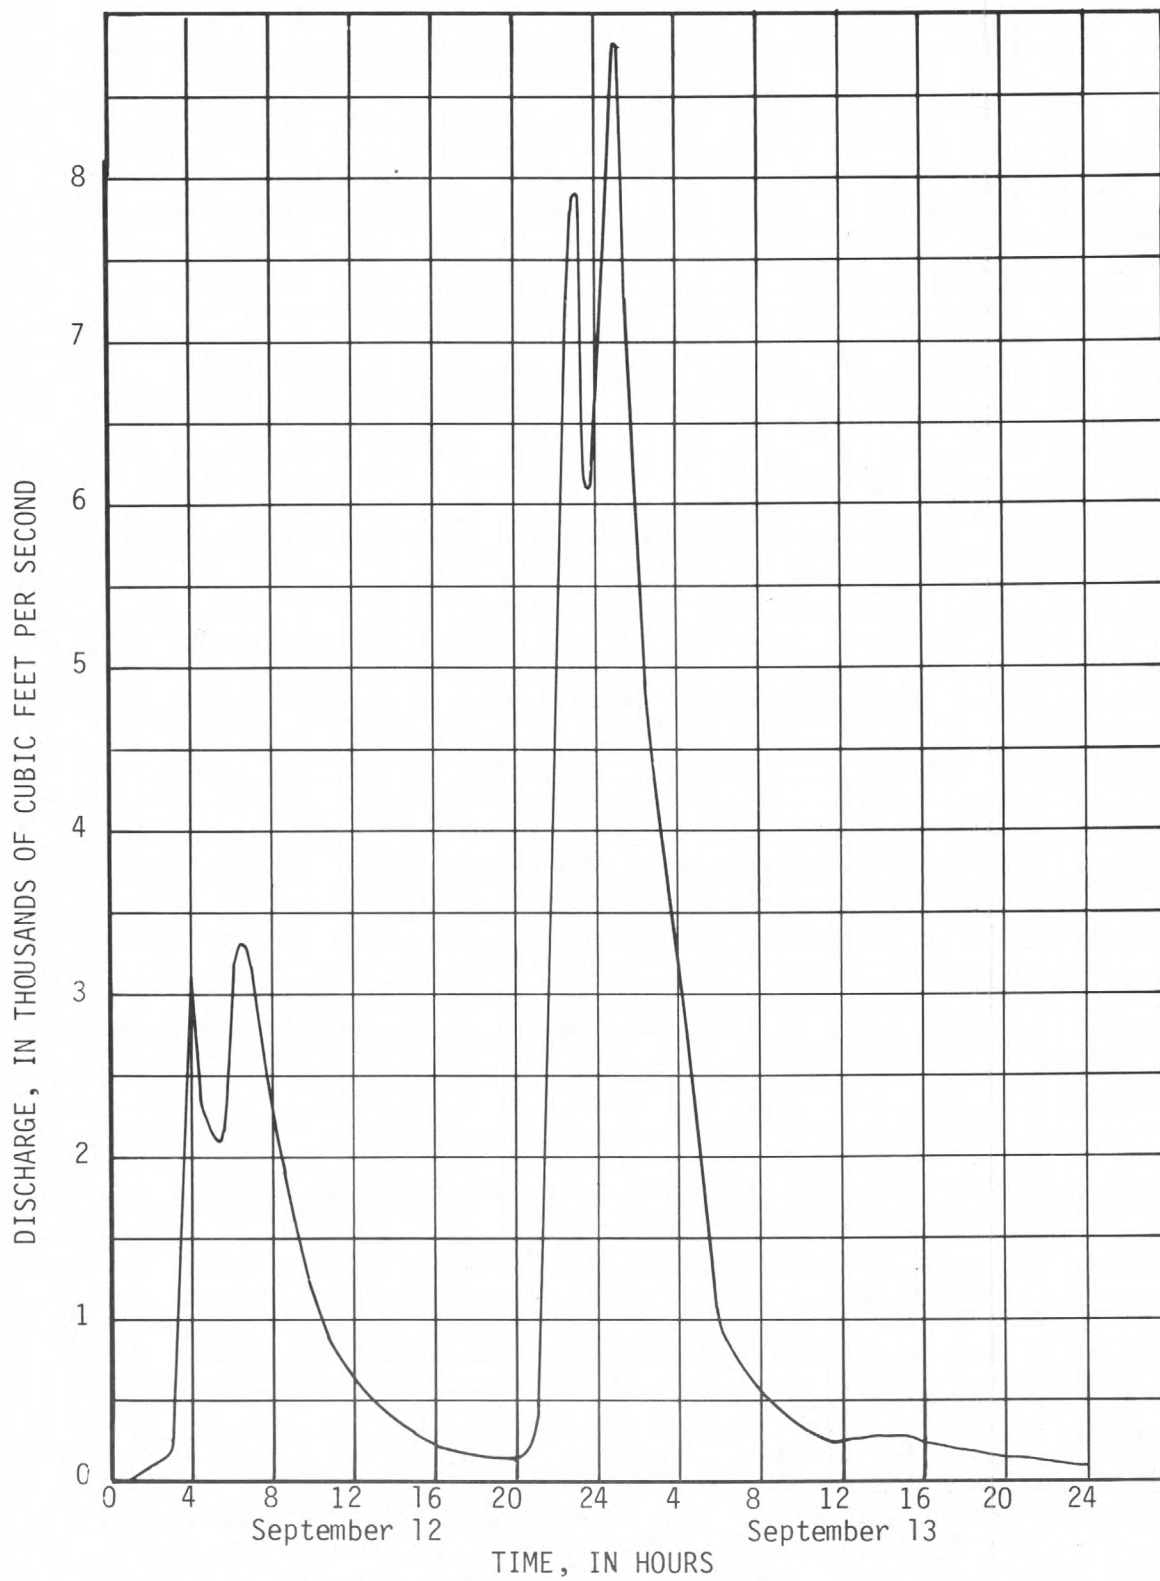
Figure 7.--Flood hydrograph at U.S. Geological Survey gaging-station, on Indian Creek at Overland Park, Kansas, flood of September 12-13, 1977.

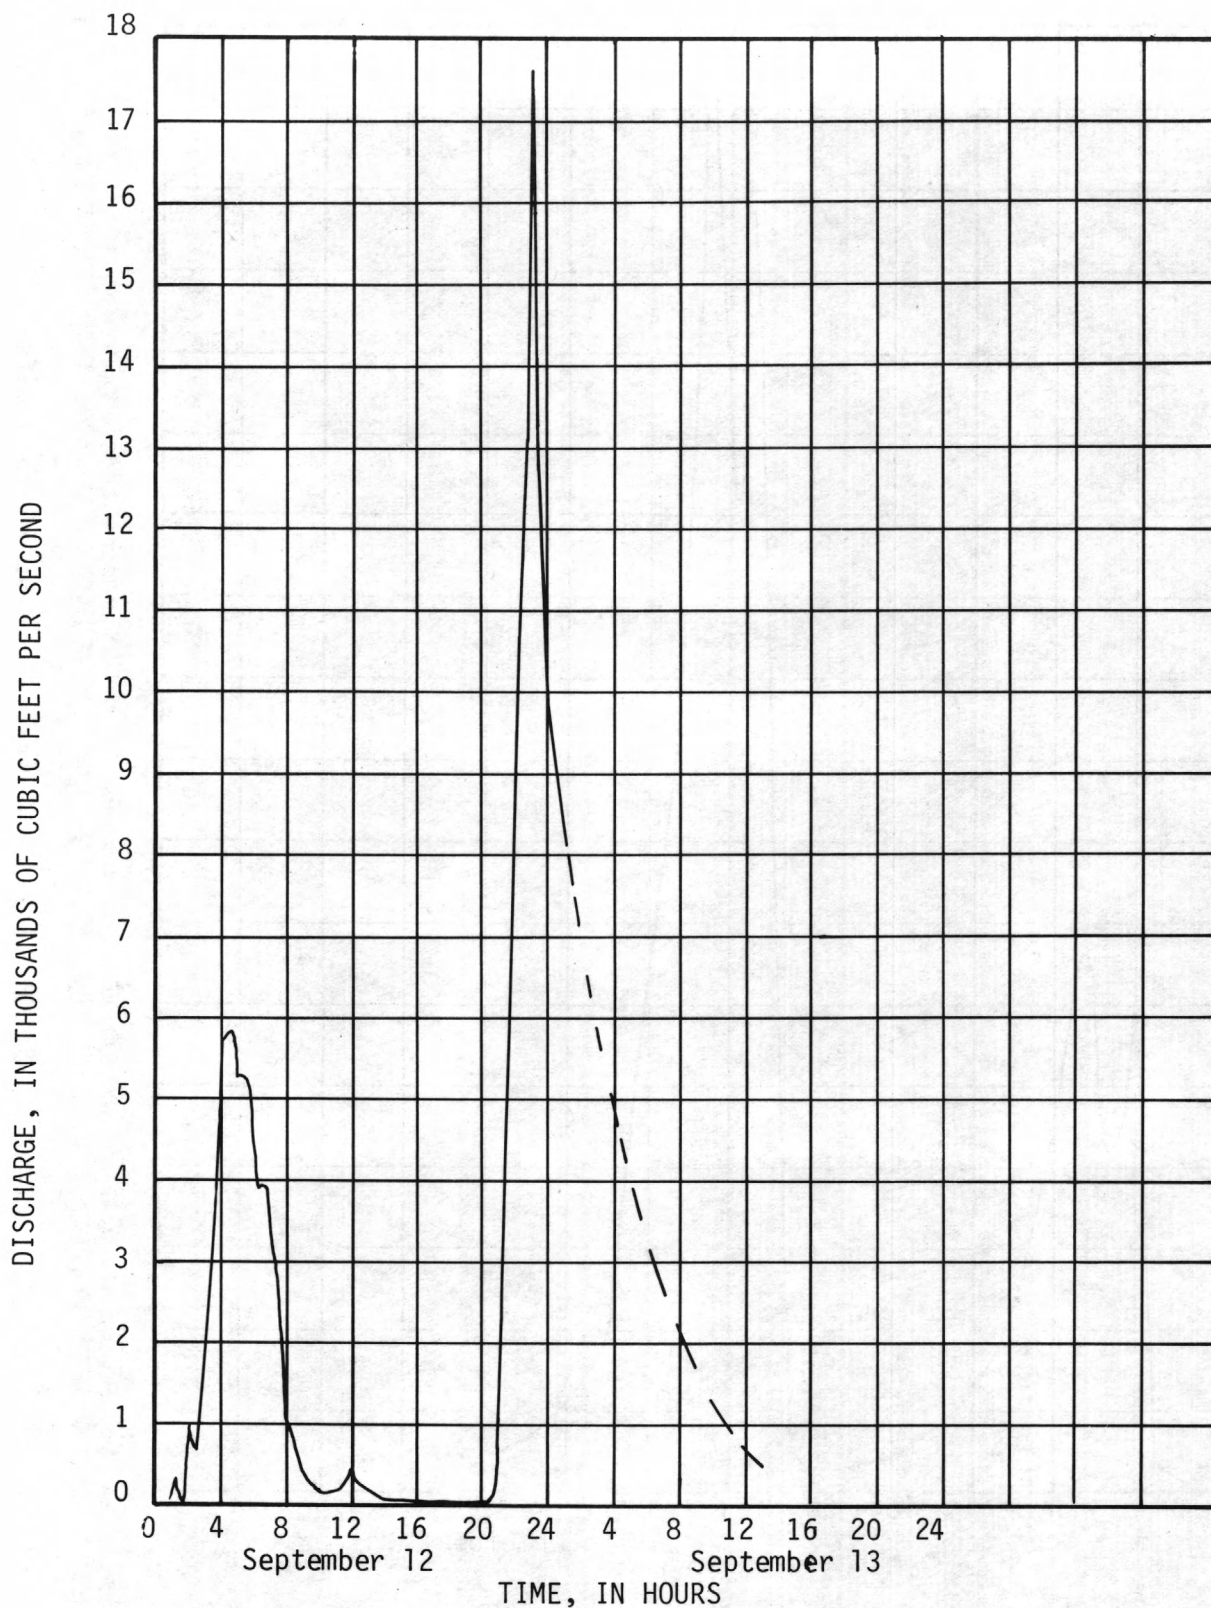
Figure 8.--Flood hydrograph at U.S. Geological Survey gaging-station, on Brush Creek at Main Street, Kansas City, Missouri, flood of September 12-13, 1977.

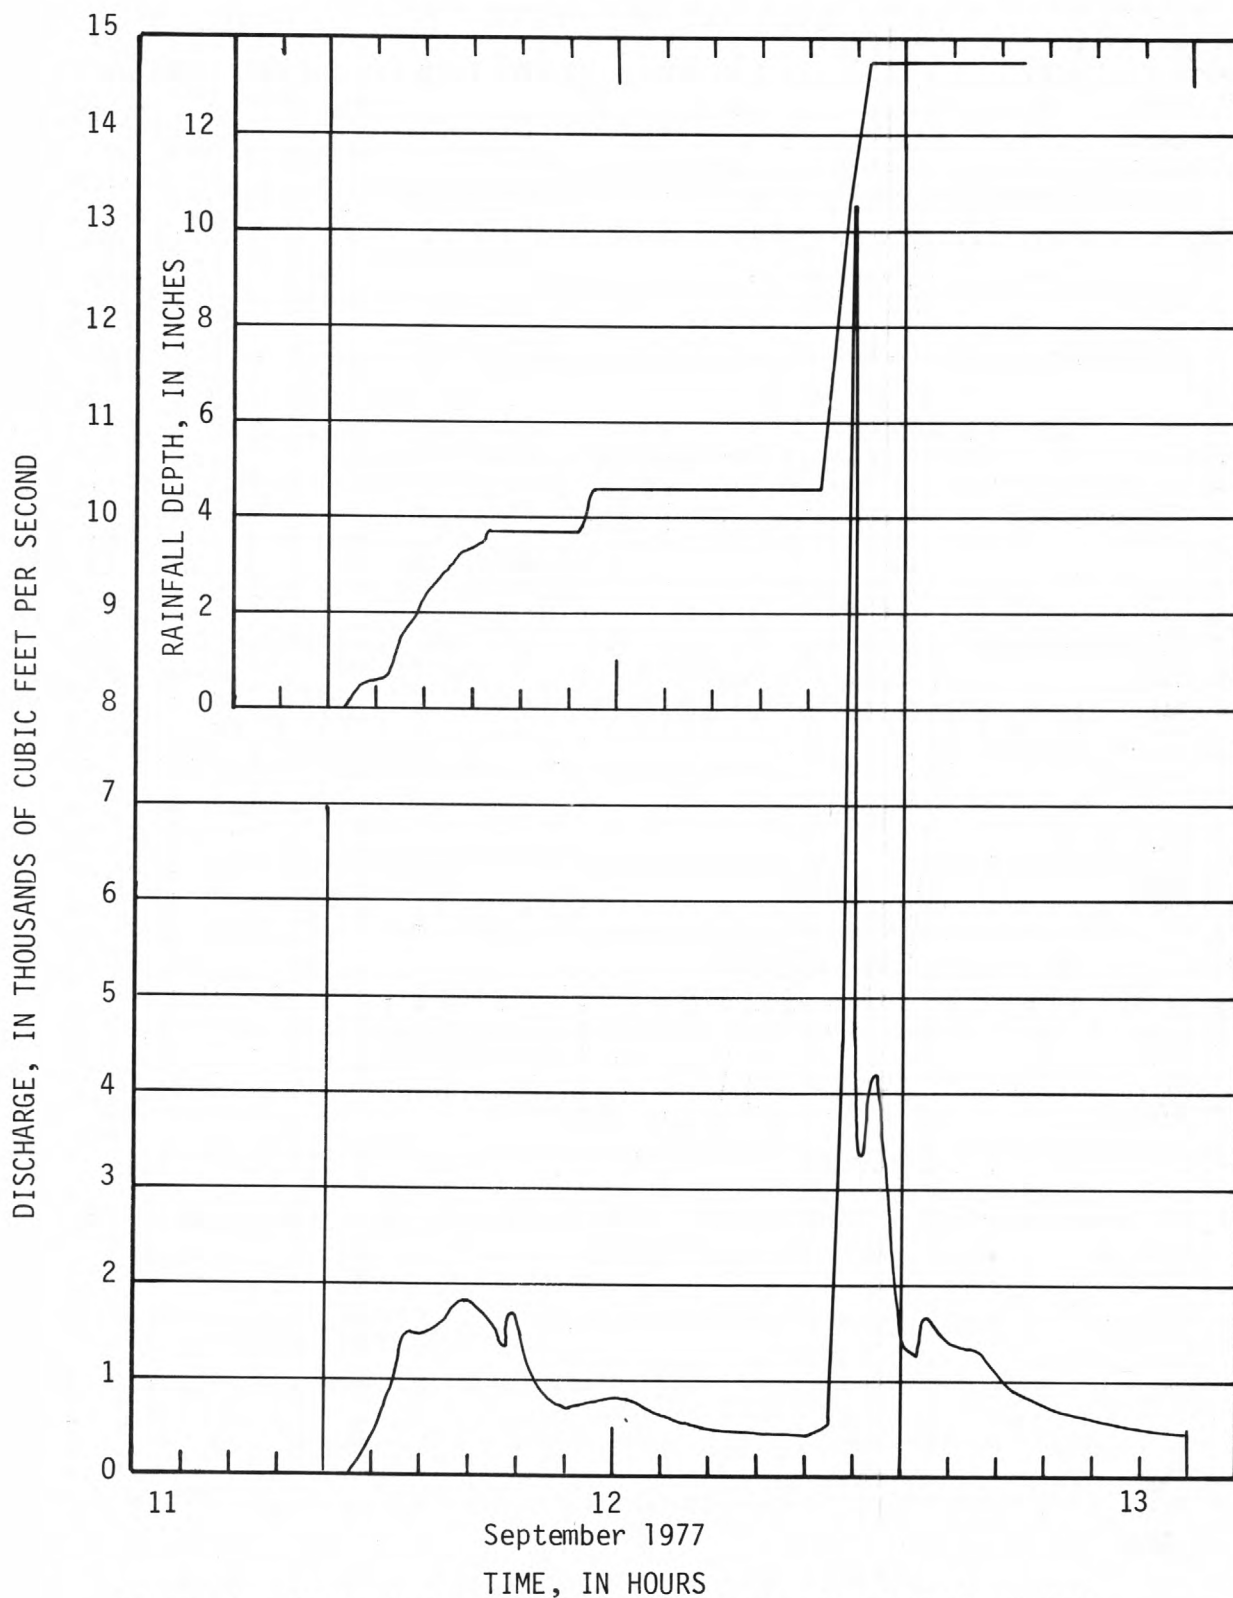
Figure 9.--Flood hydrograph and mass curve of rainfall at U.S. Geological Survey gaging-station on Round Grove Creek at Raytown, Missouri, flood of September 12-13, 1977.

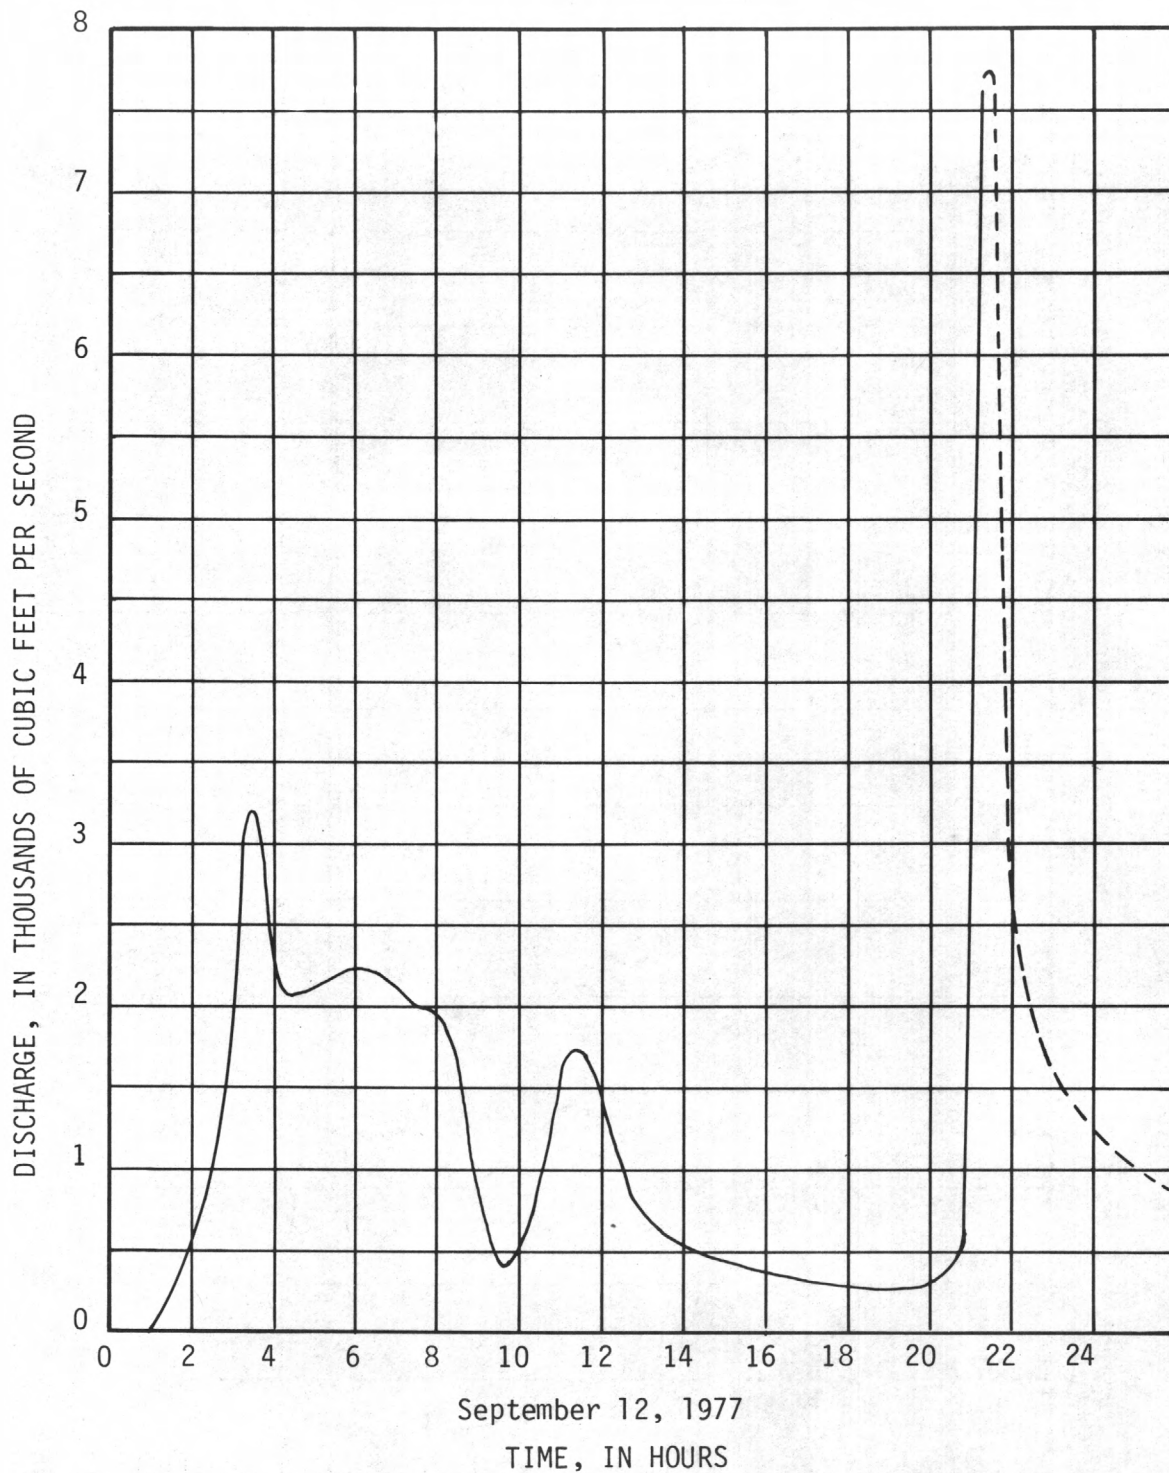
Figure 10.--Flood hydrograph at U.S. Geological Survey gaging station on Rock Creek at Independence, Missouri, flood of September 12-13, 1977.

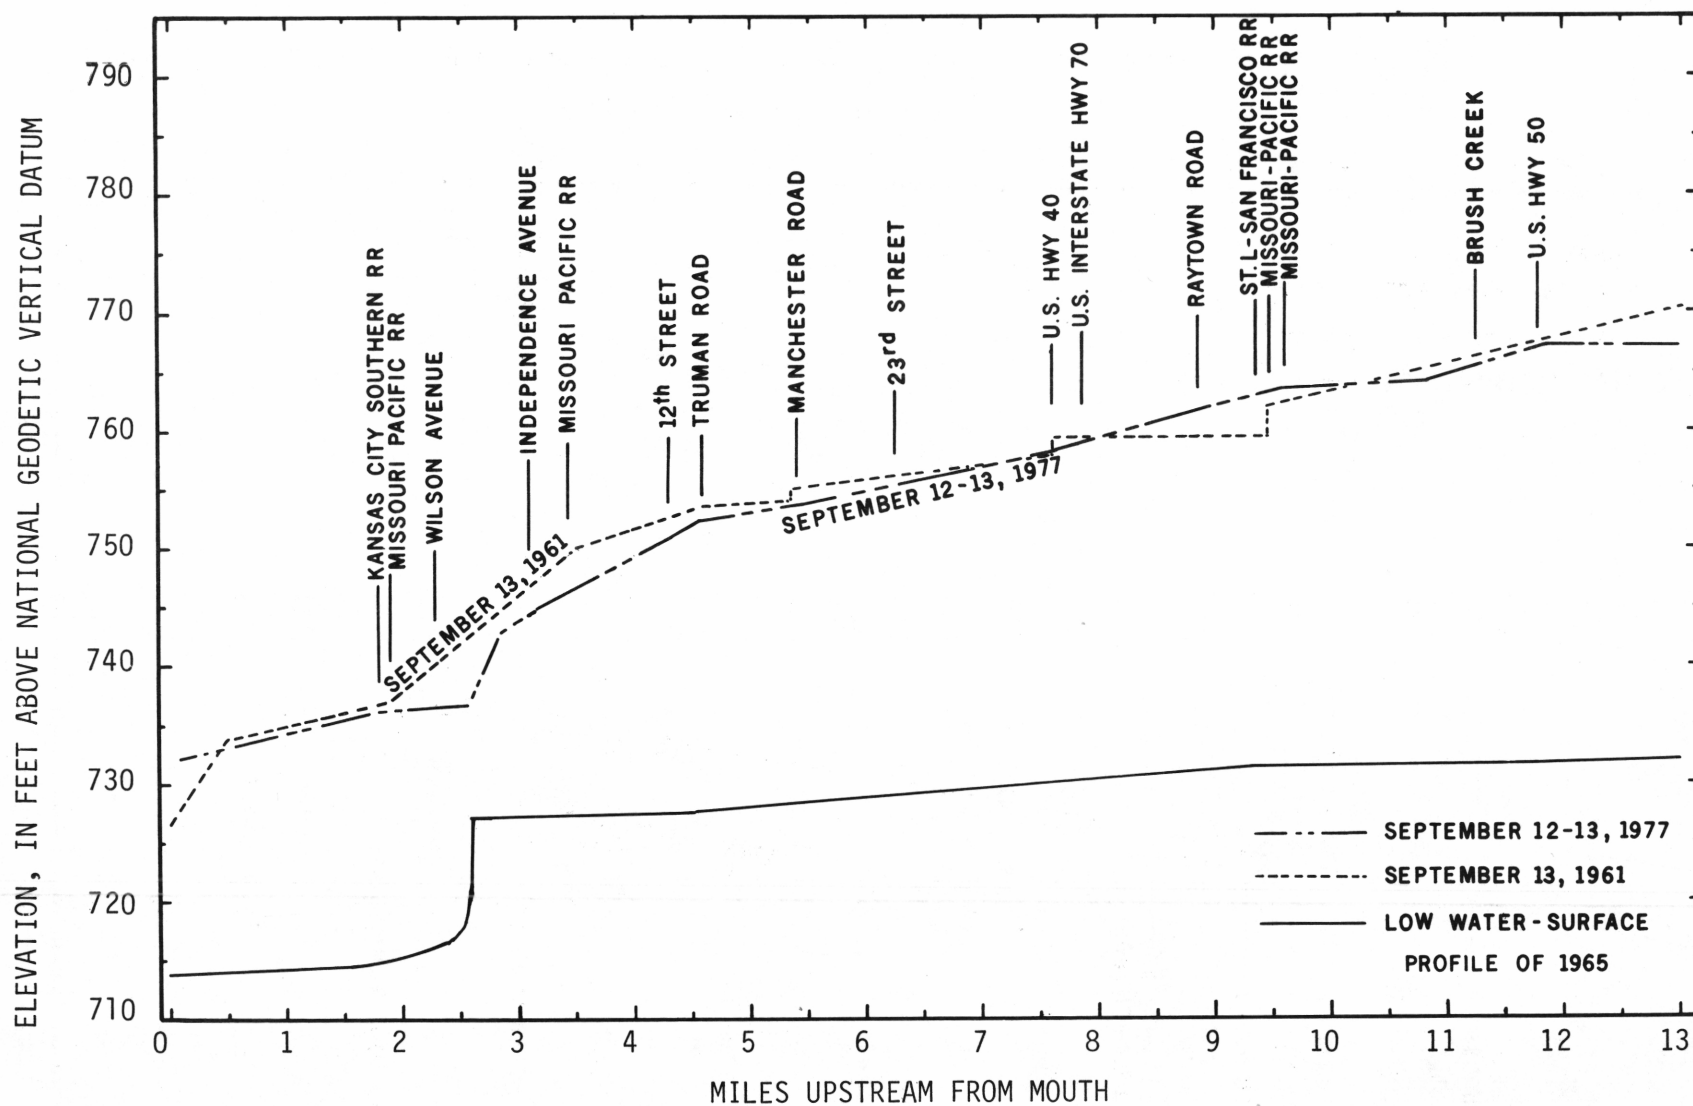
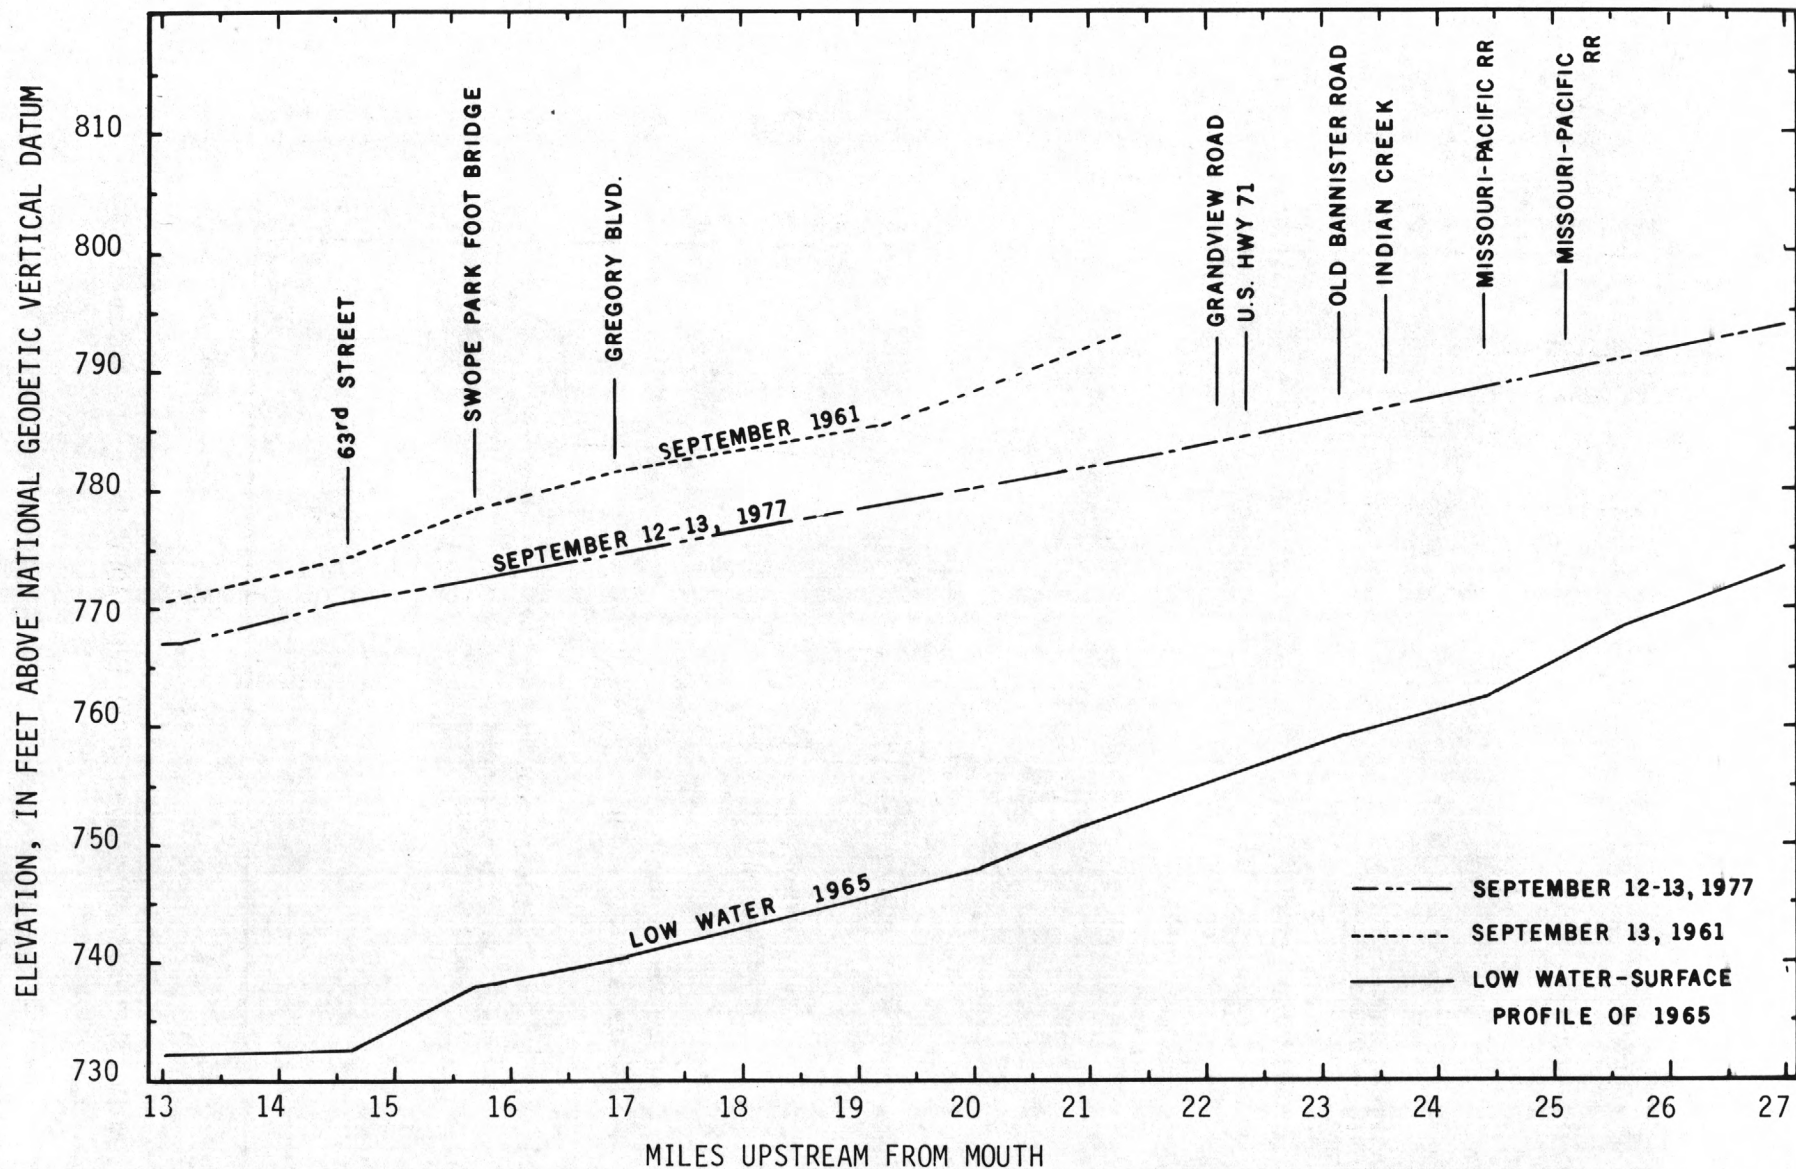
Water-surface profiles of the flood on Blue River, Brush Creek, Rock Creek (Kansas), and Little Blue River are shown in figures 11 to 14. Where information is available, elevation of bridge floors is shown to indicate road overflow. The profile of the flood of September 1961 on the Blue River is shown for comparison (fig. 11). The effect of inflow from Brush Creek at mile 11.8 is evident. Flood boundaries along streams discussed in this report are available at the office of the U.S. Army Corps of Engineers, in Kansas City, Mo.

Figure 11.--Profile of water surface of Blue River, floods of September 12-13, 1977 and September 1961.

Figure 11.--Profile of water surface of Blue River, floods of September 12-13, 1977 and September 1961--continued
