C.1
FLOODS IN KANSAS CITY, MISSOURI AND KANSAS, SEPTEMBER 12-13, 1977

U.S. GEOLOGICAL SURVEY

Water-Resources Investigations 78-63

Floods in Kansas City, Missouri and Kansas,
September 12-13, 1977

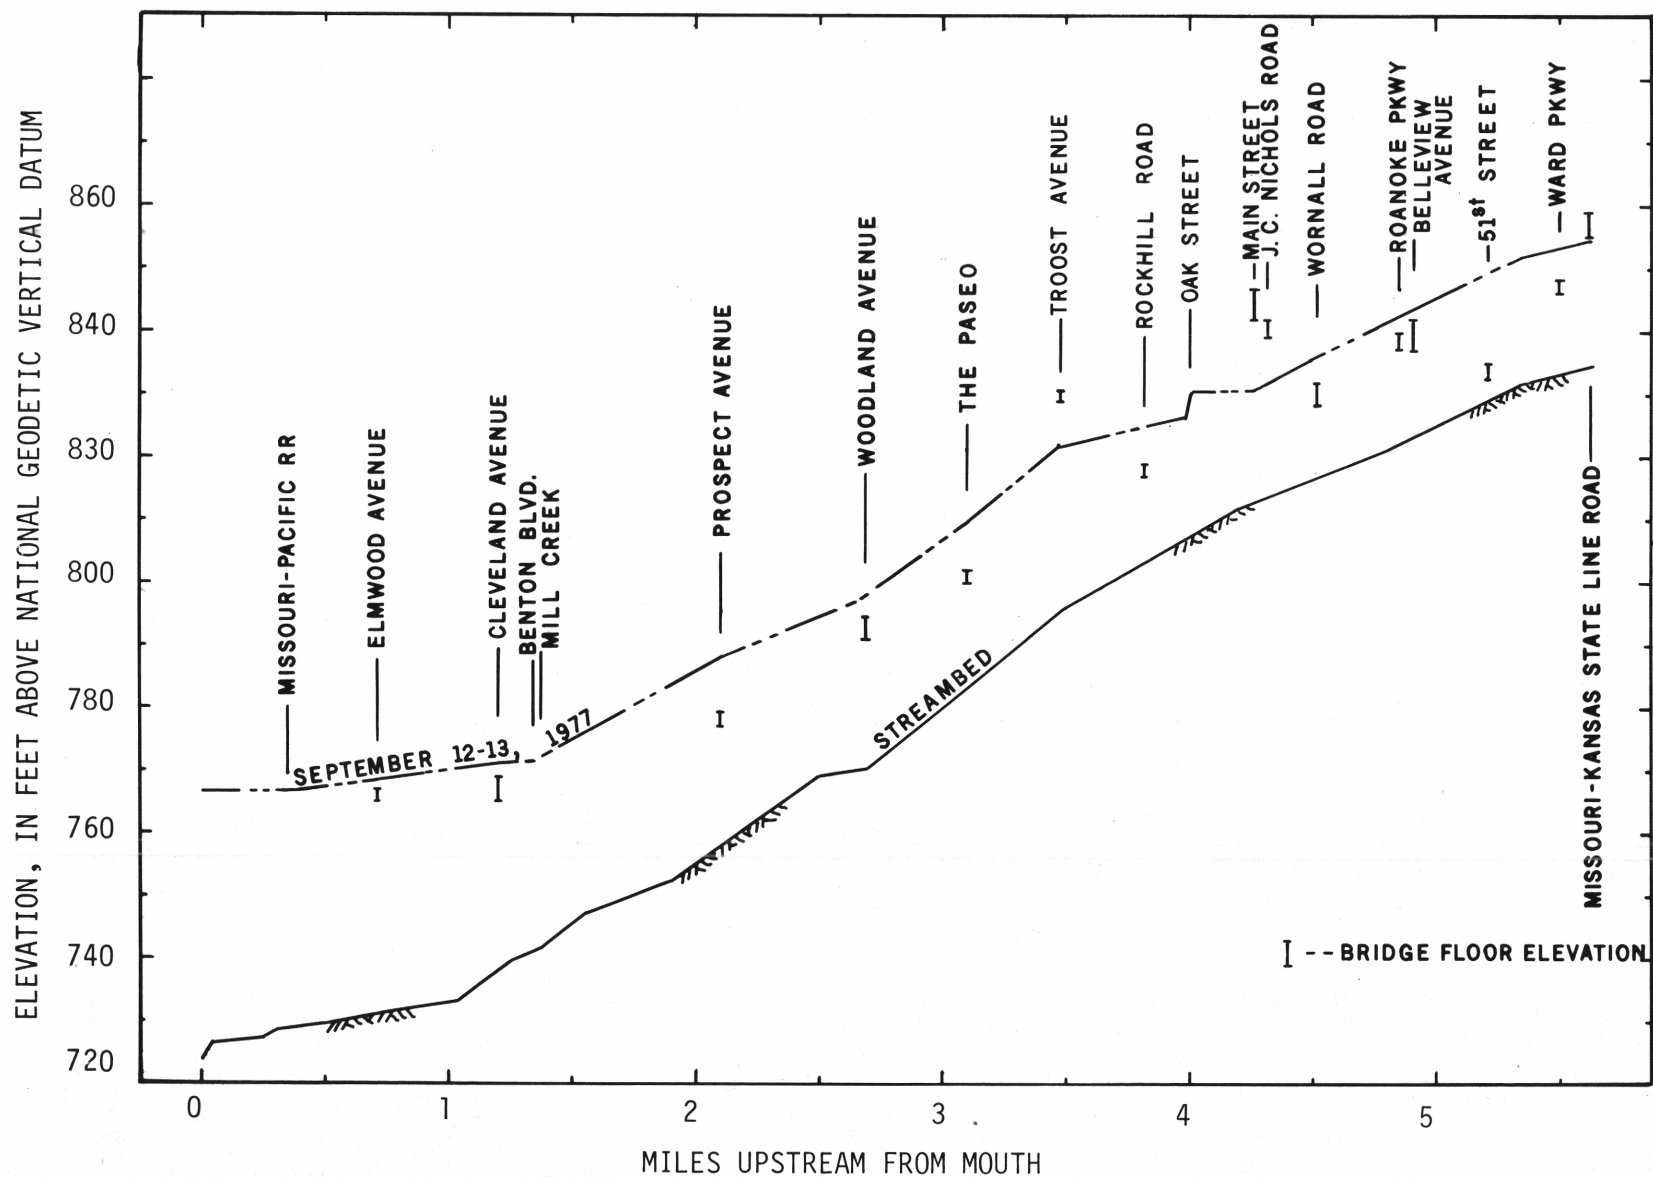
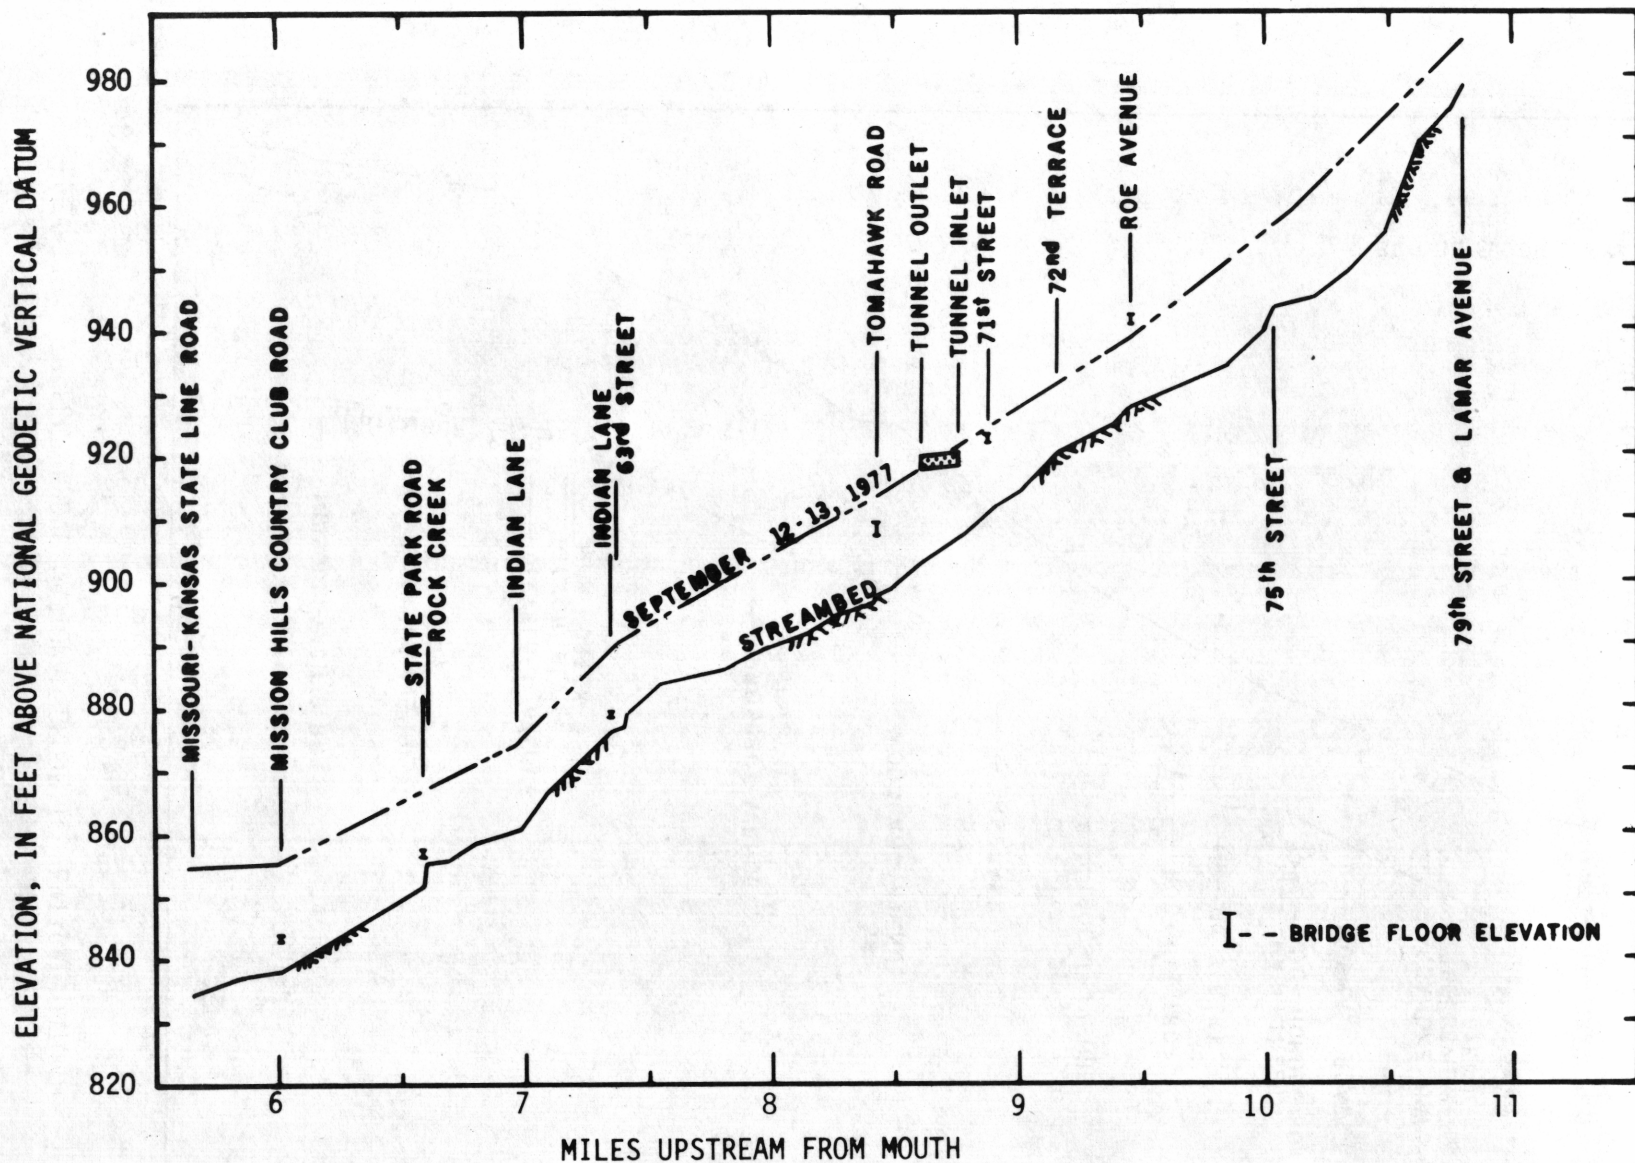
Water-surface profiles of the flood on Blue River, Brush Creek, Rock Creek (Kansas), and Little Blue River are shown in figures 11 to 14. Where information is available, elevation of bridge floors is shown to indicate road overflow. The profile of the flood of September 1961 on the Blue River is shown for comparison (fig. 11). The effect of inflow from Brush Creek at mile 11.8 is evident. Flood boundaries along streams discussed in this report are available at the office of the U.S. Army Corps of Engineers, in Kansas City, Mo.

Figure 12.--Profile of water surface of Brush Creek, flood of September 12-13, 1977.

Figure 12.--Profile of water surface of Brush Creek, flood of September 12-13, 1977--continued

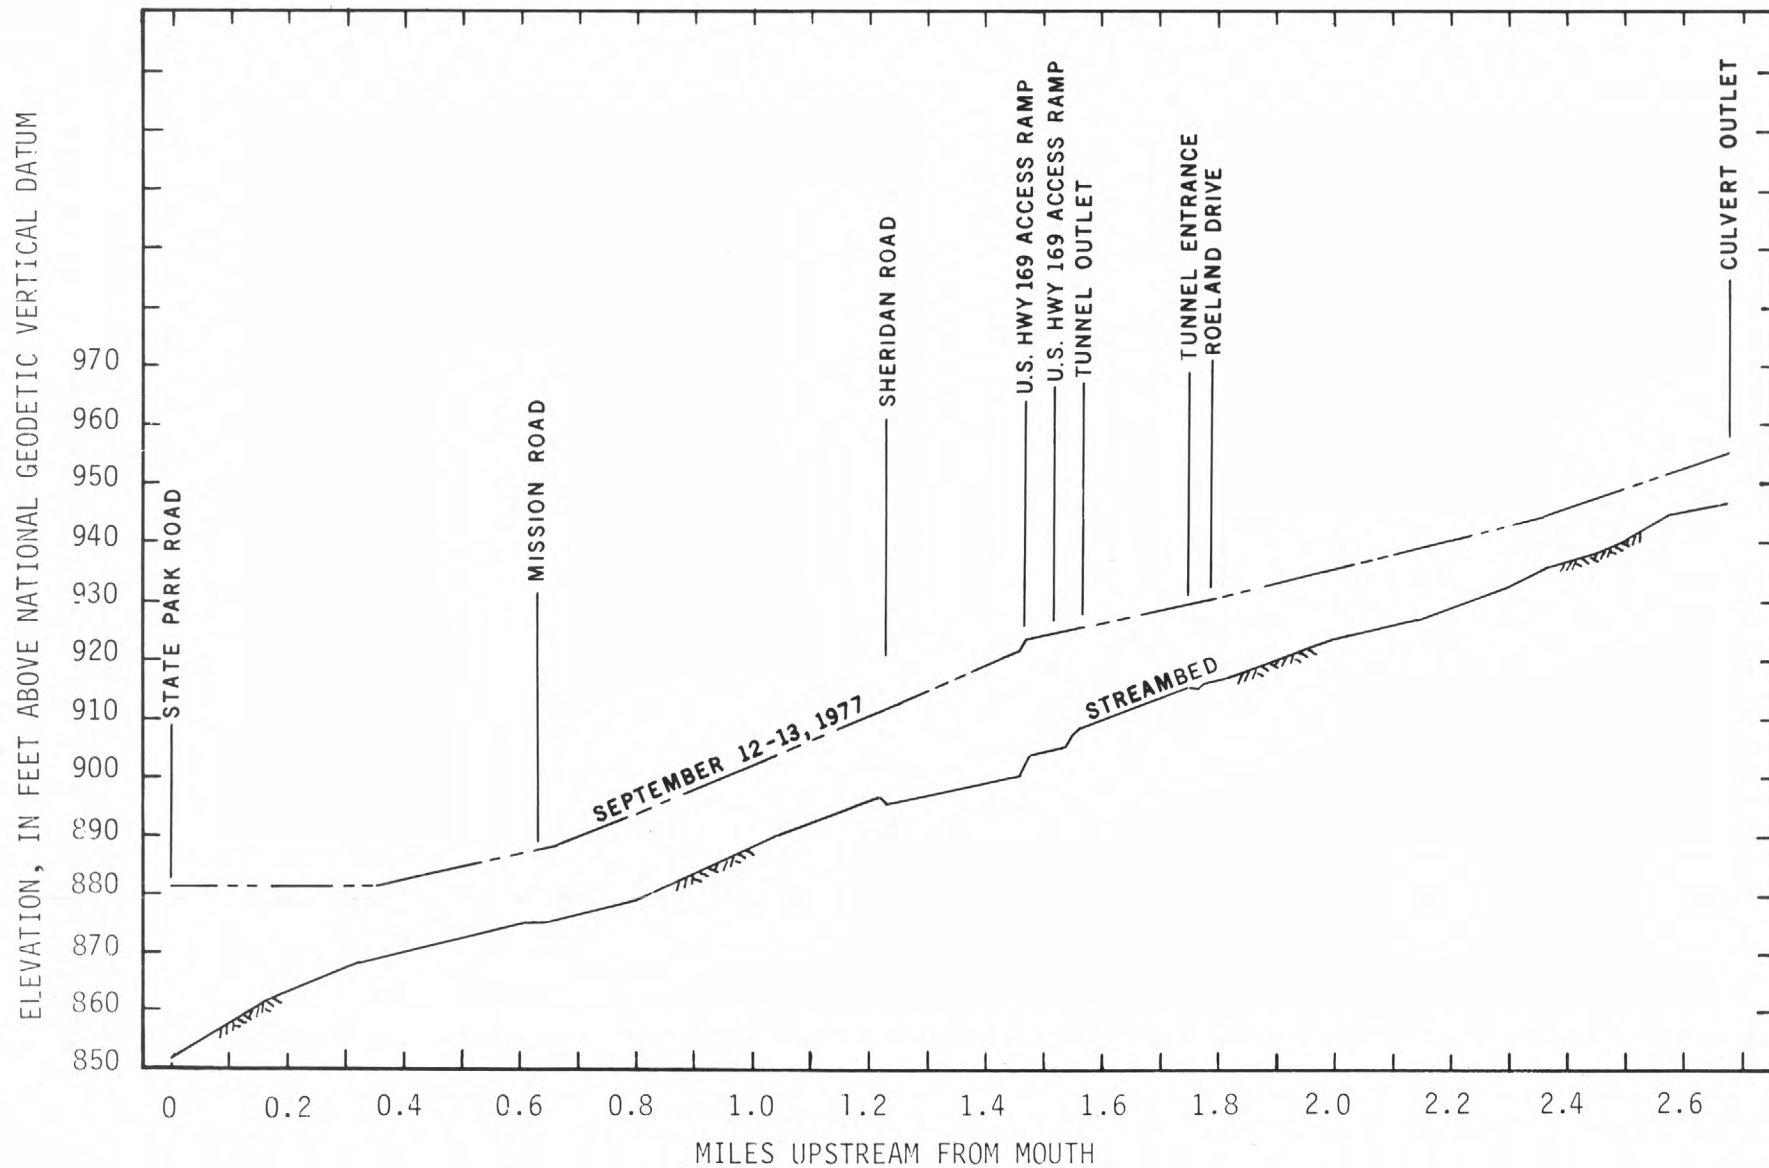
Figure 13.--Profile of water surface of Rock Creek (Kansas), flood of September 12-13, 1977.

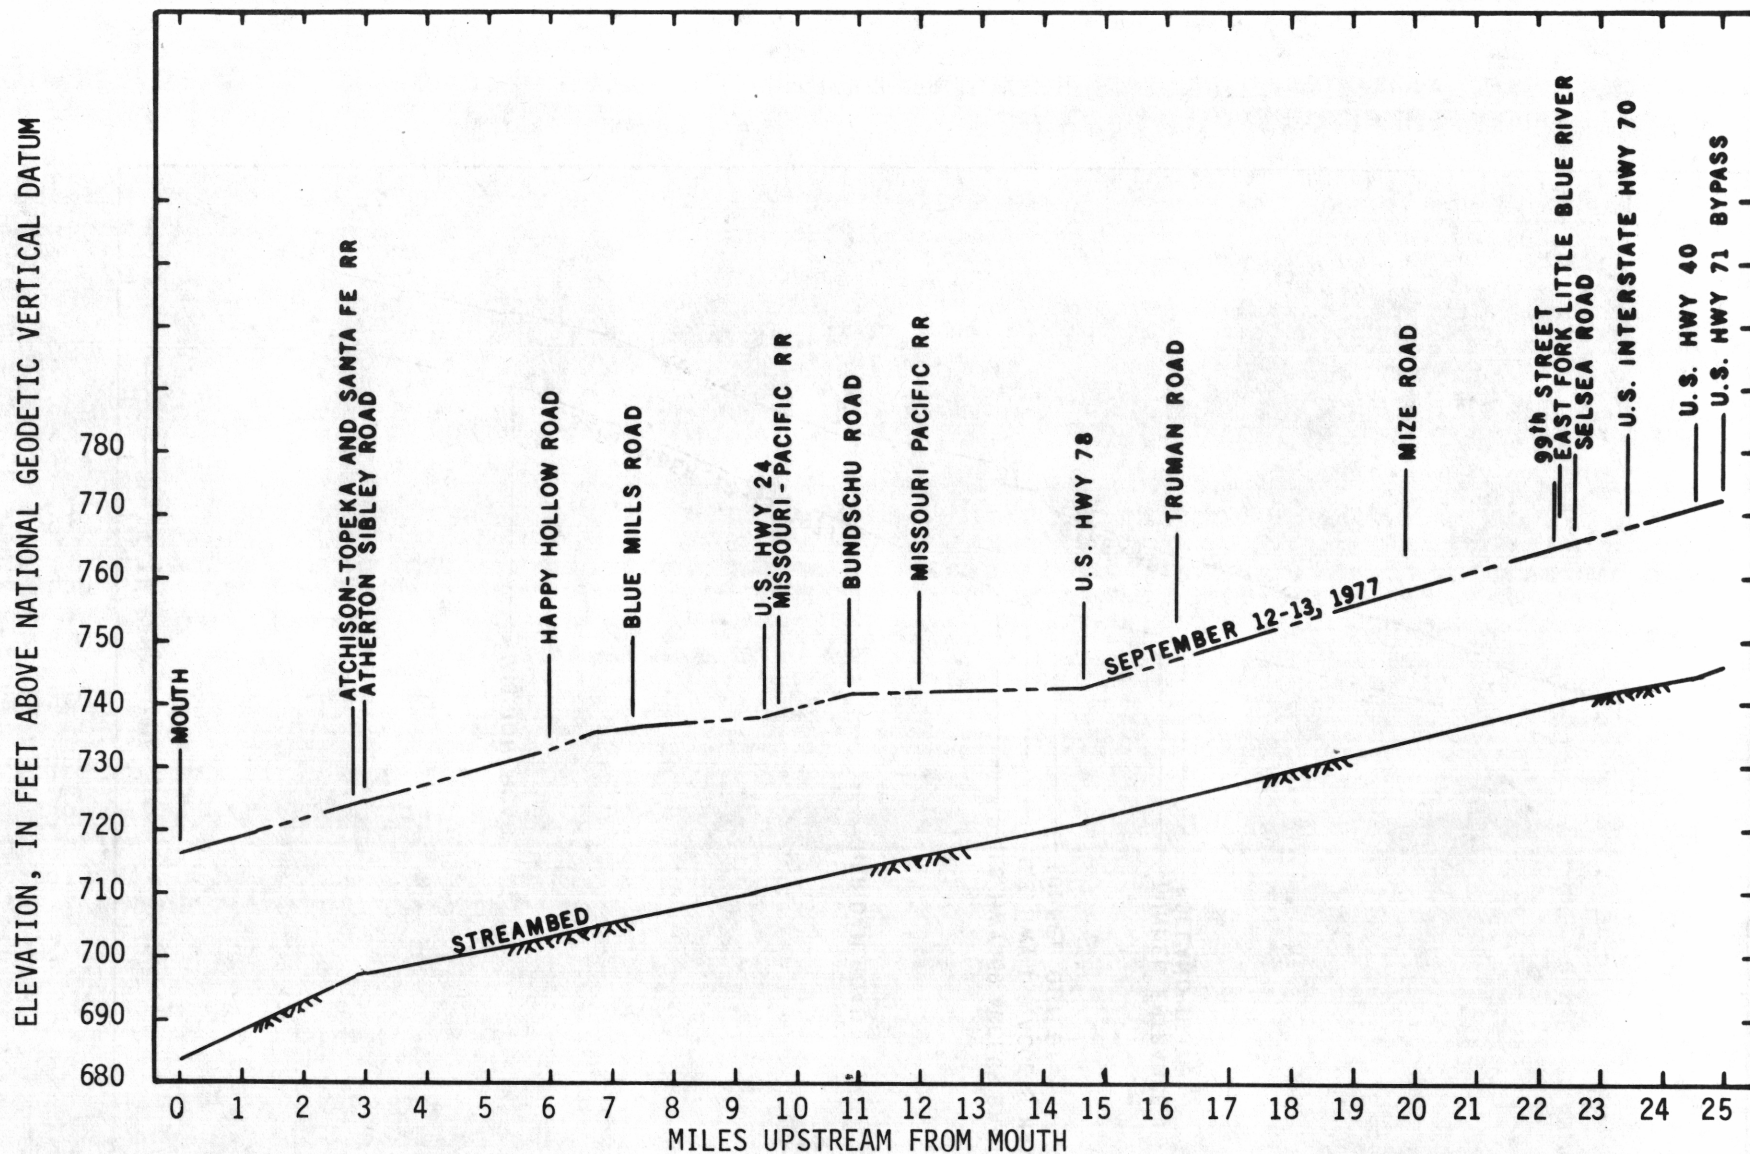
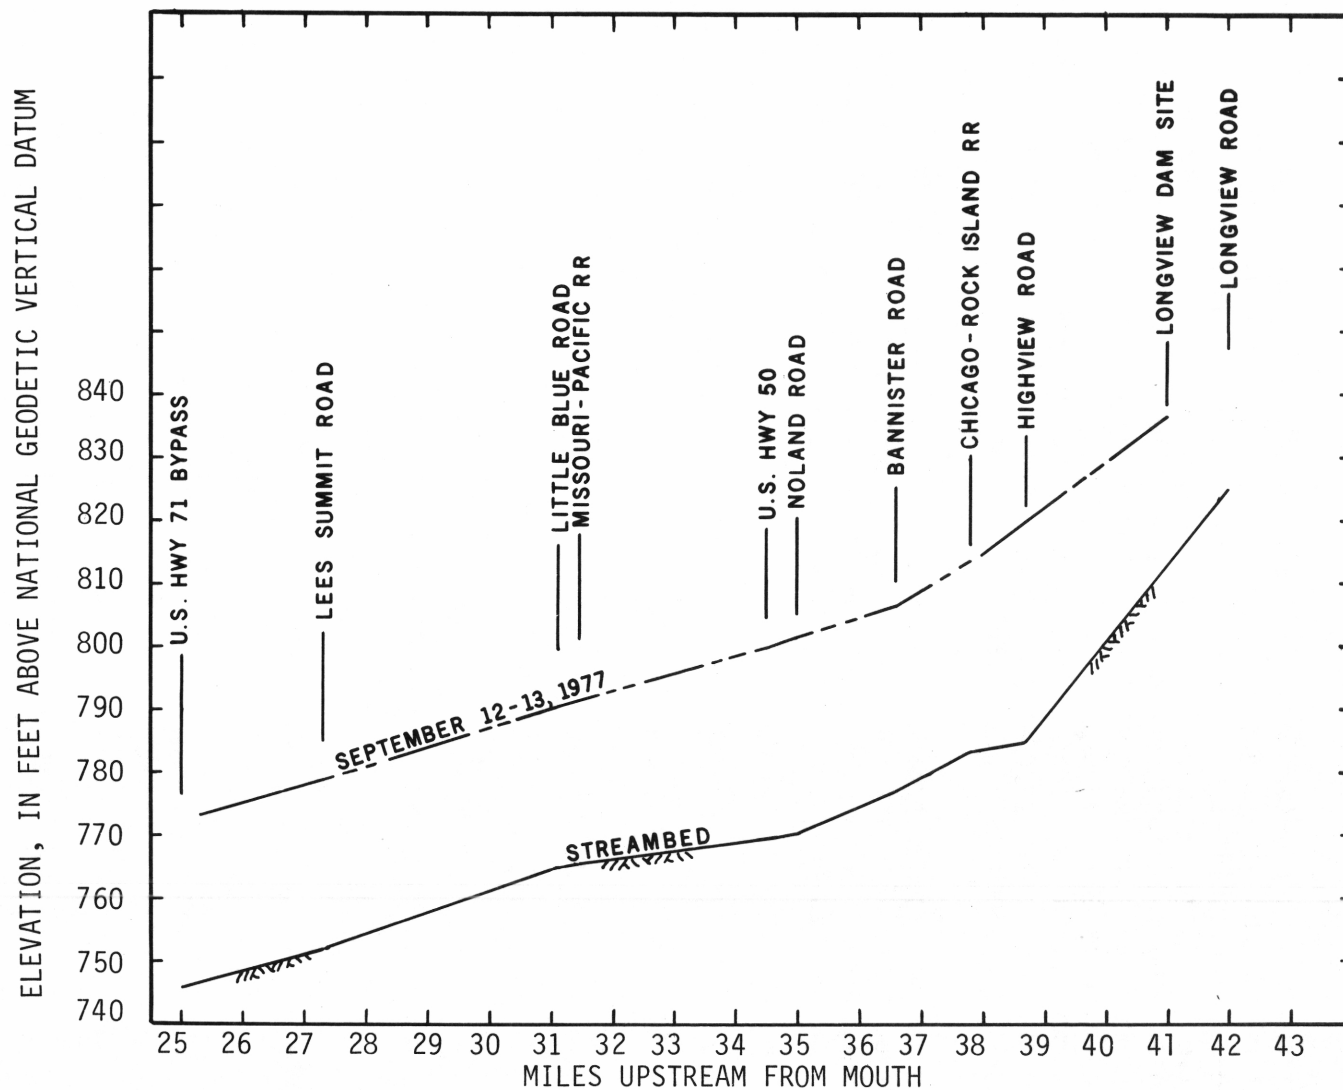
Figure 14.--Profile of water surface of Little Blue River,
flood of September 12-13, 1977.

Figure 14.--Profile of water surface of Little Blue River, flood of September 12-13, 1977--continued.

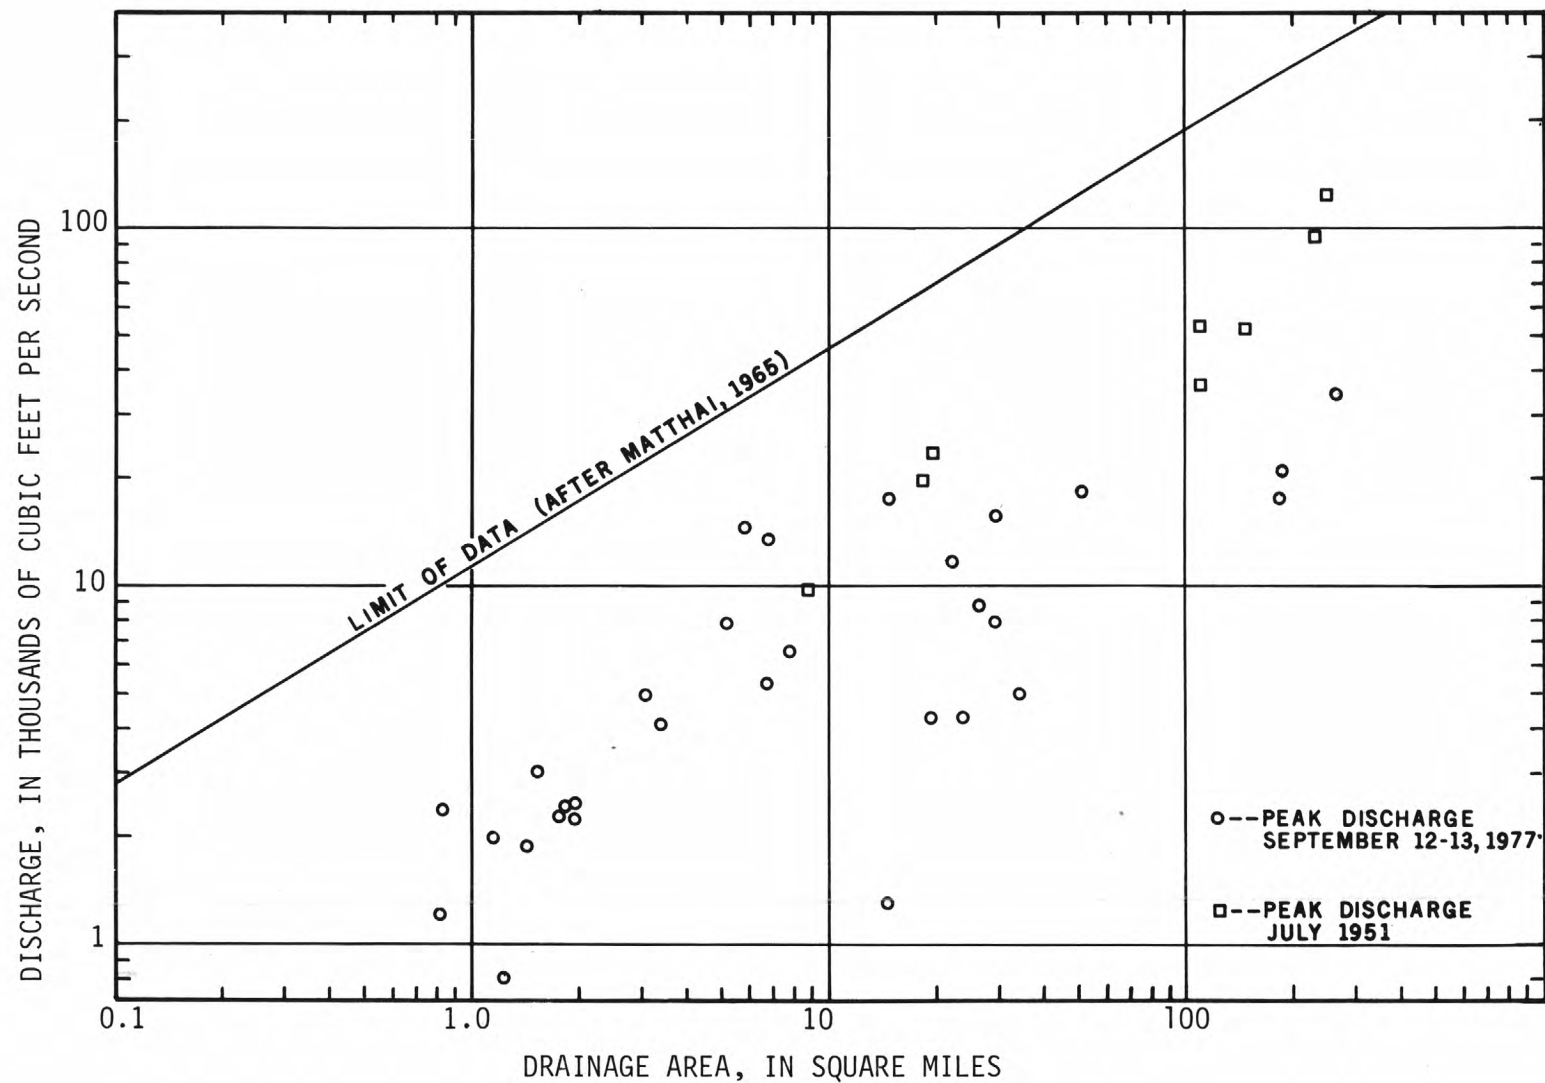
Peak discharges of the September 1977 flood, together with peak discharges of the July 1951 flood in Missouri and Kansas (U.S. Geol. Survey, 1952, p. 199), are plotted against their respective drainage areas in figure 16 for comparison with previous maximum discharges known in the United States. A curve developed by Matthai (1965) on basis of maximum floods known in the United States defines the approximate upper limit of known floods in 1965 (fig. 16). Peak discharges encountered in the September 1977 flood do not approach the maximum flood experience defined by Matthai. Curve values are more than double the highest peak flows of September 12-13, 1977.

Figure 16.--Comparison of September 12-13, 1977, peak discharges to upper limit of known floods in the United States.
