Man-Induced Channel Adjustment in Tennessee Streams

U.S. GEOLOGICAL SURVEY

Water-Resources Investigations Report 82-4098

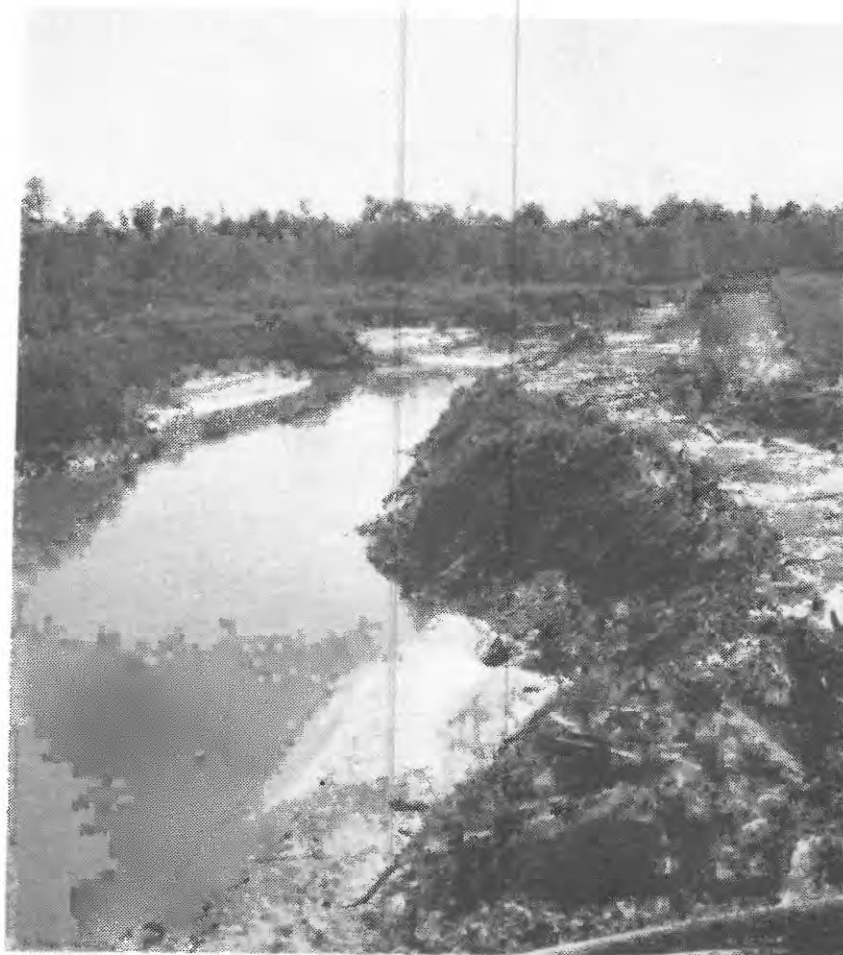
Figure 28. -- South Fork Forked Deer River at new U.S. 51 bridge.
View is upstream from bridge, October 10, 1974.

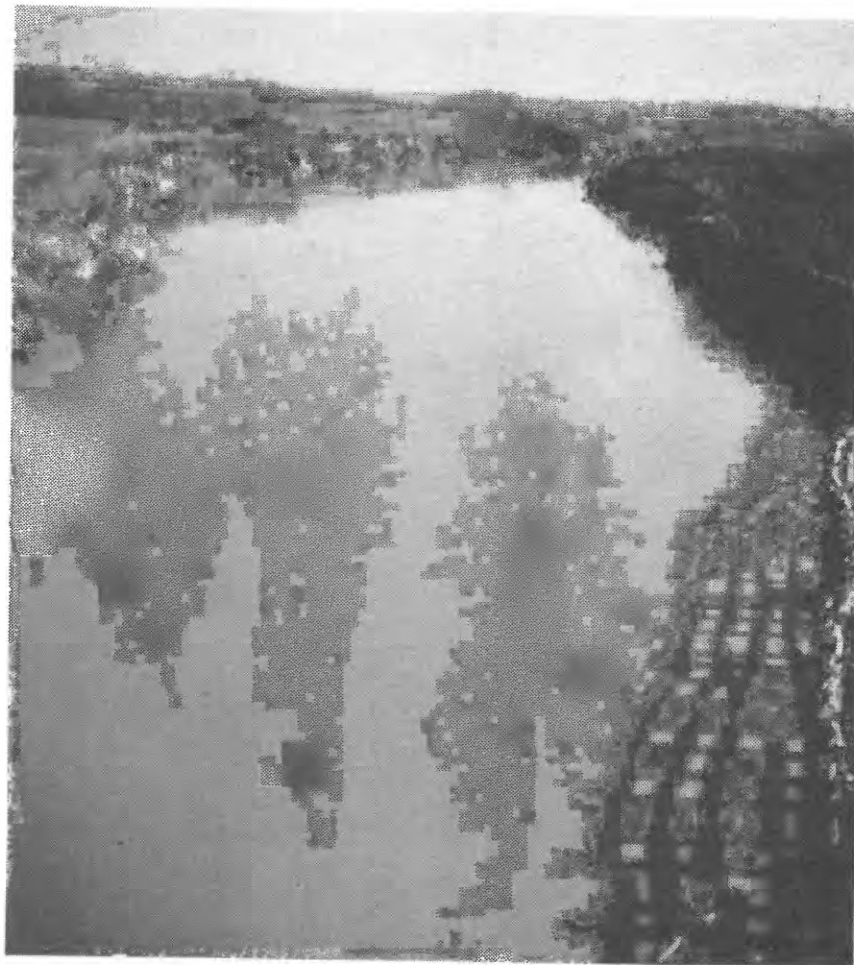
Figure 29. -- South Fork Forked Deer River at new U.S. 51 bridge.
View is upstream from bridge, March 9, 1981.

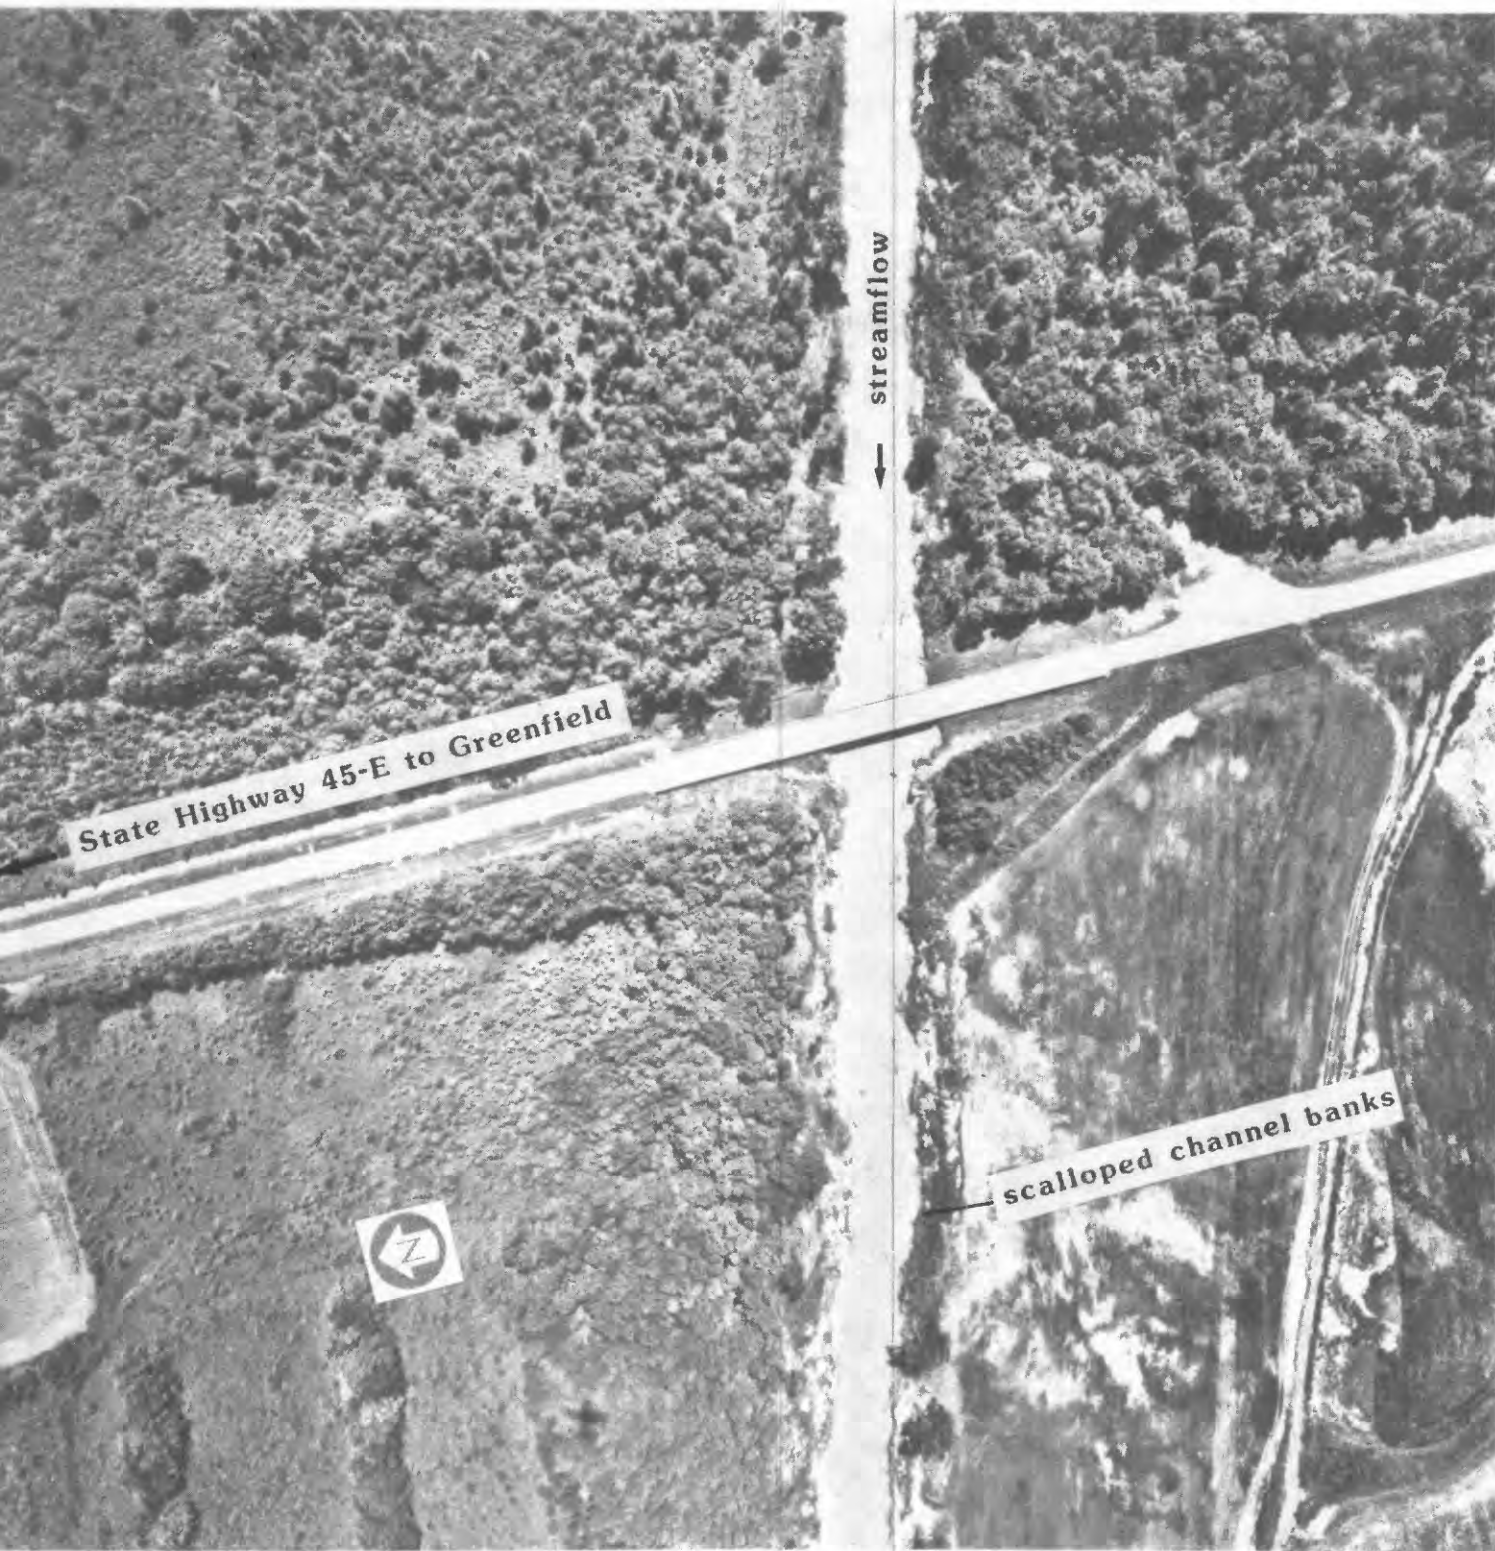
Figure 43. -- Aerial photograph of South Fork Obion River at State Highway 45-E near Greenfield, Tennessee, showing channel instability on July 31, 1979.

was partly due to the bank clearing. An aerial photograph of the South Fork Obion River at Highway 45-E, as of July 1979, is shown in figure 43. The scalloped channel banks, most prominent downstream of the bridge, are an indication of large-scale channel instability.

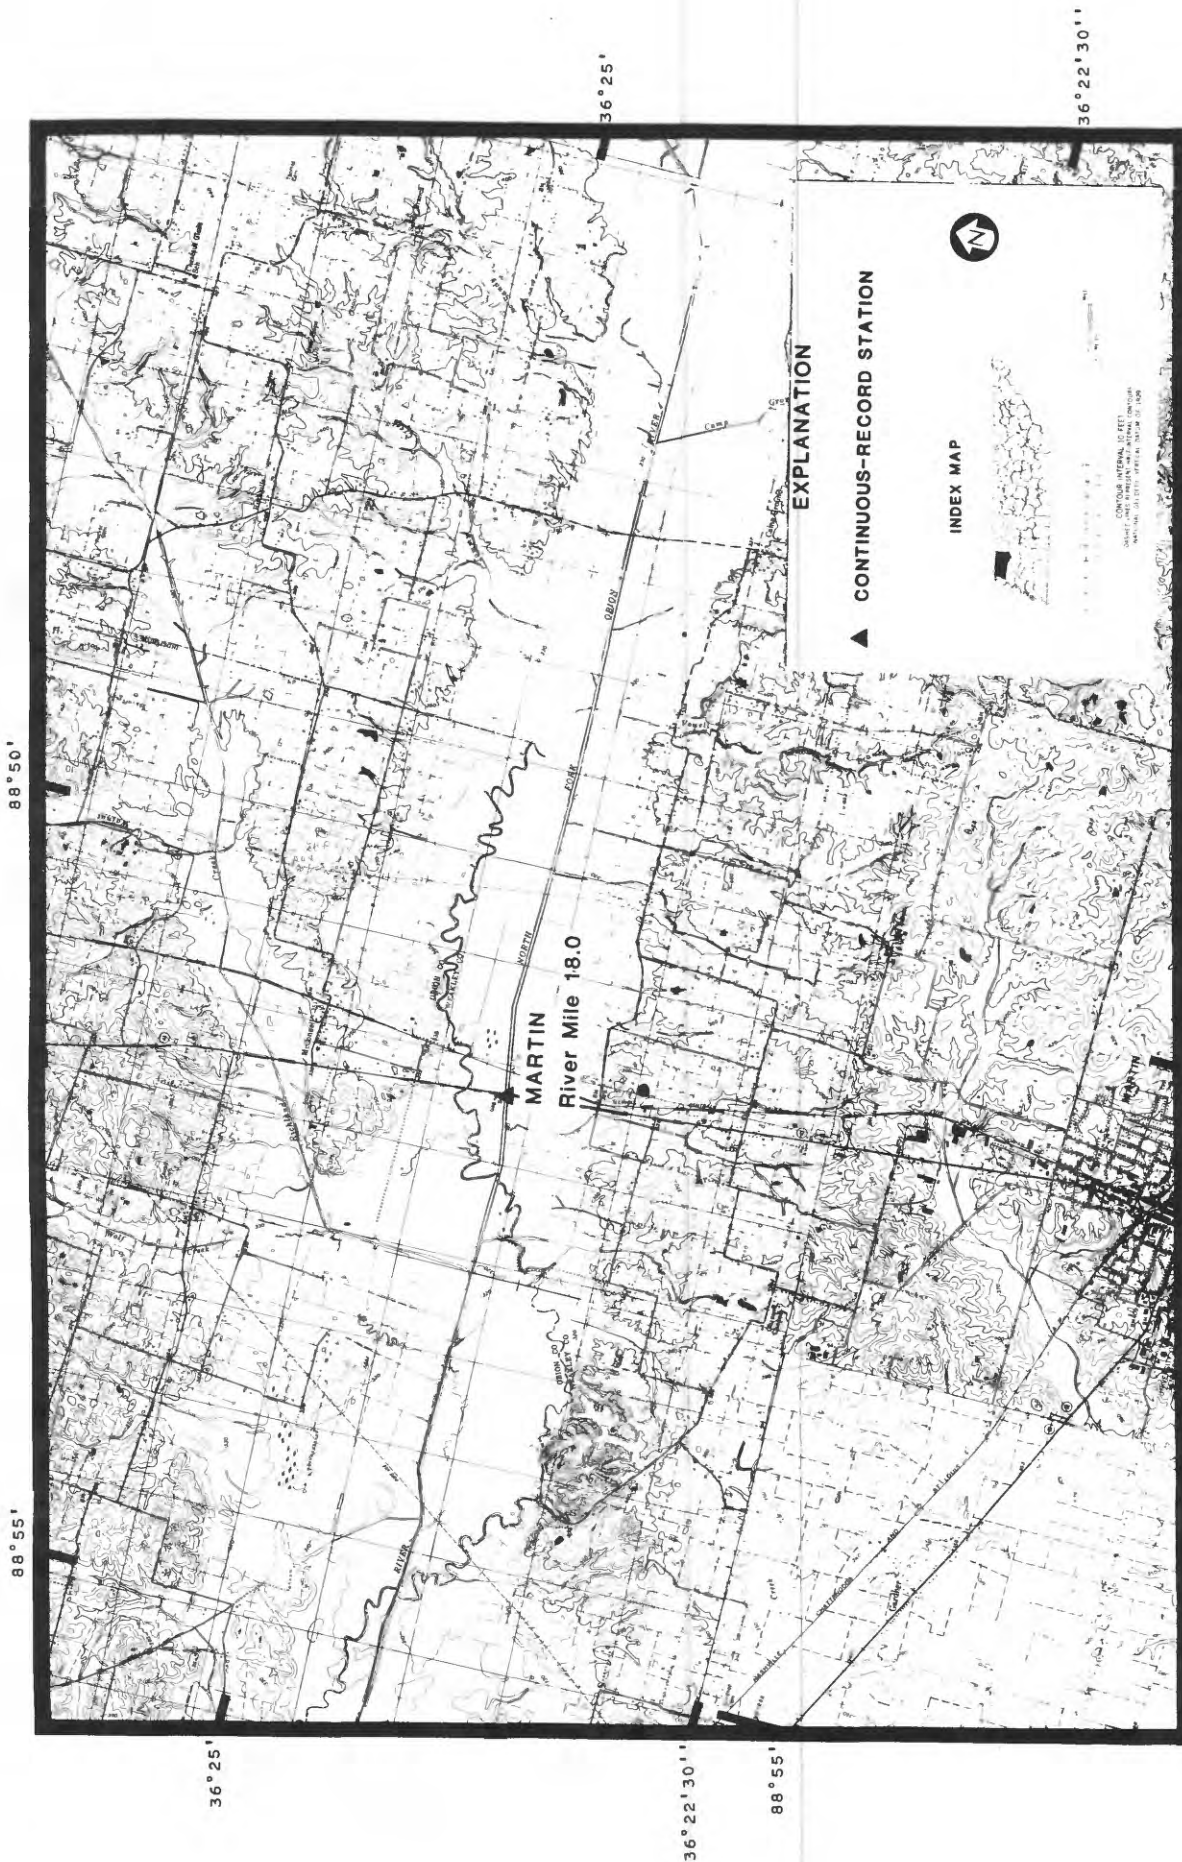
Figure 45.--Location of Martin gaging station in middle part of North Fork Obion River, Tennessee.

Prior to channelization, the North Fork Obion River in the study reach (river miles 5.9 to 34.9) followed a sinuous course in a flood plain ranging in width from approximately 1.0 miles at the upstream end of the study reach to approximately 2.0 miles at the downstream end (figs. 44, 45, and 46).

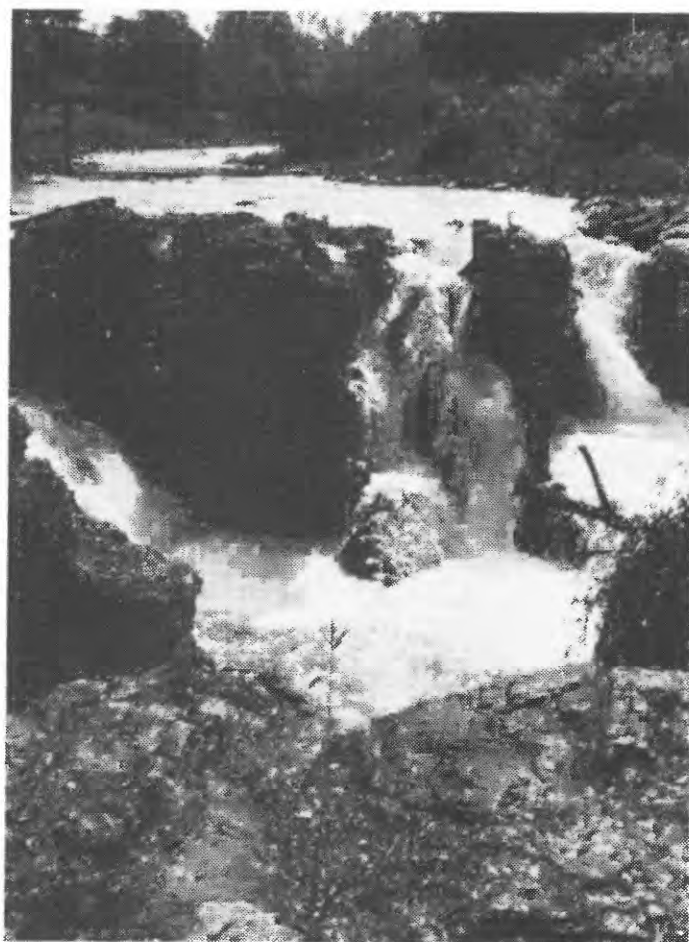
Figure 64. -- North Indian Creek at Erwin, Tennessee. View is upstream at falls and bridge from right bank, July 1, 1976.

By May 1974, the knickpoint had moved upstream to river mile 2.30 at a rate of approximately 543 feet per year. The erosion increased the channel gradient to 2.76×10^{-2} ft/ft (168 percent increase) between river miles 1.98 and 2.30, and reduced the channel gradient to 6.15×10^{-4} ft/ft (94 percent decrease) between river miles 1.36 and 1.98. By July 1, 1976, the knickpoint had moved upstream an additional 75 feet to river mile 2.32. Figure 64 is a picture of the knickpoint as it appeared on July 1, 1976. On November 6, 1977, a flood of approximately 3,500 ft³/s occurred, and on November 29, 1977, another profile was surveyed (fig. 63) and another picture was taken (fig. 65). The knickpoint had moved an additional 138 feet upstream and flattened somewhat since July 1, 1976 (fig. 65). A fifth profile was surveyed and pictures were taken on April 18, 1978, and as illustrated in figures 63, 66, and 67, the knickpoint had proceeded another 650 feet upstream. The basic shape of the knickpoint was maintained throughout its propagation upstream because of the nature of material through which the knickpoint was moving. This knickpoint differs in shape and rate of propagation from the adjustments documented in west Tennessee channels.

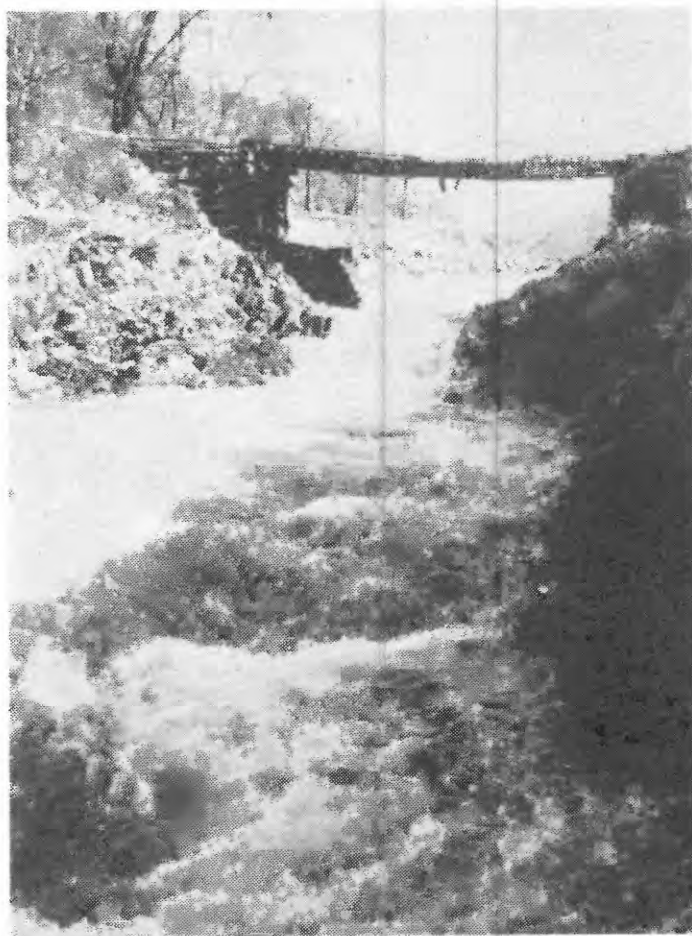
Figure 65. -- North Indian Creek at Erwin, Tennessee. View is upstream at falls and bridge from right bank, November 9, 1977.

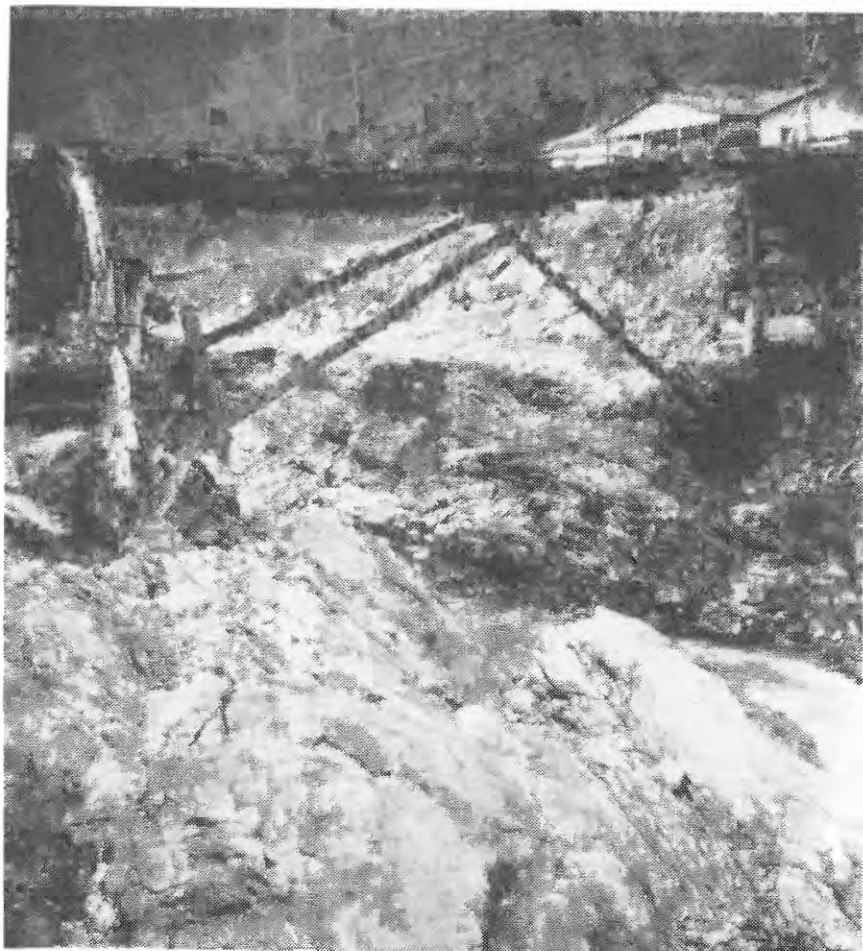
Figure 66. -- North Indian Creek at Erwin, Tennessee View
is downstream from left bank, April 18, 1978.

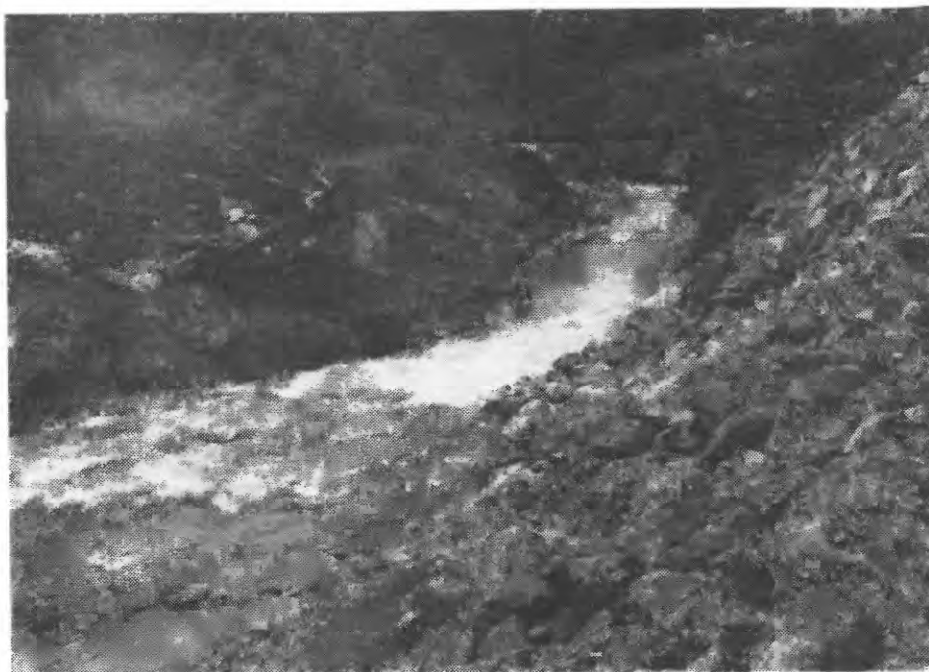
Figure 69. -- North Indian Creek at Erwin, Tennessee. View is downstream at old bridge location from right bank, May 1981.

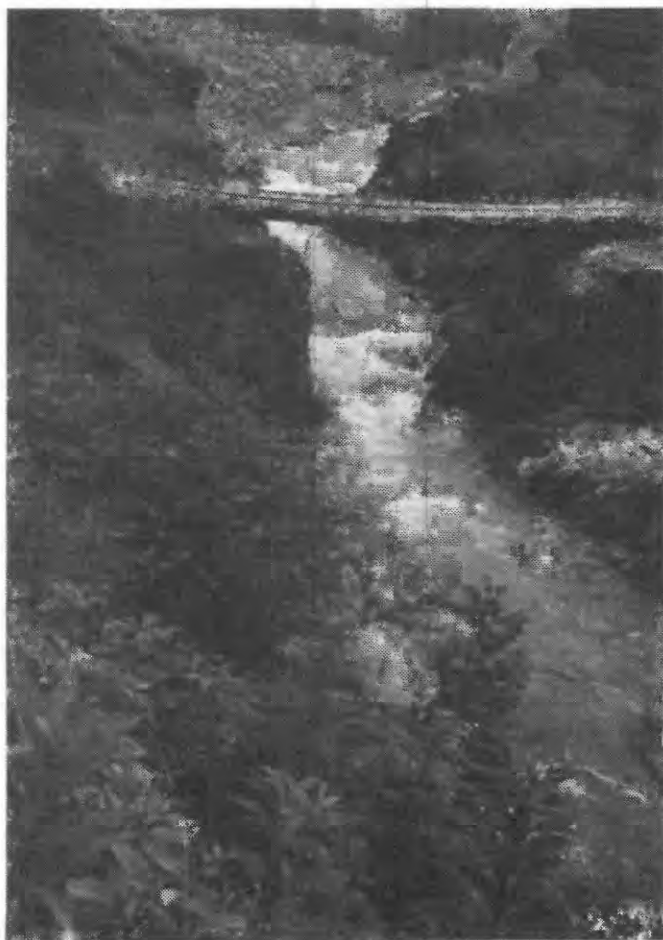
Figure 70. -- North Indian Creek at Erwin, Tennessee. View is upstream at old bridge location and new valley conditions, May 1981.
