**RECONNAISSANCE OF SURFACE-WATER RESOURCES
IN THE KOBUK RIVER BASIN, ALASKA, 1979-80**

U. S. GEOLOGICAL SURVEY
WATER-RESOURCES INVESTIGATIONS REPORT 83-4027

Prepared in cooperation with
ALASKA DEPARTMENT OF NATURAL RESOURCES
DIVISION OF GEOLOGICAL AND GEOPHYSICAL SURVEYS

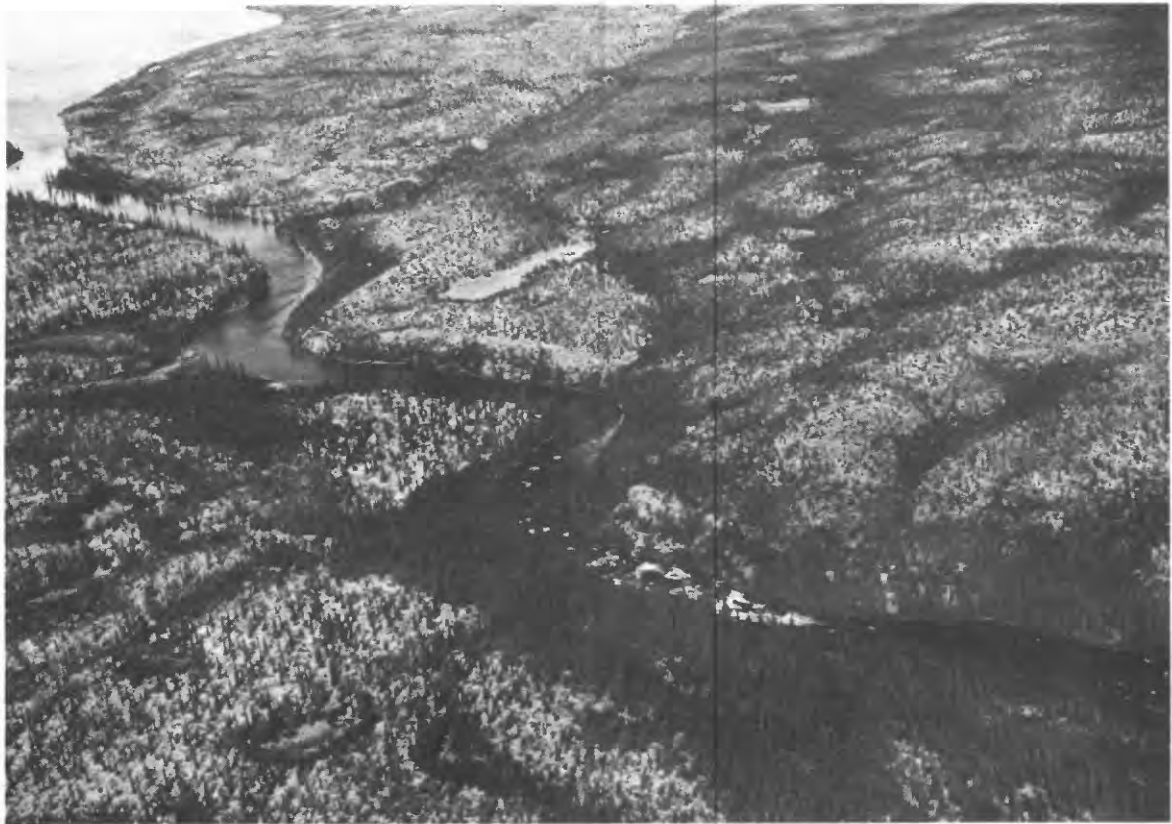
Figure 6.--Aerial photograph of Walker Lake outlet, June 1, 1979. Stream about 50 feet wide at rapids in lower center of photograph. See figure 7 for close-up of rapids.

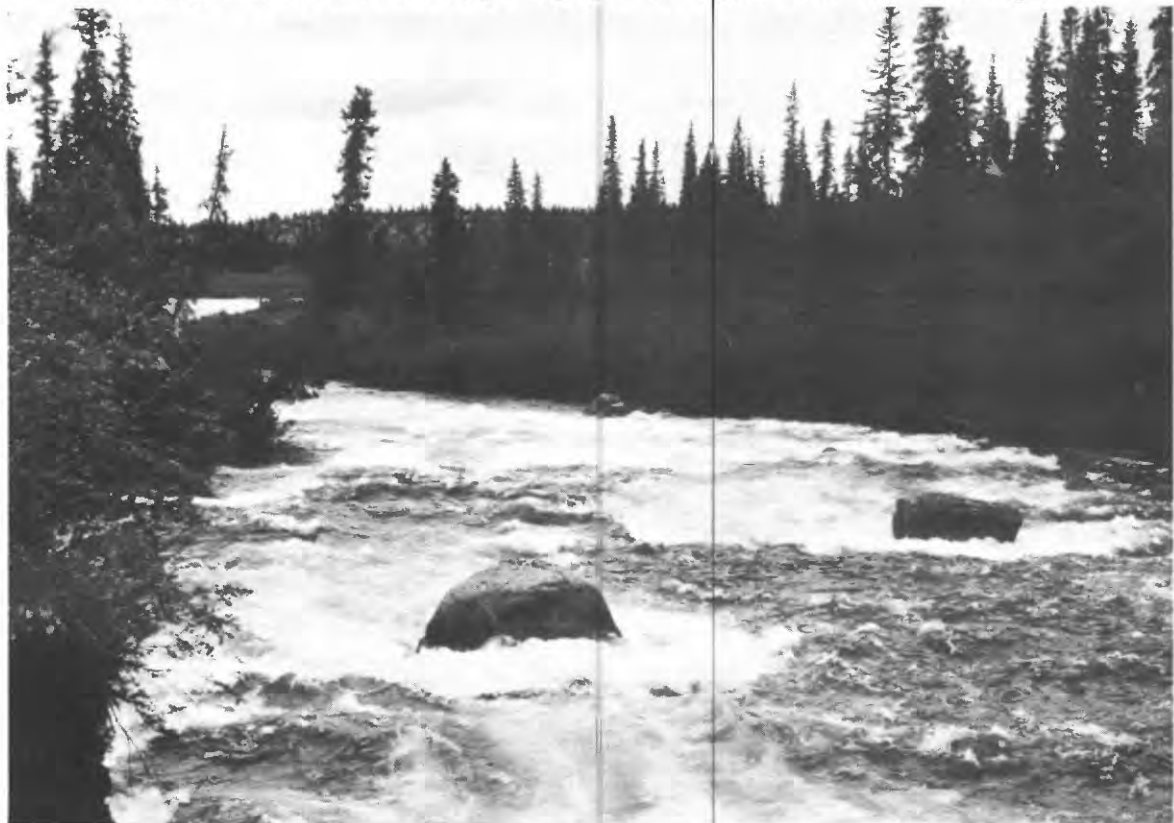
Figure 7.--Walker Lake outlet, August 11, 1979; view downstream from left bank.

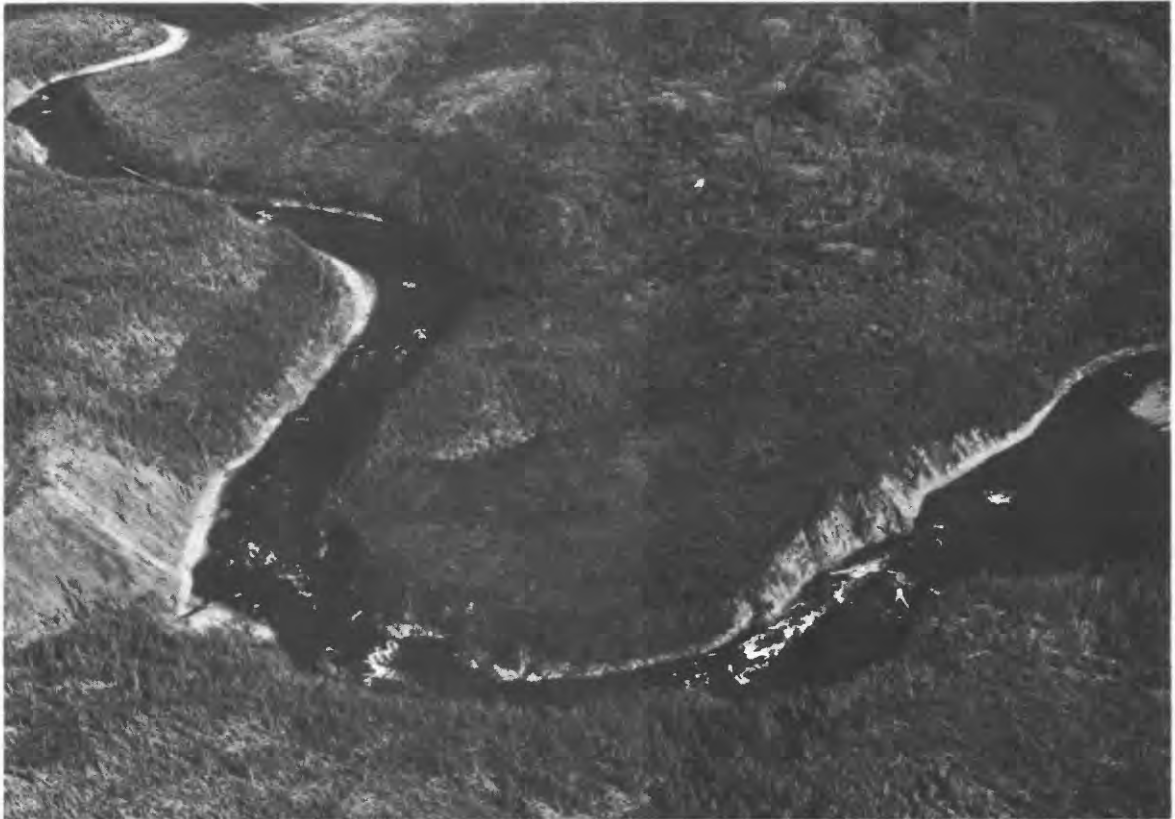
Figure 8.--Aerial photograph of Lower Kobuk Canyon rapids, June 1, 1979. Stream width about 300 feet in area of rapids, lower right-hand portion of photograph.

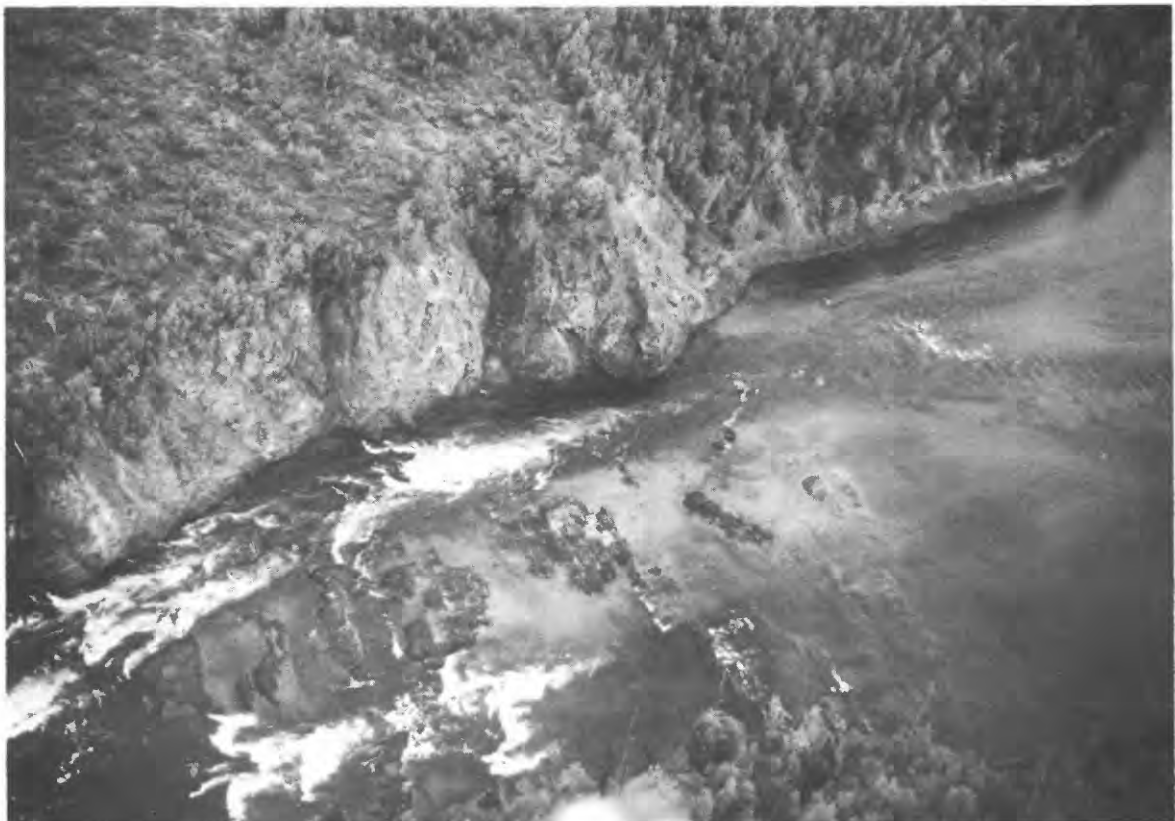
Figure 9.--Close-up aerial photograph of Lower Kobuk Canyon rapids, August 14, 1979.

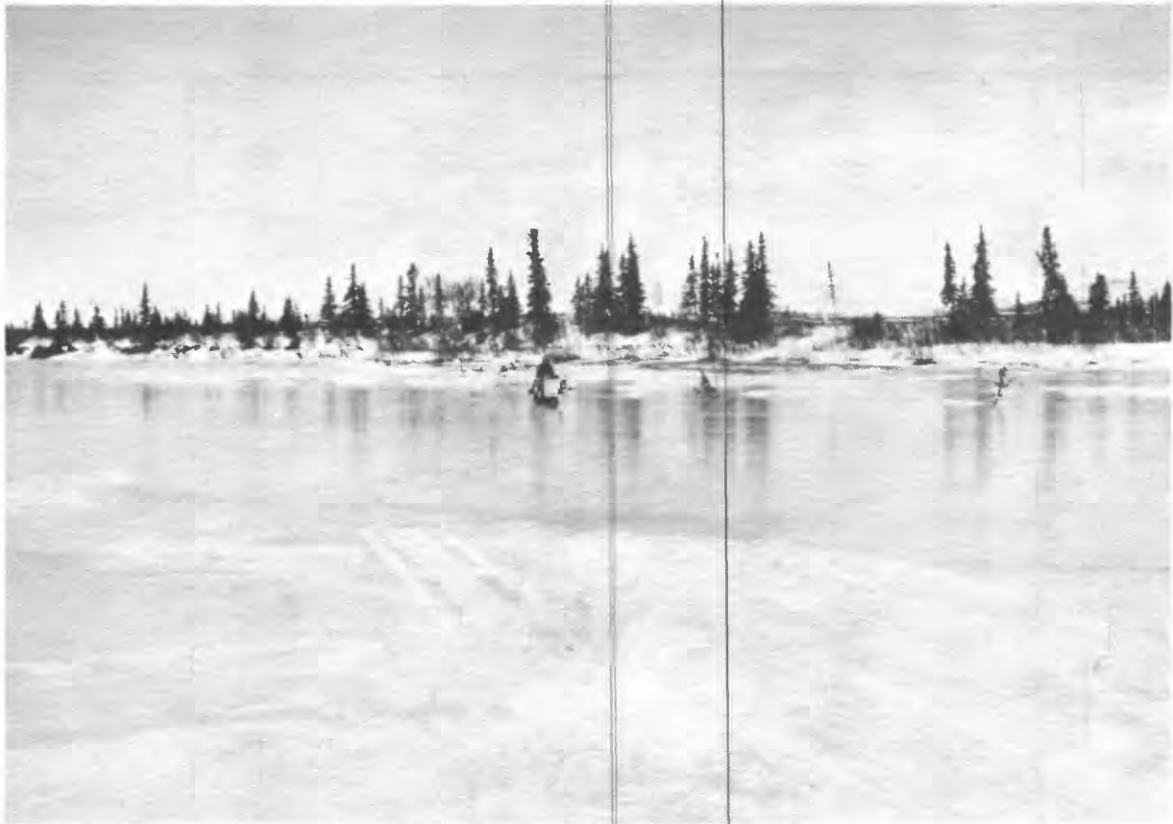
Figure 11.--Overflow ice on Shungnak River near Shungnak, April 4, 1980.

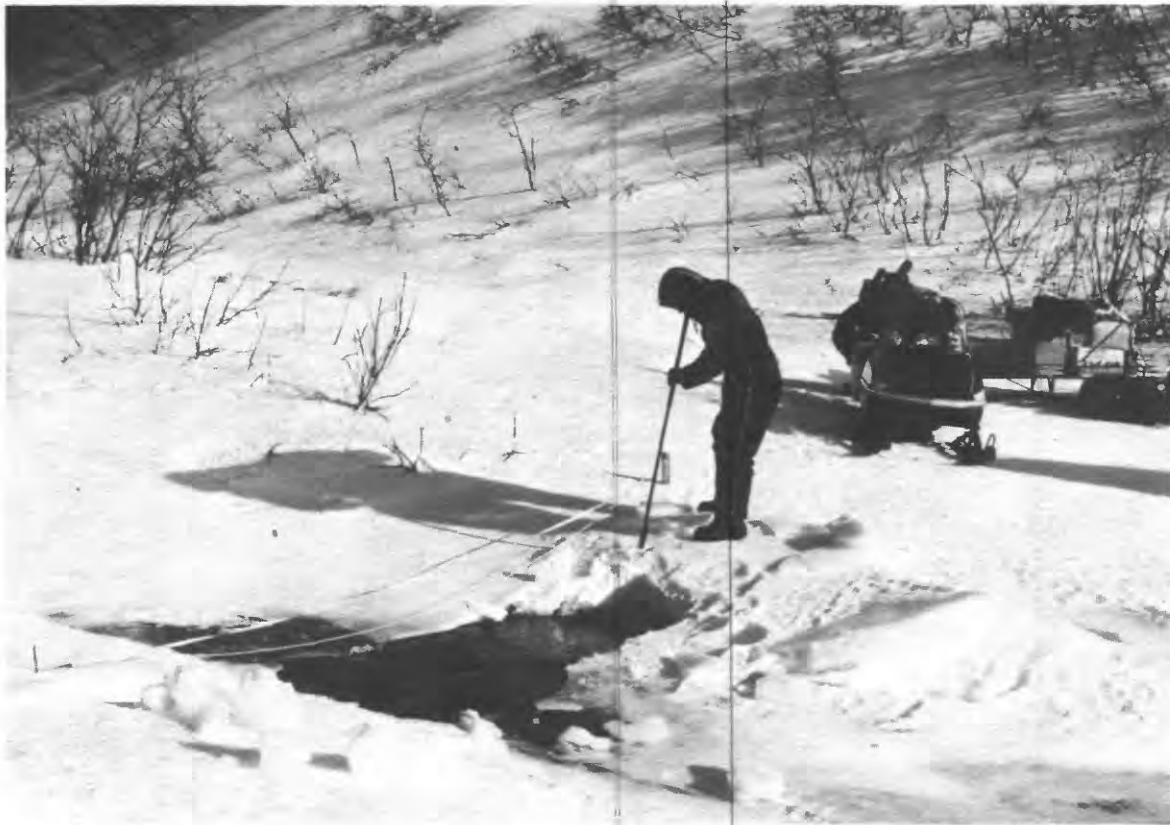
Figure 12.--Canyon Creek near Kiana at survey site, March 23, 1980.

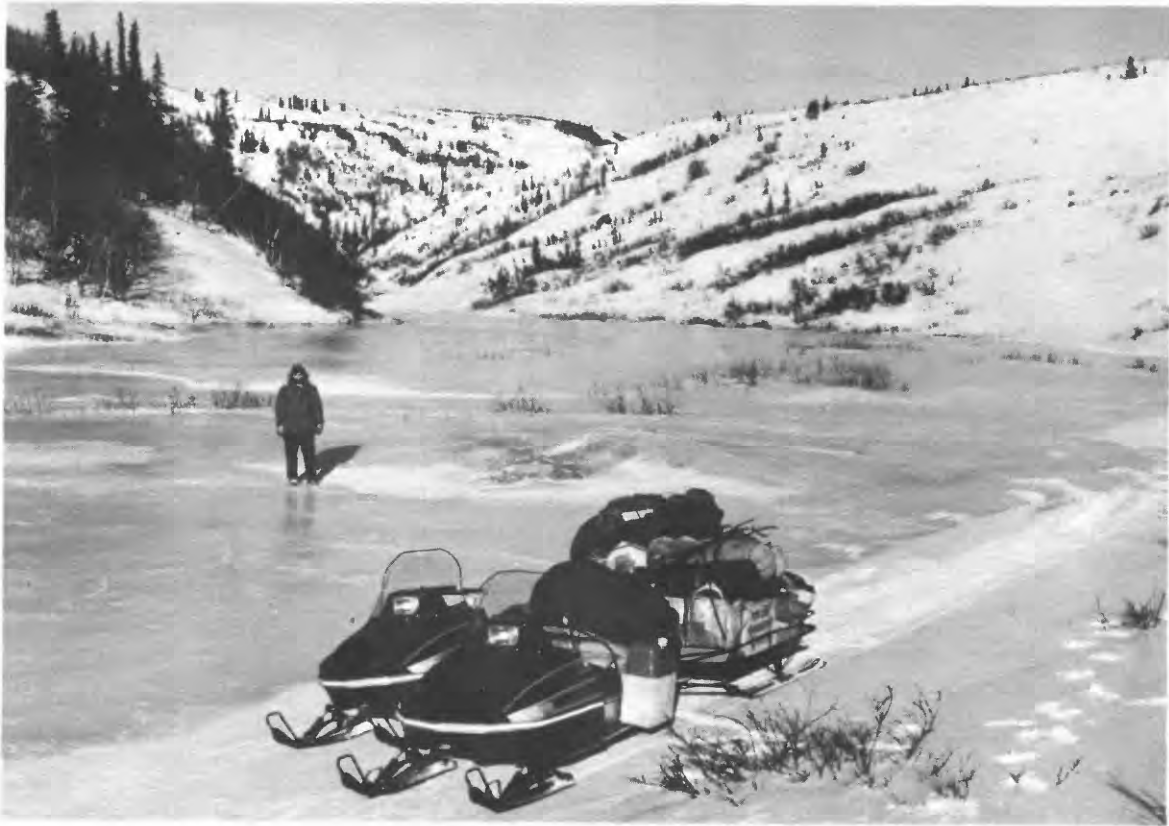
Figure 13.--Icing on Canyon Creek near Kiana, March 23, 1980.

Because of the snow-melt contributions to streamflow, discharges measured in April at the Kogoluktuk River near Kobuk (site 15) and at the Kobuk River above Kobuk (site 16) may not reflect minimum winter discharges. The minimum discharges probably occurred in late March. Overflow on the Shungnak River near Shungnak (site 21) prevented the survey party from measuring discharge (fig. 11). The discharge of Canyon Creek near Kiana (site 33) was measured in an open lead (fig. 12). Downstream from the lead the creek overflowed onto a large icing (fig. 13).

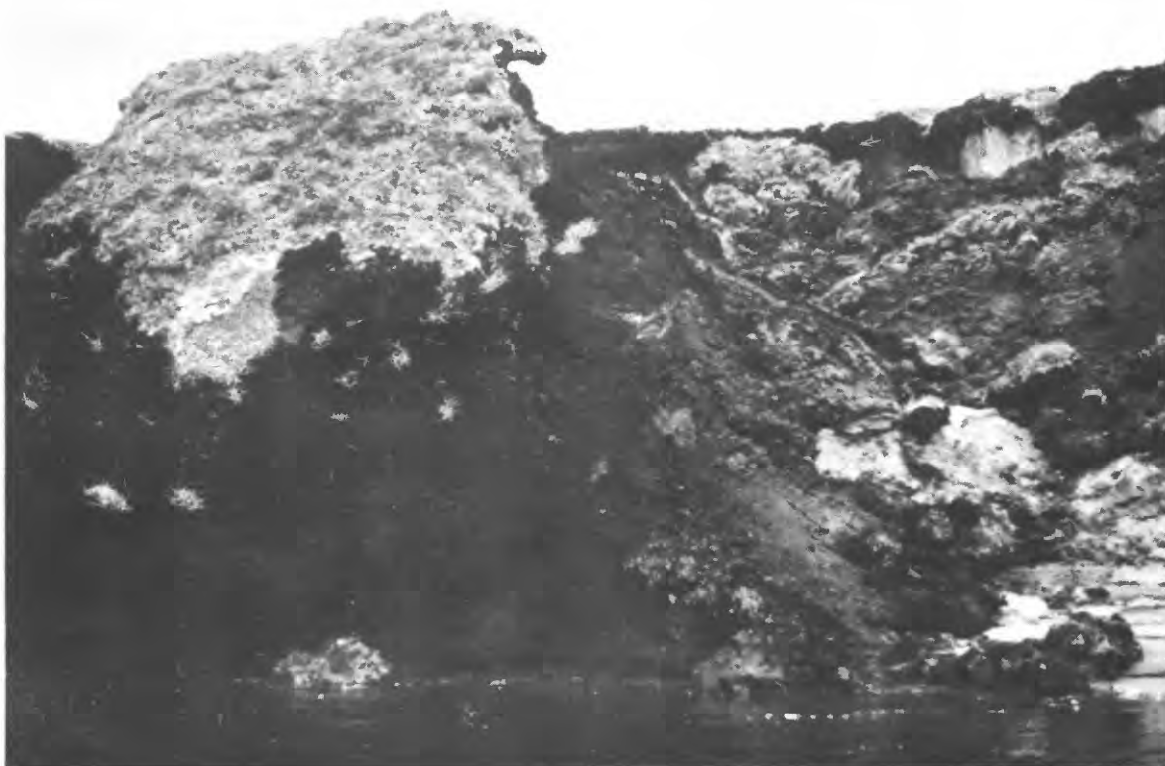
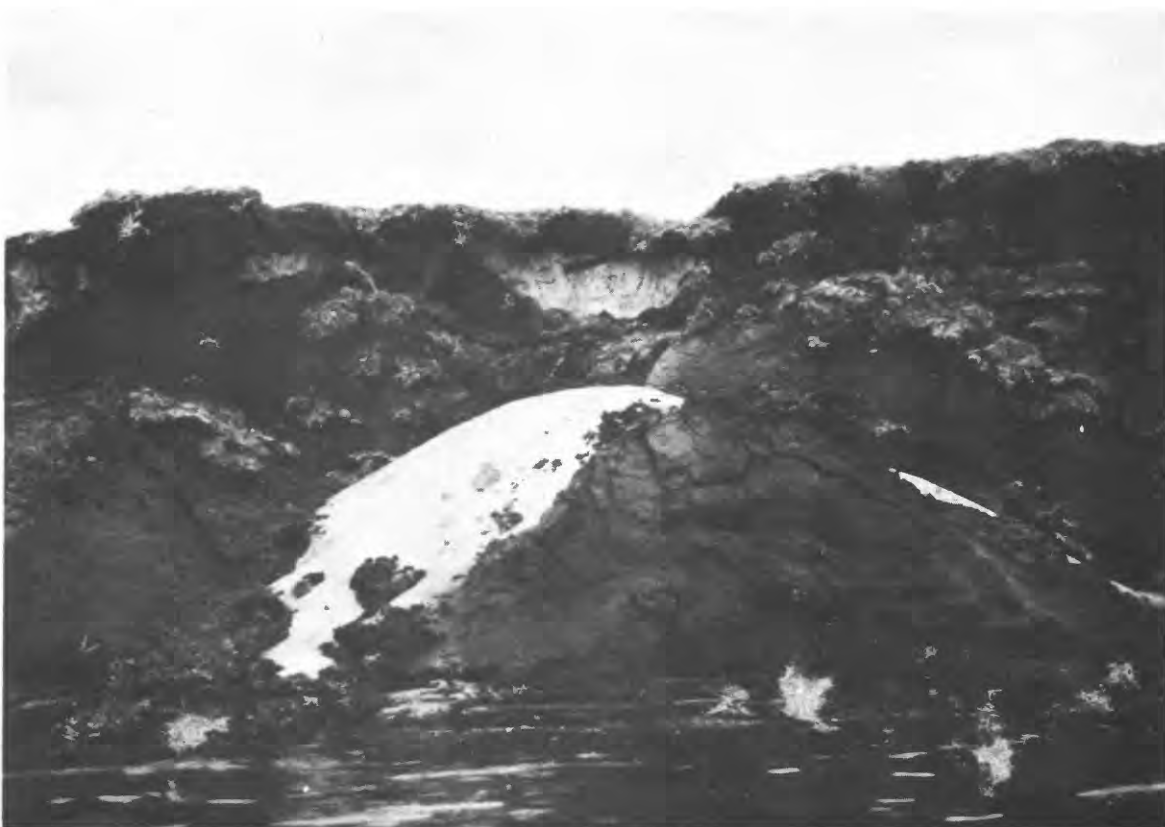
Figure 14.--Bank erosion and ice in bank along Kobuk River near Shungnak, August 26, 1979.
Banks shown are about 15 feet high.

Vegetation generally protects soils from erosion. However, many bare, high banks in the Kobuk River valley are composed of silty sands that are easily eroded during brief periods of high water. Melting of exposed permafrost can also cause erosion. When the soil-ice mass thaws, it is weakened and easily eroded by flowing water, or it may slump, sometimes as large chunks. During the August 1979 survey, the Kobuk River channel appeared to be stable at the surveyed sites and throughout most of its length. However, slumping banks and exposed ice masses were observed near Shungnak (fig. 14).
