CLARENCE H. ROBBINS, CHARLES R. GAMBLE and R. H. BINGHAM

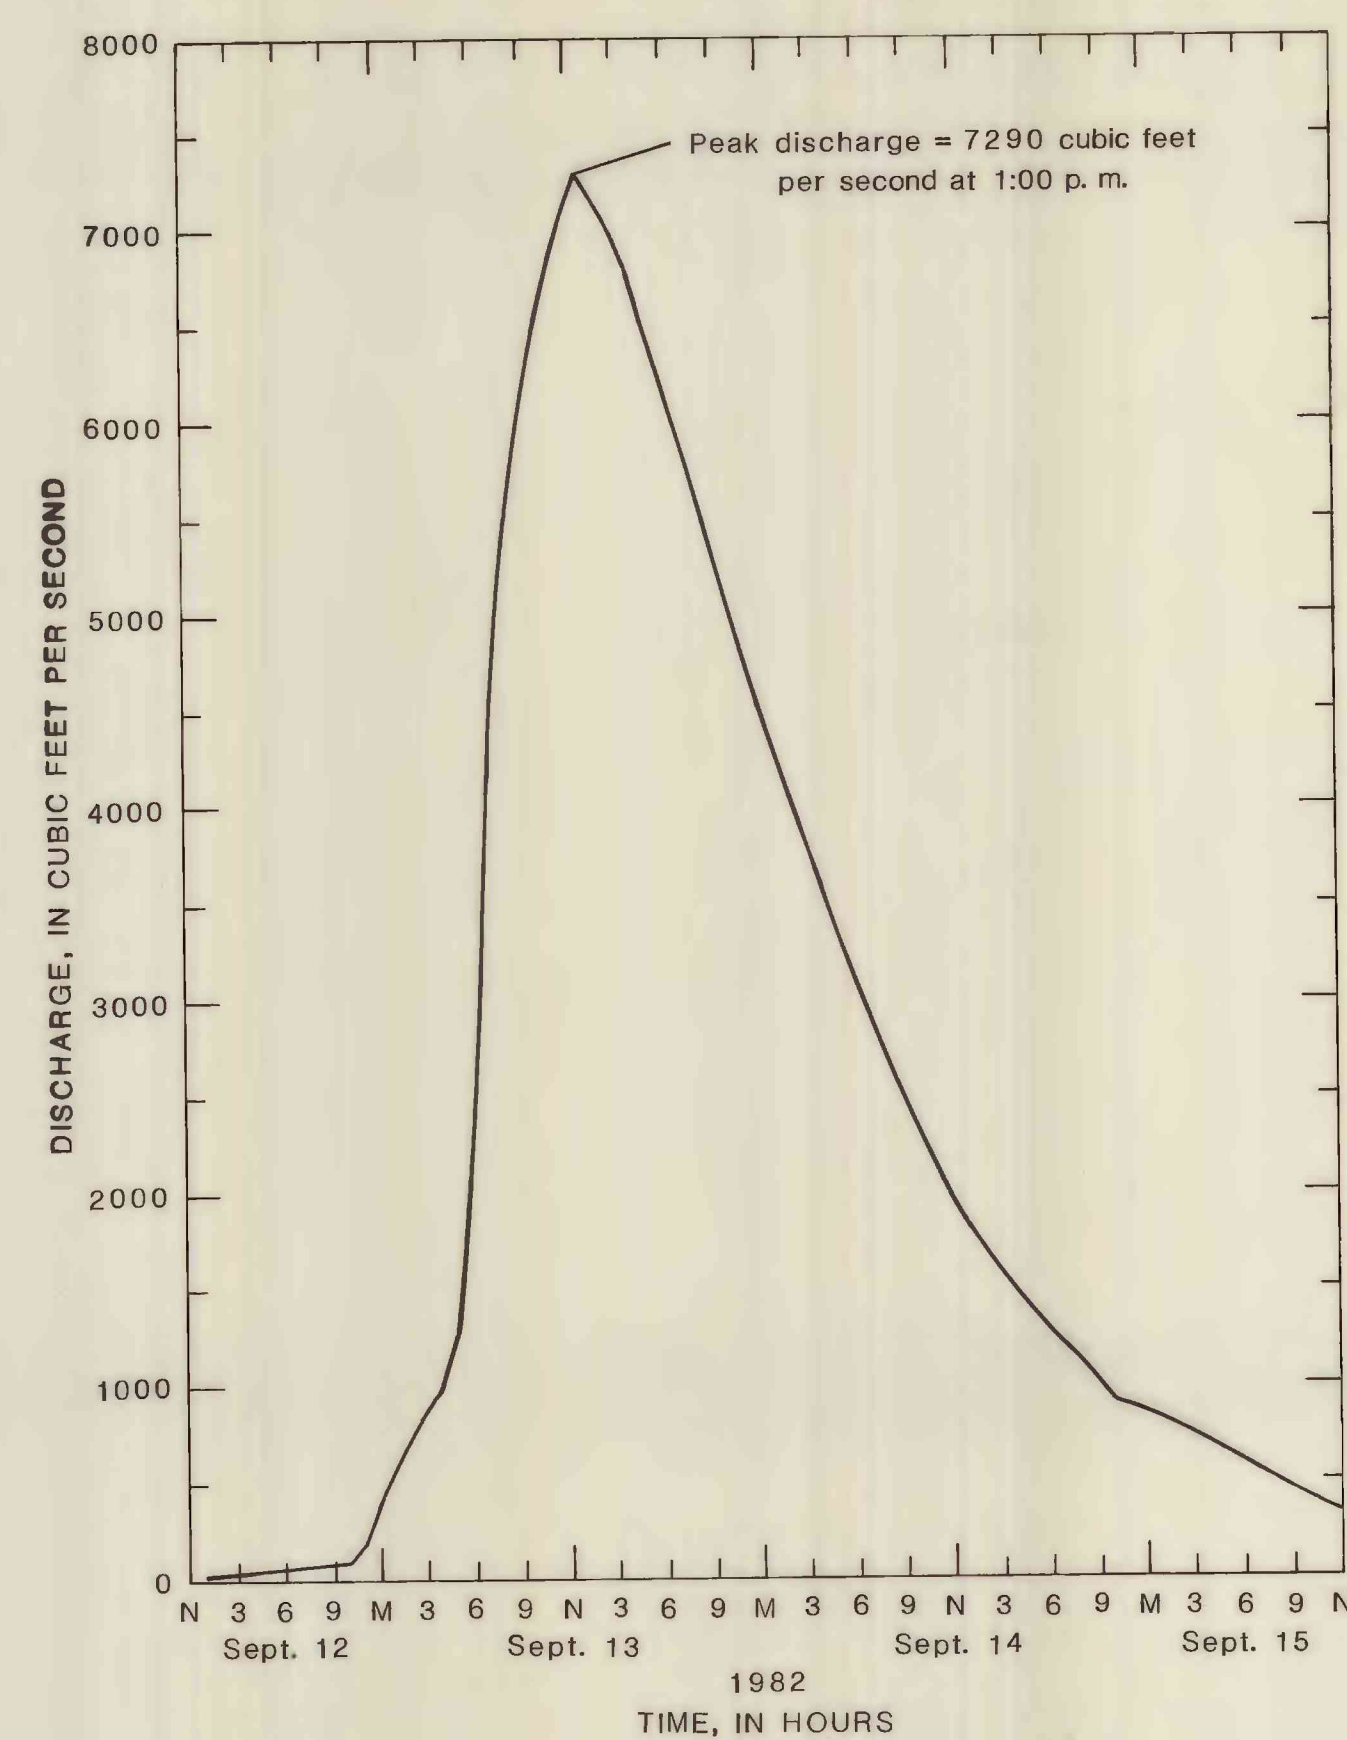
Figure 6.--Discharge hydrograph for Beaver Creek (site 1) at Huntingdon, Tenn. (see table 2 for site description).

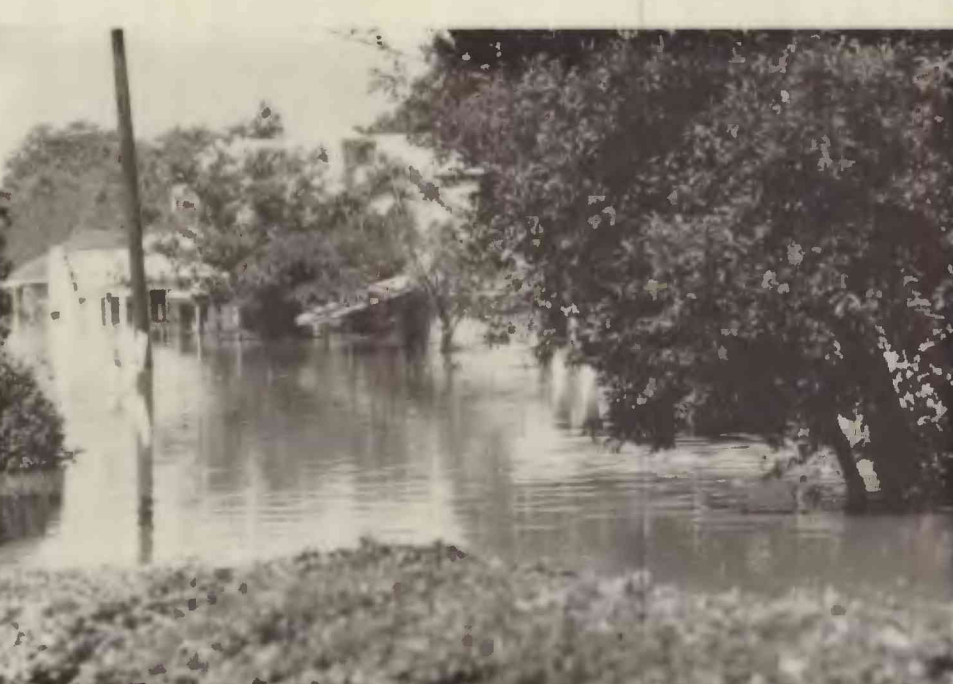
Figure 8.--Flooded residential area in Trenton, Tenn.

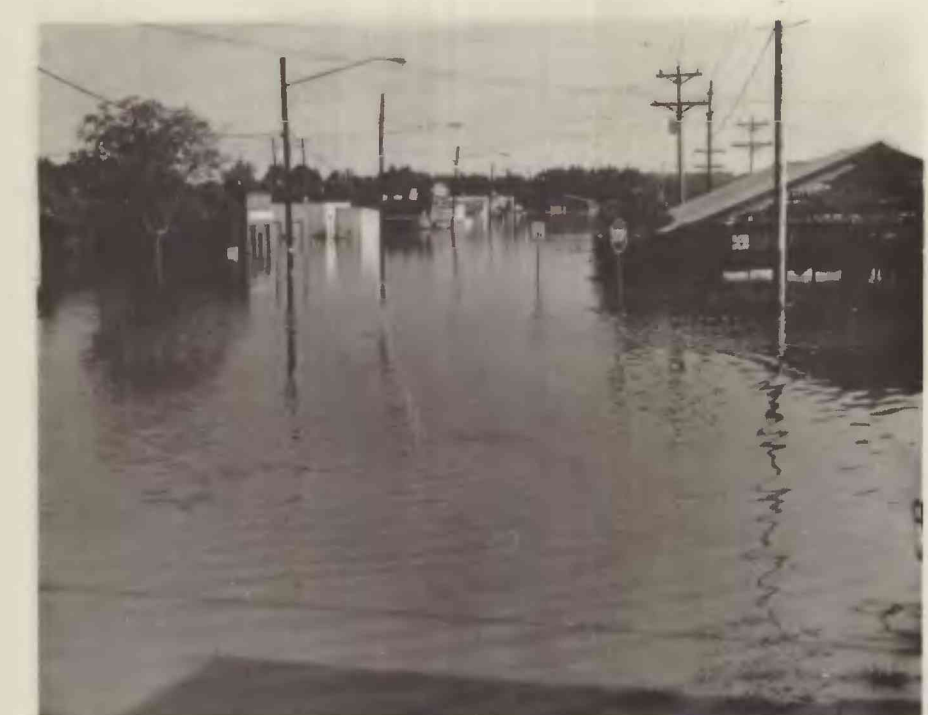
Figure 9.--Flooded business area along U.S. Highway 45W in Trenton, Tenn.

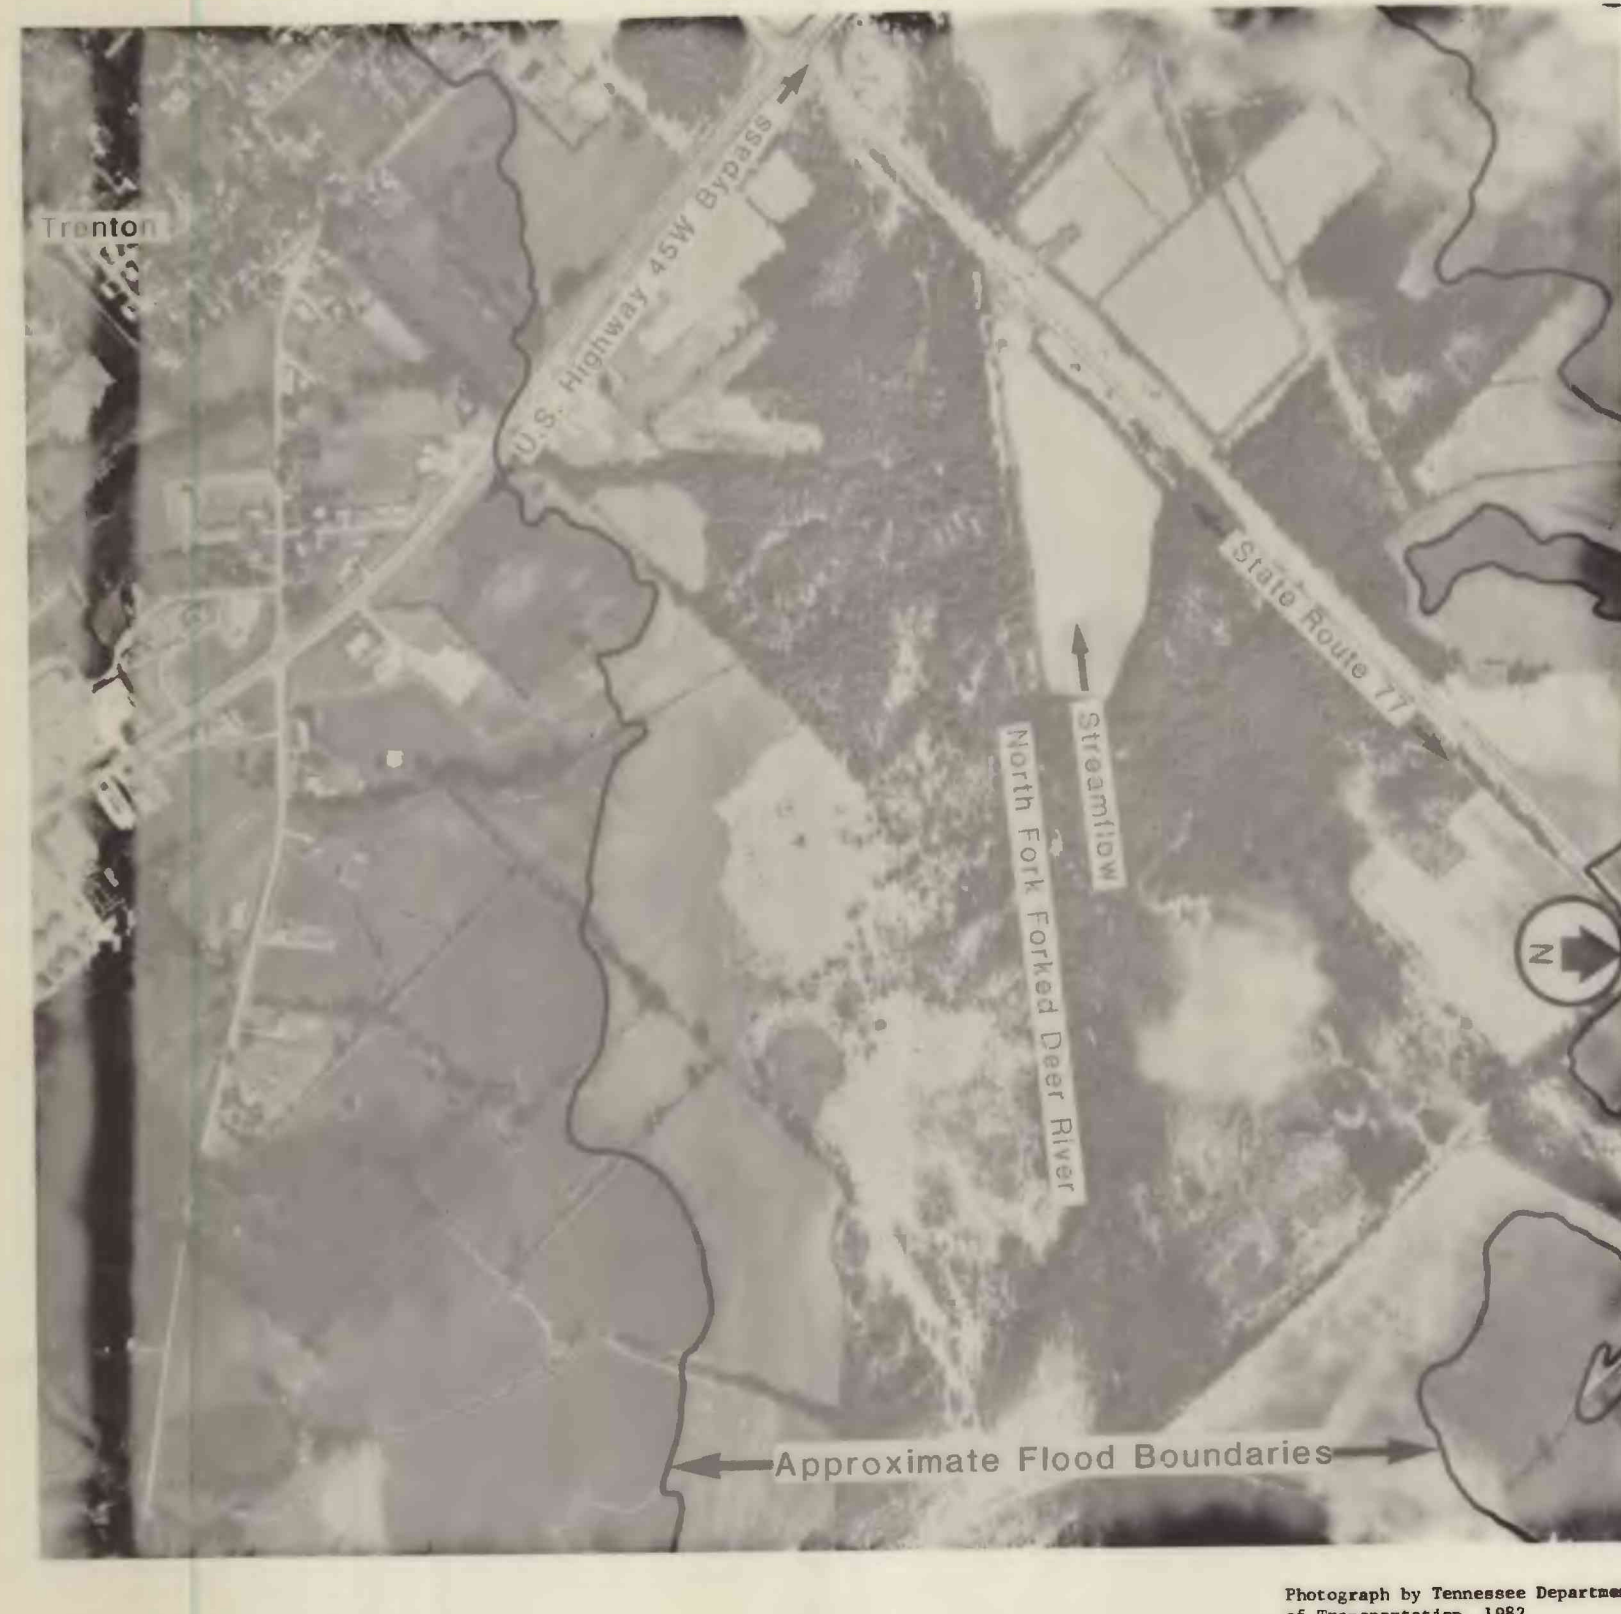
Figure 10.--Approximate flood boundaries of North Fork Forked Deer River along U.S. Highway 45W Bypass and State Route 77 at Trenton, Tenn.

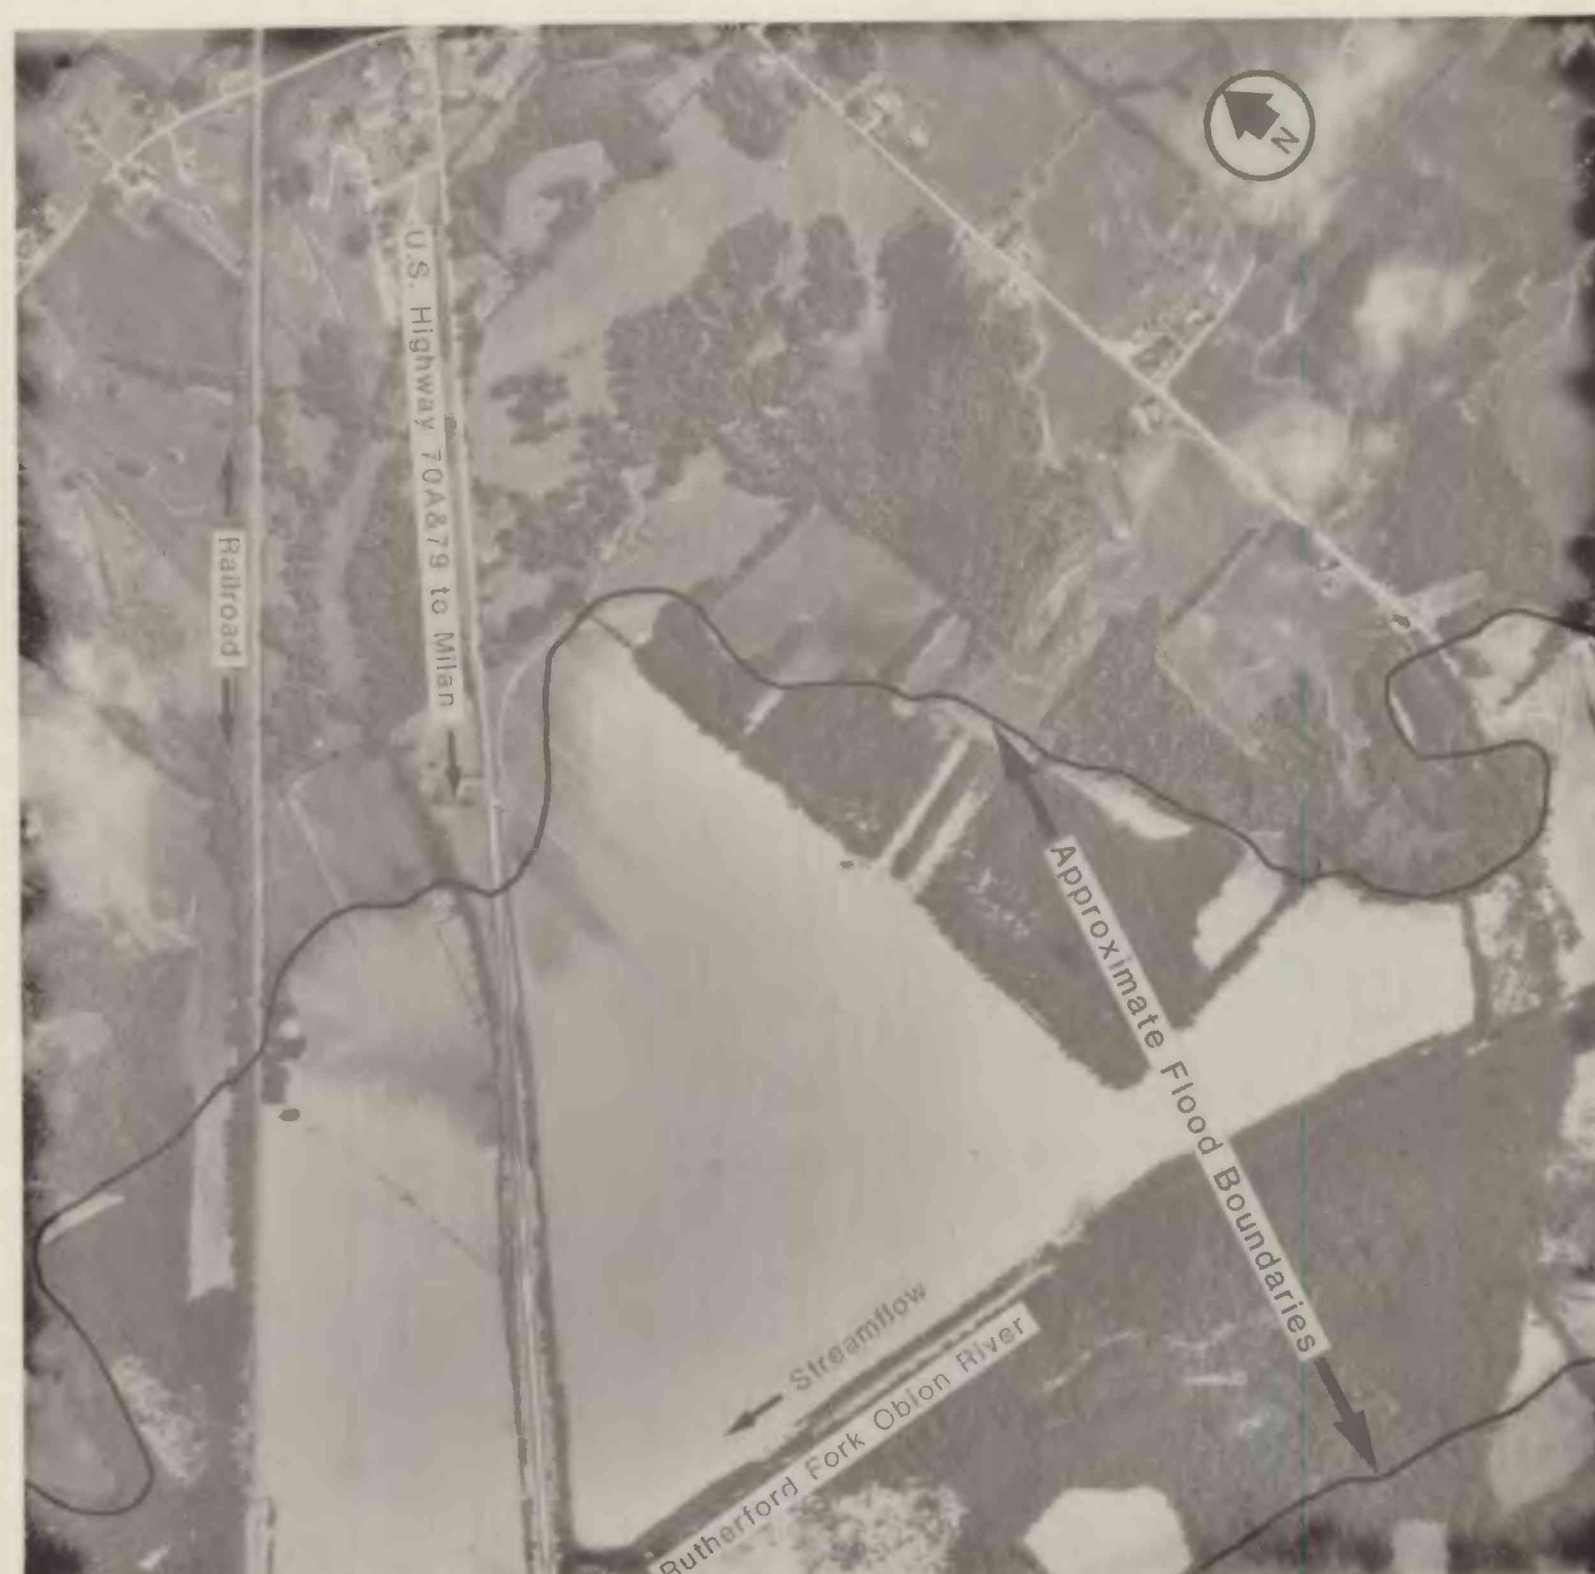
Figure 11.--Approximate flood boundaries of Rutherford Fork Obion River along U.S. Highway 70A & 79 between Milan and Atwood, Tenn.

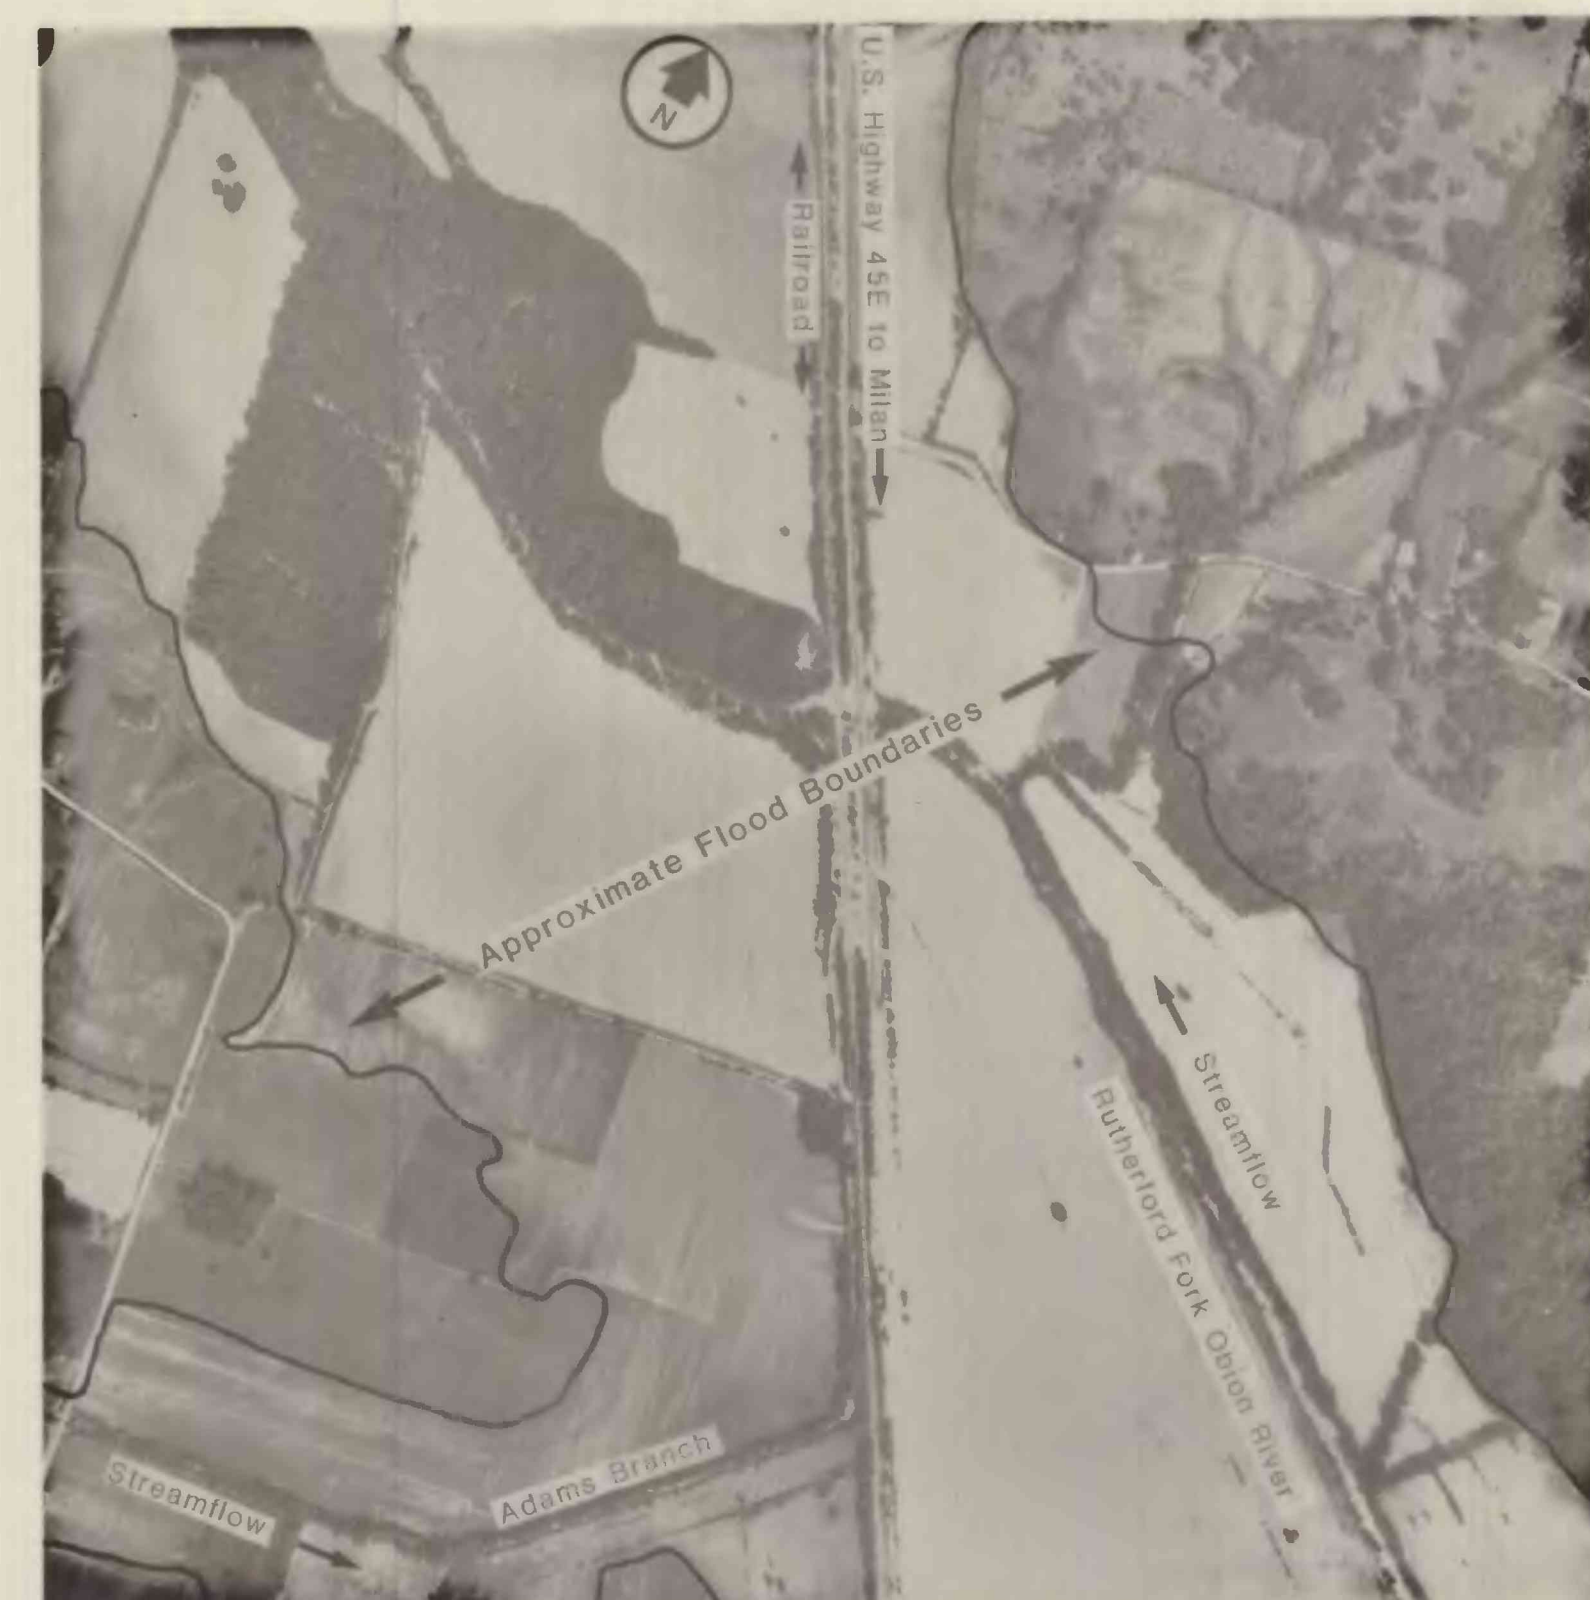
Figure 12.--Approximate flood boundaries of Rutherford Fork Obion River along U.S. Highway 45E between Milan and Bradford, Tenn.
