FLOOD OF OCTOBER 1983 AND HISTORY OF FLOODING ALONG THE SAN FRANCISCO
RIVER, CLIFTON, ARIZONA

By H.W. Hjalmarson

Water-Resources Investigations Report 85-4225-B

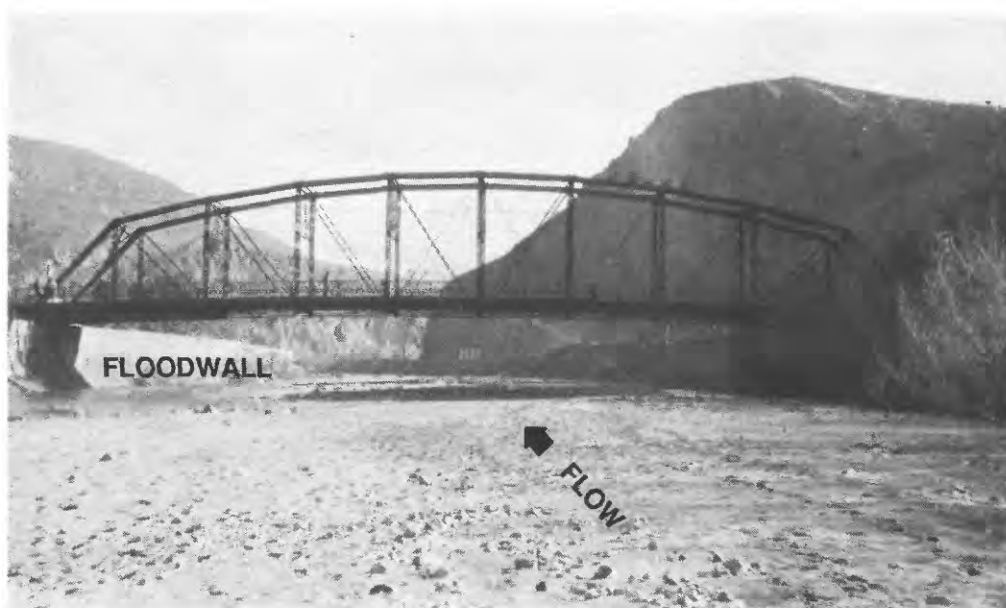
Figure 2.2-2--Floodwalls at Bridge Street along the main channel of the San Francisco River. Photograph was taken on December 1, 1930. Photograph from the files of the U.S. Geological Survey; source unknown.

Floodwalls form the banks of the San Francisco River throughout much of Clifton (figs. 2.2-1 and 2.2-2). Close examination of the walls reveals a history of the community's relation with the river. After the flood of December 4, 1906, the residents considered abandoning the town but decided instead to build floodwalls along the river banks (Patton, 1945, p. 120). In some places, floodwalls were raised an additional 2 ft after the flood of 1916. Recent repairs and additions to the floodwalls are visible. After the flood of October 1-2, 1983, raising the floodwalls was considered again, especially in south Clifton.

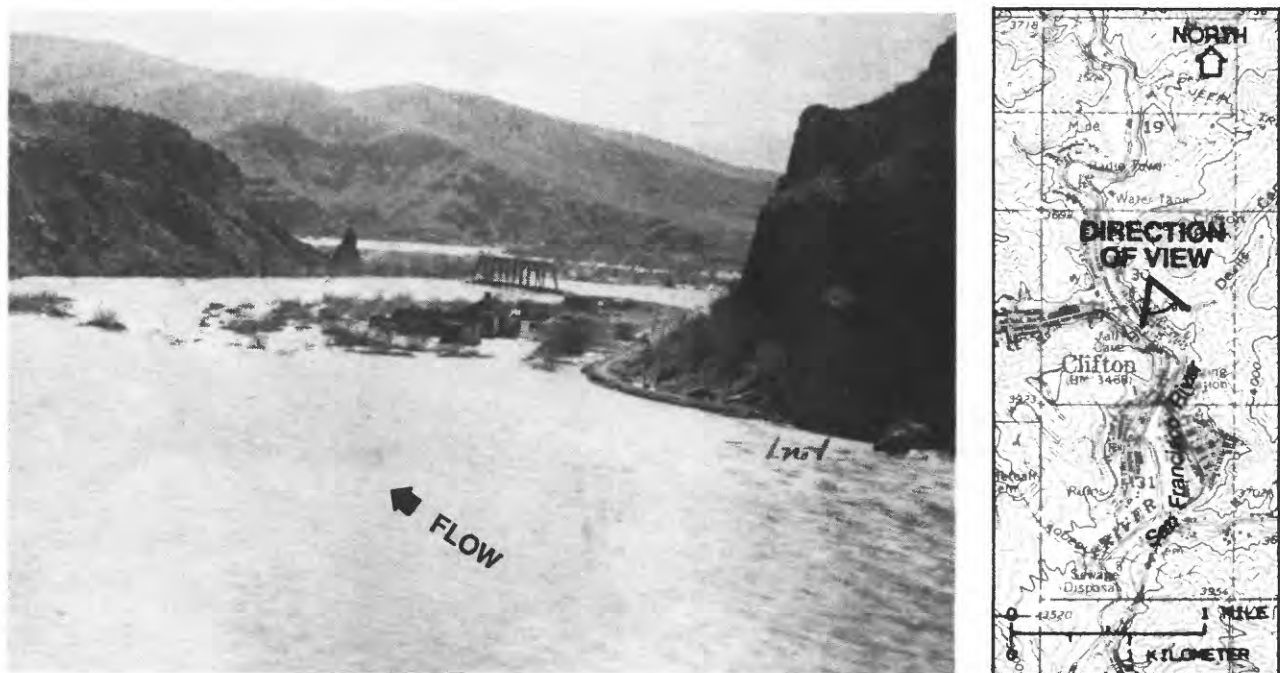
Figure 2.3-2--Flood of February 1891 at bridge site 1. No. 1 indicates location of building before the flood. Photograph from the files of the U.S. Geological Survey; source unknown.

In 1891, a single-truss railroad bridge with a trestle on each side was located at bridge site 1 (figs. 2.3-1 and 2.3-2). This bridge may have been destroyed by floodwater but its fate is uncertain because of unclear and conflicting reports. The construction date of the present railroad bridge, which has two trusses, is not known; however, the date on the bridge is 1901. Two sources indicate that the old railroad bridge (fig. 2.3-1) was destroyed by a flood in 1905 or 1906 and that the present bridge was built later; however, photographs reportedly taken in 1906 show the present railroad bridge. The center pier of the bridge at site 1 was damaged during the flood of October 1-2, 1983. In 1918, a highway bridge was constructed next to the railroad bridge connecting south Clifton at Coronado Avenue. The present highway bridge on U.S. Highway 666 replaced the 1918 bridge in 1960.

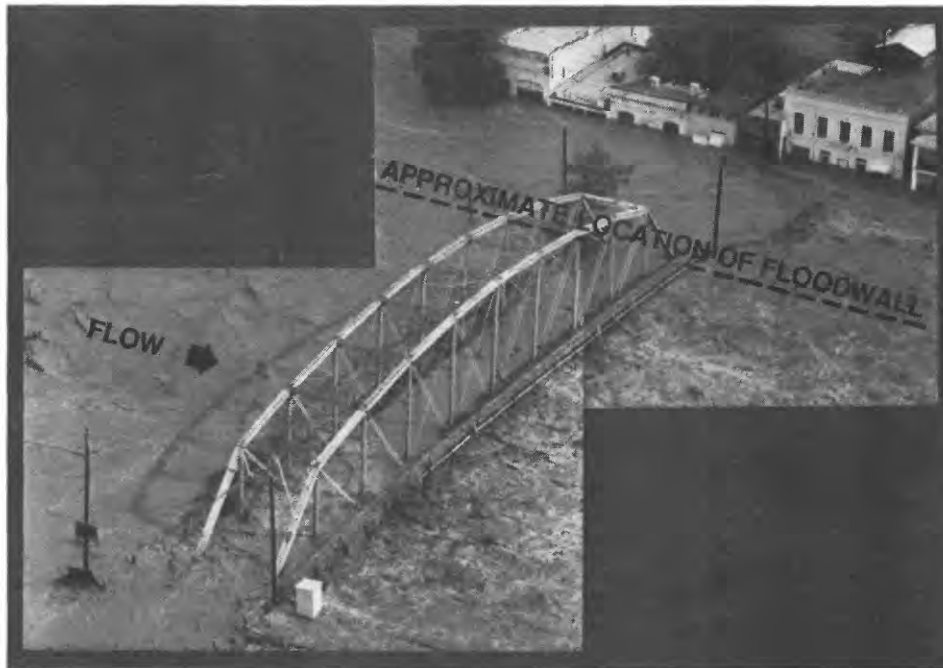
Figure 3.0-1--Bridge site 2 at Bridge Street, October 2, 1983. Discharge was at least 80,000 cubic feet per second. Photograph was taken between 0930 and 1000 hours. Photograph courtesy of John F. Hancock, Morenci, Arizona.

More than 3 in. of rain had fallen in 2 days at Clifton when the San Francisco River overtopped the floodwalls at about 1400 hours on Saturday, October 1, 1983. Tim Miller, a student at Clifton High School, said, "There was little time to grab much more than an armful of clothes before heading for high ground. The town's flood whistle sounded, and the evacuation was underway" (Brinkley-Rogers and Lawler, 1983, p. 5A). All the floodwalls along the banks of the main channel were overtopped as the floodwater rose from nearly 60,000 ft³/s to a record peak of almost 90,000 ft³/s in a little more than 4 hours. The floodwaters receded during the morning of October 2, but the river started to rise again at 0600 hours. At 0945 hours, the river crested at an even larger record peak of 90,900 ft³/s (figs. 3.0-1 and 3.0-2).

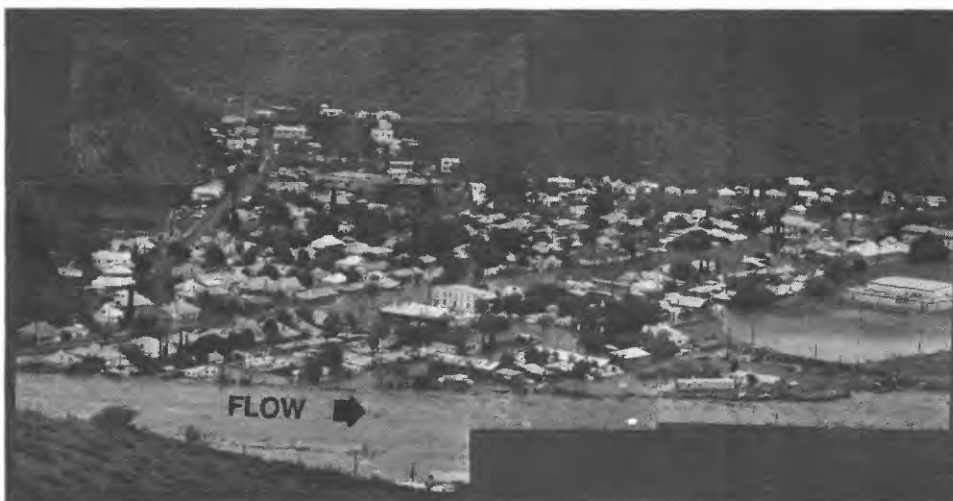
Figure 3.0-2--San Francisco River at south Clifton, October 2, 1983. Photograph courtesy of John F. Hancock, Morenci, Arizona.

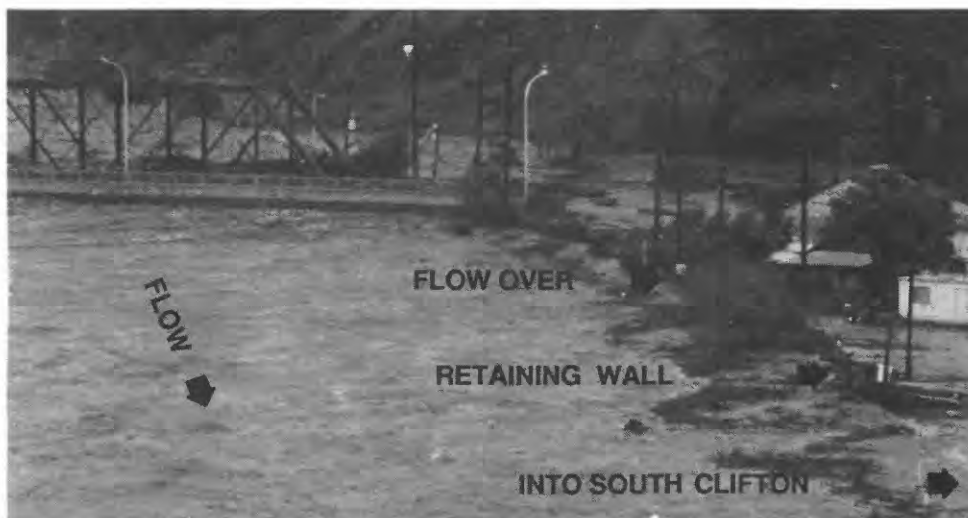
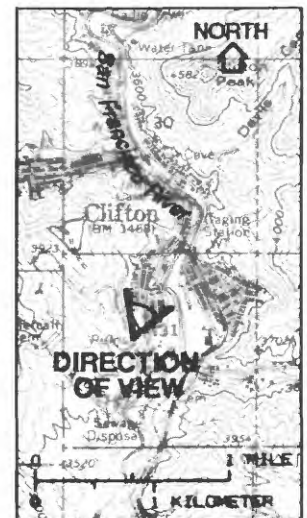
Figure 3.3.2-4--Bridge site 1 about 0900 hours, October 2, 1983. Discharge was about 75,000 cubic feet per second. Photograph courtesy of John F. Hancock, Morenci, Arizona.

On the left bank upstream from the bridge, the floodwater overtopped a masonry retaining wall (figs. 3.3.2-1, 3.3.2-2, and 3.3.2-4). Downstream from the bridge, a concrete floodwall was also overtopped. Most of south Clifton was inundated. The water, trapped behind the floodwalls, became ponded at an elevation of 3,449.5 ft. About 2,700 ft of U.S. Highway 666 was inundated in south Clifton. Large amounts of silt and debris were deposited in the area. Flow velocities were too small to cause erosion along the highway.

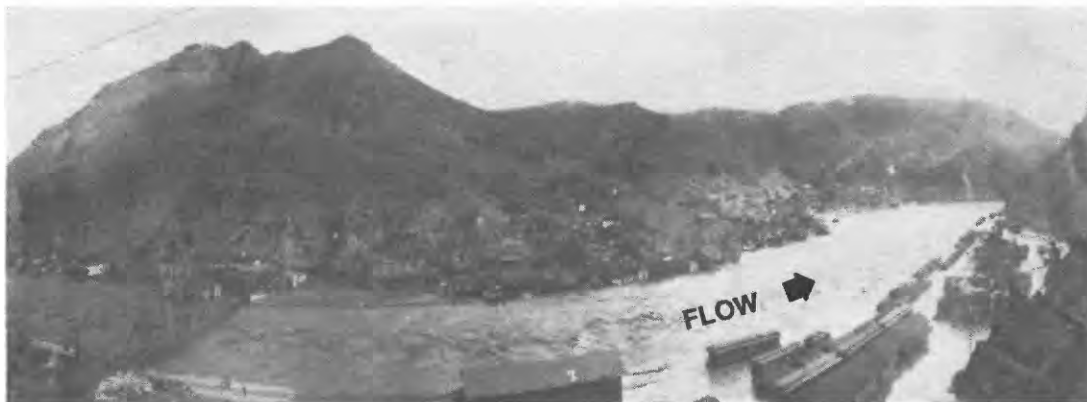
Figure 4.0-1--A flood in 1905 or 1906 in the San Francisco River, east Clifton, Arizona. The bridge on the left was built in 1905 and the houses on the right were replaced by the railroad depot before 1916. Photograph courtesy of the Arizona Historical Society.

The 1891 flood extended from mountain to mountain and inundated nearly all of Clifton. Buildings were washed away, and the railroad was greatly damaged. A larger flood occurred on December 3, 1906 (see fig. 4.0-1 for a photograph of this flood or possibly an earlier flood). Eighteen lives were lost, and damages were estimated at \$1 million. Some of the loss of life and damage was from flooding along Chase Creek.

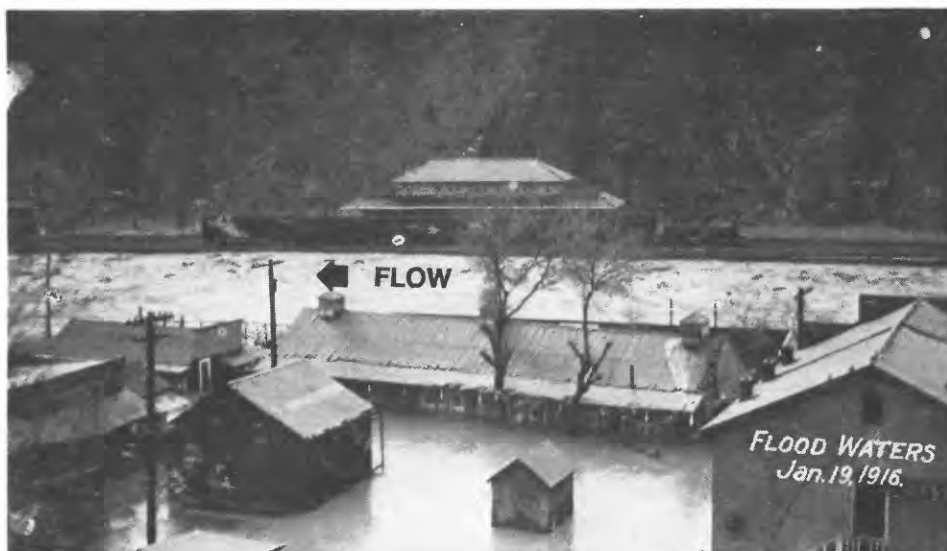
Figure 4.0-2--Railroad depot during flood of January 19, 1916, San Francisco River, Clifton, Arizona. Photograph from the files of the U.S. Geological Survey; source unknown.

Two large floods occurred in 1916 (fig. 4.0-2) and were followed by a long period of small floods until October 20, 1972. Throughout Clifton, the stage of the flood of October 1972 was higher than the stage of the two 1916 floods. In the Patterson District, the flood of October 1972 was about 1 ft lower than the flood of 1906. The slope in water surface through the town, however, was greater during the 1906 flood than that during the 1972 flood. At bridge site 2, the stages for the two flood peaks are approximately equal; however, at bridge site 1, the 1906 flood was about 2 to 2.5 ft lower than the 1972 flood.

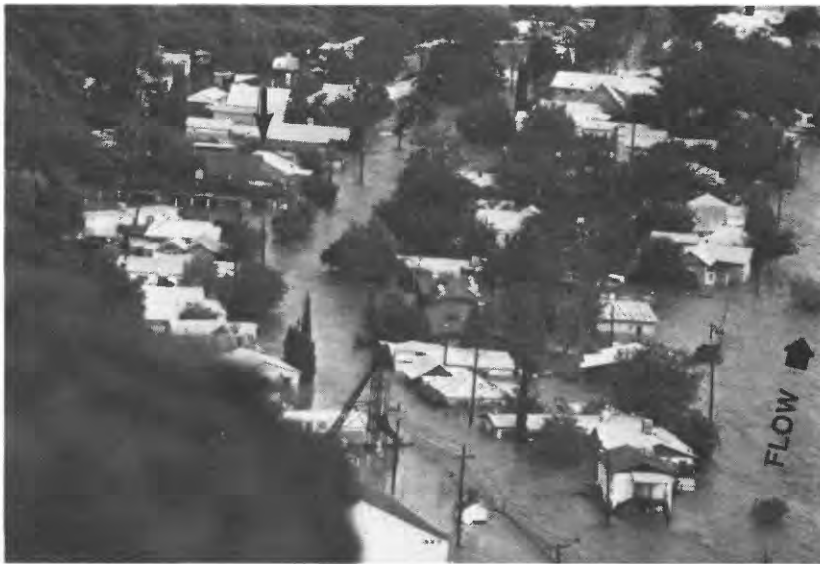
Figure 4.2.1-1--Flood of October 2, 1983, along Frisco Street, Clifton, Arizona. Photograph courtesy of John F. Hancock, Morenci, Arizona. Note that arrow on photographs indicates same house.

Photographs during or shortly after flooding in 1906 (probable year), 1916, 1972, and 1983 were taken along Frisco Street in north Clifton (figs. 4.2.1-1 to 4.2.1-3; arrows in these photographs point to the same house at 145 Frisco Street) and are used here as an example of how historic flood information was related. The house at 145 Frisco Street is in the photographs; with the aid of a magnifying viewer, a line can be seen in the early photographs that appears to be a high-water mark (fig. 4.2.1-2). In the 1906 picture, a man is holding a cane horizontally at about the level of the apparent mark, which is about 0.6 ft below the top of the porch rail (fig. 4.2.1-2). The 1972 flood was 0.8 ft below the top of the rail (fig. 4.2.1-3), and the October 1983 flood was 1.2 ft above the rail. The January 1916 flood appears to have covered about one step of the porch and was probably about 2 ft below the 1906 and 1972 floods. The high-water mark from the flood of 1916 was on a fence that no longer exists. Transit-stadia surveys of floodmarks for the 1972 and 1983 floods were made in north Clifton. The floodmarks for early floods were tied to these surveys, and a record of flood-crest elevations was compiled (table 4.2.1-1).

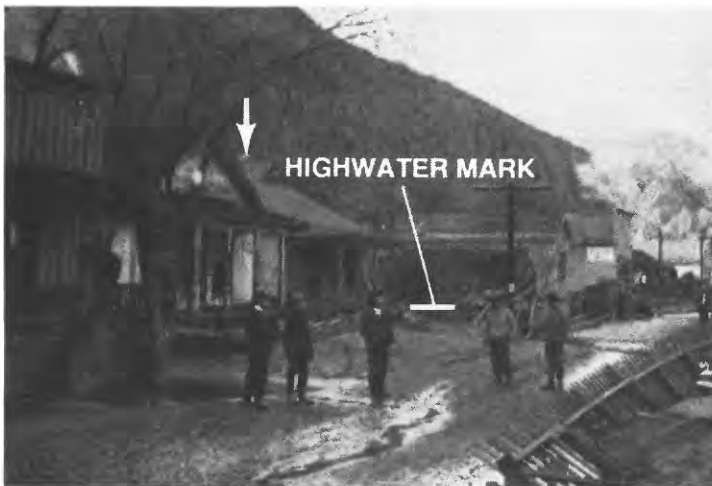
Figure 4.2.1-2--Frisco Street, 1905 or 1906. Man in center of photograph is holding a cane at the high-water mark. Photograph from the files of the U.S. Geological Survey; source unknown.

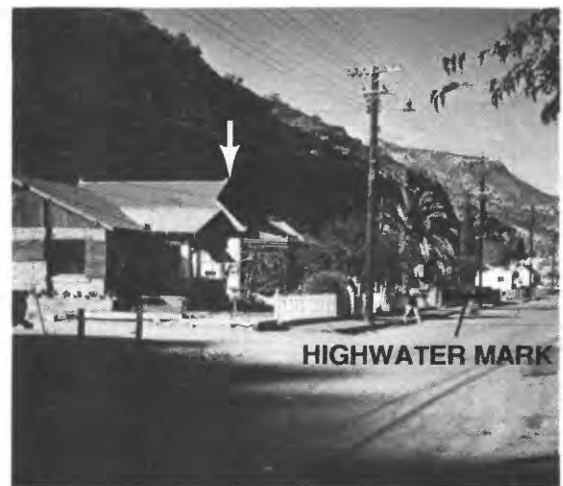
Figure 4.2.1-3--Frisco Street, November 21, 1972. Man's outstretched arms indicate the high-water mark from the flood of October 1972. Photograph from the files of the U.S. Geological Survey; source unknown.

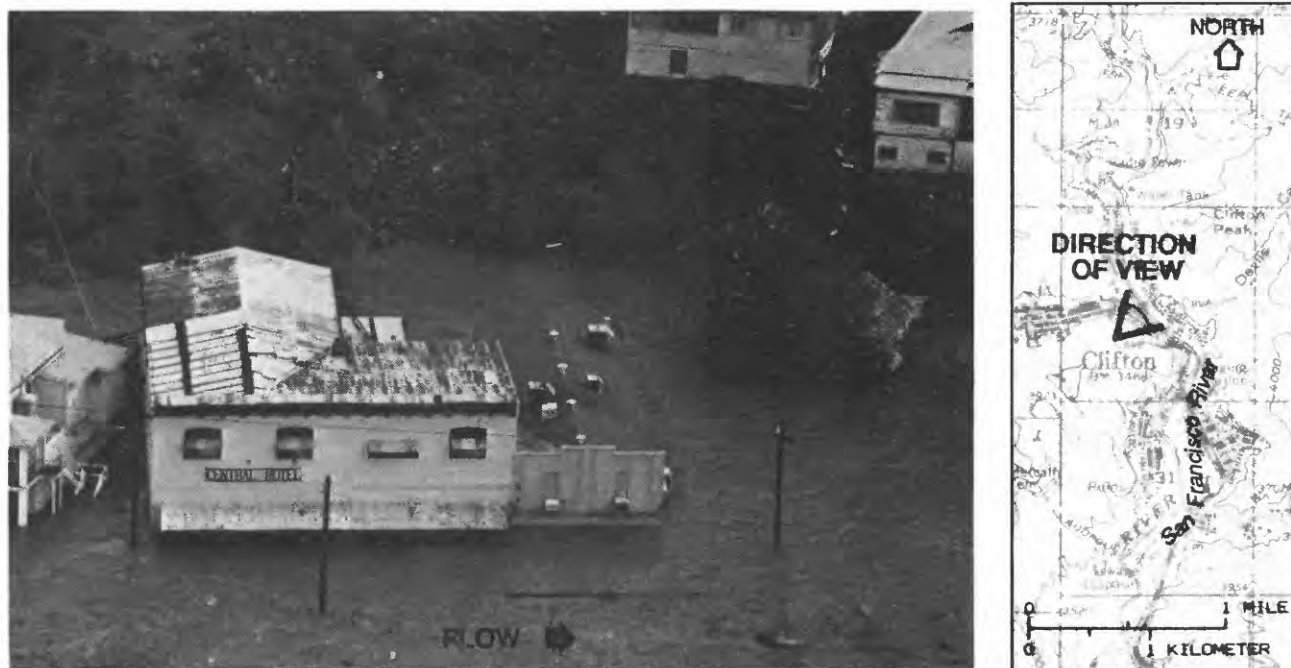
Figure 4.2.2-1--Flooding of the San Francisco River at the Central Hotel on Park Avenue in east Clifton, Arizona, October 2, 1983. Photograph courtesy of John F. Hancock, Morenci, Arizona.

The Central Hotel is a short distance downstream from the site of the old Clifton Hotel. The hotels were at about the same elevation, and observed flood depths at the Clifton Hotel can be compared with flood depths at the Central Hotel. The water surface of the November 1905 flood was up to the windows of the Clifton Hotel or about 1 ft lower than that of the December 1905 flood. Newspaper accounts indicate that the November 1905 flood was equal to the flood of 1891 in the Central Hotel area. The crest of the December 1906 flood was 4 ft deep at the Clifton Hotel or about 1 ft higher than the December 1905 flood, and the first floor of the Central Hotel was inundated with water and mud. The flood of January 1916 was 0.7 ft deep in the Clifton Hotel (The Copper Era, January 21, 1916).
