WATER RESOURCES AND HYDROLOGIC HAZARDS OF THE EXIT GLACIER AREA
NEAR SEWARD, ALASKA

By Charles E. Sloan

Water-Resources Investigations Report 85-4247

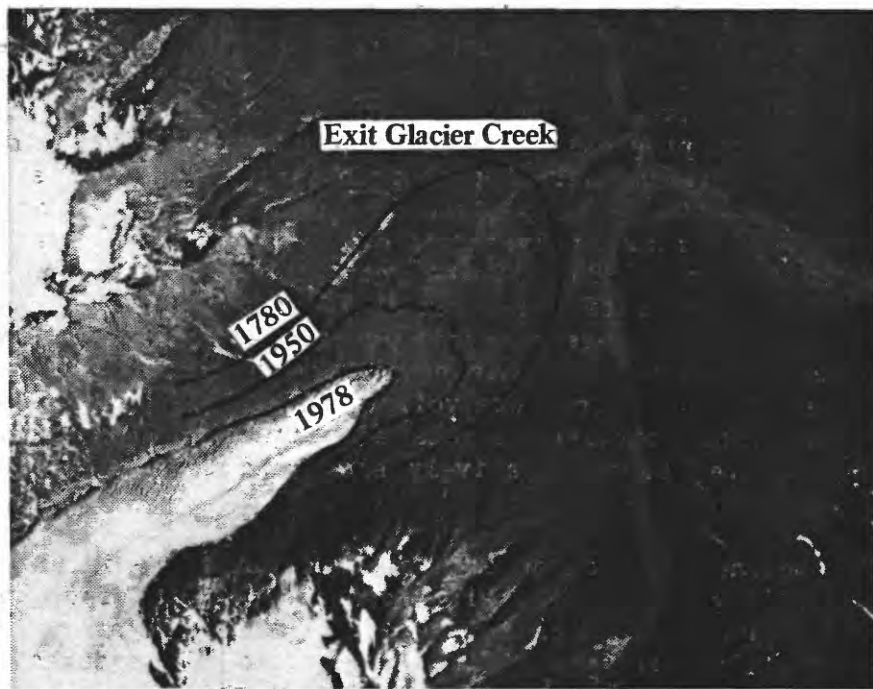
1950

1978

Figure 2.--Vertical photographs of Exit Glacier taken in 1950 and 1978, and position of glacier terminus on indicated dates.

Glacial Advance - The probability of a major advance of Exit Glacier appears to be remote, although possible, given climate shift and sufficient time. The recent history in this century of nearly all glaciers in the Kenai Mountains, according to Austin Post (U.S. Geological Survey, written commun., 1983), has been one of slow retreat for land-ending glaciers such as Exit Glacier, and drastic retreat for extended tidewater glaciers such as Northwestern and McCarty Glaciers. Post also stated that all the larger glaciers and most of the smaller glaciers have retreated from maximum positions attained about 100 to 200 years ago. The retreat of Exit Glacier is indicated by progressive upvalley positions of the terminus in the recent past (fig. 2). Vertical aerial photographs of the glacier are available from 1978 and 1950; in addition, the position of the terminus in about 1780 can be extrapolated from tree ring analyses done by the National Park Service (G.M. Ahlstrand, written commun., 1983). These retreats are not merely changes in terminus position; the thickness of the lower parts of glaciers has decreased as well, as displayed by lateral moraines and trim lines. According to Post, if increased snow accumulation were to reverse this trend, the switch to advance would not be a sudden, dramatic event; large ice reservoirs will probably require at least several decades to refill before previous levels are attained. Therefore, any terminus advances can be expected to be relatively slow, and the onset of advance delayed for many years or even decades.

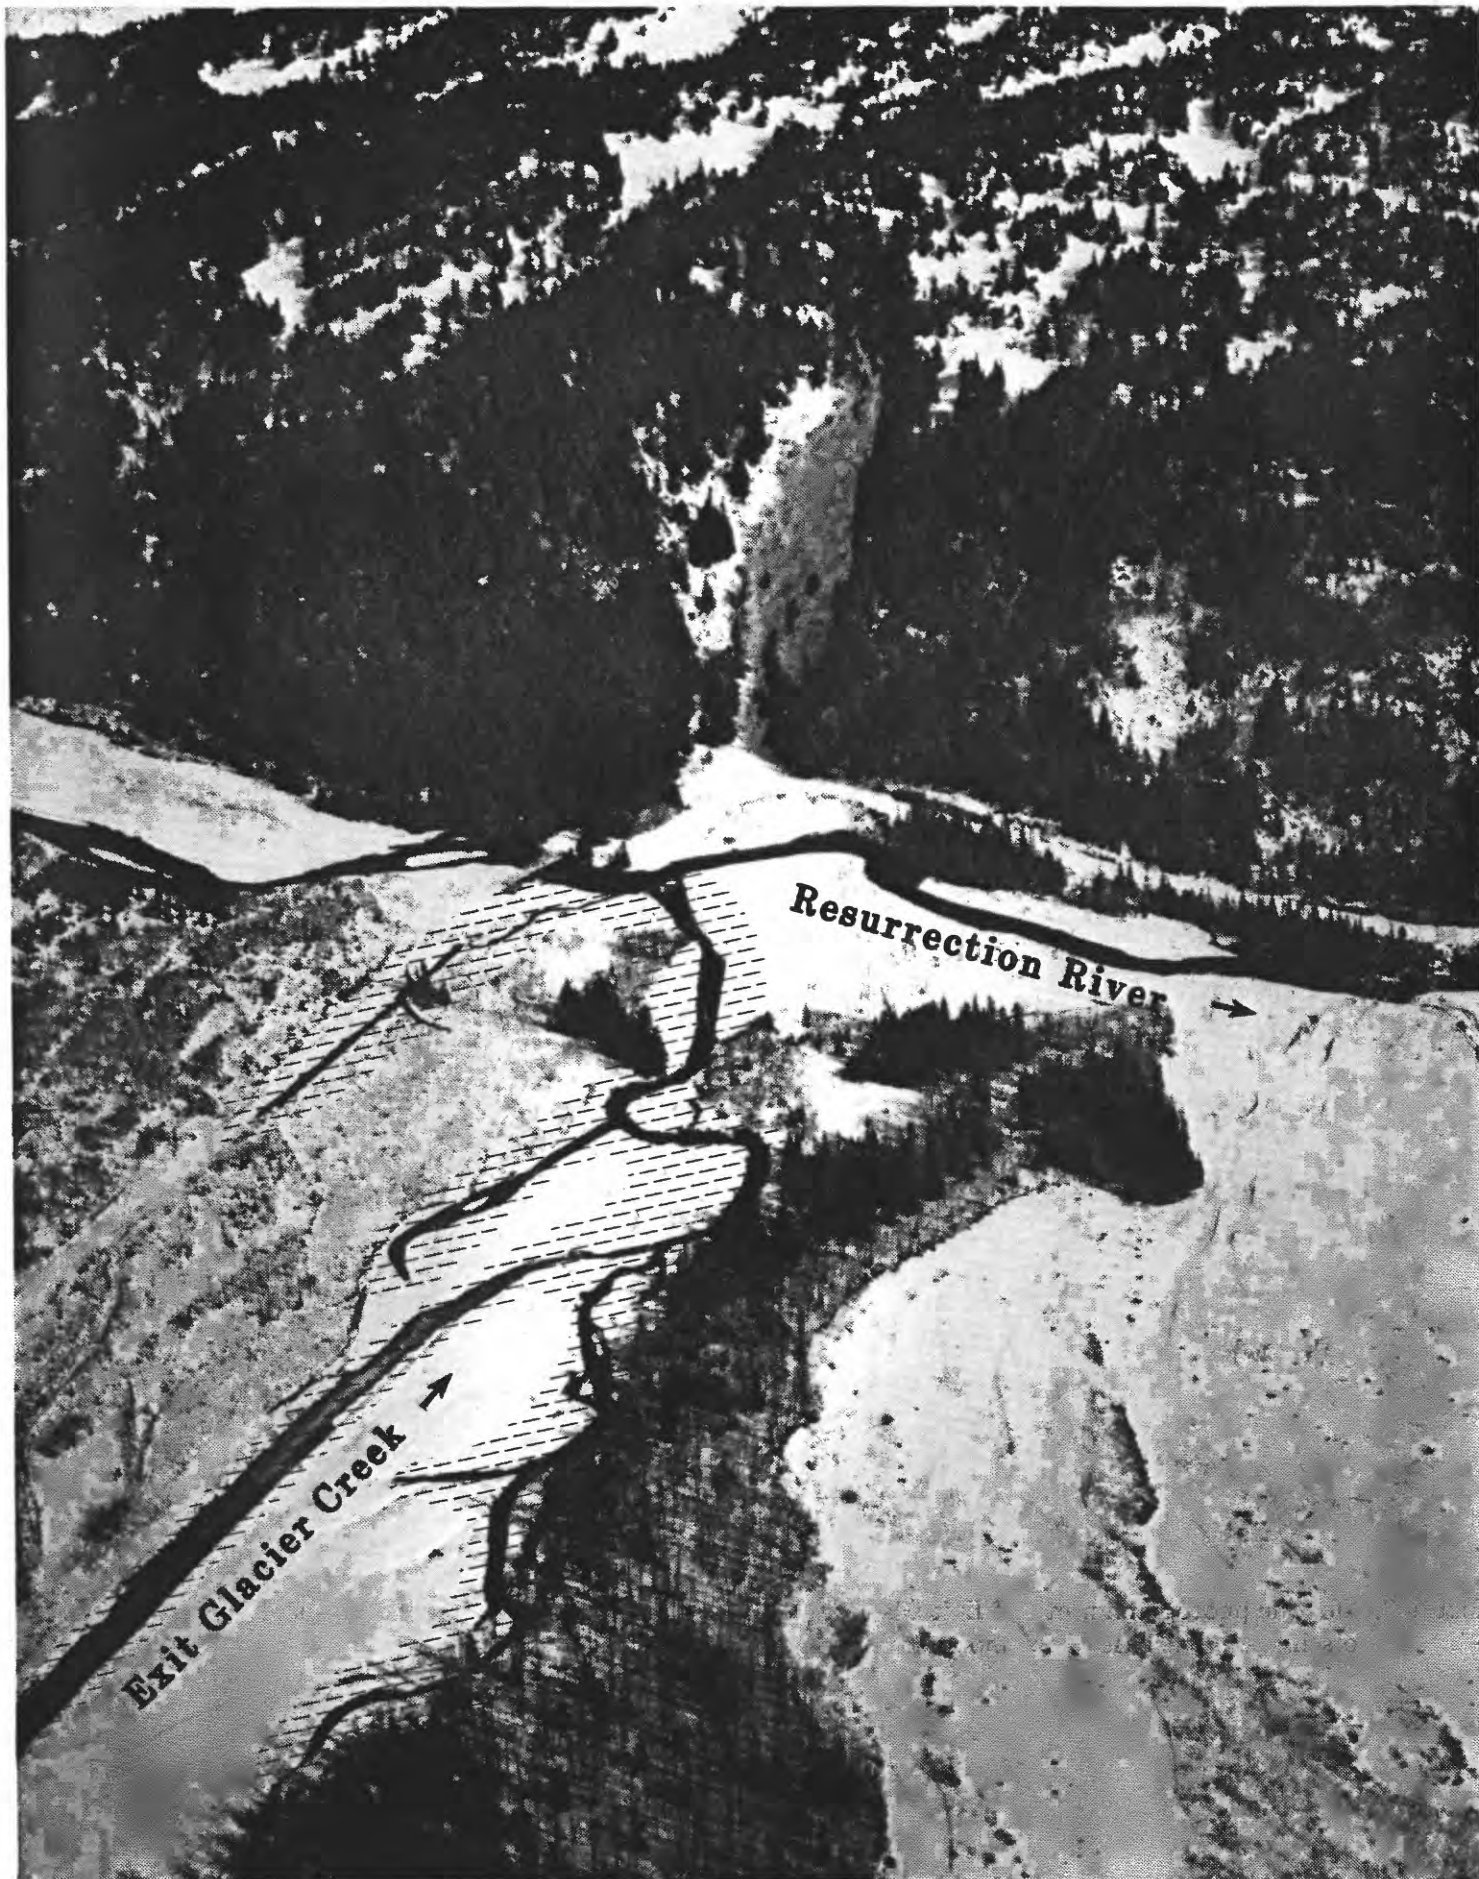
Figure 4.--Oblique photograph of the confluence of the Resurrection River and Exit Glacier Creek, March 30, 1983. Open-water leads (hachure marks) indicate ground-water discharge.

Ground Water - Springs discharge ground water from the base of the mountain slope north of the glacier terminus (fig. 3). Ground water also emerges in the lower half mile of the Exit Glacier Creek channel and in several nearby channels that empty into the Resurrection River (fig. 4). The discharge of comparatively warm ground water at about 5° C keeps these channels open and free of ice except during extended periods of extremely cold weather.
