Effect of Erosion-Control Structures on Sediment and Nutrient Transport, Edgewood Creek Drainage, Lake Tahoe Basin, Nevada, 1981-83

U.S. GEOLOGICAL SURVEY

Water-Resources Investigations Report 87-4072

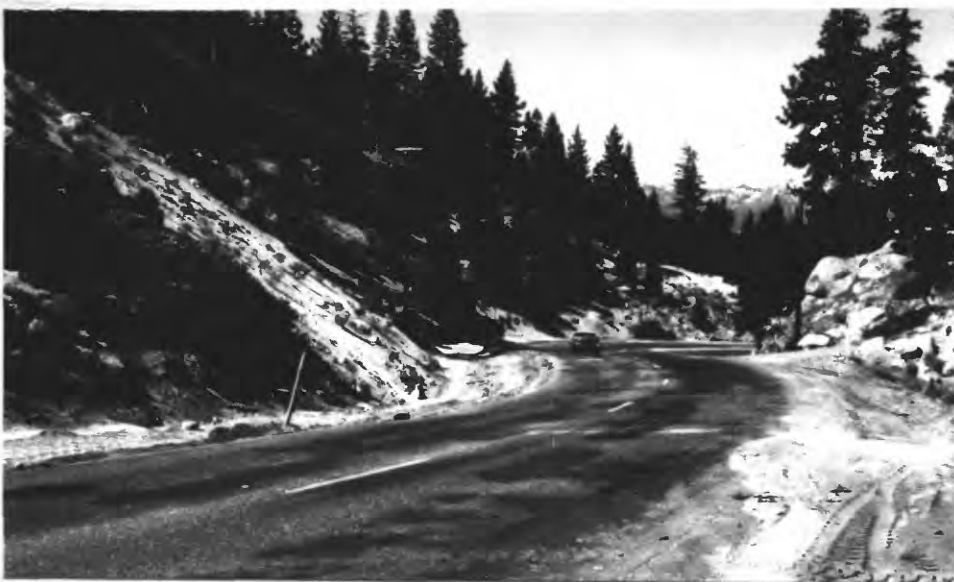
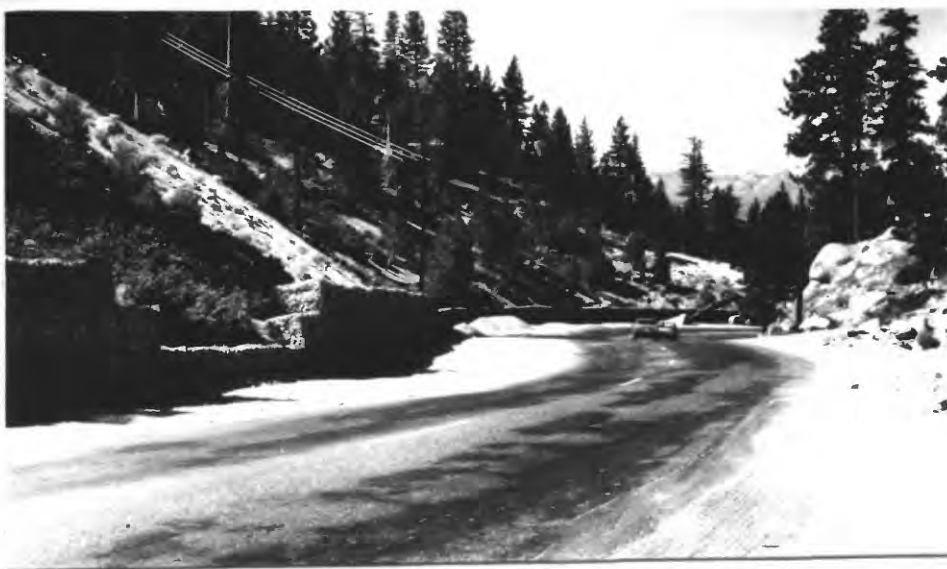
FIGURE 2.--State Highway 207 near Daggett Pass in (A) May 1982, before construction of rock gabion, and (B) August 1982, after construction.

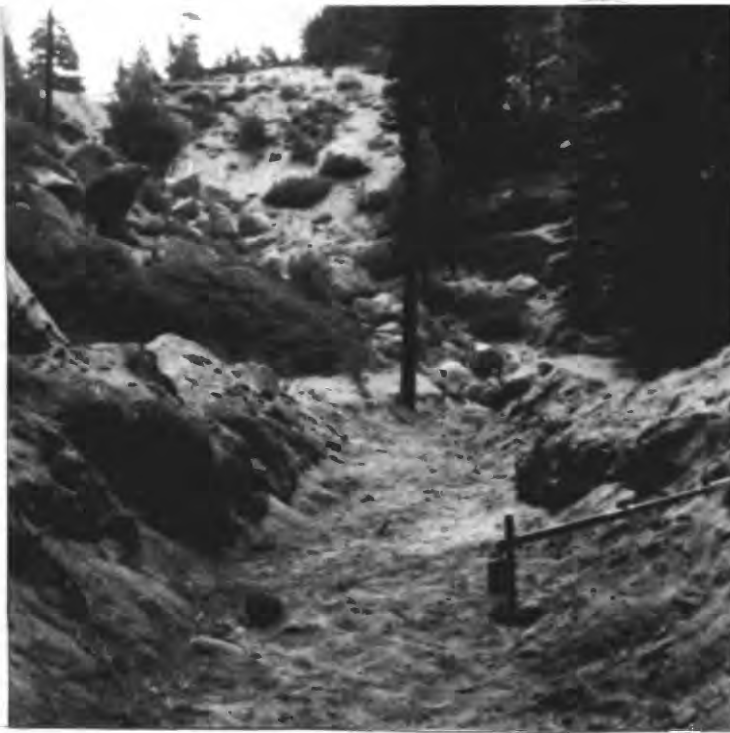
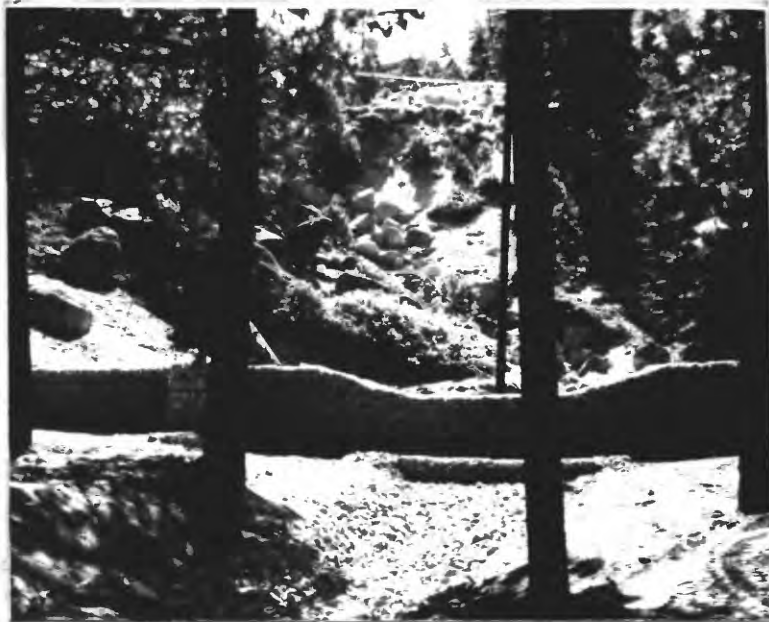
FIGURE 3.--Tributary of Edgewood Creek tributary near Tahoe Village, in (A) June 1981, before construction of retention dam, and (B) August 1982, after construction.
