RECONNAISSANCE INVESTIGATION OF SEDIMENT DISTRIBUTION, EROSION, AND TRANSPORT IN THE UPPER DESCHUTES RIVER, DESCHUTES COUNTY, OREGON, NOVEMBER 1986

By Kenneth A. Cameron and Jon J. Major

Water-Resources Investigations Report 87-4114

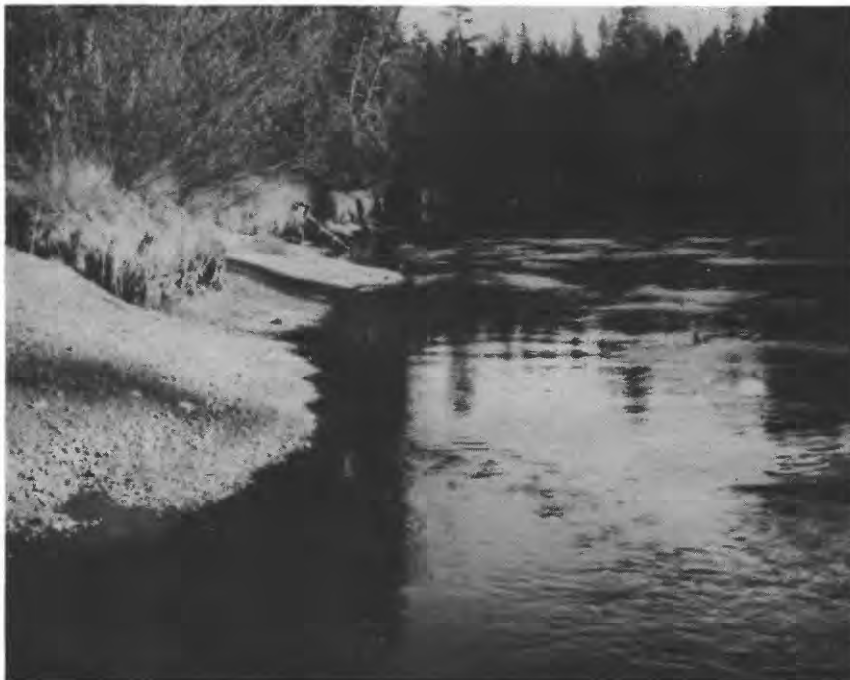
Figure 2.--Upstream view of upper Deschutes River at cross-section DR-1.

The operation of Wickiup Dam for irrigation has substantially altered the magnitude and distribution of flow rates in the upper Deschutes River (fig. 8). River flow has been significantly reduced in winter and greatly enhanced in the spring and summer. Prior to Wickiup Dam, river discharge had a similar seasonal distribution (lower discharge in winter than in summer, fig. 8), but had a markedly less pronounced variation in stage. Accentuated seasonal fluctuation of stage subsequent to dam operation has resulted in a broad streamside zone between high and low stage that is barren of the protective plant cover needed for bank stabilization (figs. 2, 4, and 5).

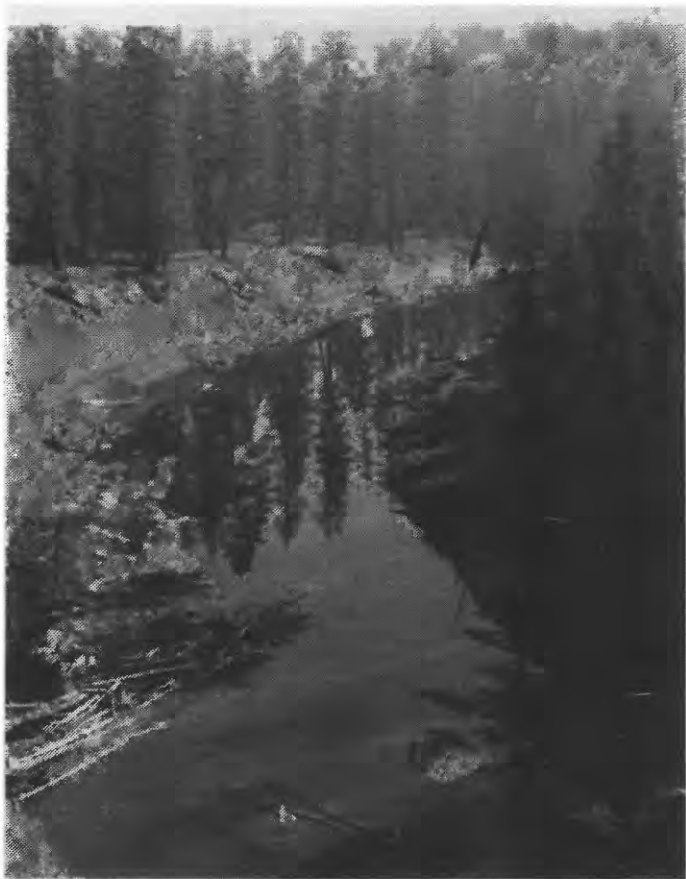
Figure 3.--Downstream view of upper Deschutes River near cross-section DR-2. Cross-section traverses downstream end of gravel bar seen in upper right corner (see arrow).

The first coring site is located about 0.3 miles upstream from DR-2, on the top of the left bank. This large cutbank (part of which is shown in fig. 3) was identified as one of the most actively eroding banks along the upper Deschutes River (E. Felix, U.S. Forest Service, oral comm., 1986). Two trees were cored; a "test" tree that had approximately 25 percent of its root base exposed by erosion and a "control" tree that was located 60 feet back from the top of the bank. Exposed roots of the undercut tree extended river-ward along an angle that reflected the slope of the pre-erosion ground surface. At its distal end, the root turned abruptly downward, which is interpreted as the location of the top of the pre-erosion bank (fig. 12). The distance from the present bank to the down-turned part of the root is a direct measure of the bank erosion. At this site, approximately 7 feet of erosion has occurred.

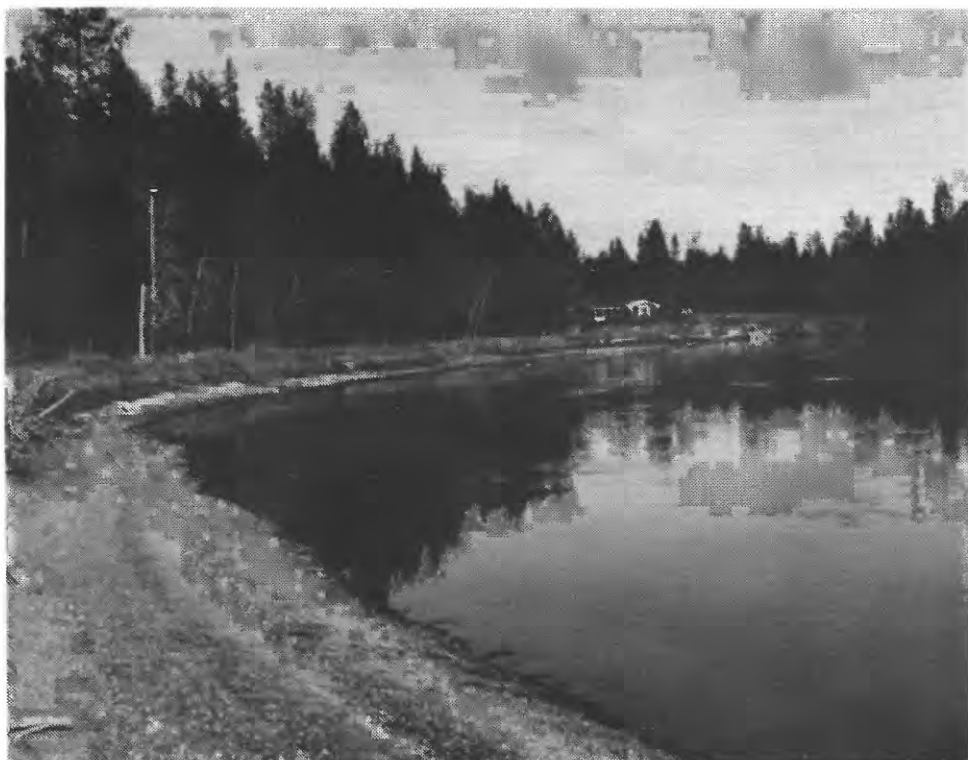
Figure 4.--Downstream view of upper Deschutes River at cross-section DR-3.

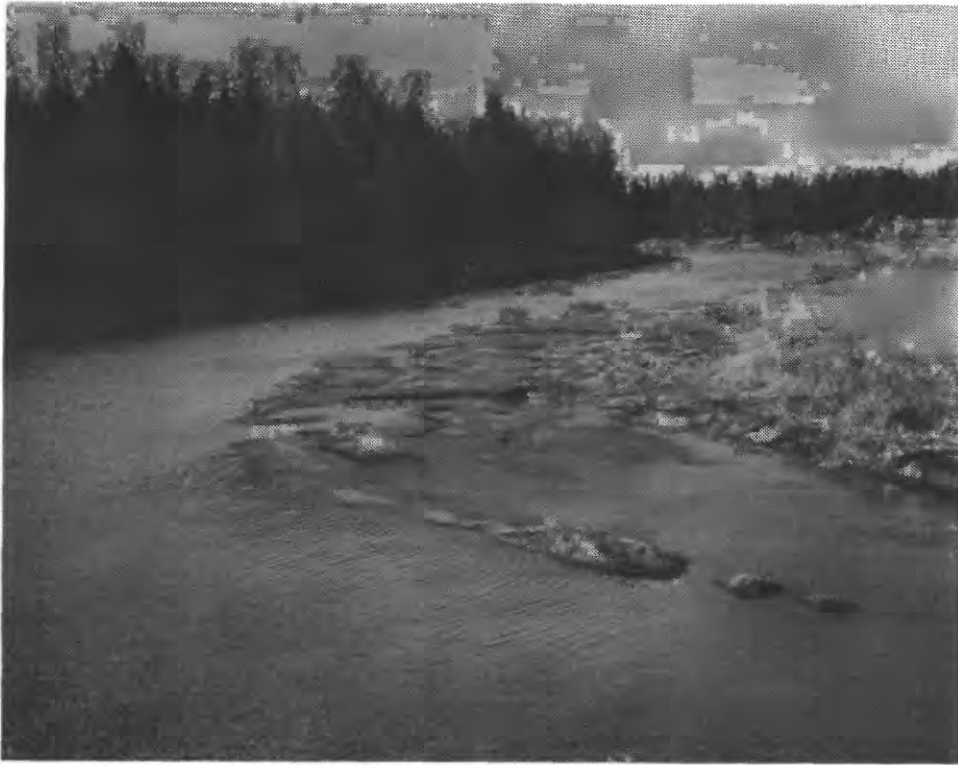
Figure 5.--Upstream view of upper Deschutes River at cross-section DR-4.

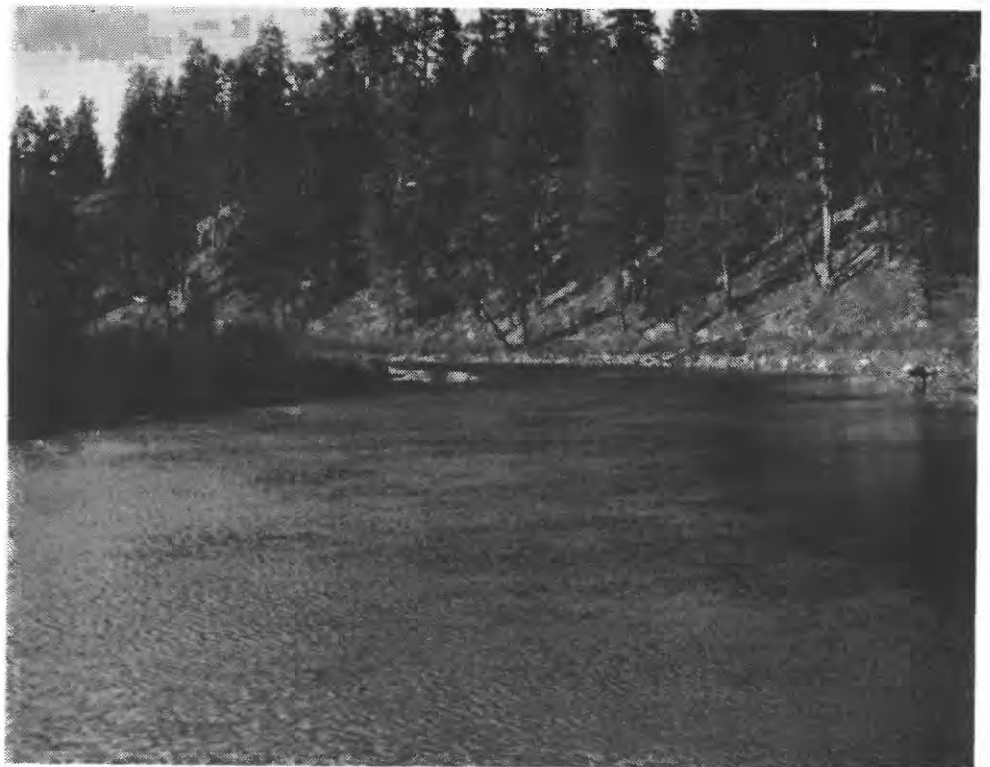
Figure 6.--Upstream view of upper Deschutes River at cross-section DR-5.

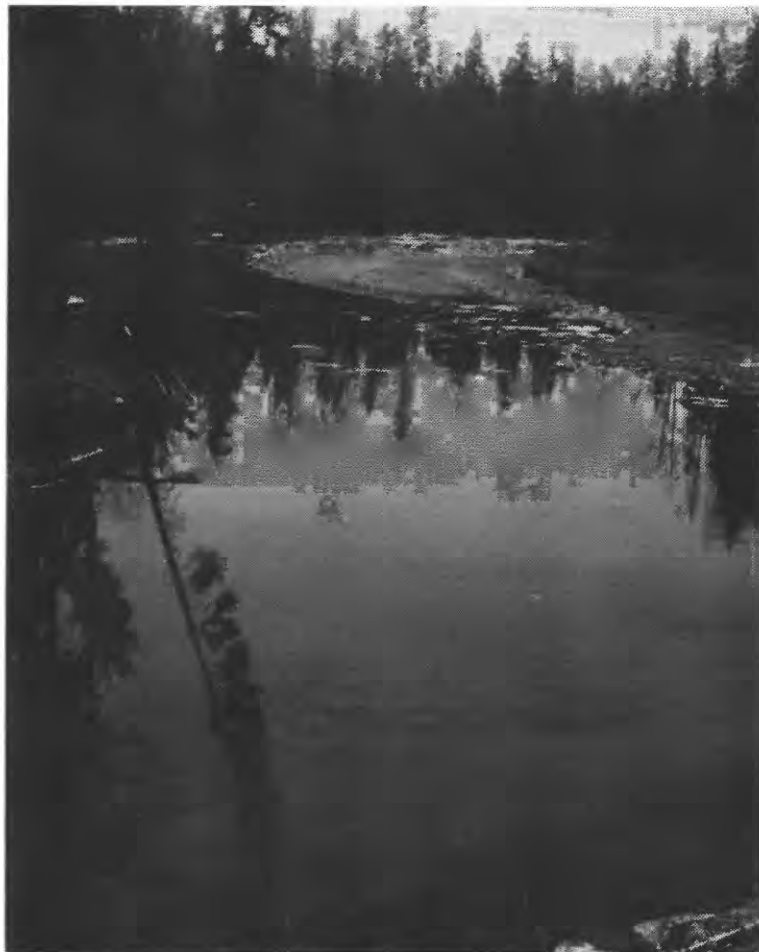
Figure 13.--"Plates" (below water surface, lower center of photograph) formed by erosion of siltstone bedrock at Bull Bend (site DR-1)

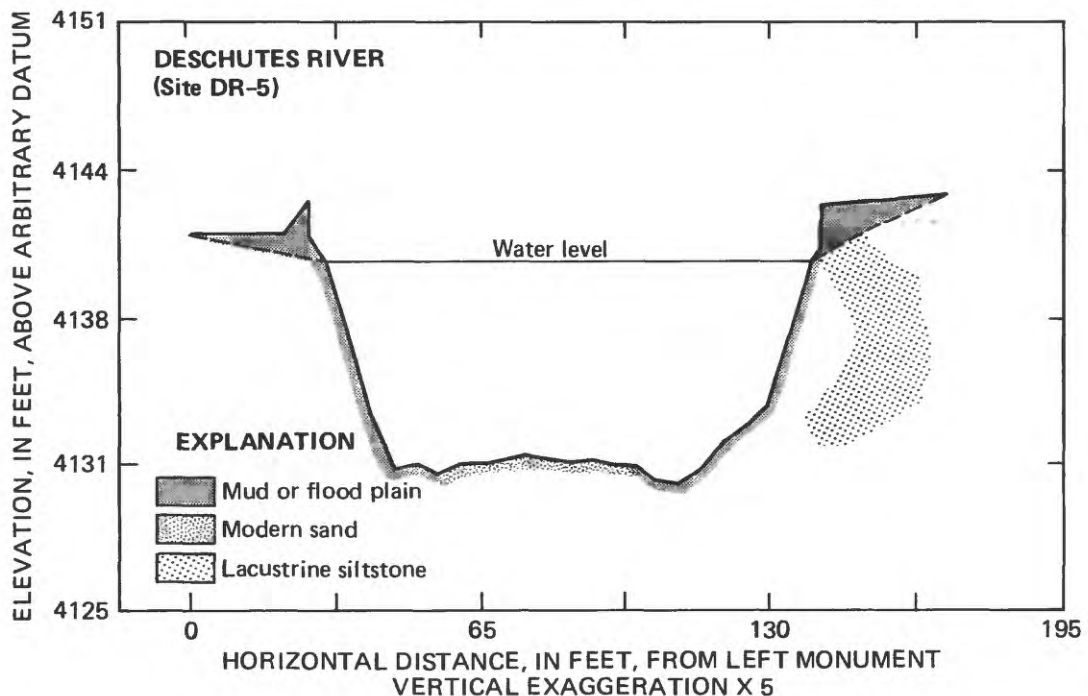
Cross-section 5 (DR-5)

The high-water channel width is 115 feet, of which 39 feet is sand covered, and the remainder presumed to be silt and clay covered. Owing to the deep water depth, bottom conditions could not be precisely determined. Maximum channel depth is about 10 feet at low water and 11.5 feet at high water. Both banks are flanked by grass covered, muddy areas of overbank deposition (maximum measured depth of silt and clay is 3 feet). A sand bar of unknown thickness occupies the channel center (fig. A-5).
