FLOOD OF AUGUST 18, 1986, NEWBERRY, SOUTH CAROLINA

U.S. GEOLOGICAL SURVEY

Water-Resources Investigations Report 88-4148

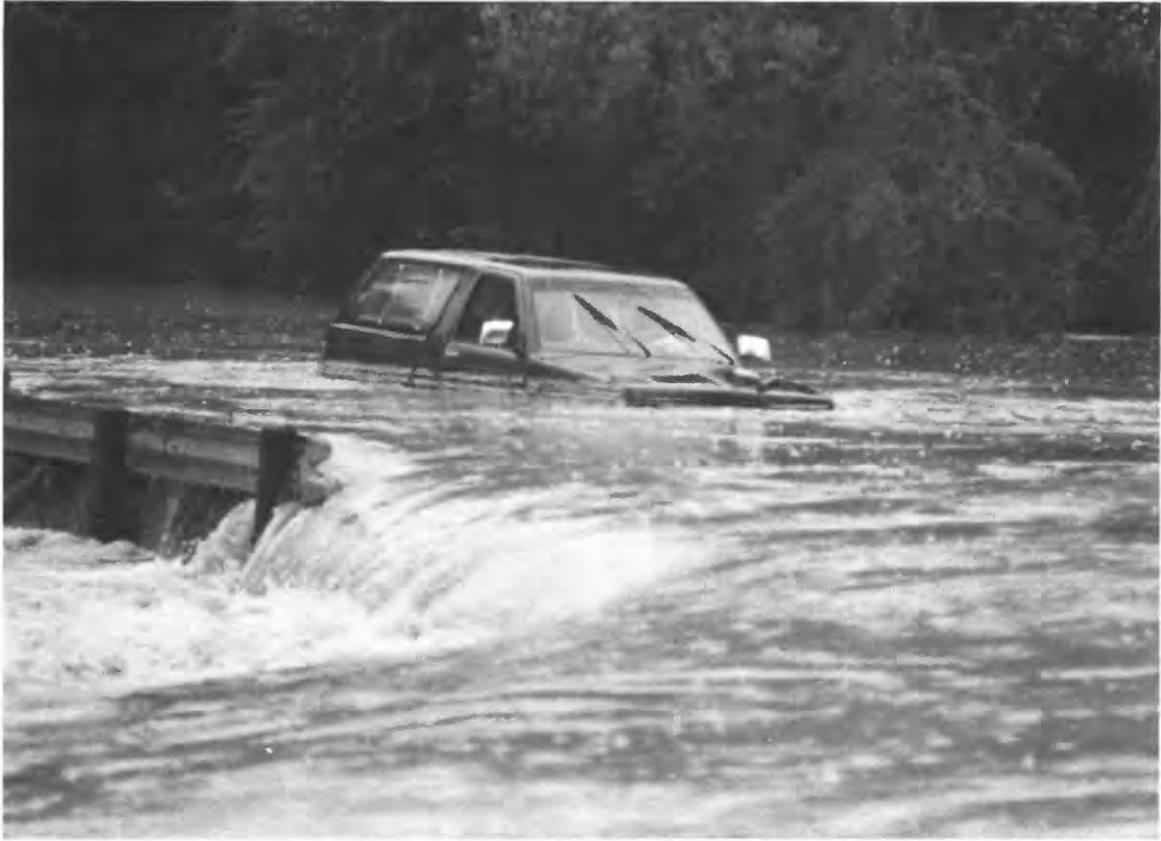
Figure 2.--Scotts Creek at O'Neal Street bridge; two occupants of vehicle lost their life at the site (Photograph courtesy of The Newberry Observer).

Two people lost their lives while trying to escape from a stranded car during the August 18, 1986 flood (fig. 2). Also, several homes, a church, and at least ten businesses were damaged. The Charles Street bridge over Scotts Creek was destroyed as well as a tennis court located in a park between Academy and Drayton Streets. All roads in the study area crossing Scotts Creek were inundated (figs. 3 and 4). Also, all streets in the South Scotts Creek study area, except the Southern Railroad embankment, were inundated. Along South Scotts Creek, water flooded a home approximately 300 feet upstream of the Southern Railroad culvert to its second story window. Also, the flooding damaged the culvert under the Southern Railroad to the extent that the culvert was replaced by a trestle (fig. 5). The flood caused an estimated \$800,000 in damage.

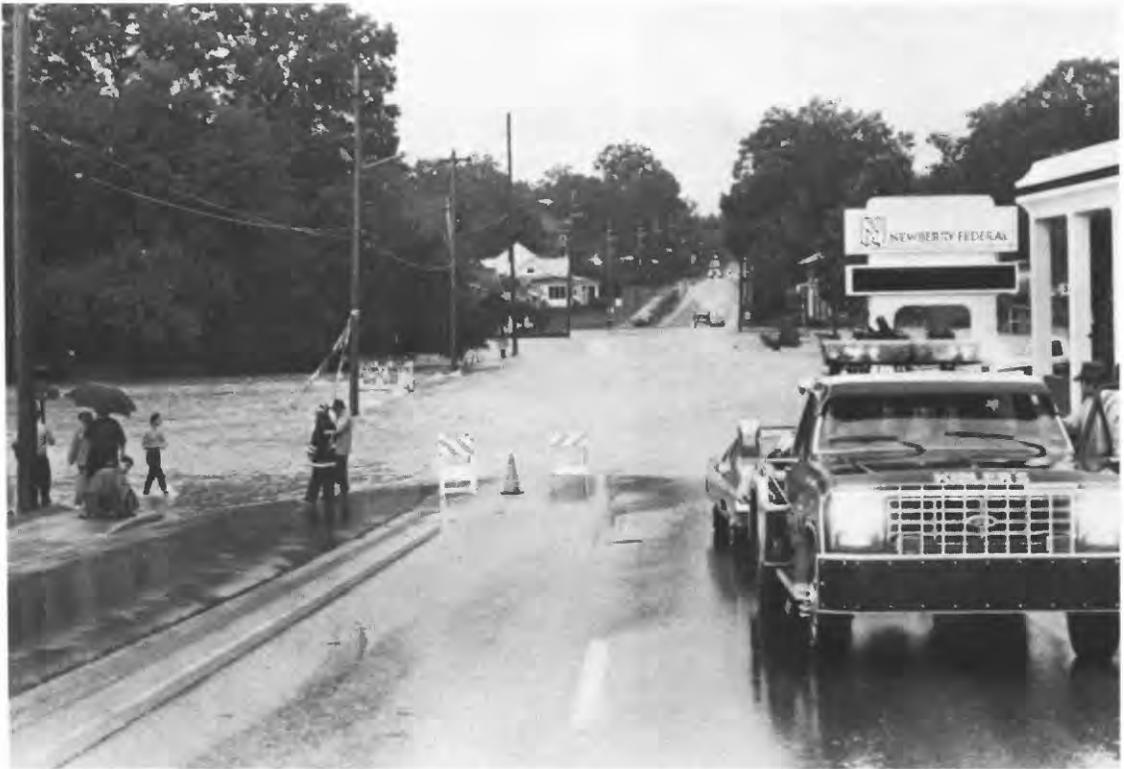
Figure 3.--Flood Waters of Scotts Creek at College Street (Photograph courtesy of The Newberry Observer).

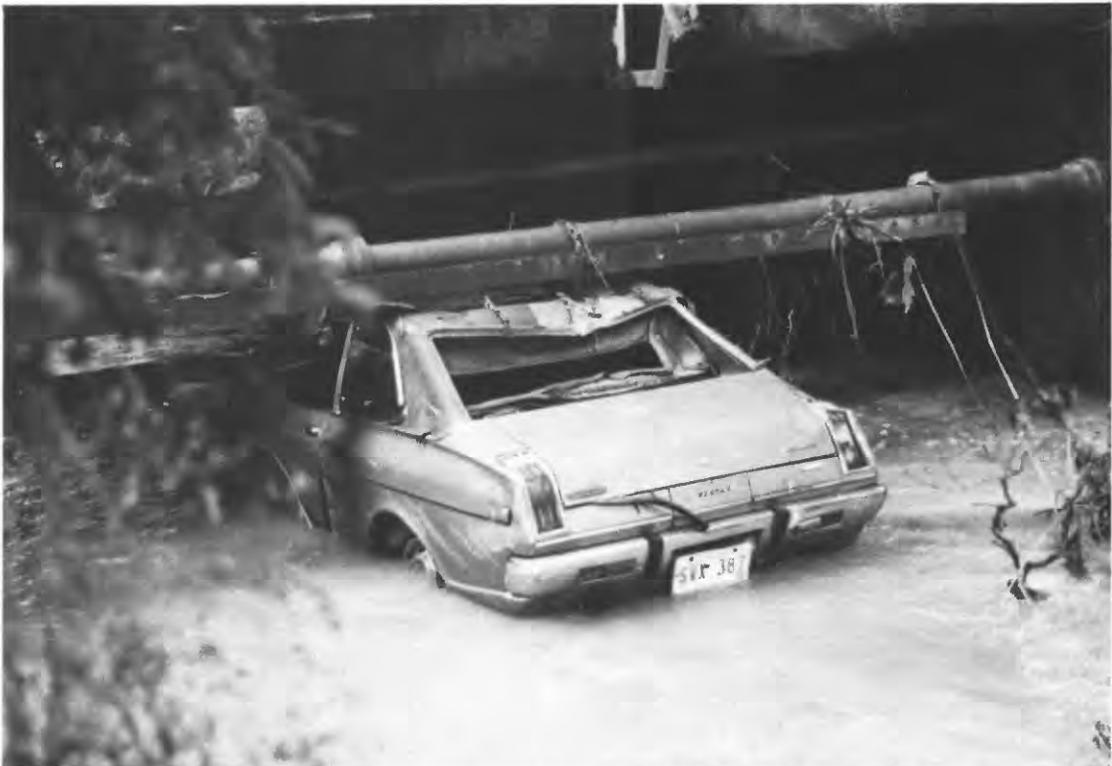
Figure 4.--Vehicle lodged under Caldwell Street bridge at Scotts Creek (Photograph courtesy of The Newberry Observer).

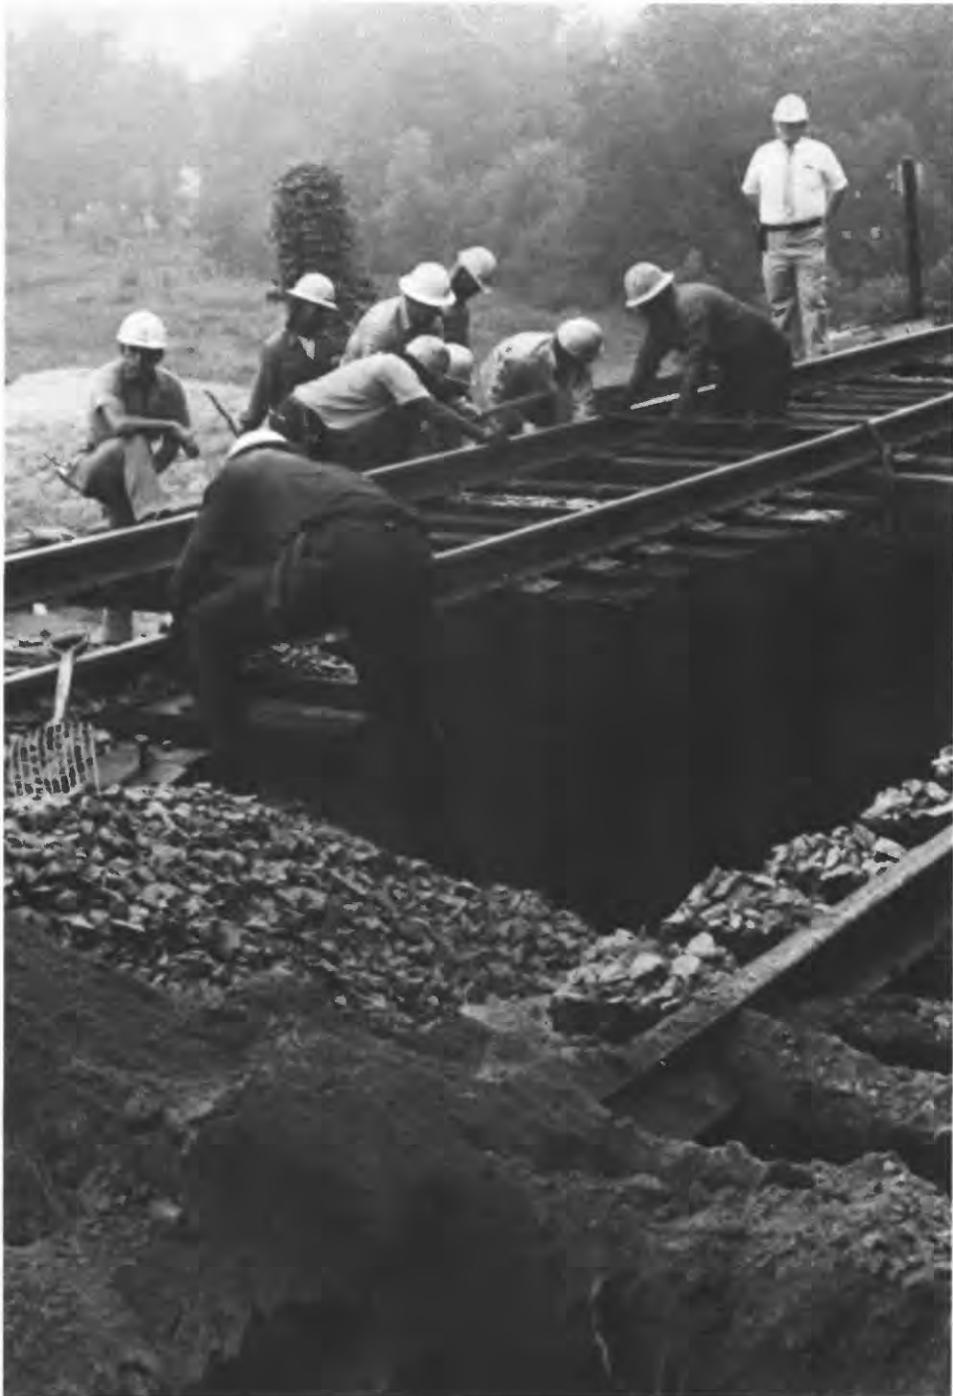
Figure 5.--Repair of Southern Railroad culvert at South Scotts Creek
(Photograph courtesy of The Newberry Observer).

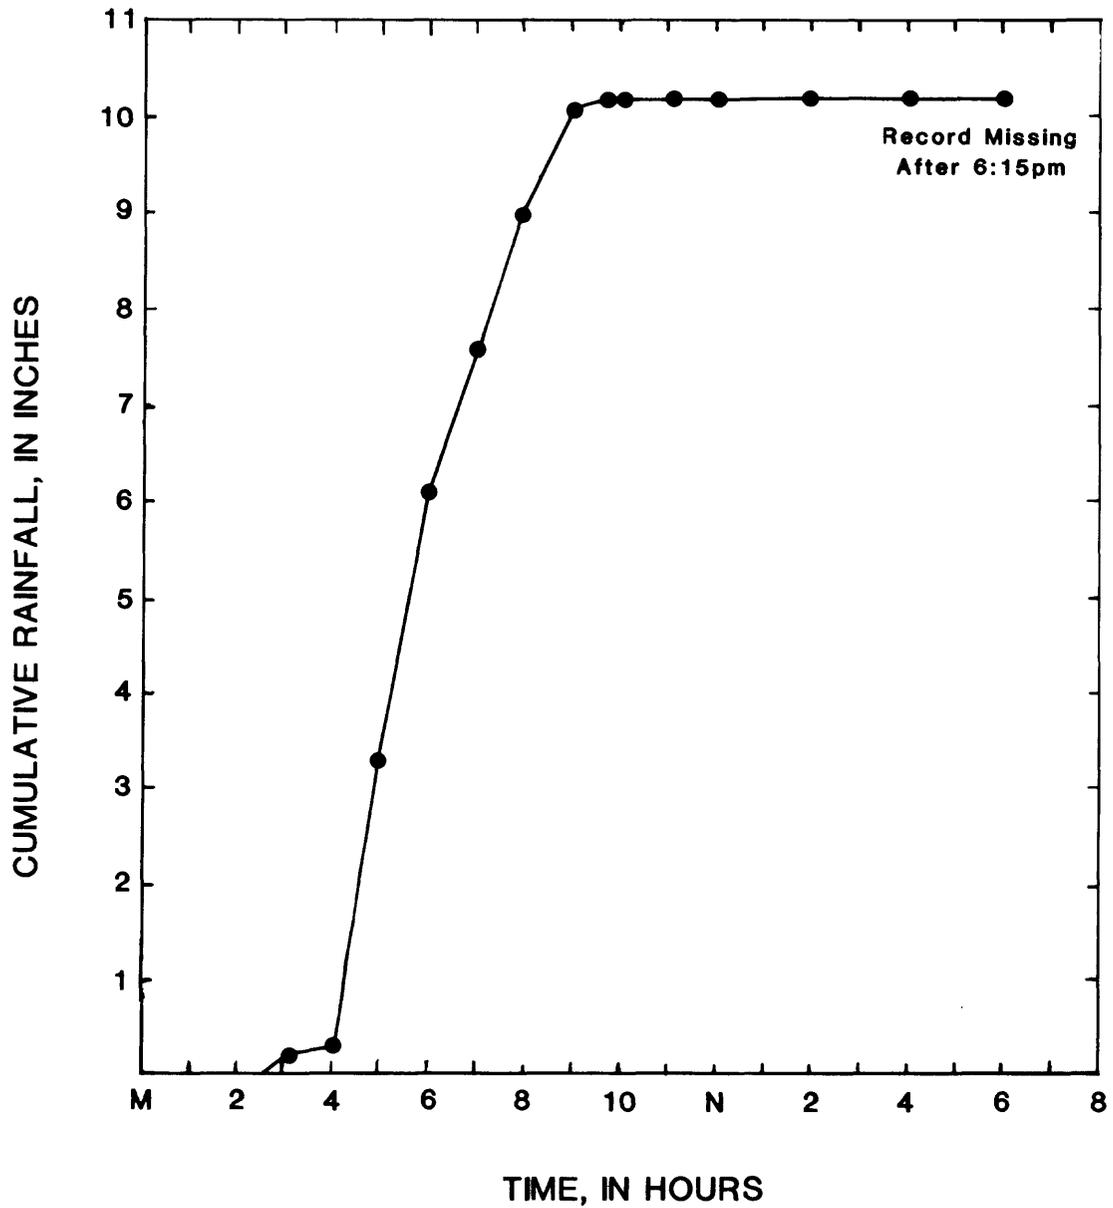
Figure 6.--Accumulated rainfall at National Weather Service gage for period midnight to 6:15 p.m., August 18, 1986.

Rainfall data for the August 18, 1986, storm in Newberry were collected by the National Weather Service at the raingage located just downstream from Nance Street near the left bank of Scotts Creek in Newberry (fig. 1). Rainfall data were collected on August 18, 1986, from midnight¹ until the recorder jammed at 6:30 p.m. Water from Scotts Creek had entered the recording station during the flood and wet the recording tape. This wet tape caused the recorder to jam. The recording tape showed that 10.2 inches of rain fell at the gage during a 7-hour period from 2:45 a.m. to 9:45 a.m. (fig. 6). No rainfall fell from 9:45 a.m. to 6:30 p.m. when the recorder failed. The two streams in this study crested at about 8:00 a.m. on August 18, 1986.

In addition to the digital recording gage the National Weather Service operates, a nonrecording rainfall gage at the same location is manually checked daily at 5:00 p.m. by the Newberry Fire Department. On August 18, 1986, the recorded rainfall was 10.42 inches. Therefore, practically all the rainfall that caused the flood was recorded at the rainfall gaging station, even though the recorder jammed.

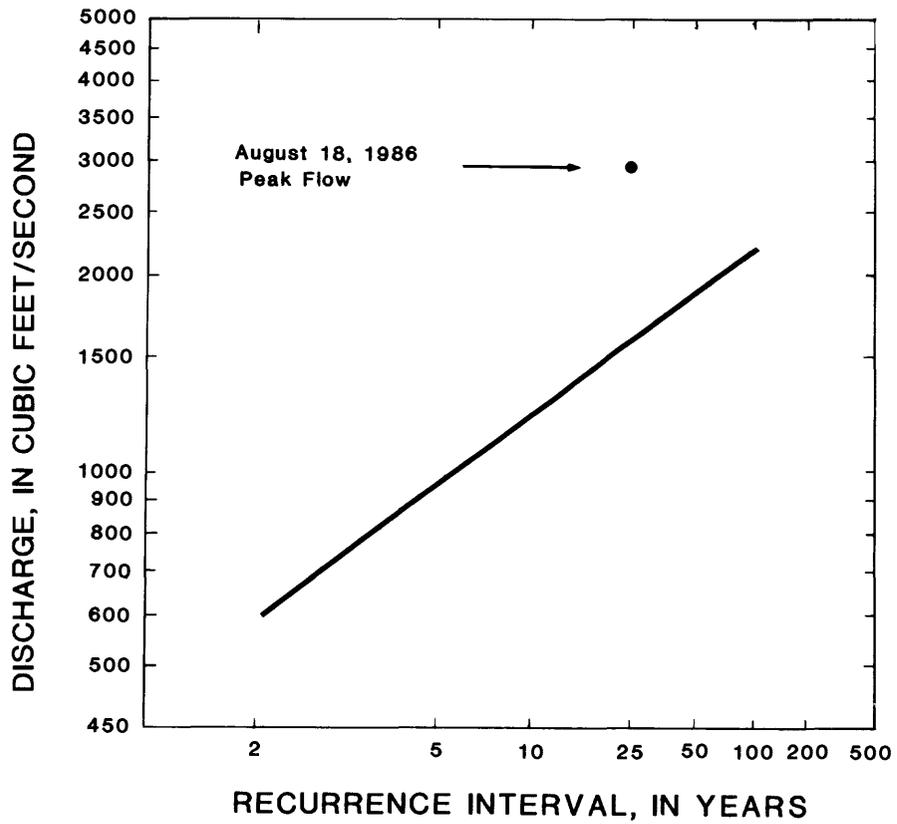
Figure 7.--Flood-frequency curve for Scotts Creek.

Peak discharges for various recurrence intervals were computed for Scotts Creek and South Scotts Creek (figs. 7 and 8) by using equations developed by Whetstone (1982) and adjusted for urbanization by using equations developed by Sauer and others (1983). Drainage area, streambed slope, percent imperviousness, storage, channel length, and basin development variables were determined from U.S. Geological Survey 7.5 minute series topographic maps of the Newberry East and Newberry West quadrangles and field inspection.

Figure 7 shows that the 100-year flood for Scotts Creek is a discharge of 2,200 ft³/s, compared to a peak discharge of 2,800 ft³/s computed for the August 18, 1986, flood.

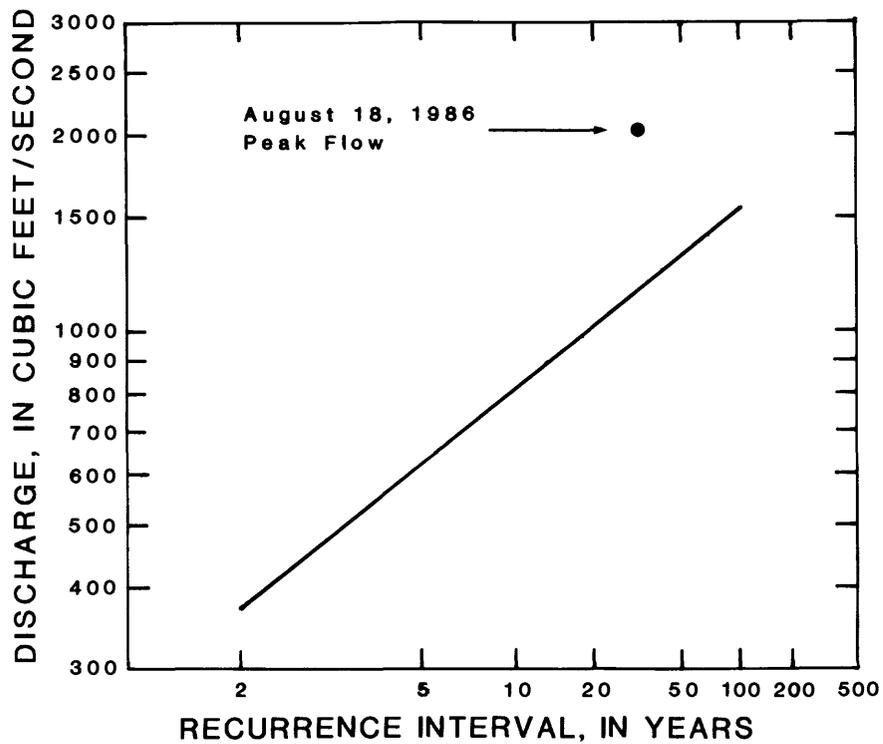
Figure 8.--Flood-frequency curve for South Scotts Creek.

Figure 8 shows that the 100-year flood for South Scotts Creek is a discharge of 1,560 ft³/s compared to a discharge of 2,000 ft³/s computed for the August 18, 1986, flood.
