STREAMFLOW, SEDIMENT, DISCHARGE, AND STREAMBANK EROSION  
IN CACHE CREEK, YOLO COUNTY, CALIFORNIA, 1953-86

By *Jerry G. Harmon*

U.S. GEOLOGICAL SURVEY

Water-Resources Investigations Report 88-4188

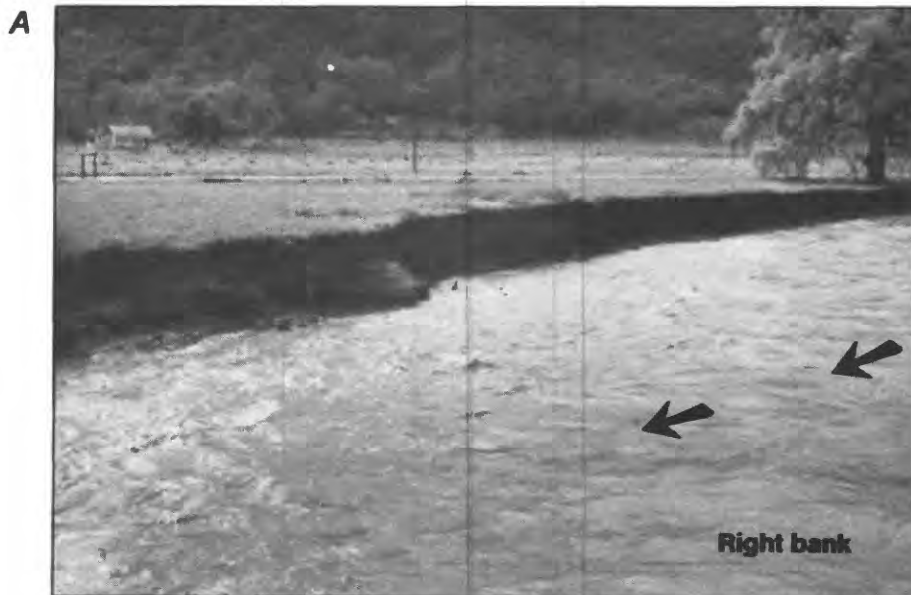
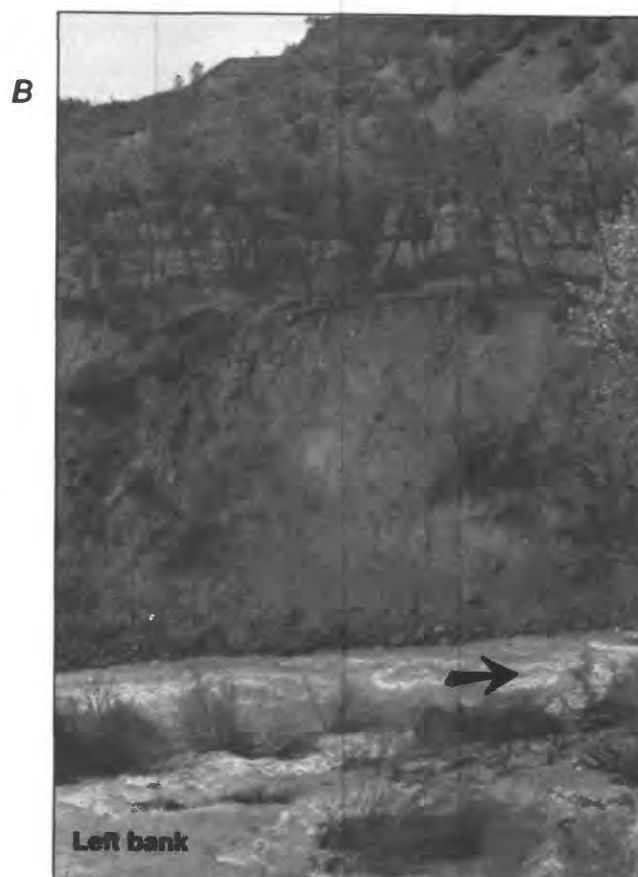
**FIGURE 4.—** Photographs showing (A) fine material exposed on right bank at cross section 36A and (B) various sizes of material on left bank near cross section 43. (Arrows indicate direction of flow.)
