USE OF PALEOFLOOD INVESTIGATIONS TO IMPROVE FLOOD-FREQUENCY ANALYSES OF PLAINS STREAMS IN WYOMING

U.S. GEOLOGICAL SURVEY

Water-Resources Investigations Report 88-4209

By Maurice E. Cooley

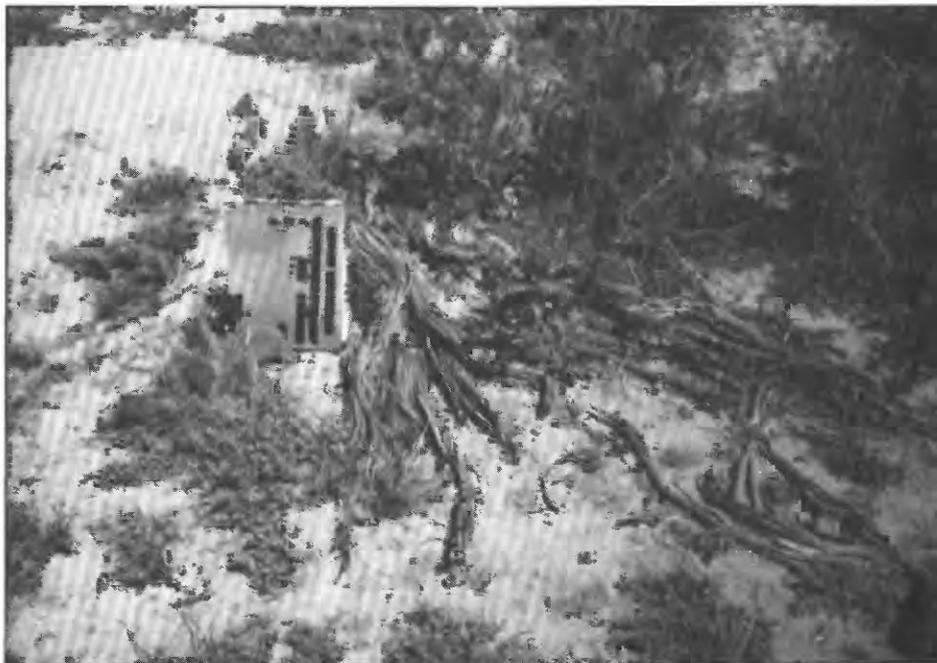
Figure 5.—Extreme state of flaking of weathered sagebrush debris deposited by a historical flood along Delaney Draw. Date of photograph: August 20, 1982.

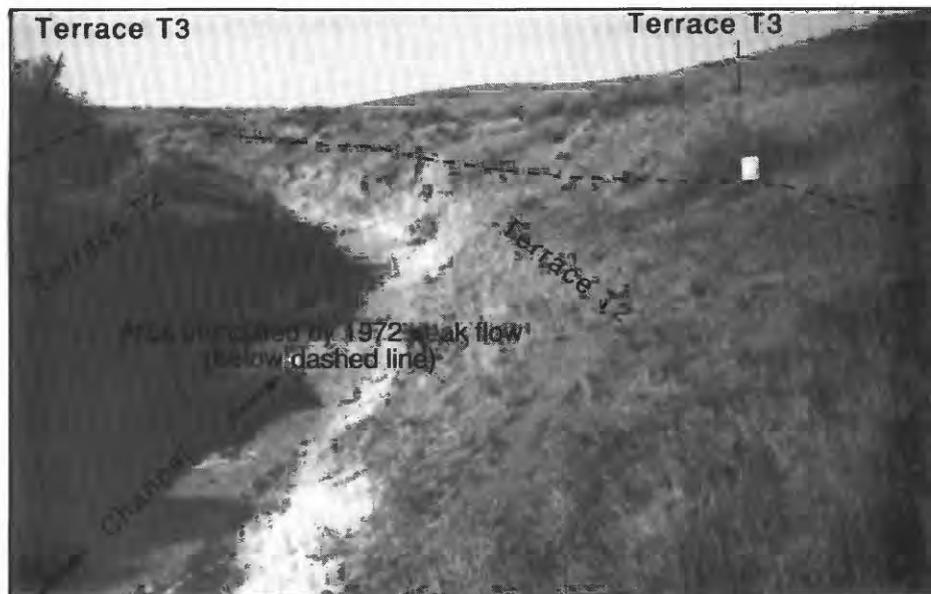
Figure 12.--Downstream view along Dead Horse Creek tributary no. 2 near Midwest, showing the relation of the 1972 peak flow to geomorphic features. The peak flow was 1,470 cubic feet per second. Date of photograph: April 28, 1982.

1. Terrace T2 is 8 ft above the streambed; this height indicates that the terrace may be inundated frequently. Sharply eroded vertical sides of this terrace indicate that numerous flows near the height of the terrace have occurred during recent years. These flows also may have caused a slight deepening of the channel.
2. Some overbank deposits overlie a soil at the top of terrace T2 deposits, indicating previous inundation(s) of the terrace.
3. Vegetation on terrace T2 is a mixed type, including types common to the overflow area and to the adjacent rangeland. Range-type vegetation is on the upper sides and on the summit of terrace T3. The combination of vegetation types common to the overflow area and to the rangeland indicates that terrace T2 may be inundated frequently, and that the upper sides of terrace T3 are seldom inundated.

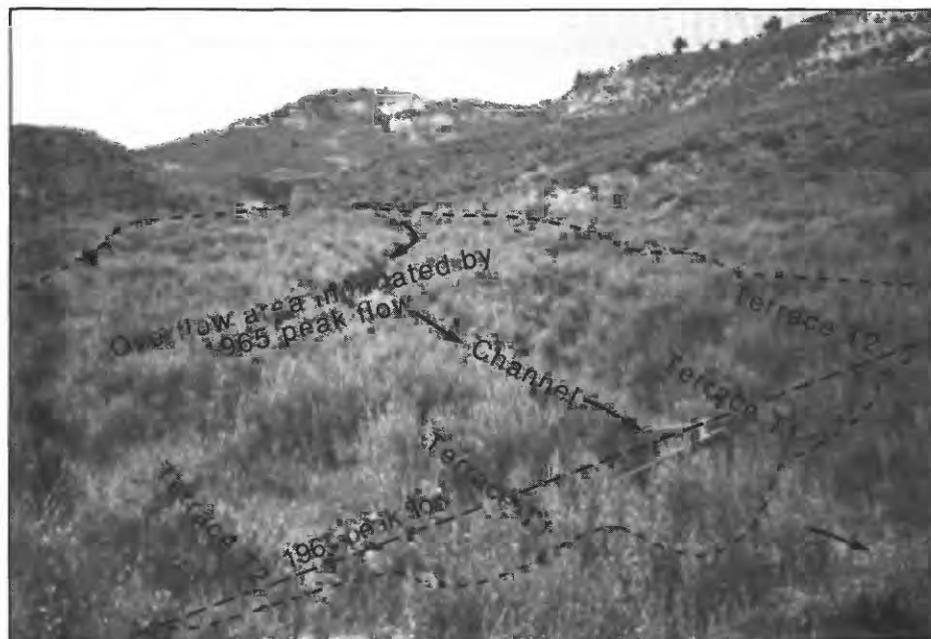
Figure 14.--Upstream view of Coal Draw near Buffalo, showing the relation of the 1965 peak flow to the principal geomorphic features. The peak flow was 2,290 cubic feet per second. Date of photograph: July 13, 1982.

Data collected in the reach of Coal Draw near the site of the streamflow-gaging station (site 5, fig. 1) indicate that the 1965 peak flow (2,290 ft³/s), the largest peak flow of record, inundated nearly all the bottom land between the steep valley sides. The 1965 peak flow inundated terrace T2 and much of the alluvial slopes adjacent to this terrace (fig. 14). Terrace T2 is only 6.5 ft above the streambed and is in the overflow area. The shape of terrace T2 has been modified, particularly by deposition of overbank sediments

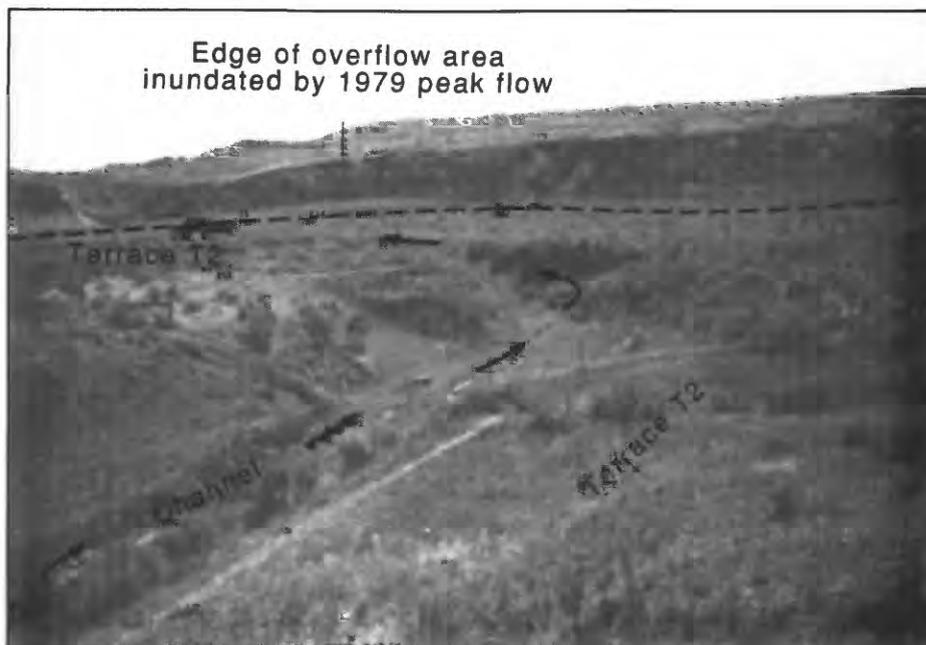
Figure 16.--Downstream view along Turner Creek near Osage, showing the relation of the 1979 peak flow to the widespread terrace T2 and the bottom land. The peak flow was 5,660 cubic feet per second. The channel in the foreground has been modified from construction of the bridge on U.S. Highway 85. Date of photograph: July 15, 1982.

1. As reported by a local resident (Milton Holwell, oral commun., 1982), the 1979 peak flow has been the largest peak flow since at least 1918. This peak flow may have been the largest peak flow since the area was settled during the early 1880's, because few large floods are known to have occurred in this region.
2. The 1979 peak flow inundated nearly all the bottom land, including all of terrace T2. Flood debris above the level of the 1979 peak flow was not recognized.
3. Flood features, such as scouring or overbank deposits, were not recognized on alluvial slopes above the level of the 1979 peak flow. Rills and small channels formed by tributary flow were recognized on slopes not inundated by the 1979 peak flow.

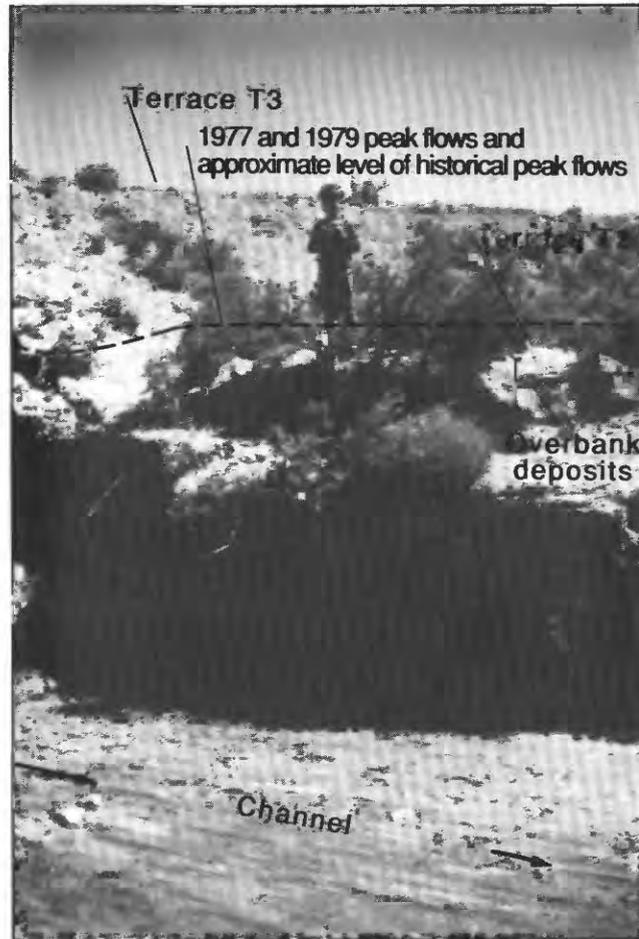
Figure 17.--View across the channel of Third Sand Creek near Medicine Bow, showing the relation of the 1977 and 1979 peak flows to the principal geomorphic features and overbank deposits emplaced by the 1977 and 1979 peak flows, and by the historical peak flows (pre-1965) on terrace T2. Peak flows, in cubic feet per second, were as follows: 1977, 1,580; 1979, 1,540. Date of photograph: June 29, 1982.

Data collected in the reach of Third Sand Creek near the site of the streamflow-gaging station (site 8, fig. 1) indicate that historical peak flows (before 1965) approximately the magnitude of the two largest peak flows of record—1,580 ft³/s in 1977, and 1,540 ft³/s in 1979—have occurred from time to time during the last several decades. Relations between all the peak flows and terrace T2 were obtained in the reach upstream from the station (fig. 17). The channel at the gaging site and downstream appears to have been deepened recently, mainly by construction activity along a county road that crosses the creek downstream from the gage. The pre-1965 historical peak flows are indicated by a buried mantle of sandy and silty overbank deposits on terrace T2. The overbank deposits are between 1 and 1.5 ft thick and are distributed over all of terrace T2; terrace T2 is 7 ft high and forms nearly all the bottom land. Root crowns of big sagebrush, buried at depths of 0.5 and 0.7 ft between layers of overbank deposits indicate that: (1) These plants have been affected during floods caused by the two largest peak flows of record and at least one historical peak flow; and (2) at least two historical peak flows emplaced most of the overbank deposits. All the peak flows are classified as large peak flows. The overbank deposits and the dense stand of silver sagebrush indicate terrace T2 is in the overflow area and has been inundated frequently since its formation.

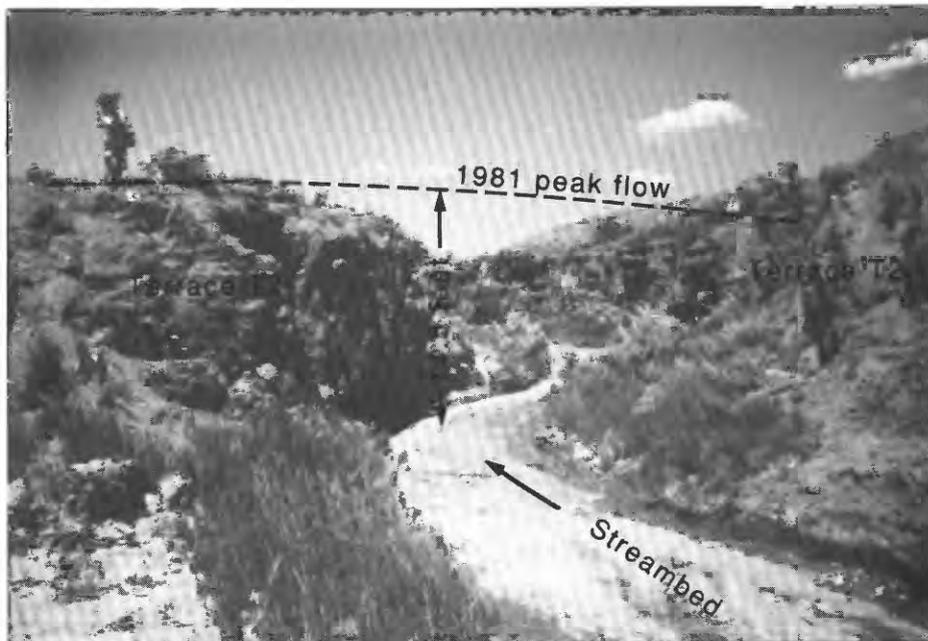
Figure 19.--Downstream view of Stinking Creek tributary near Alcova, showing the relation of the 1981 peak flow to terrace T2. The peak flow was estimated to be 2,000 cubic feet per second. This terrace was inundated at a shallow depth--just above the boy's ankle (left bank), and is at the base of the notebook (right bank). The peak flows of the systematic record were confined to the lower one-third of the channel. Date of photograph: July 1, 1982.

1. Based on information reported by R.A. Boyd of Boyd Ranch (oral commun., 1982), the 1981 peak flow in the adjacent drainage of Lawn Creek near Alcova (site 9, fig. 1), which occurred at the same time as the peak flow on Stinking Creek tributary, probably was the largest peak flow to have occurred since at least 1930.
2. A comparison of the relation of the peak flow to terrace T2 in this drainage with that in the Lawn Creek drainage indicates that the peak flow was larger in this drainage, where the peak flow inundated terrace T2, than that in the Lawn Creek drainage, where the peak flow did not inundate terrace T2 (see preceding section on Lawn Creek near Alcova).

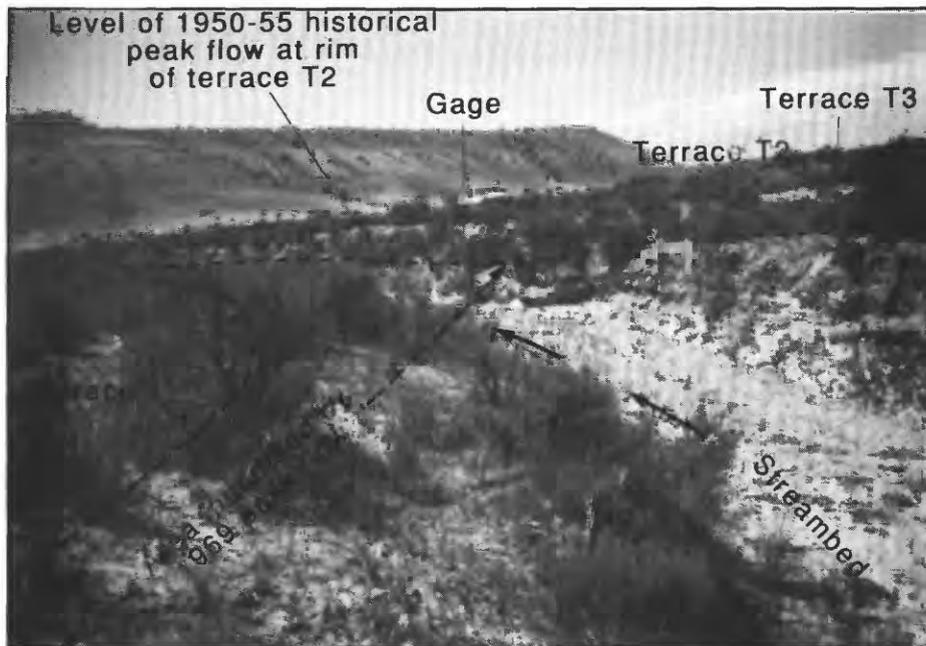
Figure 21.--Downstream view along East Otterson Wash near Green River, showing the relation of the 1950-55 historical peak flow and the 1969 peak flow (the largest peak flow of the systematic record) to the principal geomorphic features. Peak flows, in cubic feet per second, were as follows: 1950-55, 1,500 (estimated); 1969, 791. Date of photograph: August 19, 1982.

1. The absence of sagebrush debris deposited by floods higher than the level of this peak flow indicates this peak flow was the largest for at least 50 years, because a complete decay process for sagebrush debris deposited by floods in southwestern Wyoming is estimated to take more than 50 years.
2. Features formed during peak flows were not recognized on terrace T2 or on slopes higher than the area inundated by the 1950-55 peak flow, indicating those areas have not been inundated recently.
3. The abutments of a wood bridge near the station, of the type built during the 1920's or 1930's, indicate that the depth of the channel has not changed appreciably since the construction of the bridge.

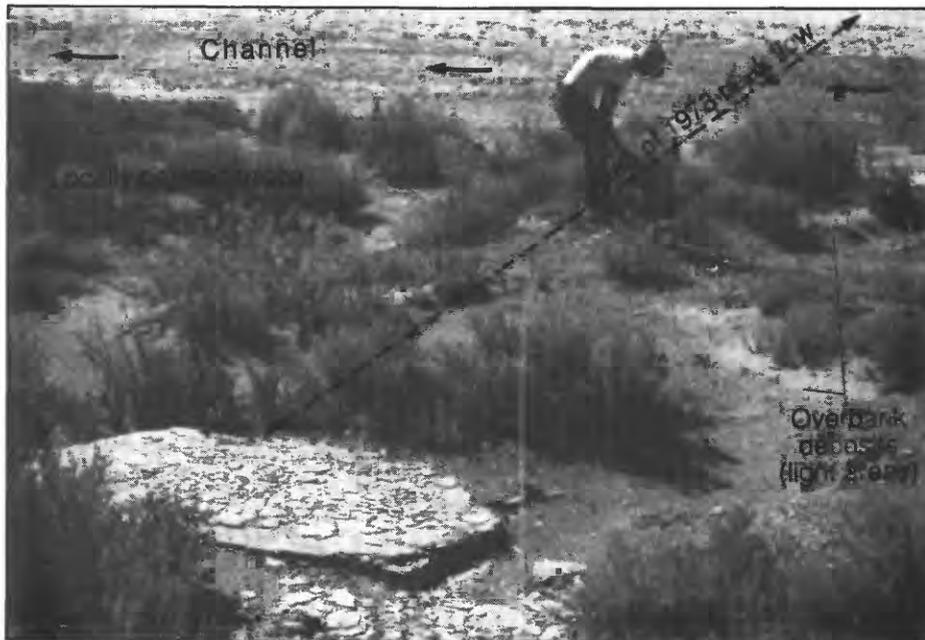
Figure 26.--View across a locally developed paired terrace along Summers Dry Creek near Green River, about 2,000 feet downstream from the streamflow-gaging station. The surface of the large sandstone slab (foreground) consists of thin sandstone flakes that have weathered from the main sandstone slab. The 1973 peak flow (13,900 cubic feet per second) did not inundate the sandstone slab but was along its lower edge. Date of photograph: August 16, 1982.

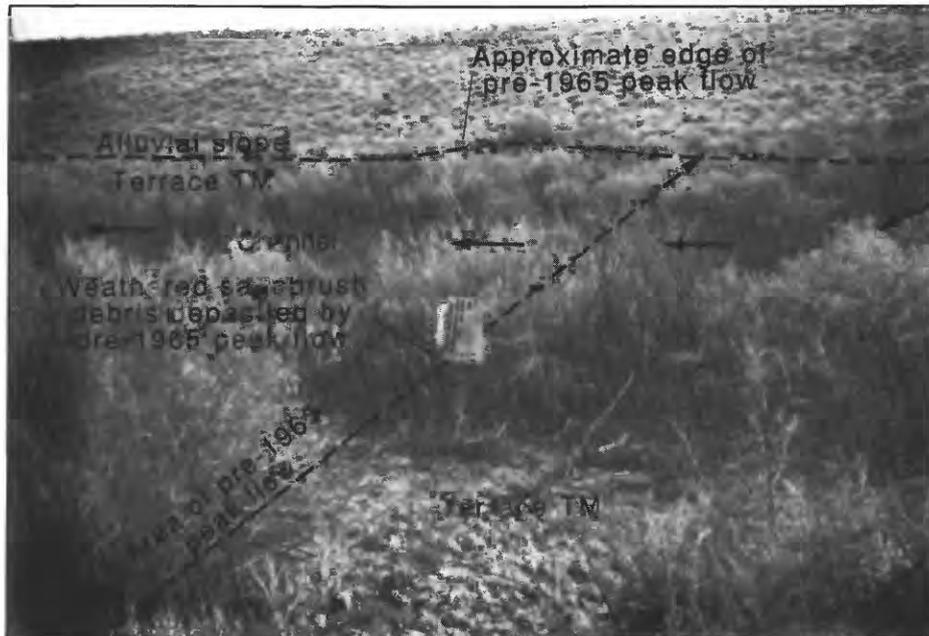
Figure 29.--View across the channel of Blacks Fork tributary no. 2 near Green River, showing the relation of the historical peak flow to the principal geomorphic features. The peak flow was estimated to be 1,000 cubic feet per second. Date of photograph: August 19, 1982.

Data collected in the reach of Blacks Fork tributary no. 2 near the site of the discontinued streamflow-gaging station (site 18, fig. 1) indicate the occurrence of a pre-1965 historical peak flow. The peak flow was estimated to be 1,000 ft³/s. The peak flow inundated terrace TM (fig. 29) and the lowest slopes of the alluvial apron. The peak flow of record, 180 ft³/s, which is classified as a small peak flow, was in 1976. This peak flow filled only about one-half of the channel.
