RESULTS OF A RECONNAISSANCE BRIDGE-SCOUR STUDY AT SELECTED SITES IN OREGON USING SURFACE-GEOPHYSICAL METHODS, 1989

By Milo D. Crumrine

U.S. GEOLOGICAL SURVEY

Water-Resources Investigations Report 90-4199

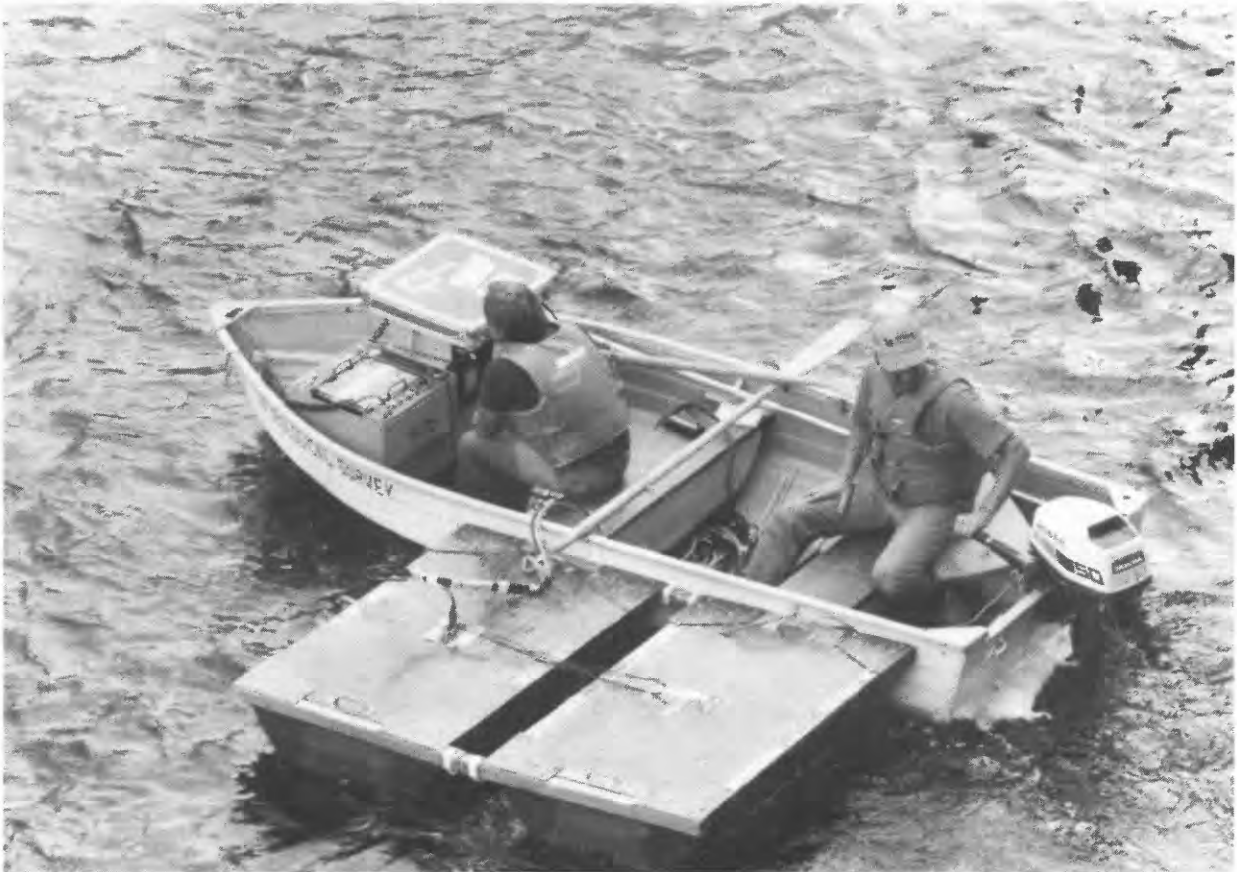
GPR transmits electromagnetic signals in the 80-1,000 MHz (megahertz) frequency spectrum. The GPR signal is transmitted and received by antennae that are usually floated along the side of the survey boat. Although GPR can be operated over dry land, all of the radar profiles made for this study were done over water. The use of GPR in a small boat is shown in figure 1.

Figure 1.--Ground-penetrating-radar equipment being operated from a small boat.

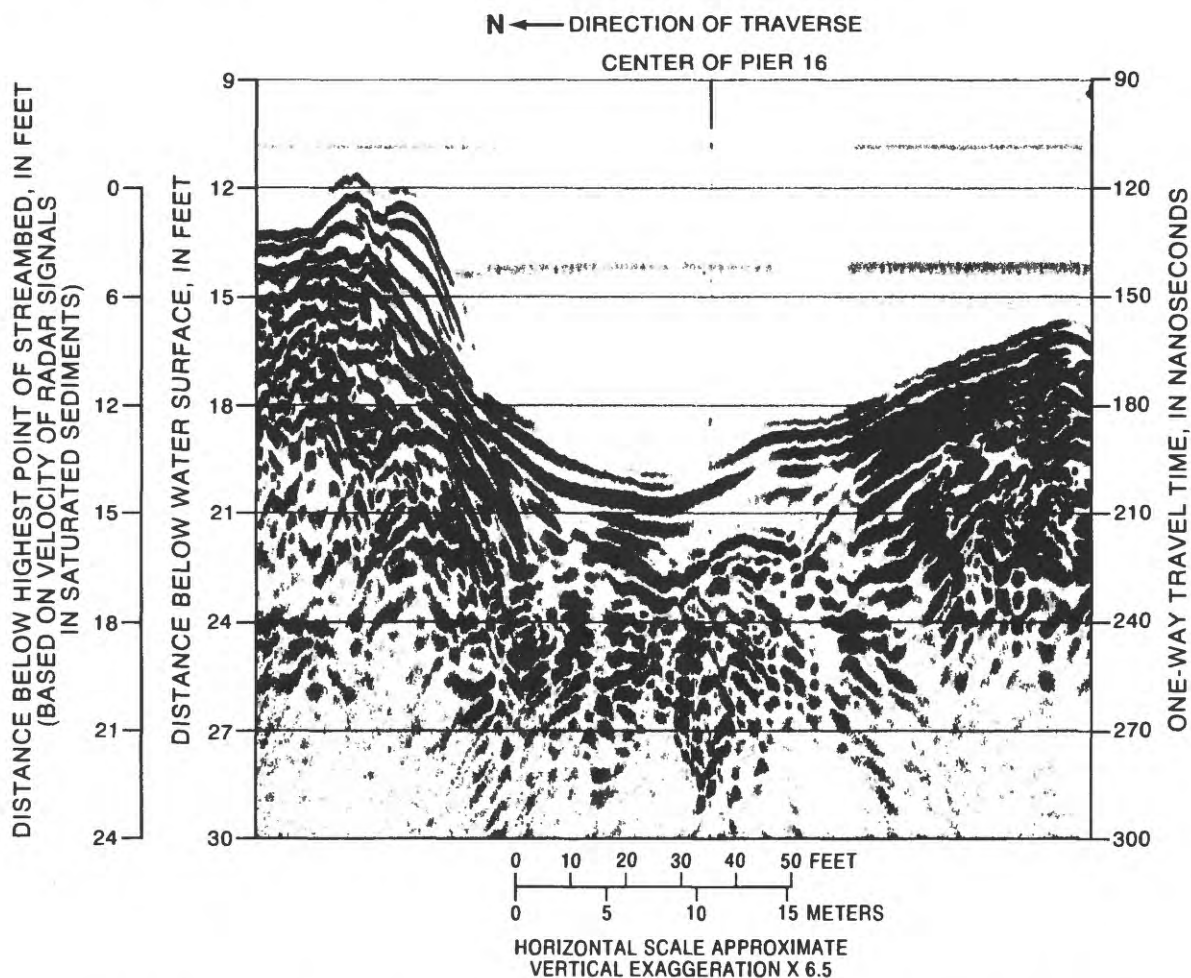
Data from GPR measurements are displayed on a chart recorder and recorded on a magnetic tape recorder. Data can be reproduced by playing the magnetic tape back into the radar receiver and recording on the chart. This is useful for reviewing the data at different gain or contrast settings and for processing the data to obtain clearer records. An example of uncorrected GPR record is shown in figure 2.

Figure 2.--Example of ground-penetrating-radar record (Columbia River at Highway I-205, 20 feet upstream from pier 16).

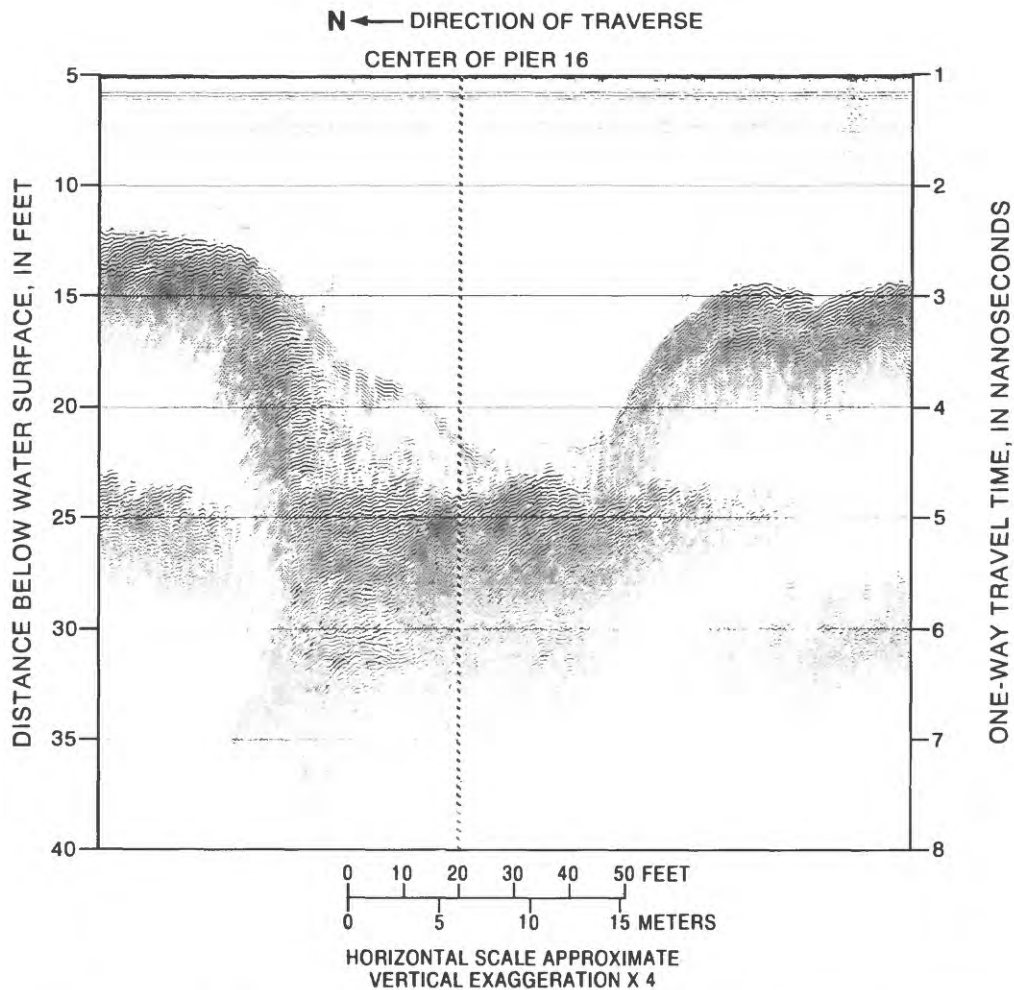
Figure 3.--Example of a 14 kilohertz tuned-transducer record (Columbia River at Highway I-205, 20 feet upstream from pier 16).

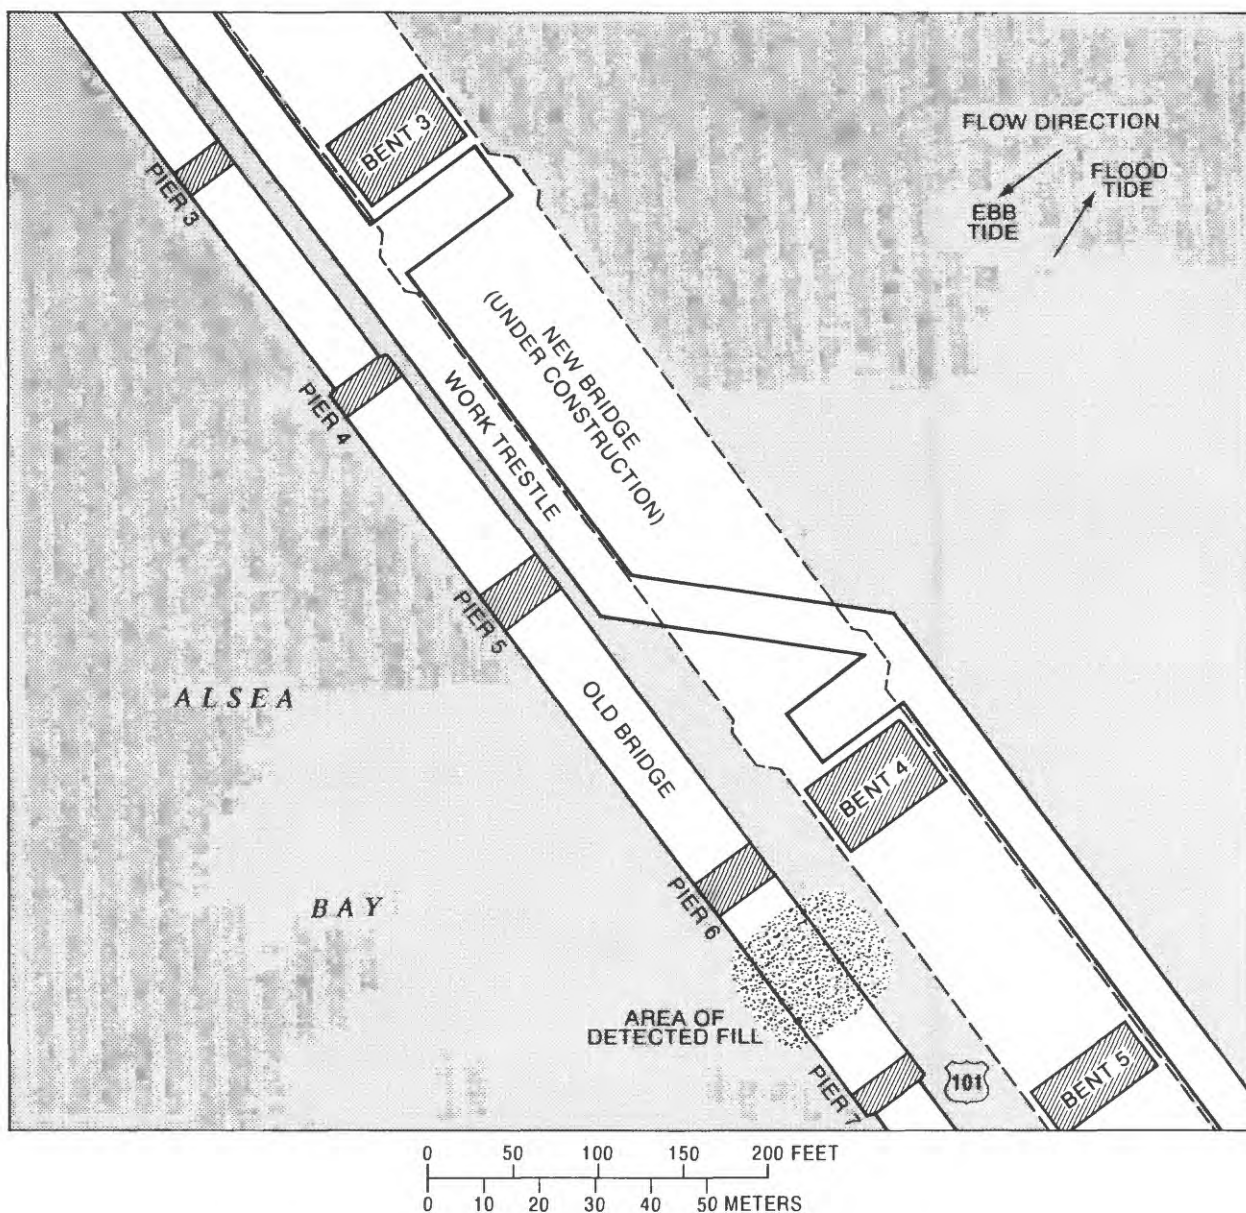
Construction of the new bridge has caused a decrease in outgoing velocity in the vicinity of pier 6 of the old bridge. This drop in velocity, along with constriction scour from the work trestle and new coffer dam, has resulted in sand being deposited underneath the old bridge between piers 6 and 7.

Figure 7.--Plan view of Highway 101 bridge and construction trestle at Alsea Bay, Oregon.

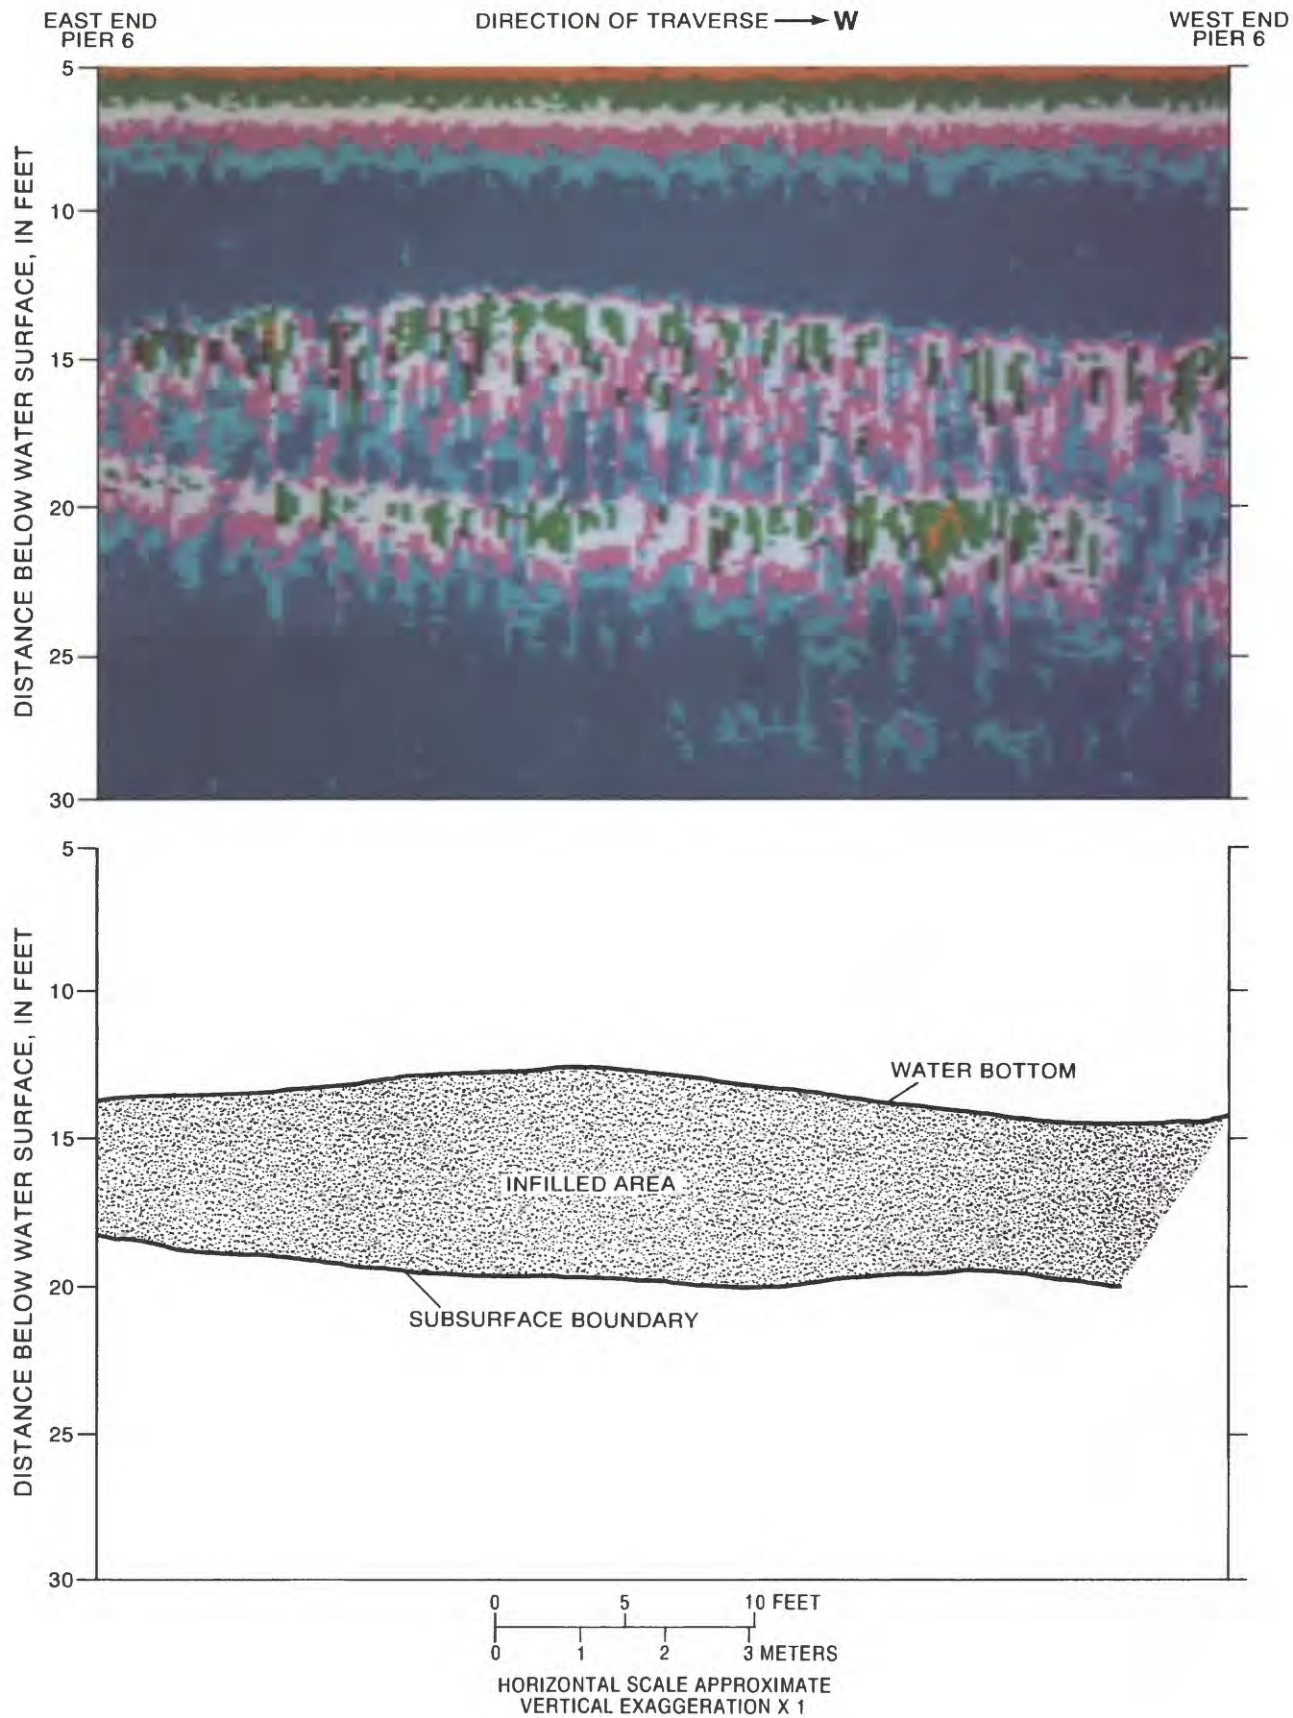
Two geophysical methods (TT and CF) were used at this site. Because Alsea Bay consists mostly of seawater, GPR could not be used. The CF record indicated a subsurface layer underneath the old bridge between piers 6 and 7. The thickness of the infill material was interpreted from the CF to be about 5 ft thick. This agrees with field measurements made in the same location (U.S. Geological Survey, unpub. data, Portland, Oregon, 1989). The TT record showed some indication of infilling, but it was not as clear as it was on the CF record. A CF photograph showing infilling 20 ft south of pier 6 is shown in figure 8.

Figure 8.--A 20-kilohertz color-fathometer record and interpretation of infilled area at Alsea Bay, Oregon.
Location of lateral run is 20 feet south of pier 6.

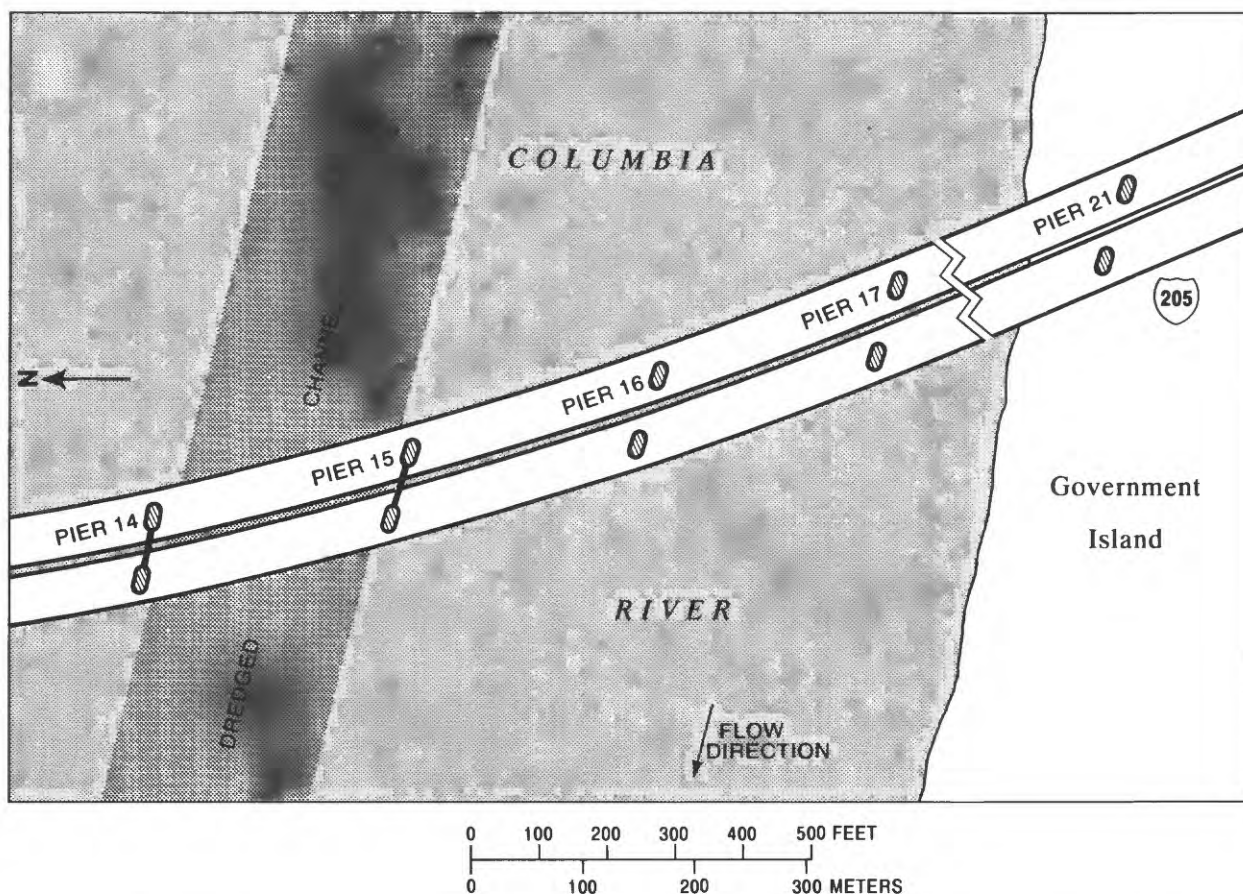
Figure 9.--Plan view showing Interstate-205 bridge over the Columbia River near Portland, Oregon.

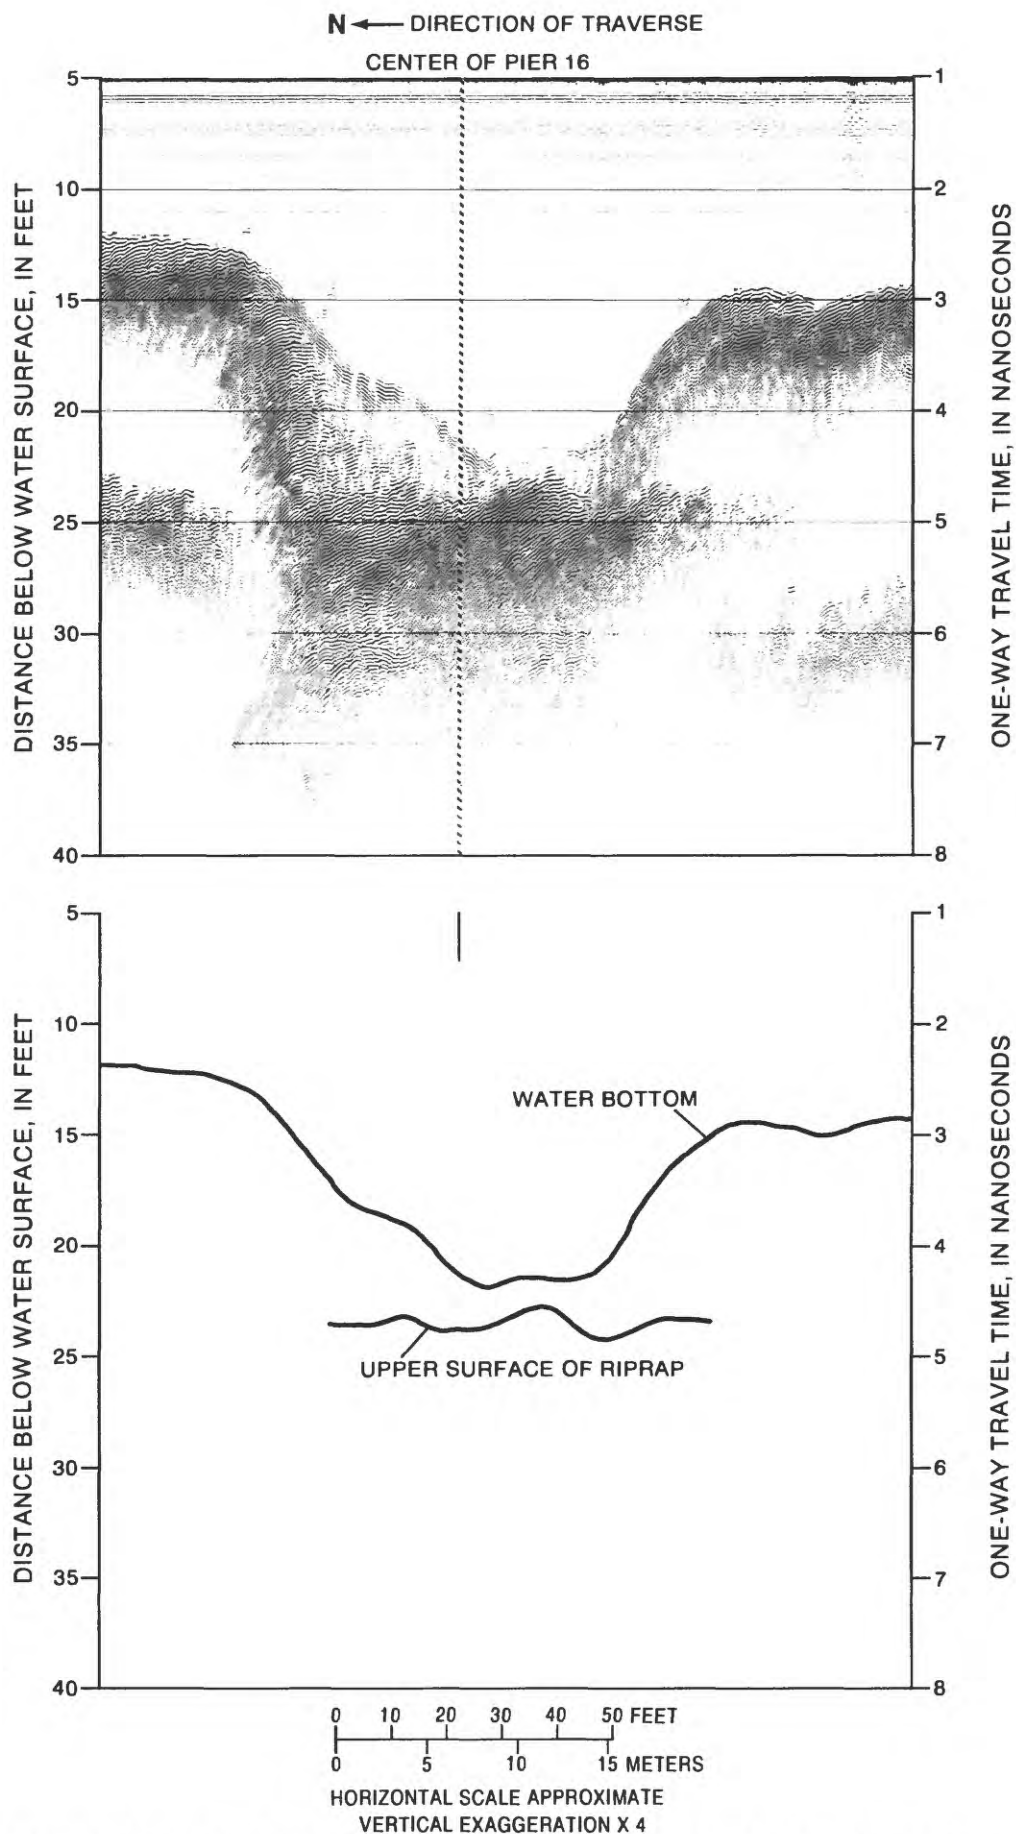
The initial investigation, using TT in conjunction with black-and-white fathometer, showed that pier 16, located north of Government Island and just south of the dredged channel, had the most infilled material (15 ft along side of the scour hole and 3 ft at the center of the scour hole). This pier was selected for further study using the other geophysical methods. The TT record (fig. 10A) clearly showed the presence of material over riprap. The GPR worked well at this site, even though depths were near 30 ft, showing 3 ft of infilled material at the center of the scour hole (fig. 10B). Relatively low specific conductance of the Columbia River (less than 200 $\mu\text{S}/\text{cm}$) allowed penetration of the GPR signals beyond the normal 20 ft limitation. The CF record clearly outlined the existing scour holes, but the buried riprap was harder to detect with this method than the other two methods (fig. 10C). Interpretations made from the geophysical records were verified by probing. The riprap layer at the upstream side of pier 16 was located at -23.5 ft, which is about 17 ft above the bottom of the pier and is approximately at the same elevation as shown on the original bridge plans.

Figure 10A.--Surface-geophysical 14-kilohertz tuned-transducer records showing scour holes and riprap layers of the Columbia River at Highway Interstate-205 Bridge, and interpretation, 20 feet upstream from pier 16.

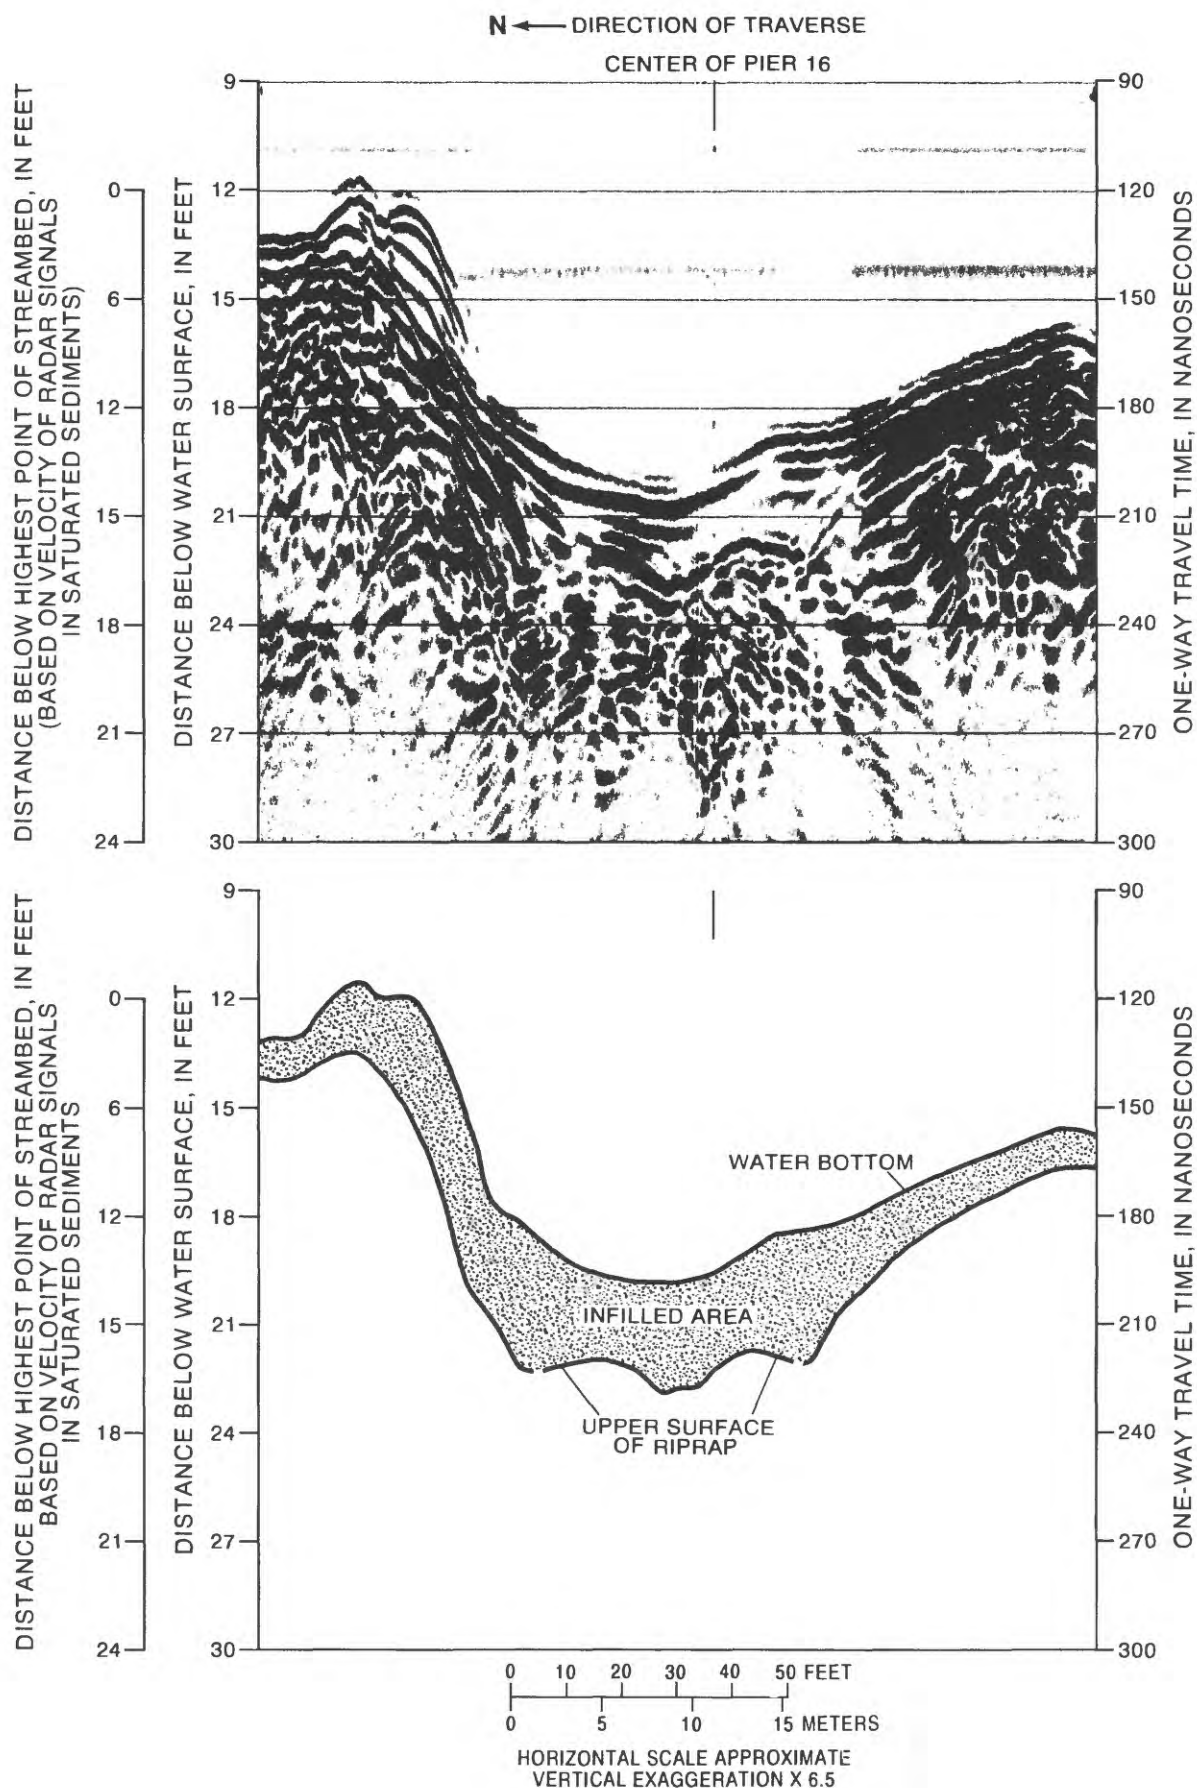
Figure 10B.--Surface-geophysical ground-penetrating-radar record and interpretation showing scour holes and riprap layers of the Columbia River at Highway Interstate-205 Bridge, and interpretation, 20 feet upstream from pier 16.

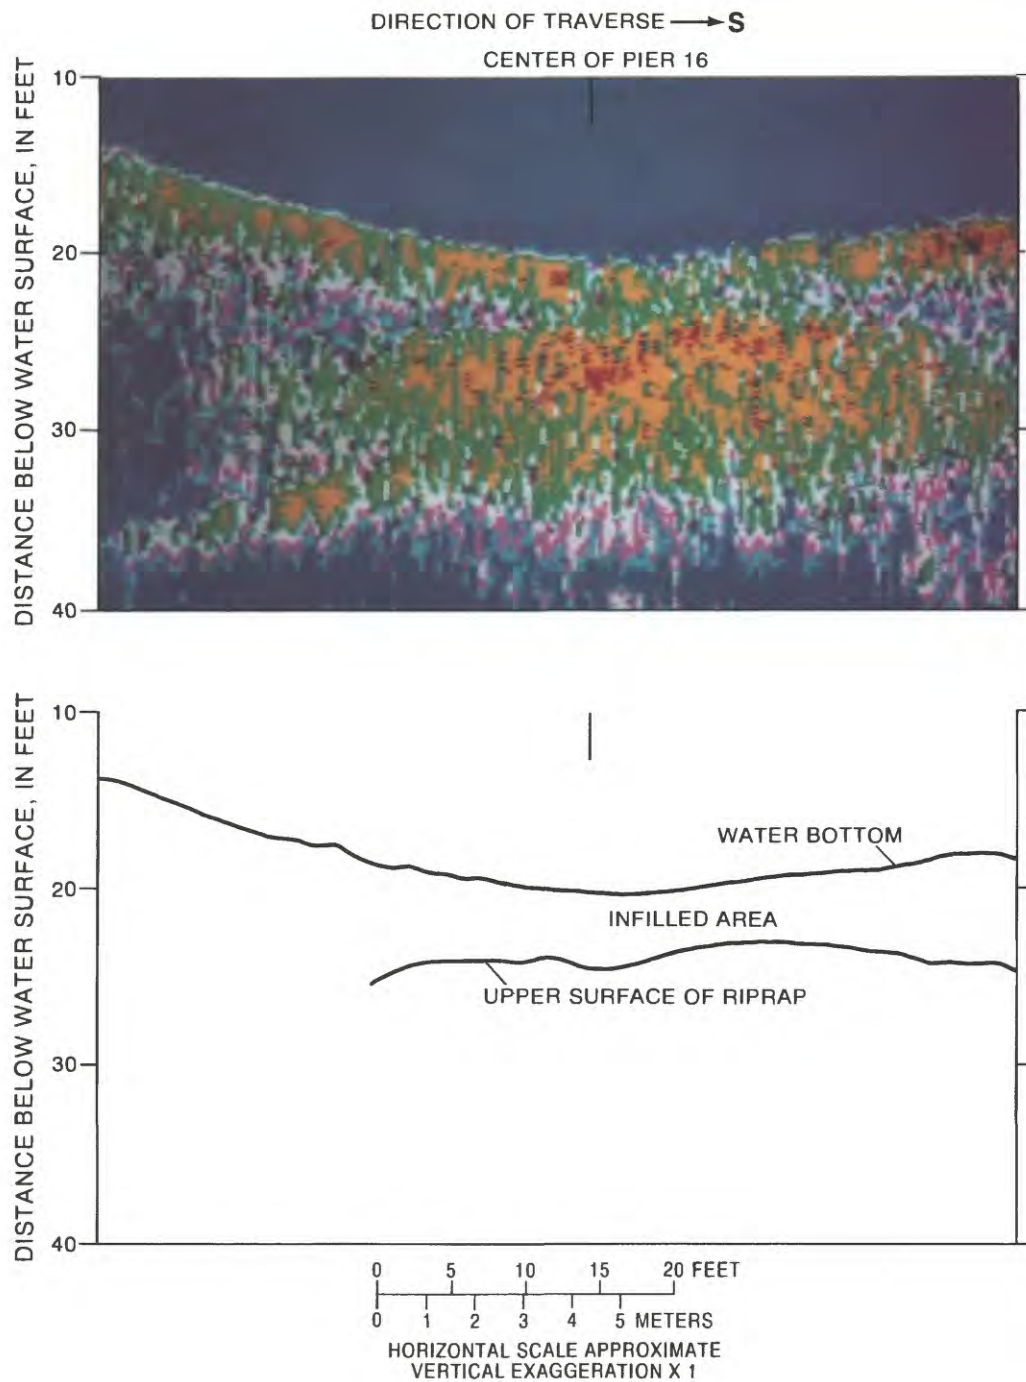
Figure 10C.--Surface-geophysical 20-kilohertz color-fathometer record and interpretation showing scour holes and riprap layers of the Columbia River at Highway Interstate-205 Bridge, and interpretation, 20 feet north of pier 16.

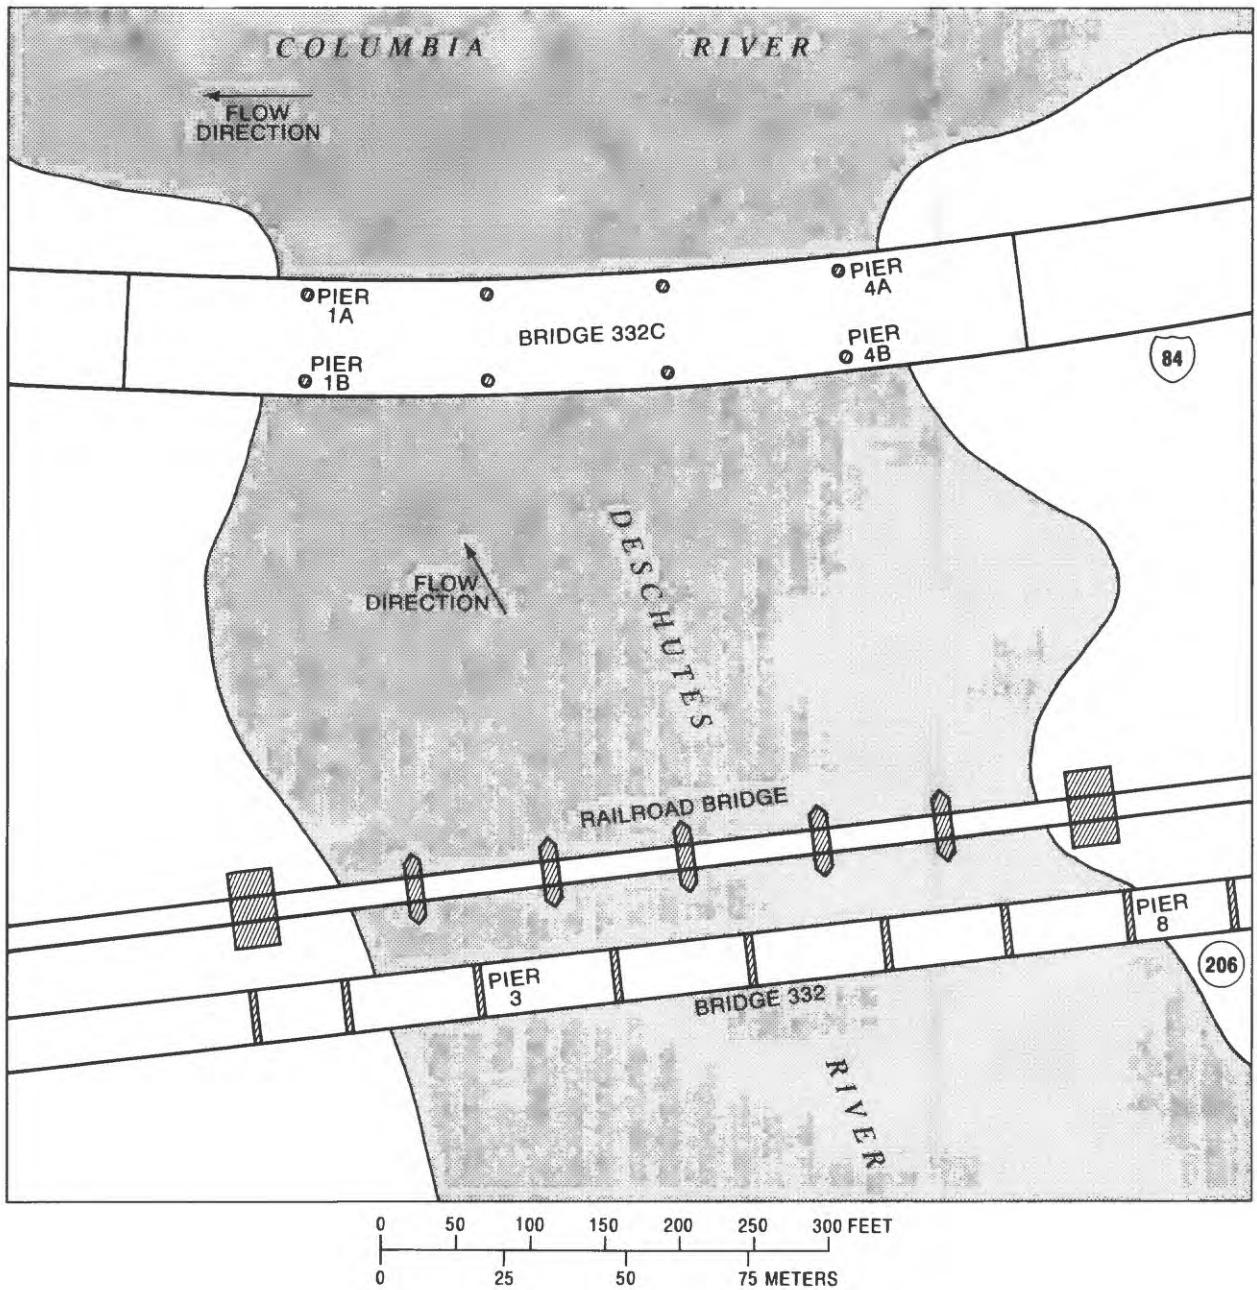
Two bridges were studied at the Deschutes River near Biggs: bridge number 332C (Highway I-84 Bridge) that crosses the Deschutes River near its confluence with the Columbia River, and Bridge number 332 (frontage road 378) that parallels I-84 about 300 ft upstream. The Columbia River is controlled at this point by The Dalles Dam located 12 miles to the west and puts these bridges in backwater at certain times. A sketch of the Deschutes River and the approximate location of the bridges is shown in figure 11.

Figure 11.--Plan view of Deschutes River Bridges 332C and 332 near Biggs, Oregon.

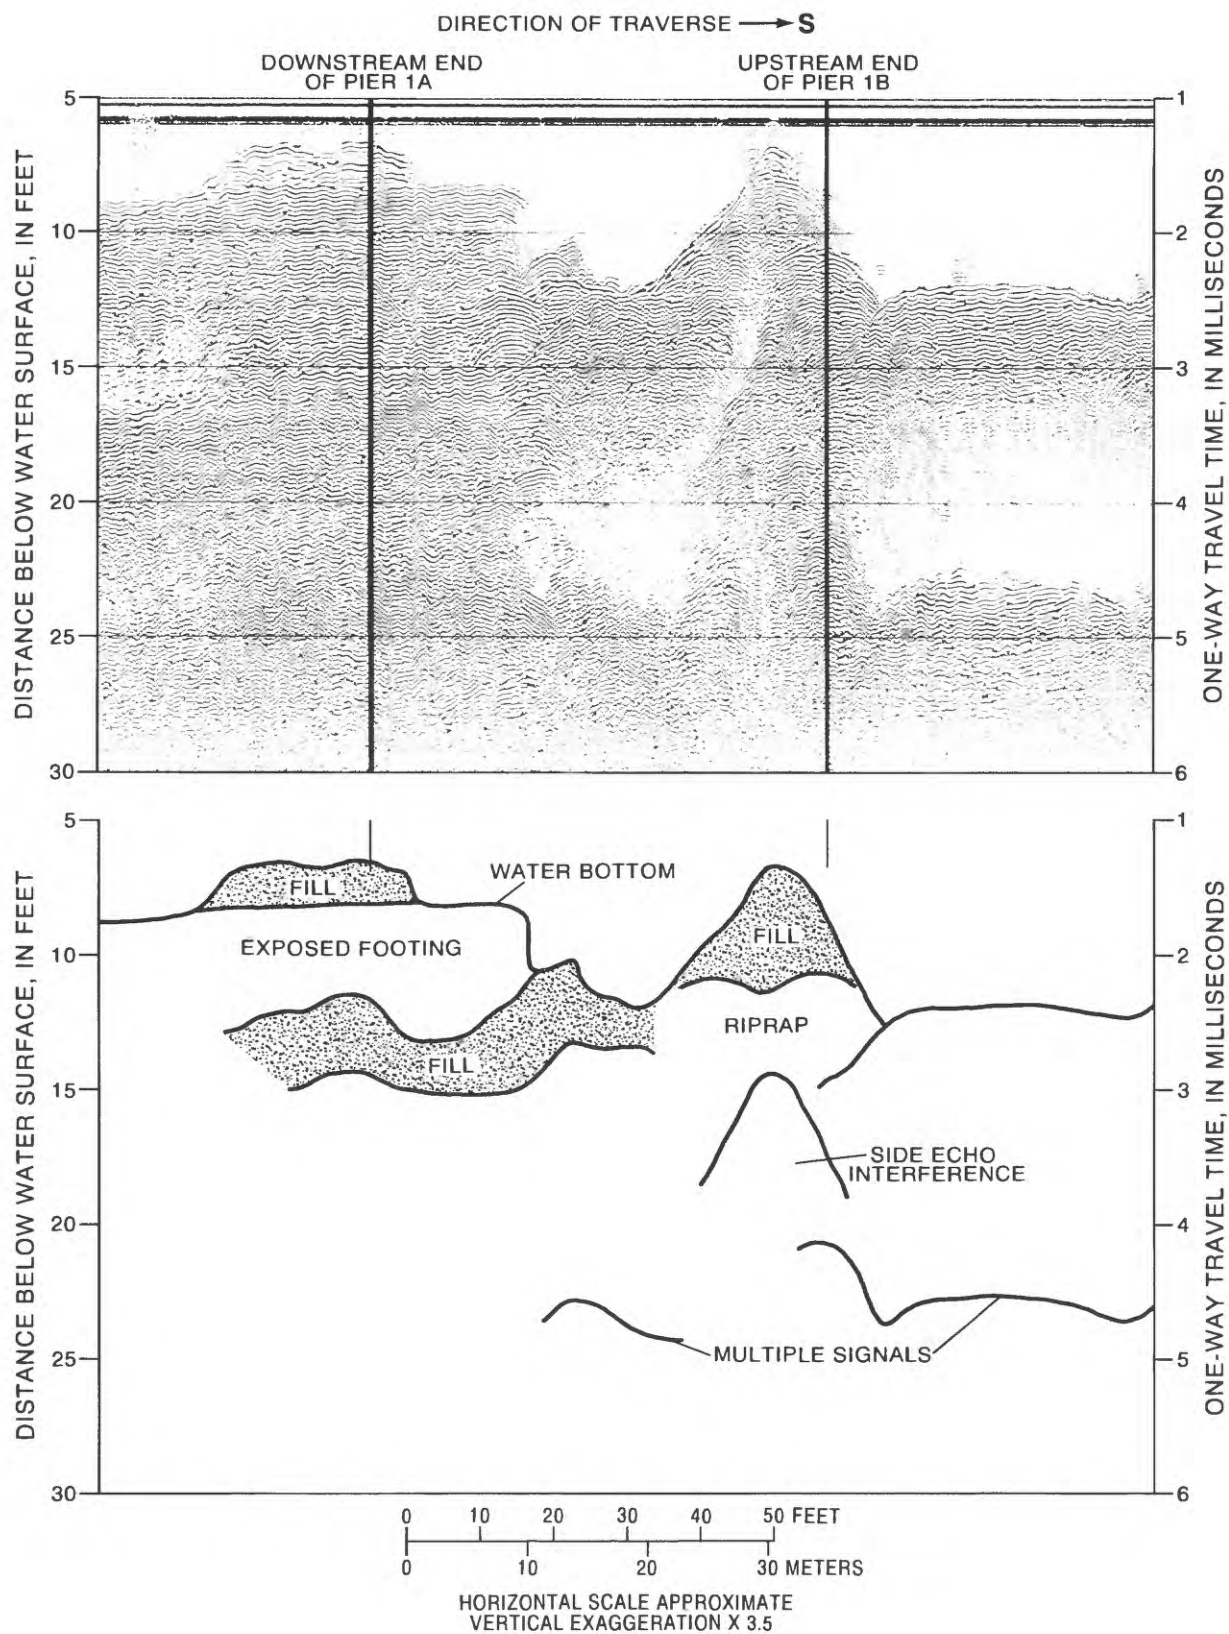
Figure 12.--A 14-kilohertz tuned-transducer record and interpretation of a lateral run 5 feet west of pier 1 of bridge 332C at the Deschutes River near Biggs, Oregon.

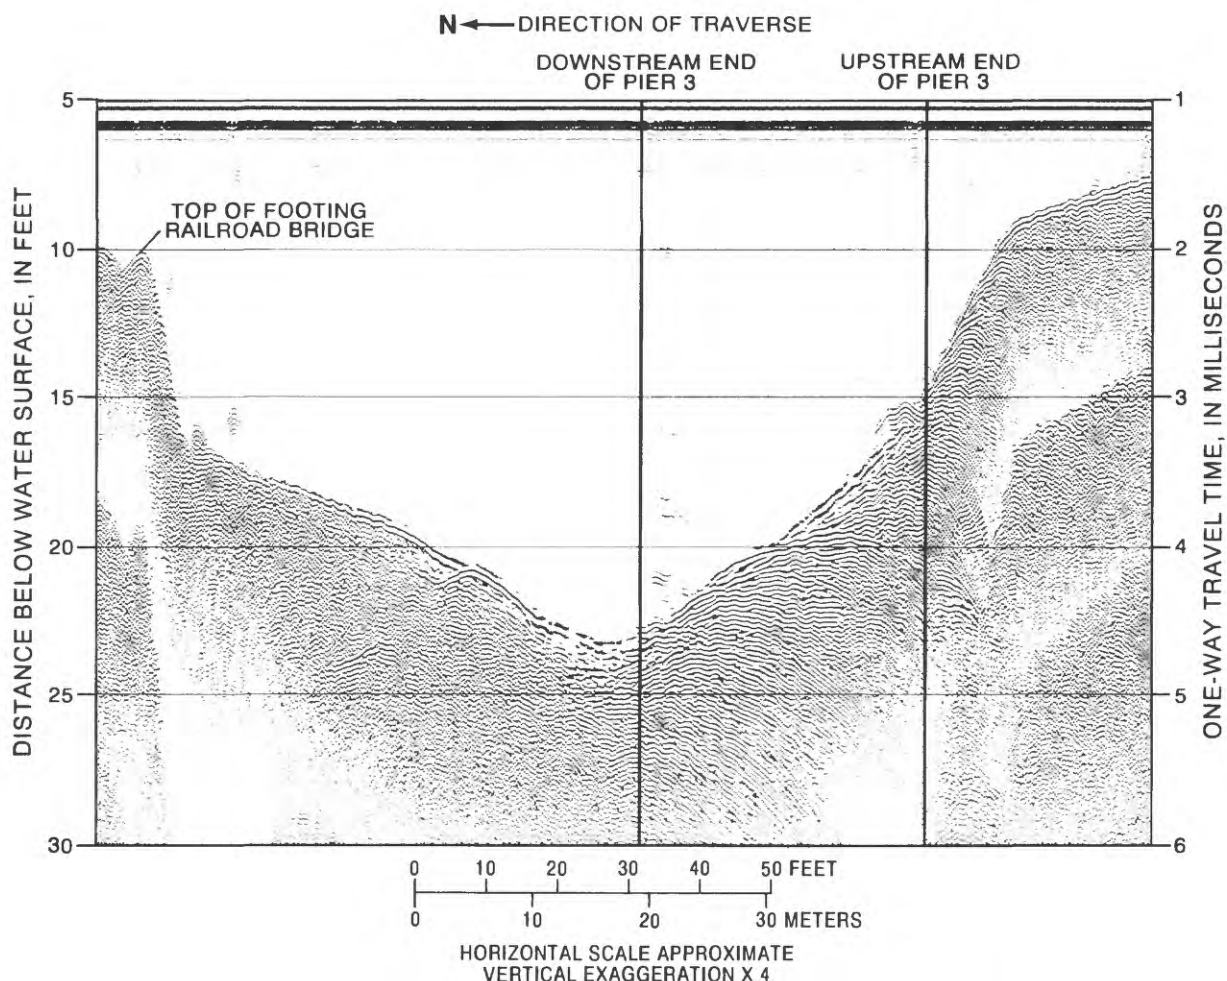
Figure 13.--A 14-kilohertz tuned-transducer record of a lateral run 2 feet east of pier 3 of bridge 332 at the Deschutes River.

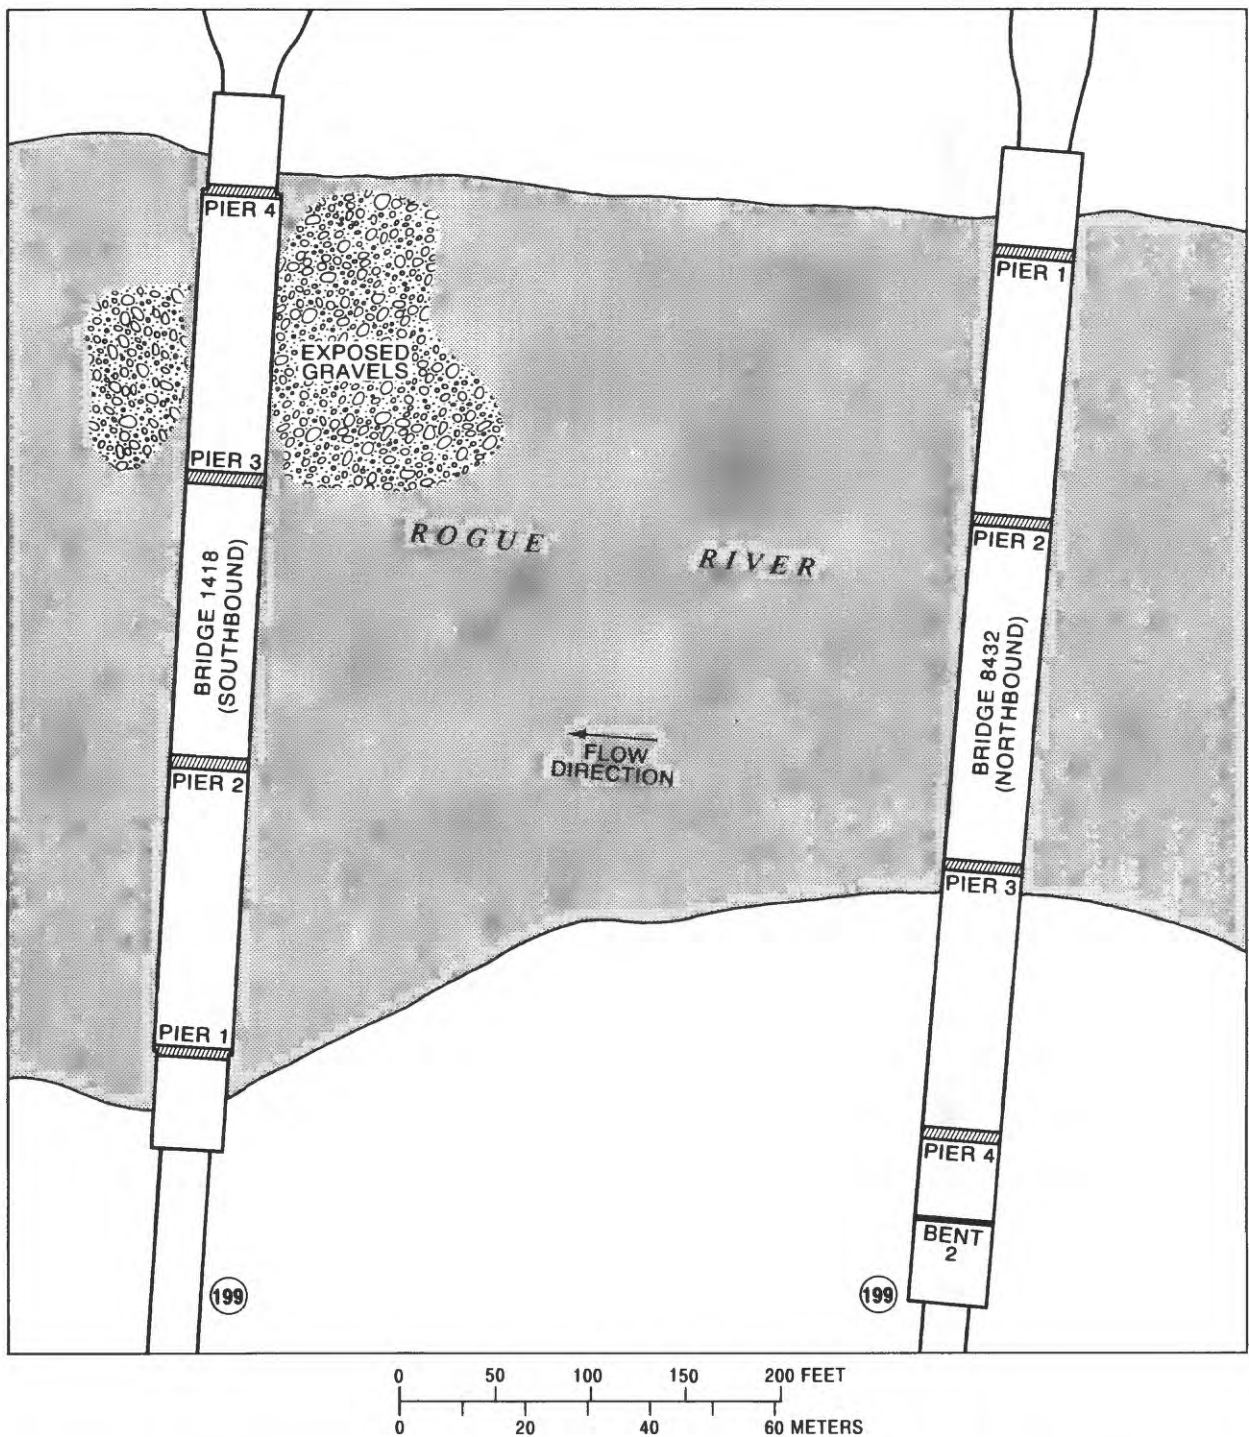
Two Highway 199 bridges over the Rogue River at Grants Pass were studied (fig. 14). Bridge 1418, built in the 1930's, was the original Highway 199 Bridge and is now the southbound bridge. This bridge has two massive piers in water, supported at each end by spread footings, with about a 6-ft gap between the footings. Bridge 8432, built in the 1960's, is the north bound Highway 199 Bridge. This bridge has two piers in water but only one pier was in water deep enough to be examined. Bridge 8432 piers are supported by one continuous spread footing. The piers in the water at both bridges were studied using the TT and black-and-white fathometer. Pier 3 at bridge 8432 and pier 2 at bridge 1418 were studied in more detail using GPR and TT. The CF did not work well at these sites because of the shallow water depths.

Figure 14.--Plan view of bridges 8432 and 1418 over the Rogue River at Grants Pass, Oregon.
