RESULTS OF A RECONNAISSANCE BRIDGE-SCOUR STUDY AT SELECTED SITES IN OREGON USING SURFACE-GEOPHYSICAL METHODS, 1989

By Milo D. Crumrine

U.S. GEOLOGICAL SURVEY

Water-Resources Investigations Report 90-4199

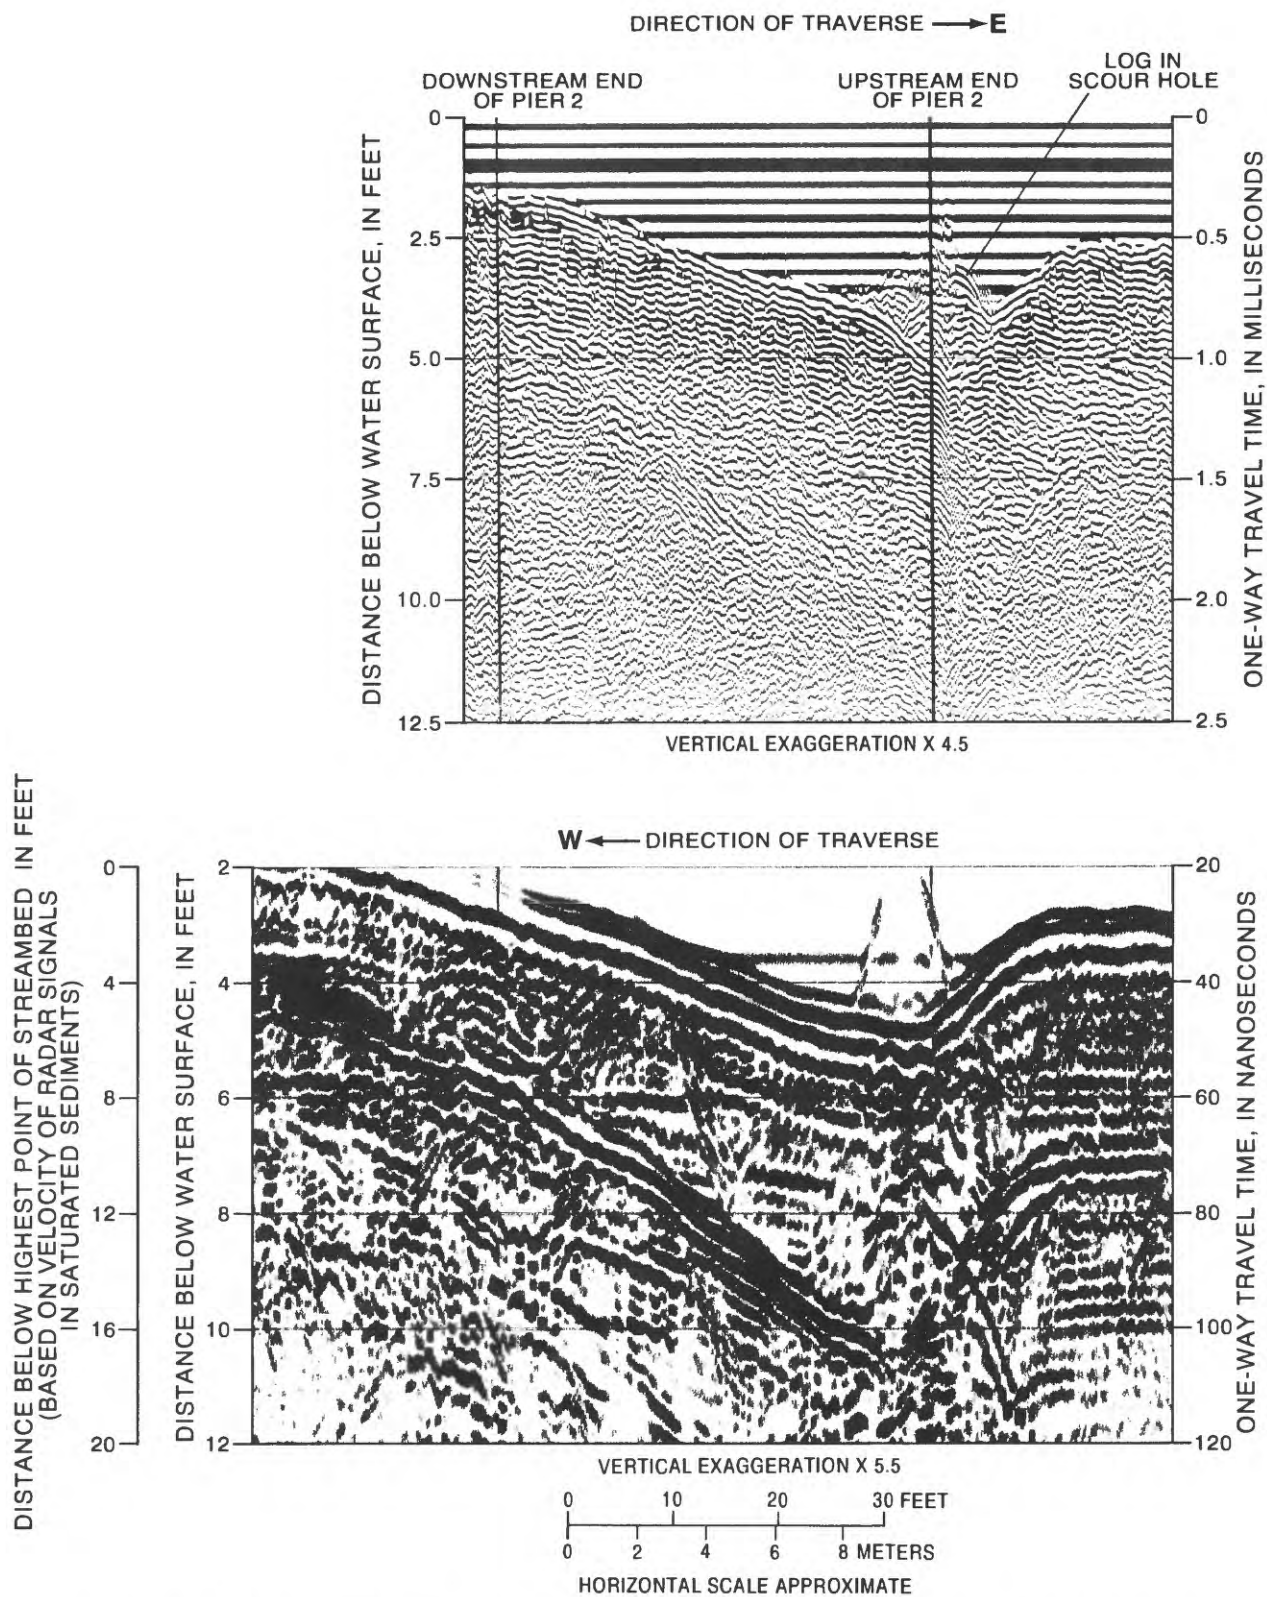
Bridge 8432 had a scour hole 2.5 ft deeper than the surrounding channel bed elevations at the upstream end of pier 2. There is a log buried along side pier 2 with part of the base exposed in the upstream scour hole (fig. 15). It is possible that about 0.5 ft of infilling exists beneath the log, but the presence of the log makes an accurate determination difficult. The bottom of the spread footing of bridge 8432 is located about 5.5 ft beneath the existing upstream scour hole. A small amount of scour (less than 0.5 ft) exists along the sides of and at the downstream end of pier 2, with no infilling detected.

Figure 15.--A 14-kilohertz tuned-transducer record (top) and ground-penetrating-radar record (bottom) of a lateral run 5 feet south of pier 2 of bridge 8432 at the Rogue River.

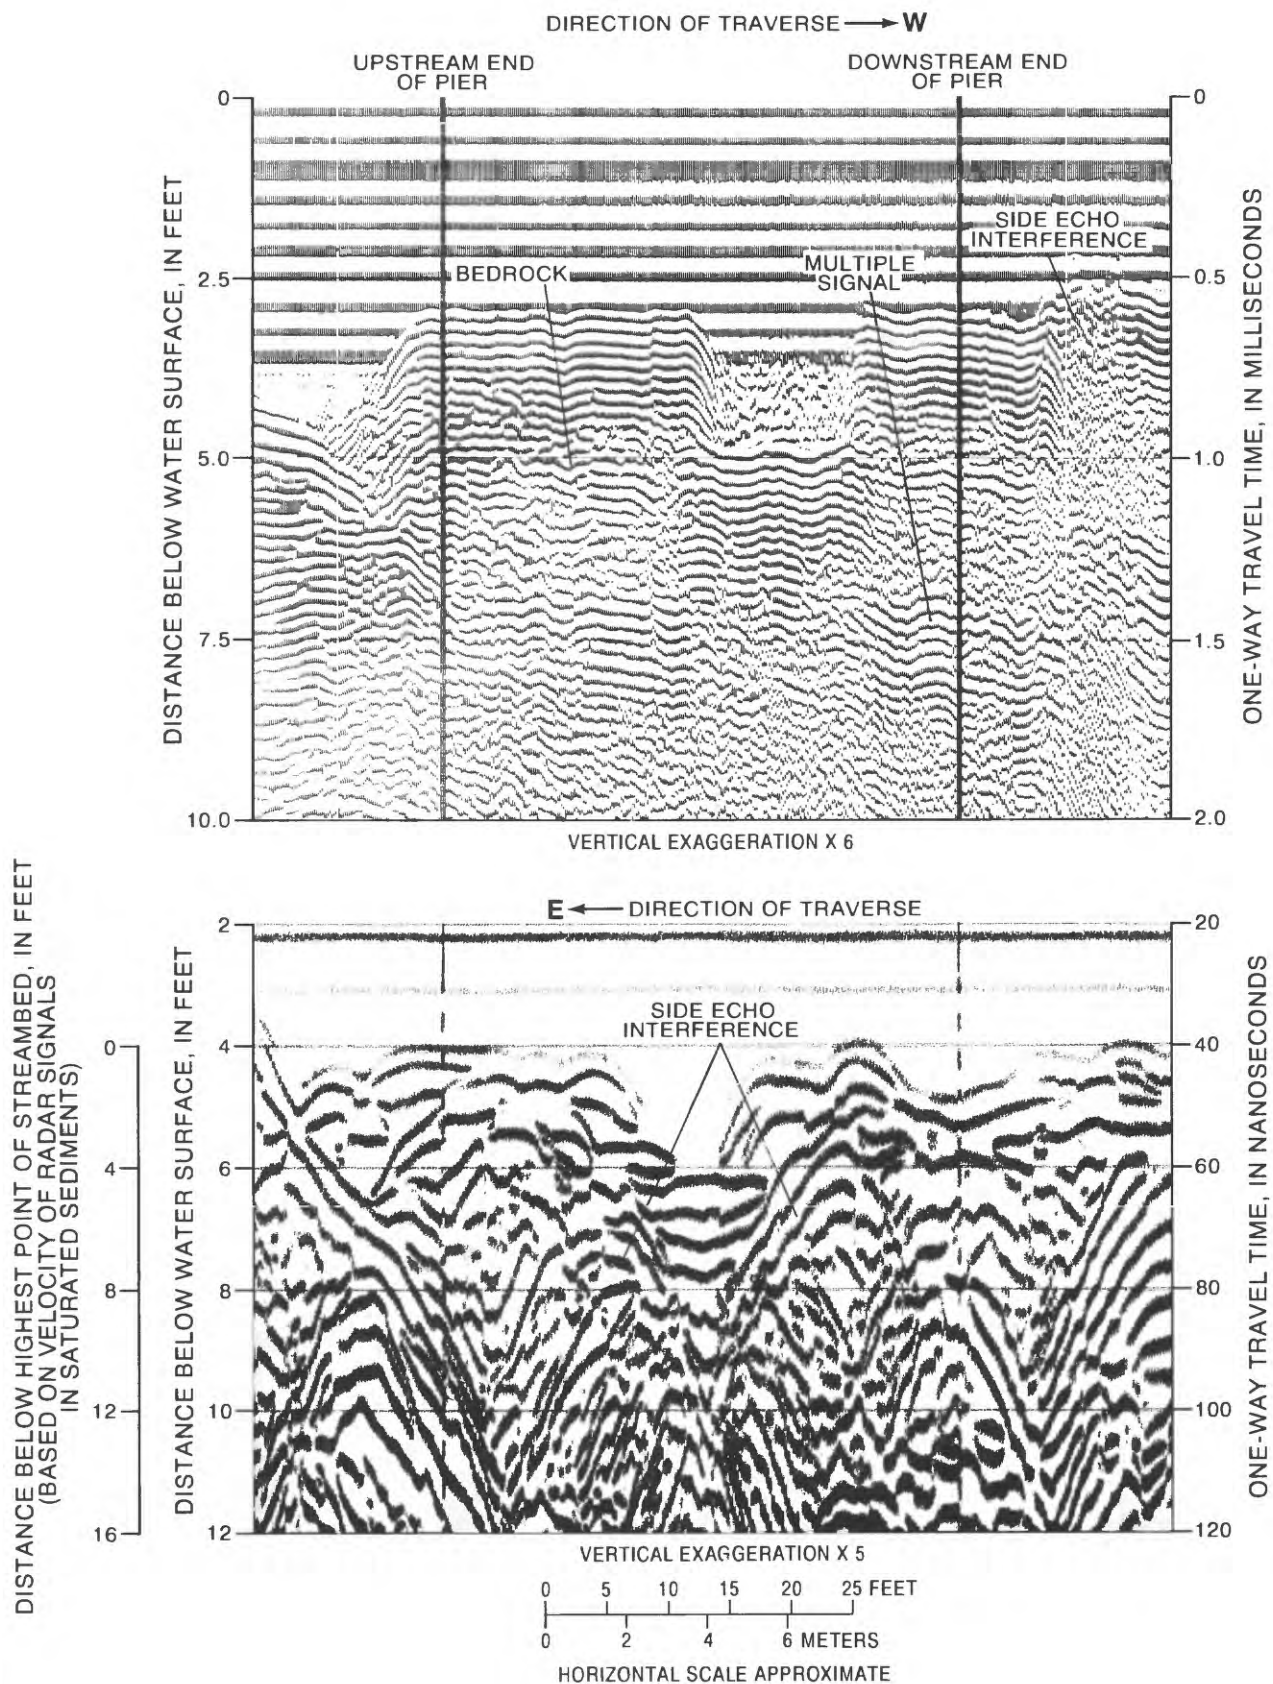
During the time of study, bridge 1418 had a scour hole 2.5 ft deep (bottom elevation 880.5 ft above mean sea level) at the upstream end of pier 1, with deeper holes along each side of the pier between the spread footings. About 10 ft out from the south side of pier 1, an exposed hole 6.0 ft deep (bottom elevation 870.0 ft) exists between the spread-footing sections, which is about 0.5 ft deeper than the bottom of the spread footing (bottom elevation 870.5 ft) [fig. 16]. A 3.0 ft trough runs parallel to pier 32 along the south side. The existing hole and trough along the north side of pier 1 is similar to the south side, but is not as deep. The bed material at the base of these holes and troughs is bedrock and large cobbles.

Figure 16.--A 14-kilohertz tuned-transducer record (top) and ground-penetrating-radar record (bottom) of a lateral run 2 feet south of pier 1 of bridge 1418 at the Rogue River.

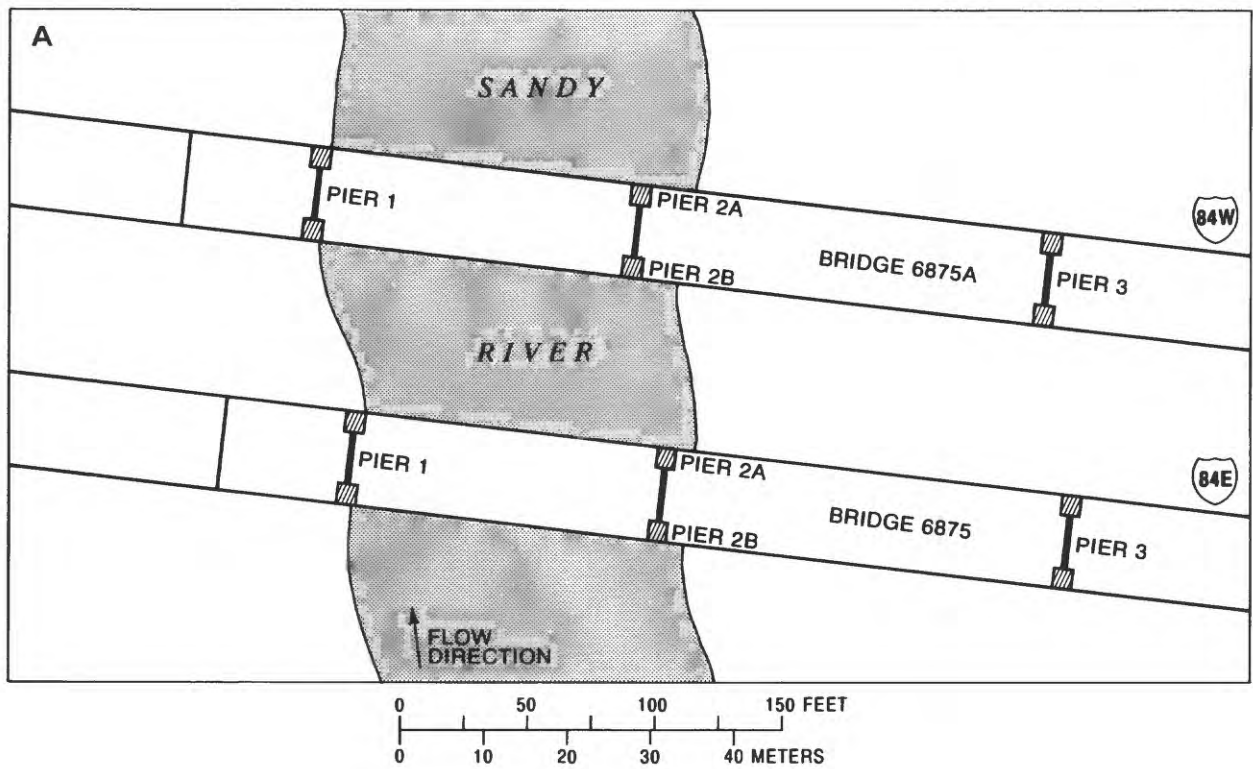
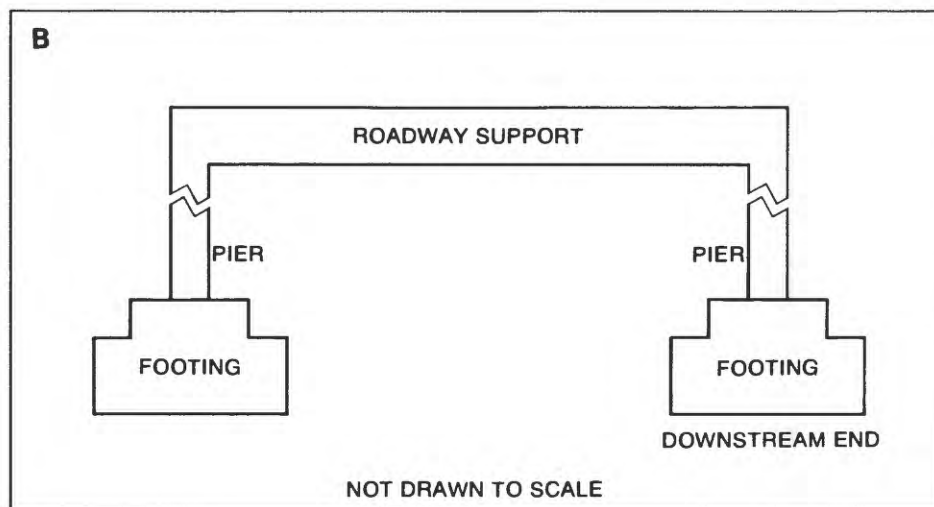
Figure 17.--Configuration (A) and pier design (B) of Sandy River Bridges 6875 and 6875A located near Troutdale, Oregon.

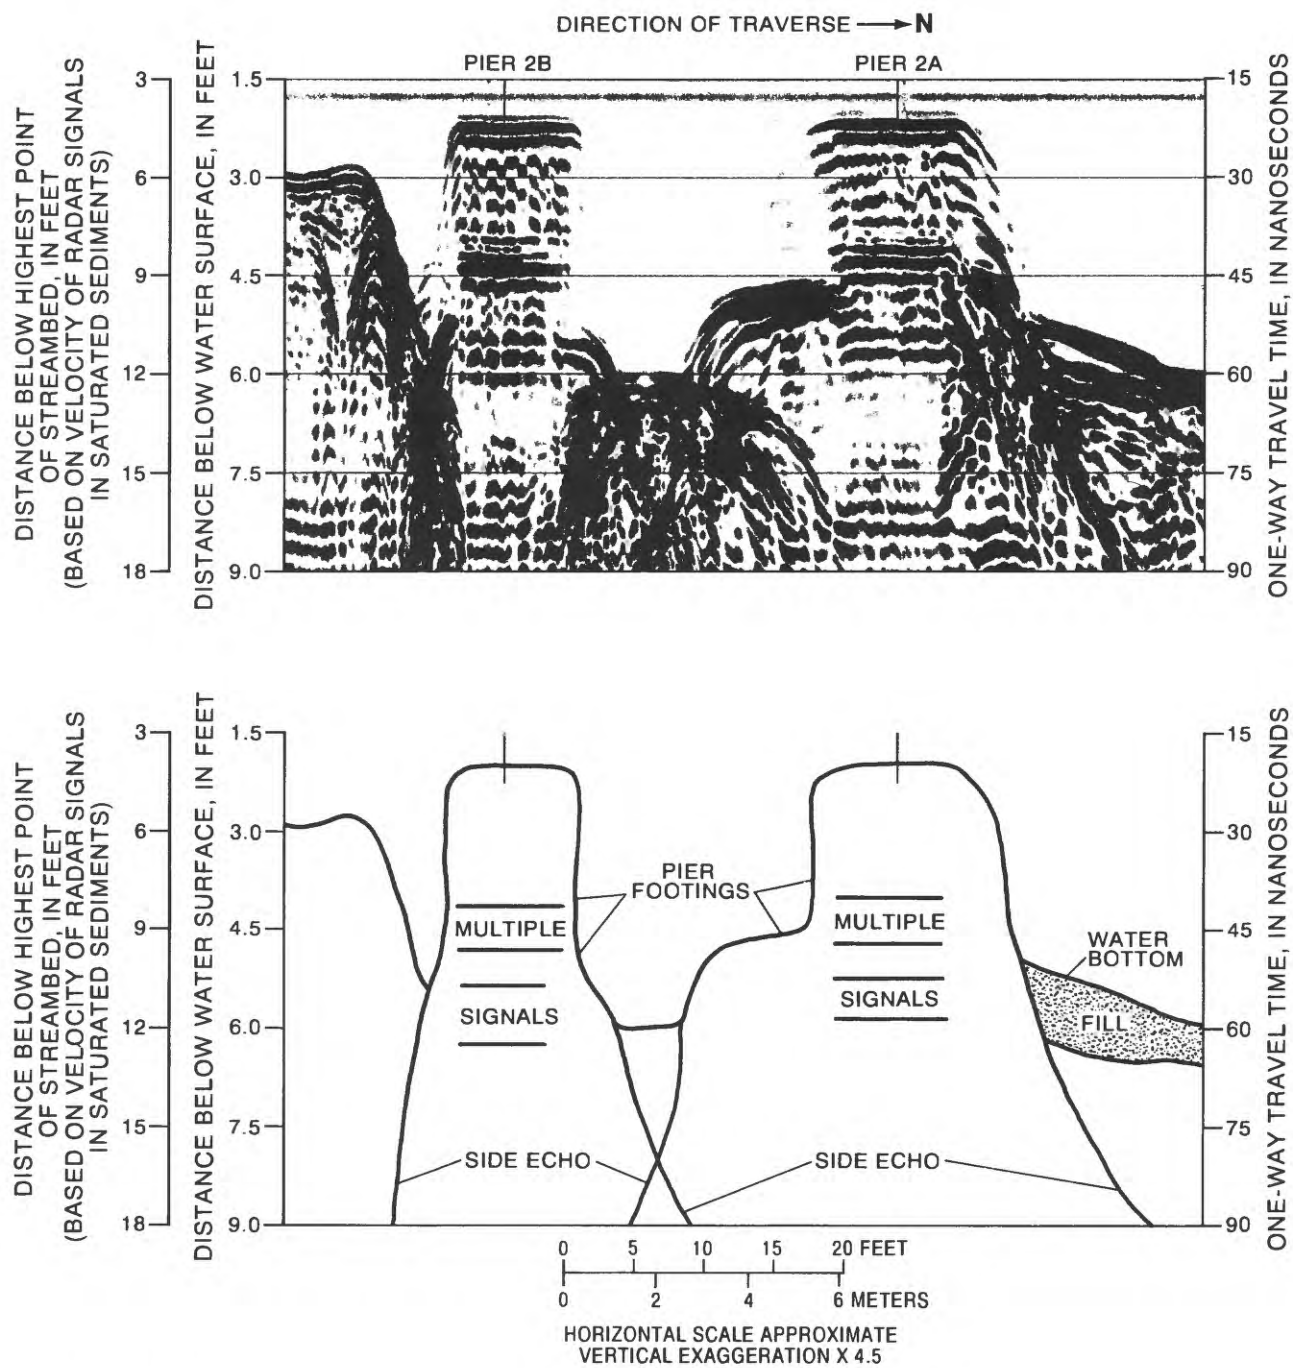
Pier 2 of bridge 6875 A (I-84 Westbound) had less debris than bridge 6875 pier 2 and GPR results were better. Side echo and multiple signals obscured some of the data around the pier, and without probe readings, interpretation of scour-hole depths would have been difficult. Results from probing data collected at this site indicate that existing scour holes are within 1.5 ft of the bottom of the footing, and some infilling (1.5 ft) was detected along the downstream end of pier 2a by GPR and probing. It is possible that less than 2 ft of infilling would not be detected because resolution of GPR is about 2 ft when using 80 megahertz antennae (table 1). An example of GPR data collected is shown in figure 18.

Figure 18.--Ground-penetrating-radar record and interpretation, Sandy River Bridge 6875A, 1 foot east of pier 2.

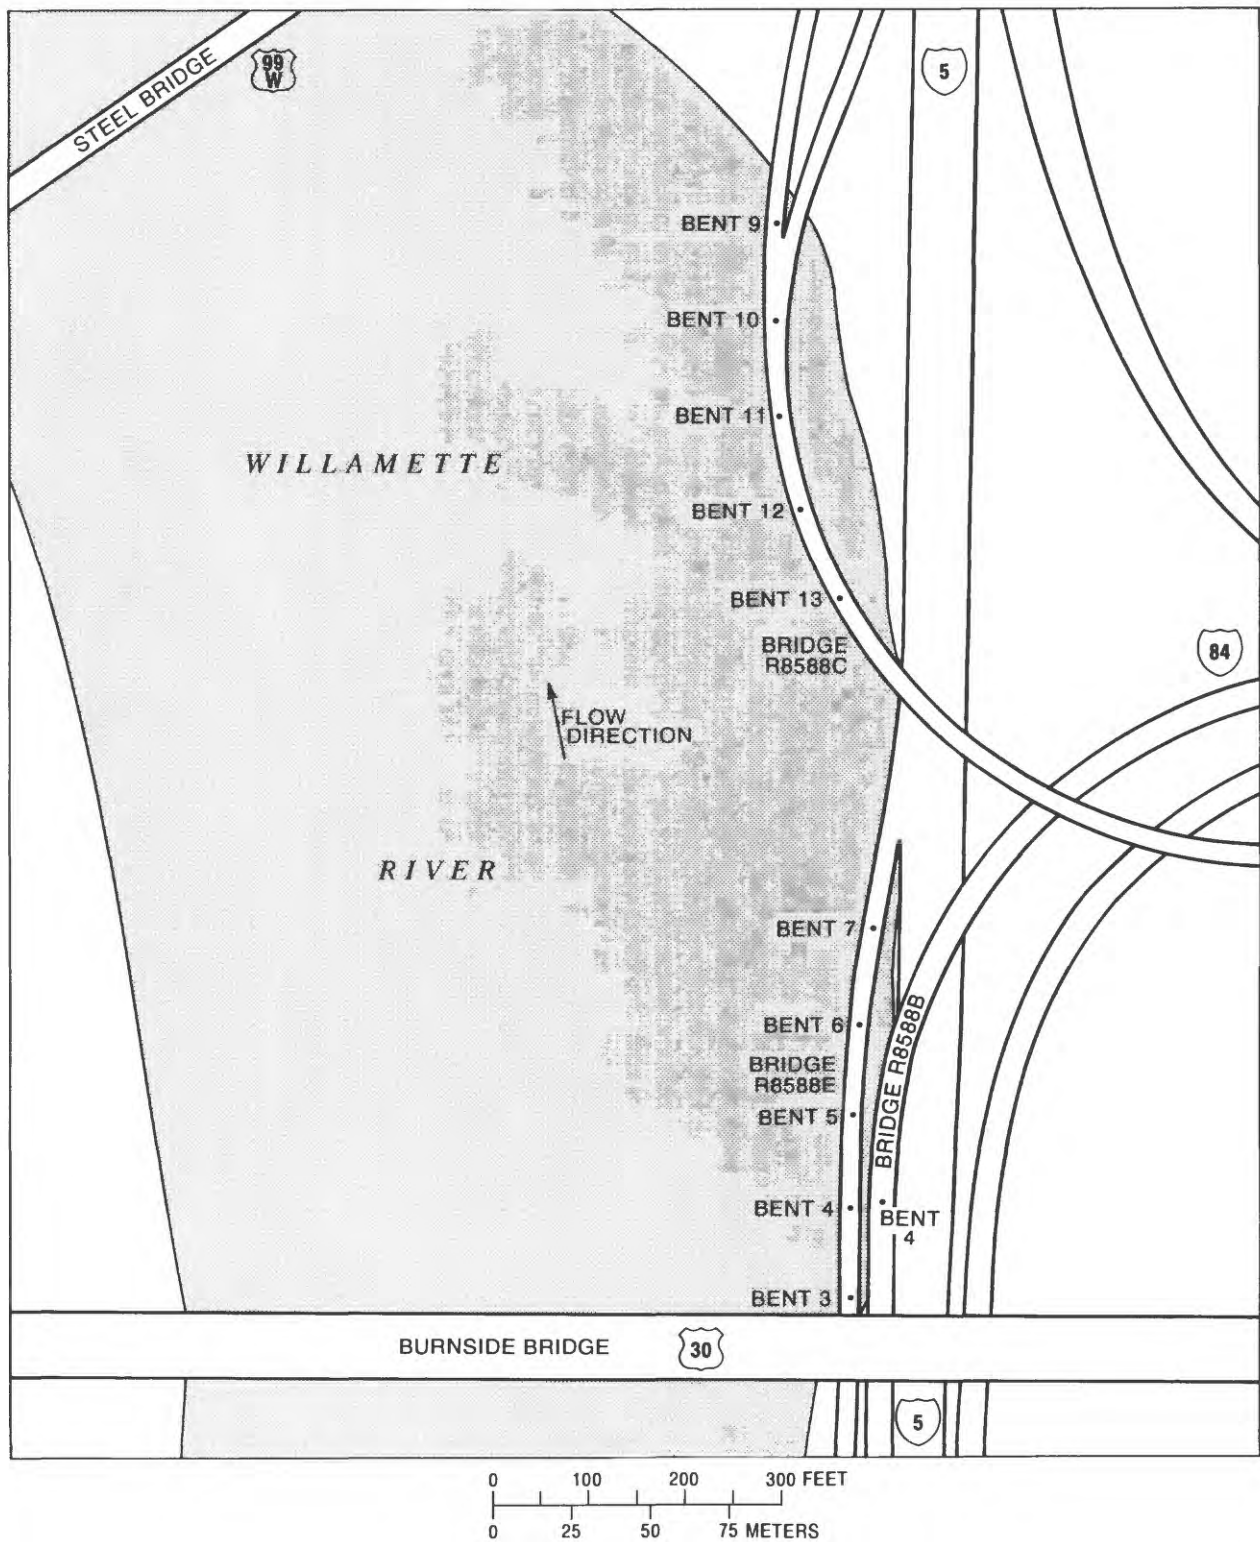
Three bridges (R8588B, R8588C, R8588E) were examined at this location using geophysical methods. A sketch showing the configuration of these bridges in relation to the highway system is shown in figure 19. All of the bents and piers studied at this site are supported by piling.

Figure 19.--Configuration of bridges R8588B, R8588C, and R8588E, Willamette River at Portland, Oregon.

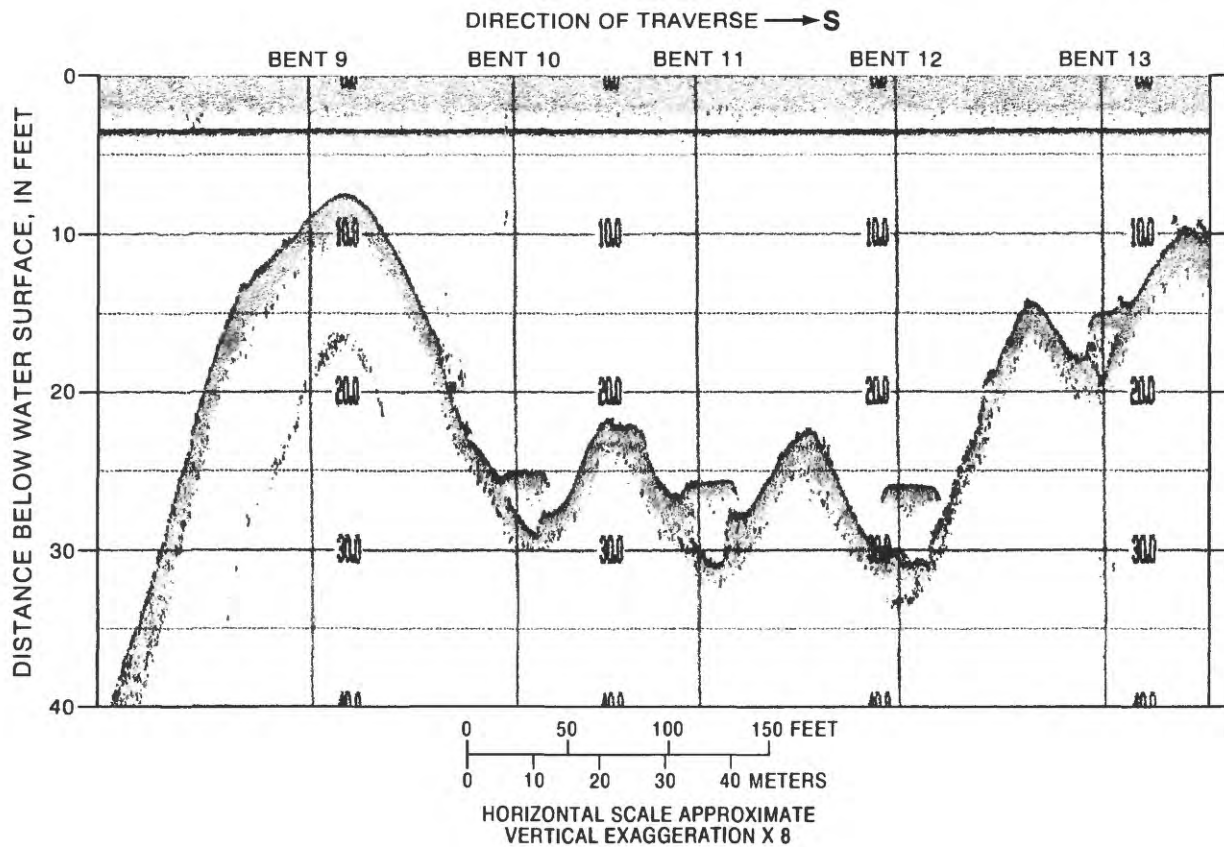
Figure 20A.--Surface-geophysical black-and-white fathometer record at Willamette River bridge R8588C. Record was taken about 15 feet west of bents 9-13 traveling in a southerly direction.

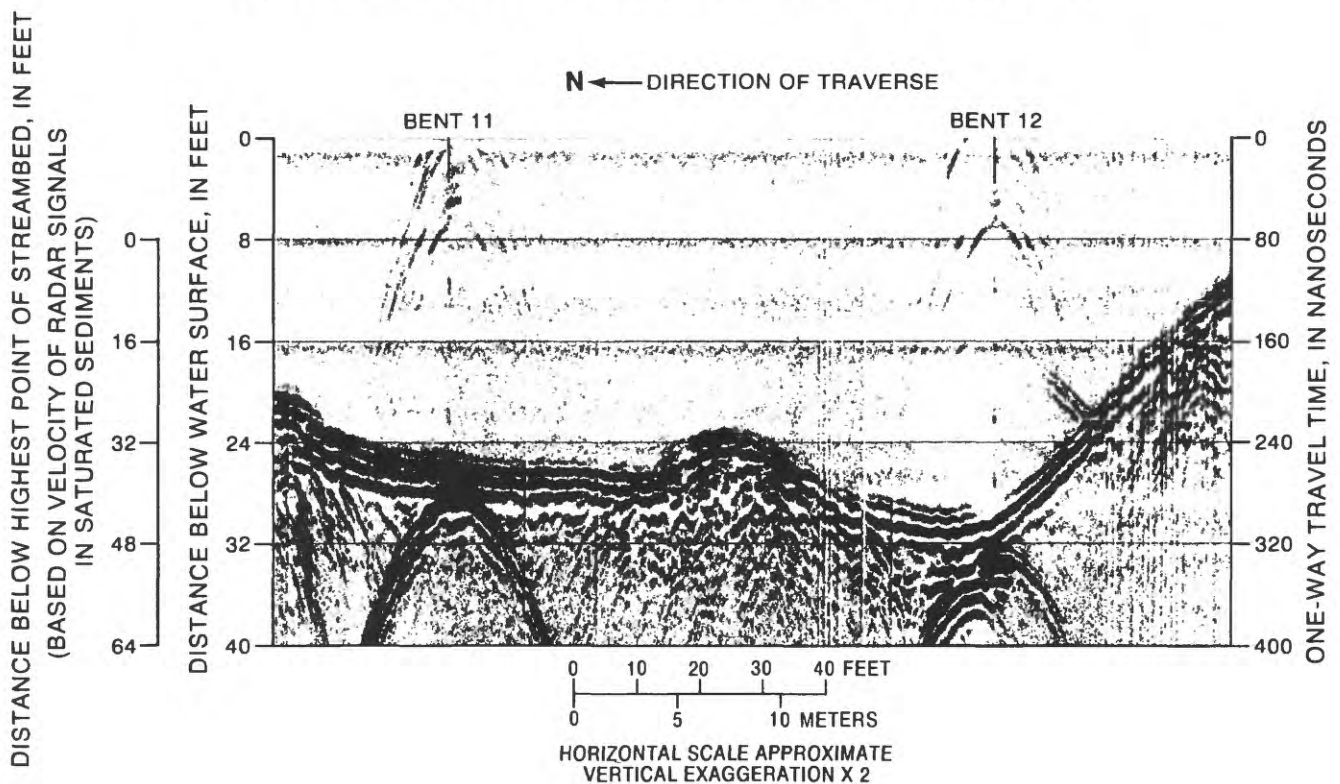
Figure 20B.--Surface-geophysical ground-penetrating-radar record at Willamette River bridge R8588C. Record of bents 11 and 12, 10 feet streamward (west) of bridge.

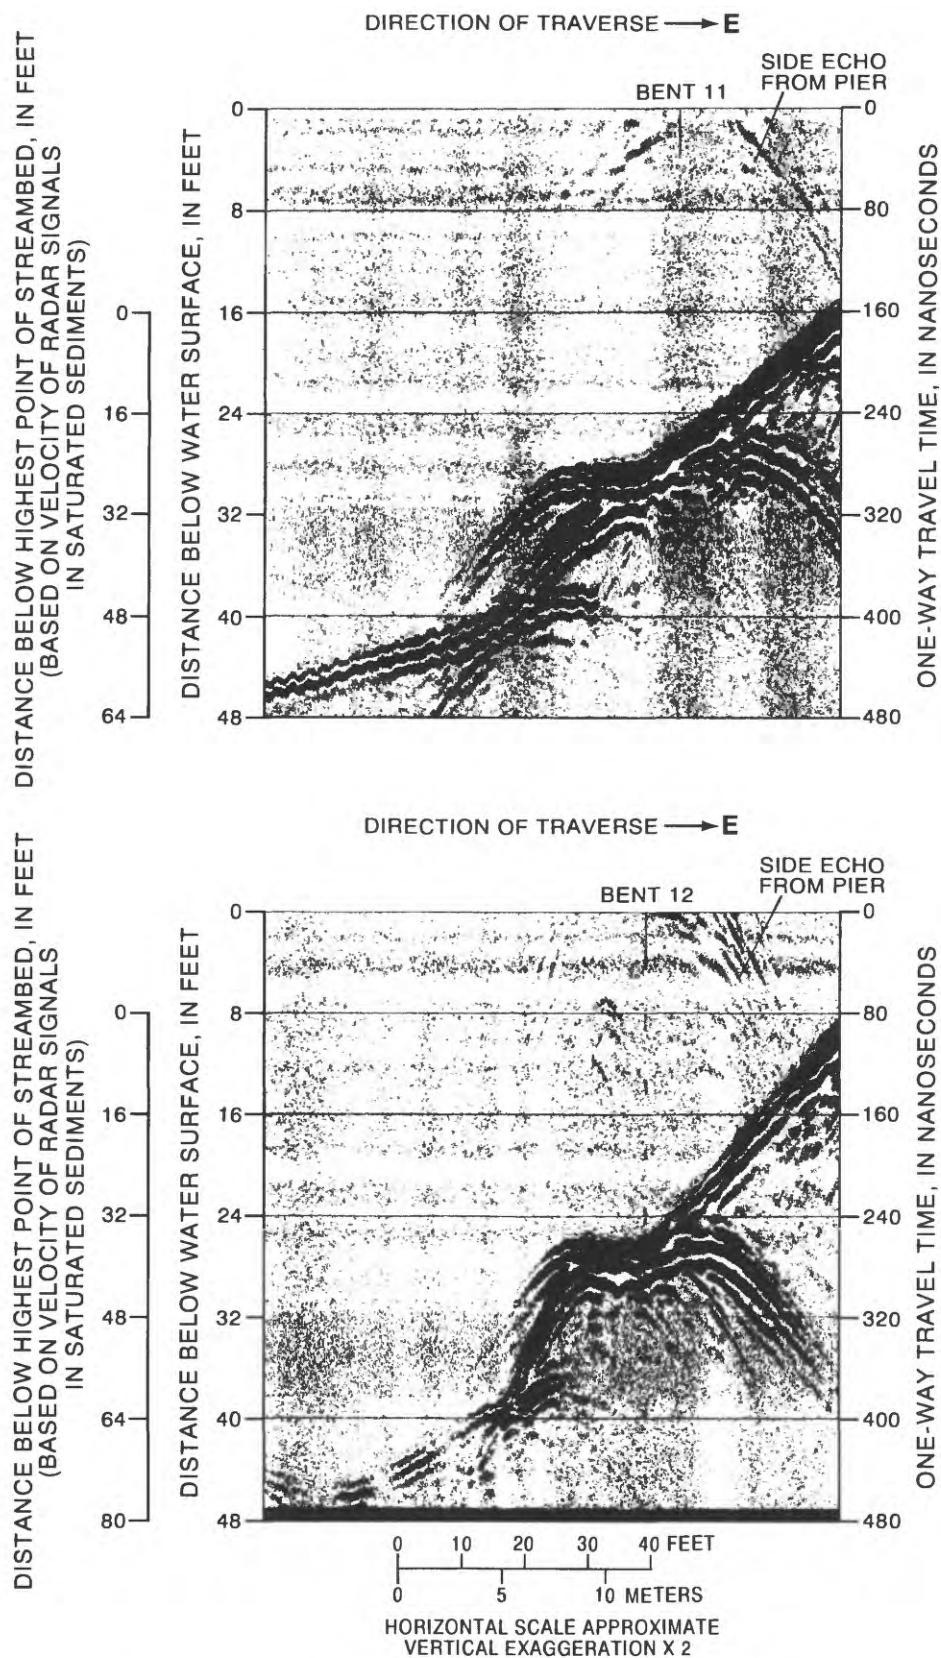
Figure 20C.--Surface-geophysical ground-penetrating-radar record at Willamette River bridge R8588C. Record of bents 11 and 12, 10 feet upstream (south) of bents.

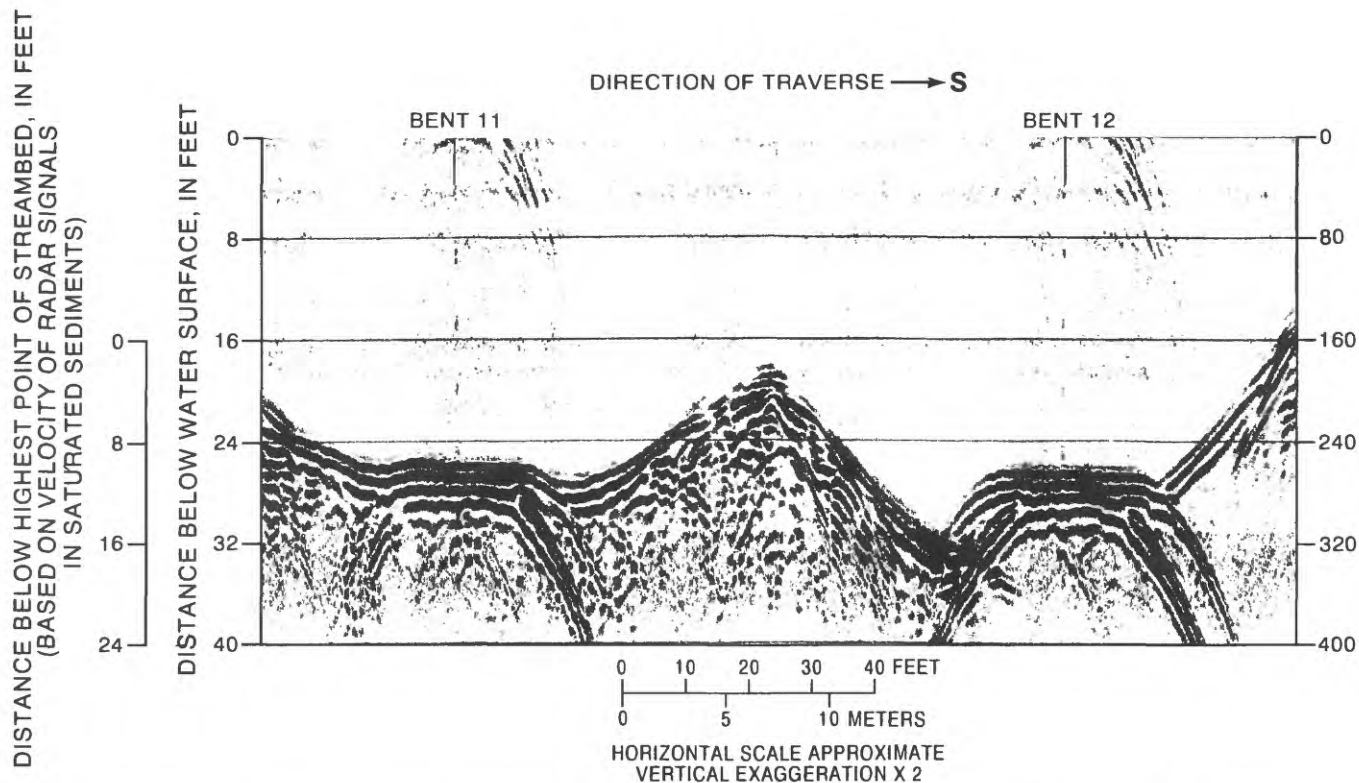
Figure 20D.--Surface-geophysical ground-penetrating-radar record at Willamette River bridge R8588C. Record of bents 11 and 12, 10 feet shoreward (east) of bents.

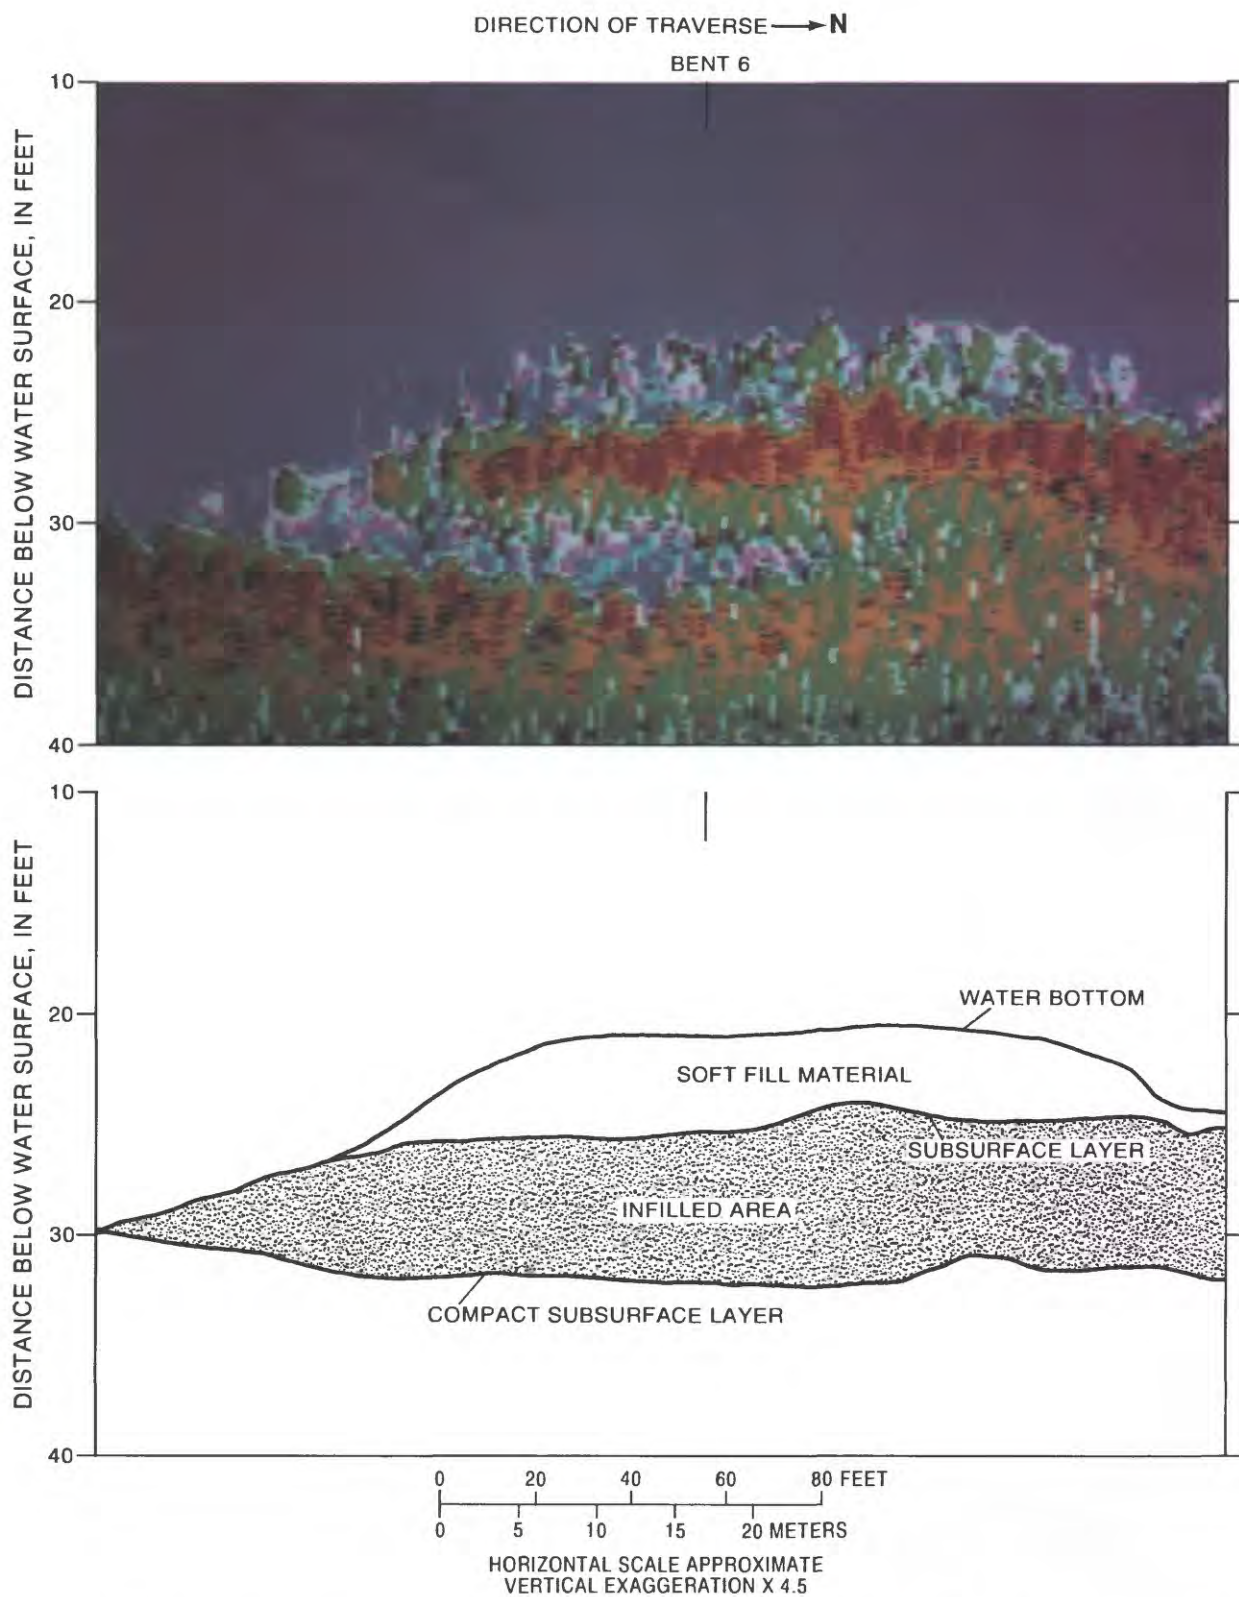
Figure 21.--20-kilohertz color-fathometer record and interpretation of subsurface layers 15 feet streamward (west) of bridge R8588E, bent 6, on the Willamette River in Portland, Oregon.

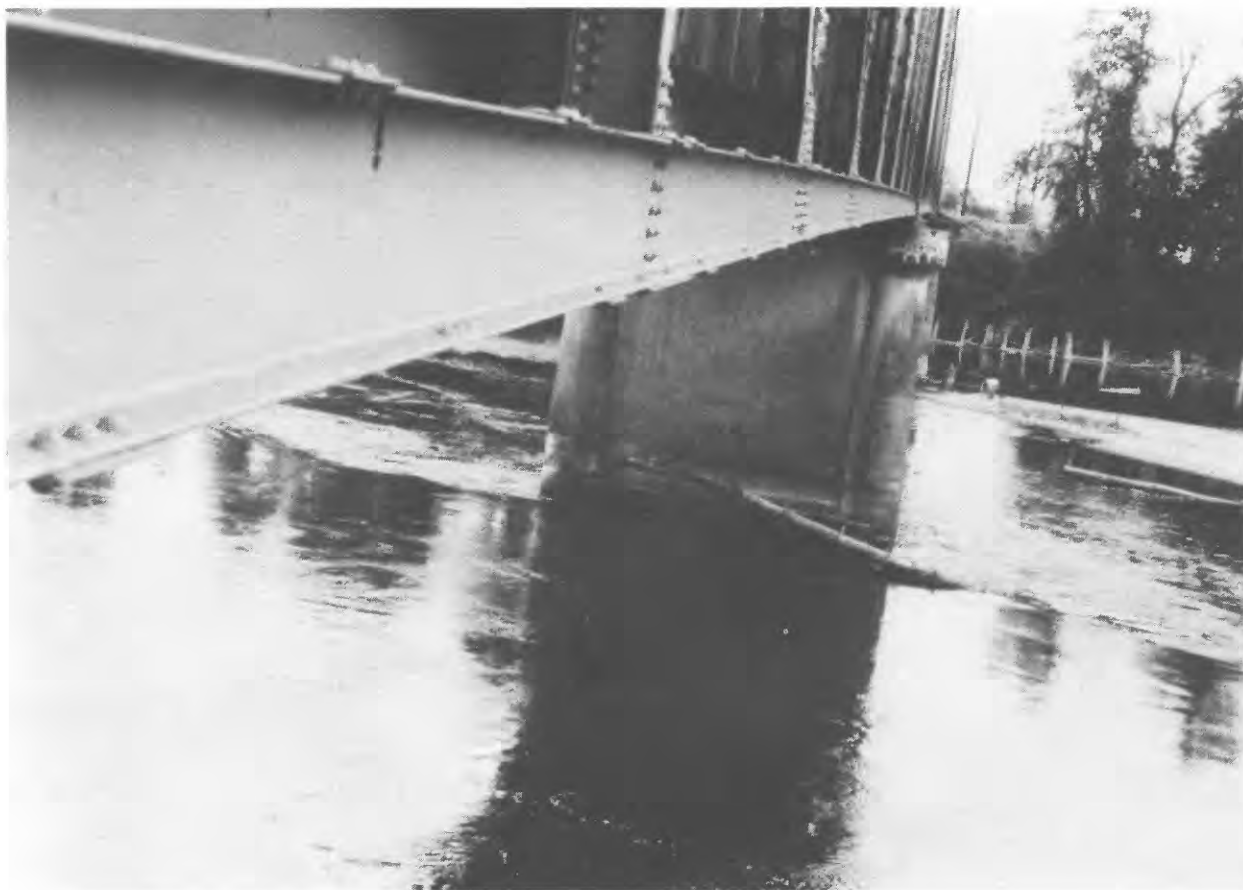
The bridge located at Willamette River at Harrisburg, Oregon was selected for study because of possible scour beneath the bottom of the seal at pier 3. Upstream from this bridge the Willamette River flows mainly along the left bank (south) side of the channel, curves abruptly at the bridge and strikes pier 3 at a 45 degree angle. Water velocities at the time of study were about 3.5 ft/s. The channel consists mostly of sand, gravel and cobbles, and the bridge is obstructed by a gravel bar 50 ft upstream from pier 3 and by numerous logs around piers 2 and 3. A photograph showing pier 3 and the approaching flow angle is shown in figure 22.

Figure 22.--Cross-stream view of bridge and pier 3 from left bank, Willamette River at Harrisburg, Oregon, September 27, 1989.
