**LAND SUBSIDENCE AND PROBLEMS  
AFFECTING LAND USE AT  
EDWARDS AIR FORCE BASE  
AND VICINITY, CALIFORNIA,  
1990**

**U. S. GEOLOGICAL SURVEY  
Water-Resources Investigations  
Report 92-4035**

**Prepared in cooperation with the  
U.S. DEPARTMENT OF THE AIR FORCE**

By James C. Blodgett *and* J.S. Williams

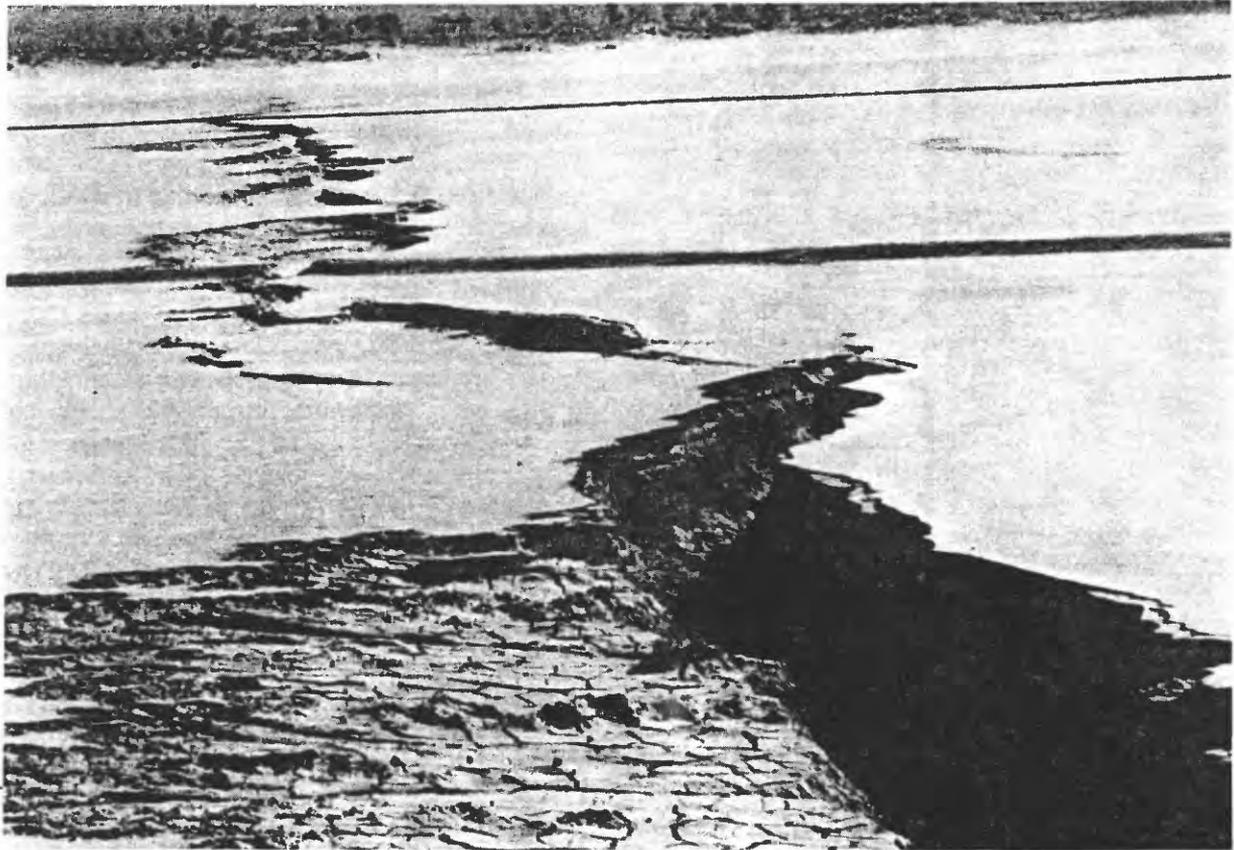
**Figure 2.** Fissure across Runway 25 on Rogers lakebed after January 1991 flooding. This fissure also is a drainage channel and point of infiltration to ground water. Note cracks that form small polygons on eroded area near fissure. Width of fissure at land surface is as much as 10 feet. Photograph courtesy of U.S. Air Force, February 1991.

Expenditures to date (1990) for runway repair have been high, and the repairs have been somewhat ineffective (Melvin Marmet, U.S. Air Force, oral commun., July 1991). The load-carrying capacity of the repaired lakebed is less than that of the original lakebed, and active deformation continues to adversely affect the repairs. Evidence of new sinklike depressions and fissures indicates that the lakebed is being subjected to continuing land-surface deformation.

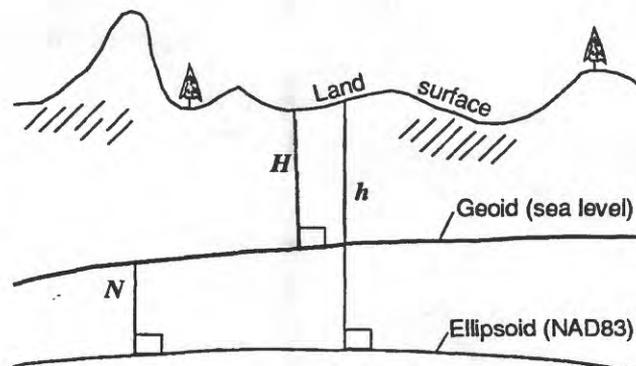
- $h$  Ellipsoidal height, referenced to the ellipsoid
- $H$  Land-surface elevation, referenced to the geoid, or sea level
- $N$  Geoid separation, NAD83—North American Datum 1983

**Figure 3.** Relation of ellipsoidal, geoidal, and land-surface heights (from Blodgett and others, 1990).

Elevations for selected bench marks were computed by calculating the separation (distance  $N$ , fig. 3) of GPS ellipsoidal heights from the geoid, which is the equipotential surface coinciding with sea level. The geoidal separation, relative to sea level, ranges from about 59 to 131 ft in the conterminous United States (Collins, 1989). These elevations can then be compared with those from earlier differential leveling surveys to calculate the amount of subsidence to date.

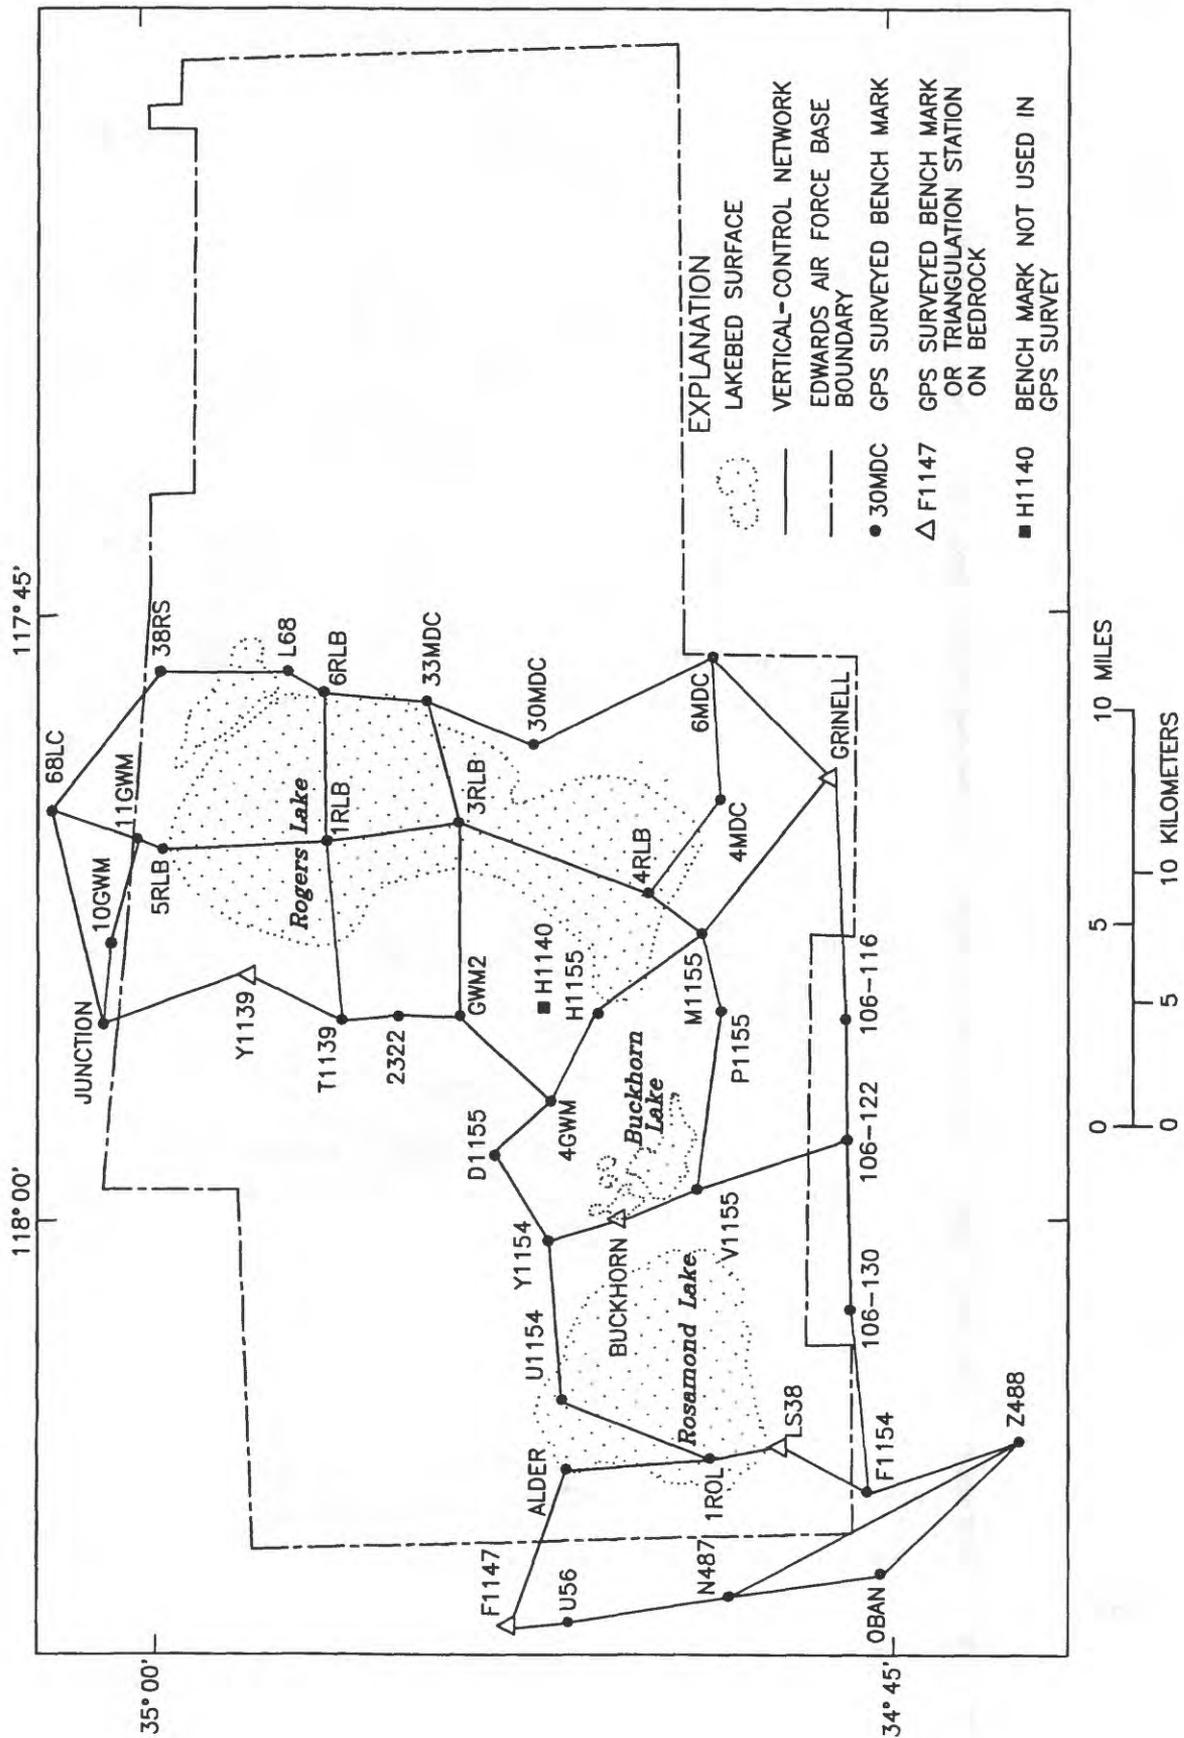
Figure 4. Global Positioning System (GPS) survey control network, March 1989.

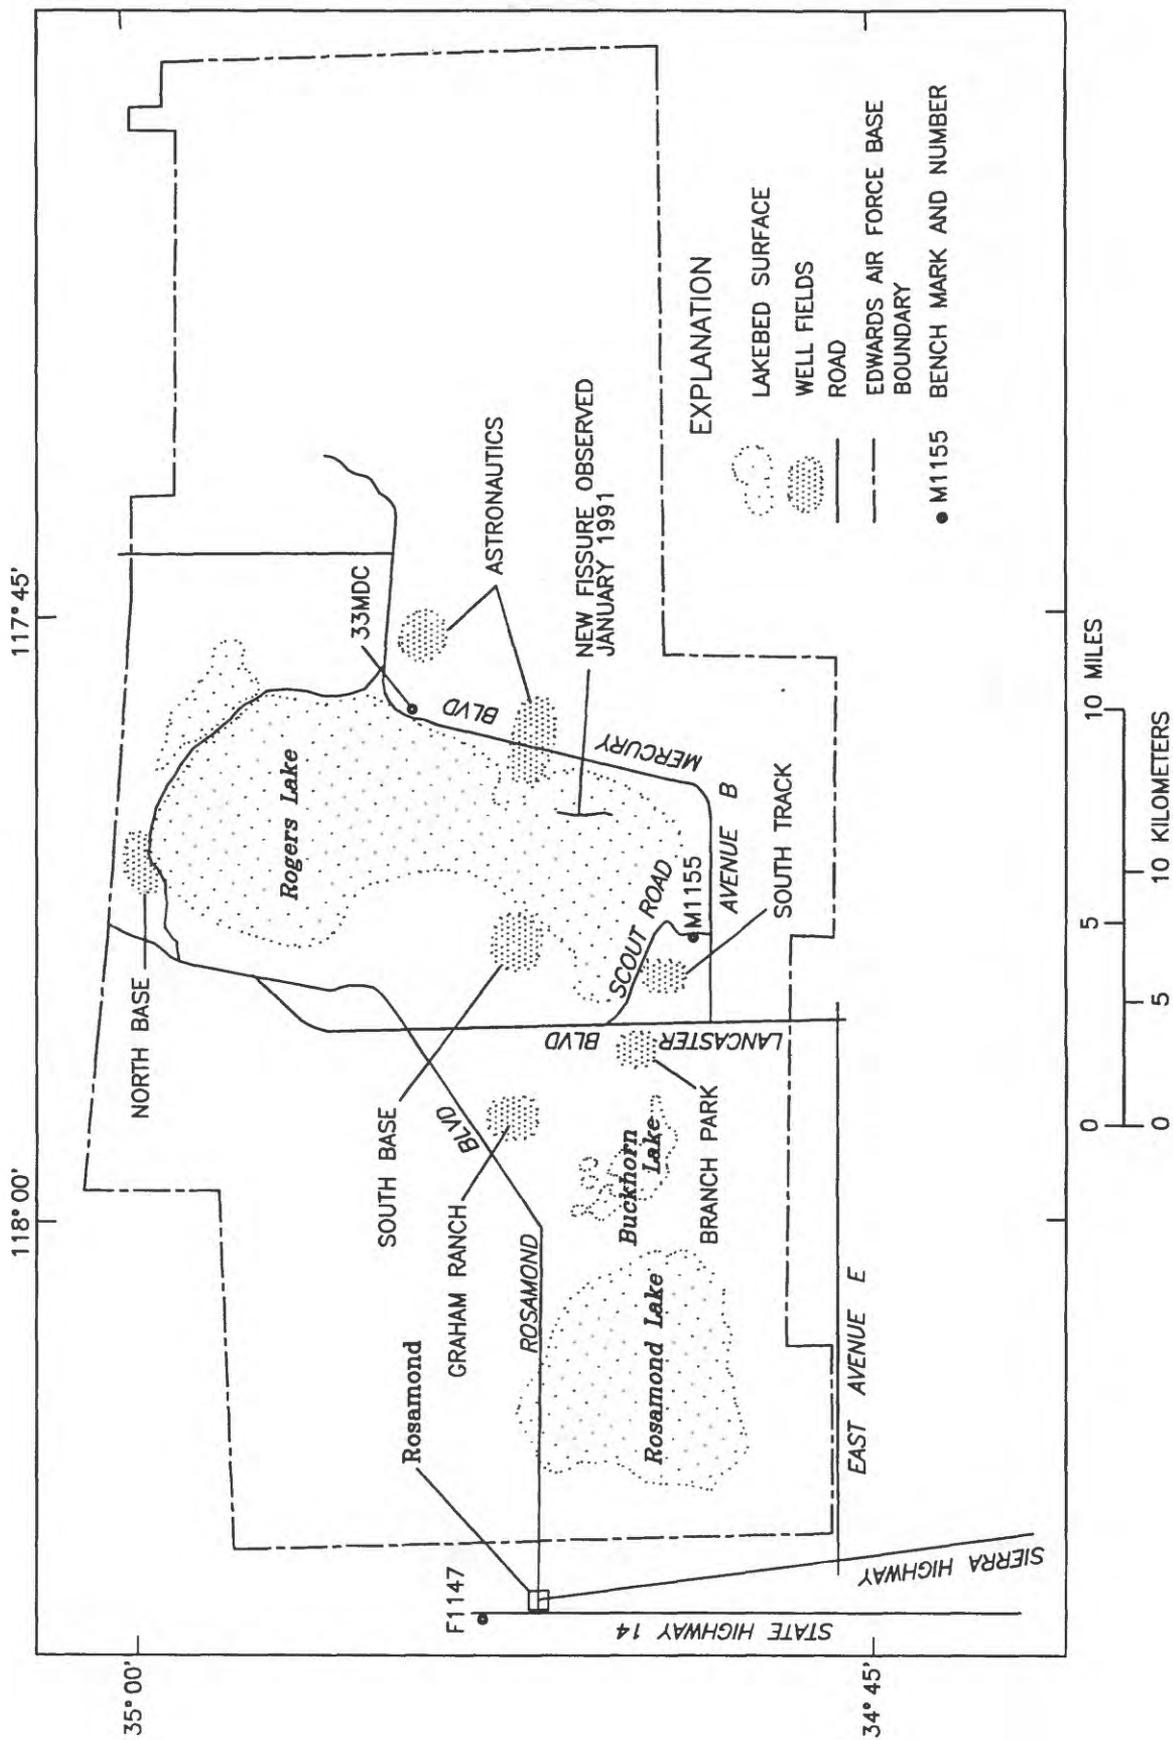
Figure 5. Location of well fields, newly observed fissure, and selected bench marks.

In May 1990, an extensometer was installed at the Holly well site (fig. 9) to measure the amount and rate of land subsidence near the South Track well field (fig. 5). This site was selected because bench marks M1155 and P1155, near the extensometer site, have subsided more than 3 ft since 1961 and represent the largest amount of subsidence documented to date on the base (fig. 6).

Land subsidence caused by ground-water pumping is a progressive phenomenon that occurs during a period of years. Several well fields are located along the margins of Rogers Lake (fig. 5). The amount and areal extent of land subsidence and associated land-use problems on Rogers lakebed are related to the lowering of ground-water levels and lithologic variations in the substrata. The effect of land subsidence on certain land-use practices may not be

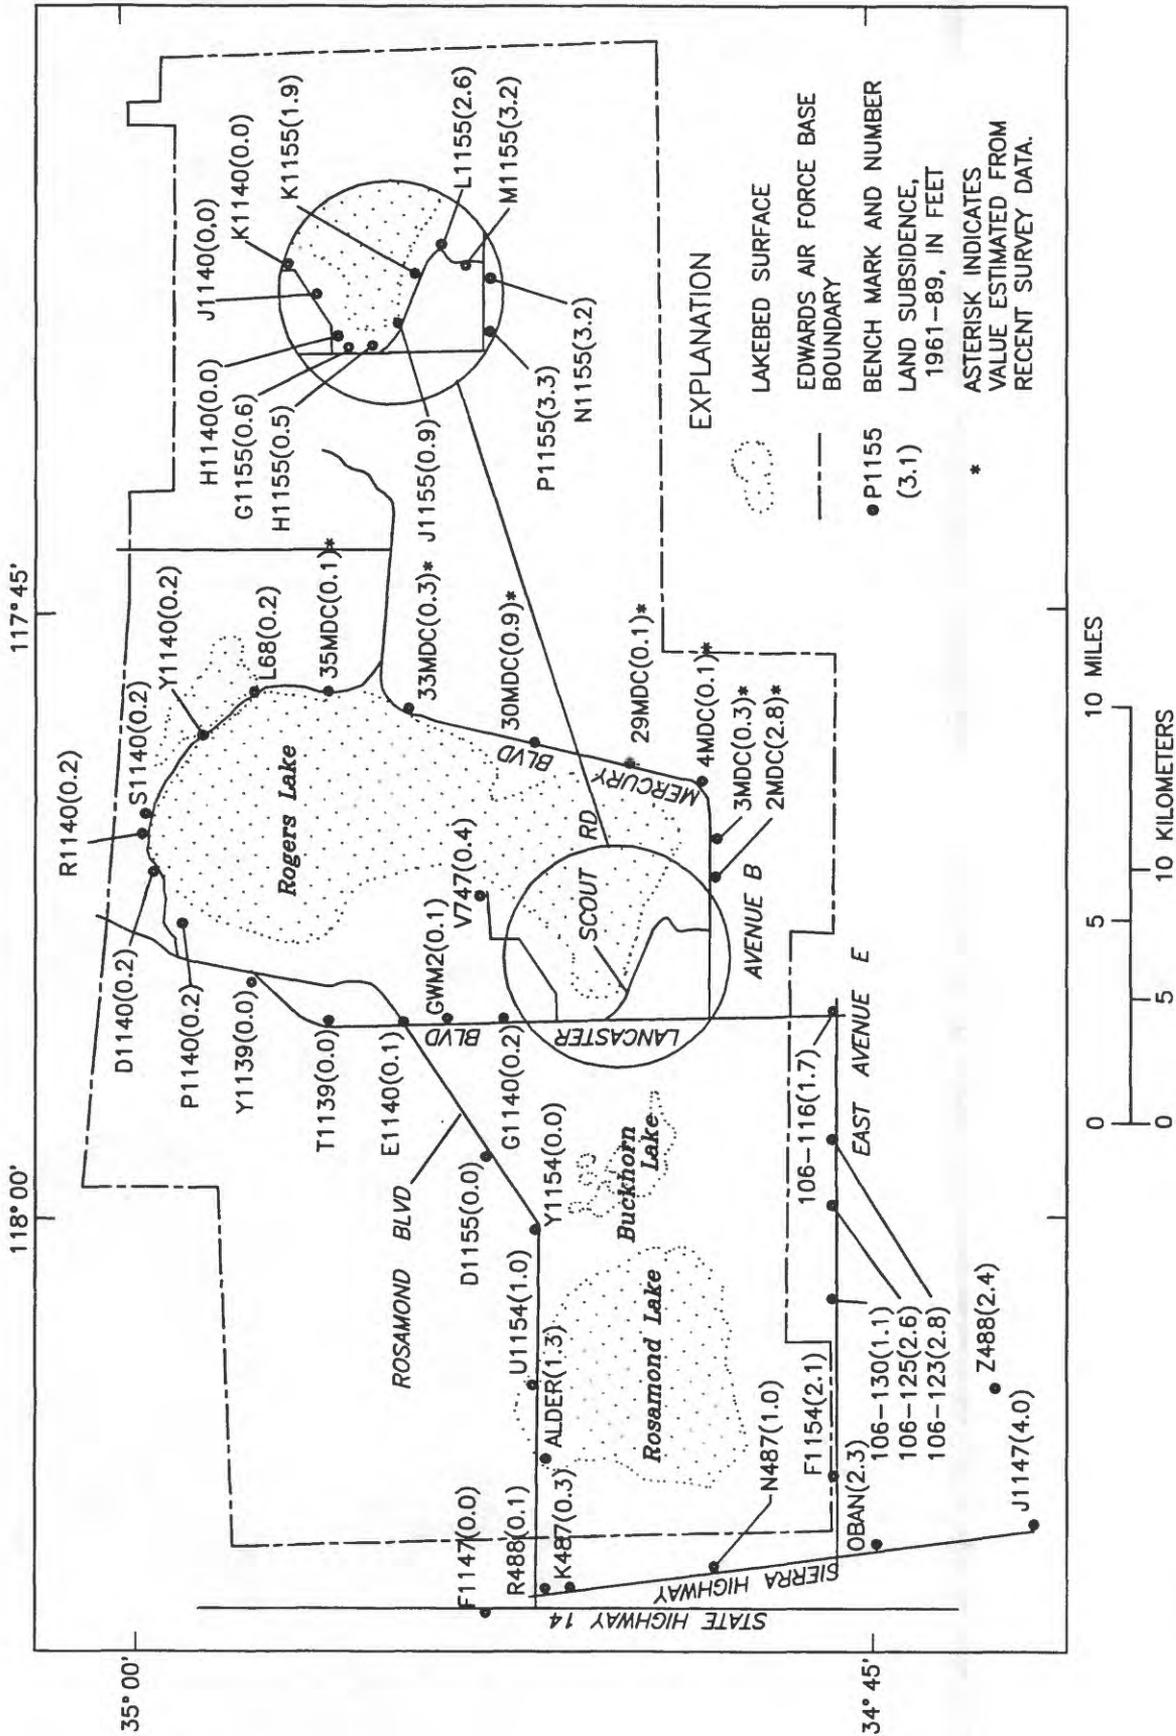
Figure 6. Subsidence (1961-91) at selected bench marks.

of land subsidence during 1961-91 (table 2). Because about 3 ft of lakebed subsidence occurred near bench marks M1155 and L1155 at the south end of the lakebed and 0.2 ft near bench mark R1140 at the north end (fig. 6), the slope of the entire lakebed probably is affected by various amounts of change in slope, with the southern part the most affected. Any change in lakebed slope represents an increase in the potential for lakebed erosion caused by wind-induced movement of water during periods of lakebed flooding. Increases in lakebed slope typically result in greater hydraulic shear stresses and increased erosion during periods of lakebed flooding that causes greater lengths and densities of existing drainage channels (number of channels in a given area) and formation of new drainage channels, which collectively are called desert flowers (fig. 16).

Land subsidence of 3.2 and 3.3 ft at bench marks M1155 and P1155, respectively (fig. 6), near the South Track well field are the maximum determined on the base to date and were determined by comparing surveys made in 1961 and 1989 (table 1). Bench mark F1147 near Rosamond was used as the stable reference for all surveys.

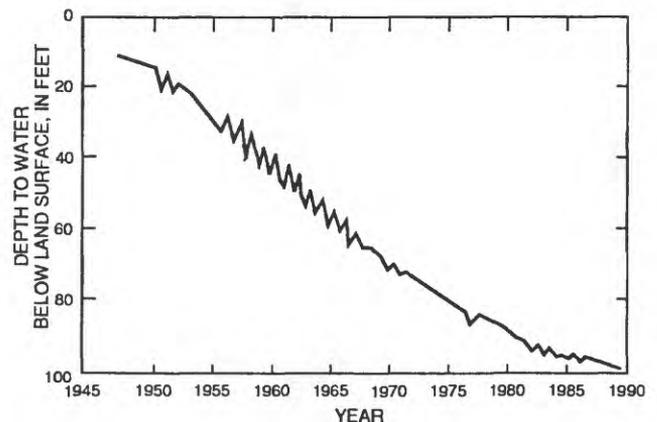
**Figure 7.** Ground-water-level decline, 1947-89, well 9N/10W-12R1S, South Base well field. Depth of well is about 250 feet.

A comparison of the results of differential leveling surveys for 1961 and 1989-91 indicates the extent of land subsidence at Edwards AFB and at selected, nearby locations. The greatest amounts of subsidence at the base for 1961-91 are near the South Track well field (figs. 5 and 6) and near the southern border of the base. Land subsidence for 1961-91 ranged from about 0.2 ft in areas near the north end of Rogers Lake to 3.3 ft south of the lake. Subsidence along the east edge of Rogers Lake near the Astronautics well fields is about 0.9 ft (figs. 5 and 6). A general decline in ground-water levels of about 90 ft since 1947 (fig. 7) is associated with land subsidence on the base.

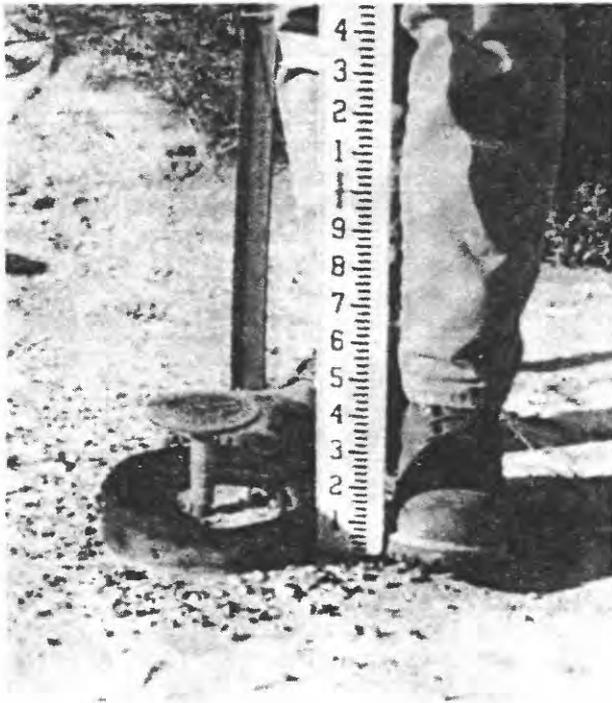
**Figure 8.** Bench mark 33MDC showing near-surface land subsidence that has caused exposure of the bench-mark stem. Bench mark, located east of Rogers Lake near Mercury Boulevard, was installed in 1973. Photographed April 1990.

Bench mark 33MDC (figs. 5 and 8), on the east side of Rogers Lake, shows an interesting subsidence phenomenon. When this bench mark was established in 1973, the brass cap and the top of the 6-inch diameter pipe were placed flush with the land surface. The brass cap presently is about 0.3 ft above the 6-inch diameter pipe, which is about 0.1 ft above the land surface. Wind erosion of the soil probably caused the 0.1 ft exposure of the 6-inch diameter

pipe. The brass cap is 0.3 ft lower in elevation than in 1973 on the basis of elevations determined from the regional vertical-control network surveyed in 1989-91 (table 1). The depth of the pipestem that supports the brass cap is unknown, but it is likely to be less than 20 ft. Therefore, there may be both shallow (depths less than 20 ft) and deep (depths greater than 20 ft) subsidence occurring at this site.

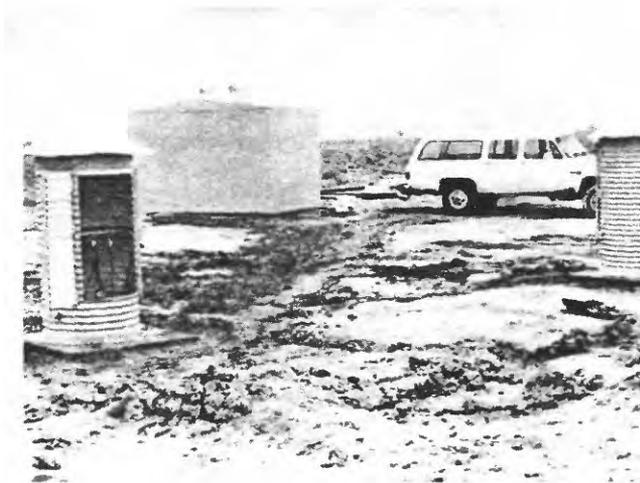
**Figure 9.** Holly extensometer site, looking east. Extensometer is in large building in center. Observation wells are in small, round buildings. Land-surface elevation is 2,302 feet. Photographed August 1990.

At the extensometer site, an 8- x 12-foot metal building houses the extensometer, and two small, round 36-inch diameter buildings (fig. 9) house the

Water levels were measured at four wells located in two buildings near the Holly extensometer (fig. 9). One building houses one 2-inch diameter pipe placed to a 130 ft depth and two wells with 3-inch diameter pipes placed to depths of 470 and 645 ft. The second building houses a well that is 1,020 ft deep. Water

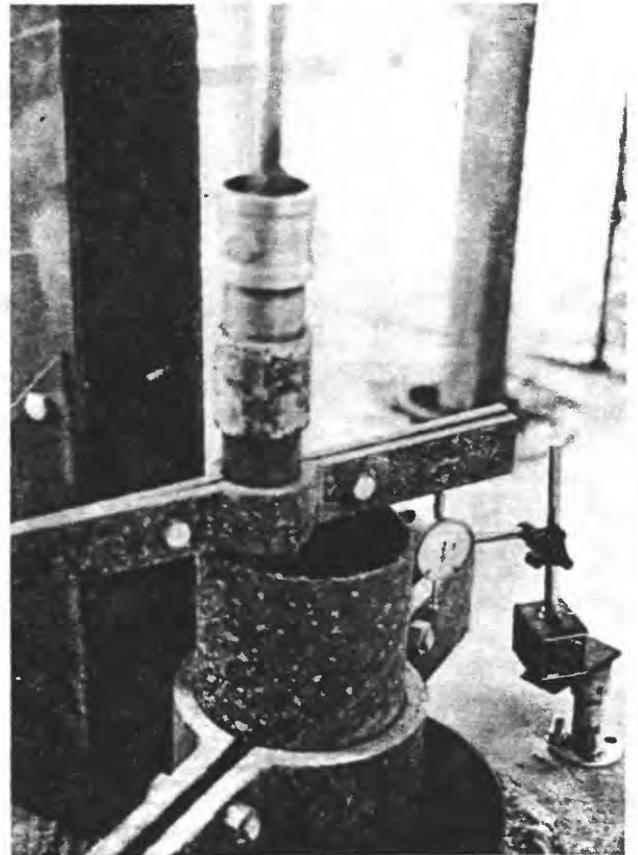
**Figure 10.** Holly extensometer. A 2-inch diameter pipe in center extends to a concrete anchor 840 feet below land surface. Dial indicator on right measures difference in distance between concrete floor (land surface) and horizontal bracket on pipe. Photographed May 1990.

nested observation wells that are used to measure water levels. The extensometer is a 10-inch diameter steel casing placed at land surface to protect a 6-inch diameter steel well casing that is 810 ft deep. Inside the 6-inch diameter casing and extending below land surface is a 2-inch diameter steel pipe embedded in concrete at a depth of about 840 ft. Granitic rock (possibly bedrock) at this site was 1,097 ft below land surface. The concrete anchor for the 2-inch diameter pipe is normally placed on bedrock or in coarse-grained strata several hundred feet below the level of ground-water pumping or strata that may be subject to subsidence. As the land surface subsides, the 2-inch diameter pipe will extend further above the land surface, and the amount and rate of land subsidence are then recorded using a data logger, drum recorder, and dial indicator (fig. 10).

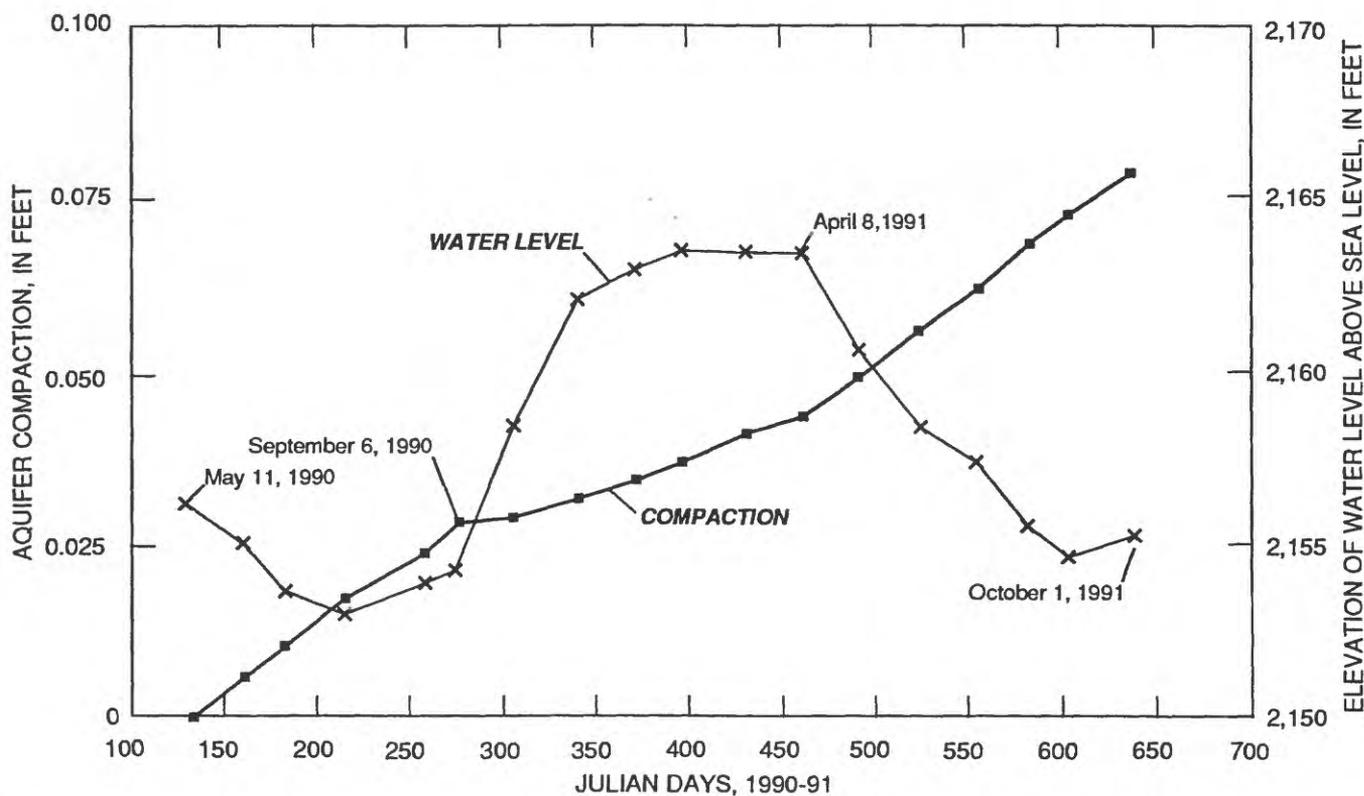
**Figure 11.** Aquifer compaction and water-level change between May 1990 and October 1991 at the Holly extensometer site.

Aquifer compaction at the Holly extensometer site between May 11, 1990, and October 1, 1991, was 0.078 ft (fig. 11). The rates of compaction shown on this figure,  $1.88 \times 10^{-4}$  ft/d prior to Julian day 259 (September 17, 1990), and  $1.97 \times 10^{-4}$  ft/d after Julian day 463 (April 12, 1991), indicate a continued rate of aquifer compaction that decreased only during the winter months of October 1990 through April 1991.

levels in the wells are measured continuously, and the data are recorded on a data logger located in the extensometer building. The period during which subsidence occurs at a reduced rate corresponds to the winter and spring months, September 1990 to April 1991 (fig. 11) when water levels at the site stabilized or rose; this period of stability is attributed to reduced pumping from the South Track well field during the winter months.

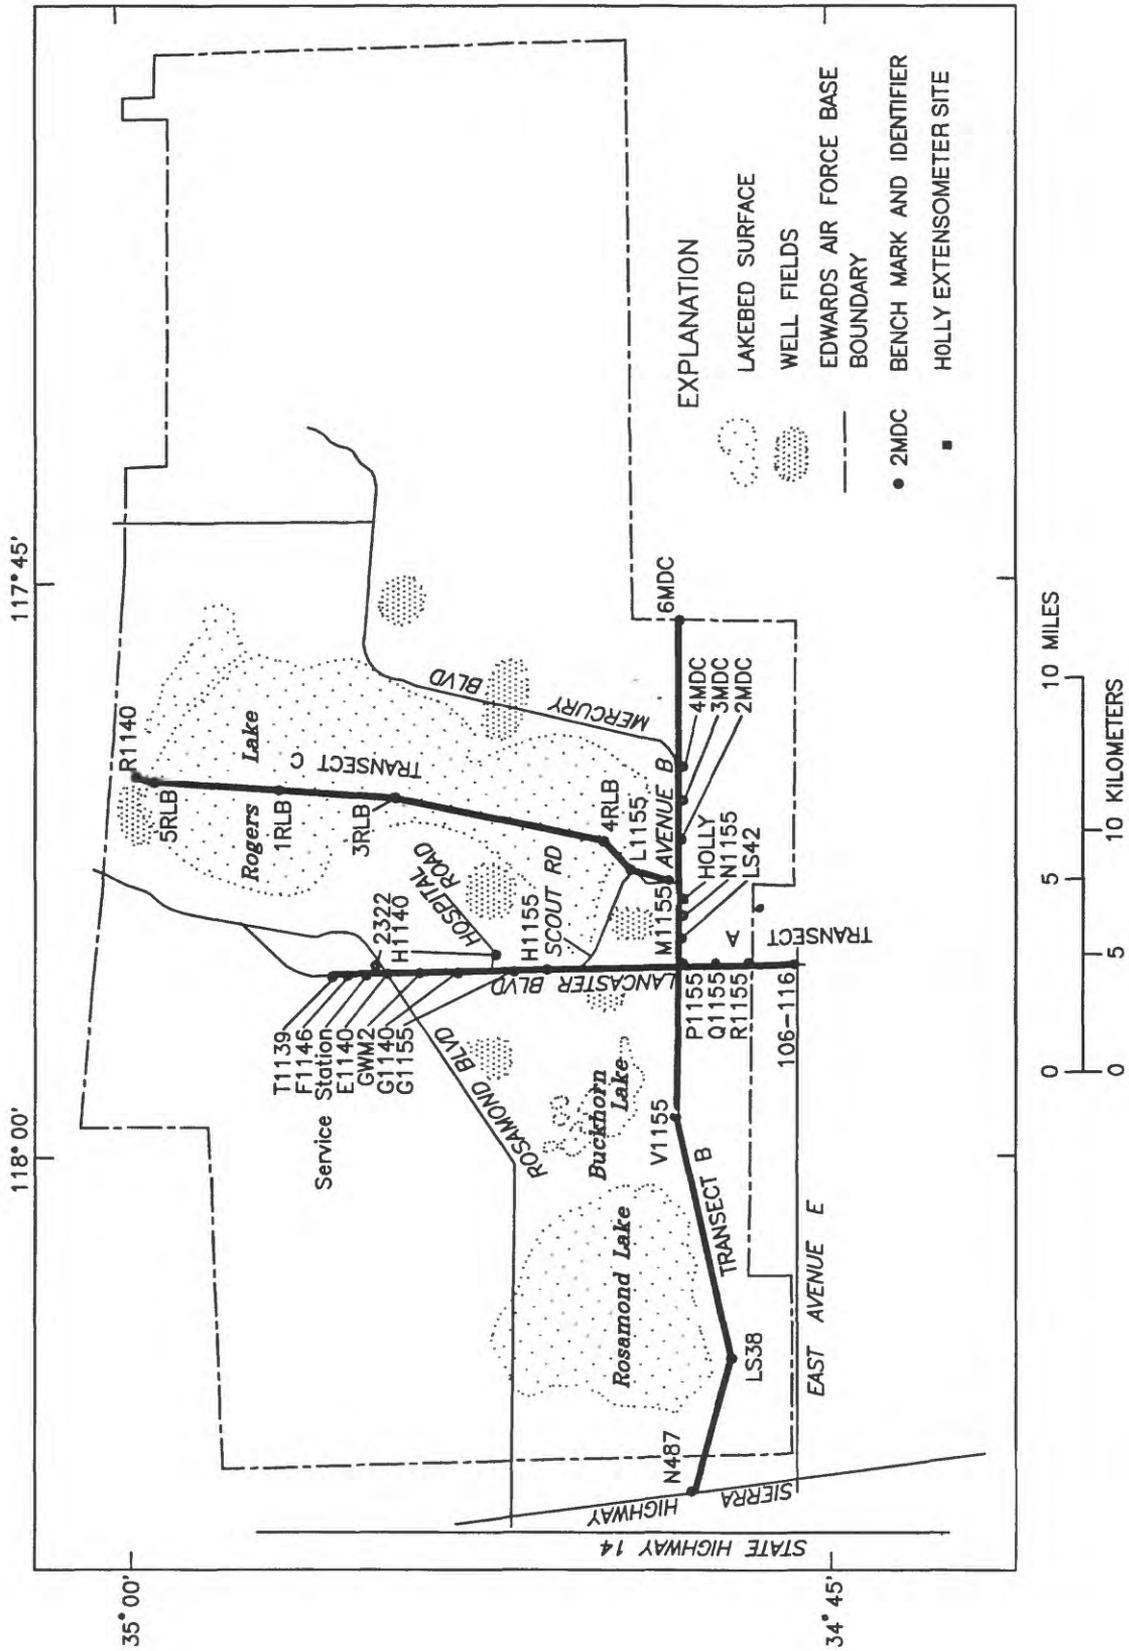
Figure 12. Location of land-surface survey transects A, B, and C.

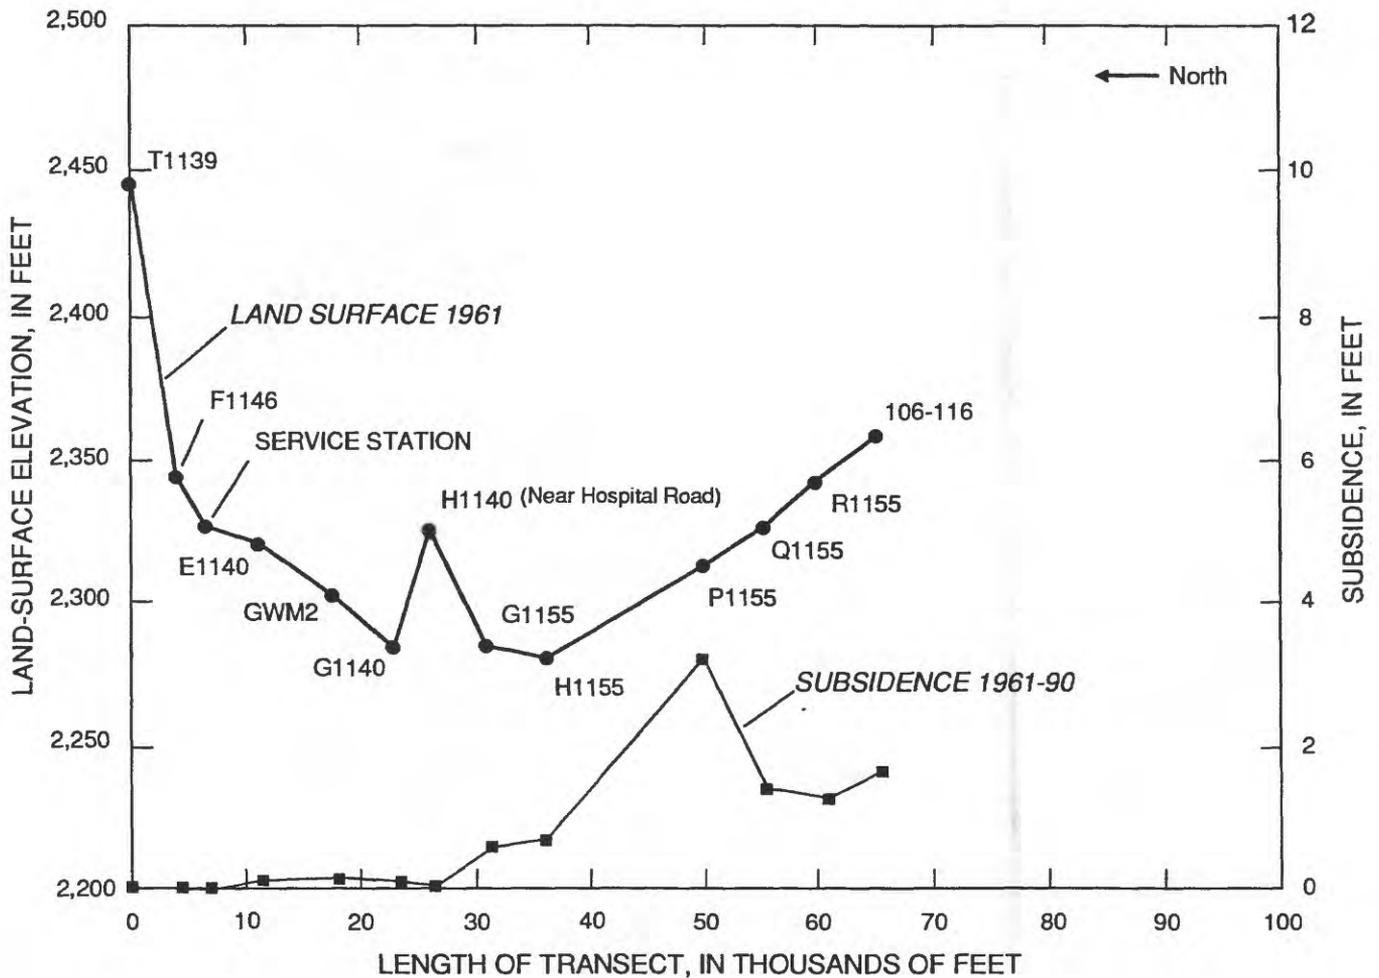
Figure 13. Land-surface elevation, transect A, Lancaster Boulevard.

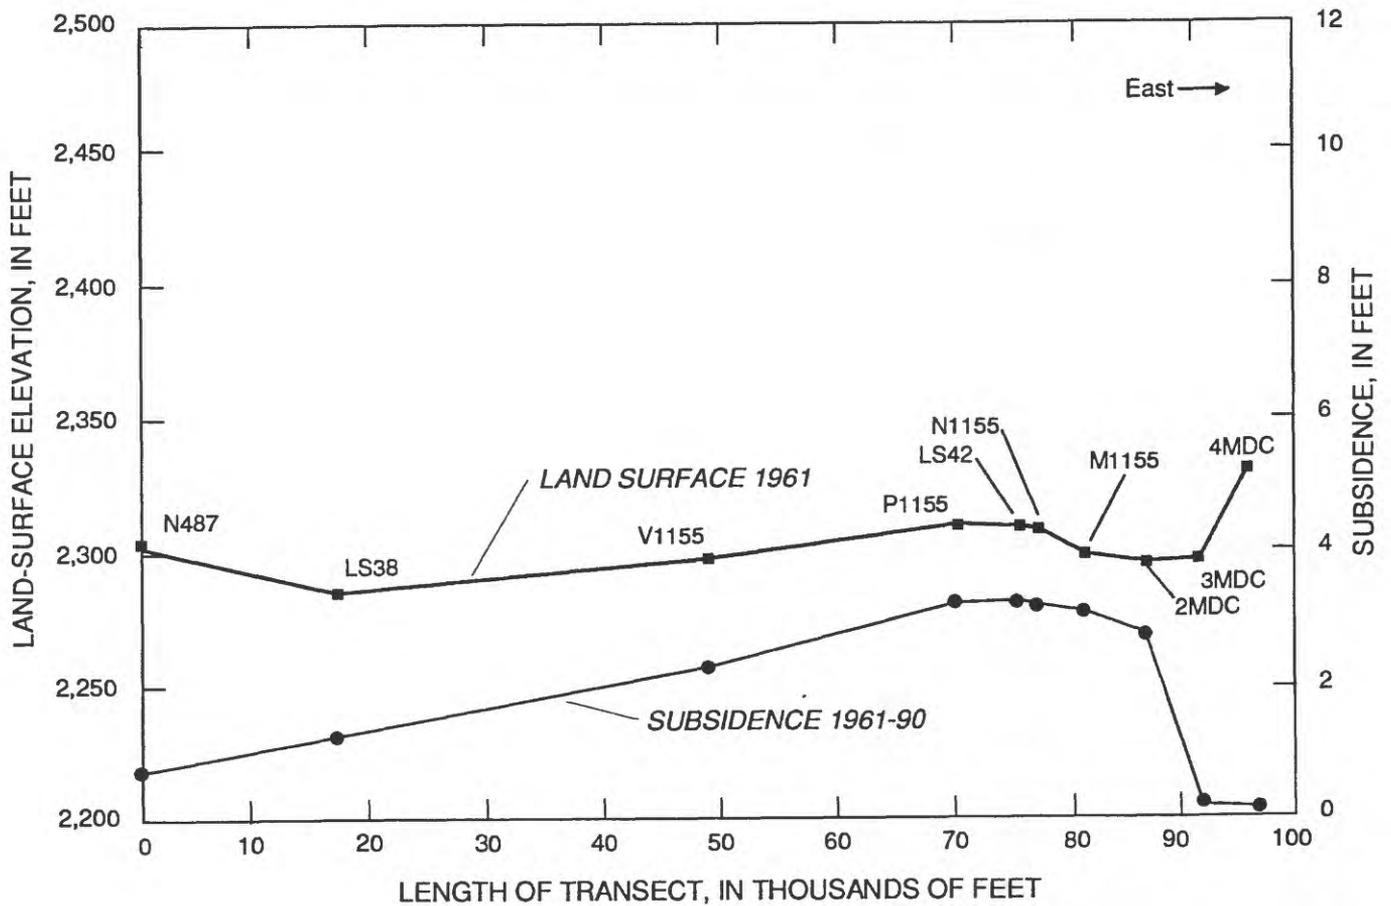
Figure 14. Land-surface elevation, transect B, Avenue B.

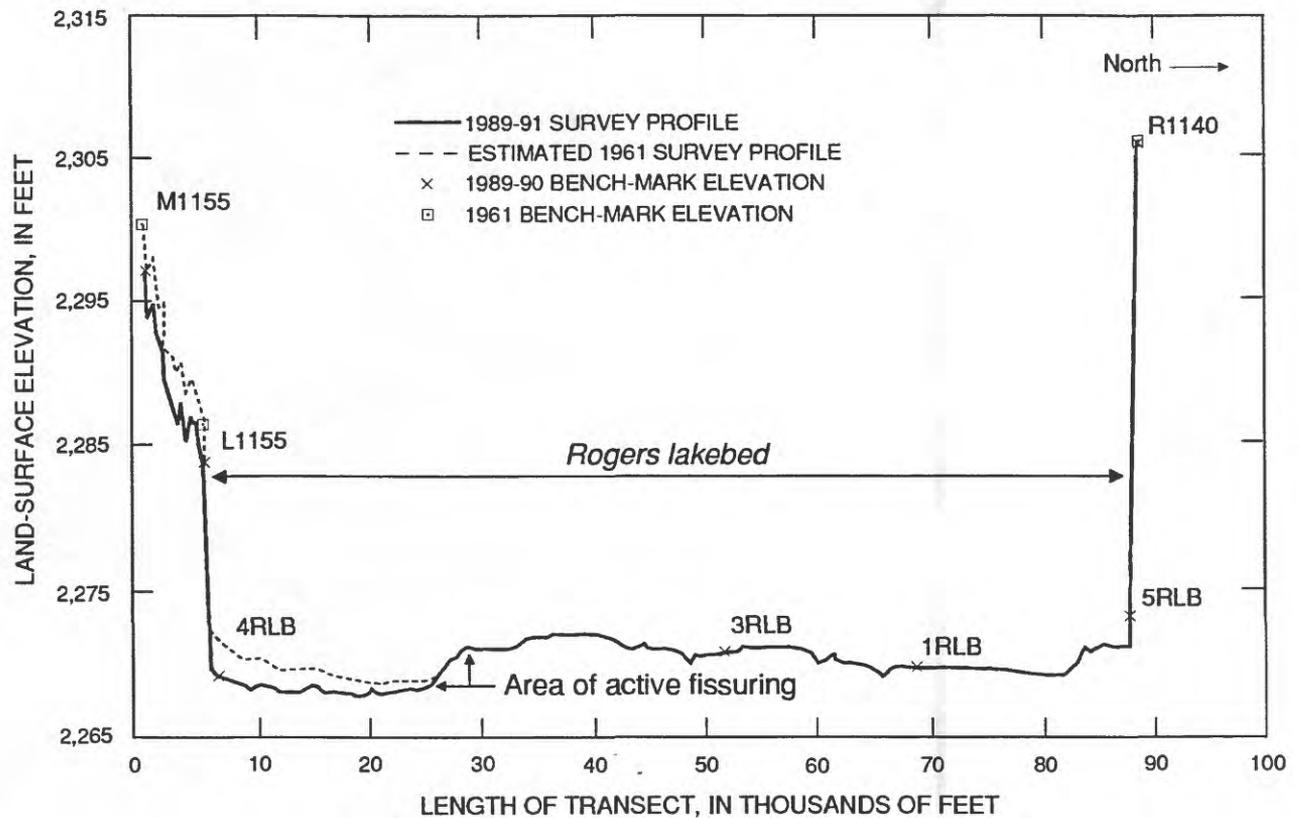
Figure 15. Land-surface elevation, transect C, Rogers lakebed.

Continued land subsidence on Rogers lakebed will affect the slope of the lakebed (fig. 15) and development of surface channels. For example, the changing and presently steeper lakebed slope between bench marks 3RLB and 4RLB (fig. 15), affects the geomorphic characteristics of natural drainage on the lakebed. As the slope increases, the lakebed is increasingly incised with drainage channels (figs. 16 and 23). The channel network density increases in the downstream direction, with lakebed channels larger in areas A and B than in area C because the

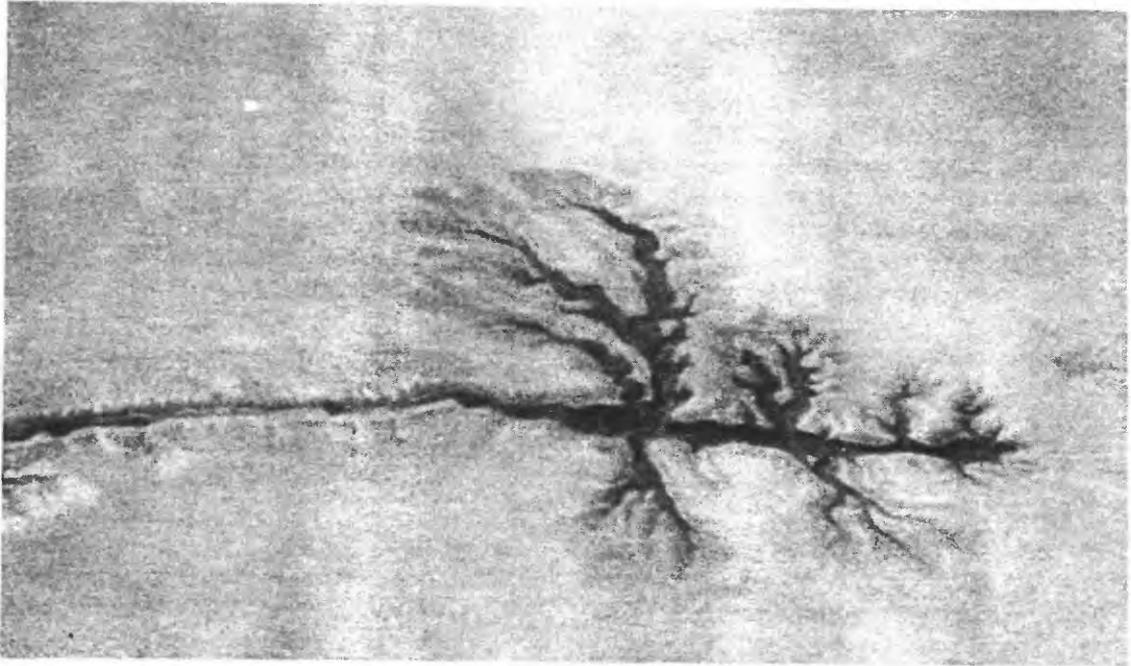
**Figure 16.** Drainage channels (collectively called desert flowers) caused by erosion during flooding of Rogers lakebed. Photographed August 1989.

- Erosion of drainage channels and formation of new drainage channels (waterways) on the lakebed caused by changes in elevation and gradient of the lakebed and wind-induced movement of the ponded water (fig. 16).

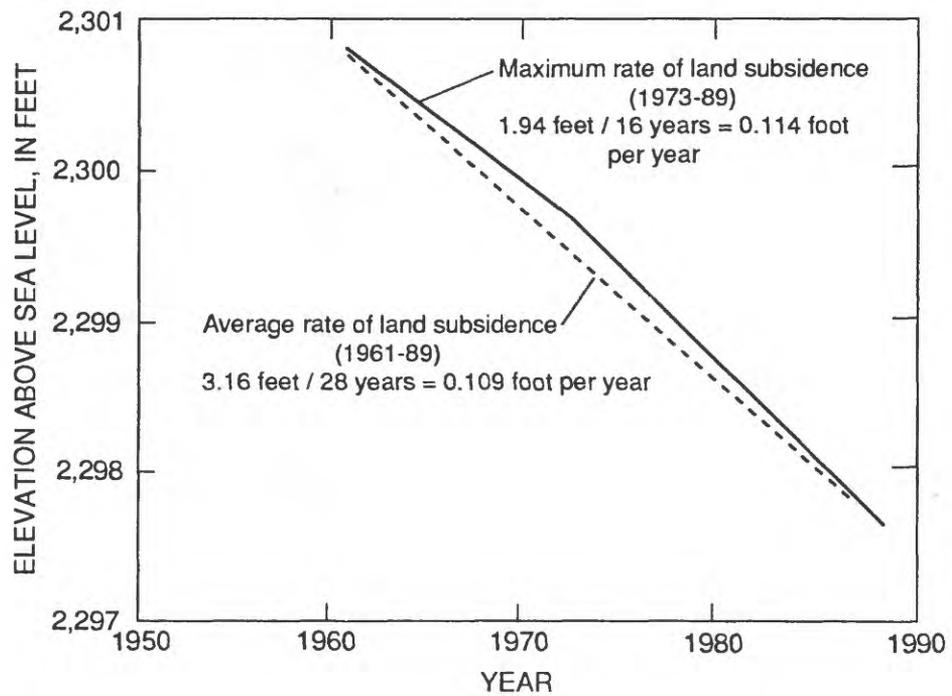
**Figure 17.** Land subsidence at bench mark M1155 near South Track well field, 1961-89.

The average rate of land subsidence at bench mark M1155 was 0.109 ft/yr between 1961-89 (fig. 17). The average rates of land subsidence at most other bench marks in the study are less than that of bench mark M1155 (fig. 6). Variation in these subsidence rates is related to the variable effects of ground-water pumping at different locations on the base and lithologic variation in the substrata.

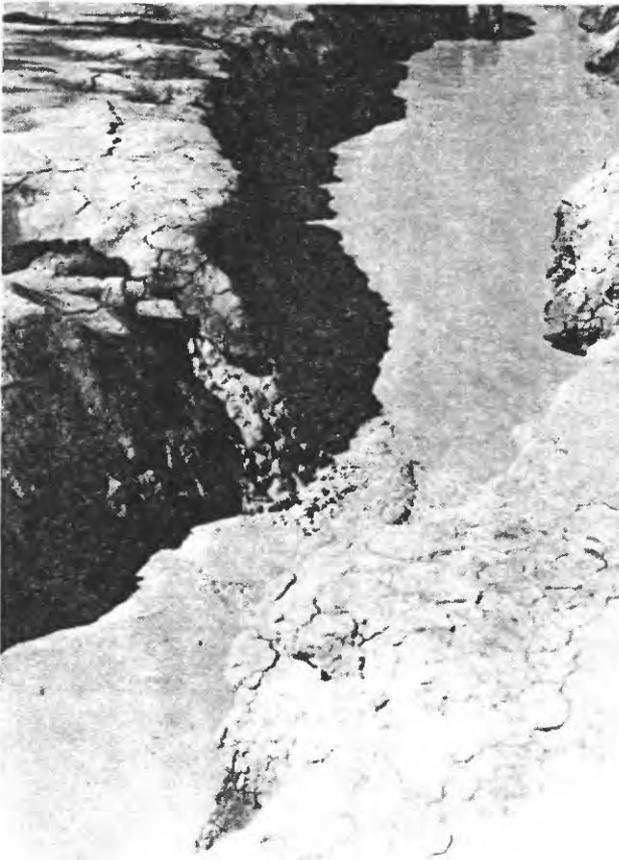
**Figure 18.** Erosion of Rogers lakebed caused by movement of ponded water to fissure opening, March 1991.

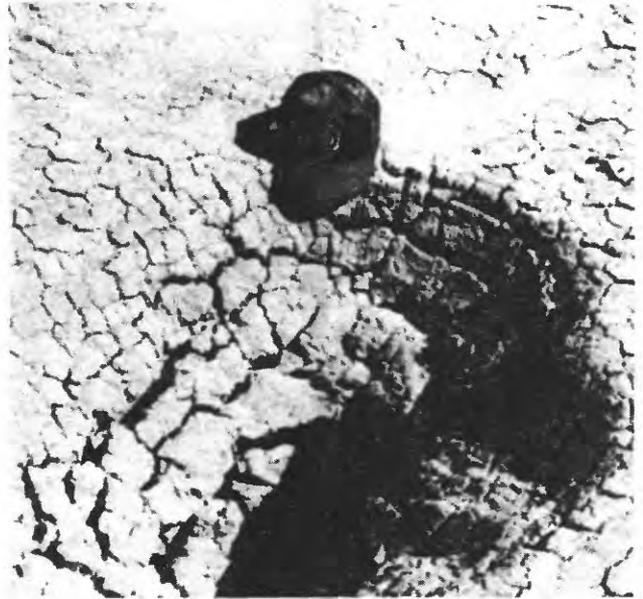
**Figure 19.** Small sinklike depression on Rogers lakebed showing small (cobblestone size) flat, sun-baked polygons on depression wall. The polygons are formed during moisture loss by evaporation. Photographed August 1988.

Dry lakebeds usually have smooth, hard, flat surfaces. Some have small (cobblestone size) polygons or large (giant) desiccation polygons (figs. 19 and 20). The small polygons range from 1 to 4 inches across; the giant polygons may exceed 300 ft (Neal, 1965).

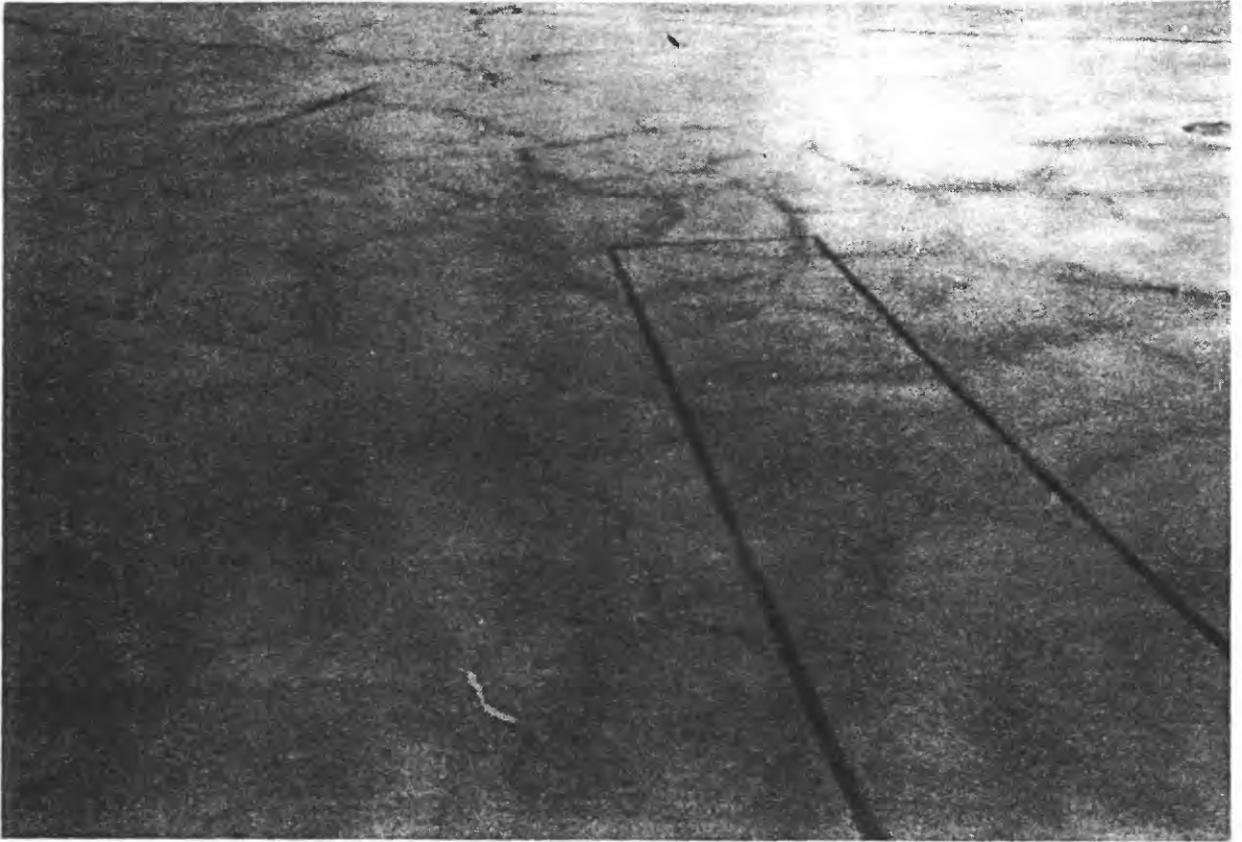
**Figure 20.** Aerial view of Rogers lakebed showing giant desiccation polygon cracks. Width of runway is about 330 feet. Photograph courtesy of U.S. Department of the Air Force, 1983.

Giant desiccation polygons are formed by the orthogonal intersection of giant mud cracks, which commonly are as much as 3 ft wide and 3 ft deep (Neal, 1965). Orthogonal polygons result from volume change in a uniform horizontal mass with one surface exposed (Neal, 1968). These features are described as giant polygons to distinguish them from

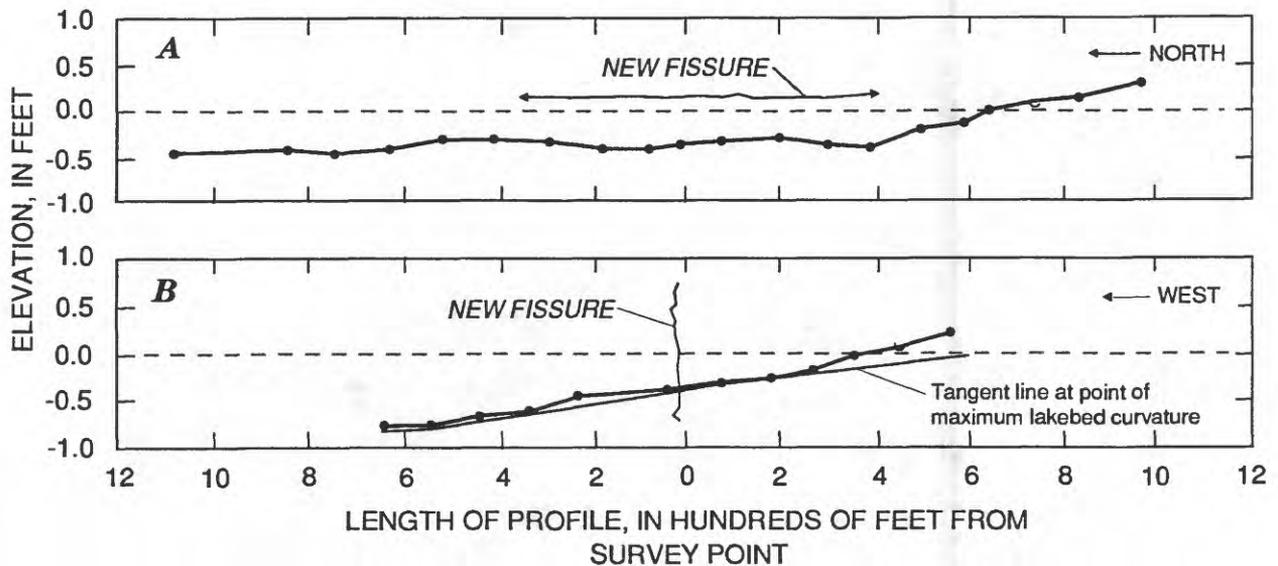
**Figure 21.** Land-surface profile at new fissure on Rogers lakebed. *A*, Longitudinal profile of land surface parallel to fissure. *B*, Cross profile of land surface at survey point.
