**LAND SUBSIDENCE AND PROBLEMS  
AFFECTING LAND USE AT  
EDWARDS AIR FORCE BASE  
AND VICINITY, CALIFORNIA,  
1990**

**U. S. GEOLOGICAL SURVEY  
Water-Resources Investigations  
Report 92-4035**

**Prepared in cooperation with the  
U.S. DEPARTMENT OF THE AIR FORCE**

By James C. Blodgett *and* J.S. Williams

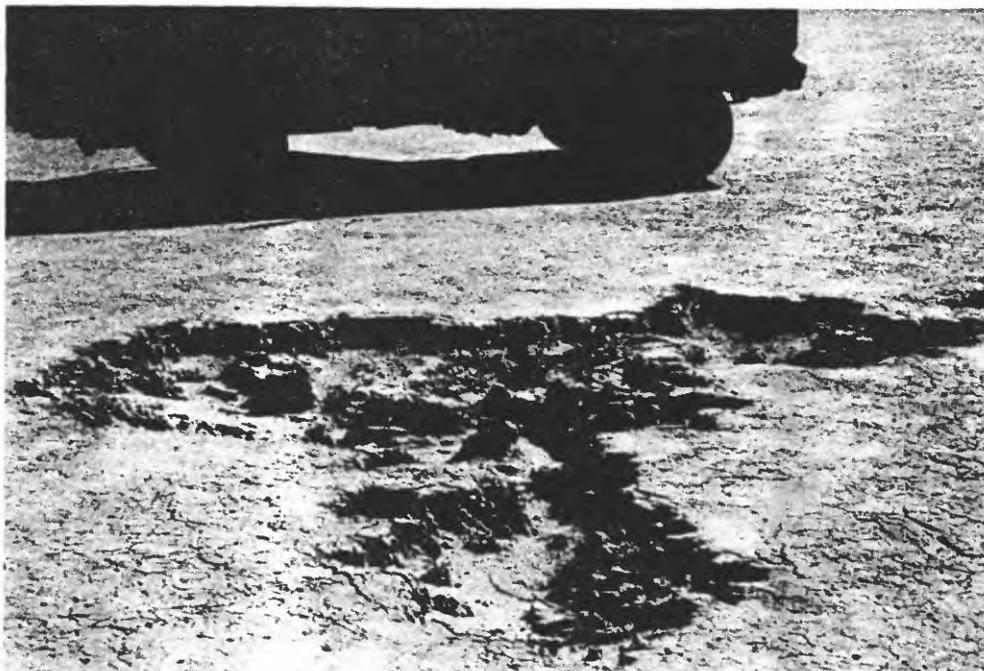
**Figure 22.** Expanding sinklike depression on Rogers lakebed caused by erosion during periods of lakebed flooding. Photographed June 1990.

Sinklike depressions on the land surface that range in size from 0.5 ft to several feet in diameter and from a few inches to 6 ft in depth (figs. 22 and 23) have been found at several Edwards AFB locations. Sinklike depressions were defined by H.H. Schumann (U.S. Geological Survey, written commun., 1991), who noted a series of holes and depressions in association with earth fissures in southern Arizona. Some of the depressions have nearly vertical sides and form along trends of earth fissures that may not yet be expressed at the land surface. Sinklike depressions observed by Schumann are similar to the localized holes and depressions observed at Edwards AFB (figs. 19 and 22), with underground voids enlarged as a result of vertical and lateral movement of water or piping. The definition of these sinklike depressions differs from that for sinkholes given by Bates and Jackson (1984, p. 470), in which a sinkhole is a "circular depression in a karst area. Its drainage is subterranean, its size measured in meters or tens of meters, and it is commonly funnel-shaped." For sinkholes and sinklike depressions, the physical process of vertical erosion during movement of surface water into an underground void is believed to be similar. The distinction is that the definition of sinkholes applies to karst (limestone) areas, whereas sinklike depressions occur in other areas.

The occurrence of sinklike depressions at Edwards AFB (fig. 22) is related to land subsidence, declining ground-water levels, and formation of giant polygons. Because all these elements are present, enlargement of older sinklike depressions and formation of new depressions are considered progressive. The rate at which new sinklike depressions form is dependent on many factors, including lakebed flooding from precipitation on the lakebed, inflow from tributaries to the lake, movement of bodies of surface water on the lakebed, and ground-water pumping that, in turn, affects the rate of subsurface (aquifer) water-level decline.

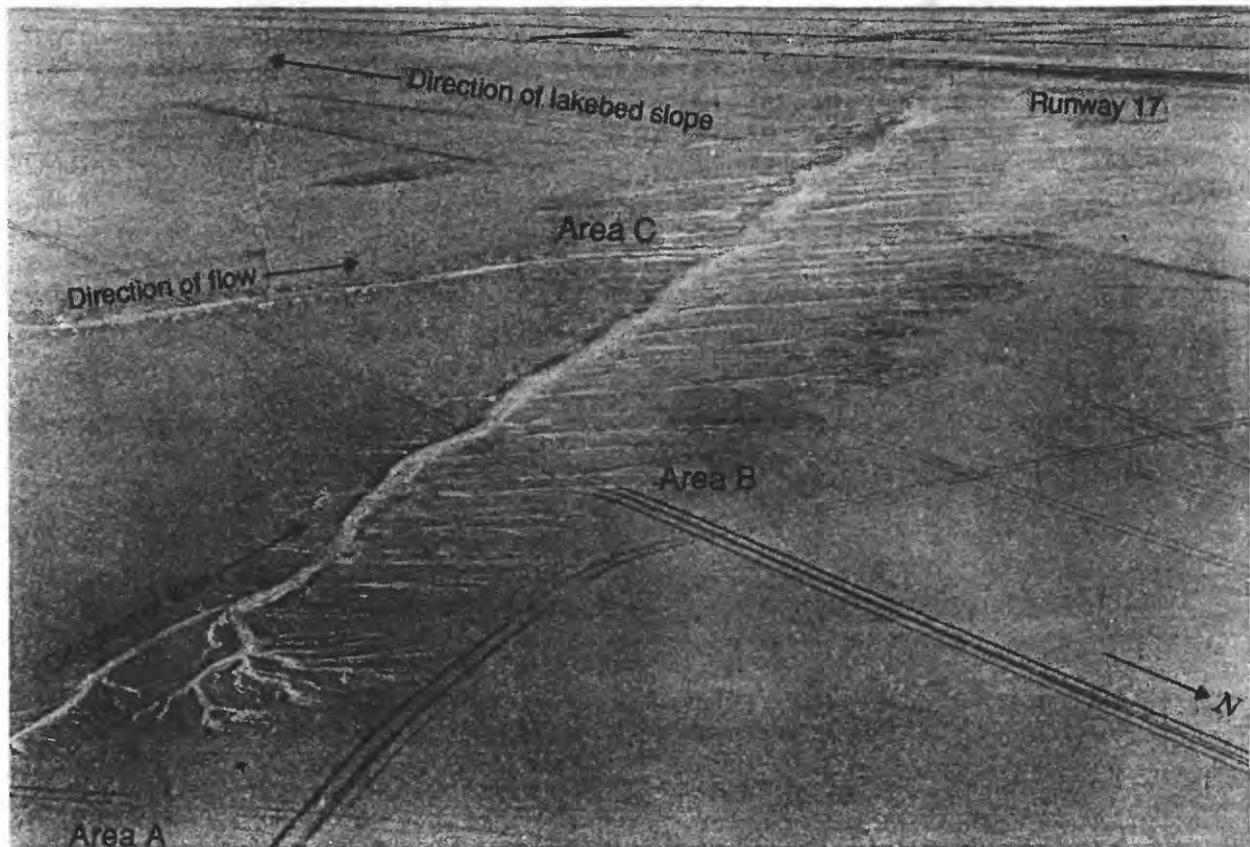
**Figure 23.** Oblique aerial photograph of Rogers lakebed east of South Base well field. A typical network of drainage channels (collectively call desert flowers) is shown at area A. Erosion in areas B and C is a result of land subsidence, which causes an increase in lakebed slope from north to south (right to left on photograph). Photograph courtesy of U.S. Department of the Air Force, August 1990.

Erosion on dry lakebeds and subsequent formation of drainage channels, collectively called desert flowers (area A on fig. 23), were first noted by Motts and Carpenter (1970). In some locations, such as Rogers lakebed, the channels forming the dendritic channel pattern adjacent to the main channel were as deep as 0.3 ft on the lakebed surface. Erosion of channels on the lakebed generally continues after each period of flooding and now covers an extensive part of the lakebed (fig. 23). Many drainage channels are several feet wide and several feet deep. The development of the channels on the lakebed is affected by the slope of the lakebed and also by the presence of fissures or erosion depressions, which serve as outlets for the flow.

Continued land subsidence on Rogers lakebed will affect the slope of the lakebed (fig. 15) and development of surface channels. For example, the changing and presently steeper lakebed slope between bench marks 3RLB and 4RLB (fig. 15), affects the geomorphic characteristics of natural drainage on the lakebed. As the slope increases, the lakebed is increasingly incised with drainage channels (figs. 16 and 23). The channel network density increases in the downstream direction, with lakebed channels larger in areas A and B than in area C because the

lakebed slope plus channel slope is greater in areas A and B than in area C. The length of the drainage channels is a function of the lakebed slope, with the length increasing from area A toward areas B and C. A detrimental feature of this type of erosion and channel formation is that the presence of water on the lakebed, either from direct rainfall or flooding by tributaries, will extend the channel erosion and sediment transport processes toward low points on the lakebed.
