EFFECTIVENESS OF HIGHWAY EDGEDRAINS

FINAL REPORT--Experimental Project No. 12,
Concrete Pavement Drainage
Rehabilitation

Water-Resources Investigations Report 92-4147

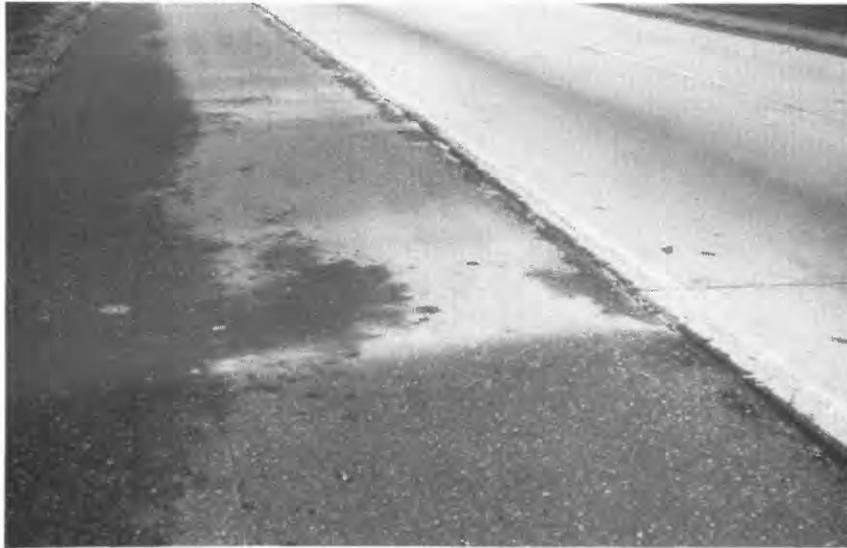
Figure 1.--Subgrade fine material removed by infiltrated water discharging along longitudinal edge joint.

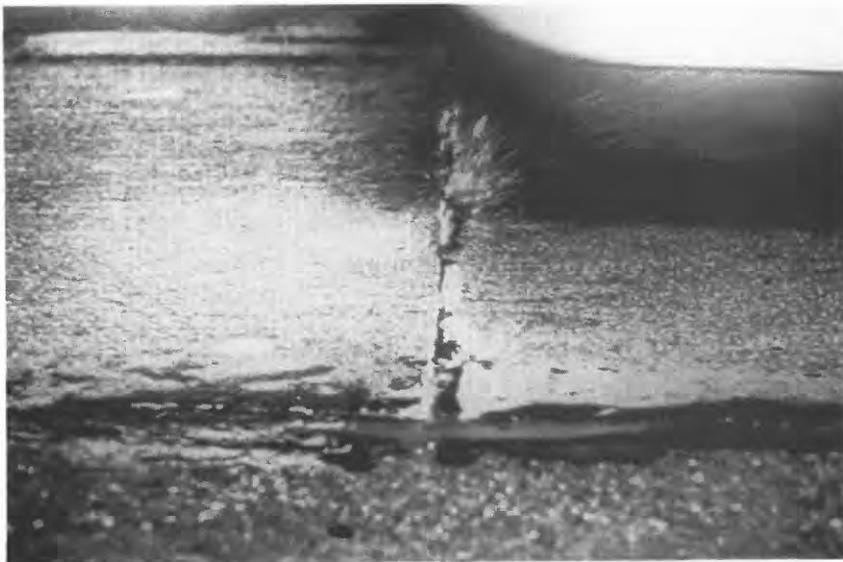
Figure 2.--Subgrade water being pumped out of joint due to passage of vehicle

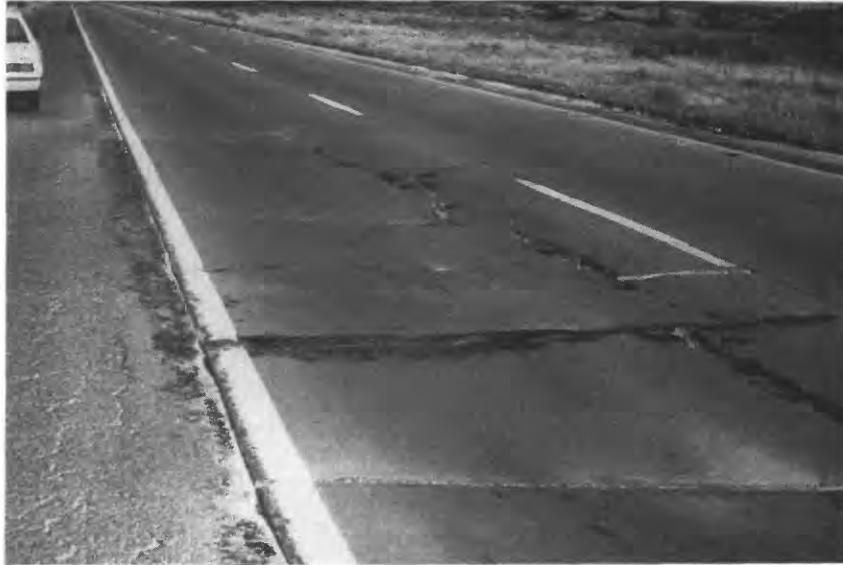
Figure 3.--Failure of highway pavement due to infiltration of water into subgrade.

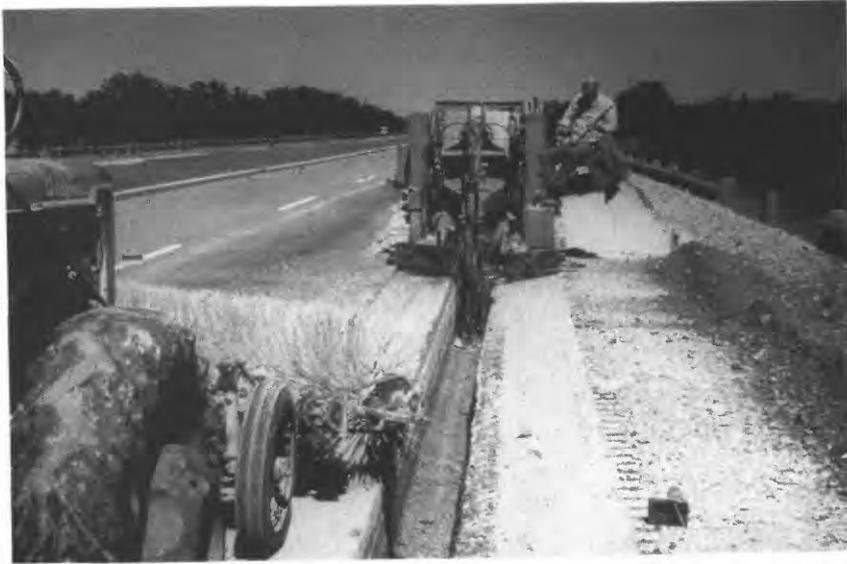
Figure 5B.--Preparing trench for installation of edgedrain.

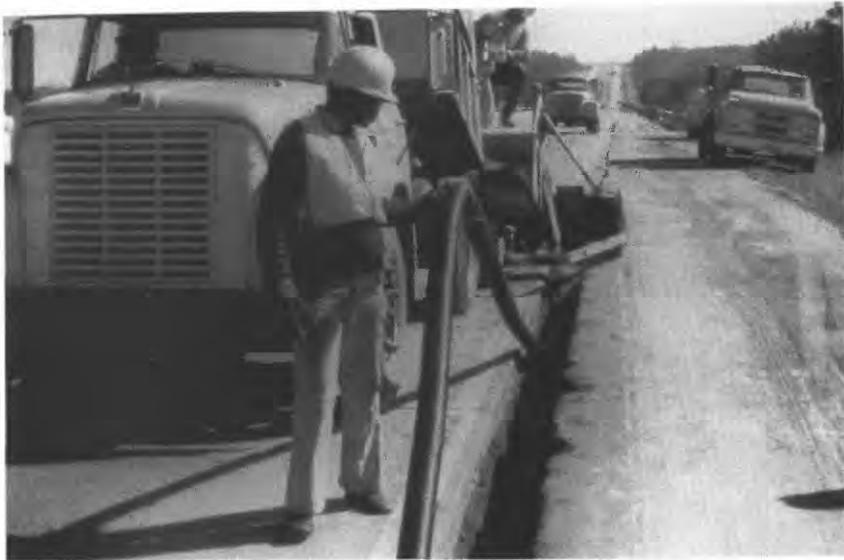
Figure 5C.--Laying of perforated flexible drain pipe in edgedrain trench.

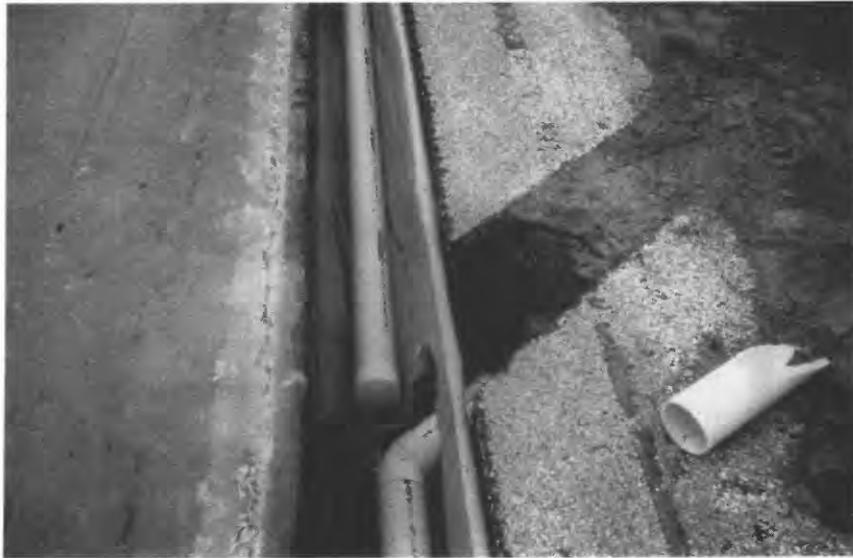
Figure 5D.--Rigid perforated PVC drain pipe and 4-inch diameter outlet with filter cloth prior to backfilling edgedrain trench.

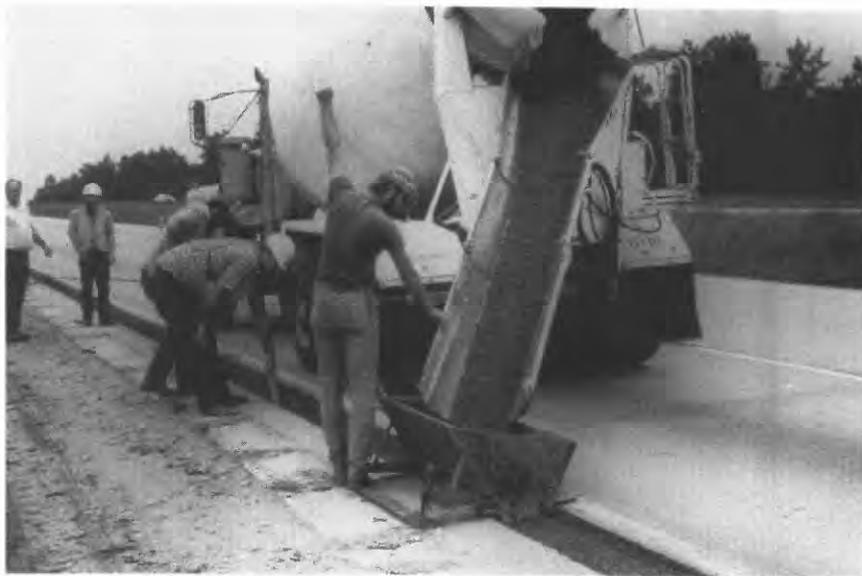
Figure 5E.--Filling of edgedrain trench with aggregated prior to topping with asphalt.

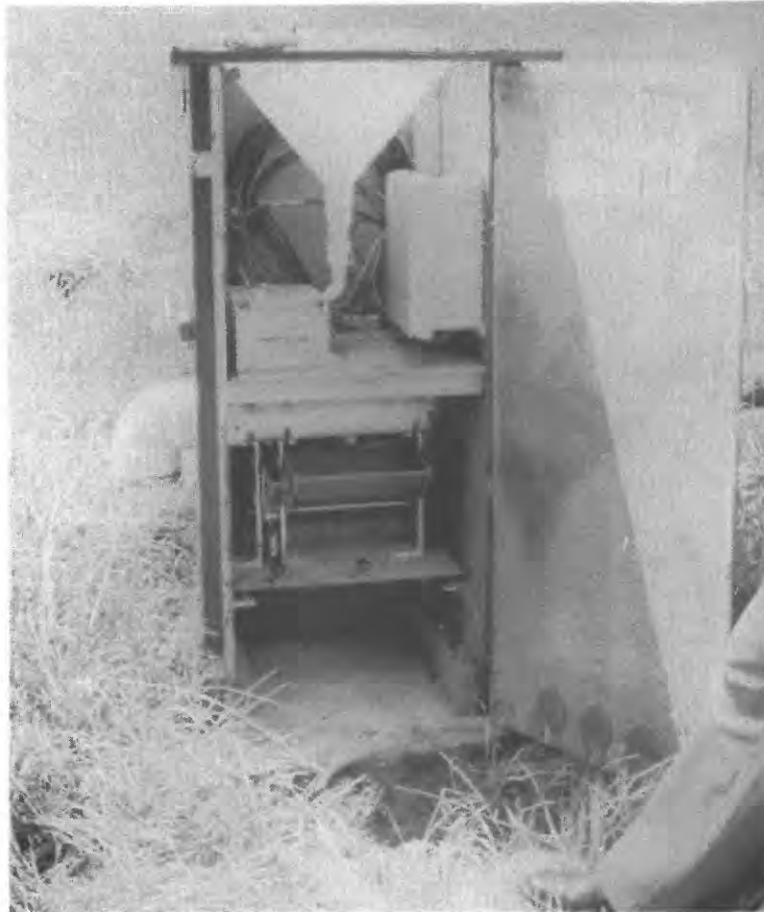
Figure 7.--Dual tipping bucket and instrumentation shelter; edgedrain discharge enters from right, spills into large bucket with any excess overflowing weir on left and out 90° elbow.

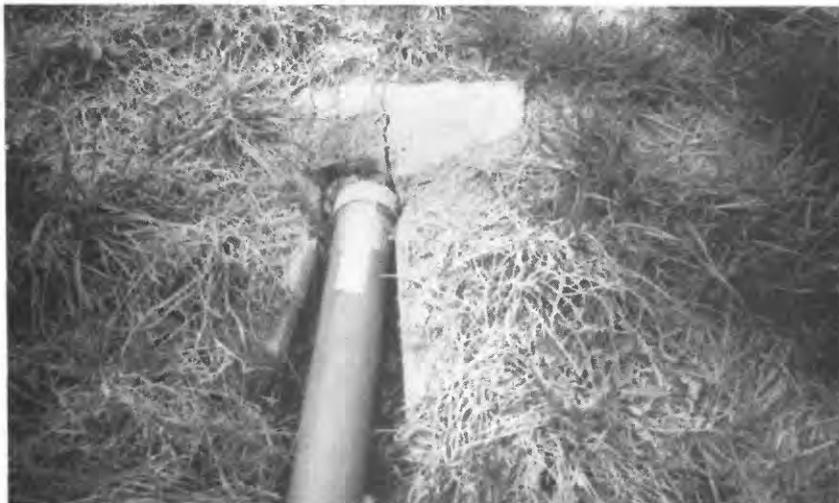
Figure 8.--Diversion of edgedrain discharge to tipping bucket using PVC pipe secured to outlet pipe.

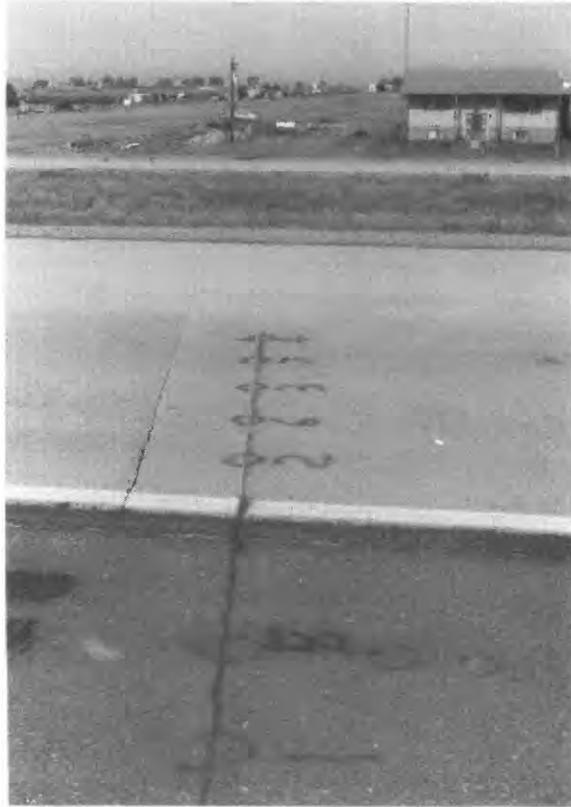
Figure 10.--Designation and location of drill holes and signal line slot for placement of sensors under pavement

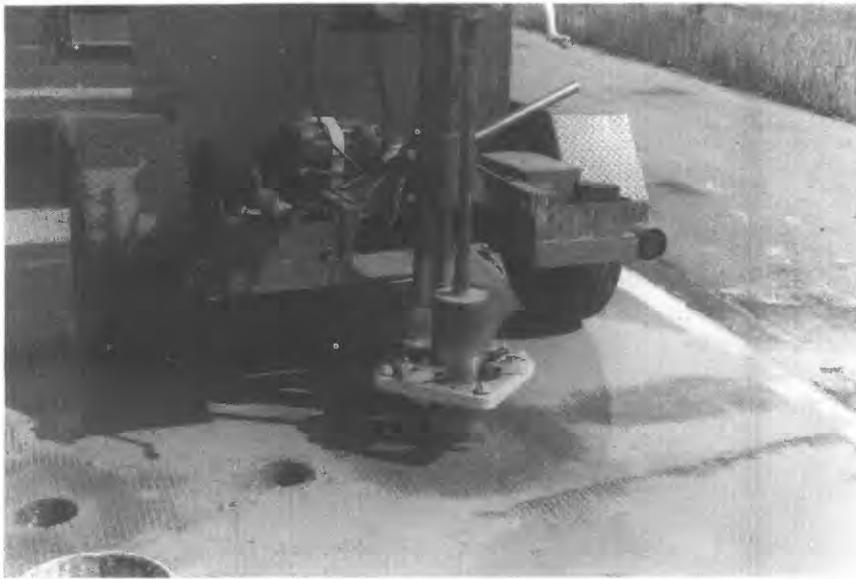
Figure 11.--Drilling of 4-inch diameter sensor holes through concrete pavement.

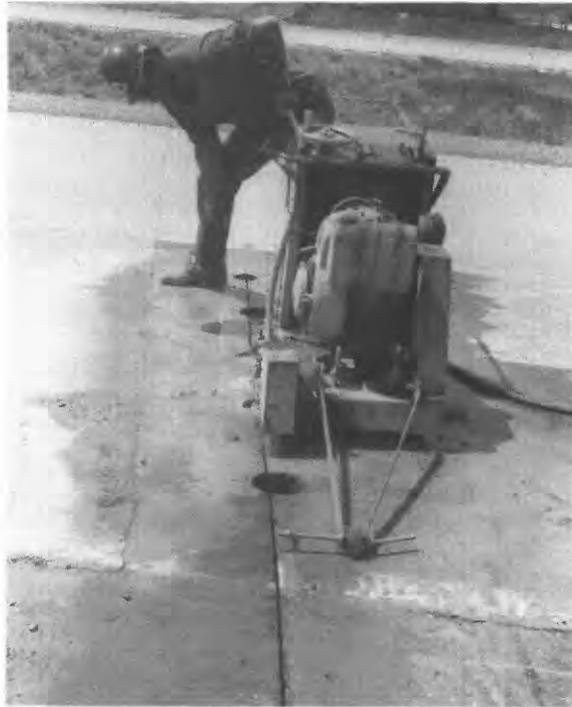
Figure 12.--Cutting slot in concrete pavement for sensor lines.

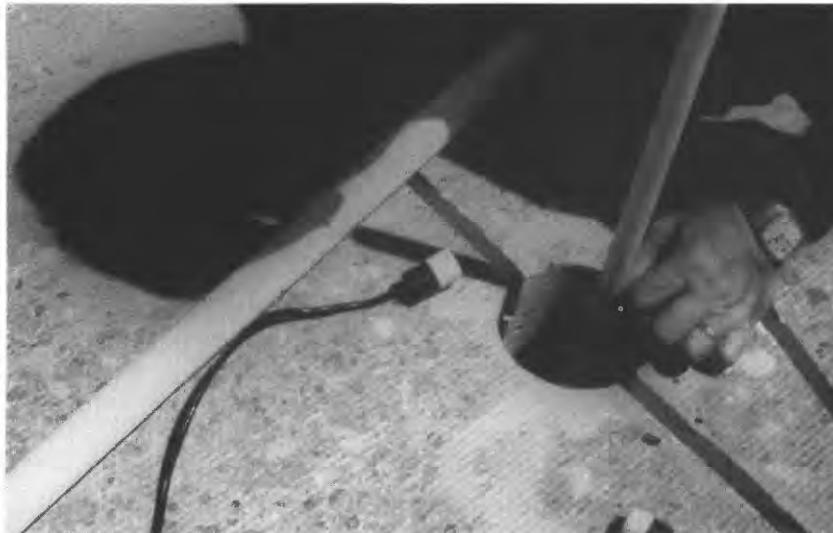
Figure 15.--Soil-moisture block prior to placement just below the underside of pavement.

Soil Moisture.--Gypsum soil-moisture blocks (fig. 15) provide a method for estimating soil moisture by measuring the negative soil pressures in unsaturated soils. Given sufficient time, the gypsum block assumes the same moisture level as the soil surrounding it. Two electrodes in the block measure resistance, which varies with water content and can be calibrated for each block. Figures 9 and 18 show the location of the soil moisture blocks in each highway test section.

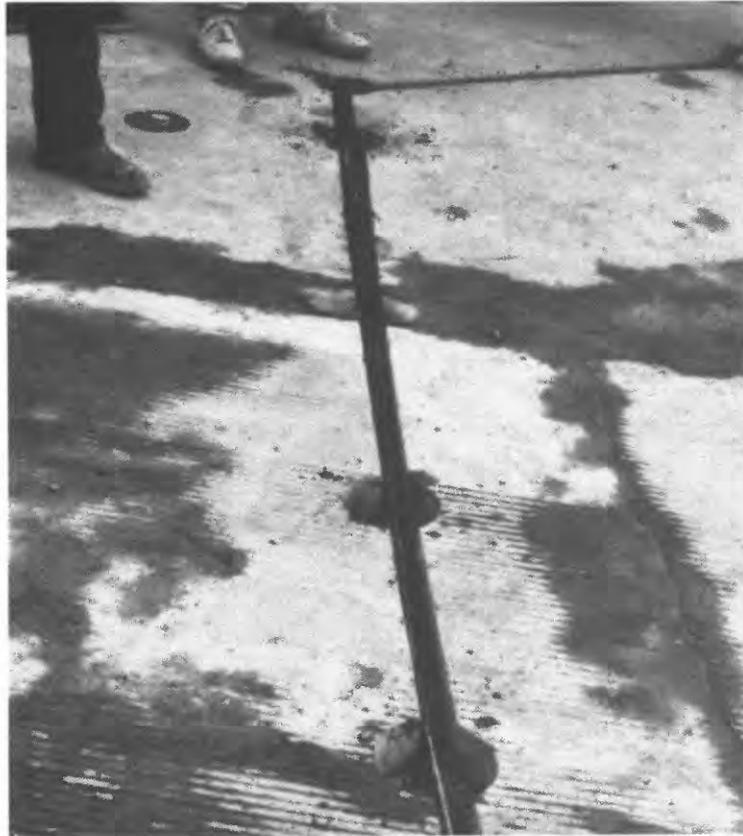
Figure 16.--All sensors in place just prior to filling holes and signal line slot.

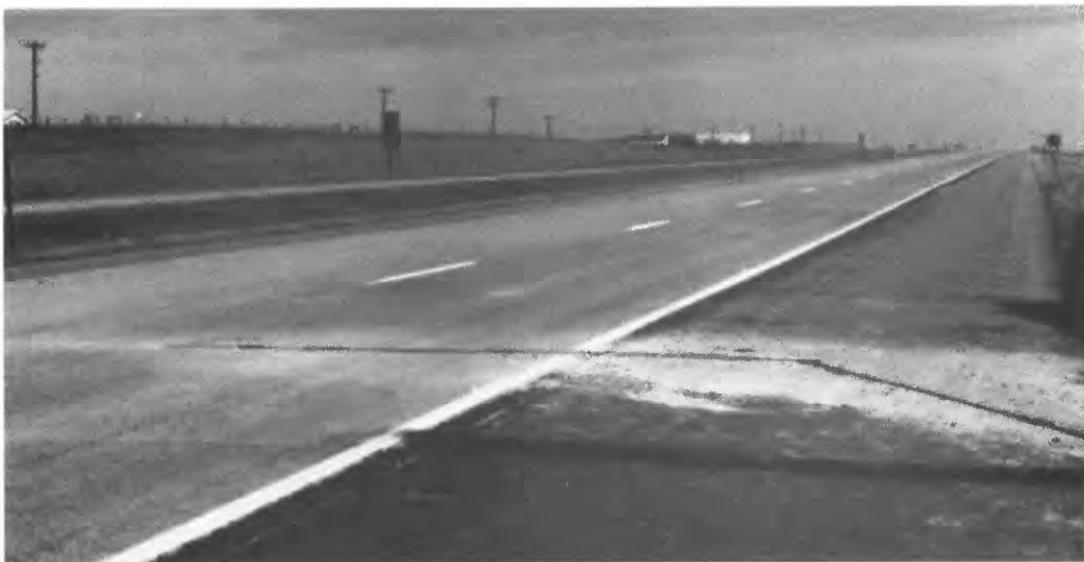
Figure 17.--Completed installation with sensor holes and signal line slots sealed with epoxy cement.
