GEOMORPHIC AND HYDRAULIC ASSESSMENT OF THE BEAR RIVER IN AND NEAR EVANSTON, WYOMING

U.S. GEOLOGICAL SURVEY

Water-Resources Investigations Report 93-4032

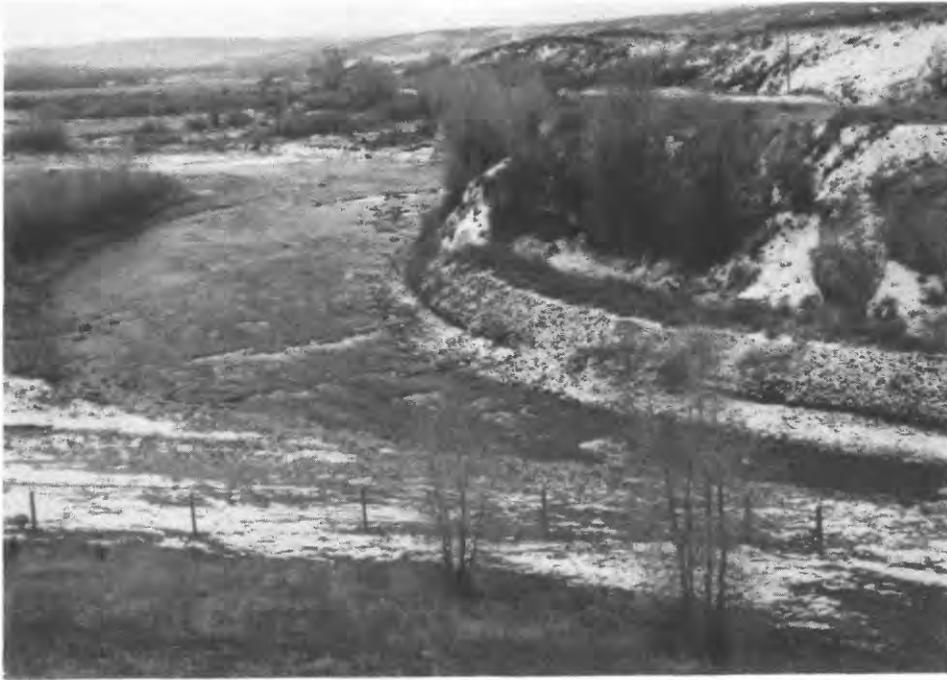
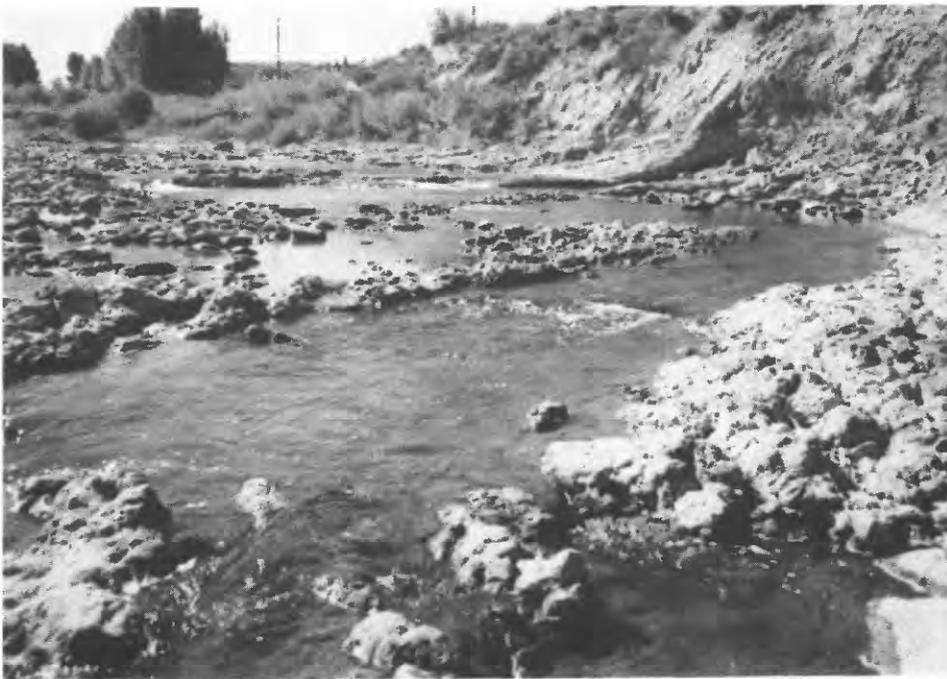
Figure 9.--Photographs of the Bear River showing the resistant bedrock outcrops controlling the channel immediately upstream from Interstate 80 near Evanston. Both views are upstream.

Development of this braided pattern probably is not related to channelization of reach 2 because of the bedrock outcrops upstream from the Interstate-80 Bridge. The braided channel is upstream from these outcrops, and, according to principles of open-channel hydraulics, should be subject to control by the outcrops and not by conditions (streambed degradation) below it.

The bedrock outcrops above the Interstate-80 Bridge were identified as a hydraulic control, from onsite inspections and geomorphic analysis. This controlling effect, both in preventing degradation processes from moving farther upstream and in defining the lower limit of channel braiding in reach 3, is supported by WSPRO analysis. Even at the 100-year peak discharge, the Froude number in cross-section 27 is close to 1 (0.96), indicating that flow is close to critical. Hydraulically, this result confirms that channel conditions upstream and downstream of these outcrops are effectively independent of each other.

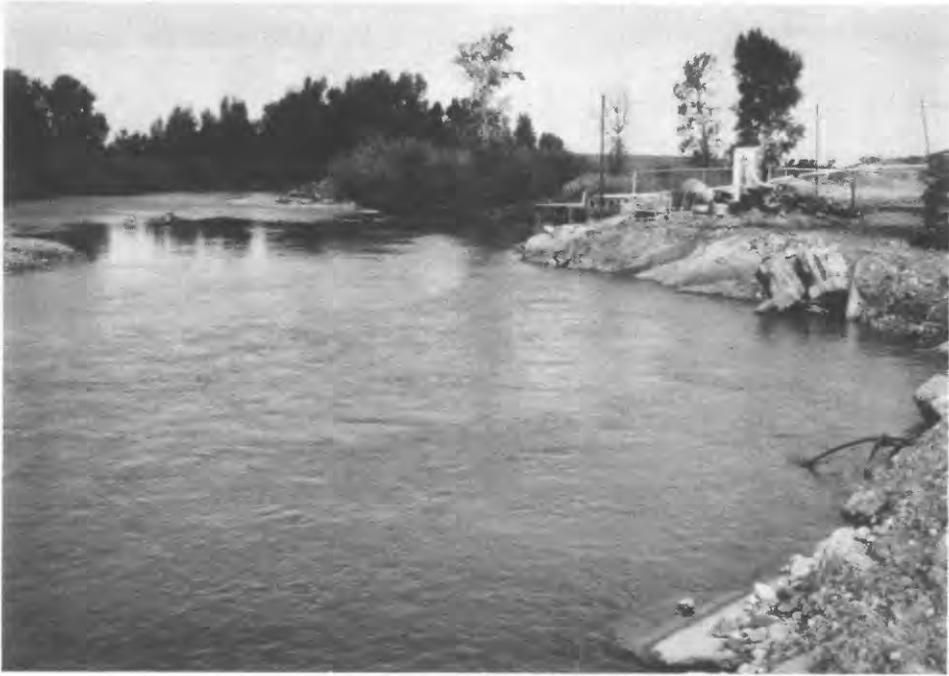
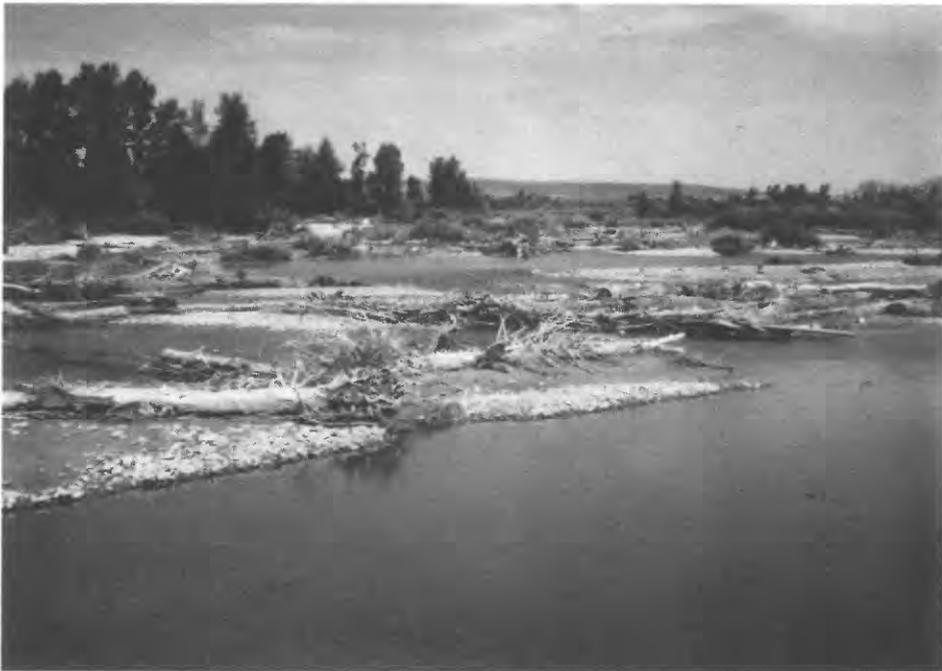
Figure 10.--A, present-day bank erosion and riprap materials used for bank protection; B, deposition of debris and channel braiding downstream from Evanston. Both views are downstream.

Bed/bank erosion of the channel throughout the study reach has led to individual efforts to stabilize channel banks with various forms of riprap. Onsite inspection of the channel by M.E. Cooley (U.S. Geological Survey, oral commun., 1987) determined that much of the channel in reach 2 has been stabilized and that some bends in reaches 1 and 3 also have been protected. These stabilization measures have proved to be inadequate, as evidenced by deposition of dislodged riprap material downstream from the placement sites. Materials used to protect banks include bags of cement, concrete slabs, boulders, and tires [fig. 10 (A)]. Other human influences include channel infilling for property enhancement, dredged cutoffs of meander loops by landowners (upstream from reach 3) for land management and farming, and artificial channel constrictions at bridge crossings.
