Hydrologic and Mass-Movement Hazards near McCarthy, Wrangell-St. Elias National Park and Preserve, Alaska

U.S. GEOLOGICAL SURVEY

Water-Resources Investigations Report 93-4078

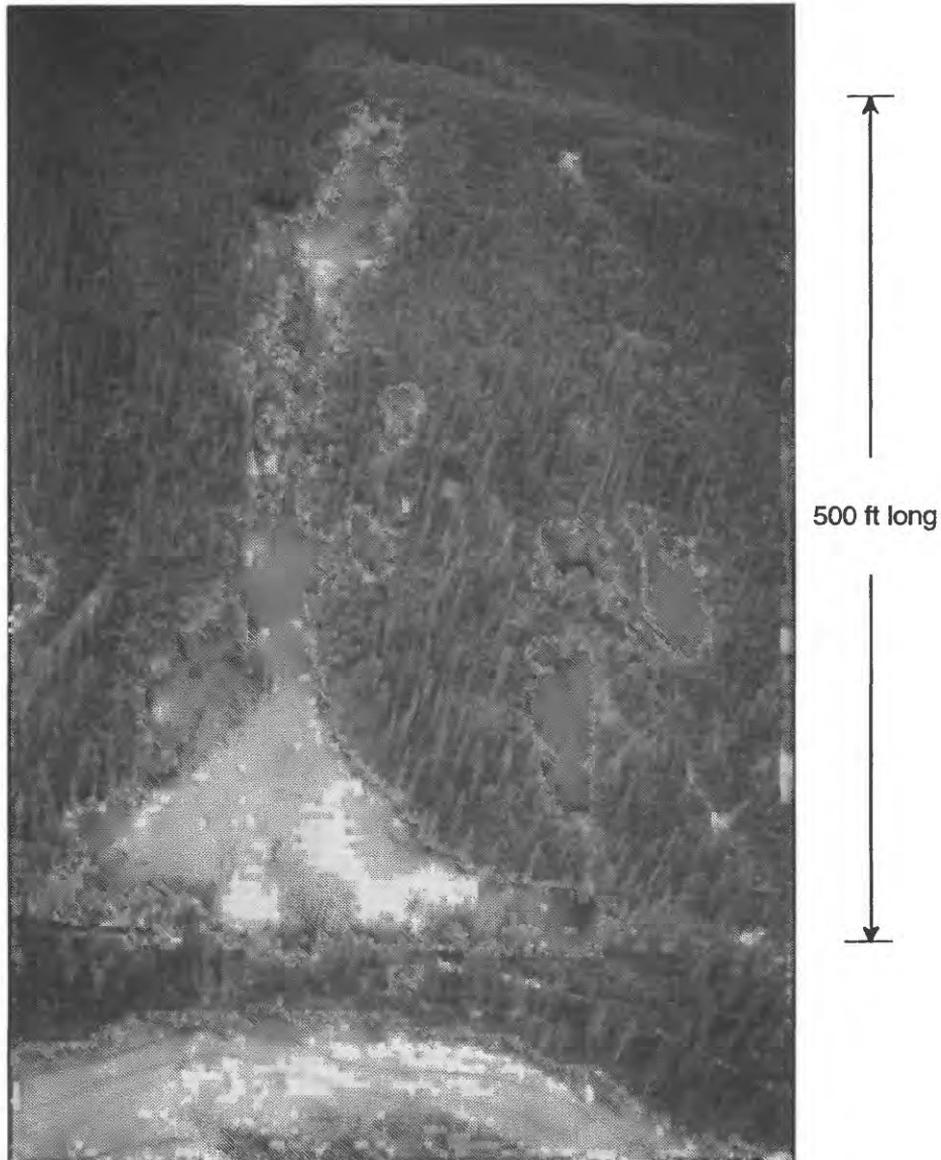
Figure 5. Debris-avalanche scar (approximately 500 feet long) along the south terrace of lacustrine sediments, McCarthy Creek (stream mile 4) , July 12, 1990.

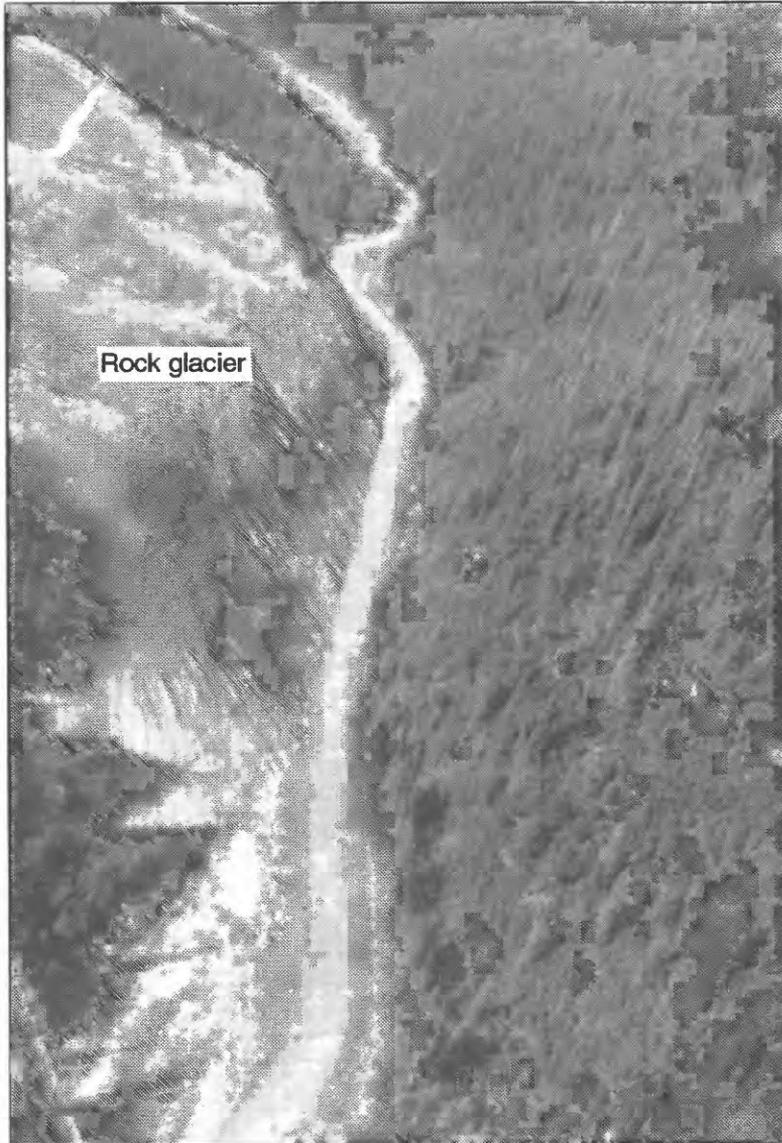
Figure 7. Lower end of Porphyry Mountain rock glacier on McCarthy Creek (stream mile 10.3), July 12, 1990. Vertical height at terminus is 100 to 150 feet.

Although the potential for hazard at rock glaciers is low, an earthquake could cause a landslide at the steep-faced front of the rock glacier at the lower end of Porphyry Mountain (stream mile 10.3 of McCarthy Creek, fig. 7); the landslide could form a dam across the stream channel. Capps (1910) stated that, "McCarthy Creek is now actively cutting into the lower end of the rock glacier originating in the cirque headwall of Porphyry Mountain, which has been in existence long enough for large spruce trees to grow upon its surface. * * * McCarthy Creek has so far been unable to do more than keep a narrow channel open along the foot of the rock glacier [fig. 7, p. 369]. * * * There is no evidence that the rock glacier ever extended the 75 feet farther east which would have carried it to the rock bluff on the east side of the valley."

Where rock glaciers and creeping landslides enter McCarthy Creek, the streamflow is able to remove materials at the same rate as they are deposited into the stream channel. The steep-faced front of Porphyry Mountain rock glacier (fig. 7) presents a low hazard of damming between stream miles 10.2 and 10.4. Aerial photographs taken between 1957 and 1990 show no change in the location of the lower end of Porphyry Mountain rock glacier on McCarthy Creek. However, an earthquake could cause a large volume of rocks to fall or slide into McCarthy Creek and form a dam. If rock and snow avalanching increased loading in the upper accumulation zone of the rock glacier, the downslope movement of the rock glacier could increase. Several rock glaciers are traversed by foot trails, and travel over their angular rocks is not difficult. The trail traversing Porphyry Mountain rock glacier appears to be stable and has not changed significantly since it was built, probably about 20 years ago.

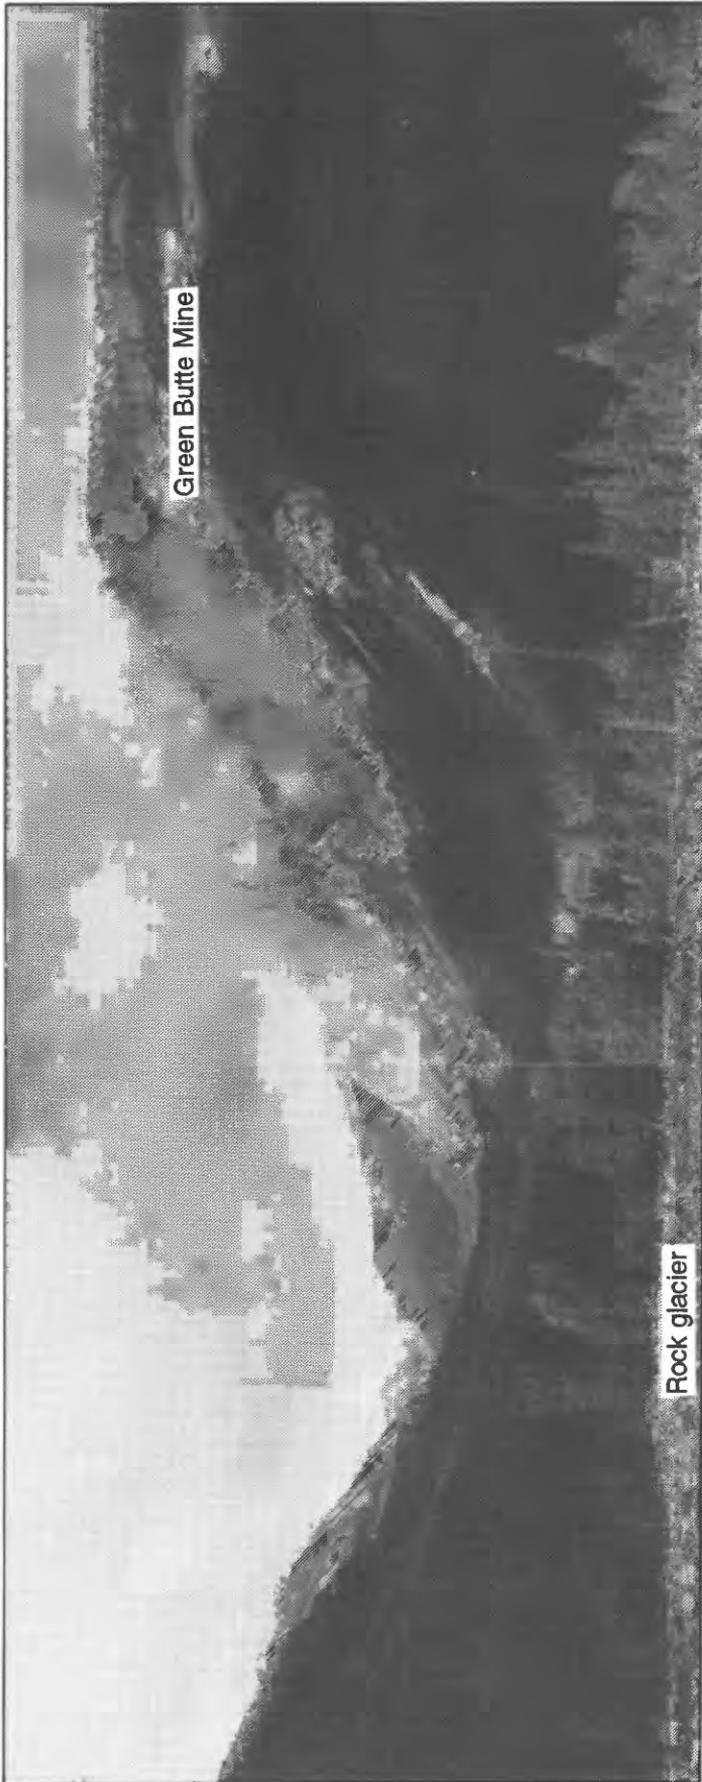
Figure 8. View from Porphyry Mountain rock glacier showing McCarthy Creek drainage and Green Butte Mine, July 12, 1990.

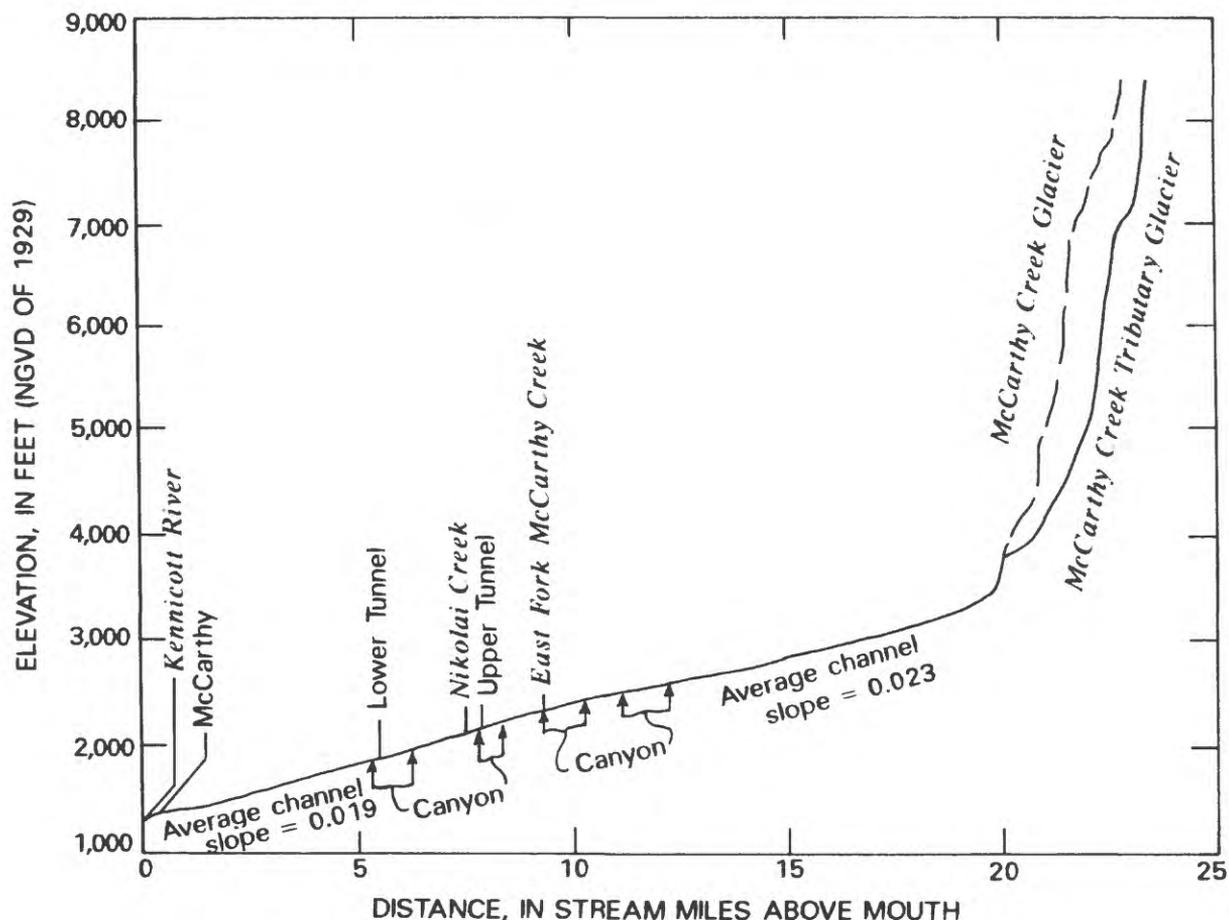
Figure 9. Longitudinal profile of McCarthy Creek.

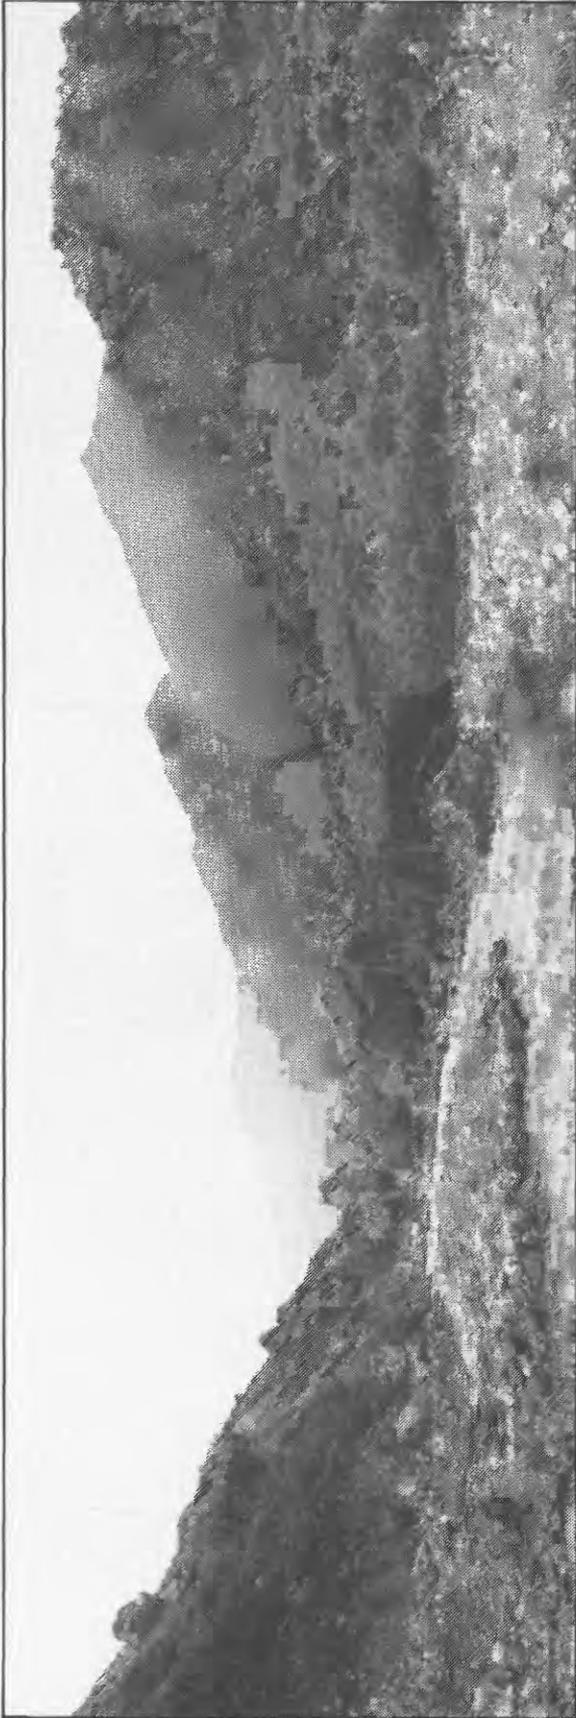
Figure 10. McCarthy Creek tributary at McCarthy Creek Glacier (site 10), July 24, 1990. View downstream at McCarthy Creek Glacier lateral moraine. Boulders range from 6 feet to 18 feet long.

Lateral moraines approximately 100 ft above surrounding terrain have formed along the lower part of McCarthy Creek Glacier (fig. 10). A comparison of a photograph taken by Moffit (1938, plate 12B) and vertical aerial photographs taken on July 29, 1957, shows that the glacier and its lateral moraine along the western margin have remained unchanged. One of the 1957 photographs shows that the moraine-covered part of the glacier was in contact with the eastern streambank of McCarthy Creek at stream mile 20 and that the stream was draining subglacially. By August 1978, the ice-cored moraine had receded and thinned, exposing till deposits. Aerial photographs taken on August 22, 1990 show that since July 29, 1957, the lower glacier has thinned and receded more than 800 ft along its eastern margin and receded 1,500 ft at its terminus. These photographs also indicate that other glaciers within the McCarthy Creek basin have thinned and receded more rapidly during the past 10 to 15 years than during the years 1938 to 1957.

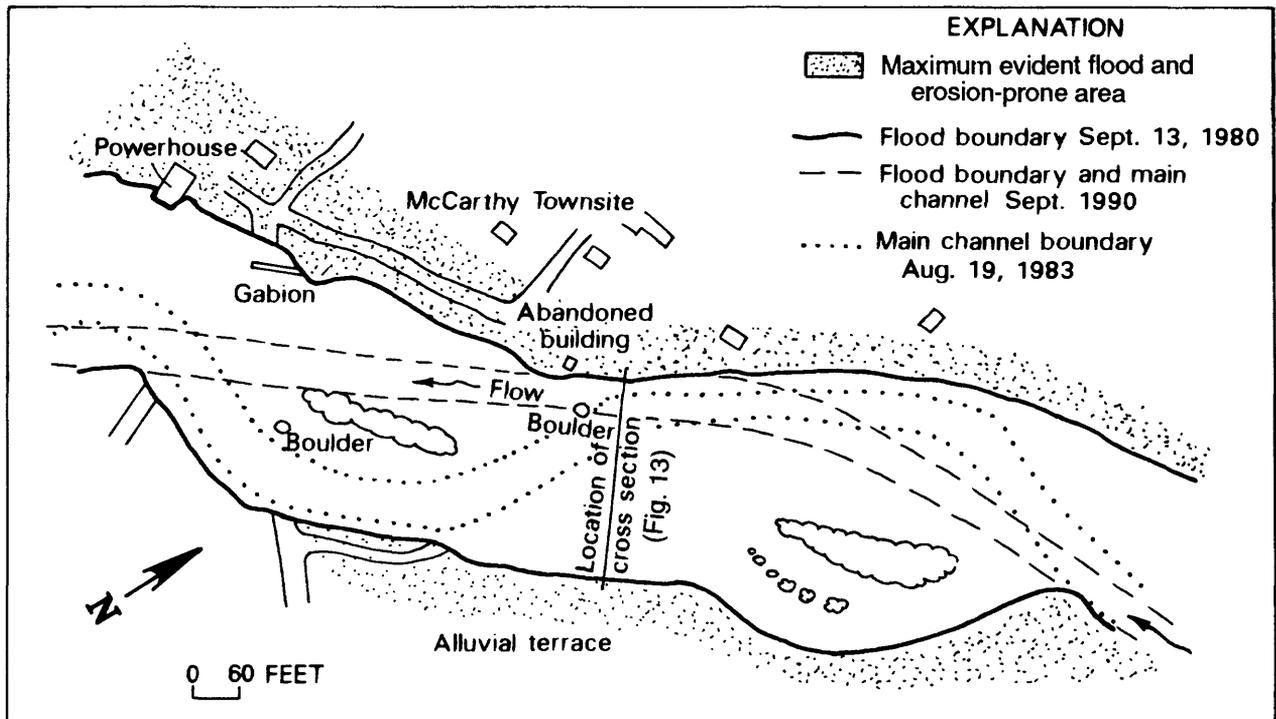
Figure 12. Active flood channel, McCarthy Creek at McCarthy (site 20).

The streambank of McCarthy Creek at McCarthy townsite (fig. 12) is eroding and erosion will eventually destroy historical buildings if the streambank remains unprotected. A few hundred feet upstream from the town, McCarthy Creek is eroding its northern bank, whereas near the town the channel is aggrading and shifting its course closer to buildings on the northern bank (Jones, 1988, p. 5). The locations of the main channel in 1983 and in 1990 are shown in figure 12; a cross section of McCarthy Creek surveyed during September 1990 is shown in figure 13. Several structures, including the historical powerhouse, are on lowlands bordering the stream. After a flood in 1980, town residents began building retaining walls and gabion dikes to help prevent or lessen damages from future floods. However, a flood in 1985 covered these structures with sediment and

the active stream channel moved closer to the buildings. Farther upstream, at stream mile 11.2, lateral erosion of the eastern streambank of McCarthy Creek will eventually breach a series of interconnected beaver dams and may suddenly release the impounded water. Methods to protect streambanks are described by Charlton (1982).

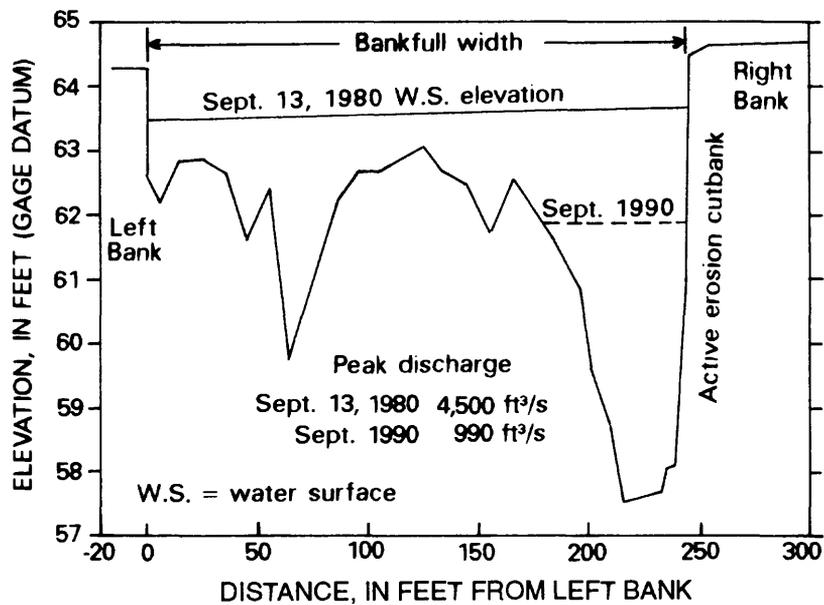
Figure 13. Channel cross section, McCarthy Creek at McCarthy (site 20), September 1990. (See figure 12 for location.)

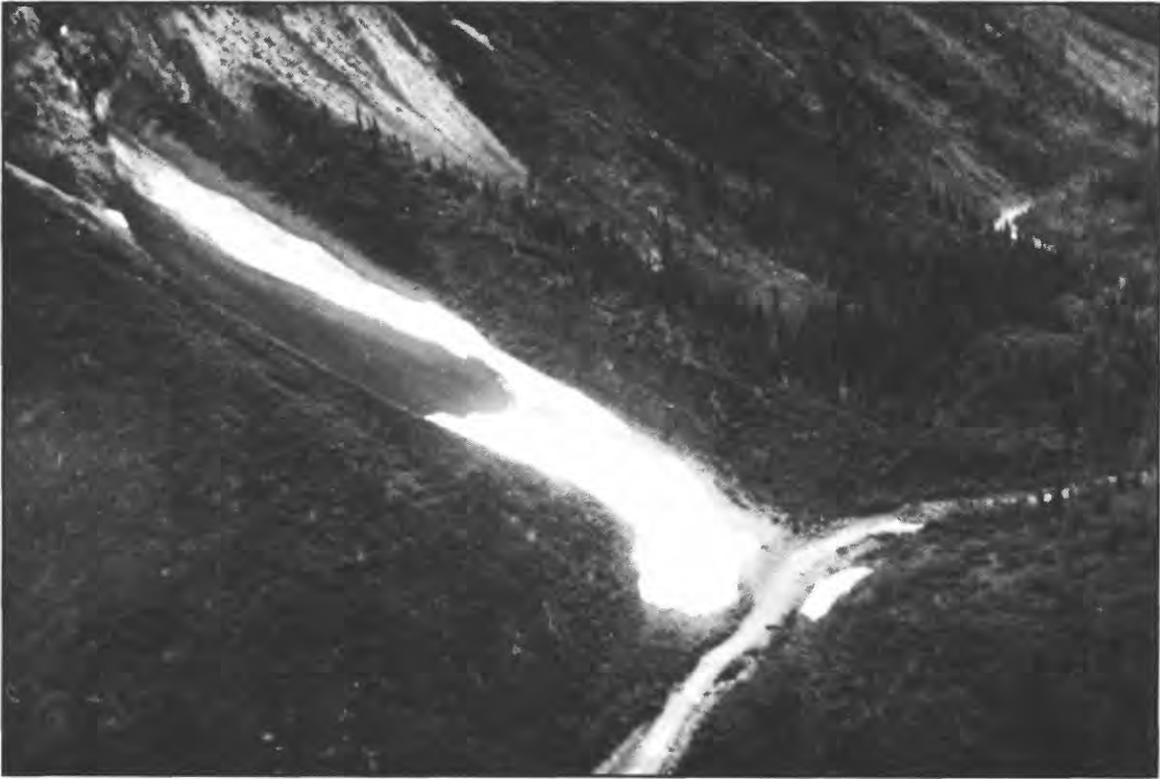
Figure 14. Aerial photograph of McCarthy Creek landslide and snow avalanche dam site, (stream mile 12.2) , July 12, 1990.

Rock, debris, and snow avalanches frequently dam McCarthy Creek at stream mile 12.2 (fig. 14). A photograph taken by Moffit (1938, plate 7) shows an active landslide at stream mile 12.2. Rock and remaining snow avalanche deposits found on July 12, 1990 at this site indicate that the 50-foot-wide stream channel had been blocked earlier that year and had a maximum snow depth of about 25 ft. Streamflow may have been sufficiently low to percolate through coarse streambed materials, snow, and rock debris and prevent the formation of a lake. Sediment deposits upstream from the damming site indicate a frequent recurrence of avalanching, but there is no evidence of catastrophic water release downstream. Although no evidence of the formation and failure of a short-term natural reservoir was found, the potential is high, nevertheless, for the formation of a large dam and a subsequent catastrophic failure at this site during excessive rainfall, rapid snow-melt, or an earthquake.

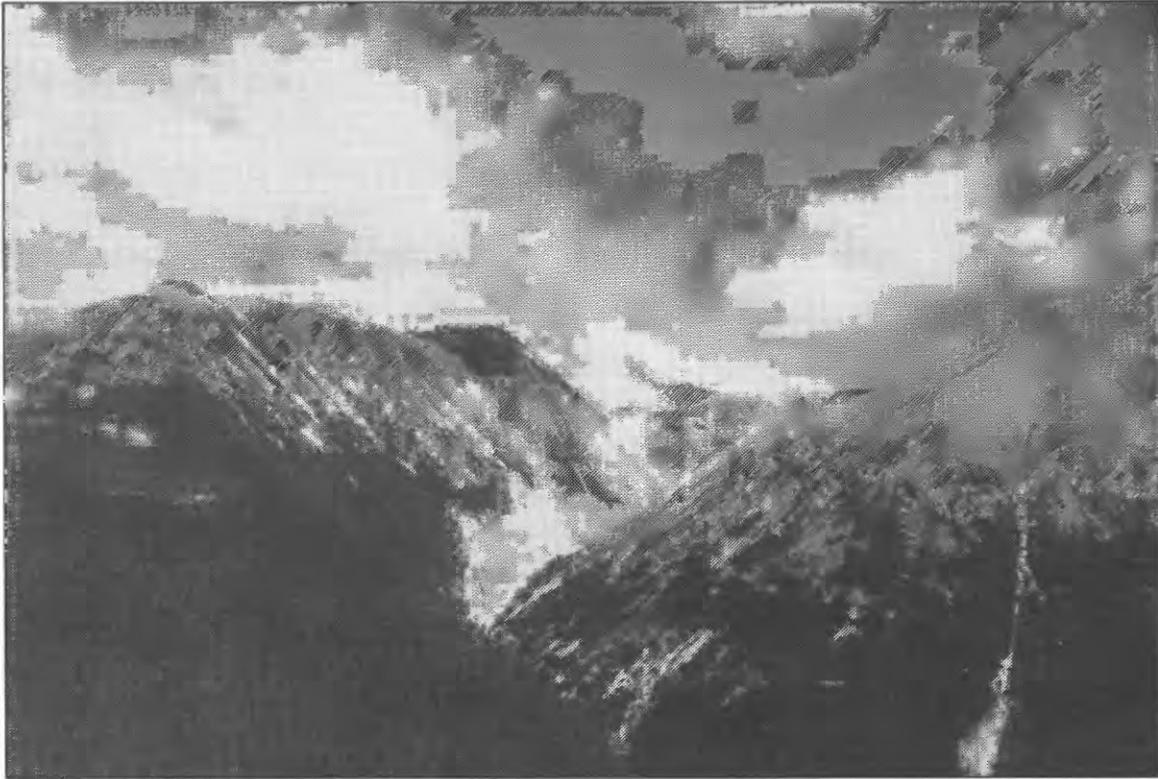
Figure 15. Landslide scars in Nikolai Creek tributary, July 12, 1990.

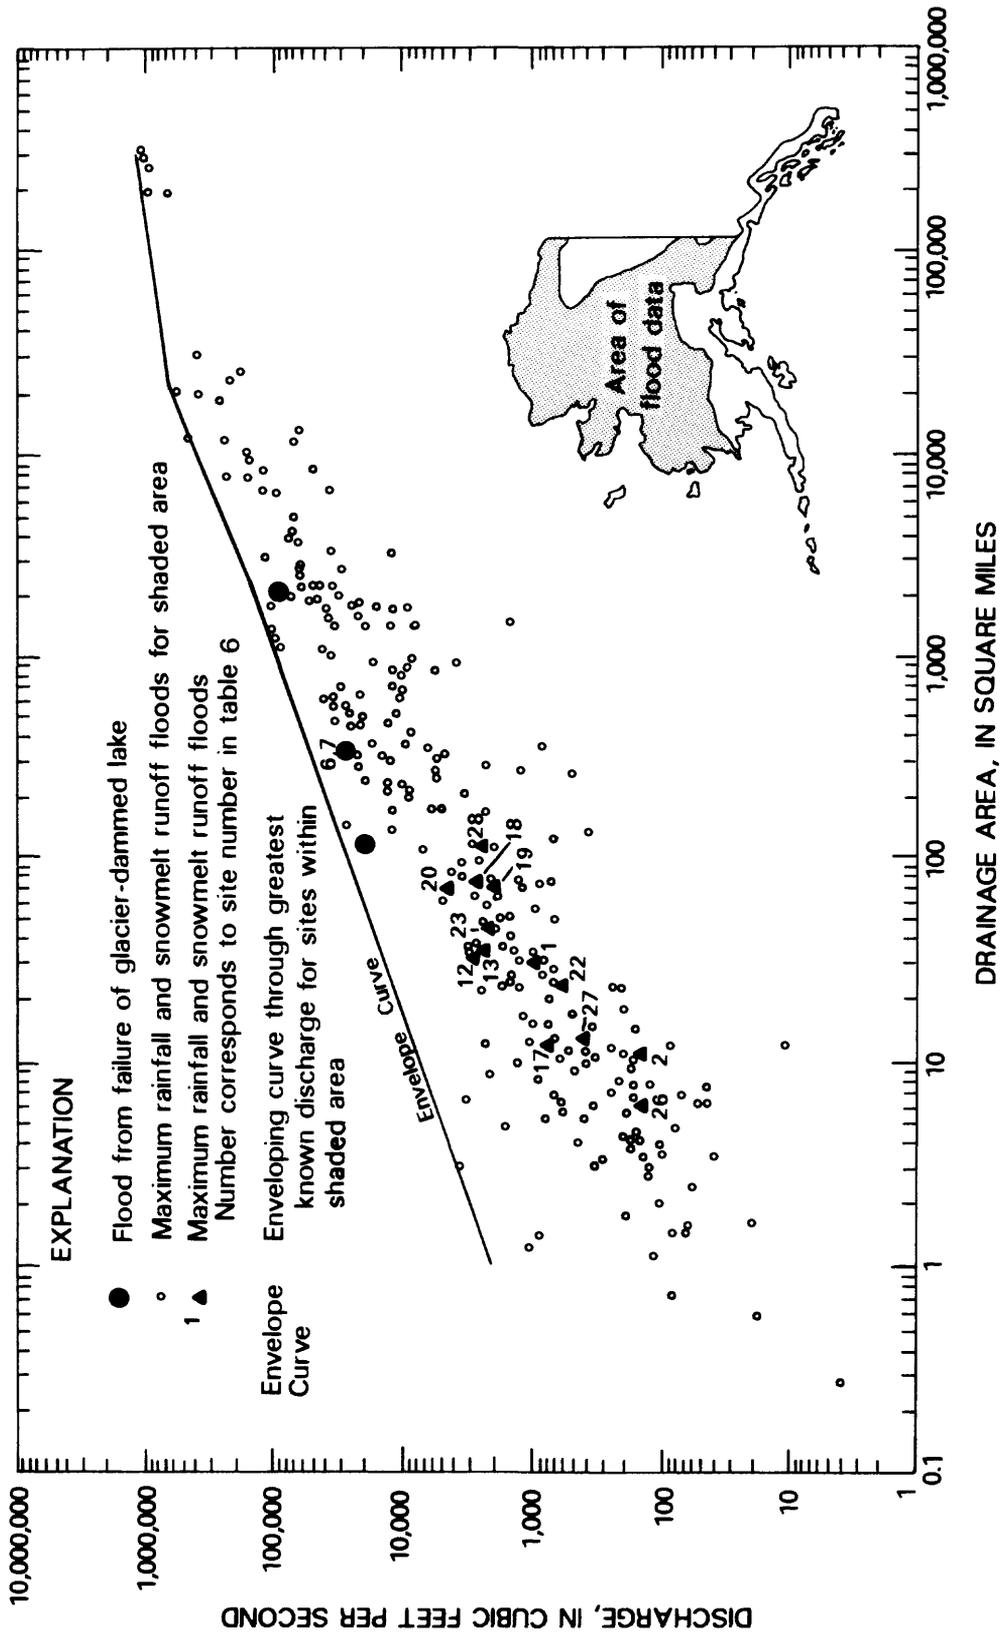
Figure 16. Peak discharge as a function of drainage area.

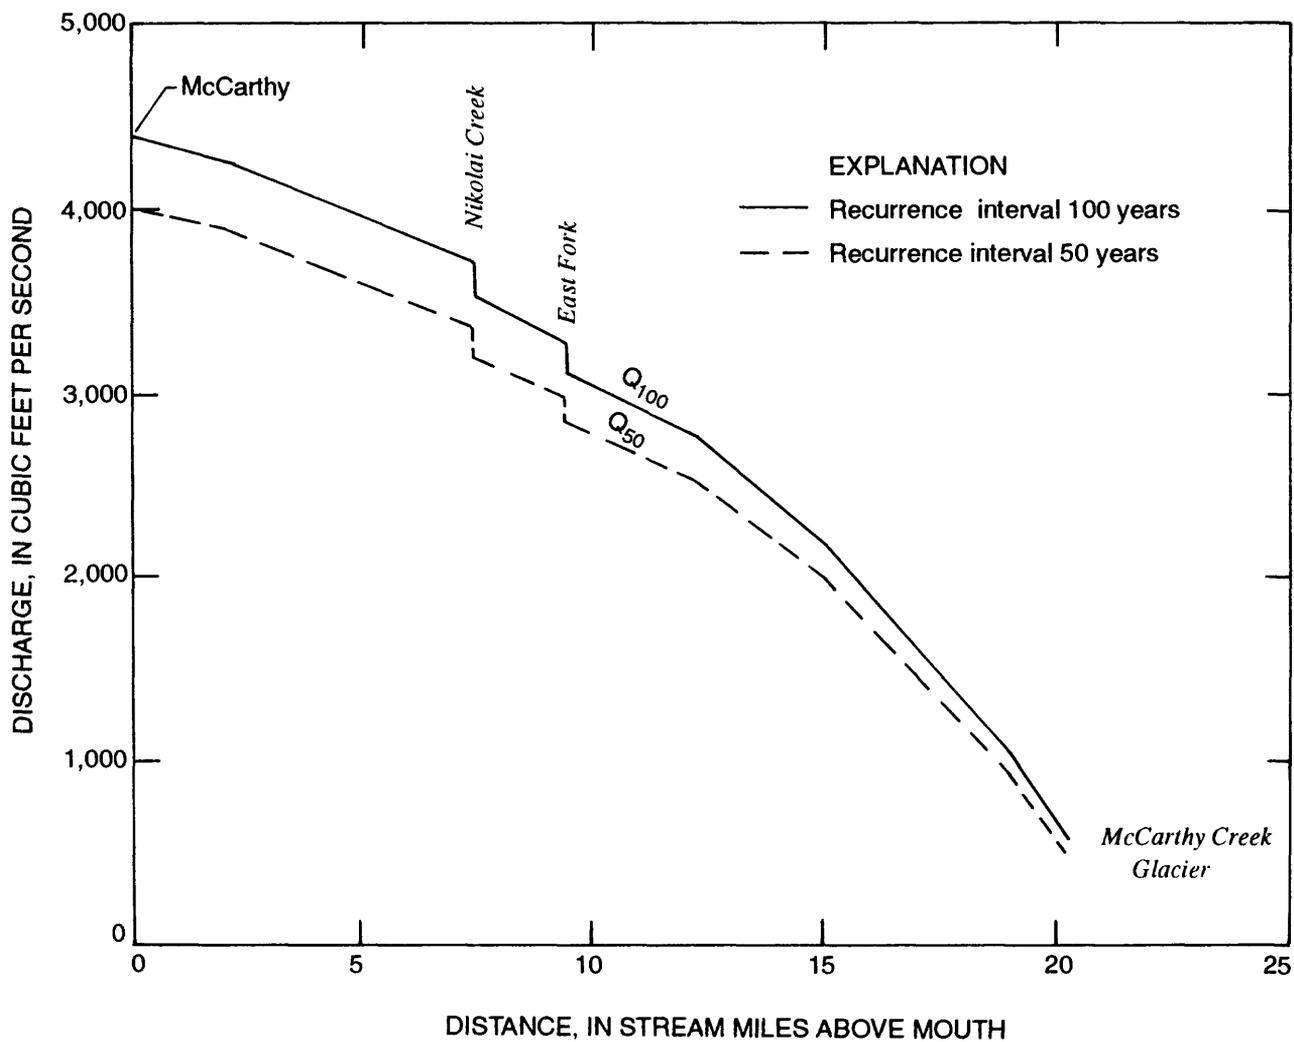
Figure 17. Estimates of 50-year and 100-year recurrence interval floods for McCarthy Creek.

The flood-frequency area flood-discharge values (table 8) can be used for eight sites on McCarthy Creek to help estimate the magnitude and frequency of rainfall and snowmelt floods at any site along the stream. The relation between discharges at 50-year and 100-year recurrence intervals and distance upstream from the mouth of McCarthy Creek is shown in figure 17.
