FLOOD ON THE VIRGIN RIVER, JANUARY 1989, IN UTAH, ARIZONA, AND NEVADA

By Darrell D. Carlson and David F. Meyer

Water-Resources Investigations Report 94-4159

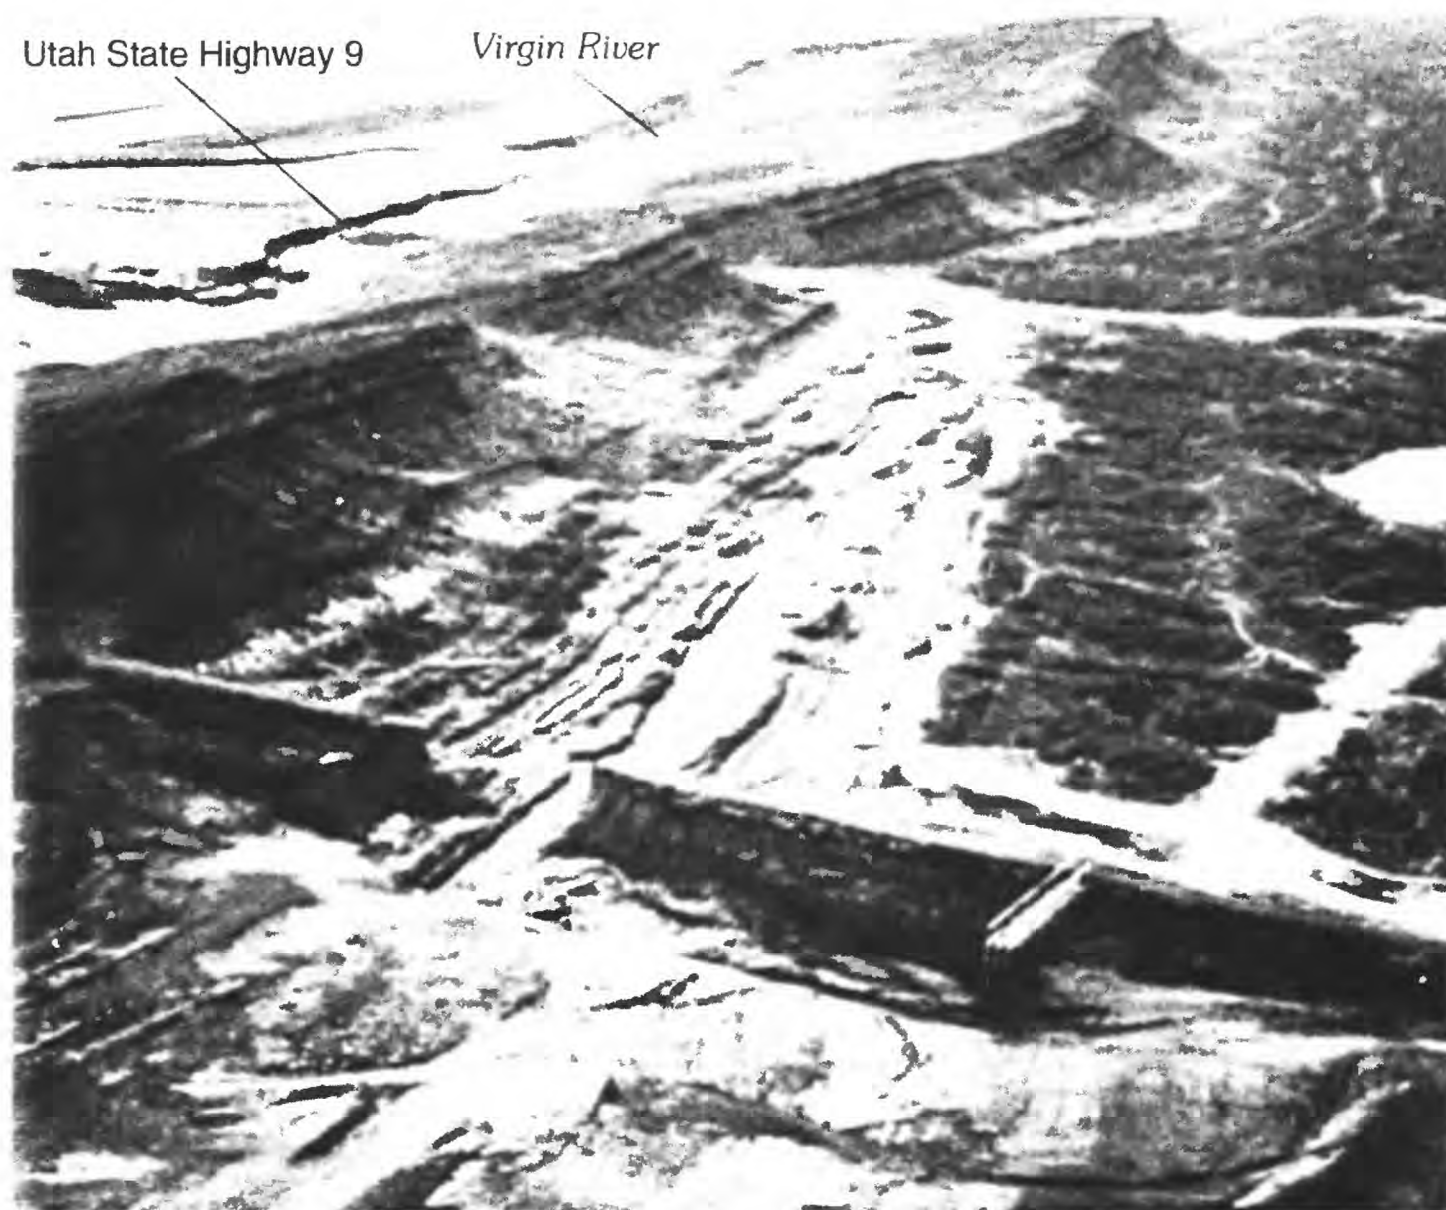
Figure 5. Quail Creek Reservoir dike after failure. (Photograph from the Utah Department of Natural Resources, Division of Water Rights.)

The path the water took after the dike breached is shown in figures 5, 6, and 7. The water entered the Virgin River at the Utah State Highway 9 bridge crossing (fig. 1, site 1). Top soil was completely removed between the dike and the confluence with the Virgin River (fig. 6). In addition, it is estimated that about $75,000 \text{ yd}^3$ of material were removed from the dike at the breach. Most of this material was deposited in the Virgin River channel at the Utah State Highway 9 bridge crossing (figs. 8 and 9).

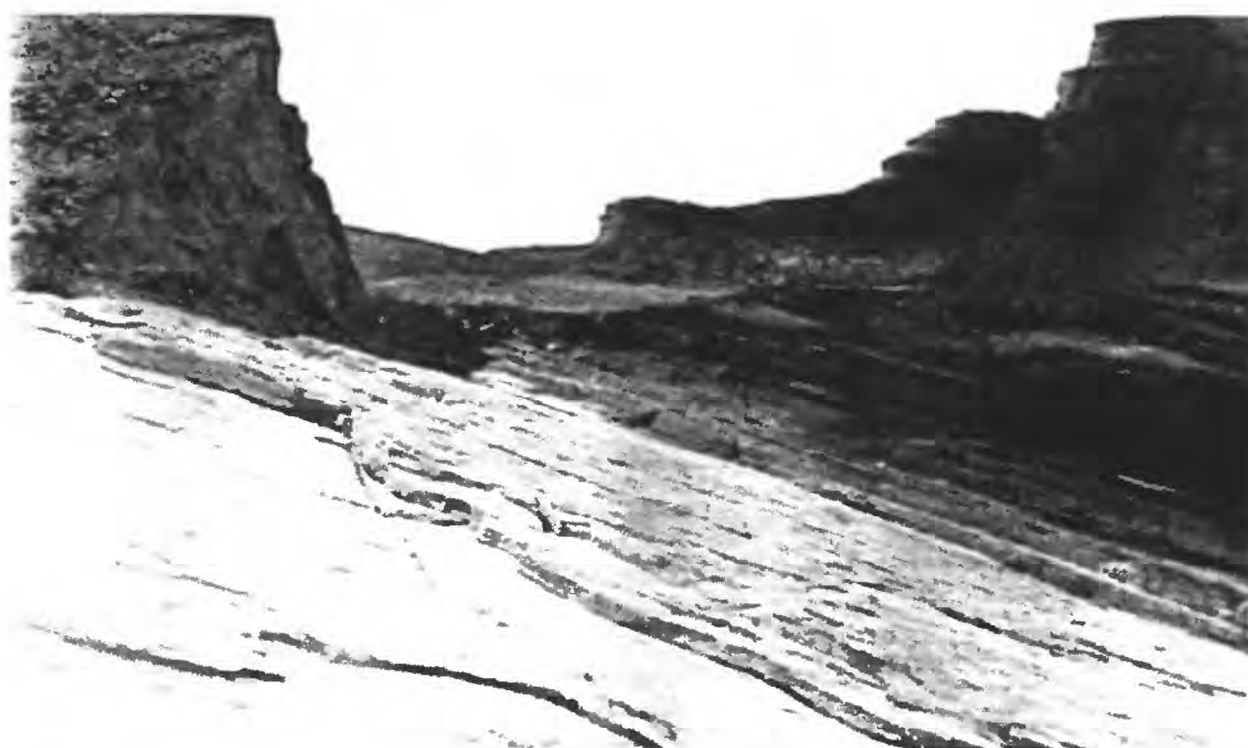
Figure 6. Upstream view of the breach in the Quail Creek Reservoir dike near Hurricane, Utah, January 1990.

The topsoil was completely eroded between the dike and the Utah State Highway 9 bridge where the flood entered the Virgin River (fig. 6). Most of this topsoil, along with the eroded dike material, was deposited at the Utah State Highway 9 bridge crossing over the Virgin River and blocked a large part of the bridge opening (fig. 9).

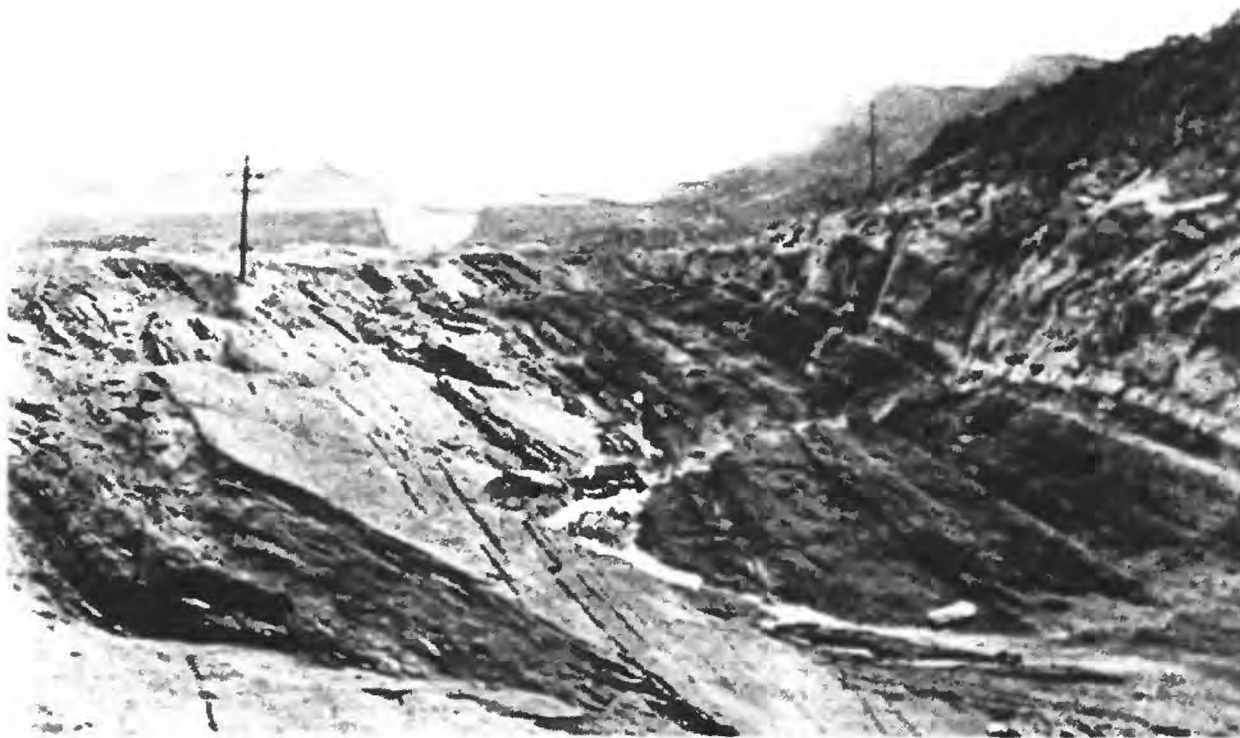
Figure 7. Upstream view from Utah State Highway 9 of the floodwater path between the breach in the dike and Utah State Highway 9 near Hurricane, Utah.

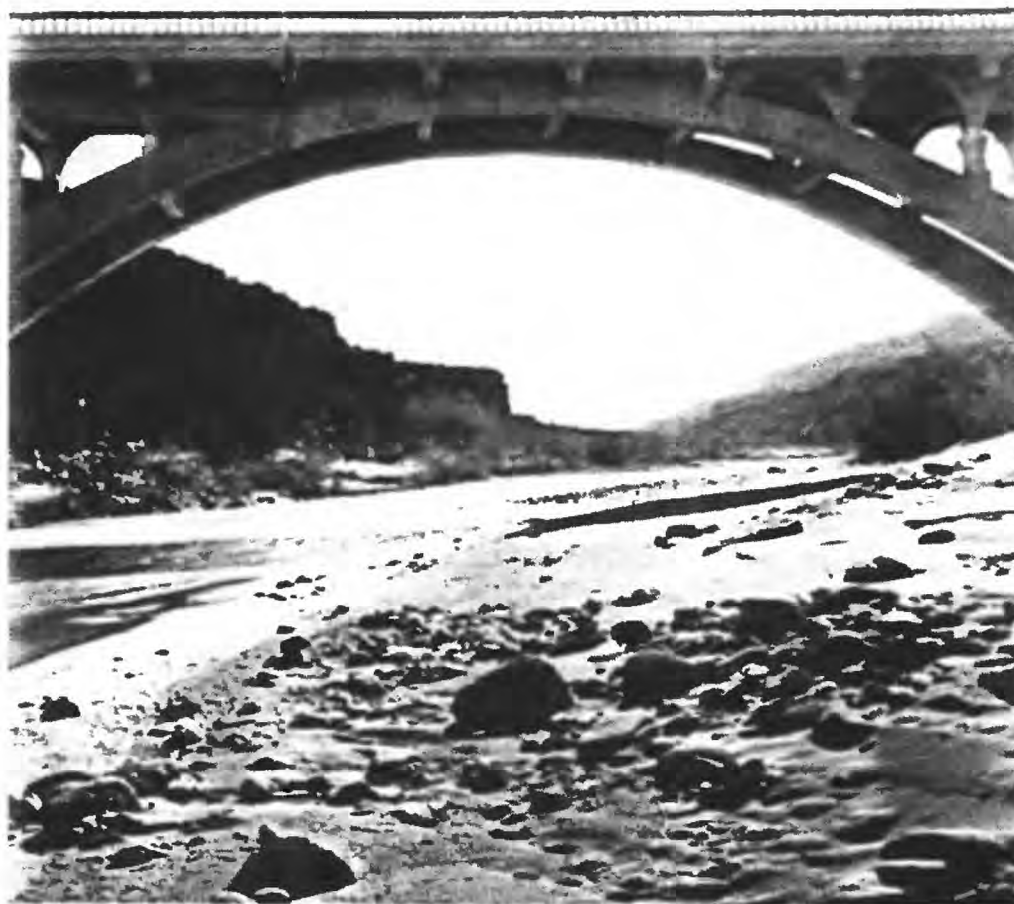
Figure 8. Downstream view of the Utah State Highway 9 bridge across the Virgin River near Hurricane, Utah, before the dike failure.

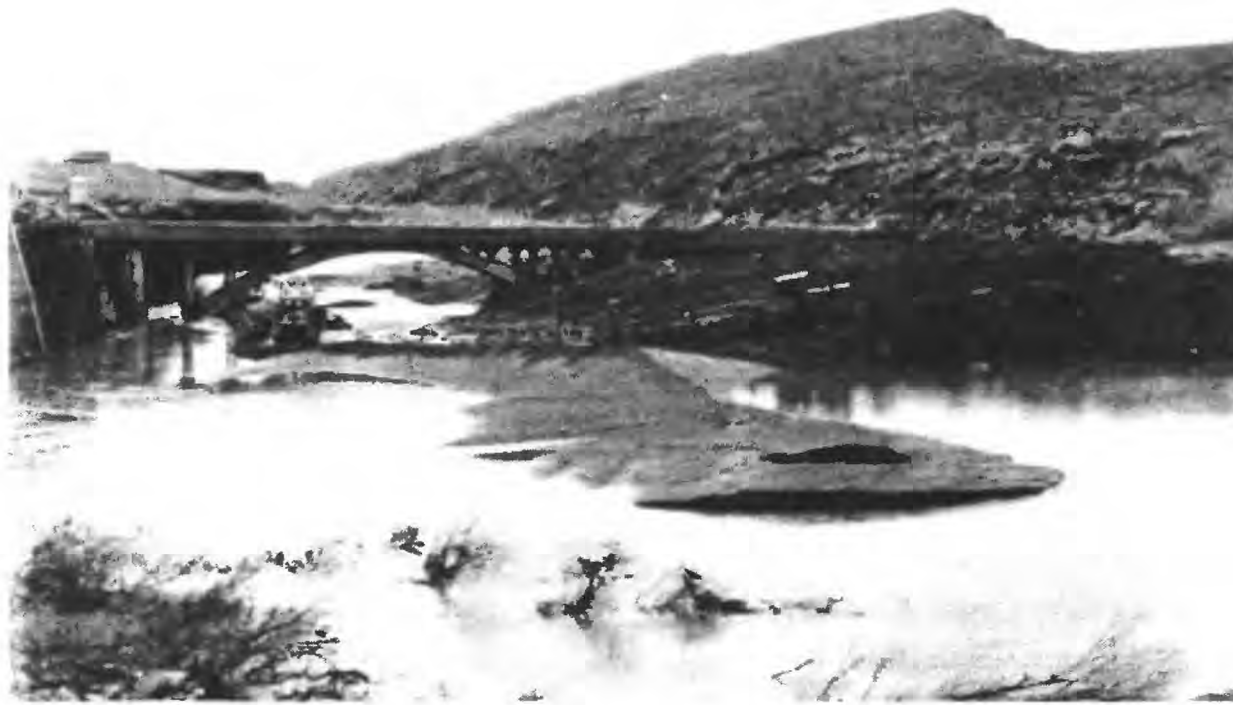
Figure 9. Downstream view of the Utah State Highway 9 bridge across the Virgin River near Hurricane, Utah, after the dike failure.

Damage to public property also was substantial. The Utah State Highway 9 bridge near Hurricane (fig. 9) had to be replaced, and the approach roadway to the bridge was washed out (fig. 18). The River Road bridge near St. George, Utah, was completely washed out (fig. 19). The Interstate Highway 15 bridge near St. George

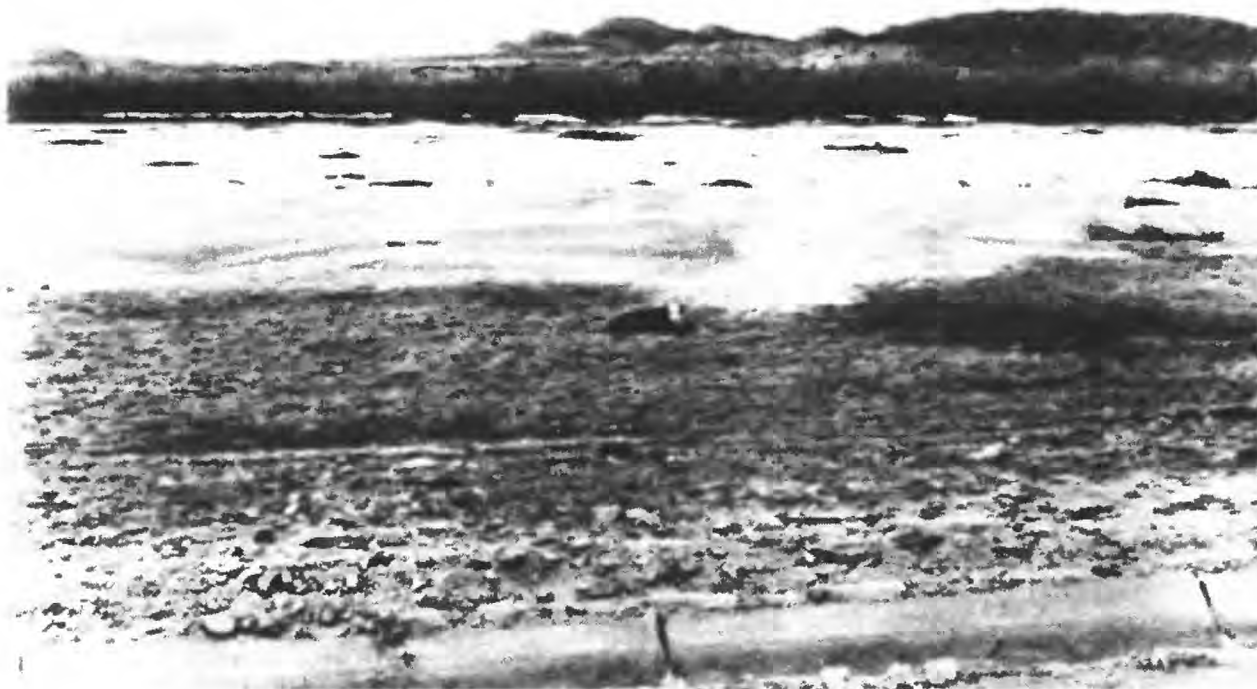
The main channel of the Virgin River was unable to contain the flood; therefore, the floodwater was forced out onto the flood plain. The velocity of the water decreased across the flood plain, causing sediment to be deposited (fig. 14).

Figure 14. Deposition of sediment on an agricultural field near Washington, Utah, January 1990.

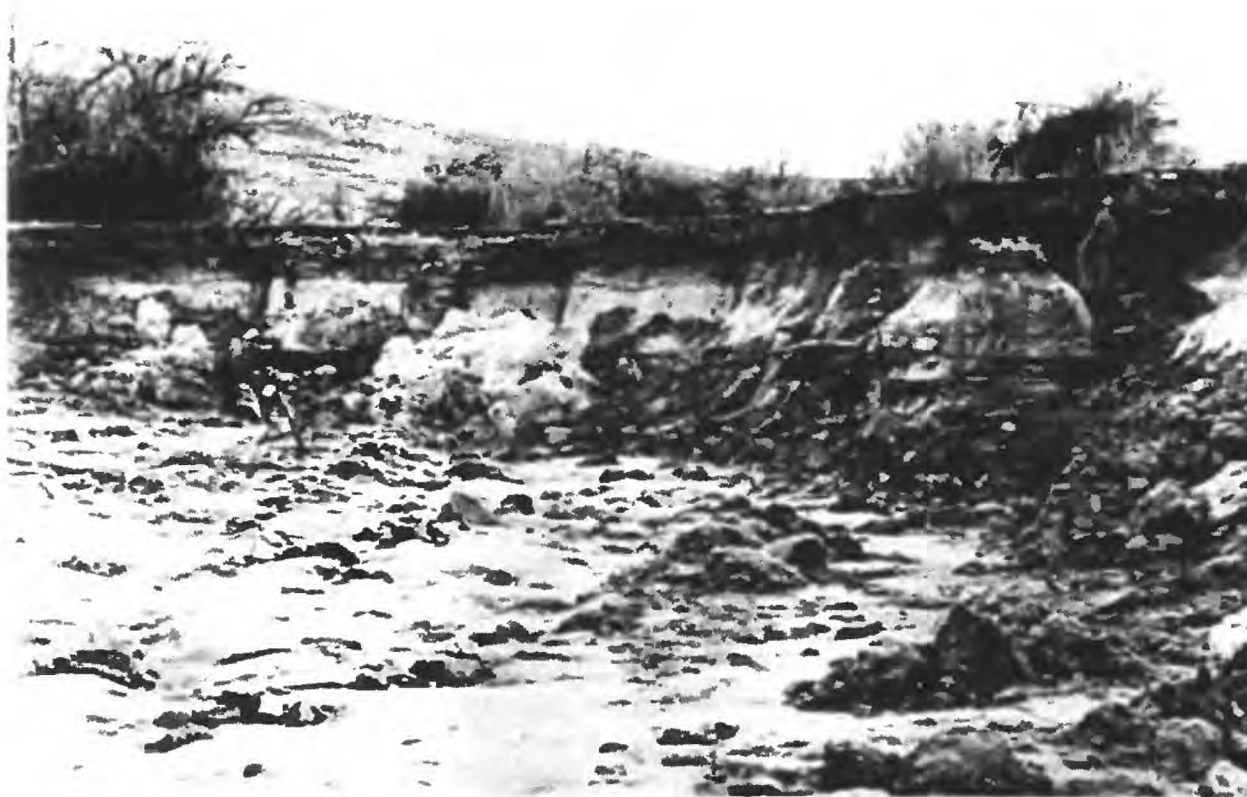
Headcutting also occurred during this flood. The headcut near the Washington Fields diversion dam was about 10 ft deep (fig. 15).

Figure 15. Headcutting near the Washington Fields diversion dam near Washington, Utah. January 1990.

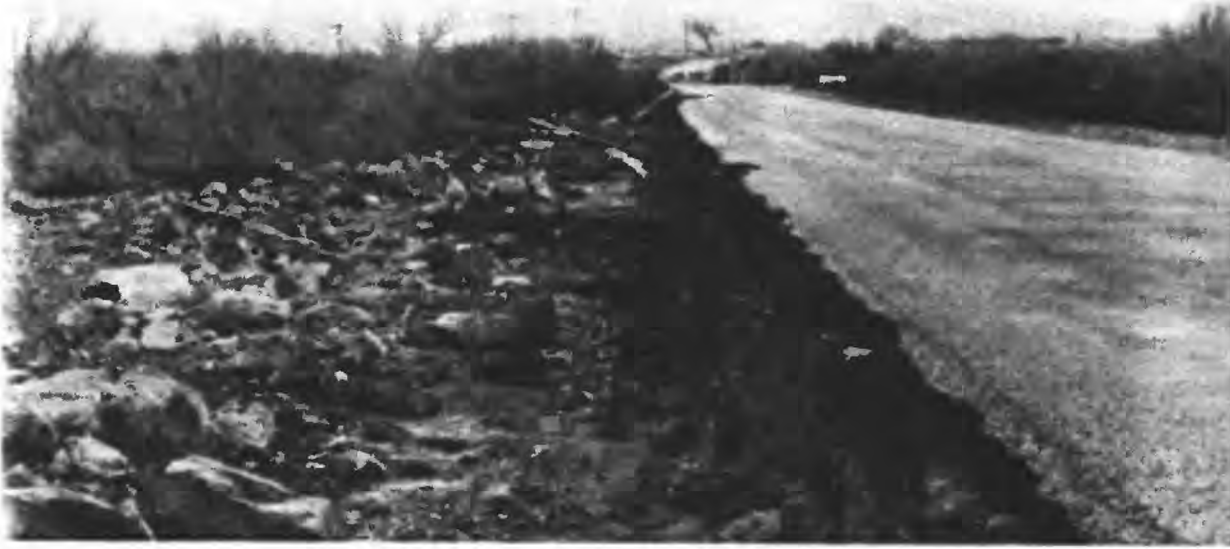
Erosion of roadbeds from Hurricane, Utah, to Bloomington, Utah, occurred during this flood (fig. 16). Some degradation of the Virgin River channel occurred at the Man-of-War bridge. The scour at this bridge was severe enough to expose the piles under two of the piers.

Figure 16. Erosion to downstream side of roadbed at approach to River Road bridge near St. George, Utah, January 1990.

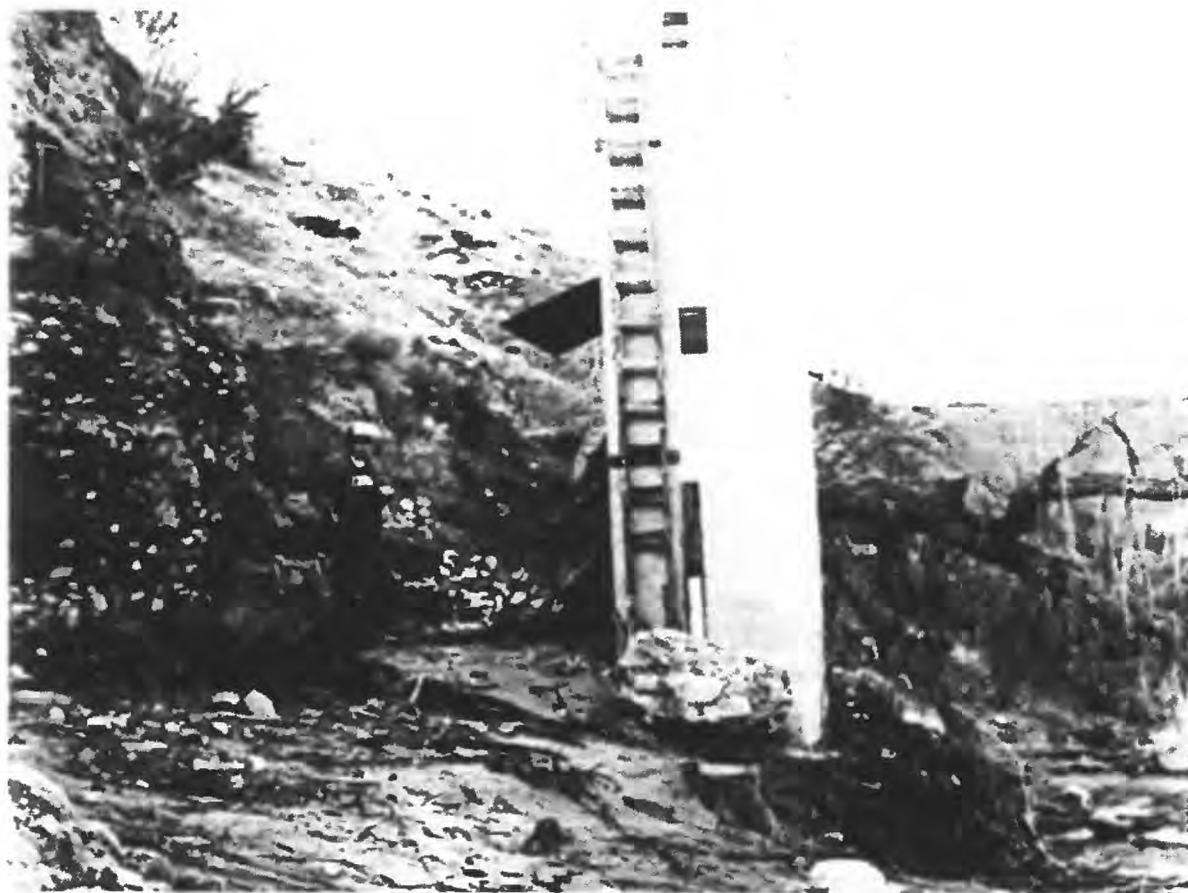
An irrigation ditch occupied the right bank (outside bank of the meander) at the Littlefield gage prior to January 1, 1989. Photographs of the gage taken following the flood of December 6, 1966, indicate that at that time a pipe or aqueduct existed along the right bank. Fill was placed along this bank between 1966 and 1987 about 25 ft from the bank and about 25 ft high. The January 1, 1989, flood eroded about 20 ft of this fill at the gage (fig. 17), including beam-and-cable bank protection along the irrigation ditch.

Figure 17. Eroded right bank of the Virgin River at site 5, Virgin River at Littlefield, Arizona, January 1990.

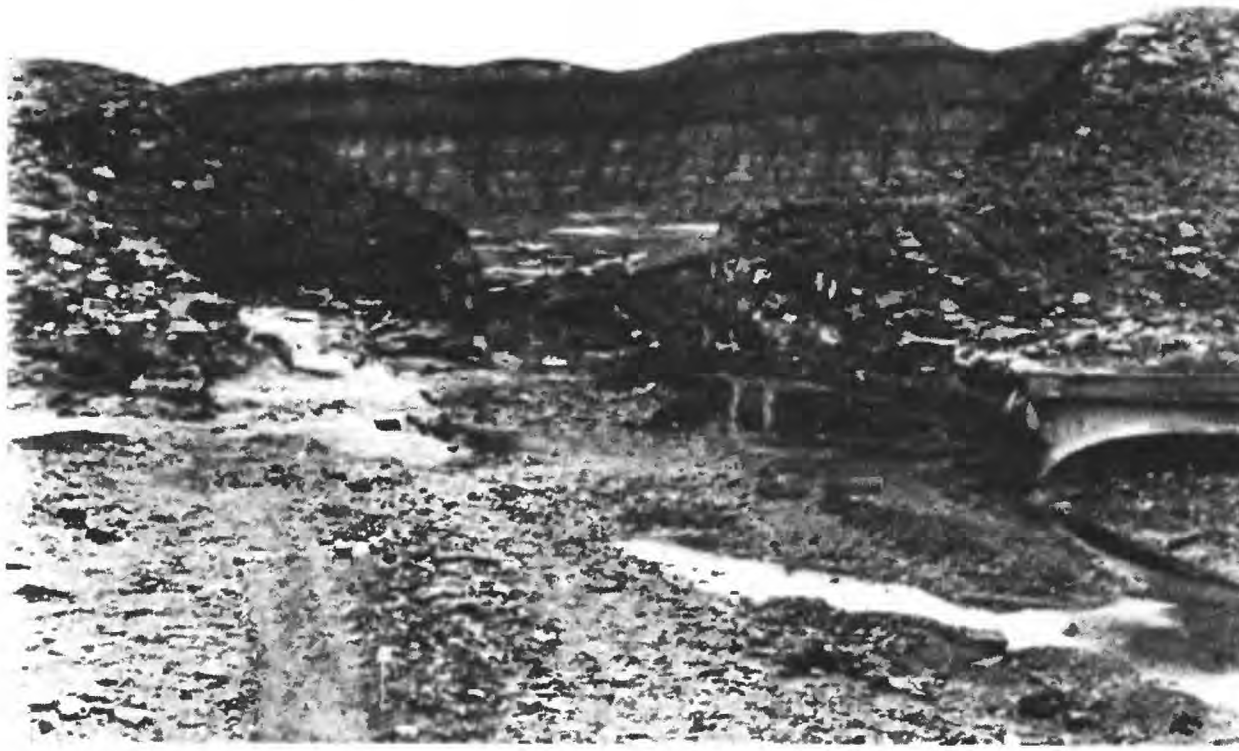
Figure 18. Upstream view of the washout of approach to Utah State Highway 9 bridge near Hurricane, Utah, January 1990.

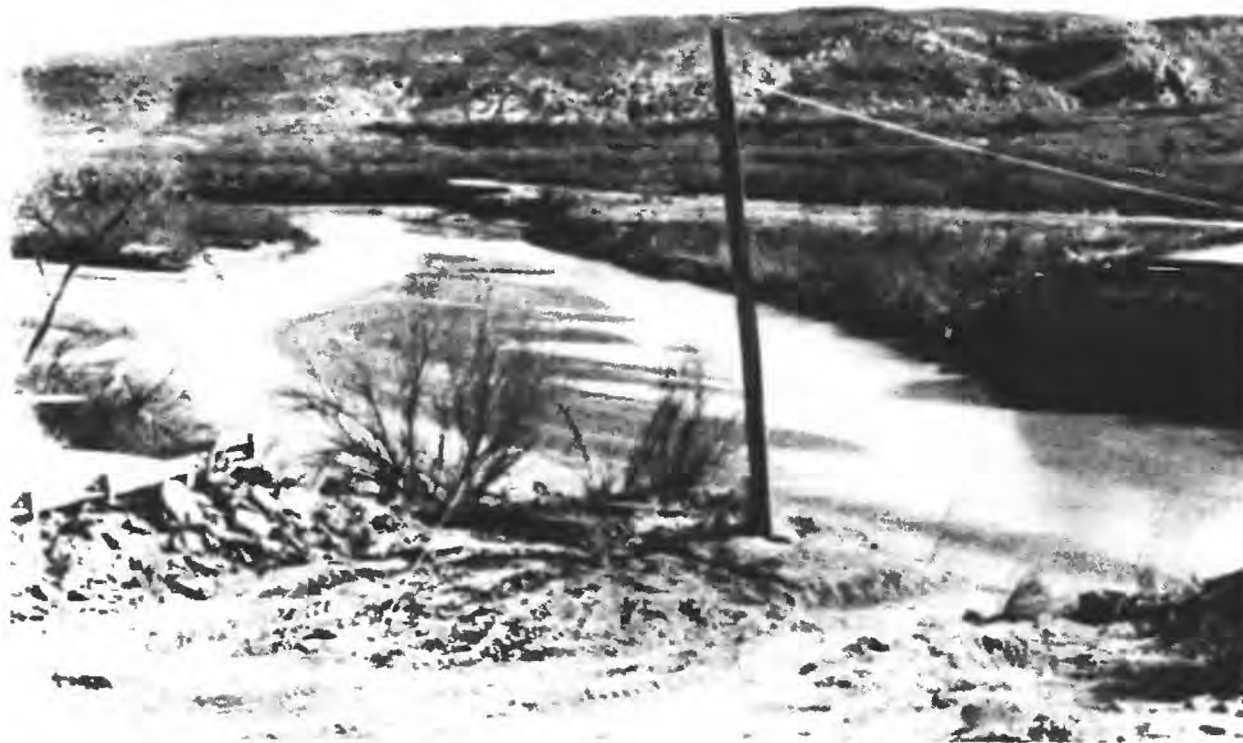
Figure 19. Upstream view of flood damage to River Road bridge near St. George, Utah, January 1990.

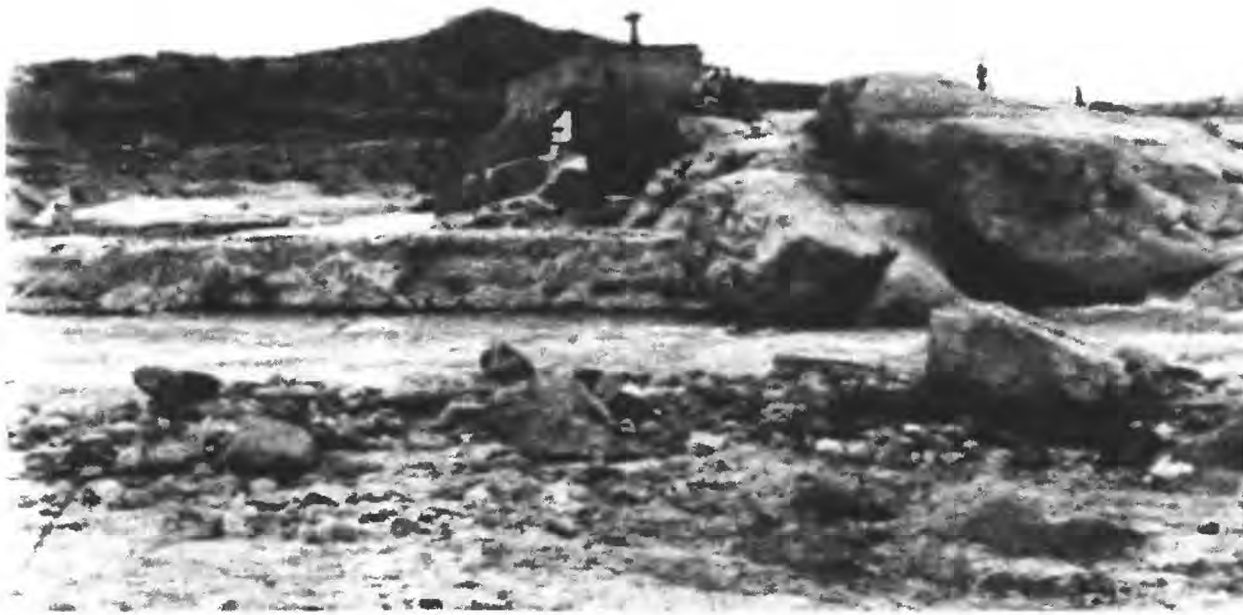
Figure 20. Flood damage to Washington Fields diversion dam near Washington, Utah, January 1990.

and the Man-of-War bridge at Bloomington, Utah, were damaged. The Washington Fields diversion dam was completely destroyed (fig. 20). This diversion dam was relocated to the present site in January 1891 after a pile dam about 5 mi downstream was swept away by the floods of January 1889 (Reid, 1964). The present site was selected in 1889 to allow the natural constriction in the flood plain to form part of the dam (fig. 21). A solid rock ledge creates part of this constriction on the north side of the Virgin River. Irrigation utilities in Utah incurred losses amounting to more than \$5 million, including the estimated cost to repair the dike, add a more extensive cutoff trench for the dike, and repair other irrigation utilities.

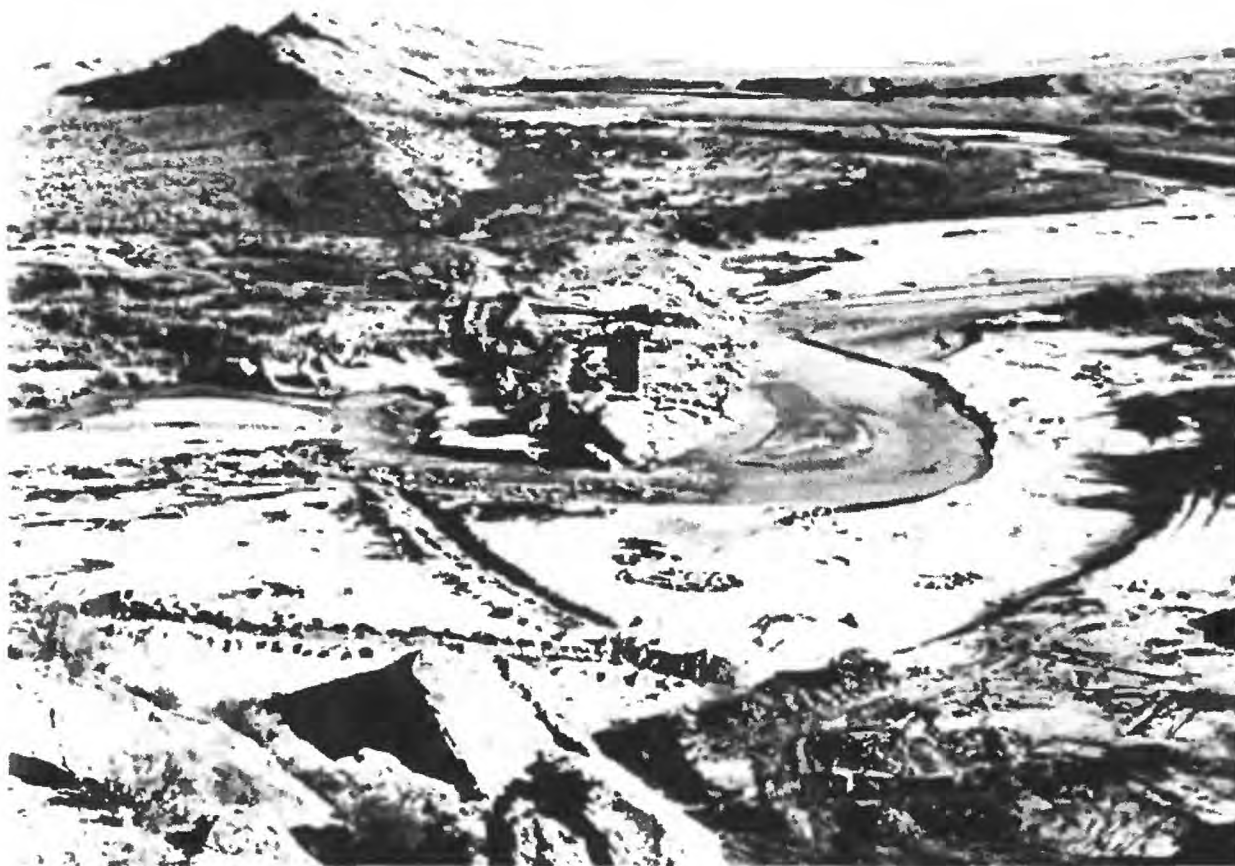
Figure 21. Upstream view of Washington Fields diversion dam and natural constriction in Virgin River flood plain, Utah, January 1990.
