# **Application of Surface Geophysical Techniques In a Study of the Geomorphology of the Lower Copper River, Alaska**

U.S. GEOLOGICAL SURVEY

Water-Resources Investigations Report 94-4165

ALASKA DEPARTMENT OF TRANSPORTATION  
AND PUBLIC FACILITIES

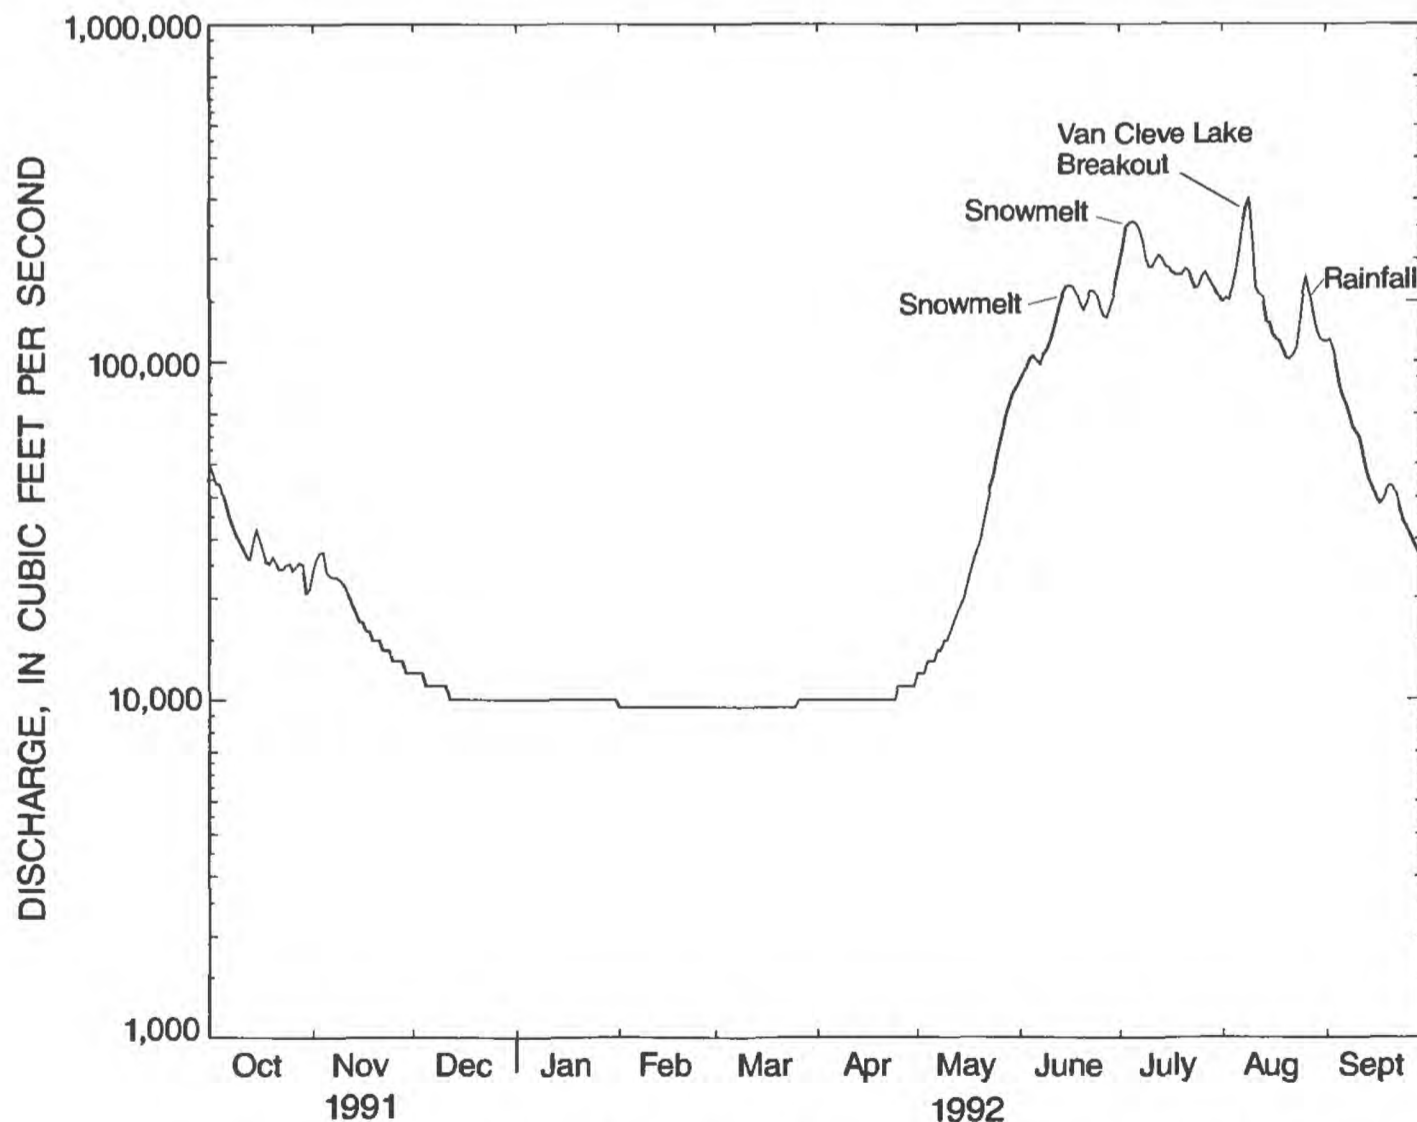
**Figure 2.** Daily mean discharge of the Copper River at Million Dollar Bridge, 1992 water year.

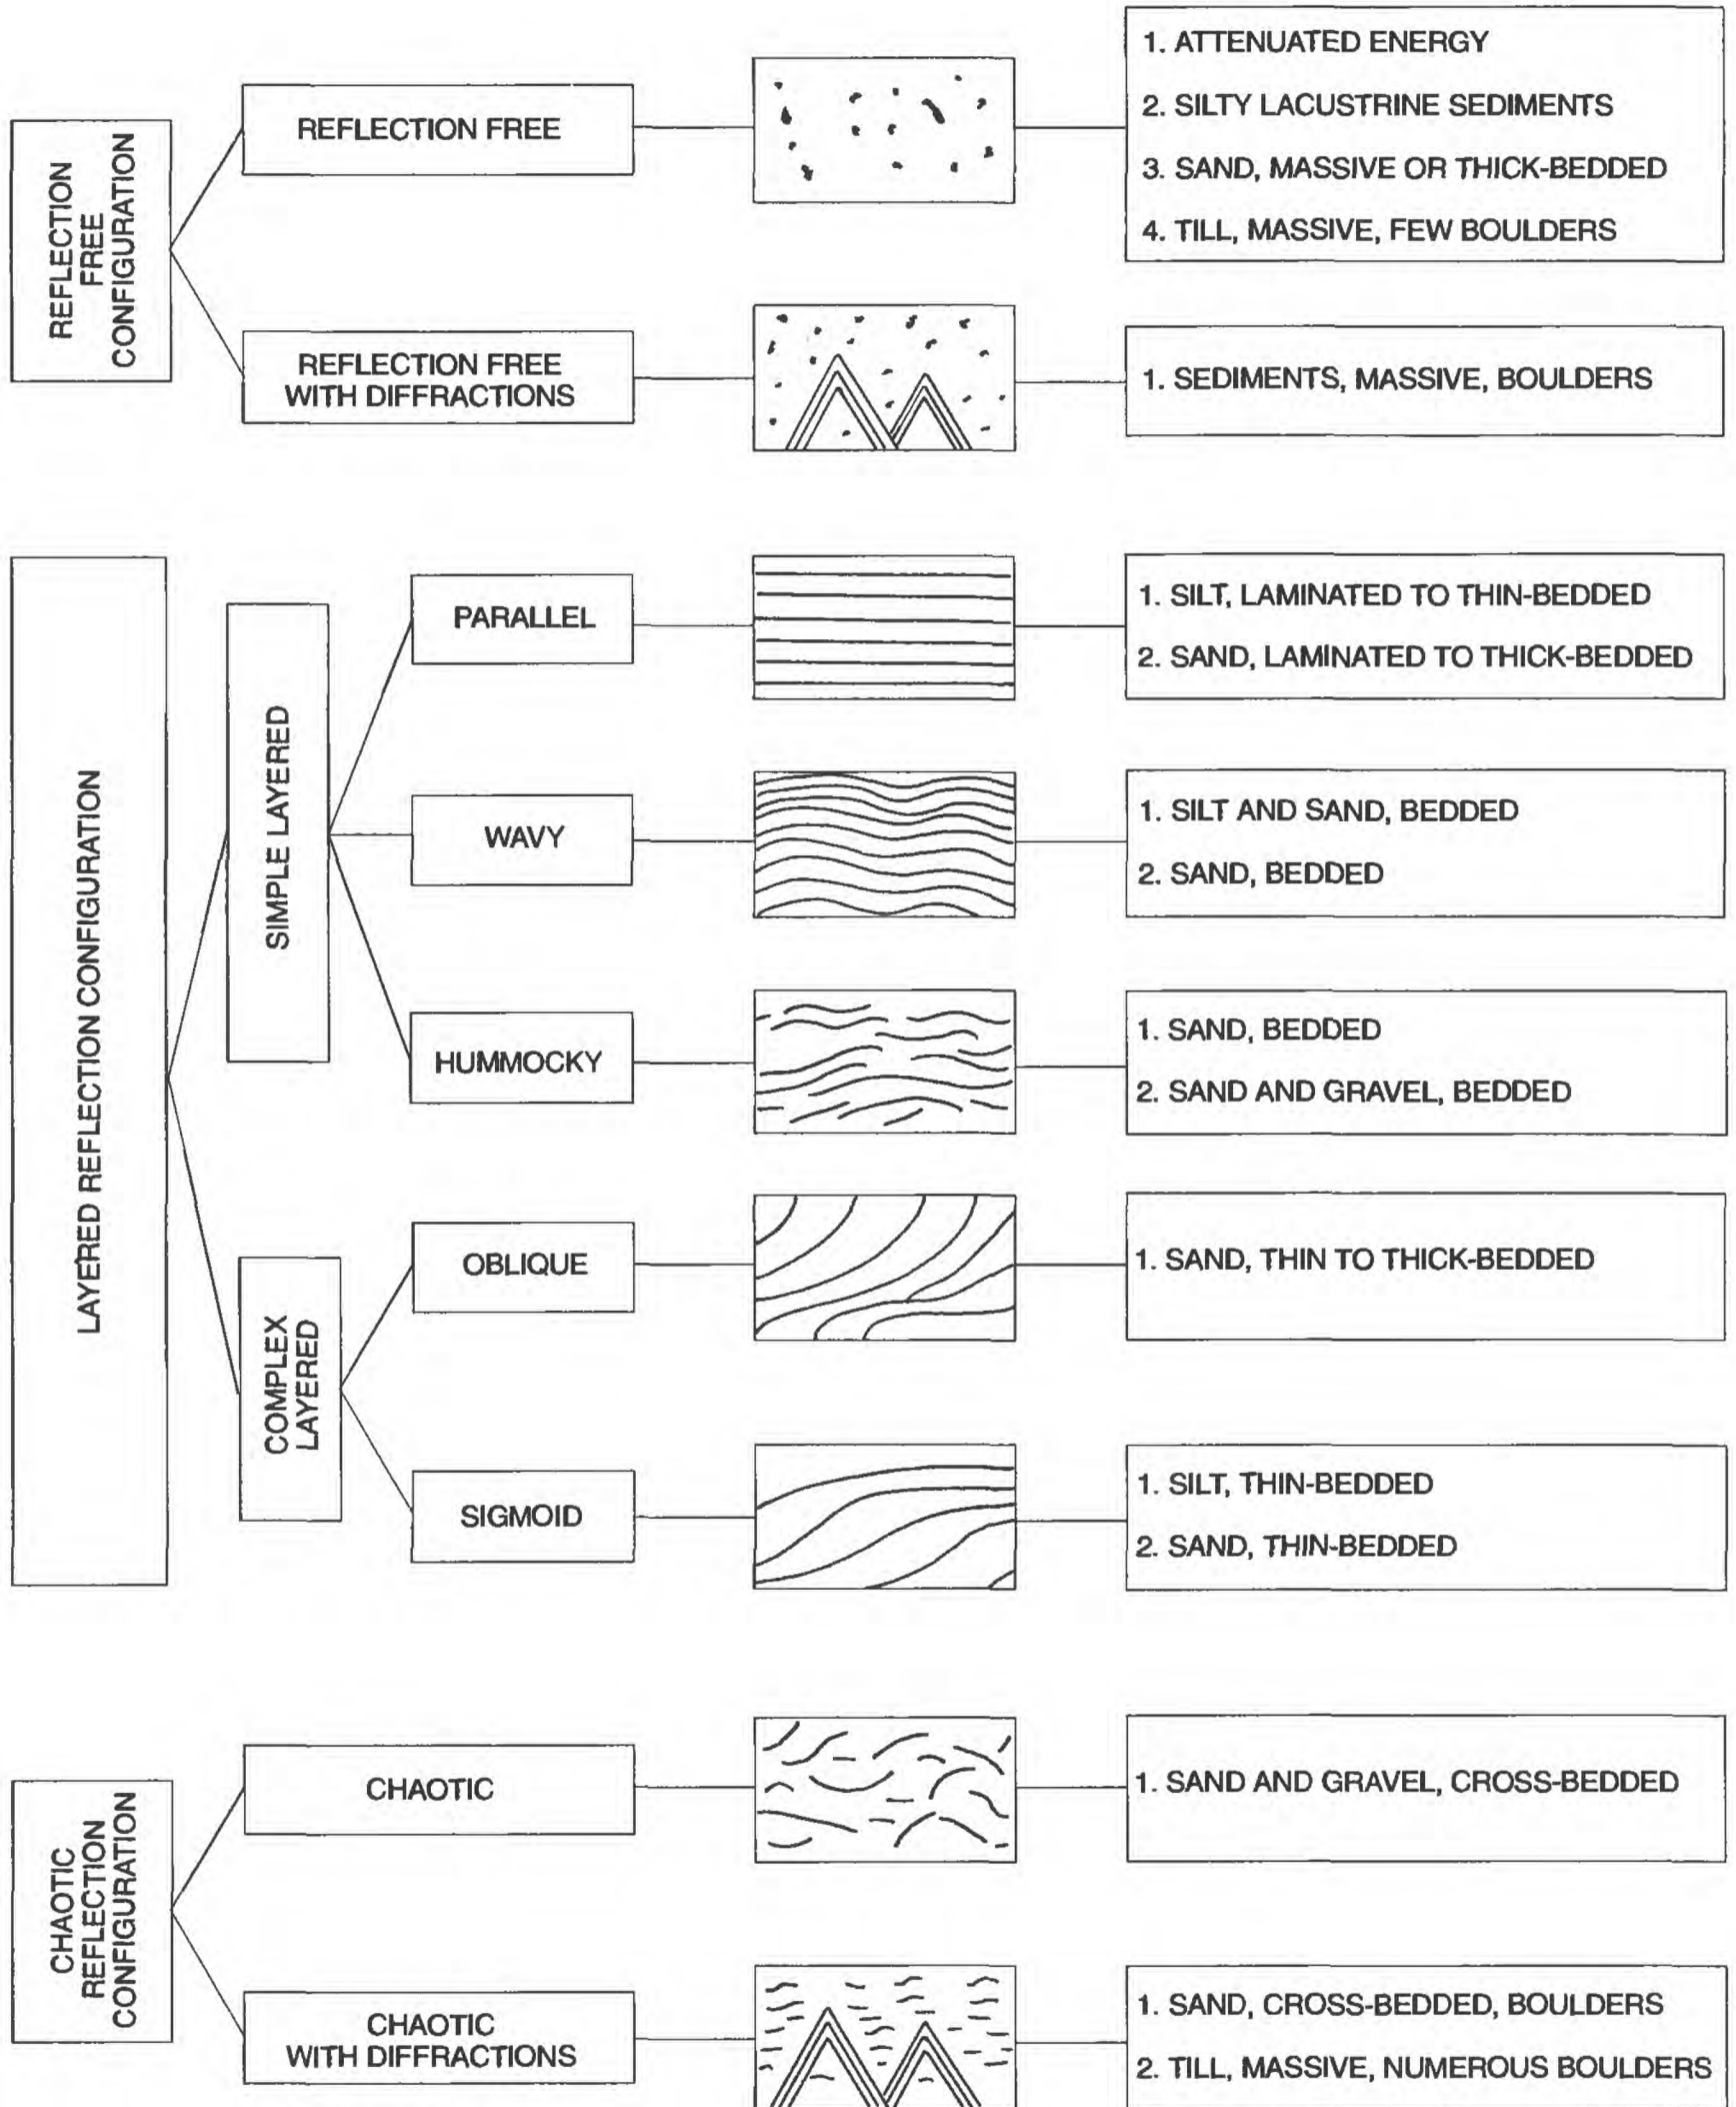
**Figure 4.** Chart relating reflection configurations to the lithologic and stratigraphic properties of sediments in the glaciated northeast (modified from Haeni, 1988b).

Ground-penetrating radar operates under much the same principles as seismic techniques, except that electromagnetic energy, rather than a sound wave, is transmitted into the subsurface. The reflected signal will depend on the dielectric and conductivity characteristics of the materials. Haeni (1988b) related some reflection configurations of radar records to the stratigraphic and lithologic properties of unconsolidated aquifers in the glaciated northeast (fig. 4). These basic relations also apply to this study area.

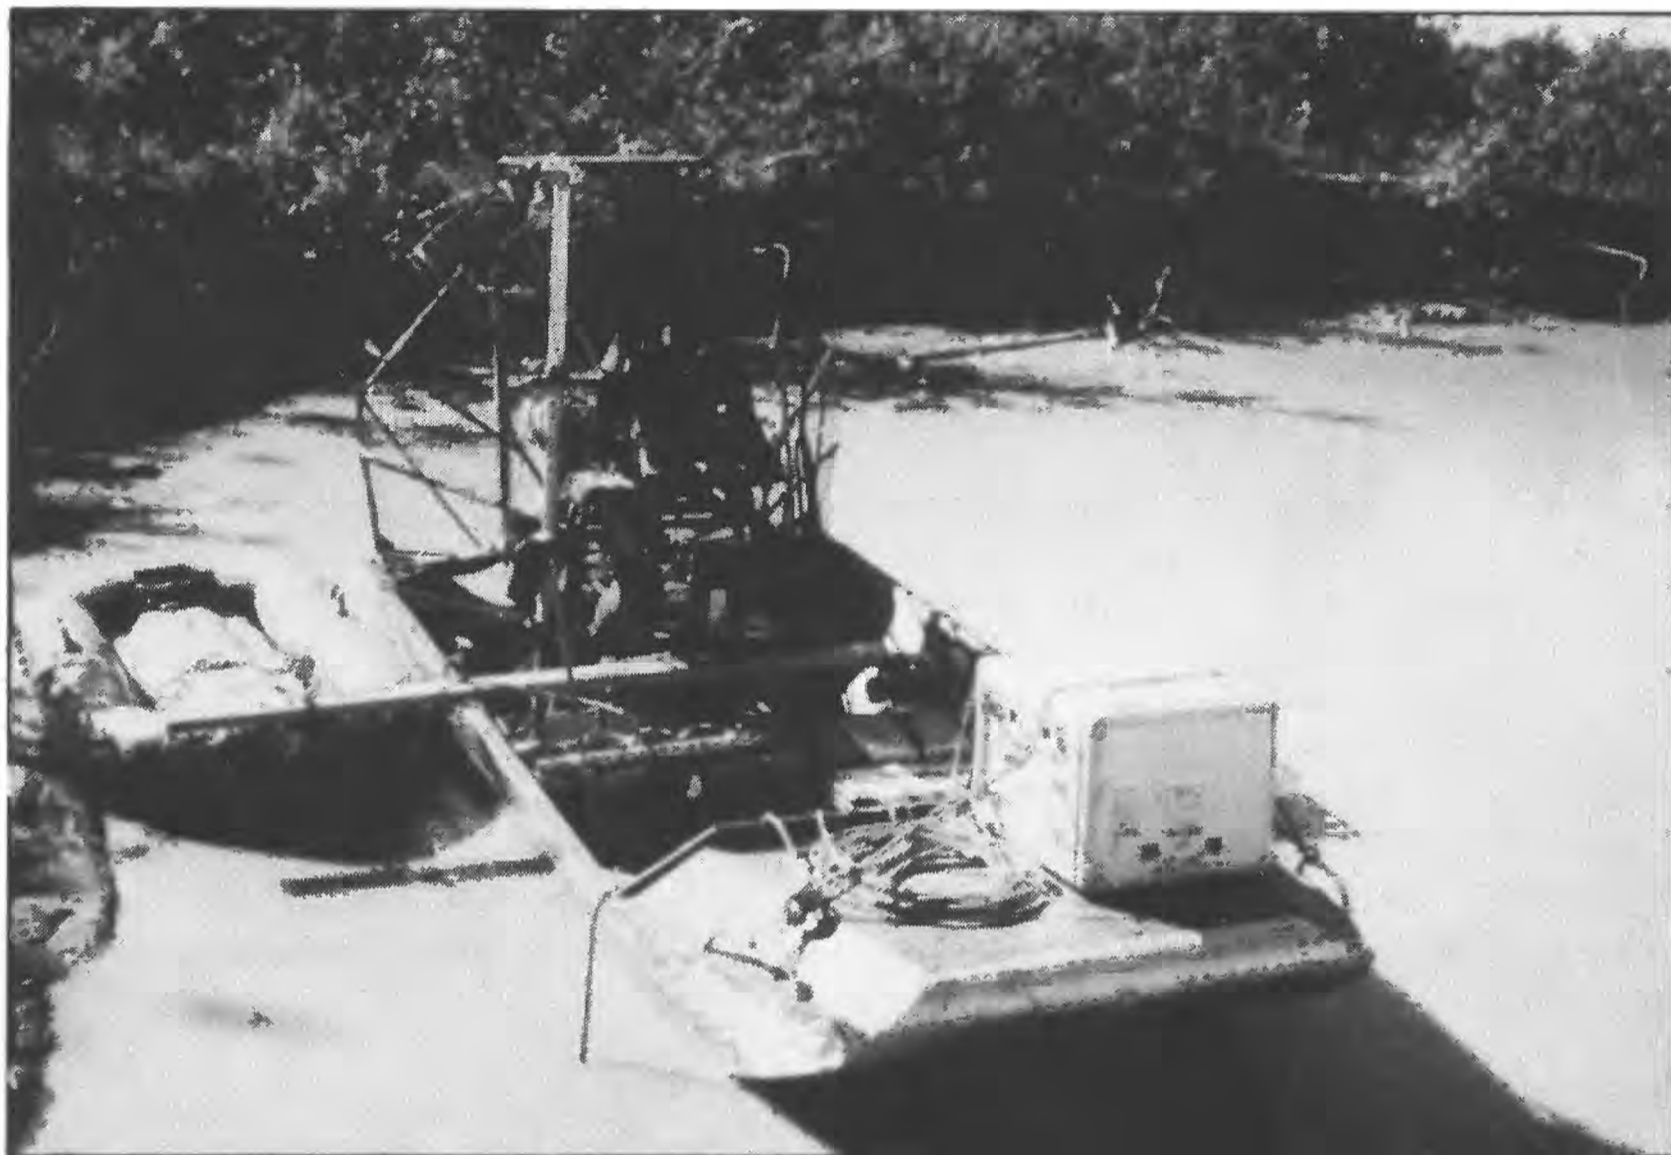
**Figure 5.** Airboat equipped with ground-penetrating radar.

All field work was done by use of an airboat (fig. 5). The airboat was the most reliable way to collect field data because it could easily maneuver through shallow water or around sandbars. In certain locations, primarily near piers, the velocity of the Copper River was relatively high. In these areas, no attempts were made to collect data.

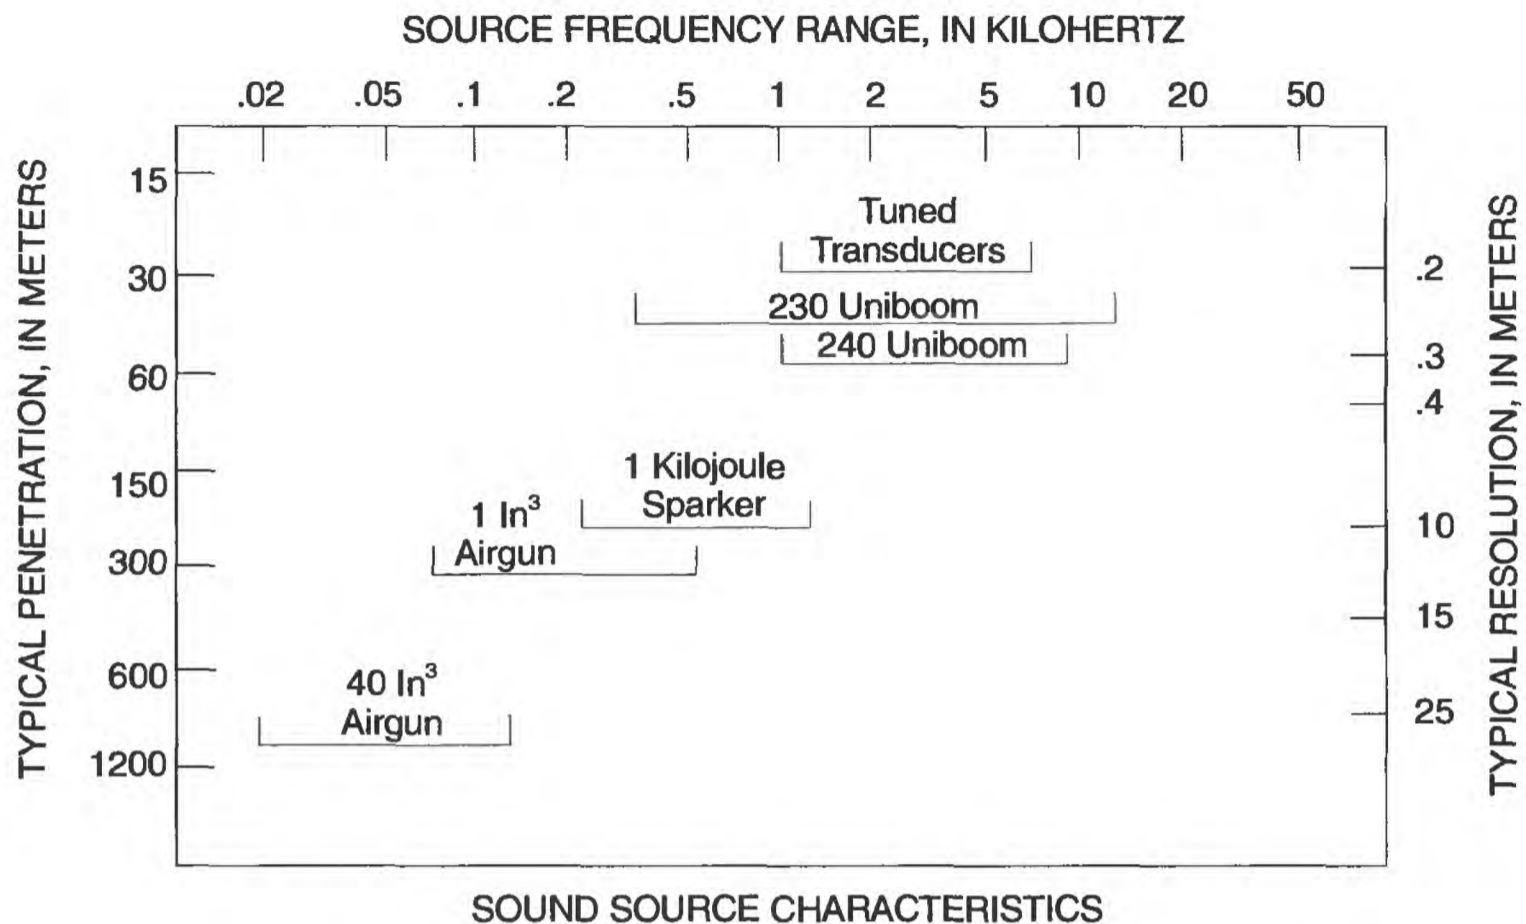
**Figure 6.** Characteristics of seismic reflection sound sources [modified from Sylwester, 1983].

Acoustic sources available for use in seismic reflection surveys are airguns, sparkers, uni-booms, and a tuned transducer. Each source has its own penetration, frequency, and resolution characteristics (fig. 6). The tuned transducer was used for this study primarily because of its ease of use and because the penetration and resolution characteristics were acceptable for this study. The transducer operated at a frequency of 3.5 kHz or at a frequency of 7.0 kHz. The instrumentation and transducer were manufactured by Ferranti O.R.E. Incorporated.

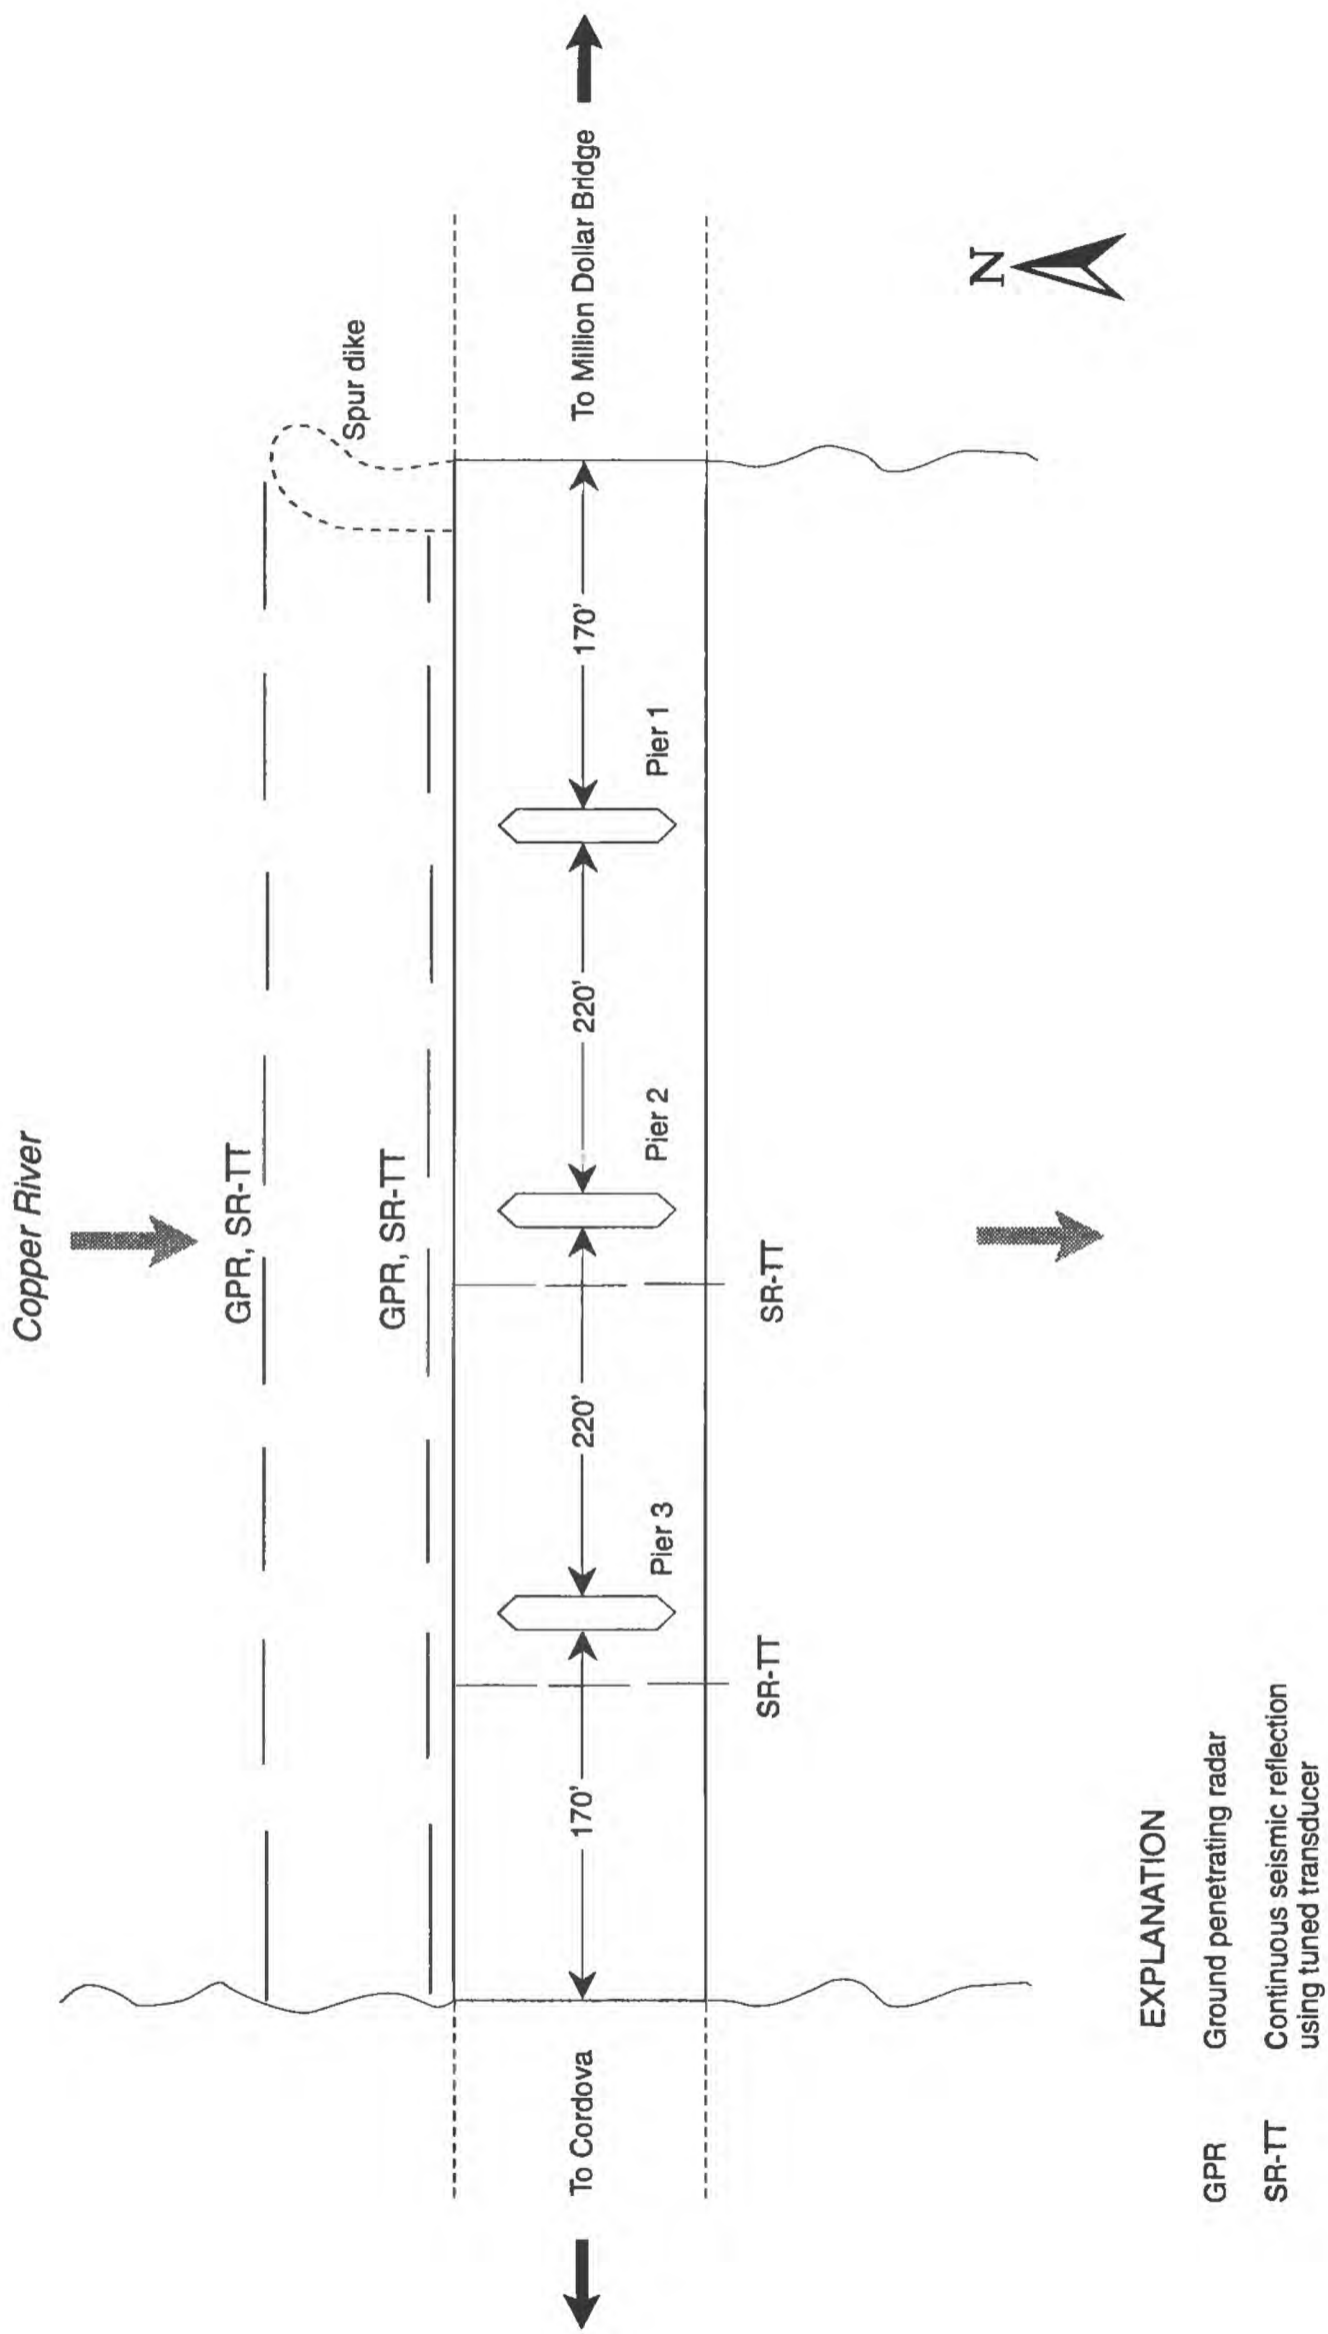
**Figure 7.** Plan view of Bridge 331 on the Copper River Highway, showing locations of geophysical profiles.

Bridges 331, 1187, and 332 (fig. 3) are located at Flag Point, Mile 27 of the Copper River Highway. Traveling east from Cordova, these are the first bridges that cross the Copper River. The bridges were constructed during 1970-72 to replace bridges damaged by the 1964 earthquake. Each bridge is supported by concrete piers that are 5.5 ft wide, 18 ft long, and pointed at both upstream and downstream ends. Bridges 331 and 332 are both 780 ft long and supported by three piers spaced 220 ft apart. Bridge 1187 is 1,220 ft long and is supported by five piers spaced 220 ft apart. Spur dikes were constructed at the left upstream abutment of Bridge 331 and at both upstream abutments of Bridge 1187 (figs. 7-9) (Note: figures 7 to 33 are at the end of the report, starting on p. 17.)

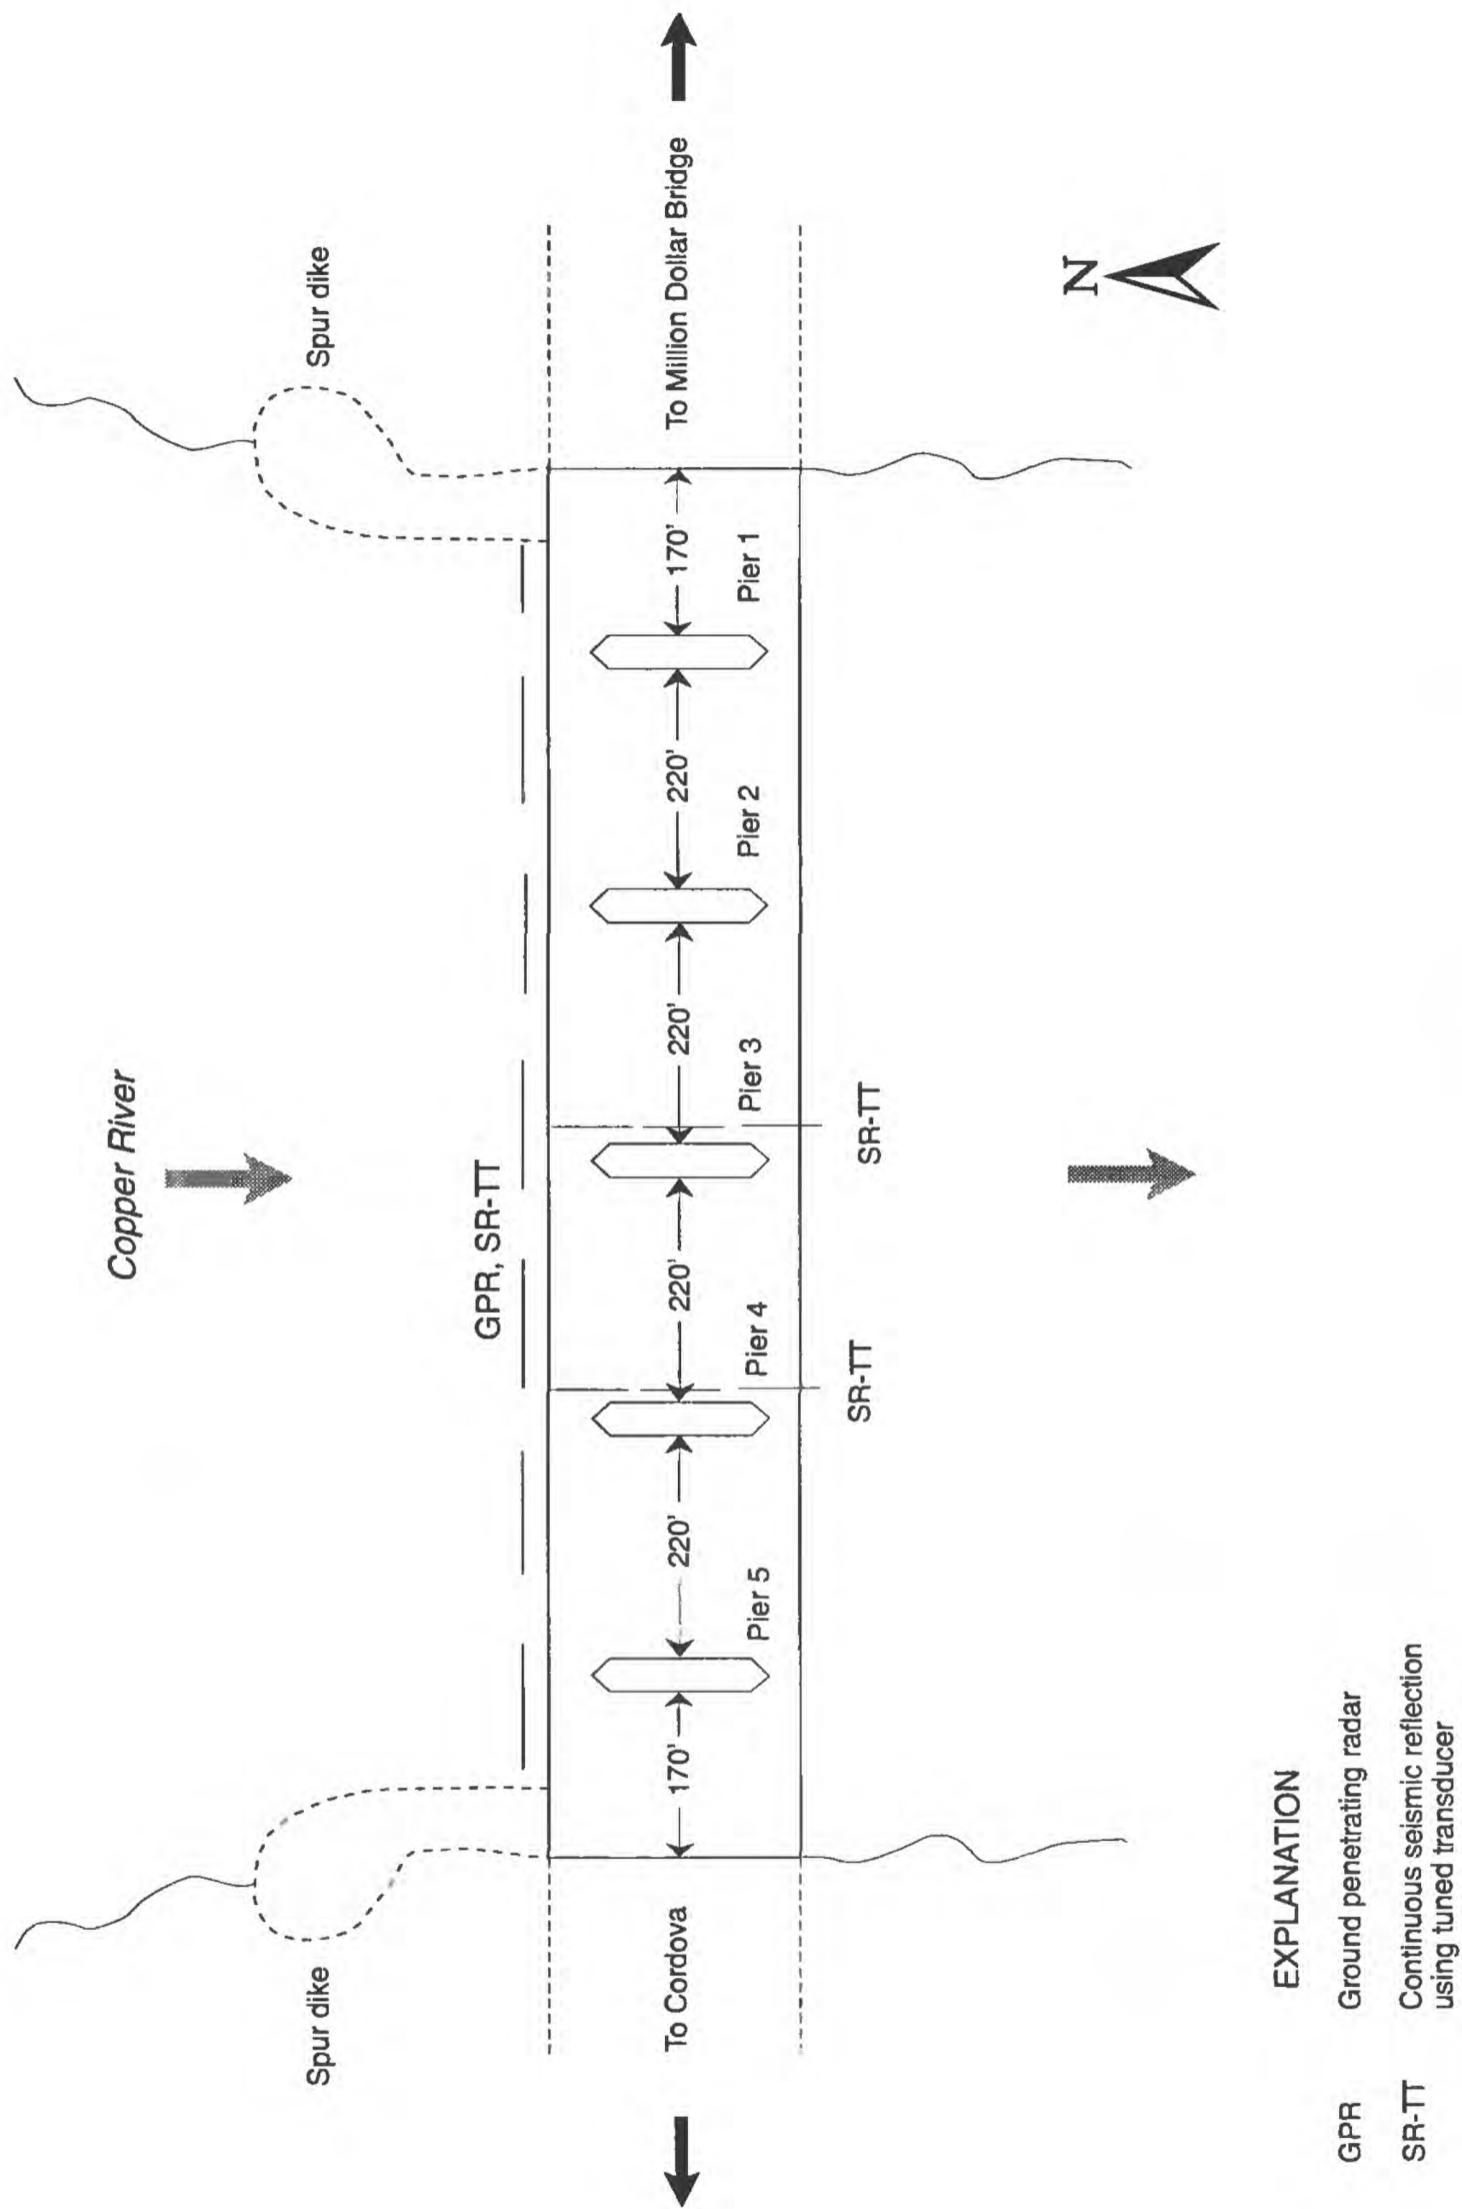
Figure 8. Plan view of Bridge 1187 on the Copper River Highway, showing locations of geophysical profiles.

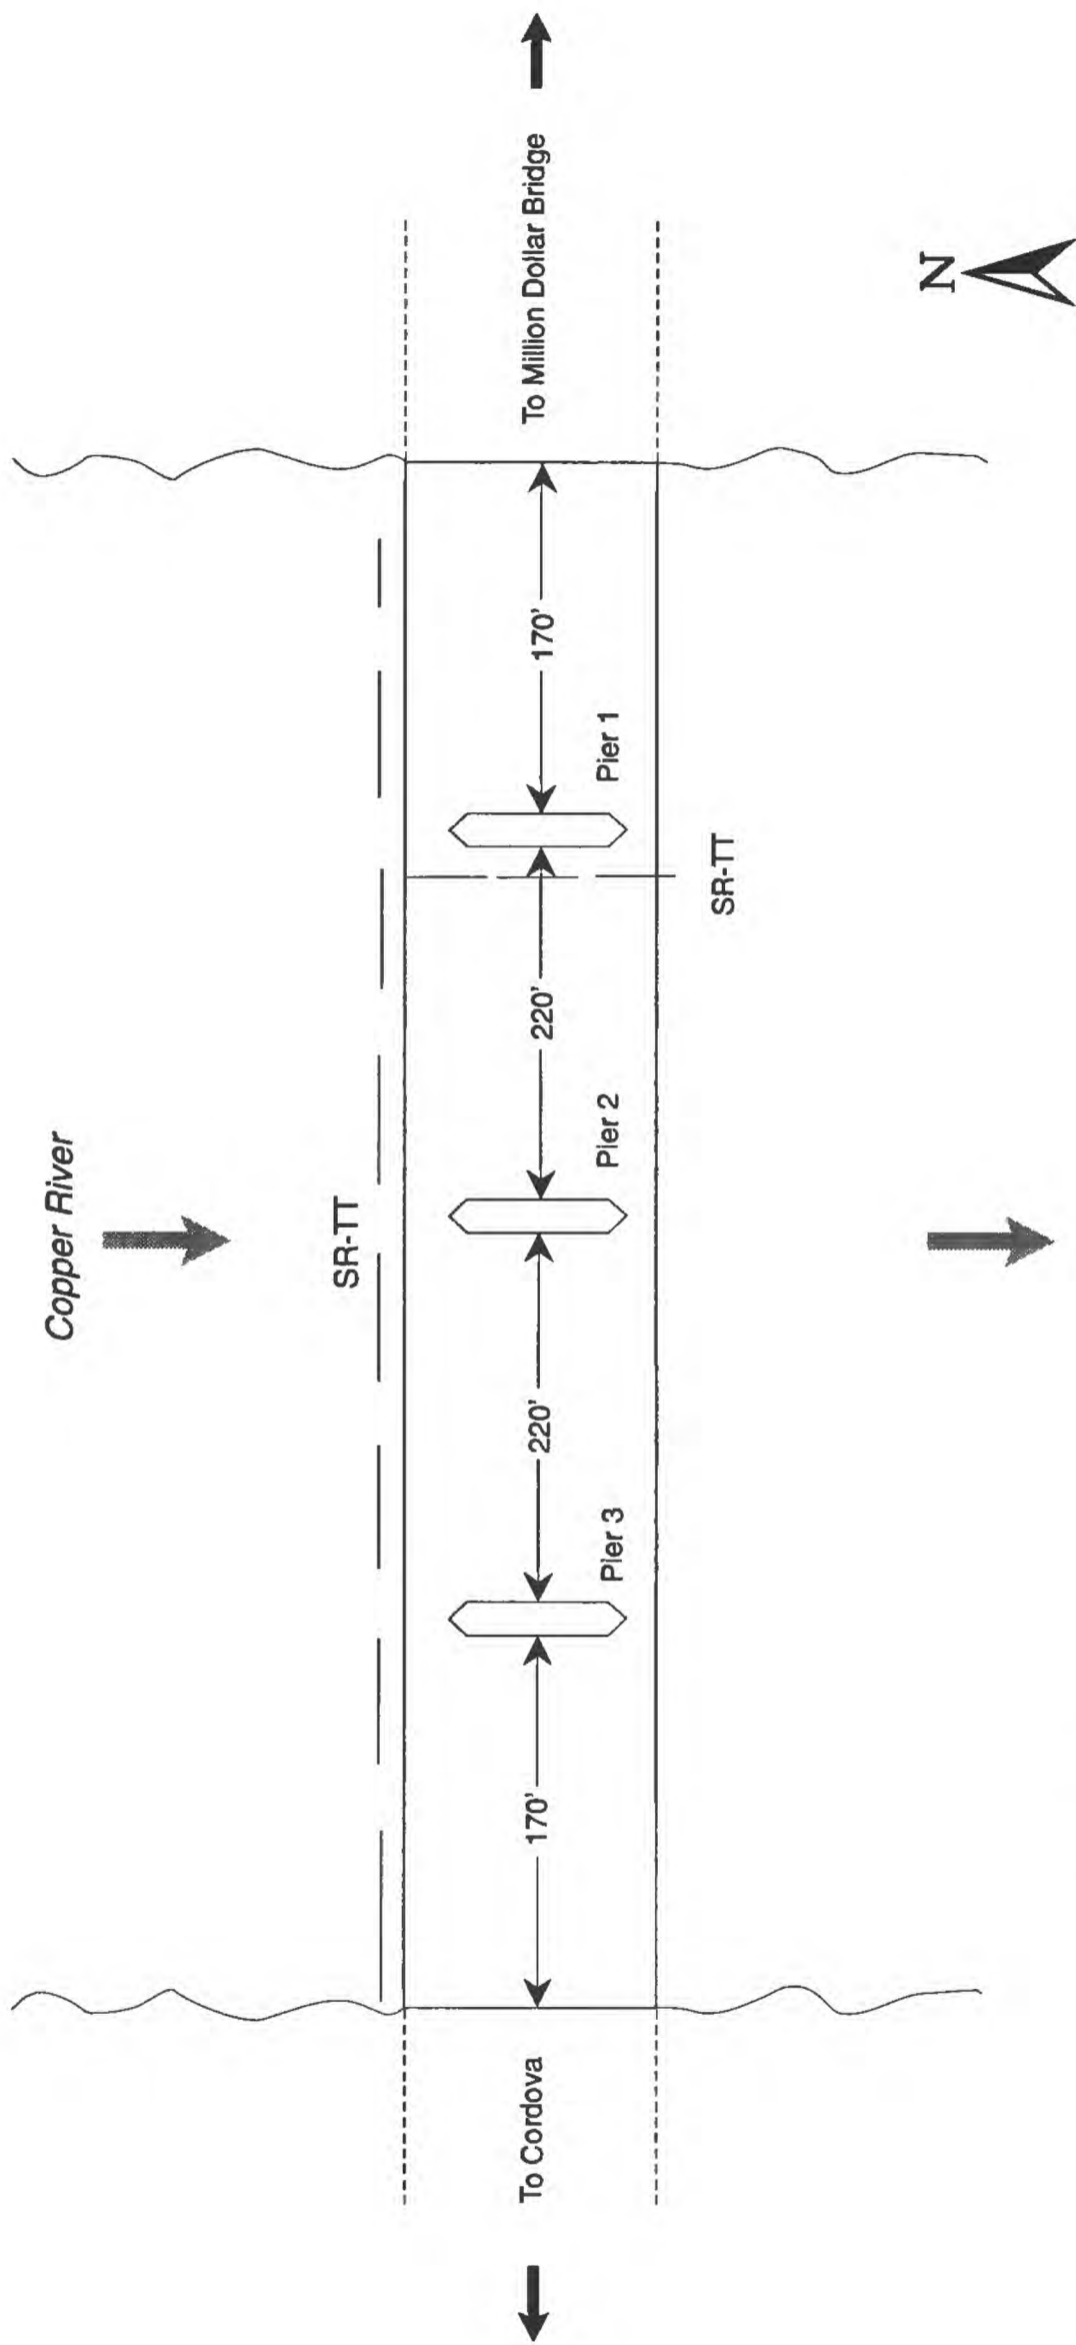
SR-TT    Continuous seismic reflection using tuned transducer

**Figure 9.** Plan view of Bridge 332 on the Copper River Highway, showing locations of geophysical profiles.

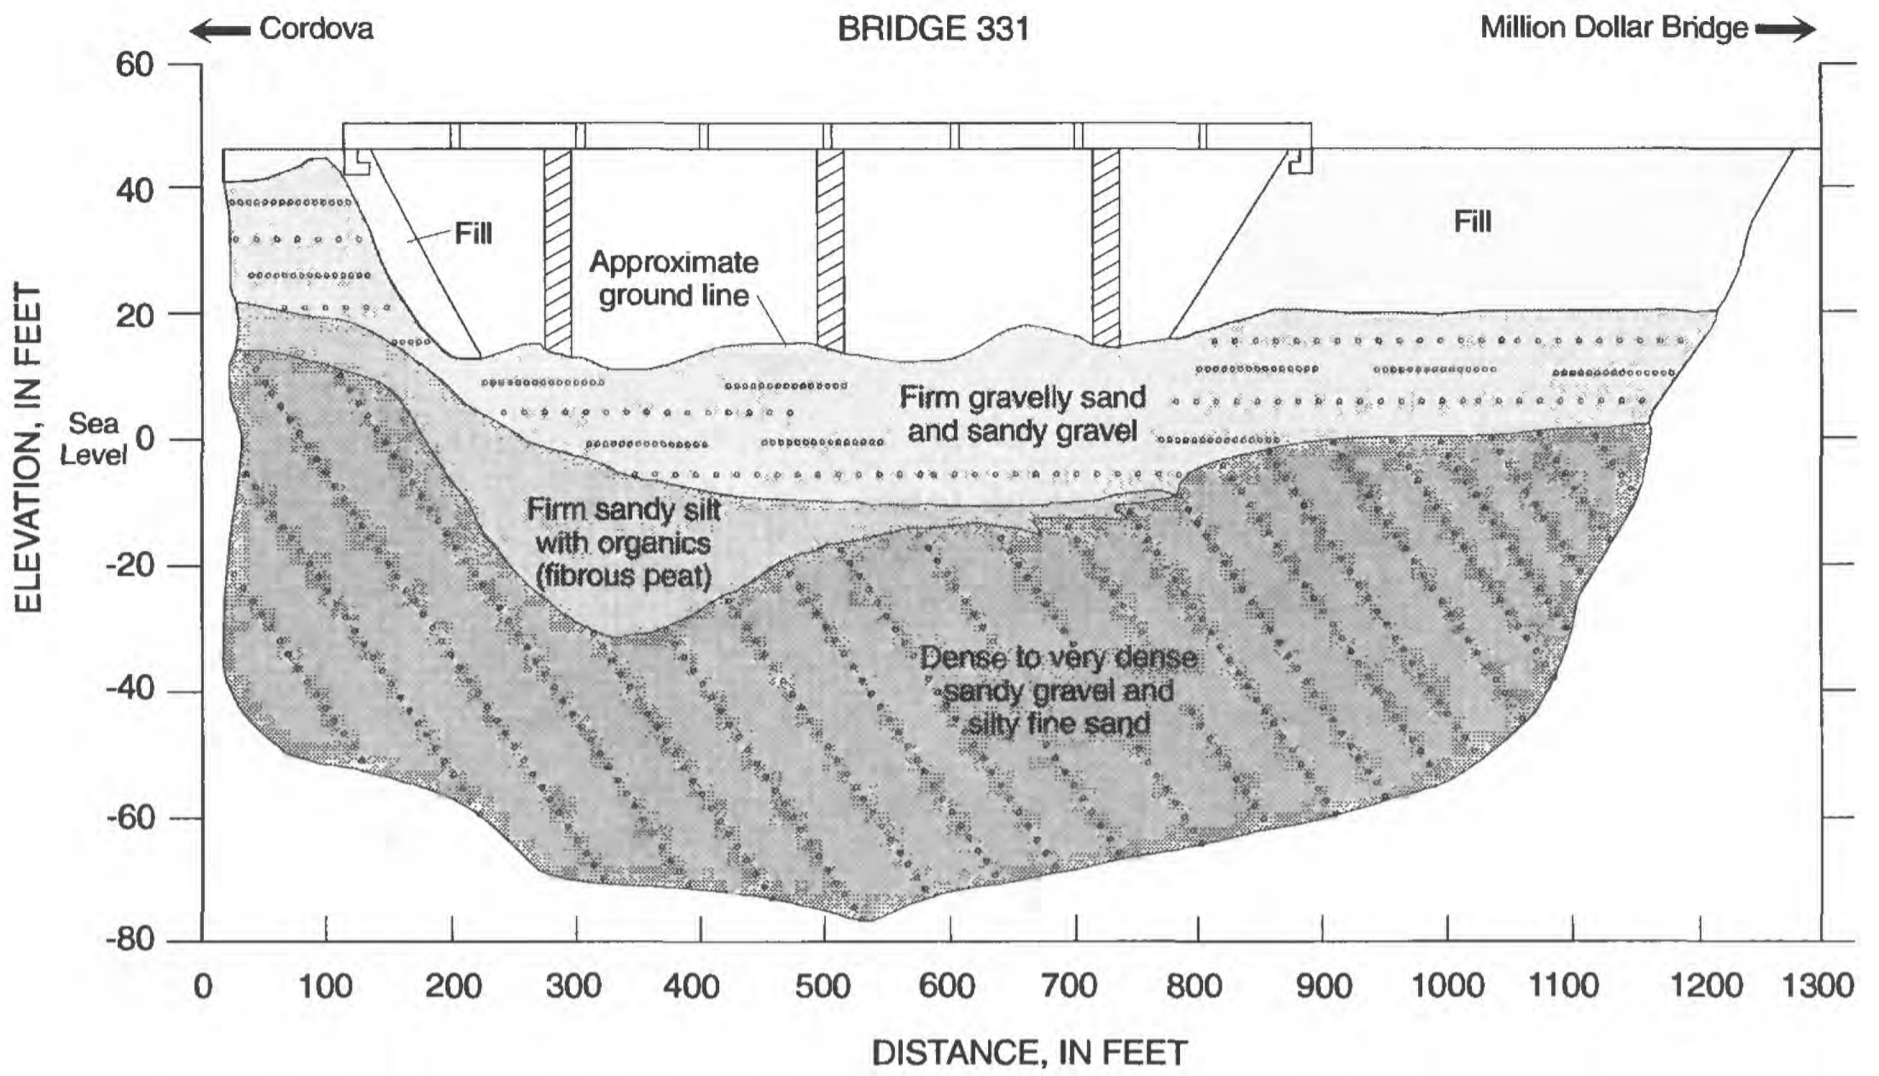
**Figure 10.** Generalized geologic cross section at Bridge 331 on the Copper River Highway, (modified from Alaska Department of Transportation and Public Facilities files).

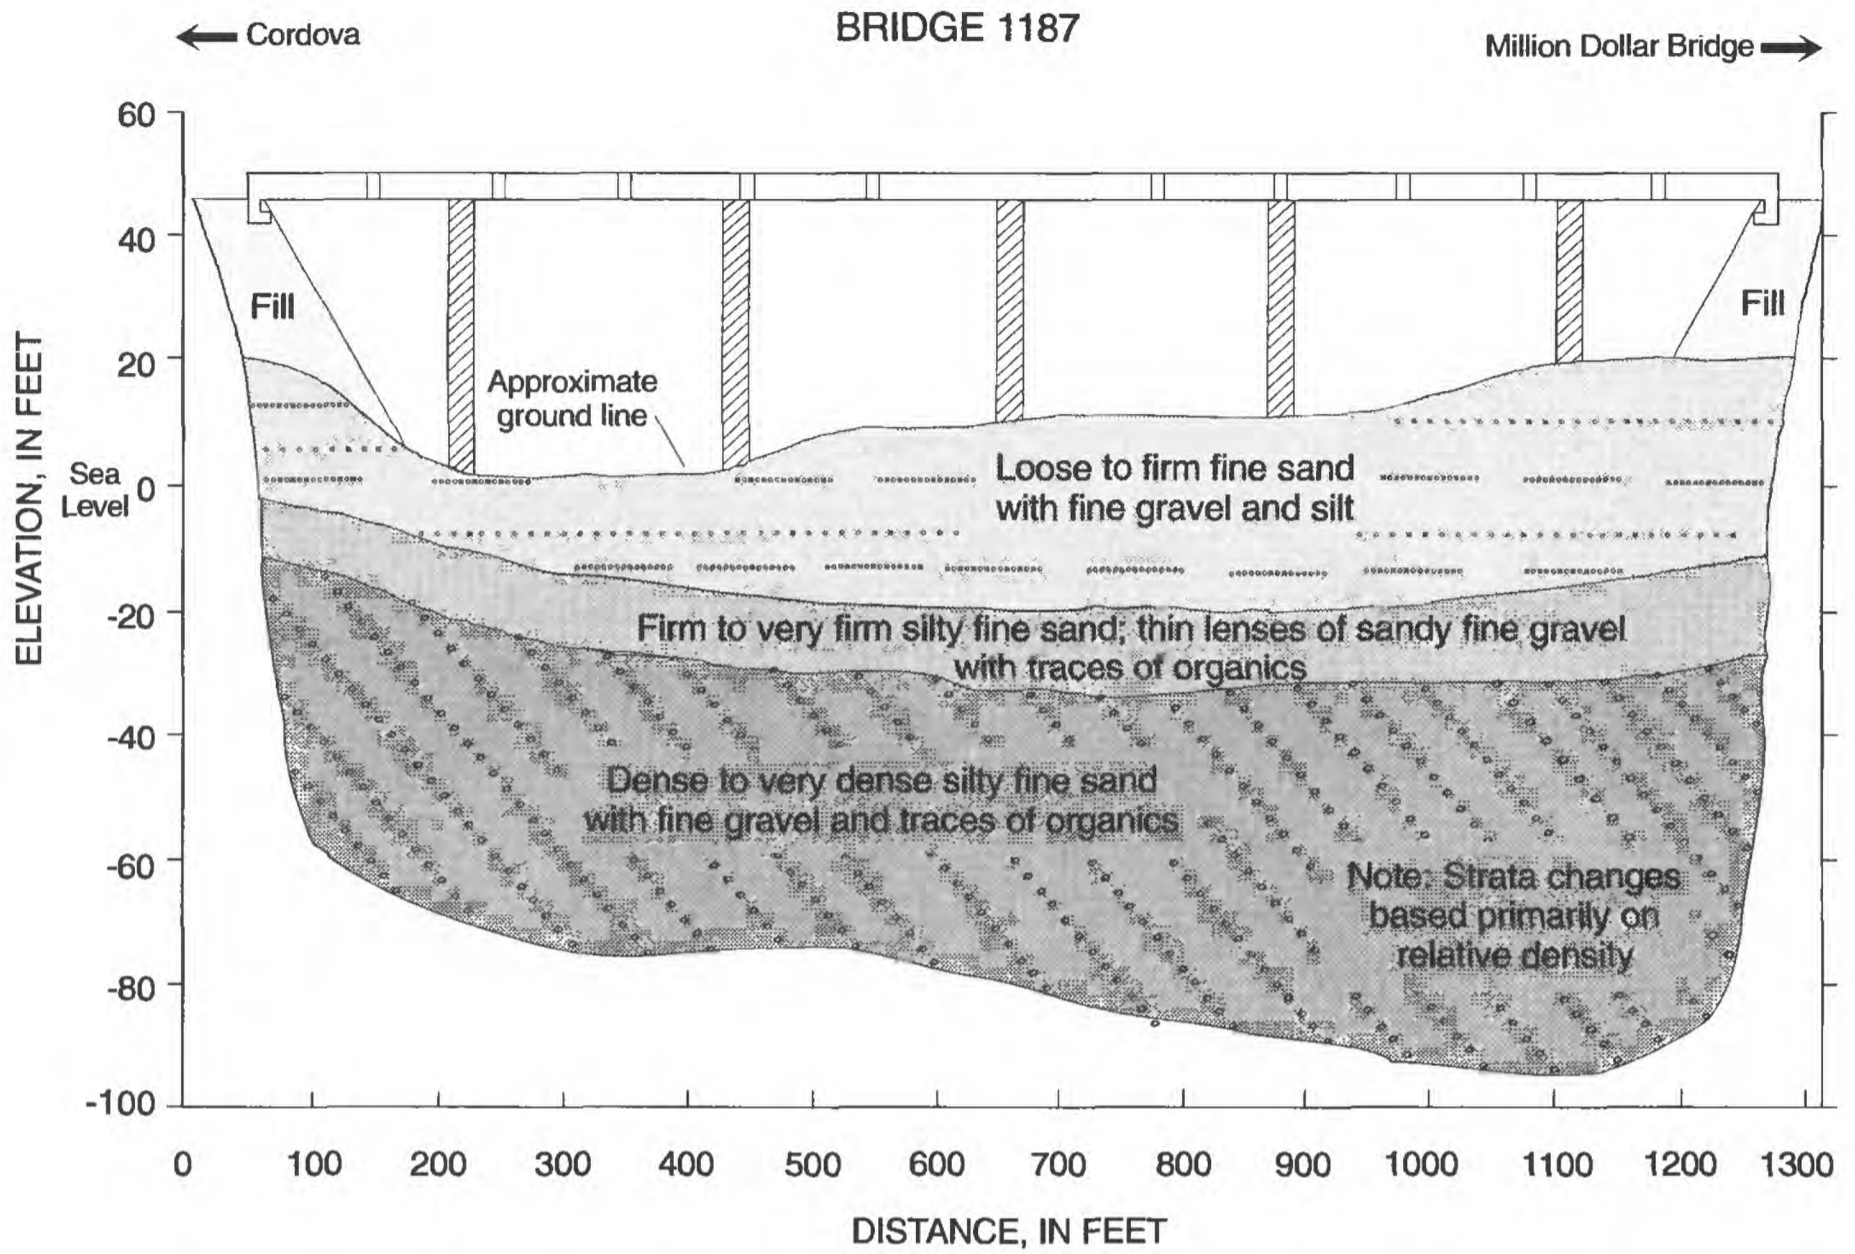
**Figure 11.** Generalized geologic cross section at Bridge 1187 on the Copper River Highway, (modified from Alaska Department of Transportation and Public Facilities files).
