# **Application of Surface Geophysical Techniques In a Study of the Geomorphology of the Lower Copper River, Alaska**

U.S. GEOLOGICAL SURVEY

Water-Resources Investigations Report 94-4165

ALASKA DEPARTMENT OF TRANSPORTATION  
AND PUBLIC FACILITIES

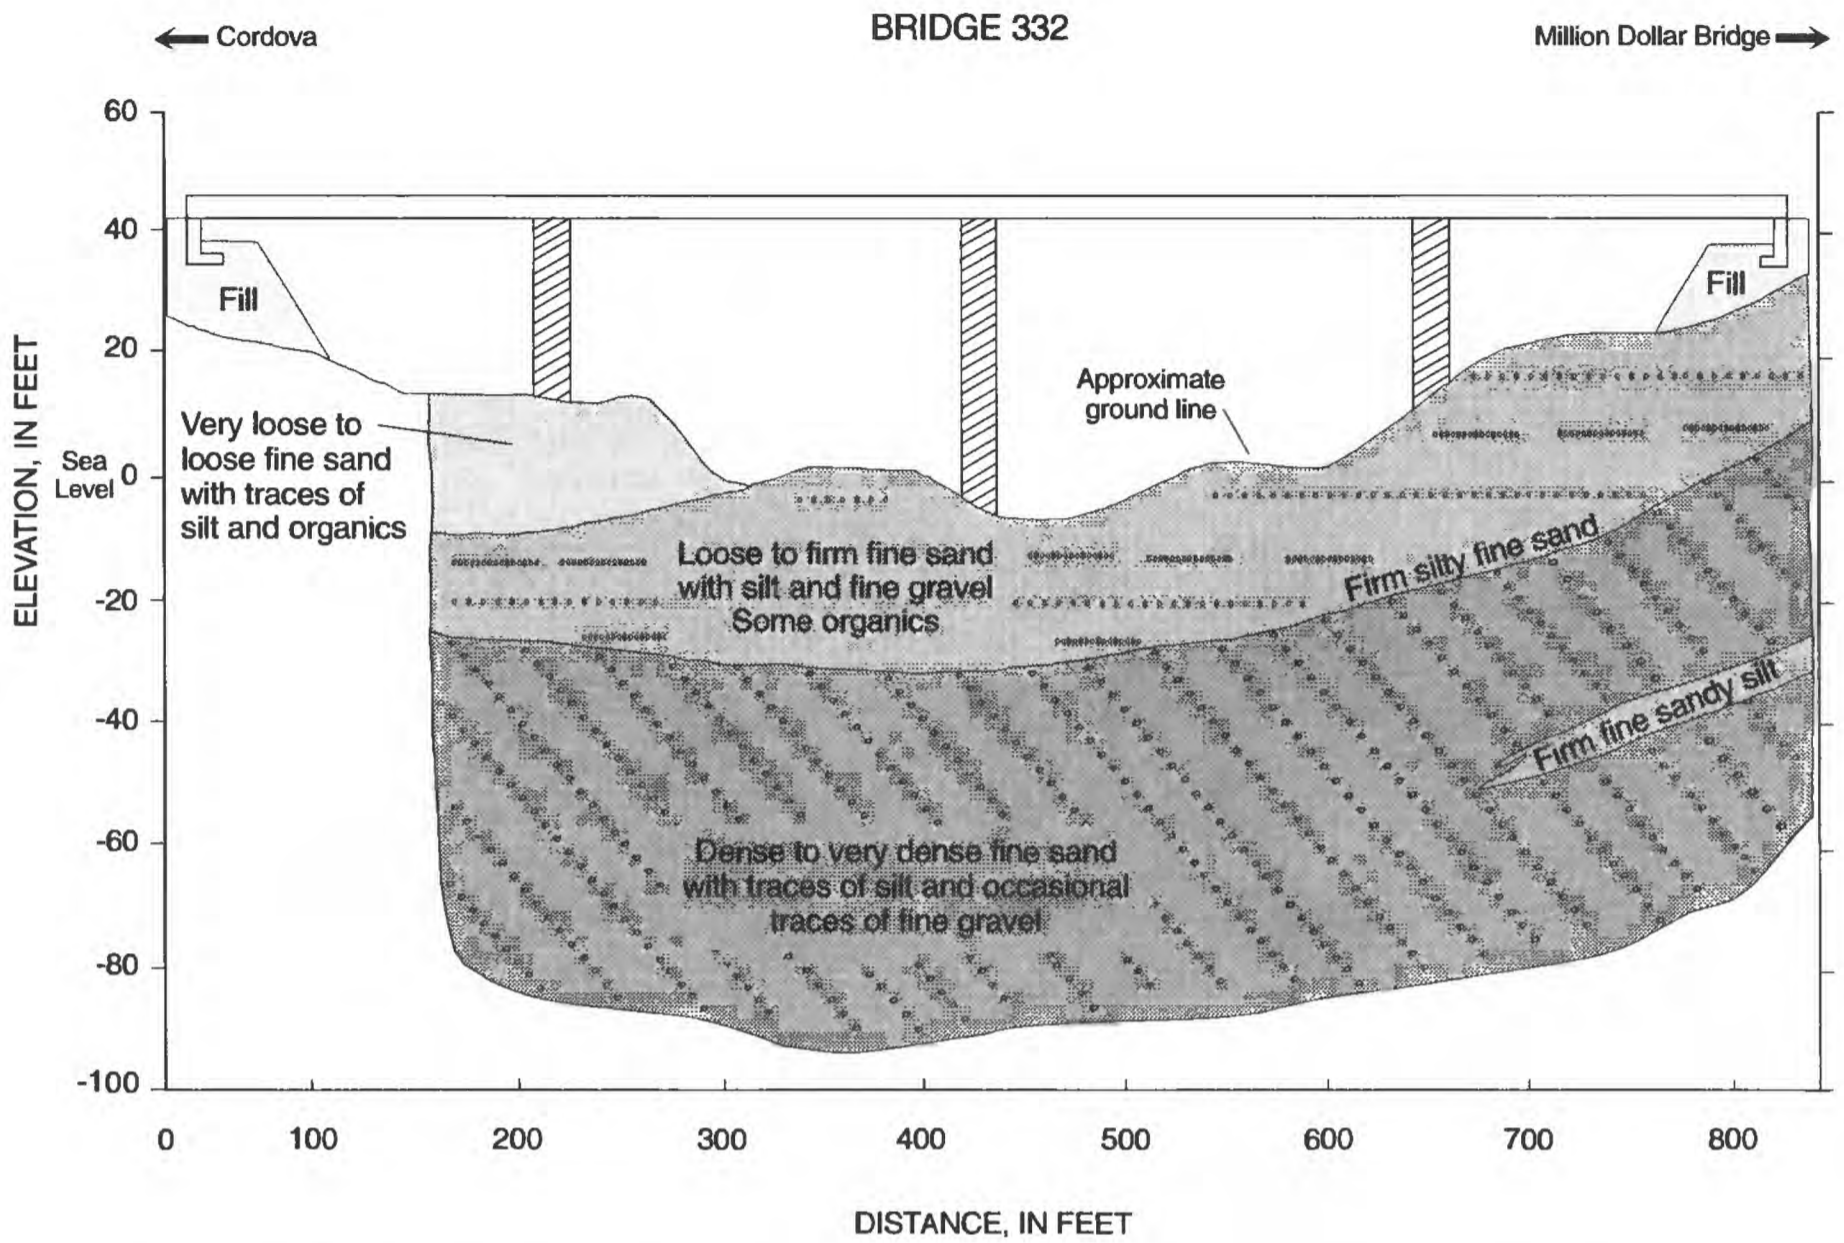
**Figure 12.** Generalized geologic cross section at Bridge 332 on the Copper River Highway, (modified from Alaska Department of Transportation and Public Facilities files).

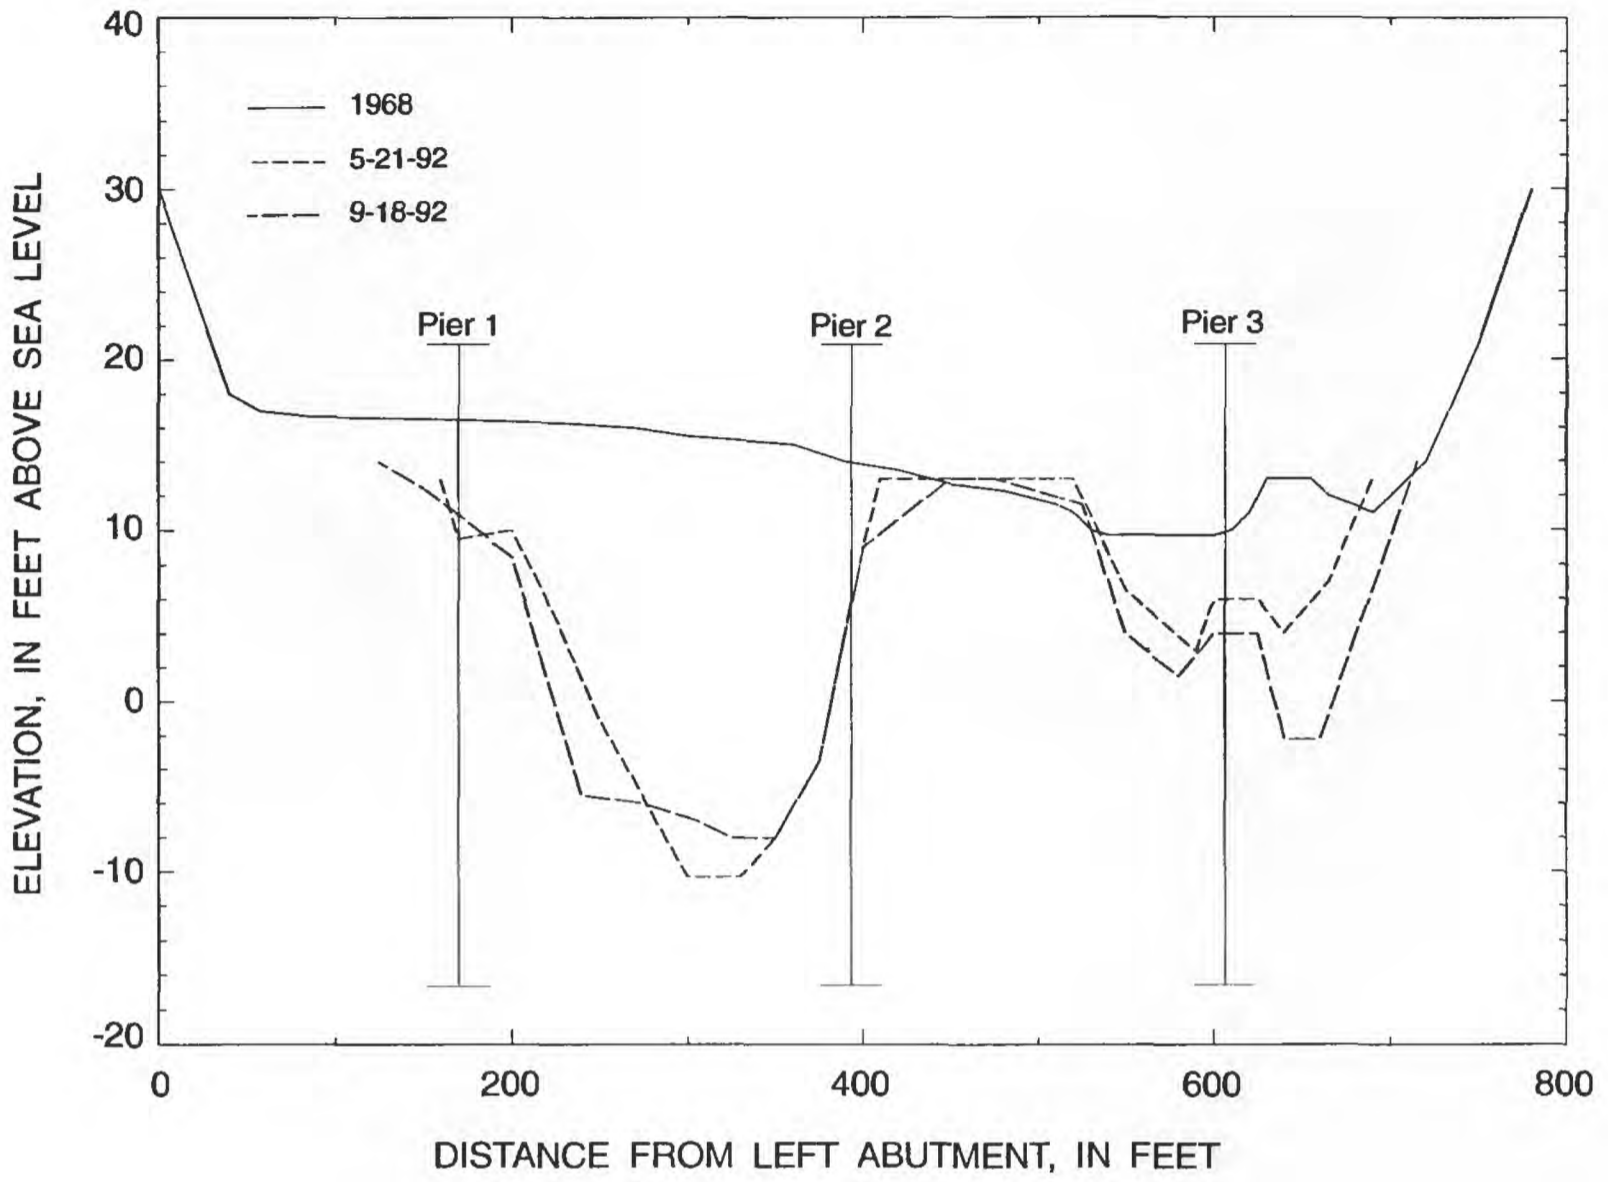
**Figure 13.** Cross sections of the Copper River, downstream side of Bridge 331.

At Bridge 331, a comparison of cross sections obtained from the downstream side of the bridge indicates that two main channels have formed at this bridge since 1968 (fig. 13). Because the cross section data also indicated that scour has taken place at all three piers, the geophysical methods were tested at all three piers.

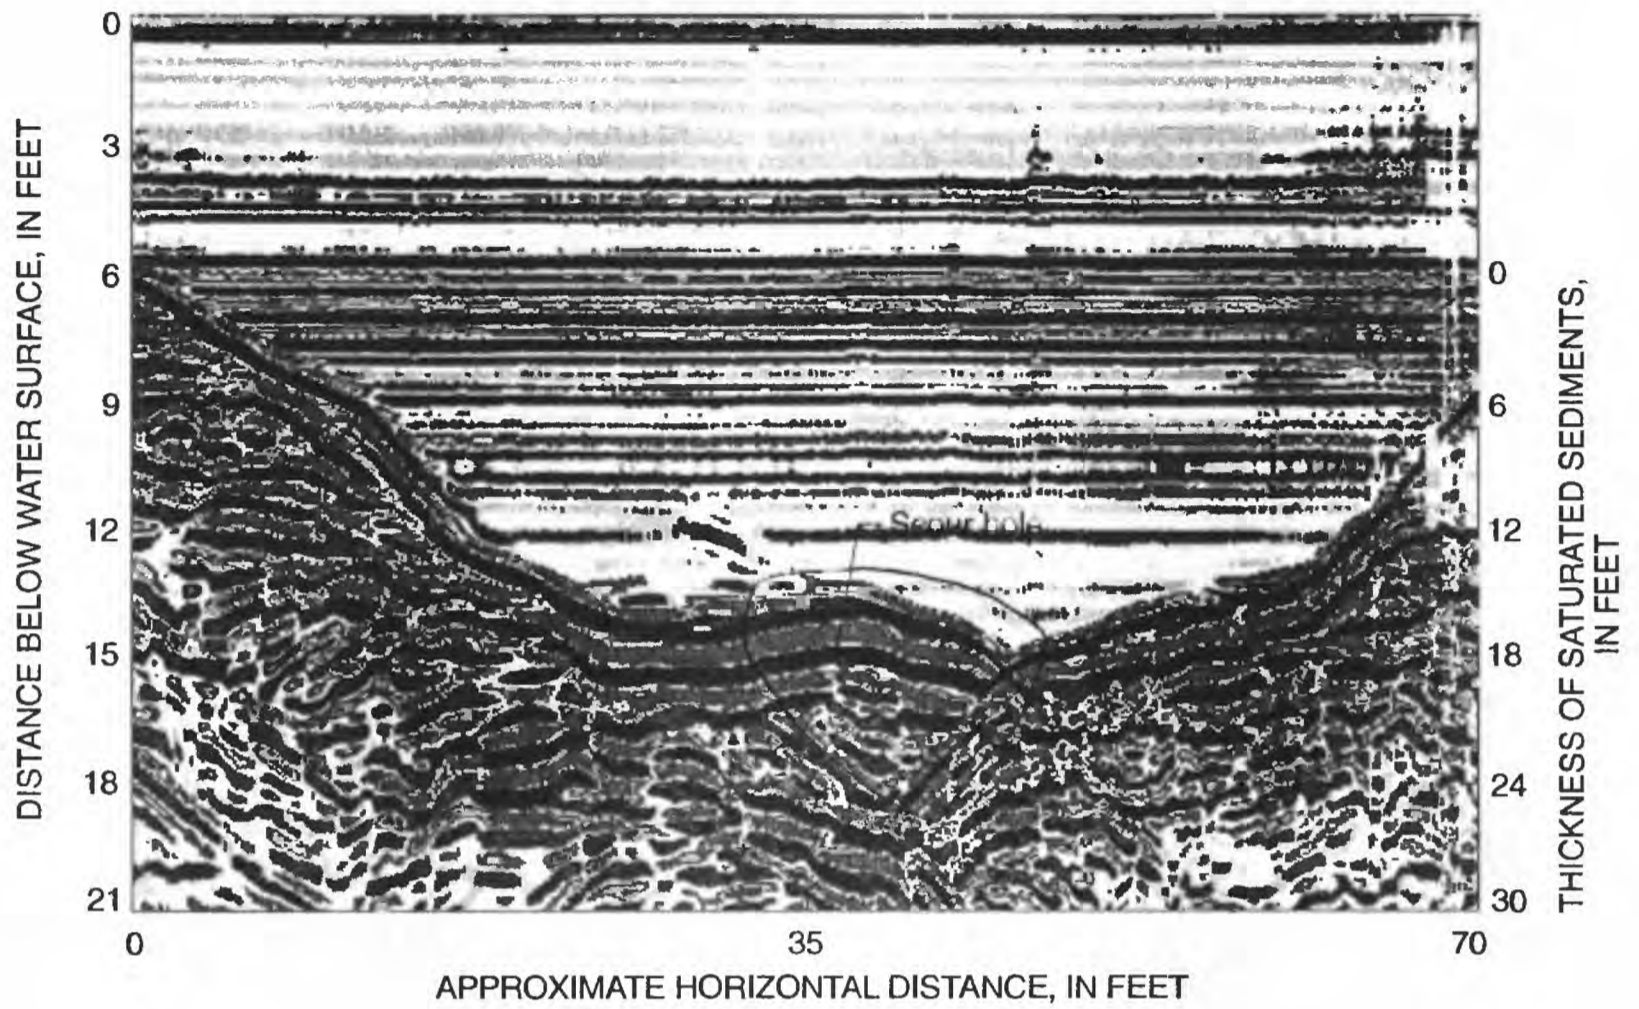
**Figure 14.** Record of a 100-mHz ground-penetrating radar cross section and interpretation of infilled area at Bridge 331 near pier 3, on the Copper River Highway.

Using the 100-mHz antennas, the ground-penetrating radar provided a good record of an infilled scour hole near pier 3 (fig. 14). This profile was taken approximately 15 ft upstream from pier 3, moving from the right edge to the left edge of water and is approximately 70 ft wide. Using a value of 0.11 ft/ns for radar waves in fresh water and a value of 0.20 ft/ns for radar waves in saturated sediments, the depth of this scour hole was about 12 ft (fig. 14). The profile did not show any infilled scour holes near piers 1 and 2.

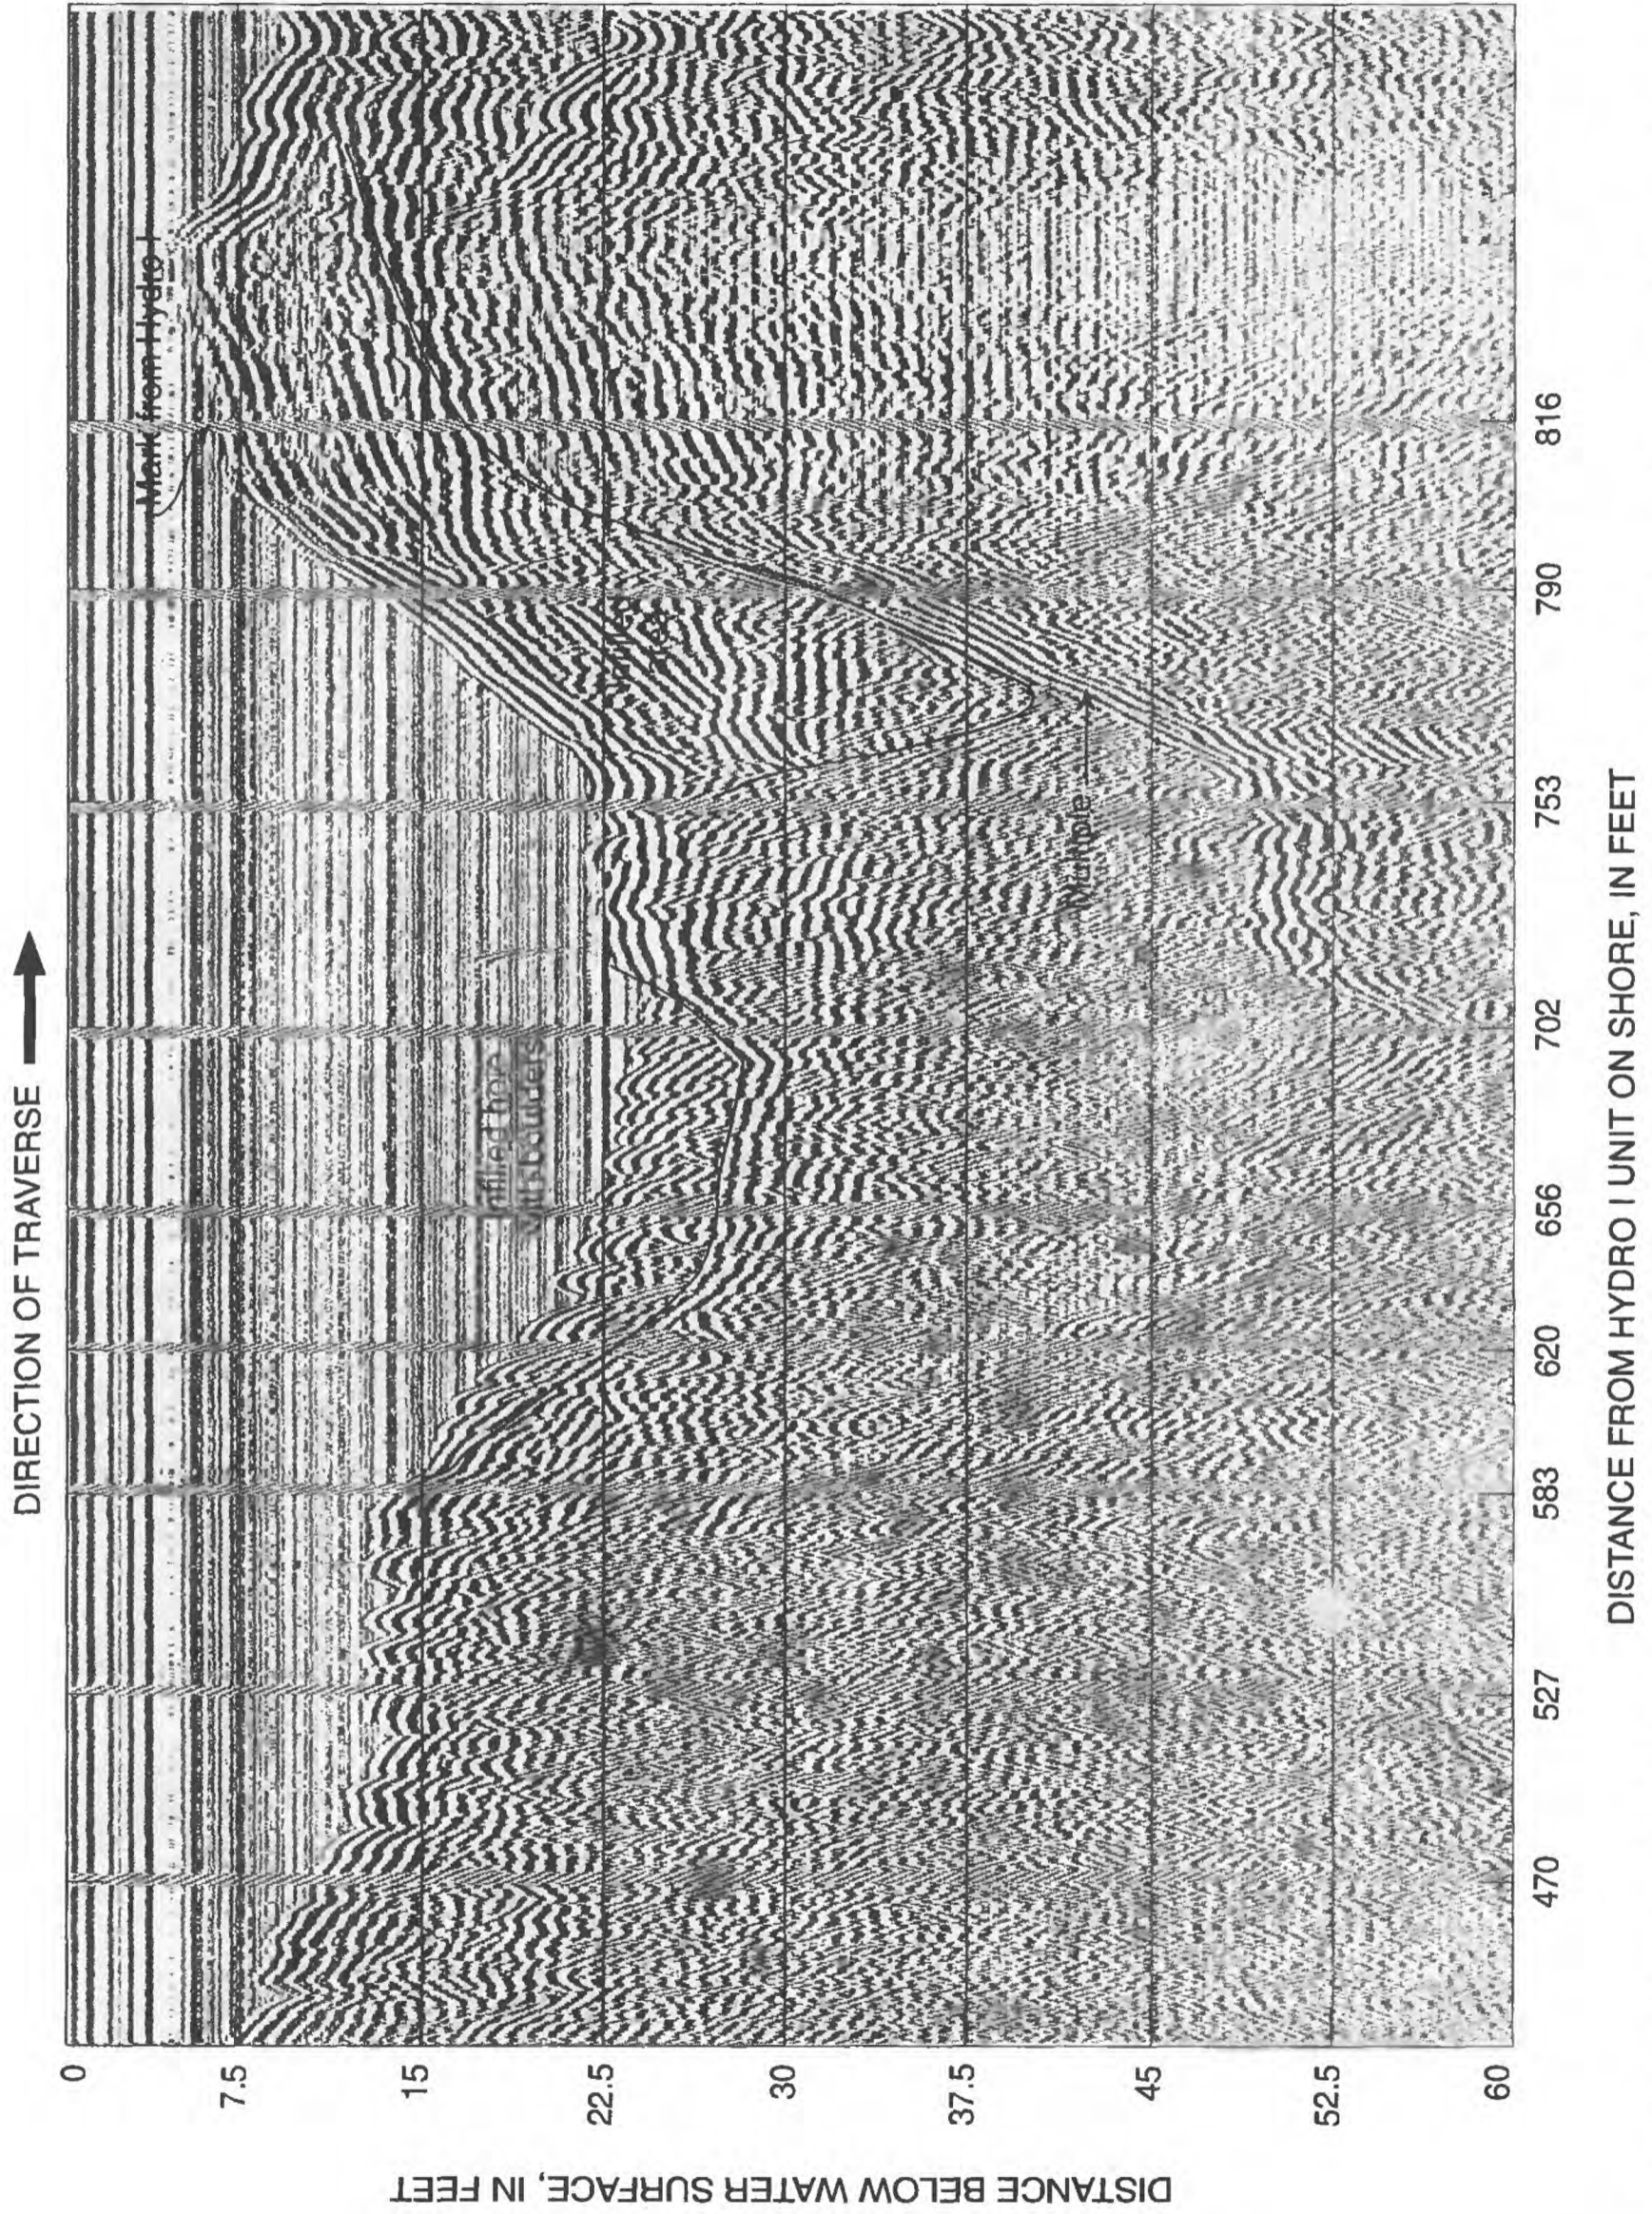
**Figure 15.** Record of 7.0-kHz continuous seismic reflection and interpretation of infilled area at Bridge 331 near pier 1, on the Copper River Highway.

Continuous seismic reflection using a 7.0-kHz tuned transducer also provided good data at Bridge 331. A profile was taken 50 ft upstream from pier 1, moving from right edge to the left edge of the water. This profile indicated two infilled scour holes (fig. 15): one scour hole approximately 5 ft deep was filled with boulders and the other scour hole approximately 15 ft deep was filled with fine-grained sediments.

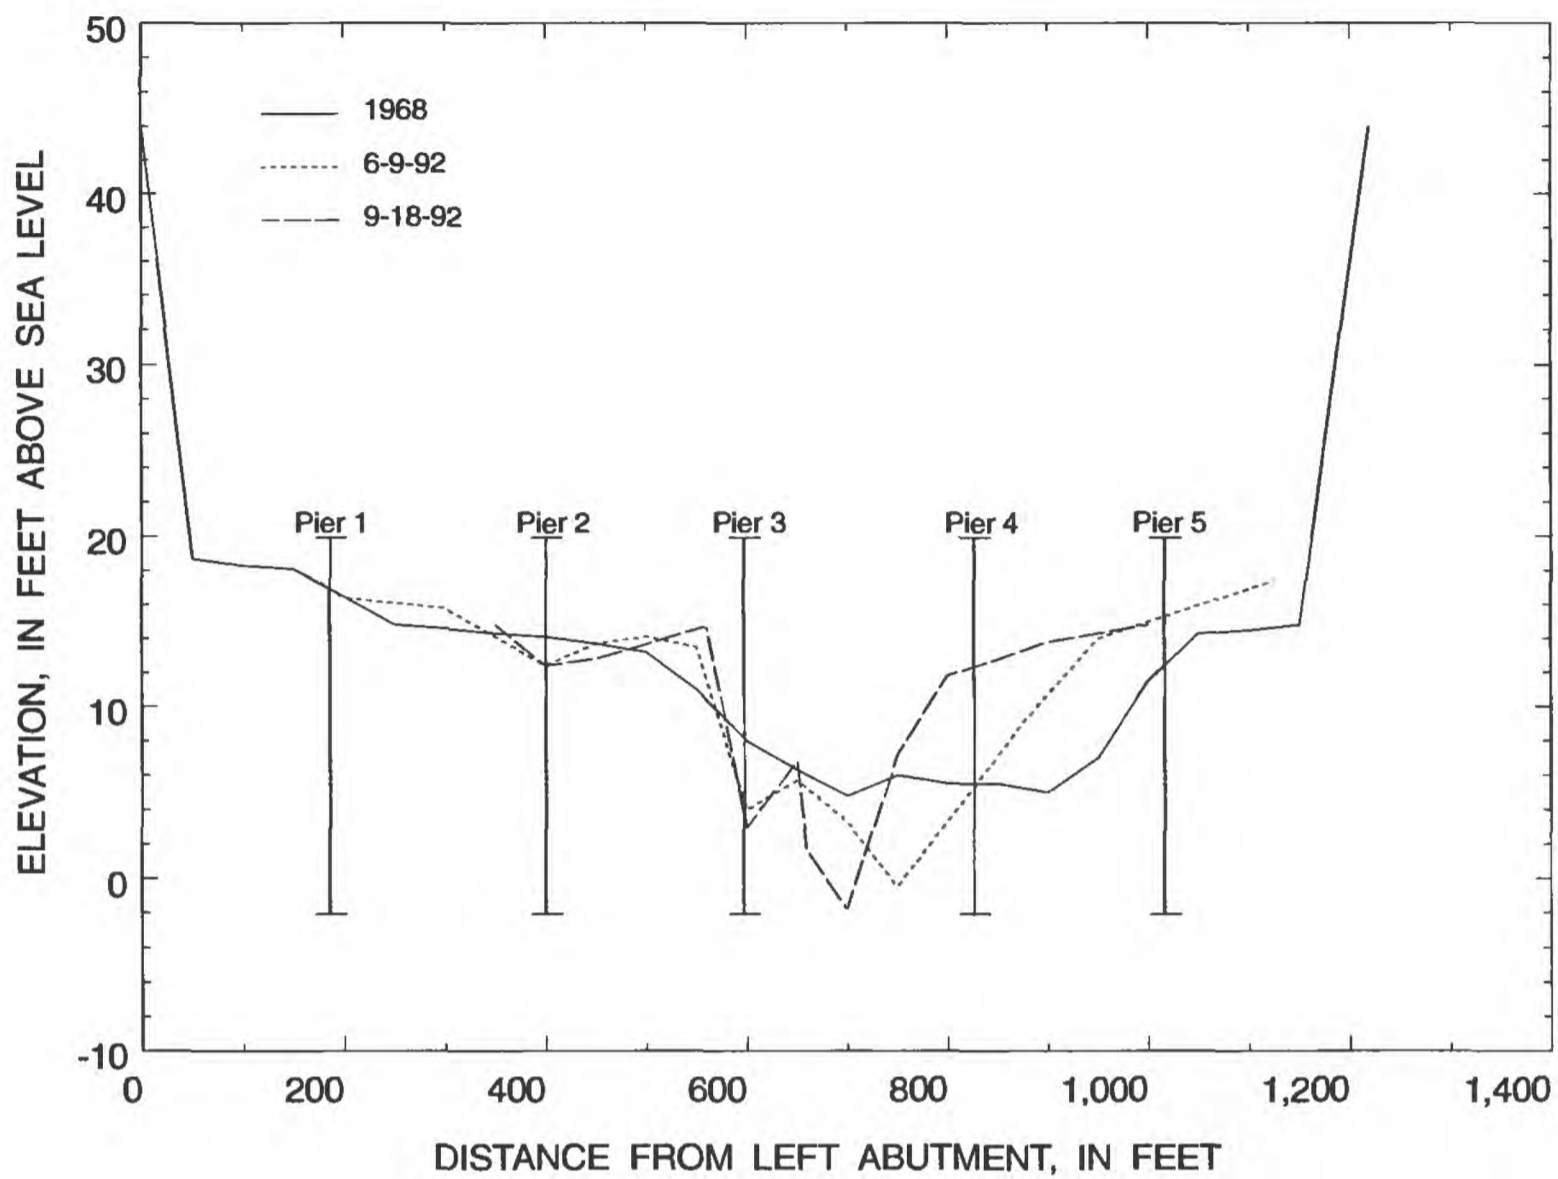
**Figure 16.** Cross sections of the Copper River, downstream side of Bridge 1187.

Inspection of cross sections taken from the downstream side of Bridge 1187 (fig. 16) indicates that scour and infill have occurred primarily near piers 3 and 4. Using these data as a guide, efforts were focused on inspecting piers 3 and 4, using ground-penetrating radar and continuous seismic reflection with the tuned transducer.

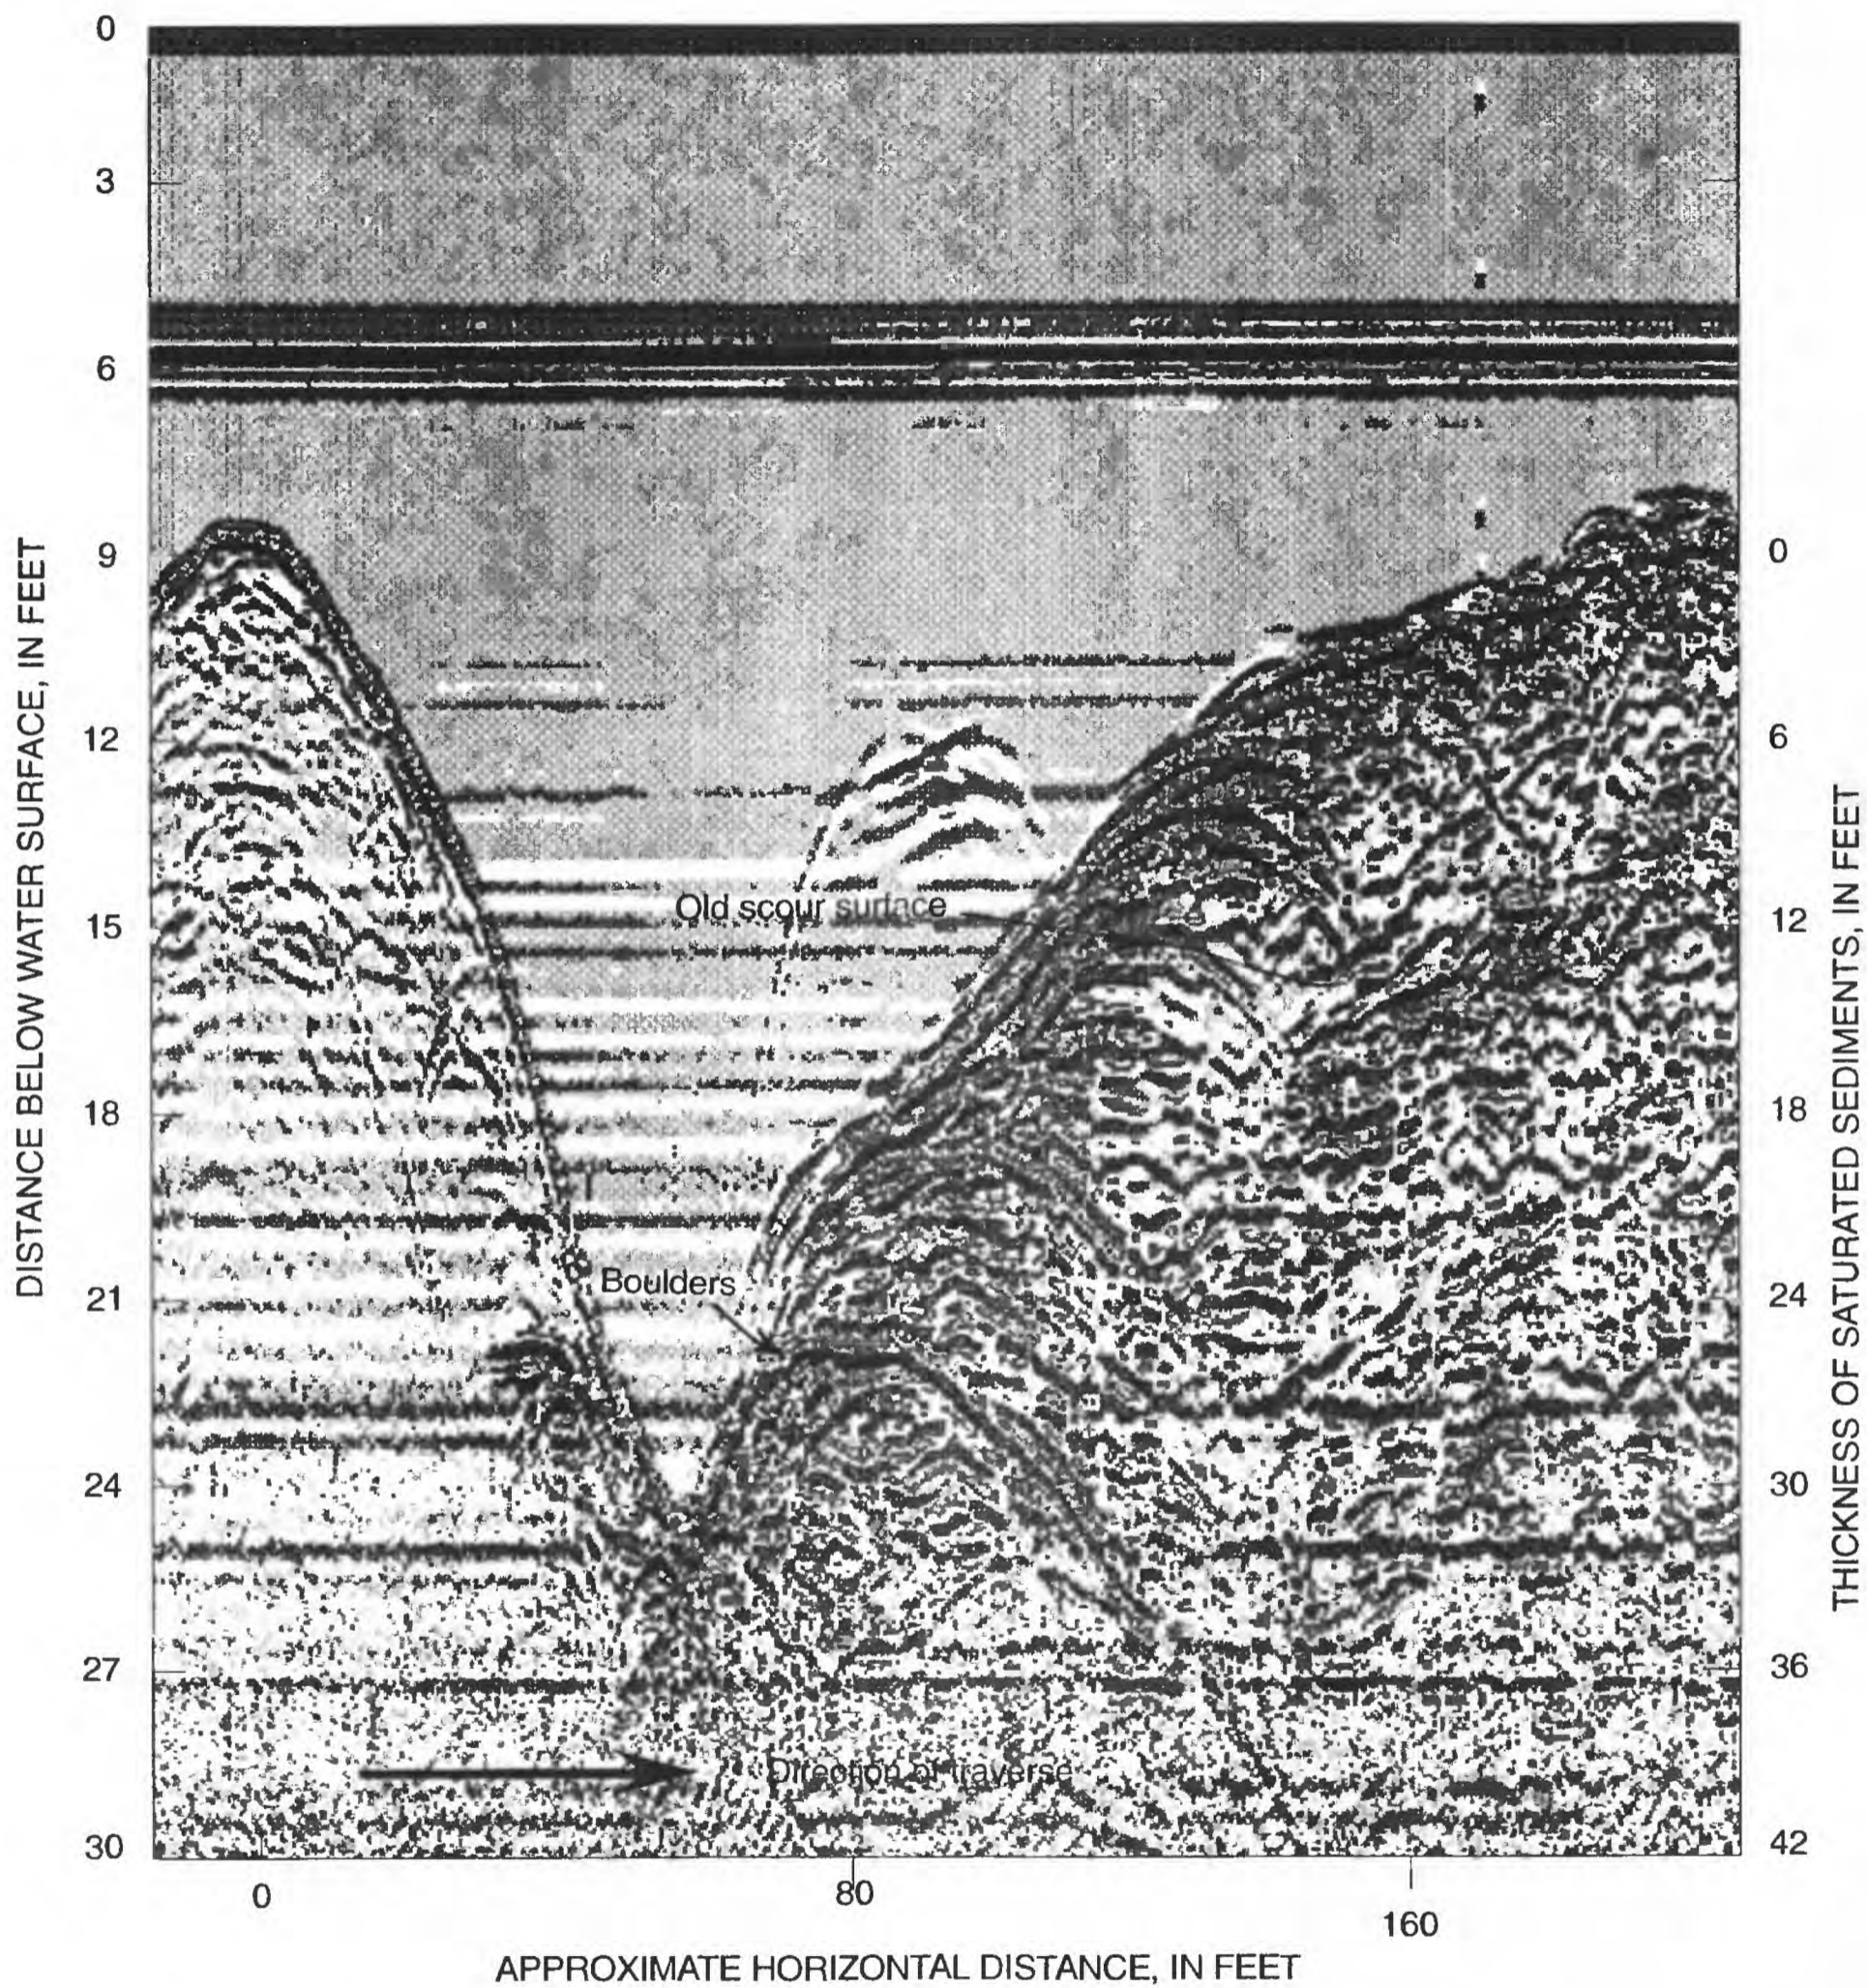
**Figure 17.** Record of 300-mHz ground-penetrating radar cross section from Bridge 1187 near pier 3, on the Copper River Highway.

Using the 300-mHz antennas, a ground-penetrating radar profile was taken approximately 50 ft upstream from Bridge 1187, moving from the right bank to the left bank. The section shown in figure 17 is approximately 150 ft wide near pier 3. At the deepest section, no infilled scour hole is apparent, most likely because the depth—approximately 24 ft—is outside the range of the ground-penetrating radar. Moving towards the left bank, there appears to be some infill.

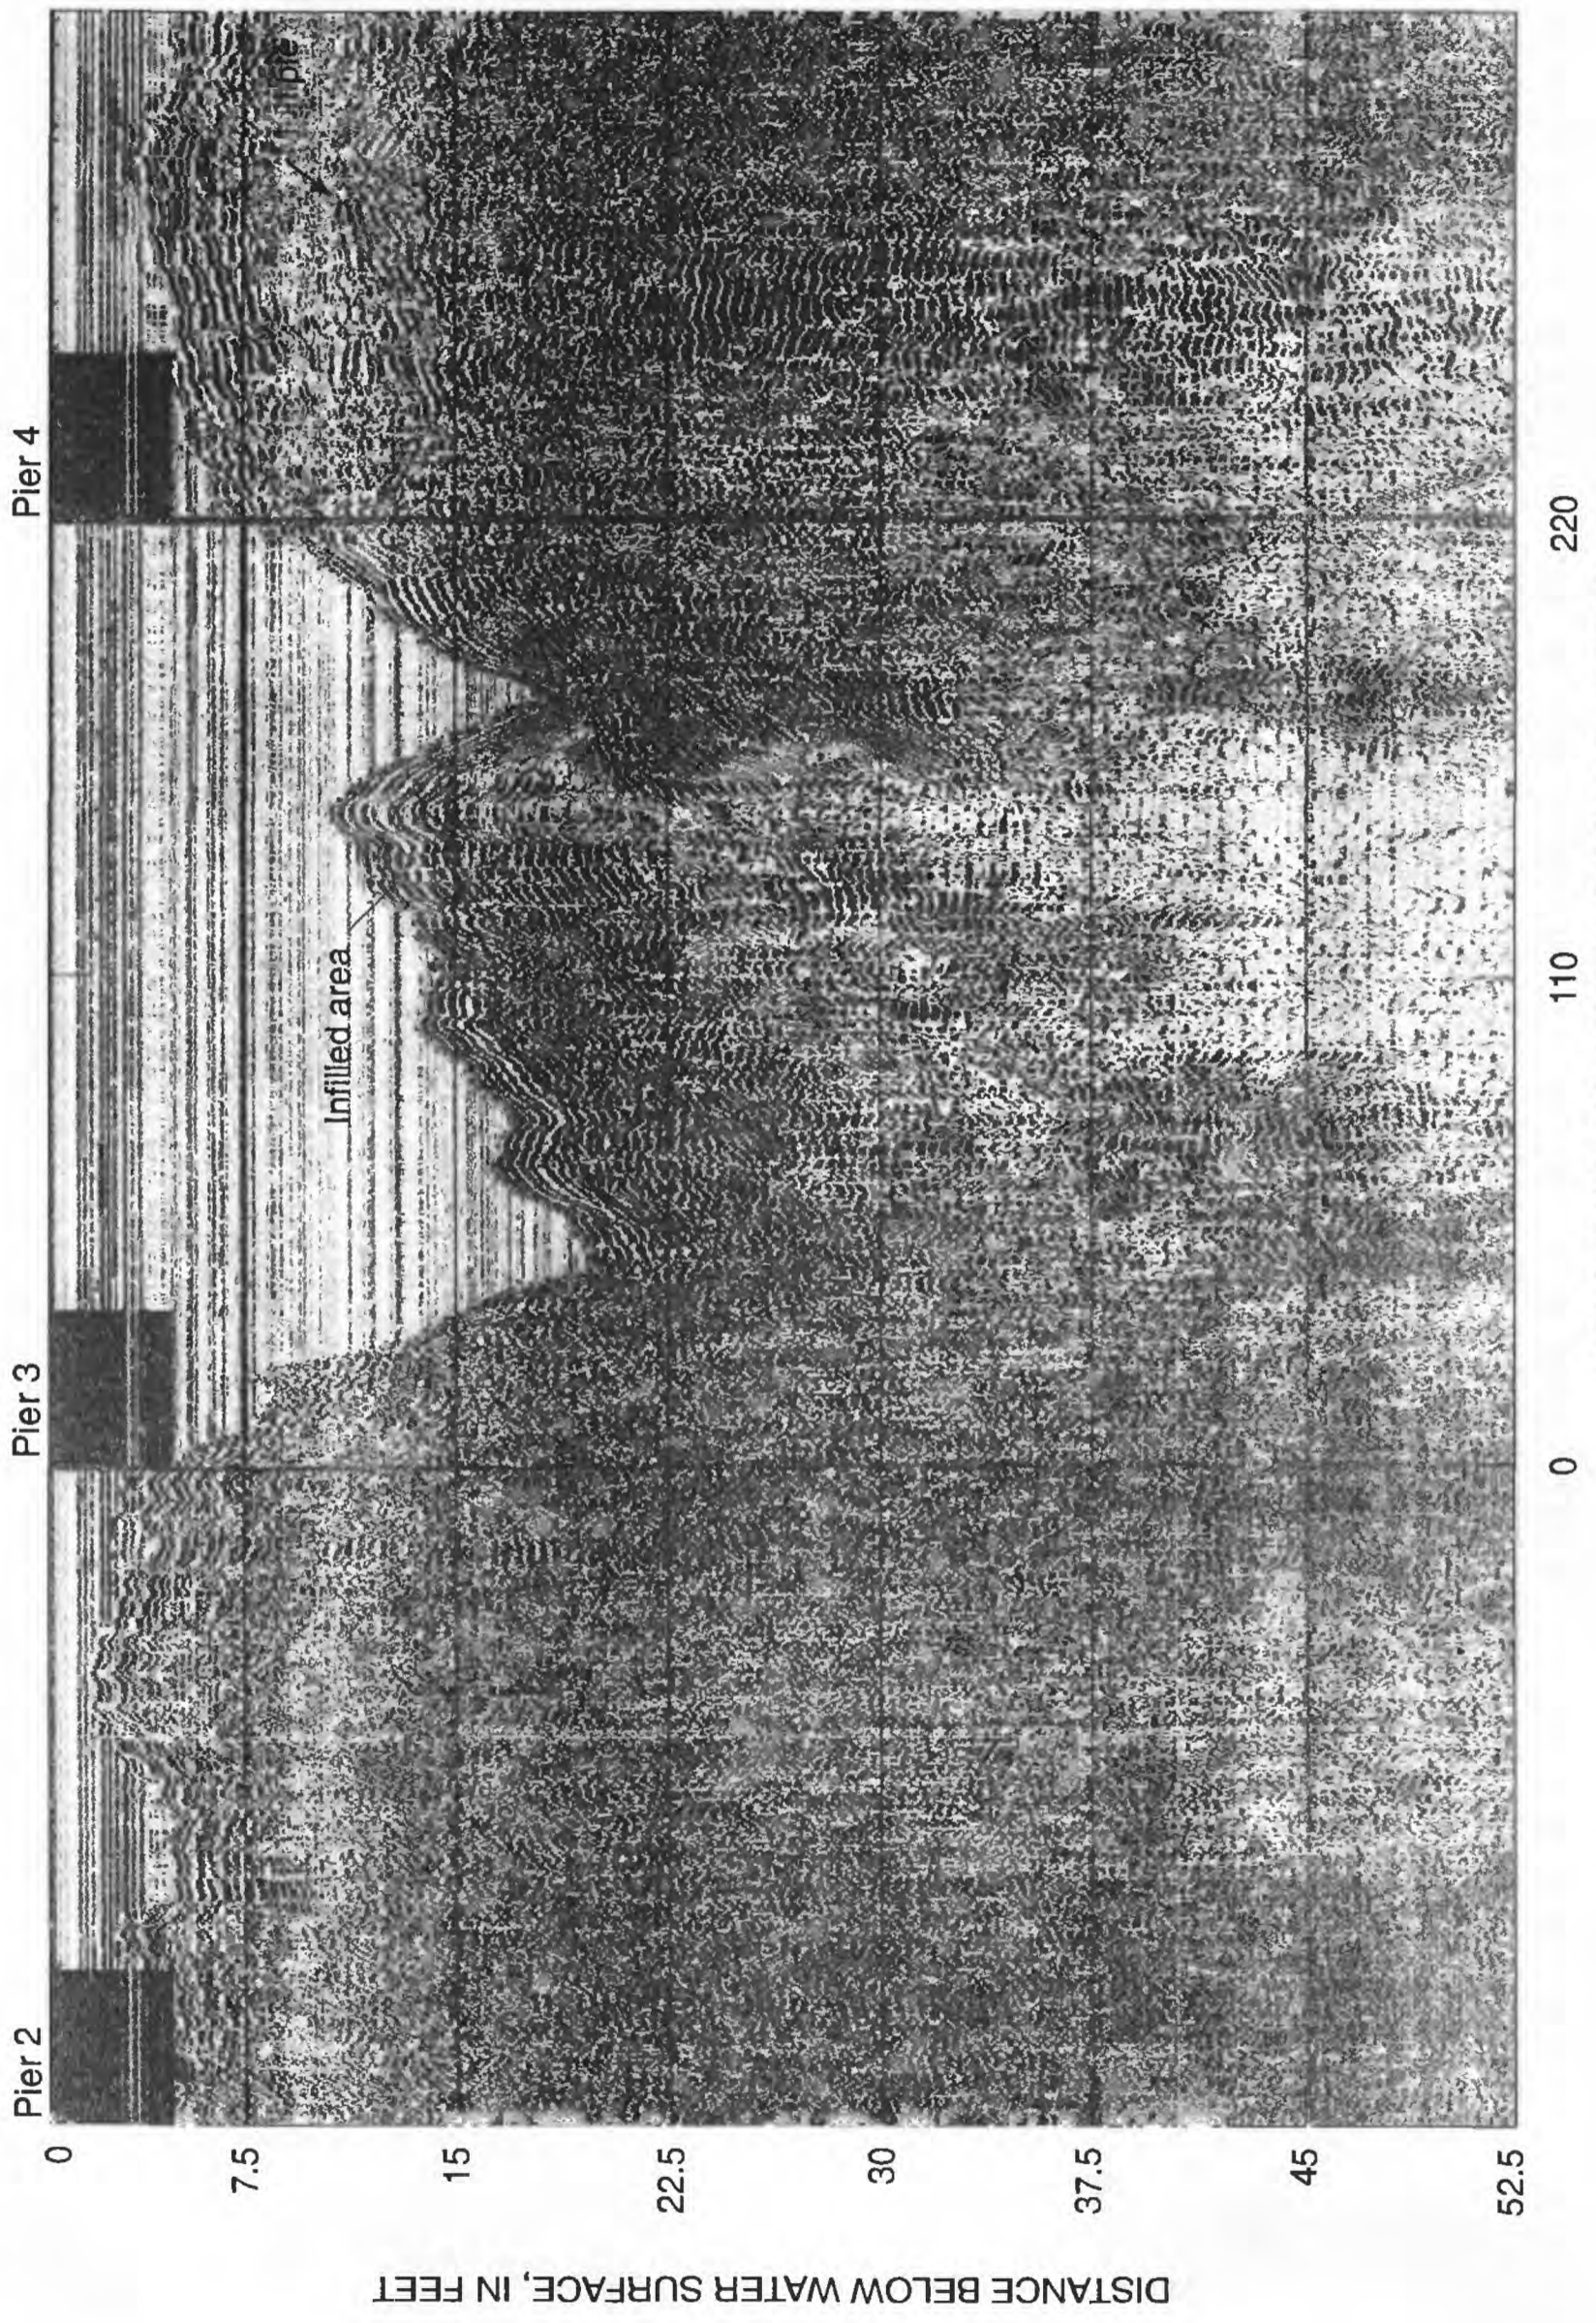
**Figure 18.** Record of 7.0-kHz continuous seismic reflection cross section from Bridge 1187 near pier 3, on the Copper River Highway.

Continuous seismic reflection using a 7.0-kHz-tuned transducer at approximately the same location provided more information (fig. 18). This technique was able to penetrate the subbottom to a greater degree than the ground-penetrating radar. About 3 ft of infill apparently occurs at the deepest part of the section, and some infill seems to appear towards pier 4.

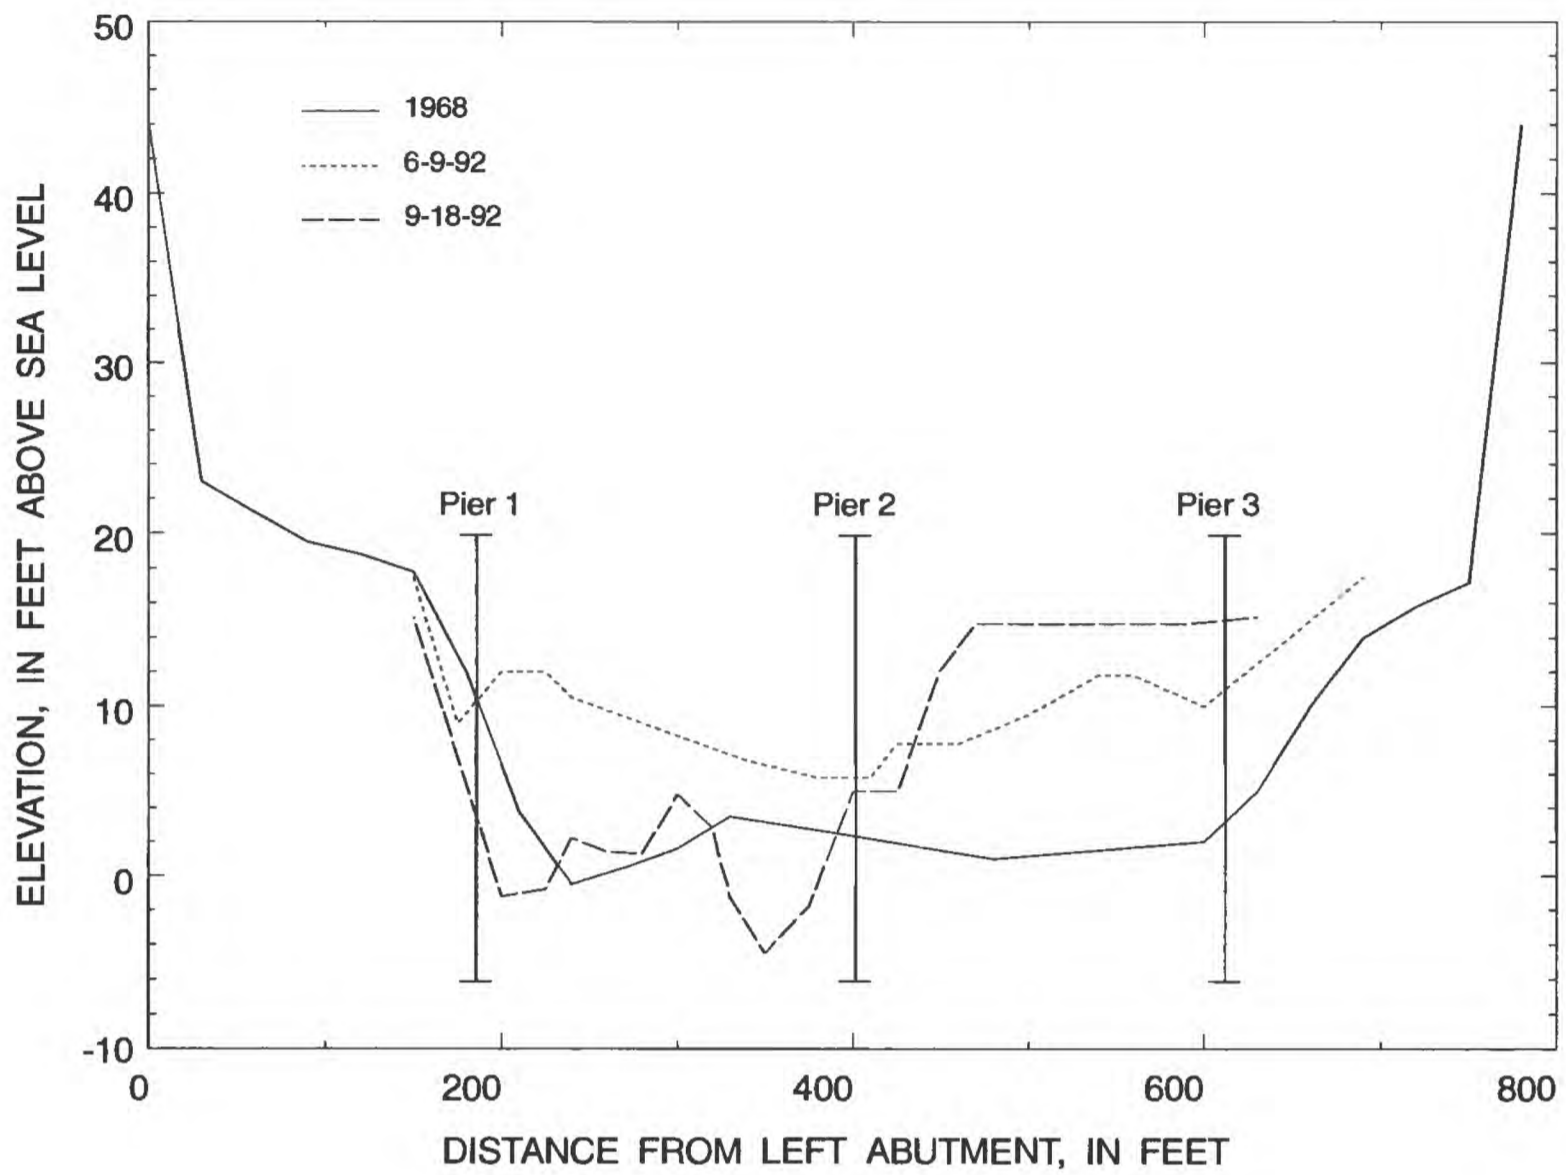
**Figure 19.** Cross sections of the Copper River, downstream side of Bridge 332.

Comparison of cross sections of the Copper River obtained from the downstream side of Bridge 332 (fig. 19) indicates that the channel at this location is unstable. For example, it appears that the channel has filled in between 1968 and June 1992. However, between June 9, 1992 and September 18, 1992, a significant quantity of scour occurred between piers 1 and 2. Thus, the approach taken at this site was to examine all three piers.
