# **Application of Surface Geophysical Techniques In a Study of the Geomorphology of the Lower Copper River, Alaska**

U.S. GEOLOGICAL SURVEY

Water-Resources Investigations Report 94-4165

ALASKA DEPARTMENT OF TRANSPORTATION  
AND PUBLIC FACILITIES

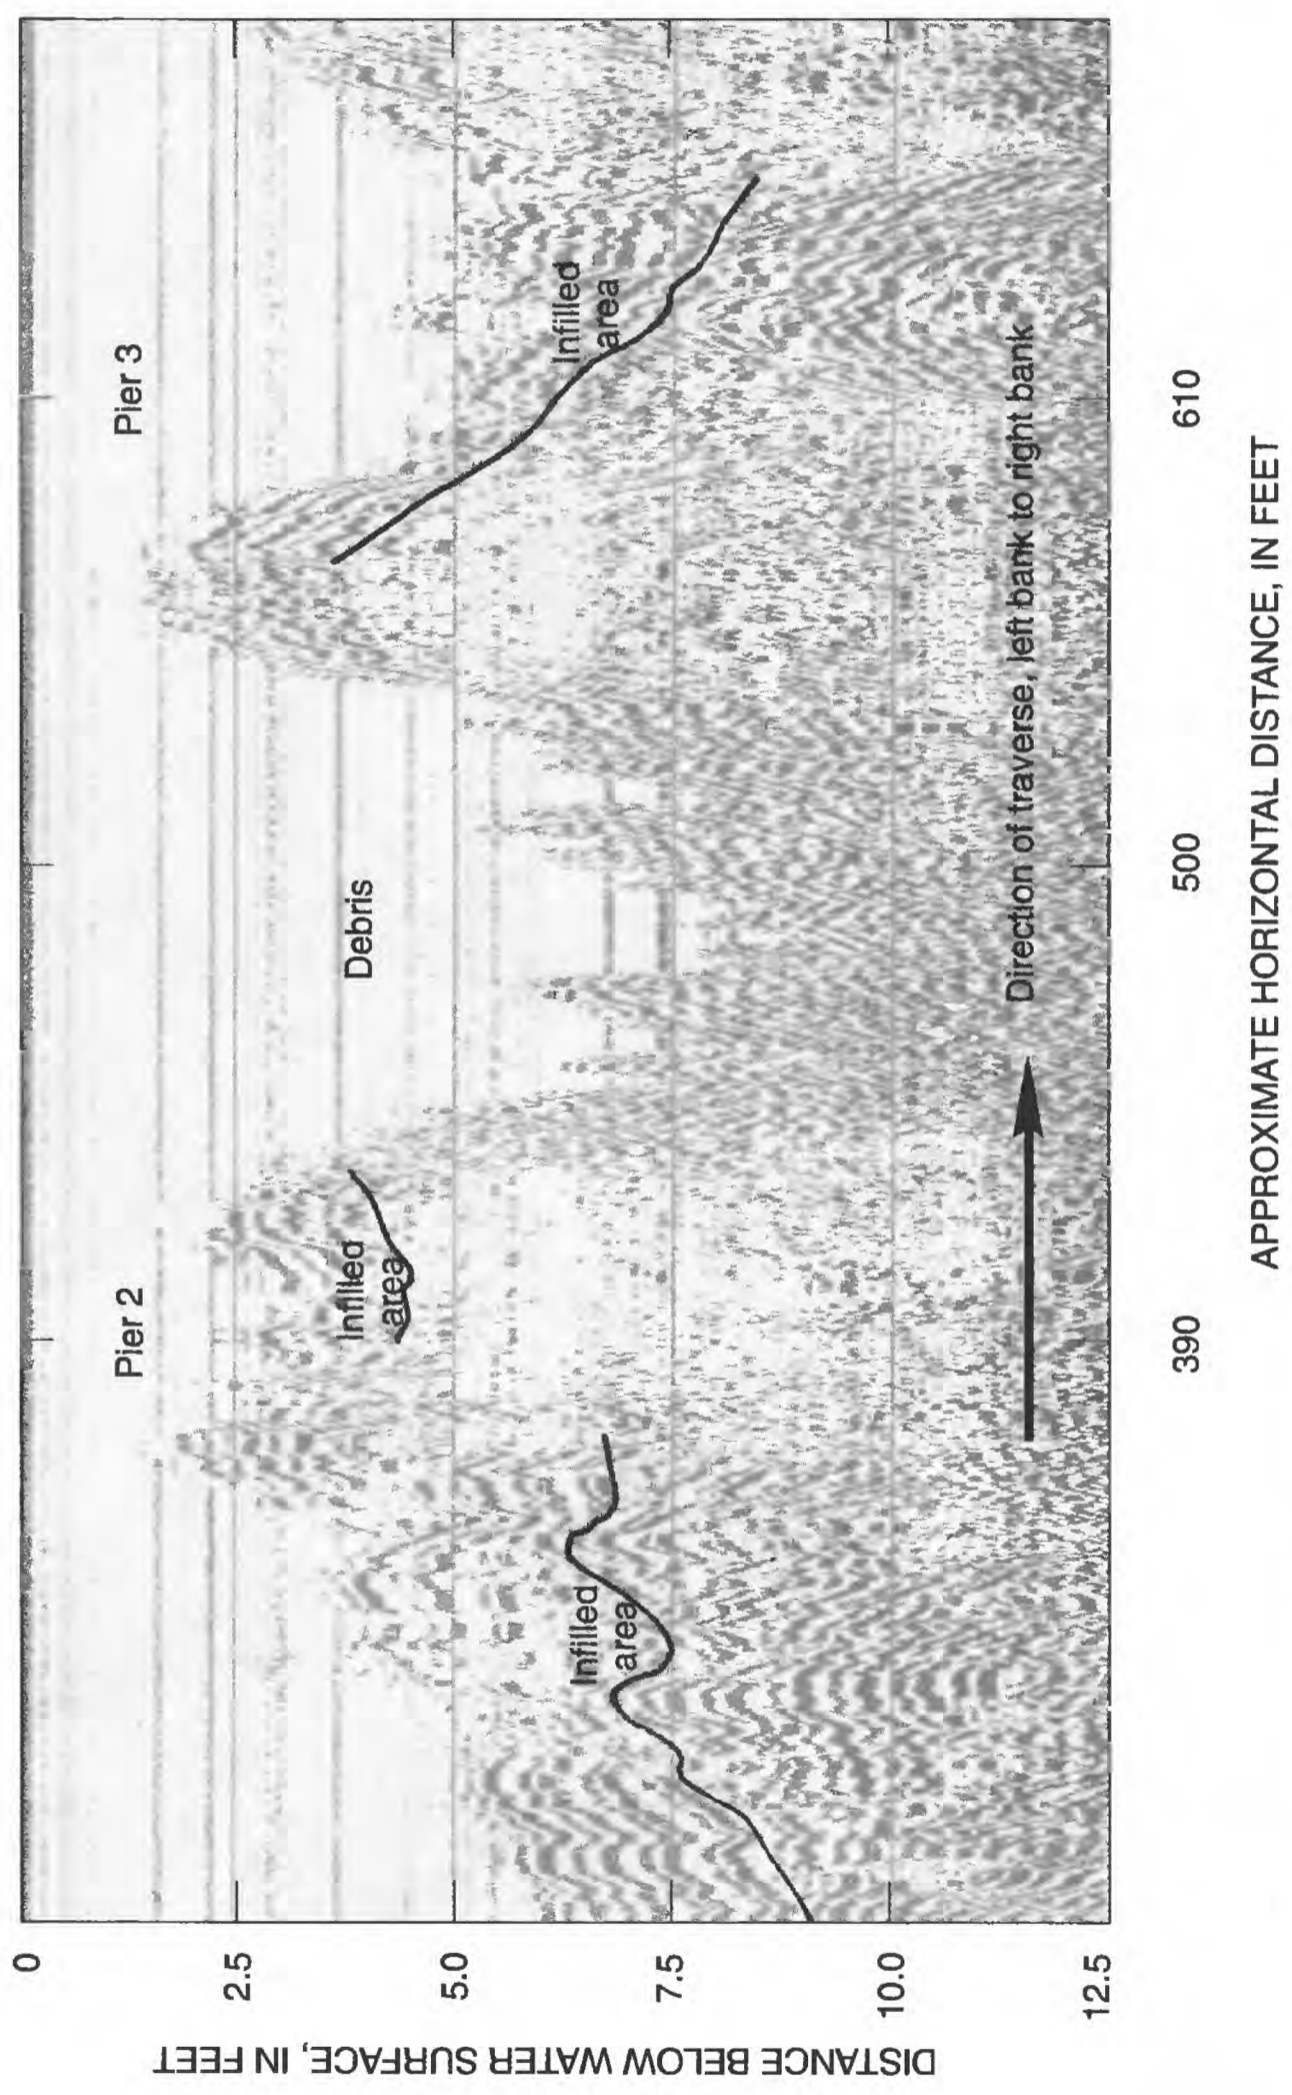
Figure 20. Record of 7.0-kHz continuous seismic reflection from a cross section from Bridge 332 near pier 1, on the Copper River Highway.

Using continuous seismic reflection with a 7.0-kHz tuned transducer, a profile was obtained approximately 50 ft upstream from the bridge, traversing from the left bank to the right bank. This profile (fig. 20) showed about 3 ft of infill near pier 2, some debris between piers 2 and 3, and some infill near pier 3.

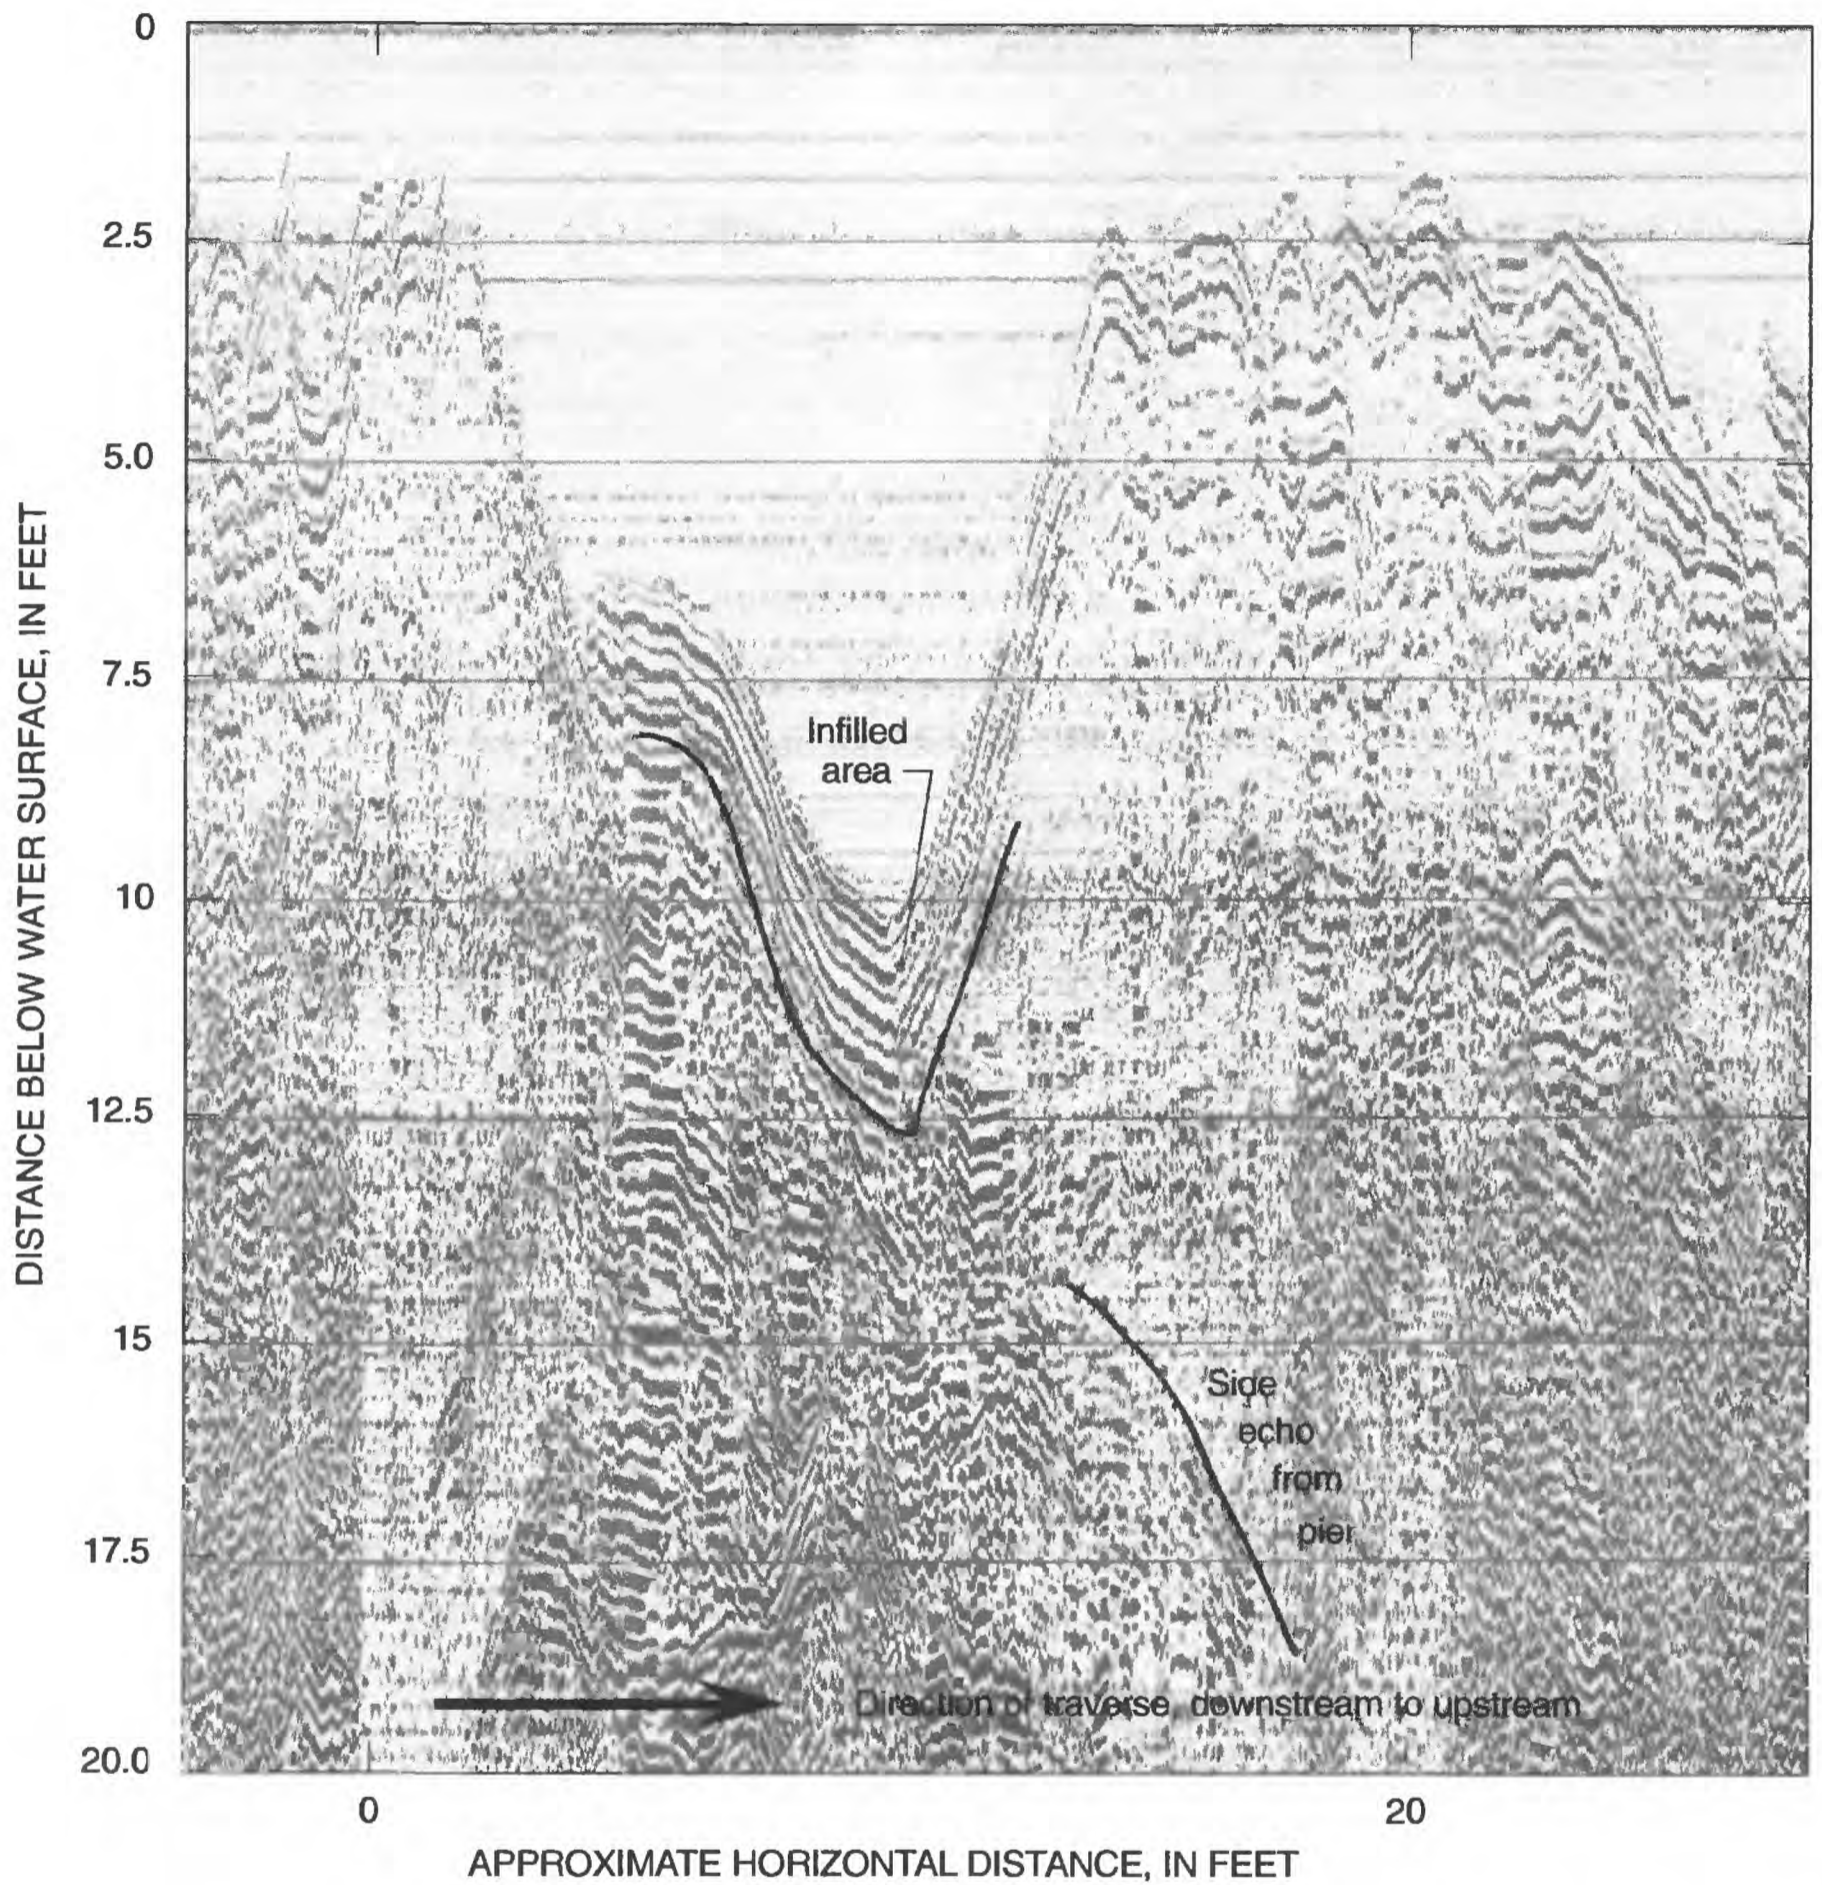
**Figure 21.** Record of 7.0-kHz continuous seismic reflection from longitudinal profile near pier 1, Bridge 332, on the Copper River Highway.

Longitudinal profiles were obtained along each pier. At piers 2 and 3, no significant infill was noted. Along pier 1, using the 7.0-kHz tuned transducer, about 3 ft of infill was noted toward the upstream part of the pier (fig. 21). A side echo from either the pier or the pier footing was also detected.

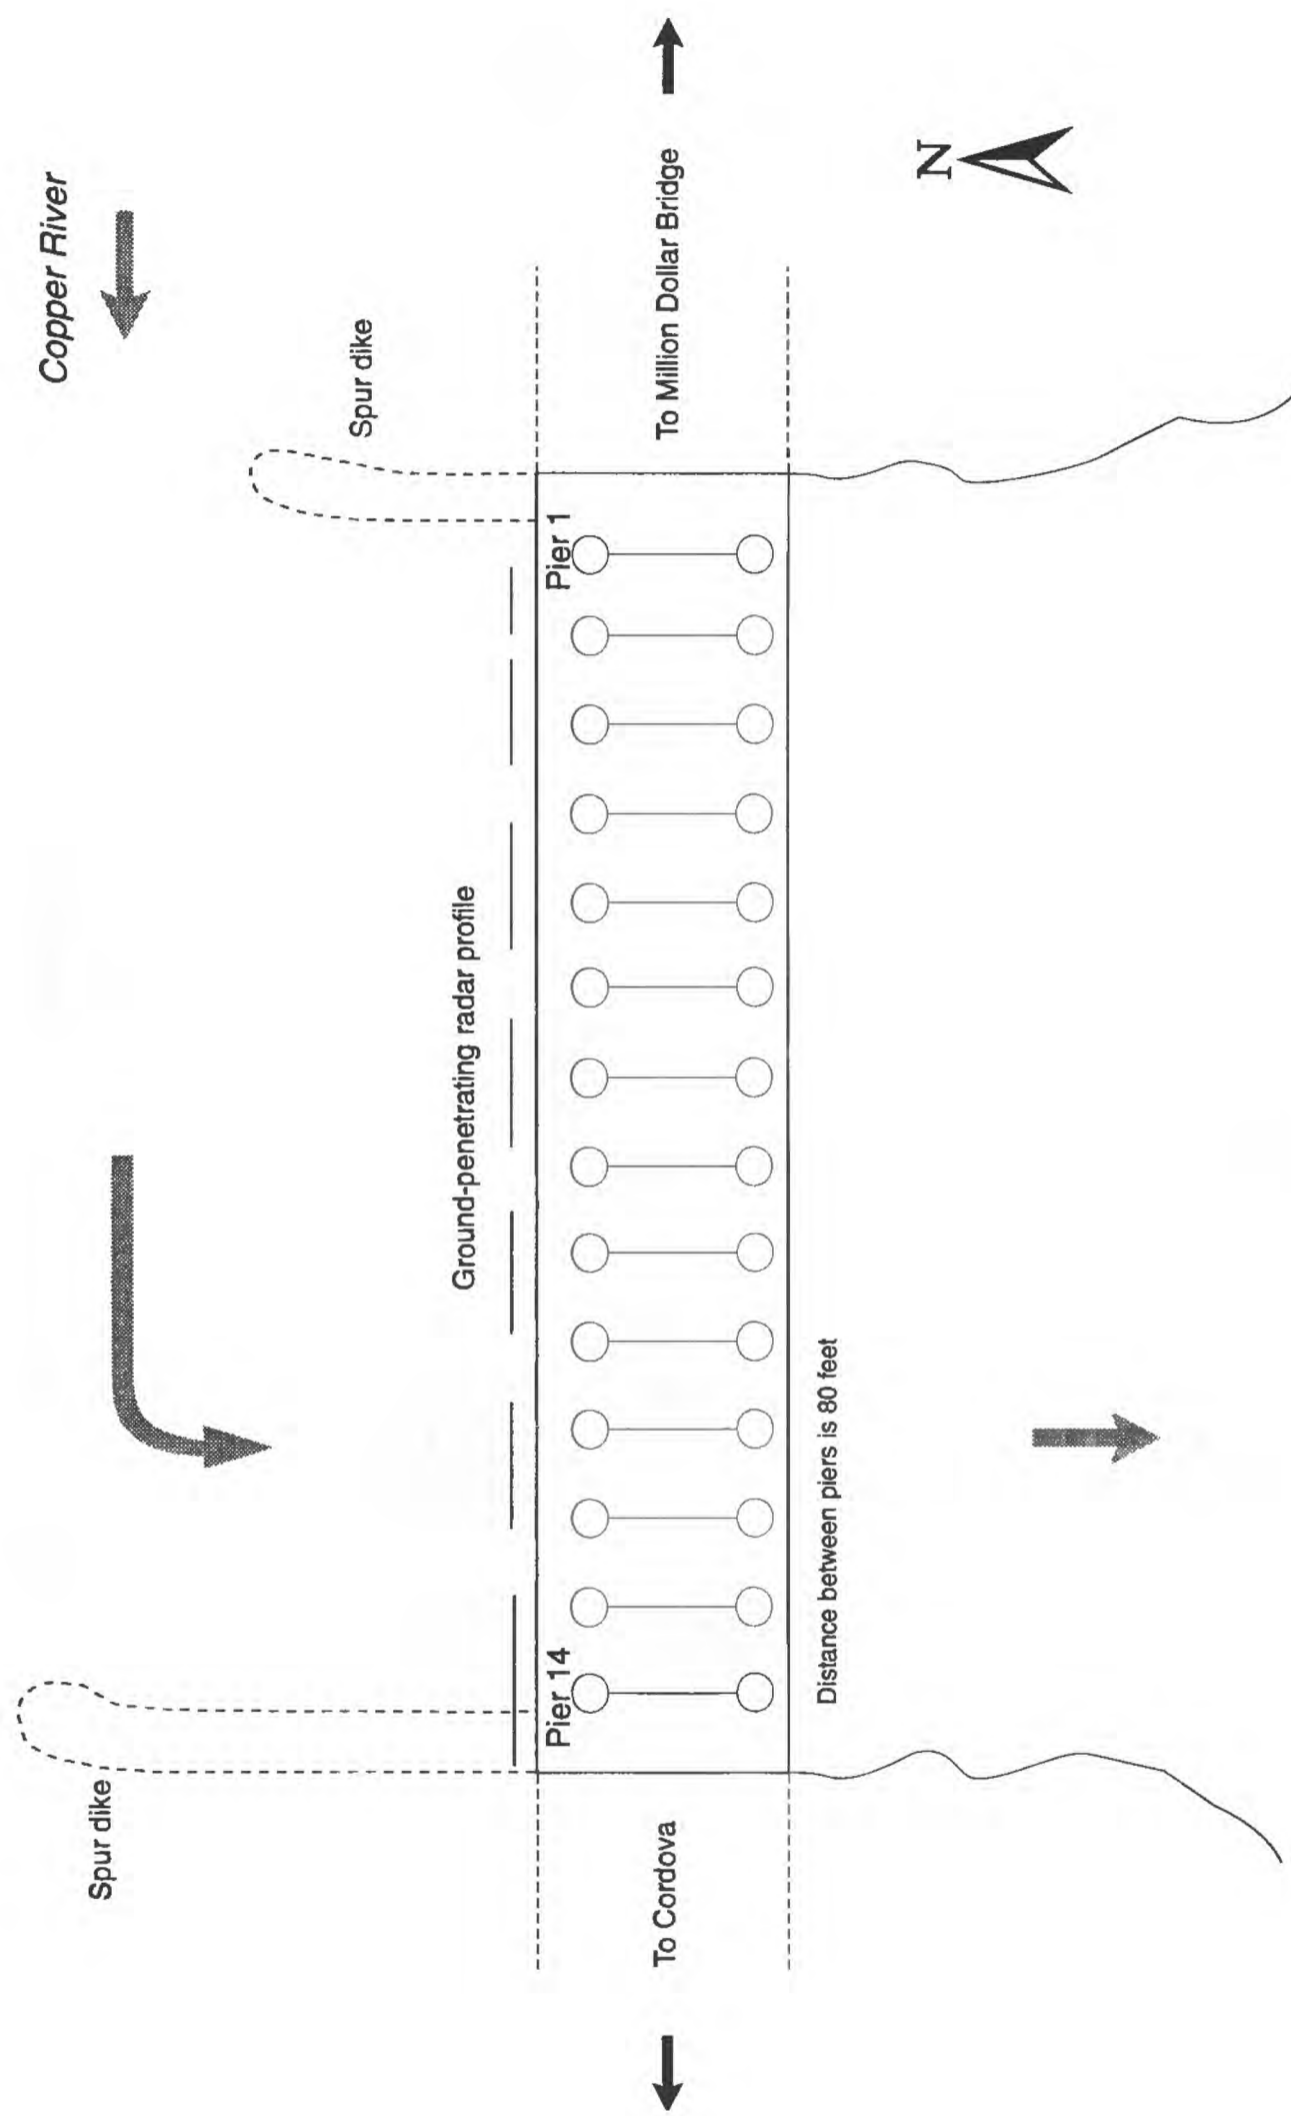
**Figure 22.** Plan view of Bridge 334 on the Copper River Highway, showing location of ground-penetrating radar profile.

At one time, a significant portion of the Copper River flowed under Bridge 334. Over time, the channels of the Copper River have shifted, and most of the flow presently is distributed among Bridges 331, 1187, 332, and 342. In 1968, before construction of the present bridge, the main channel was approximately 850 to 950 ft from the left abutment (fig. 23). However, since construction of Bridge 334, this part of the channel had filled in, and in 1992 the main channel was approximately 1,050 to 1,150 ft from the left abutment.

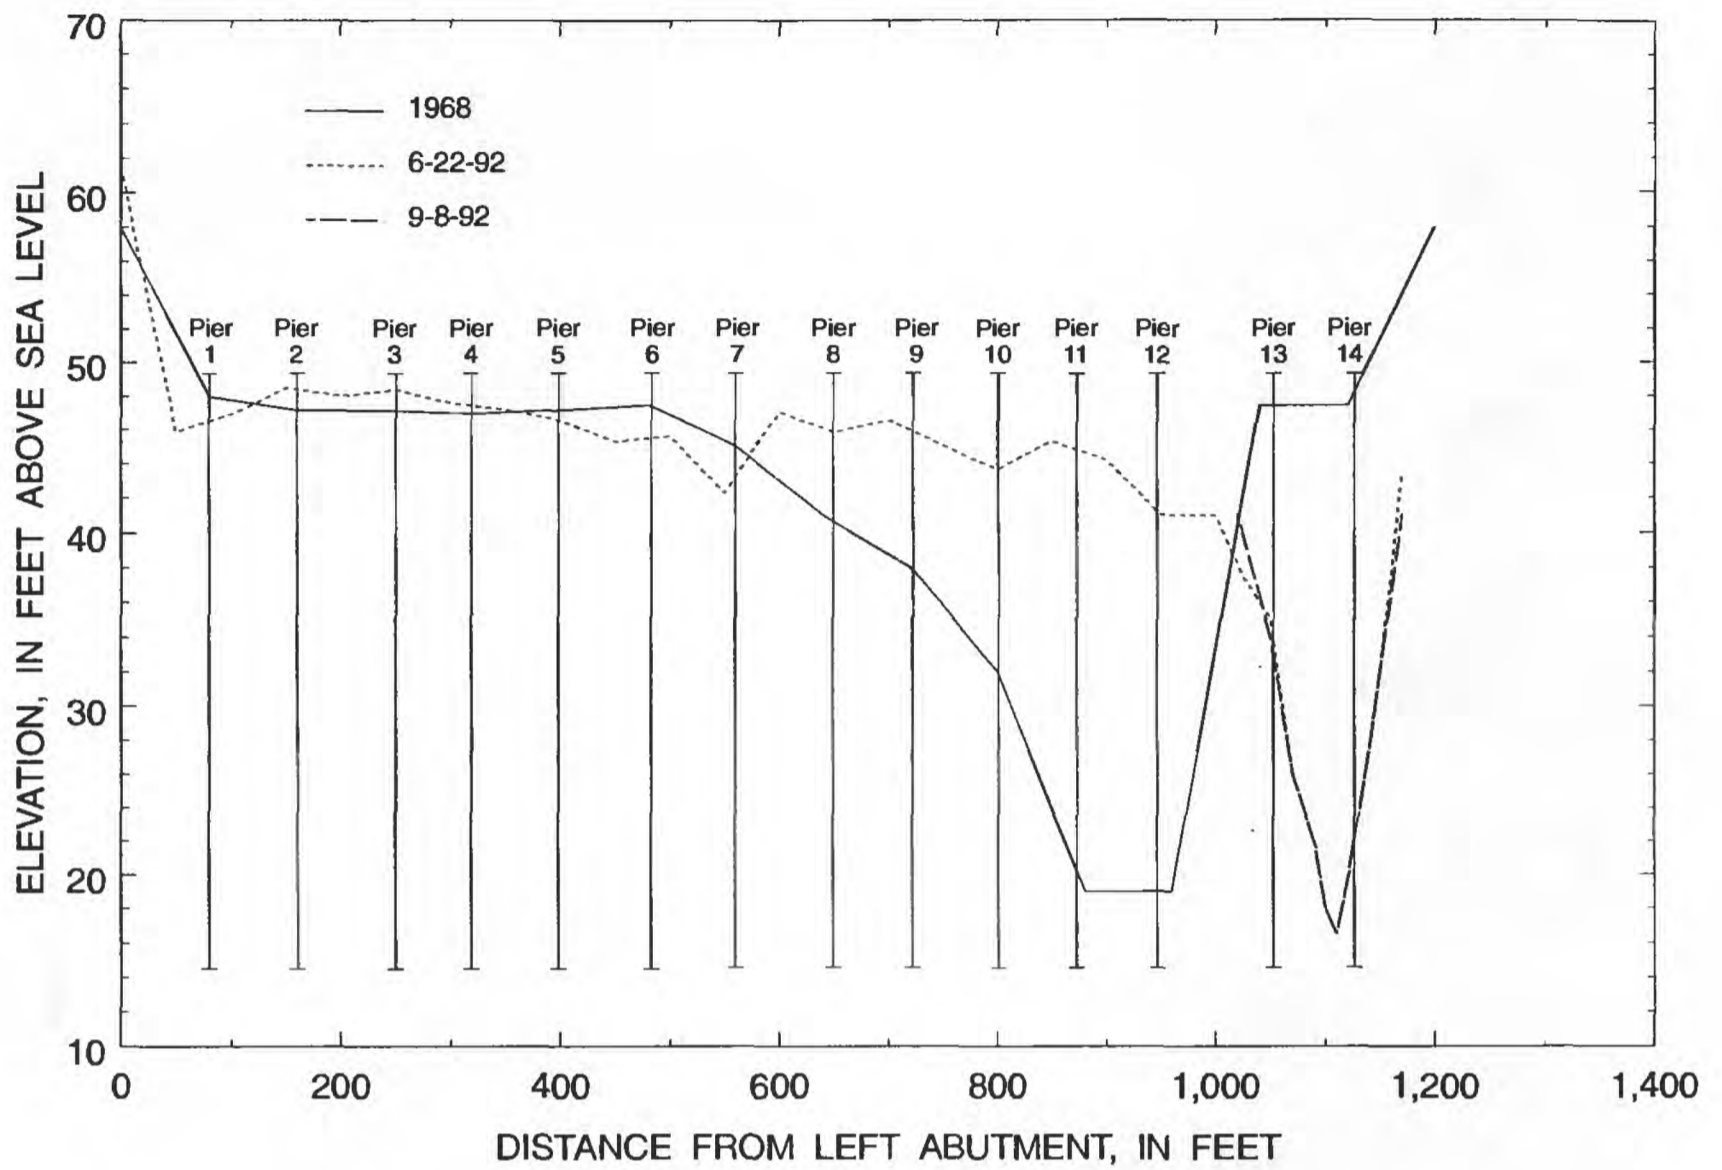
Figure 23. Cross sections of the Copper River, downstream side of Bridge 334.

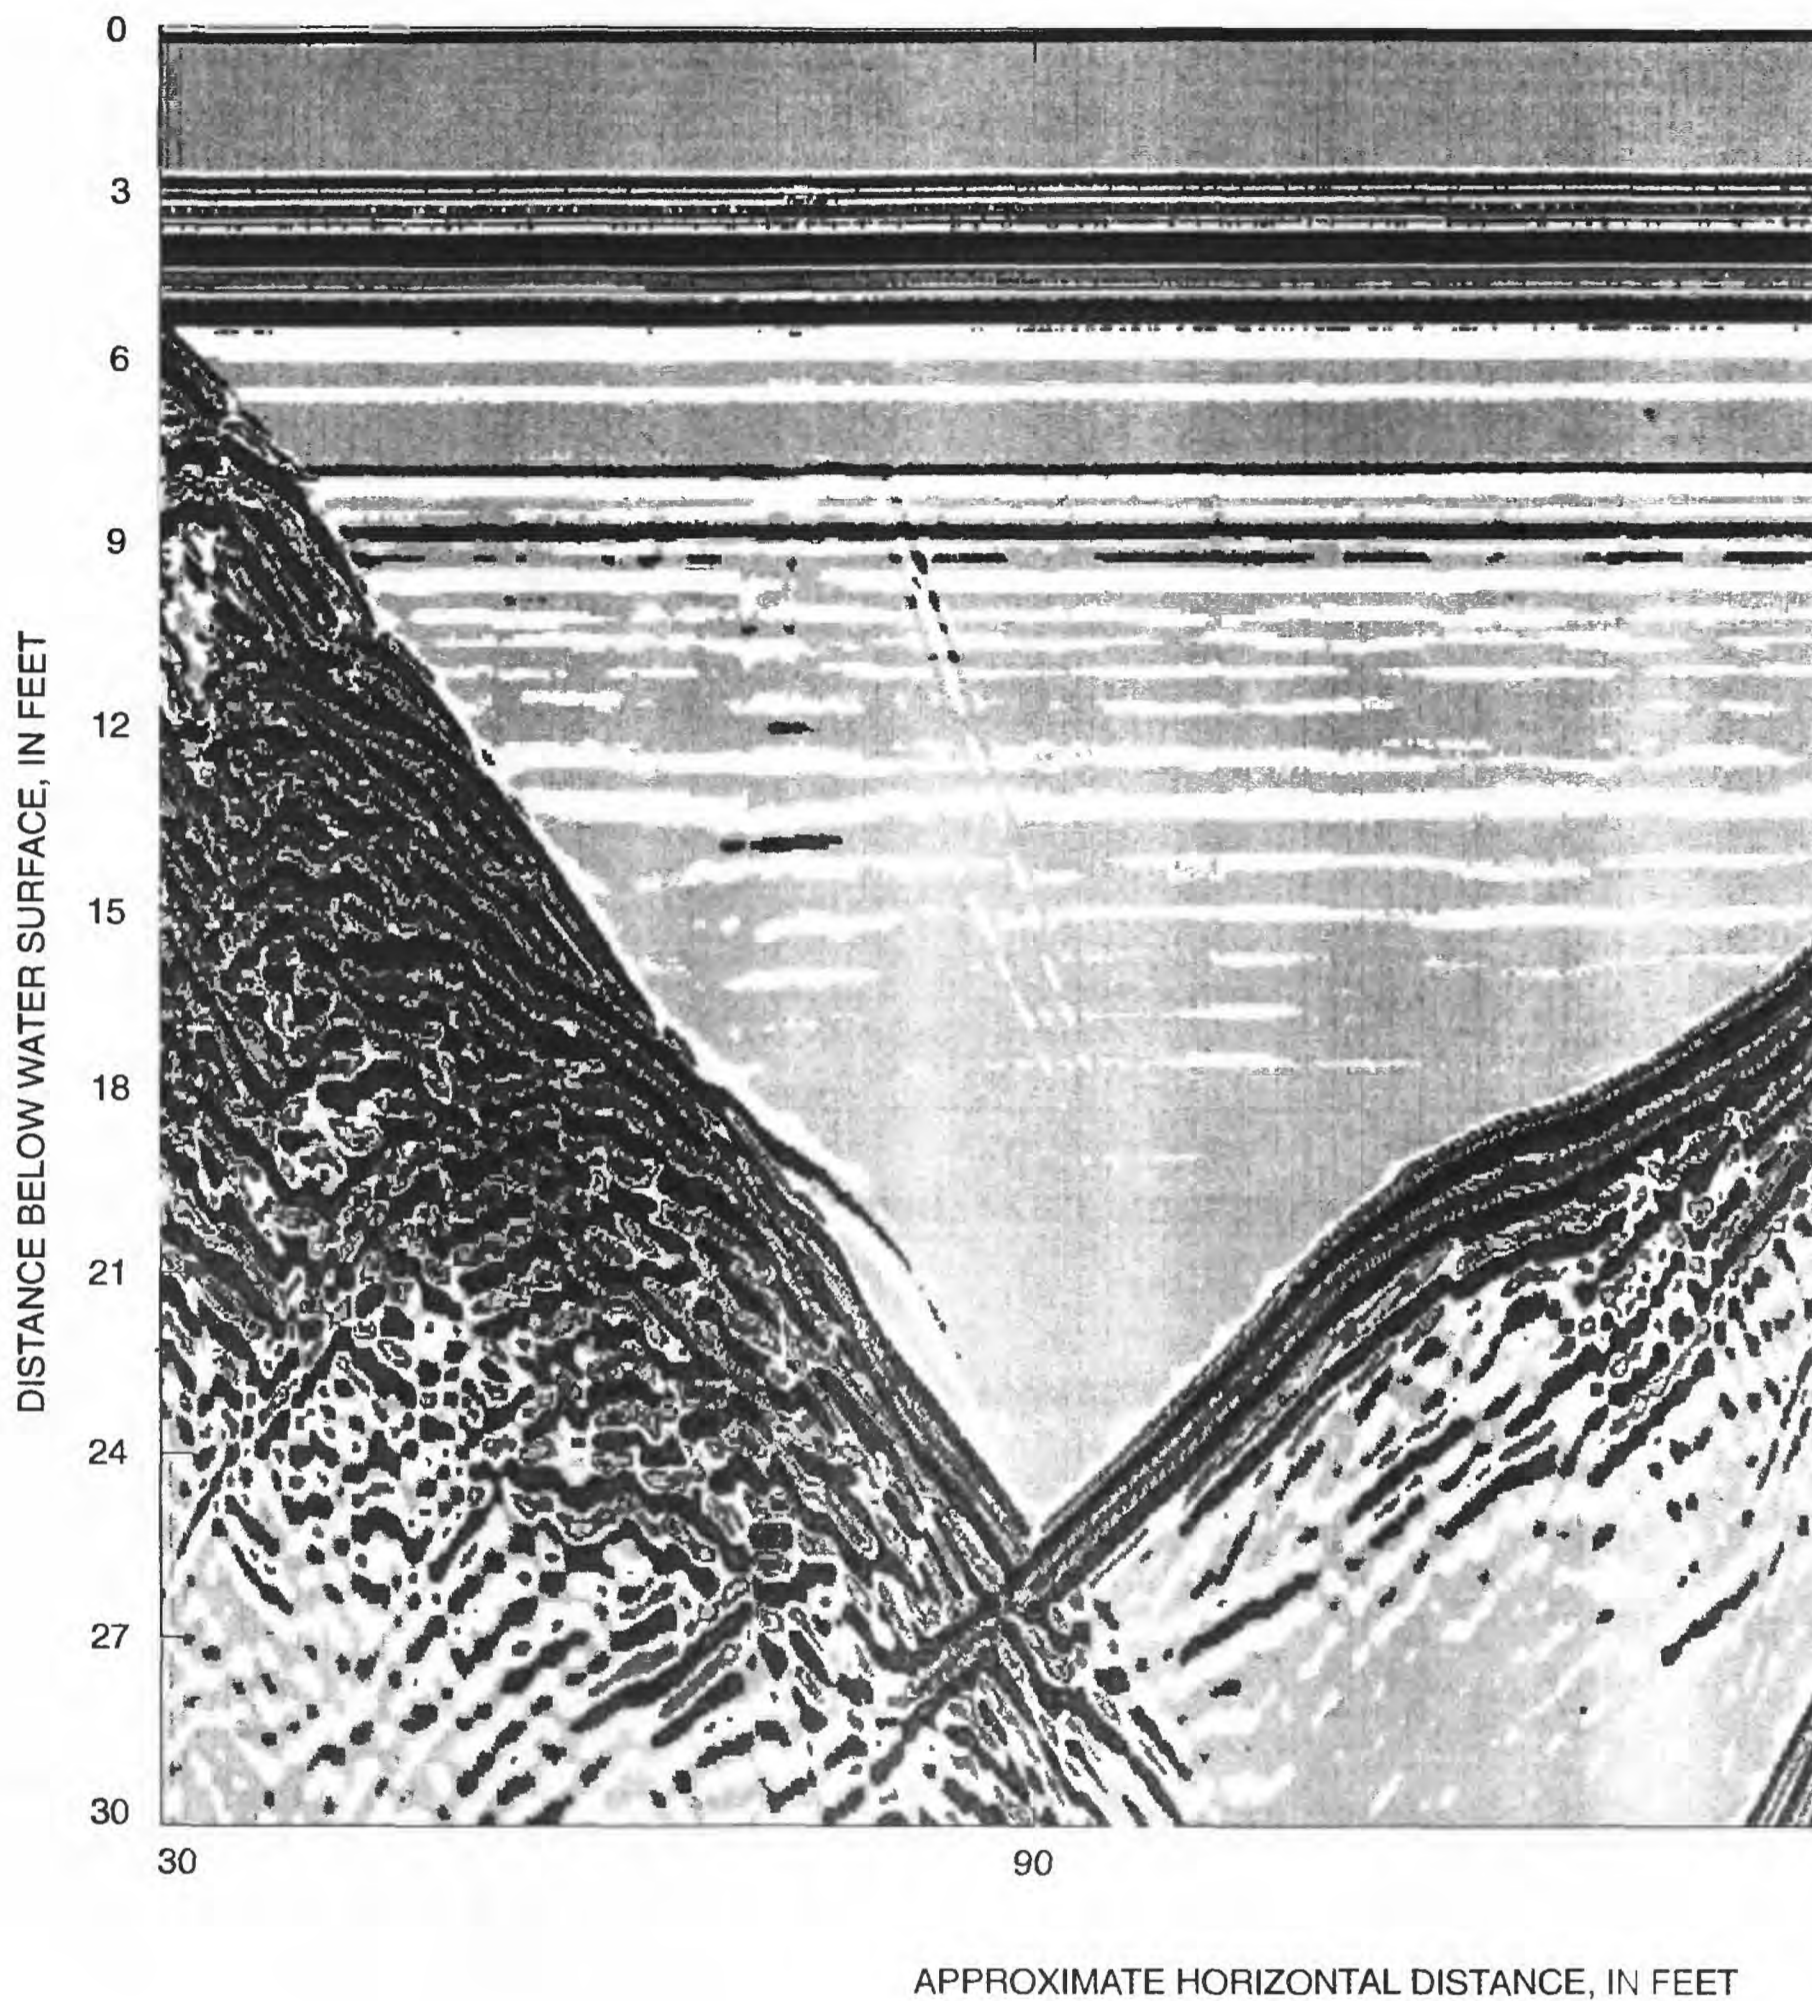
**Figure 24.** Record of 100-mHz ground-penetrating radar cross section from Bridge 334, on the Copper River Highway.

Using the 100-mHz antennas, a ground-penetrating radar profile was obtained at the upstream side of the bridge (fig. 24). The profile showed a water depth of about 27 ft. Moving towards the left abutment, the ground-penetrating radar indicated an area of infill which is probably the old channel. The depth of infill was estimated to be approximately 30 ft and probably consisted of fine-grained sediments. Thus, it appears that this geophysical method is useful in detecting old river channels.

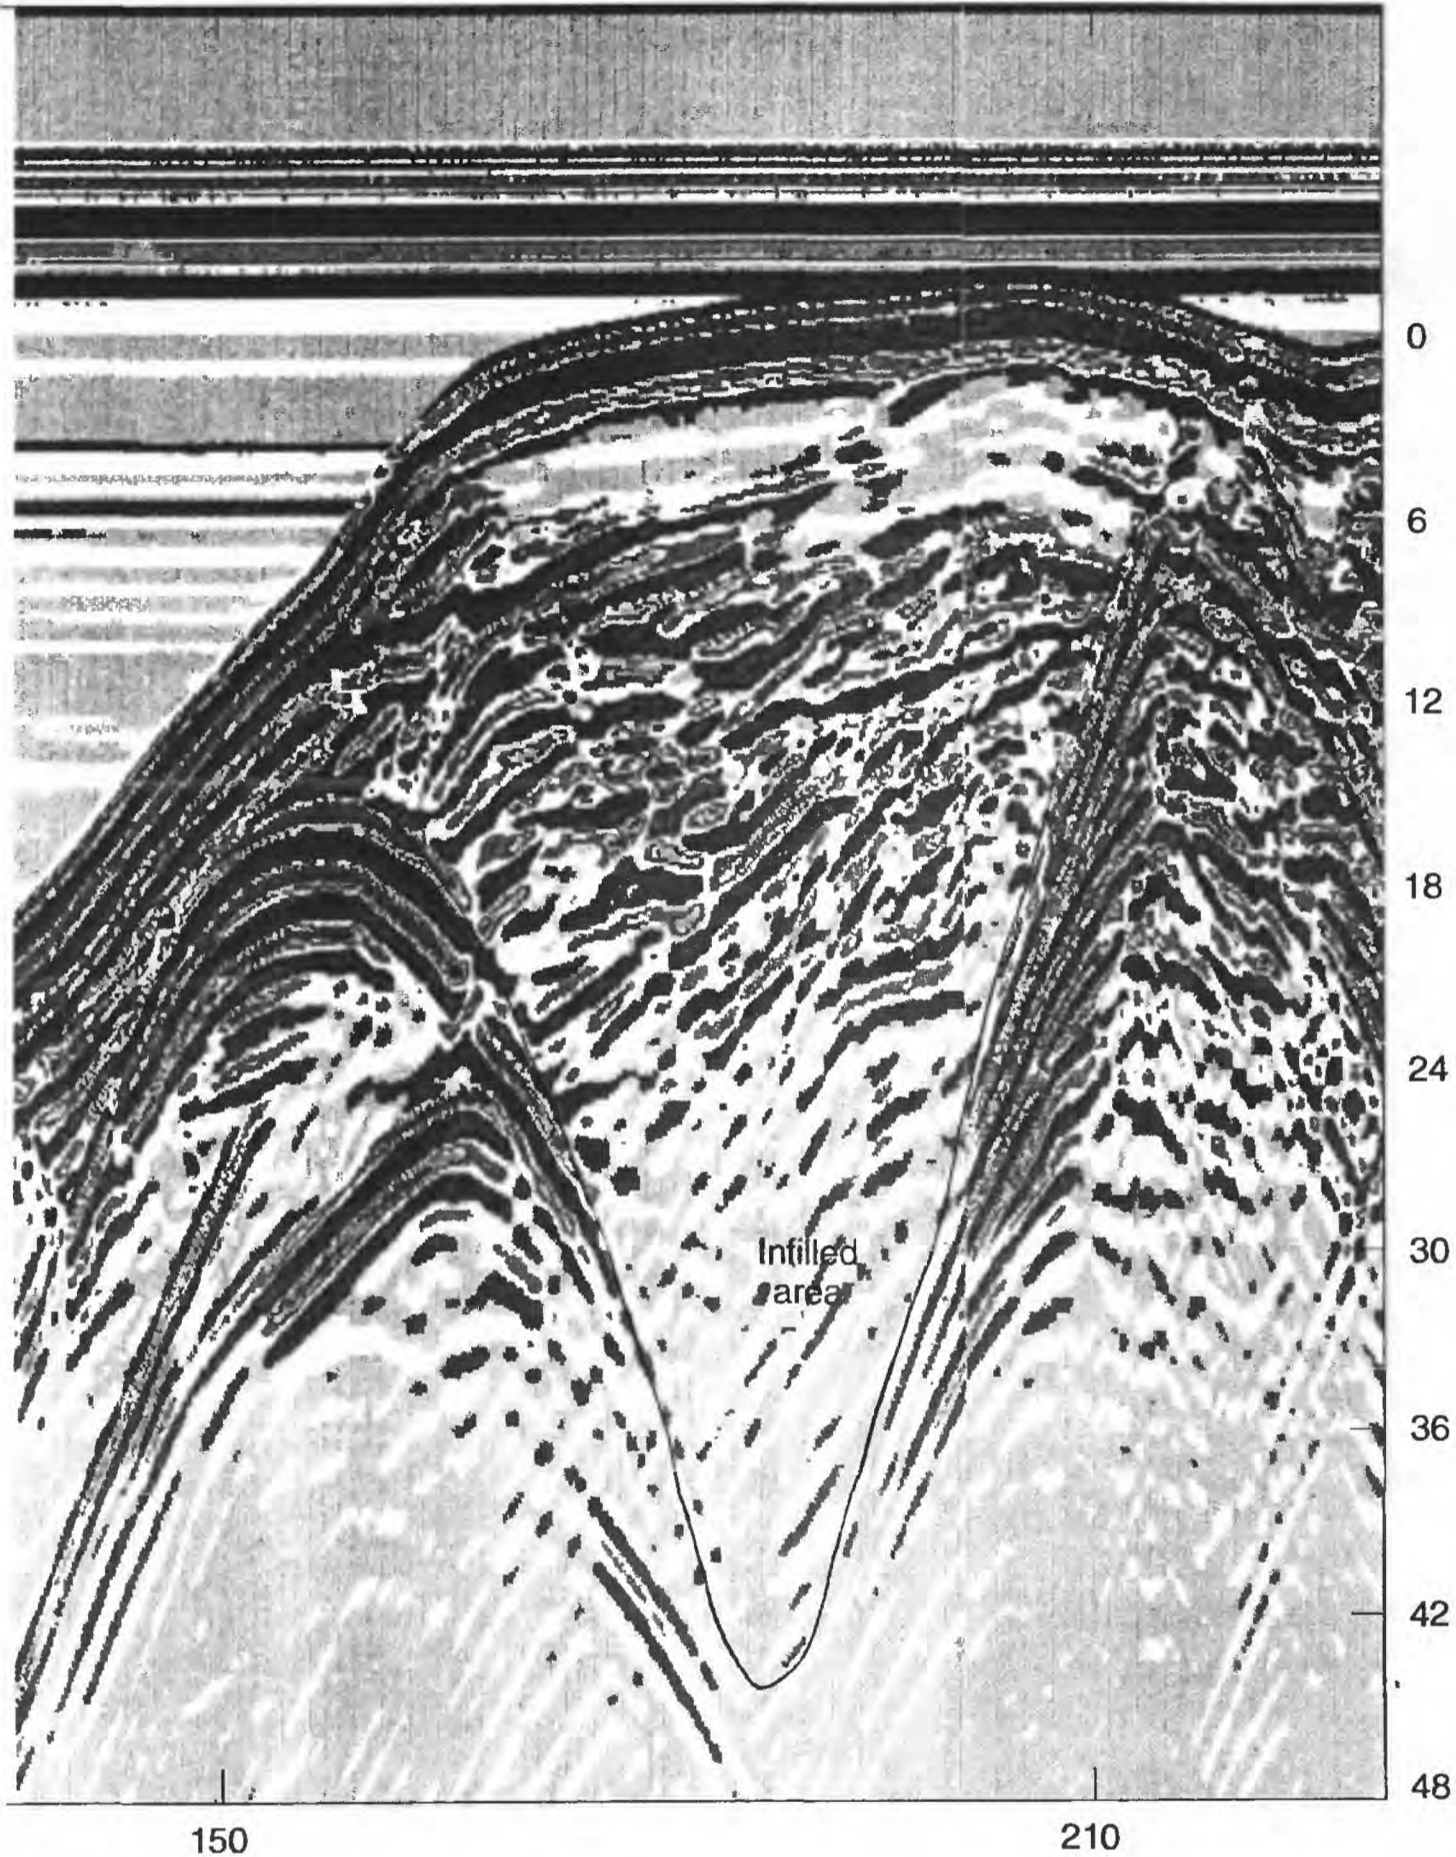
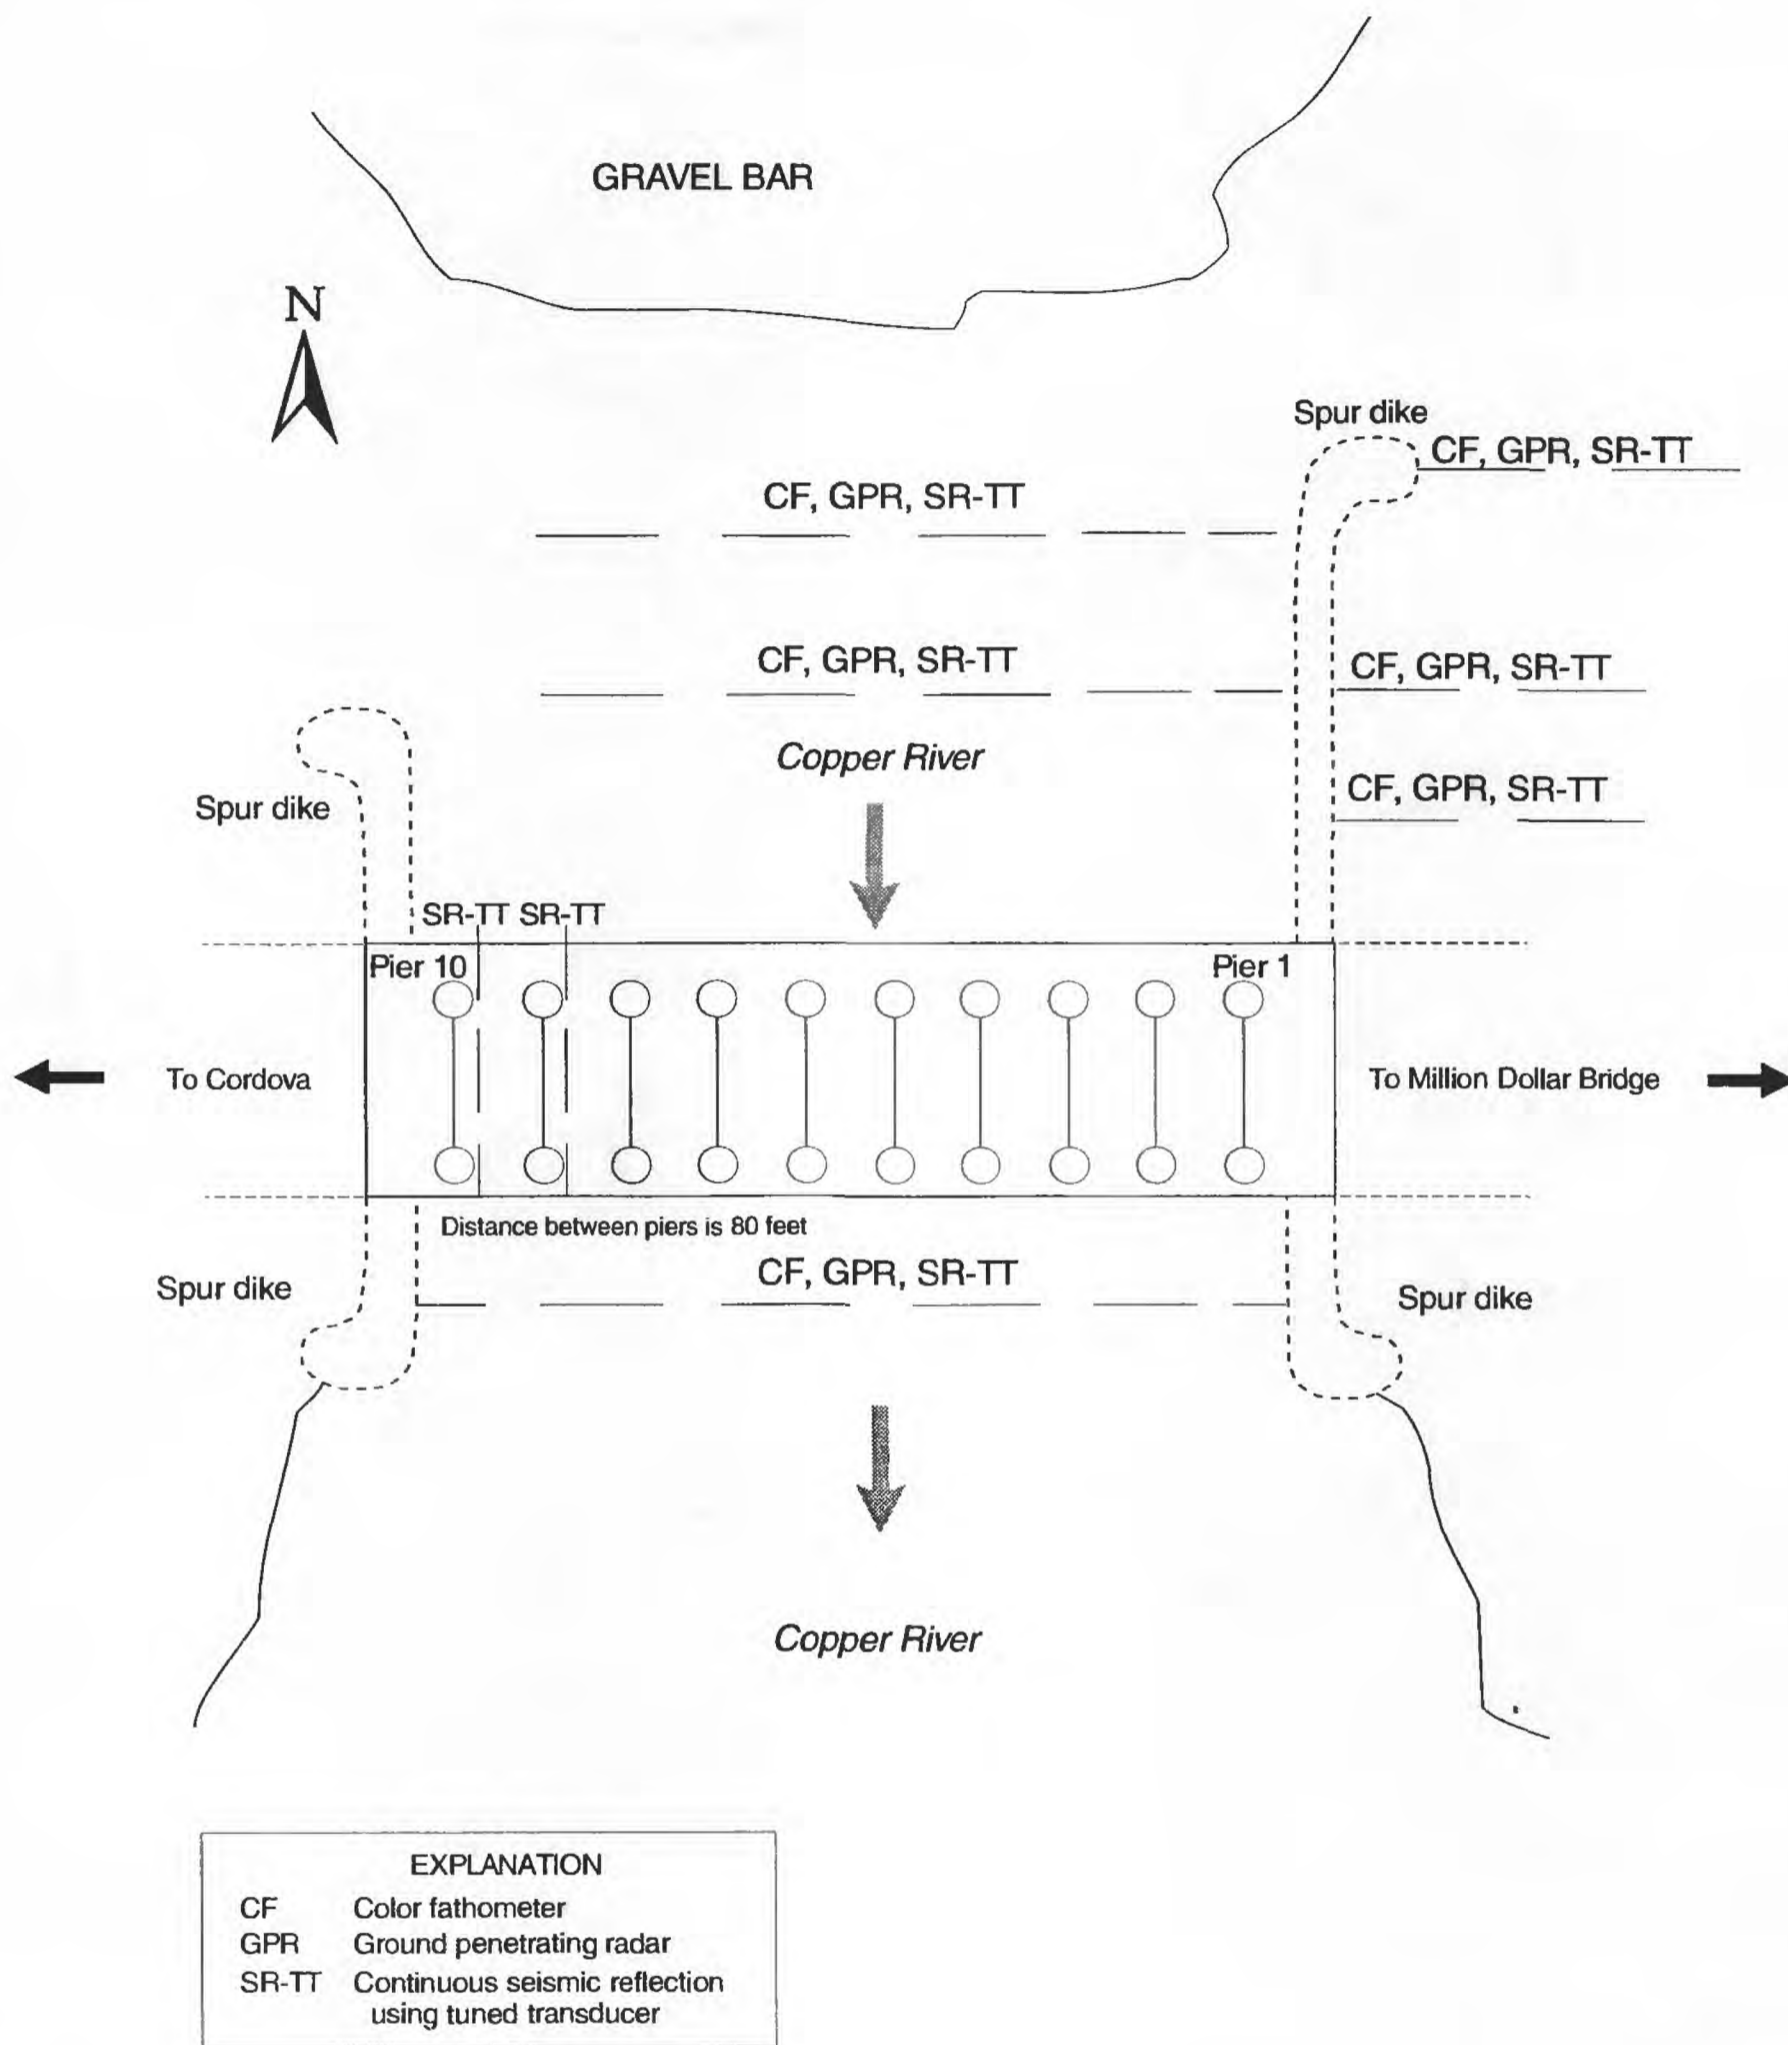
**Figure 25.** Plan view of Bridge 342 showing locations of geophysical profiles.

Ground-penetrating radar and continuous seismic reflection using a color fathometer were used at Bridge 342 in August 1991. Continuous seismic reflection using a tuned transducer was used in June 1992. Profiles were obtained with all three methods at locations east of the spur dike, upstream and downstream from the bridge, and laterally near piers 9 and 10 (fig. 25).
