# **Application of Surface Geophysical Techniques In a Study of the Geomorphology of the Lower Copper River, Alaska**

U.S. GEOLOGICAL SURVEY

Water-Resources Investigations Report 94-4165

ALASKA DEPARTMENT OF TRANSPORTATION  
AND PUBLIC FACILITIES

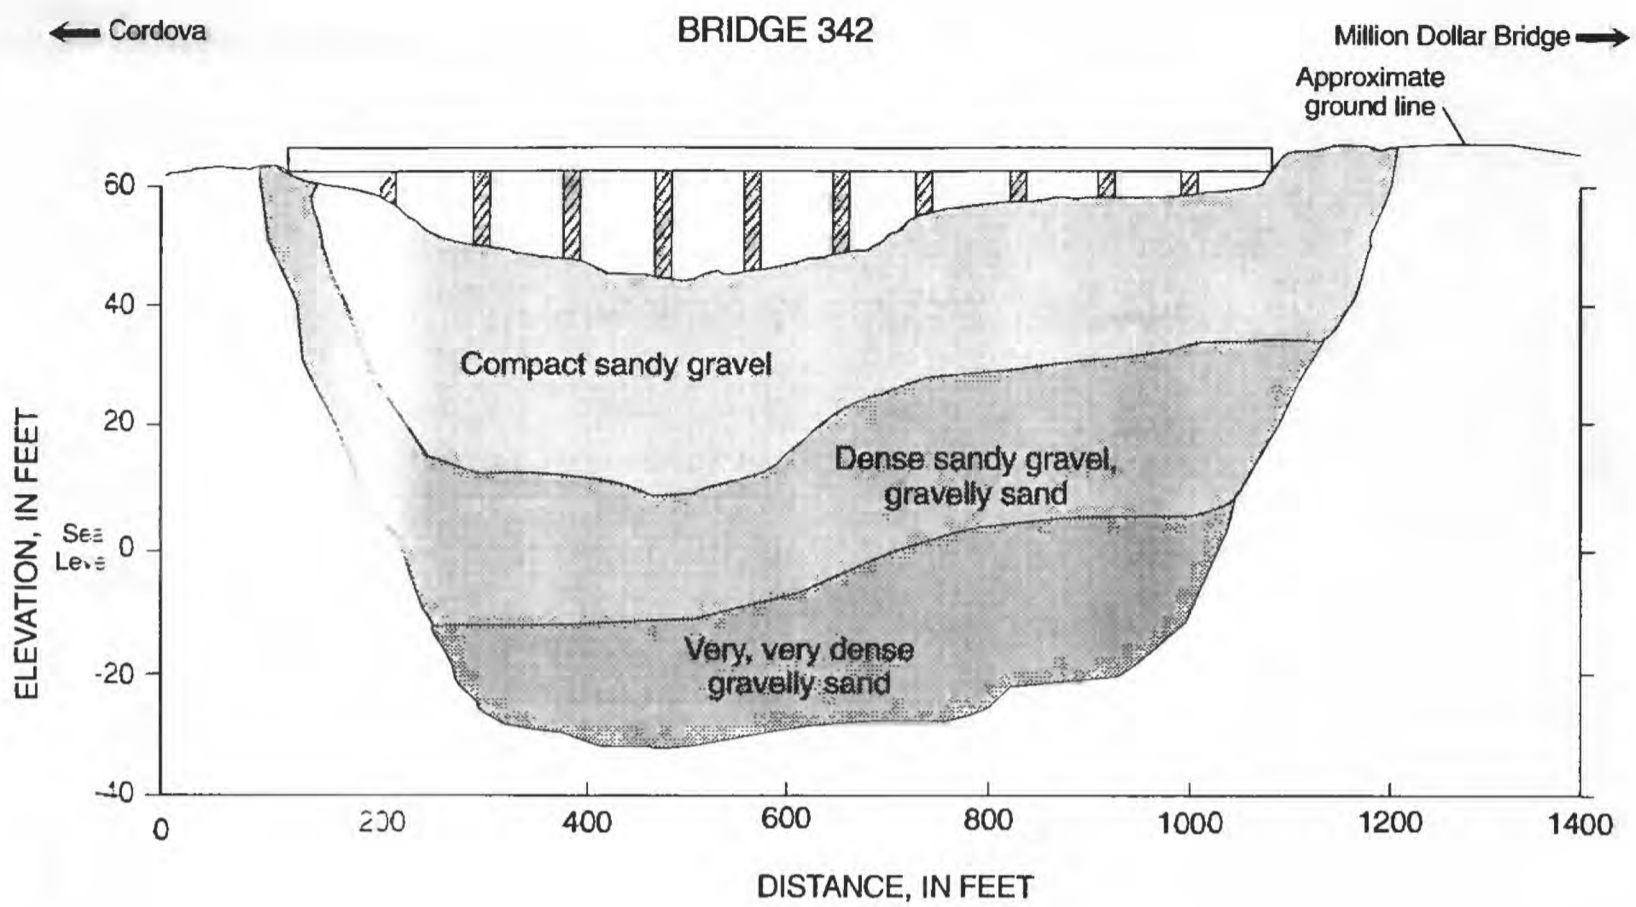
**Figure 26.** Generalized geologic cross section at Bridge 342 on the Copper River Highway, (modified from Alaska Department of Transportation and Public Facilities files).

During the open-water periods of 1991 and 1992, discharge at Bridge 342 ranged from 13,400 to 91,400 ft<sup>3</sup>/s (Brabets, 1992; 1993). These discharges represent between 33 and 67 percent of the total flow of the Copper River past the Million Dollar Bridge. Suspended-sediment concentrations ranged from 262 to 2,316 mg/L. Most of the sediment is finer than 0.062 mm. Bedload discharge ranged from 1,000 to 14,700 ton/d. The range in bedload transport probably reflects the scouring of a gravel bar just upstream from the bridge. Median diameter,  $d_{50}$ , of the bedload ranged from 0.8 to 16.0 mm. The generalized geology in the vicinity of the bridge (fig. 26) indicates that the riverbed is composed of sandy gravel.

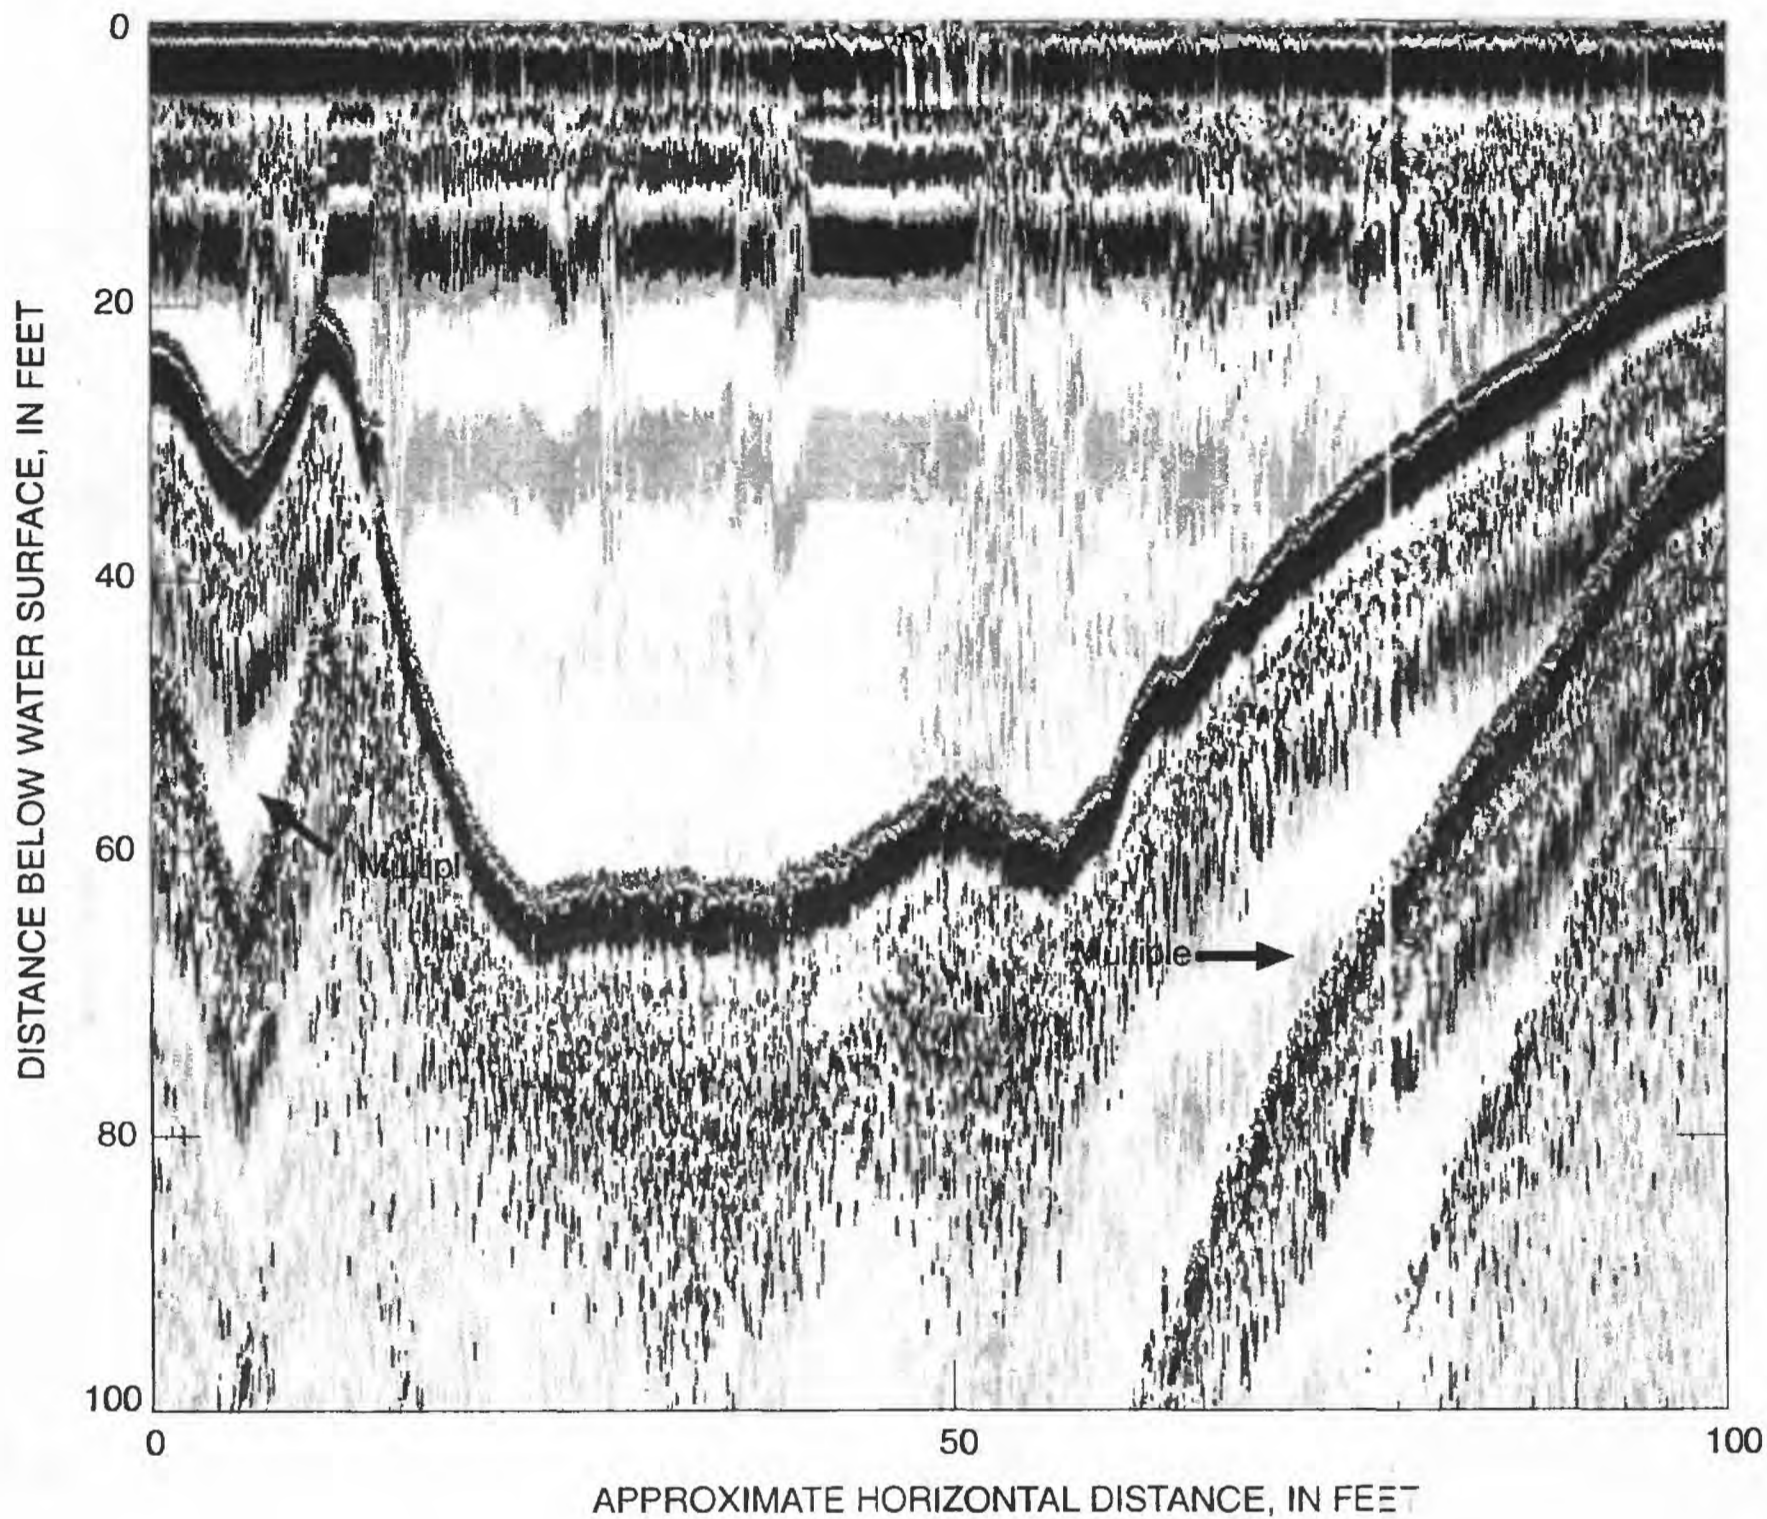
**Figure 27.** Color fathometer record near upstream left spur dike at Bridge 3-2, on the Copper River Highway.

The color fathometer provided good records of the depth to the river bottom and was useful in determining the depth of an existing scour hole located off the tip of the spur dike (fig. 27). The scour hole was approximately 60 ft deep and 70 ft wide. However, the color fathometer did not provide subbottom information. The ground-penetrating radar, using 300-mHz antennas, also was not able to penetrate the subbottom in areas where the water depths were greater than 20 ft. One ground-penetrating radar profile, in water approximately 10 ft deep, did show an infilled scour hole near pier 5 (fig. 28), about 10 ft thick.

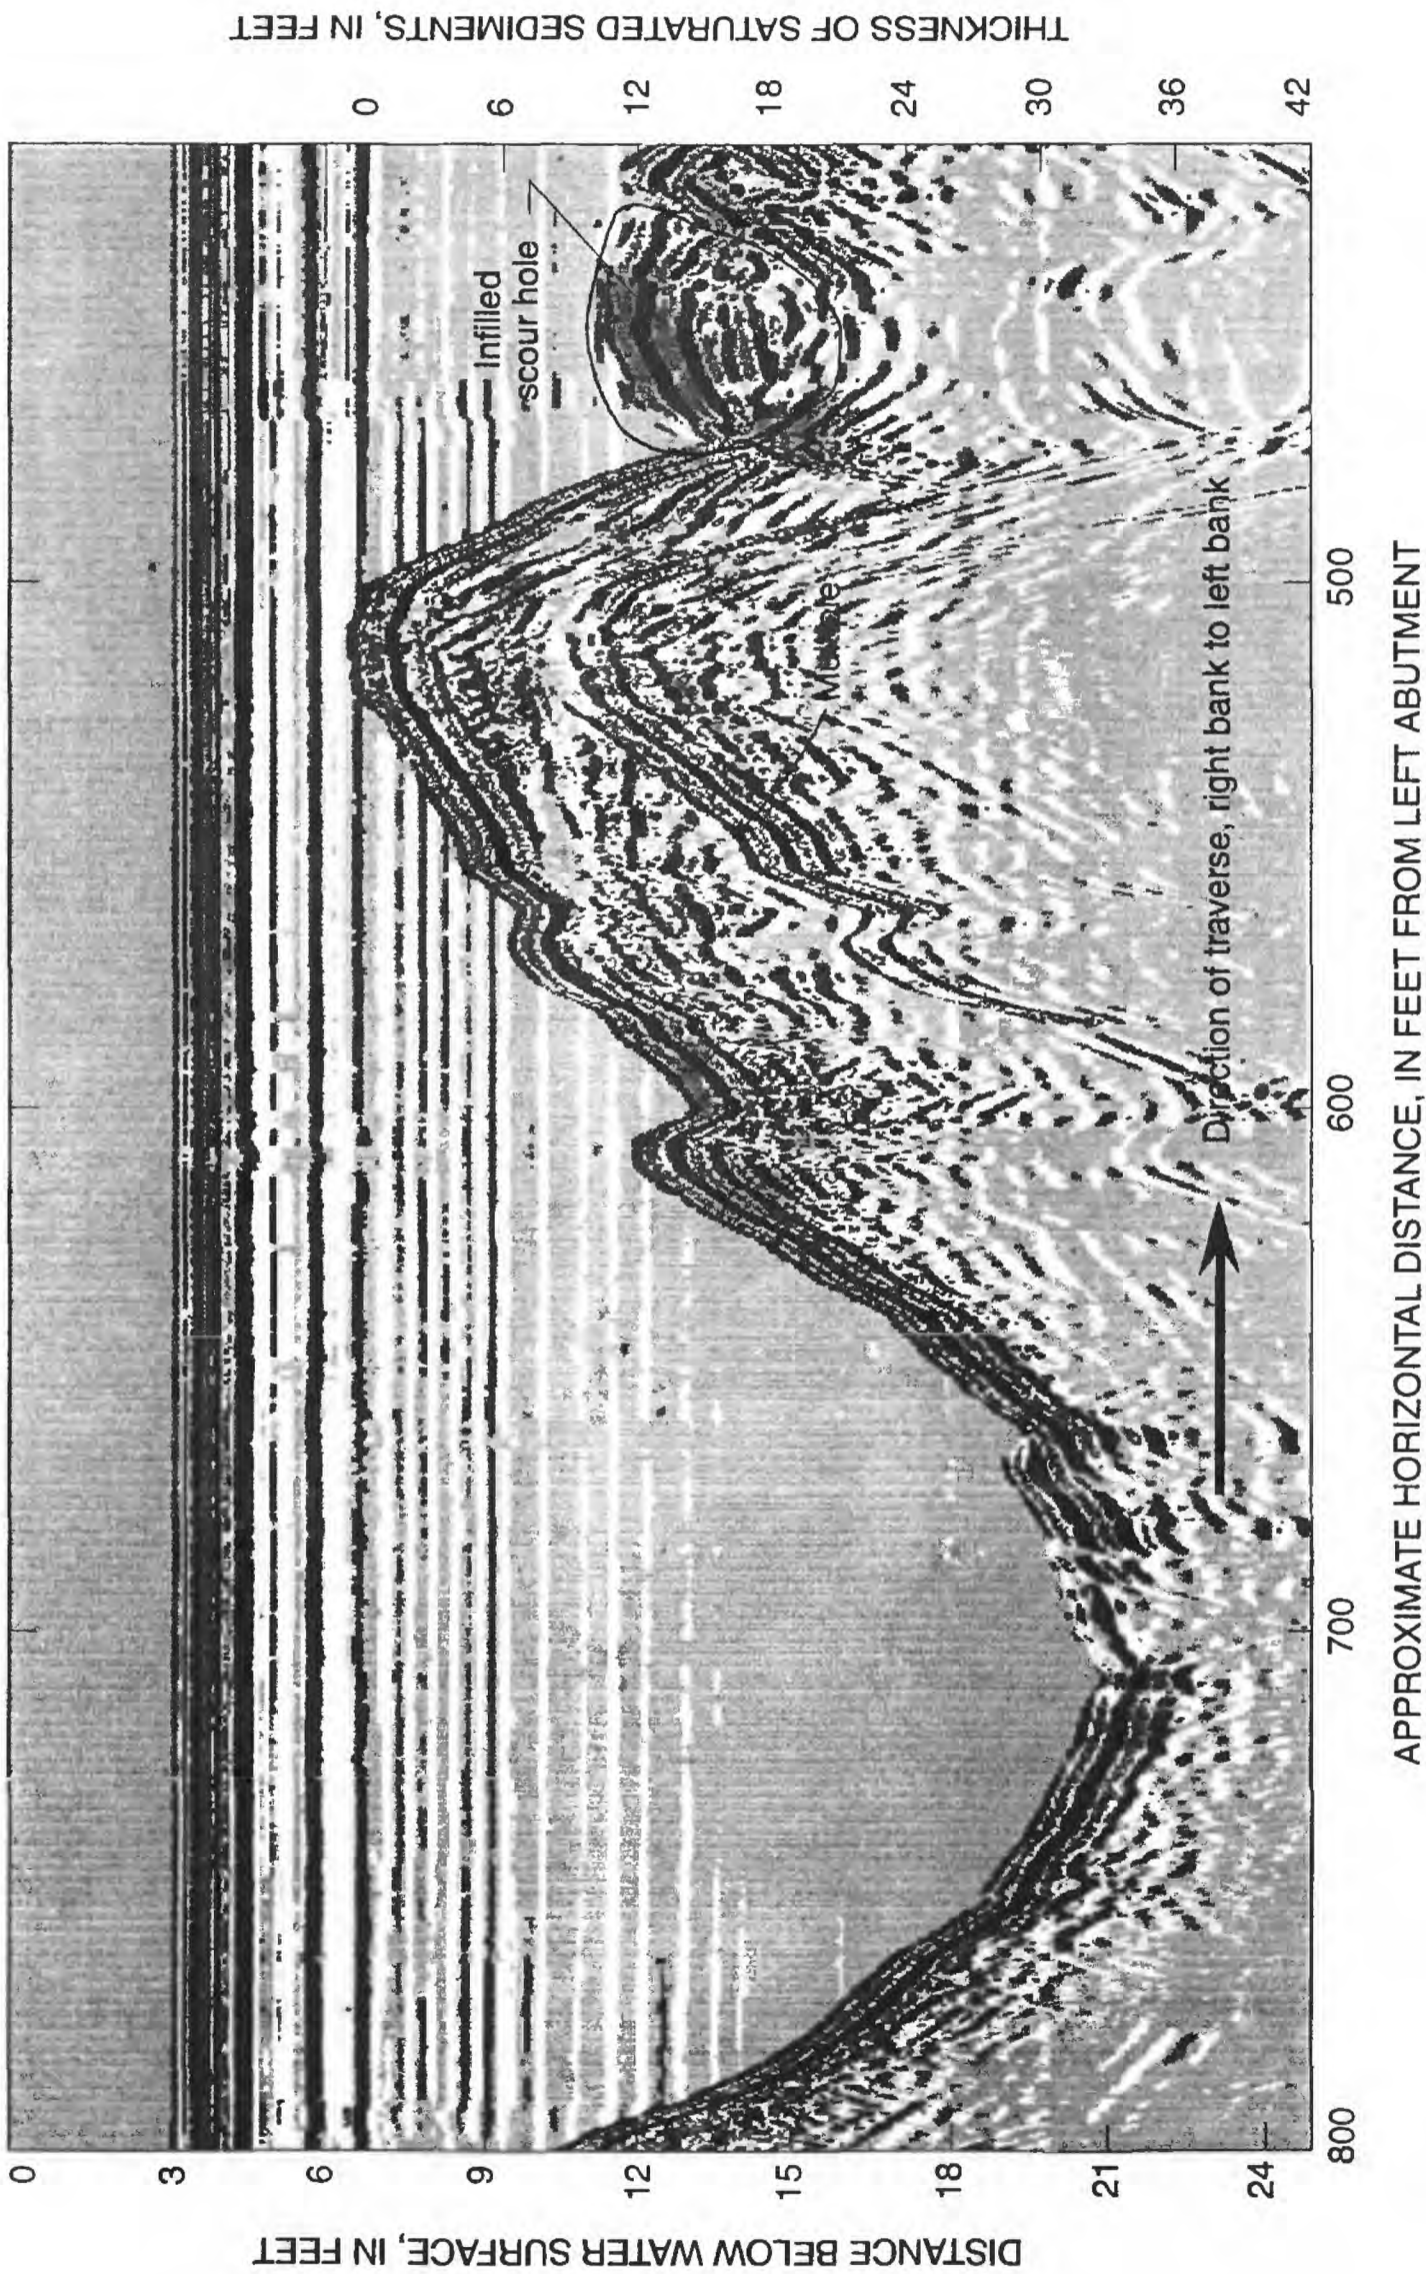
**Figure 28.** Record of 300-mHz ground-penetrating radar cross section from Bridge 342 near pier 5, on the Copper River Highway.

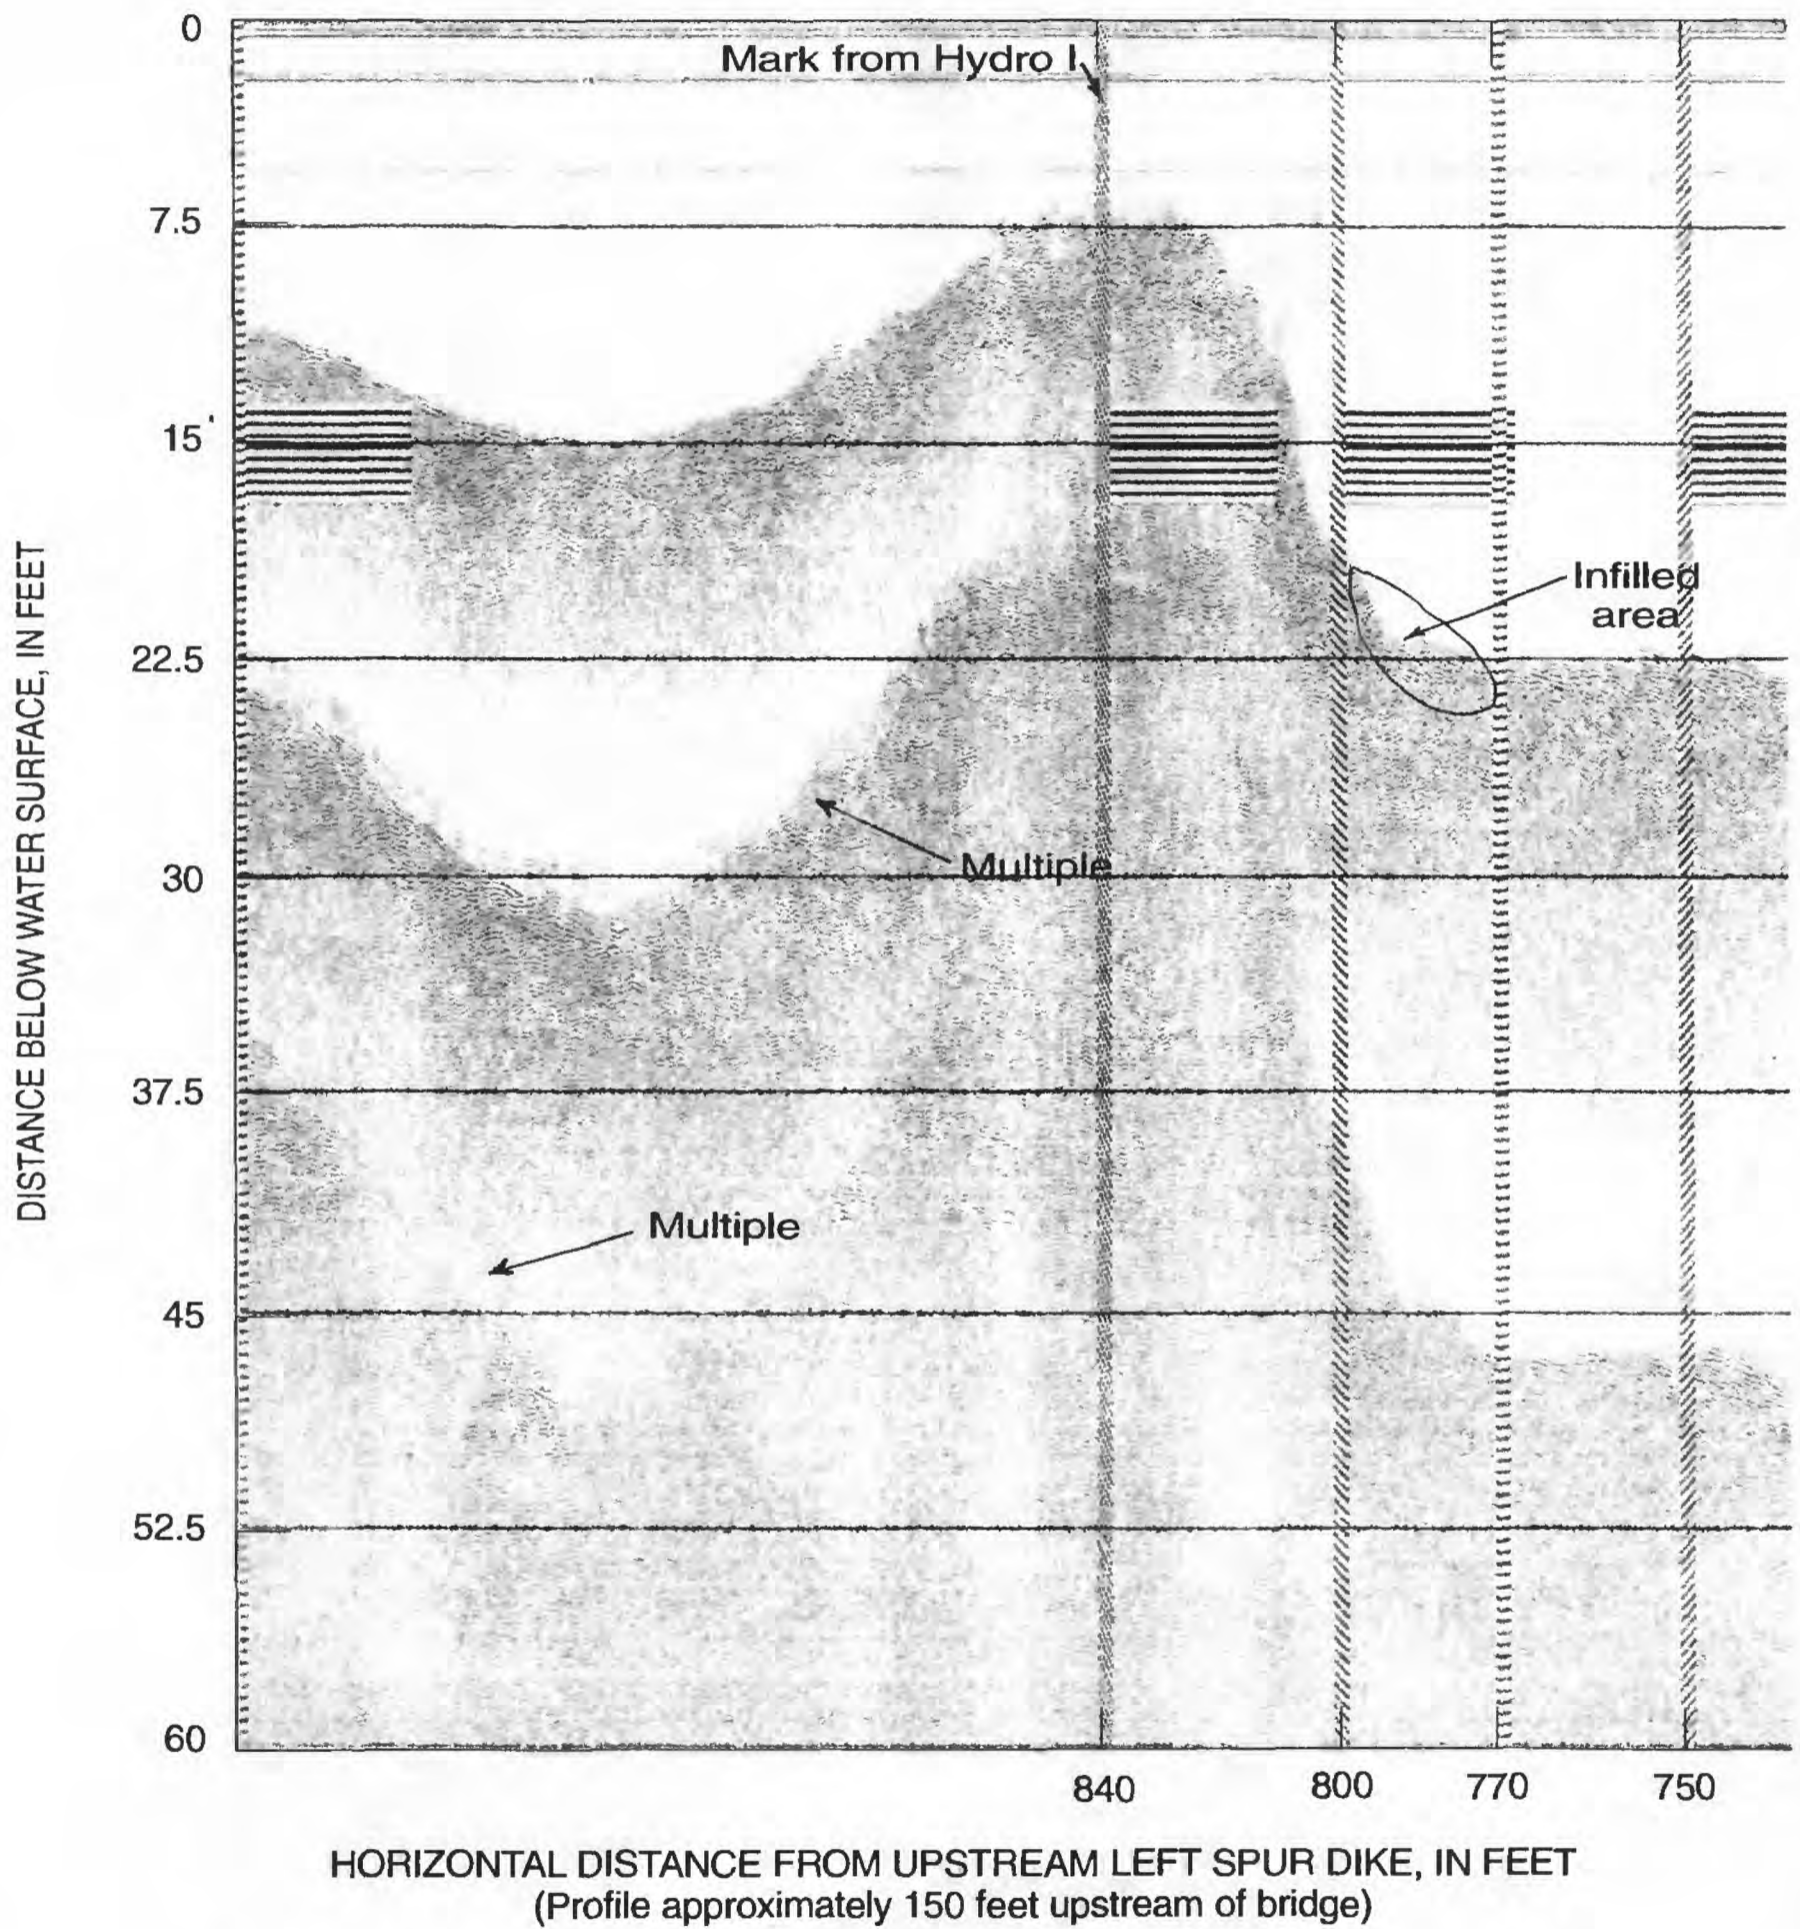
**Figure 29.** Record of 3.5-kHz continuous seismic reflection cross section from Bridge 342, on the Copper River Highway.

Because of the relatively deep water and fast currents at this site, no attempts were made to use the 7.0-kHz transducer. Instead, continuous seismic reflection was done using a 3.5-kHz transducer. Although the 3.5-kHz transducer did not provide as much penetration of the subbottom as the 7.0-kHz transducer did, it still proved to be the most useful technique at this site. A profile upstream from the bridge (fig. 29) indicated slight infill in some areas, but no significant infilled holes were detected. The reasons may be that the material is relatively similar, the channel is undergoing constant scouring and infilling, and no residual infill material was present at the time of this study.

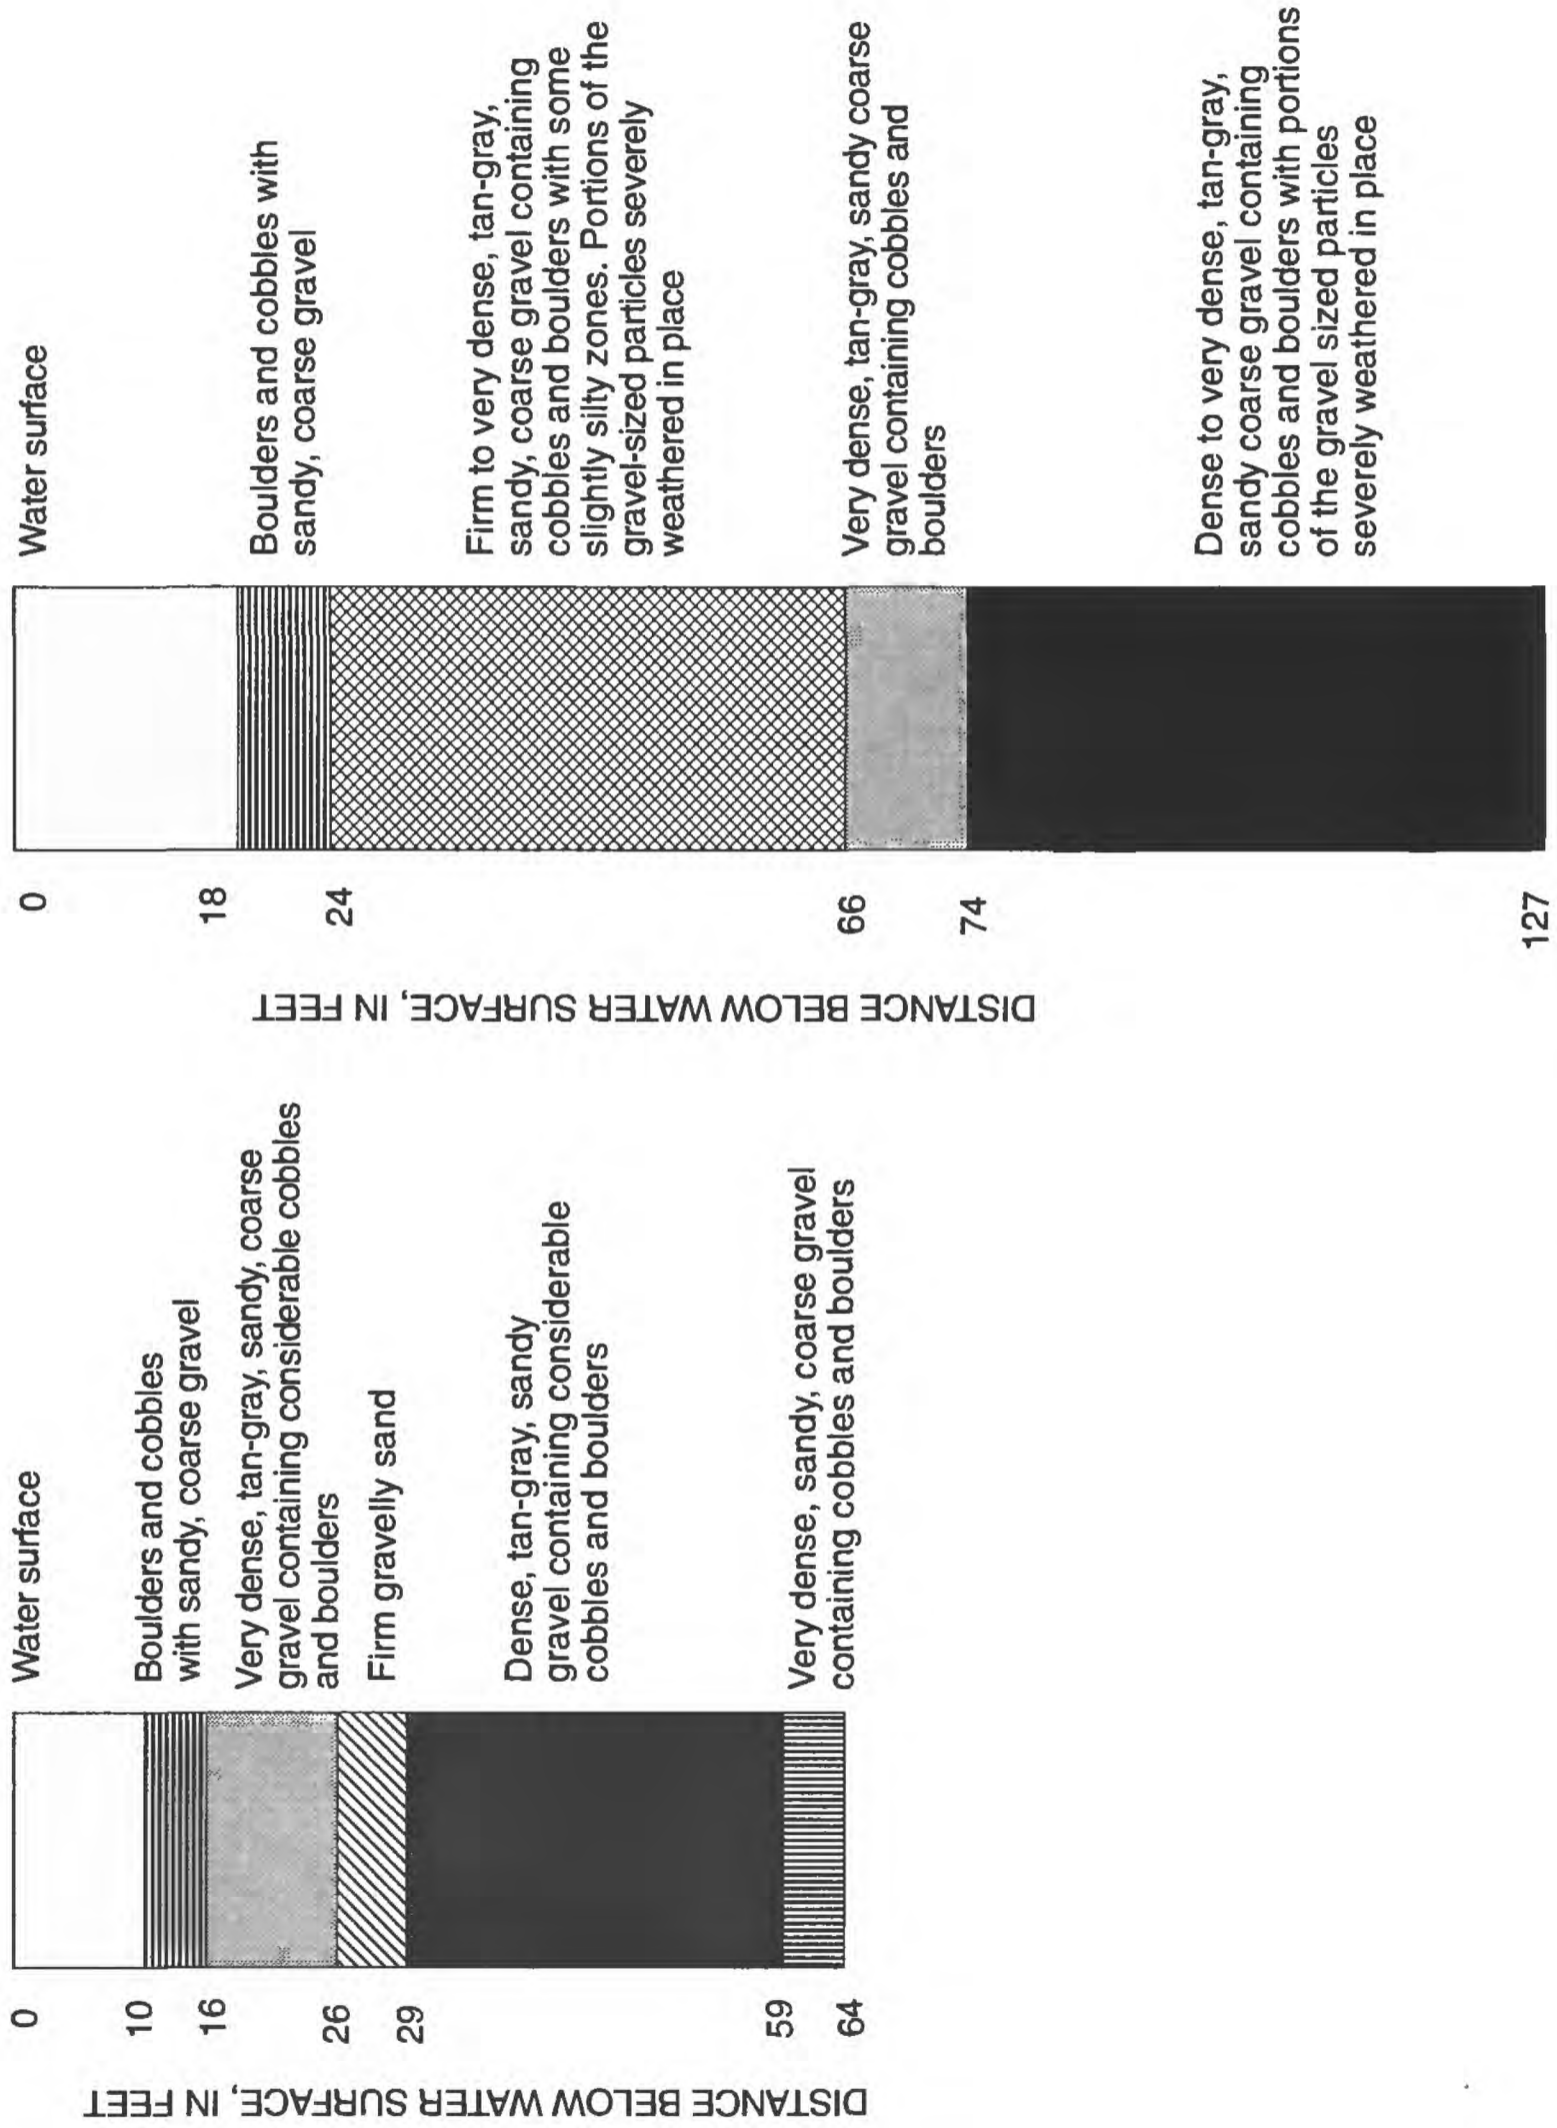
**Figure 31.** Borings from area near the Million Dollar Bridge on the Copper River Highway.

On the basis of borings collected near the Million Dollar Bridge in 1980 (fig. 31), it was determined that the bottom of Miles Lake probably consists of large boulders, cobbles, and gravel. Also, data collected at the Million Dollar Bridge in 1991 and 1992 indicated that no bedload was being transported past the Million Dollar Bridge (Brabets, 1992; 1993). To determine whether Miles Lake might be a sediment trap for bedload being transported by the Copper River north of Miles Lake, continuous seismic reflection methods were used in June 1992 to determine the depositional features of the bottom sediments in Miles Lake.

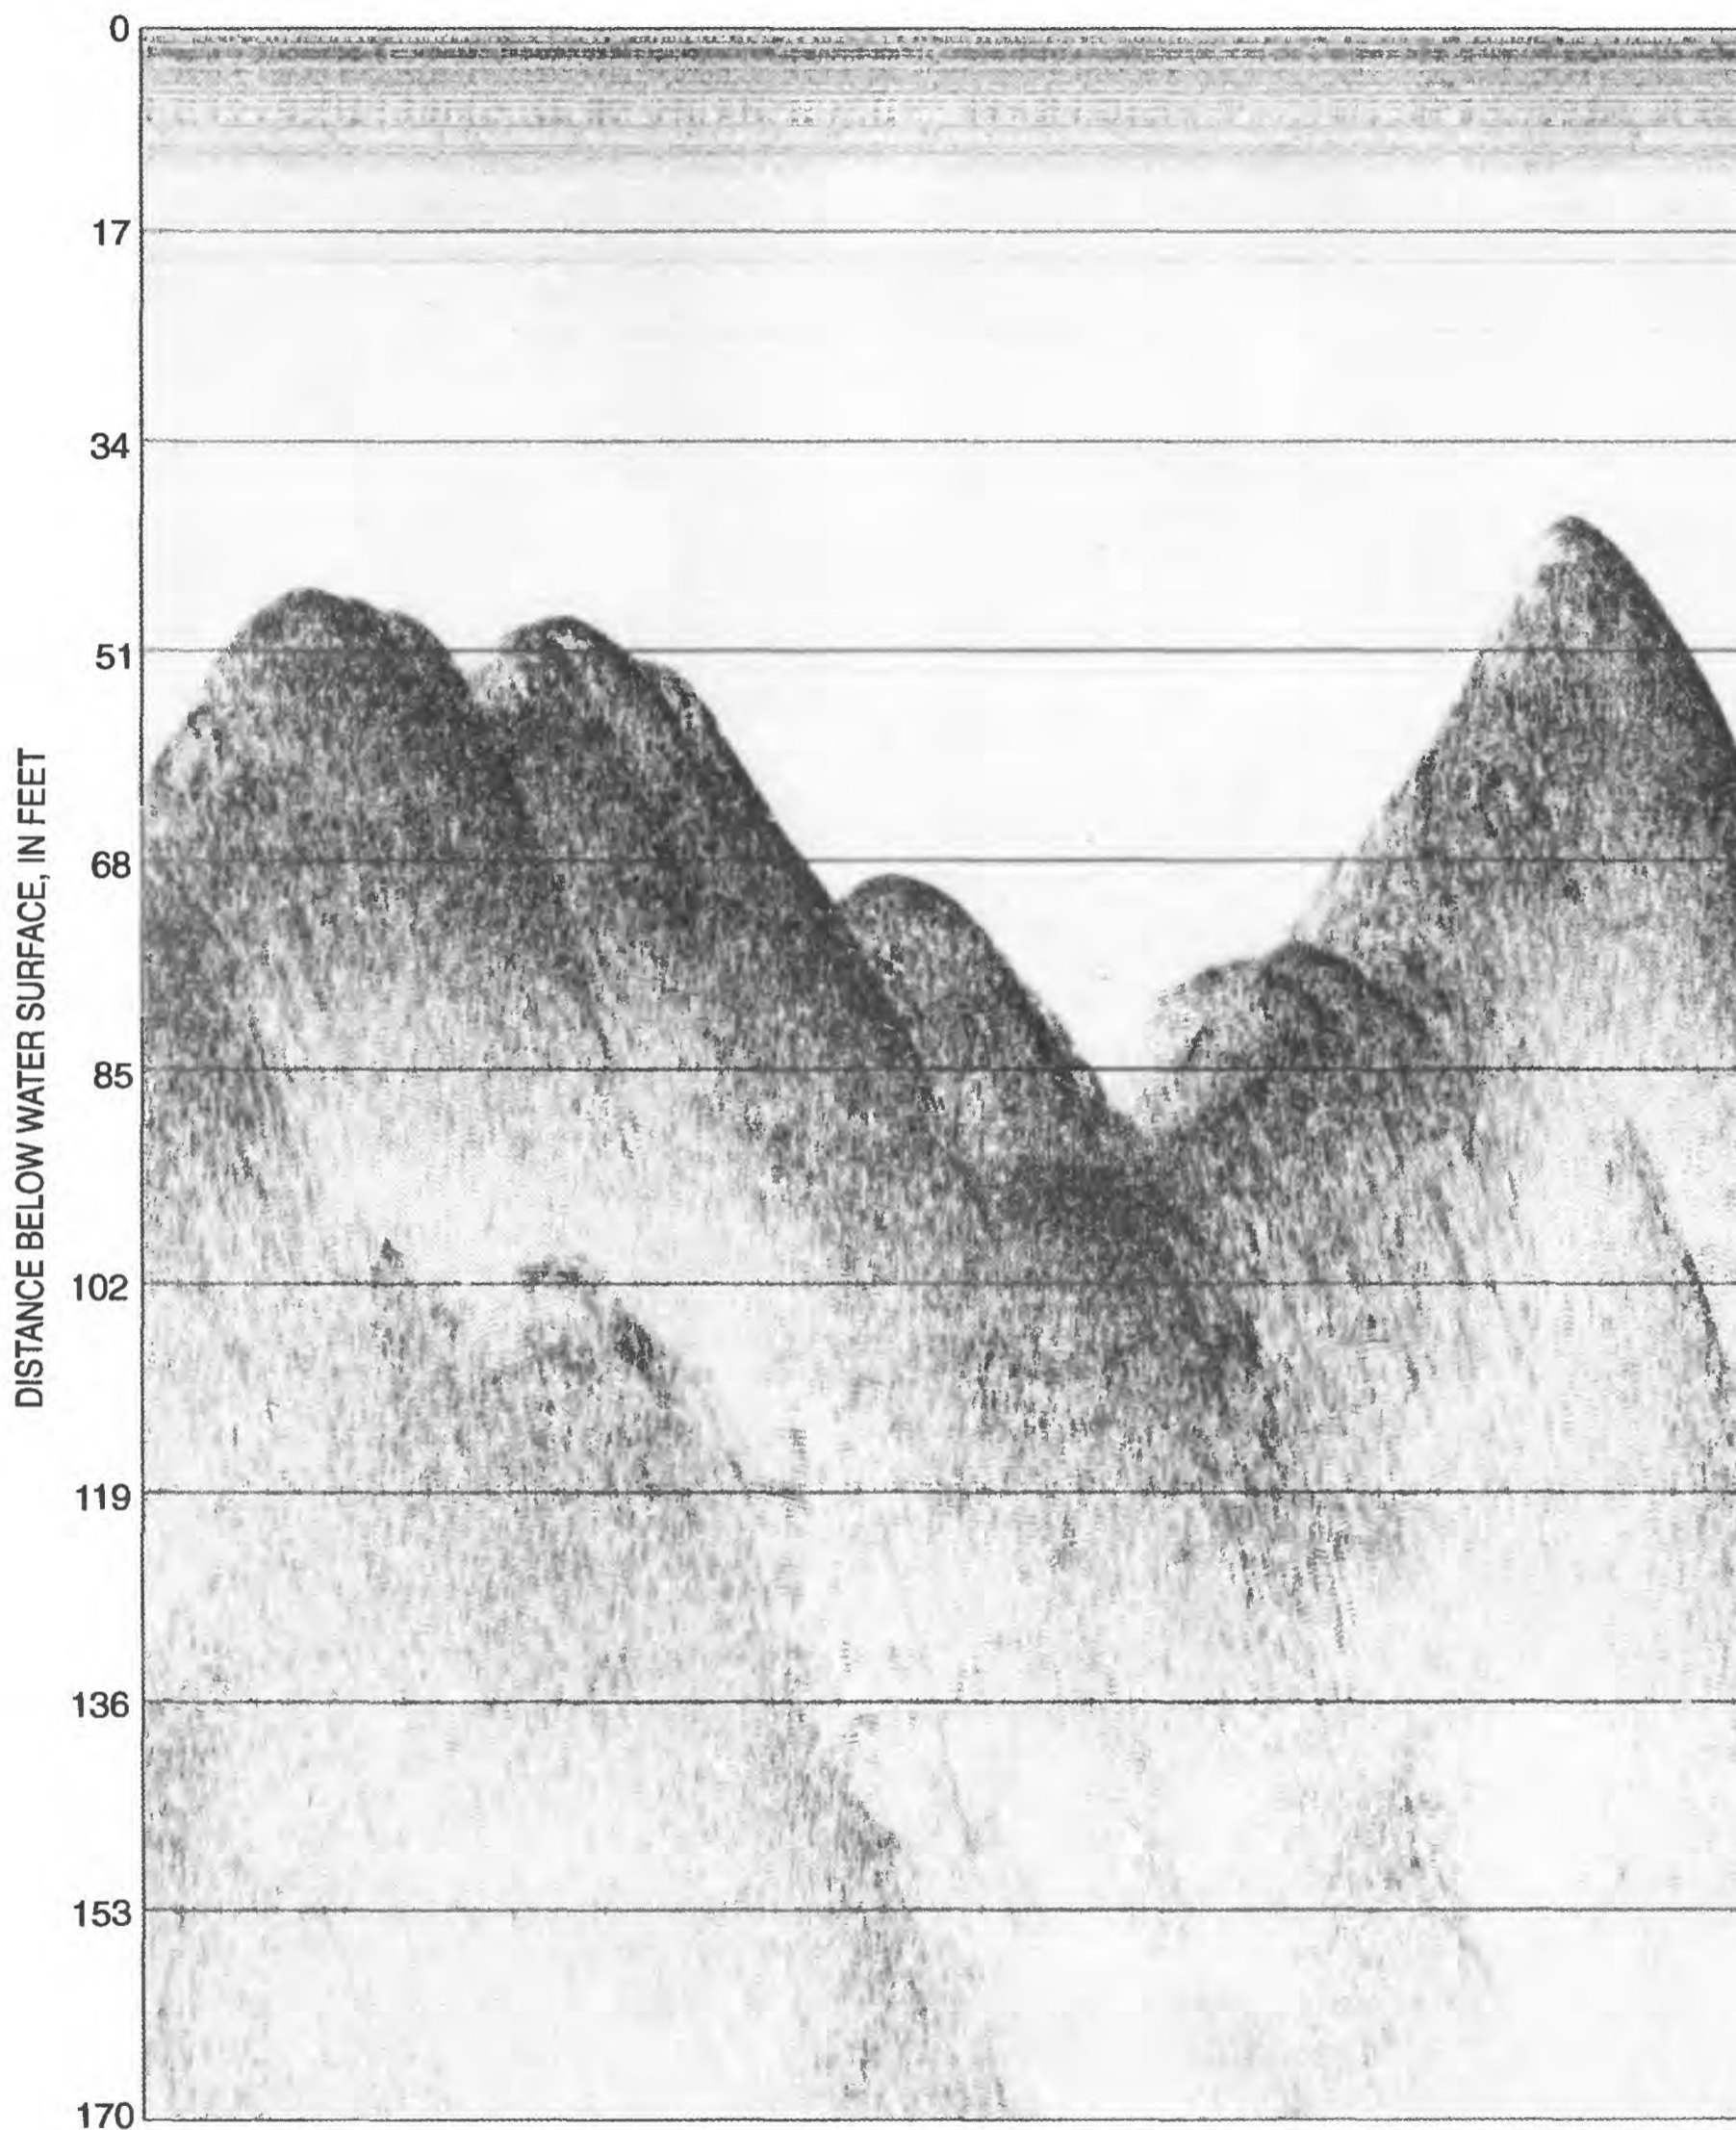
**Figure 32.** Record of 7.0-kHz continuous seismic reflection cross section from Profile 1 at Miles Lake.  
 (Approximate length of profile is one-half mile, see fig. 30 for location.)
