# **Application of Surface Geophysical Techniques In a Study of the Geomorphology of the Lower Copper River, Alaska**

U.S. GEOLOGICAL SURVEY

Water-Resources Investigations Report 94-4165

ALASKA DEPARTMENT OF TRANSPORTATION  
AND PUBLIC FACILITIES

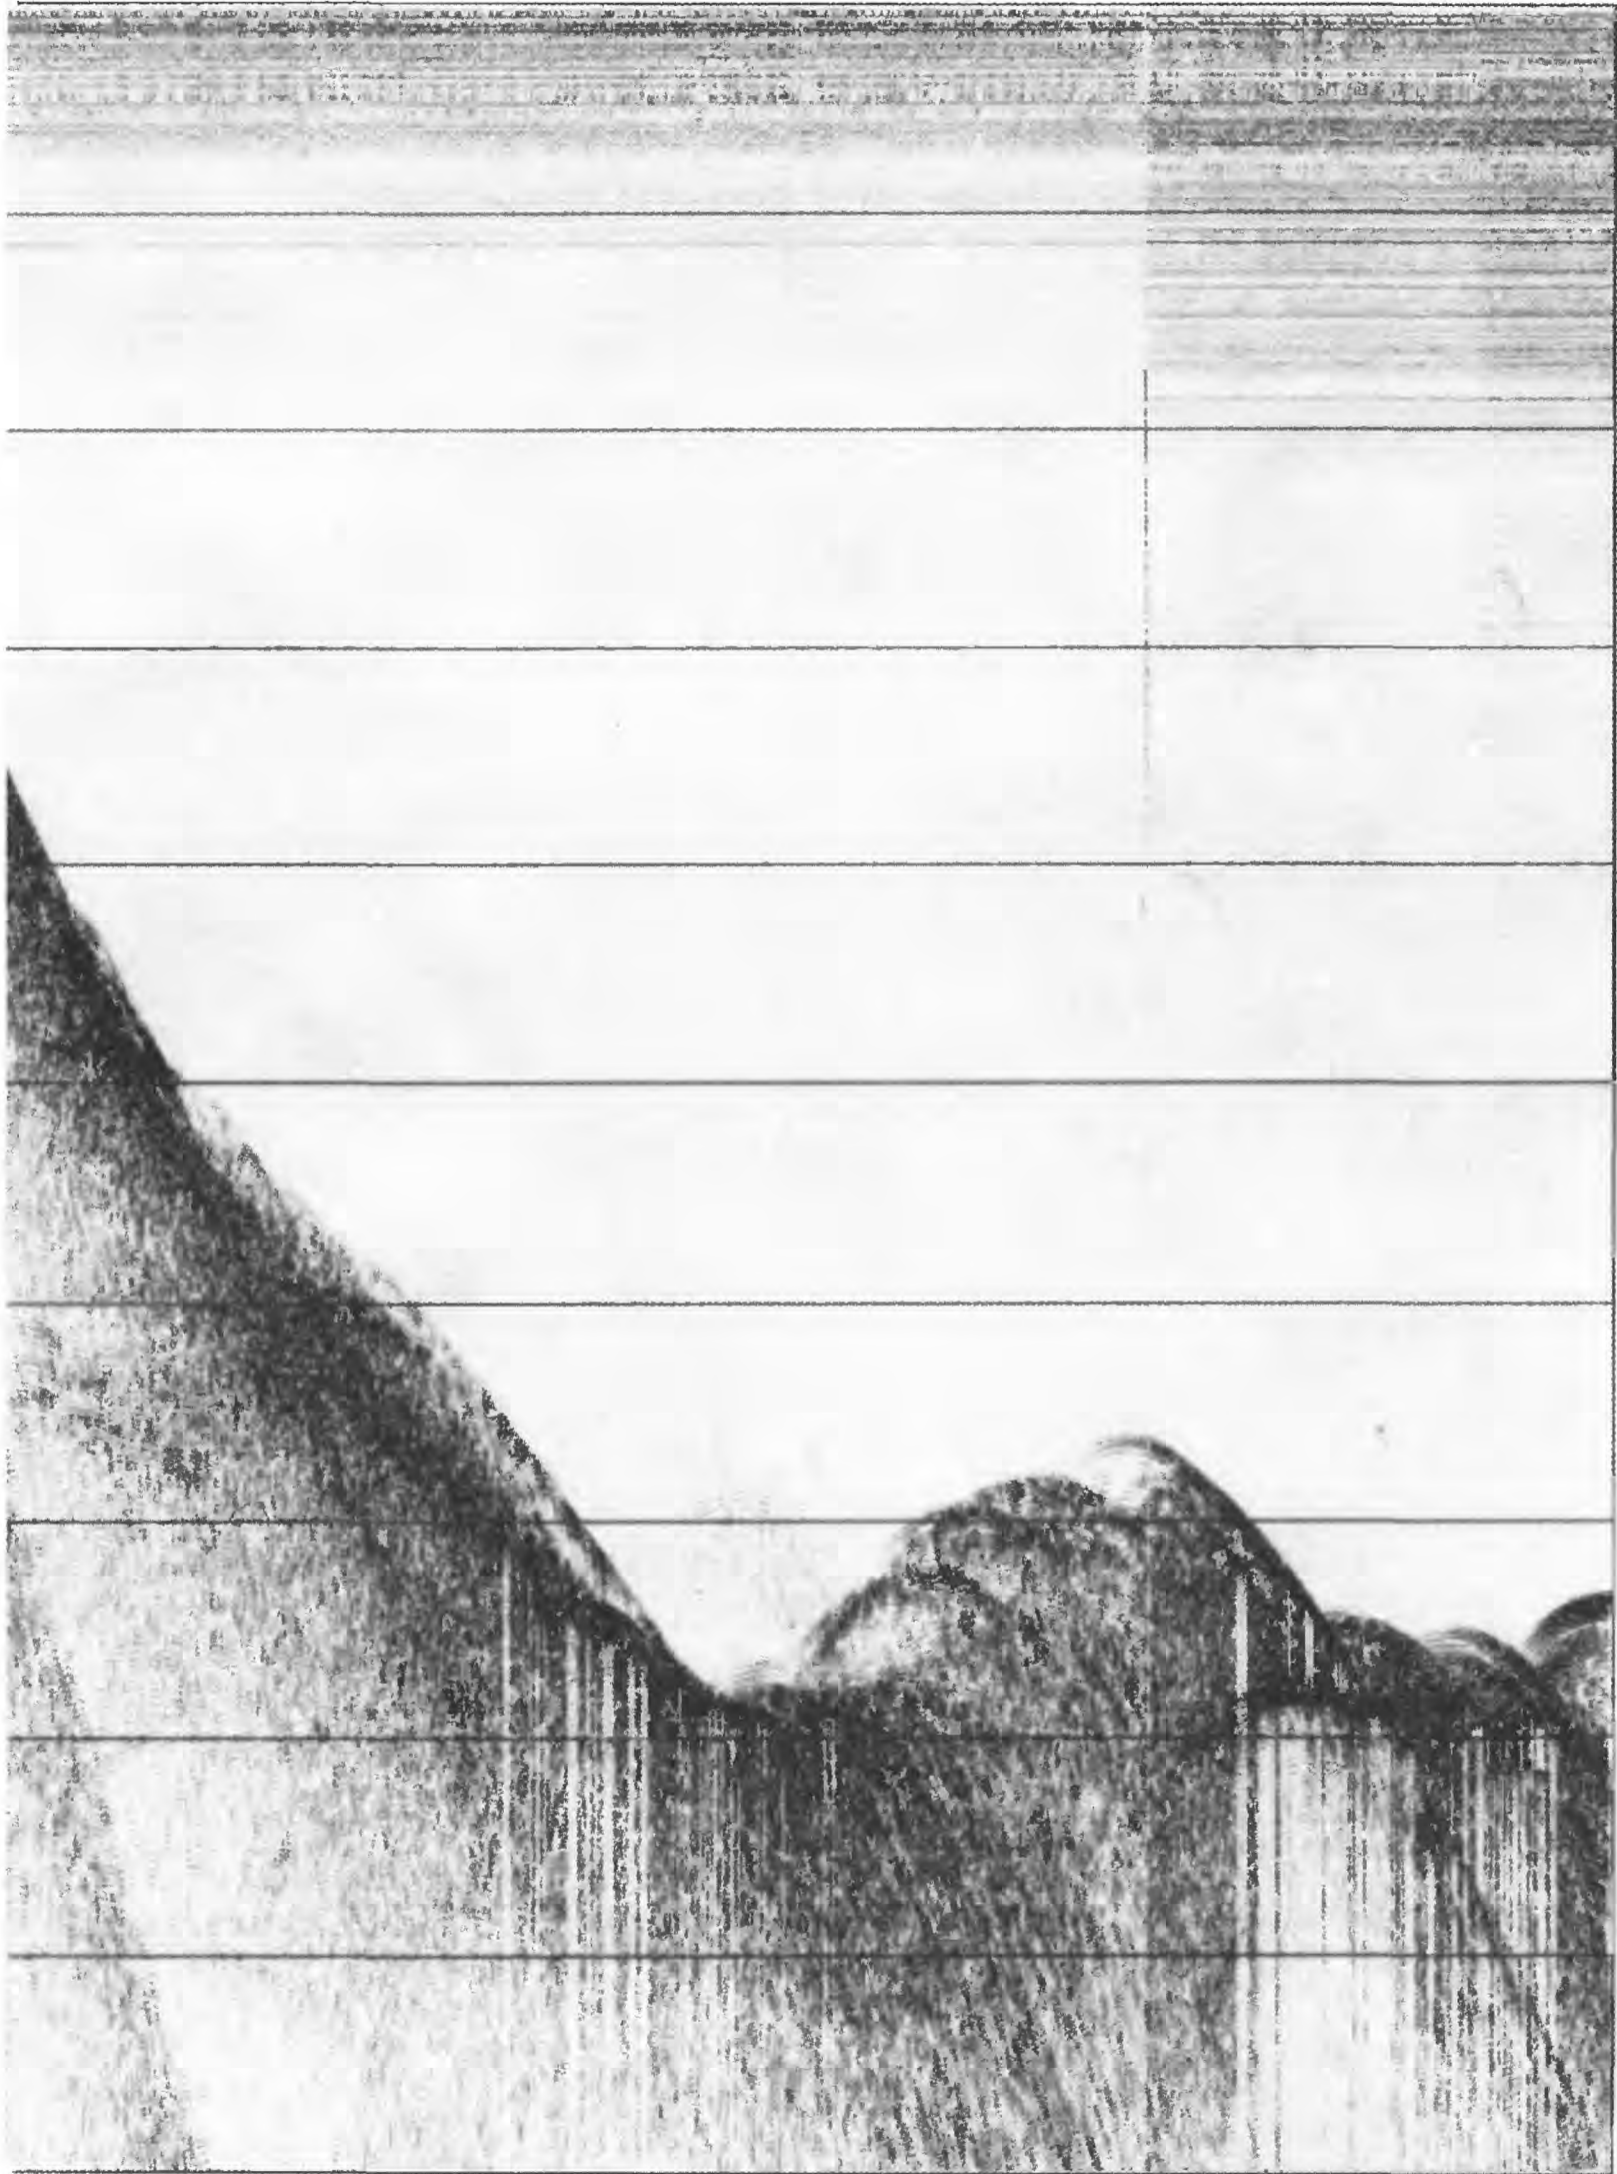
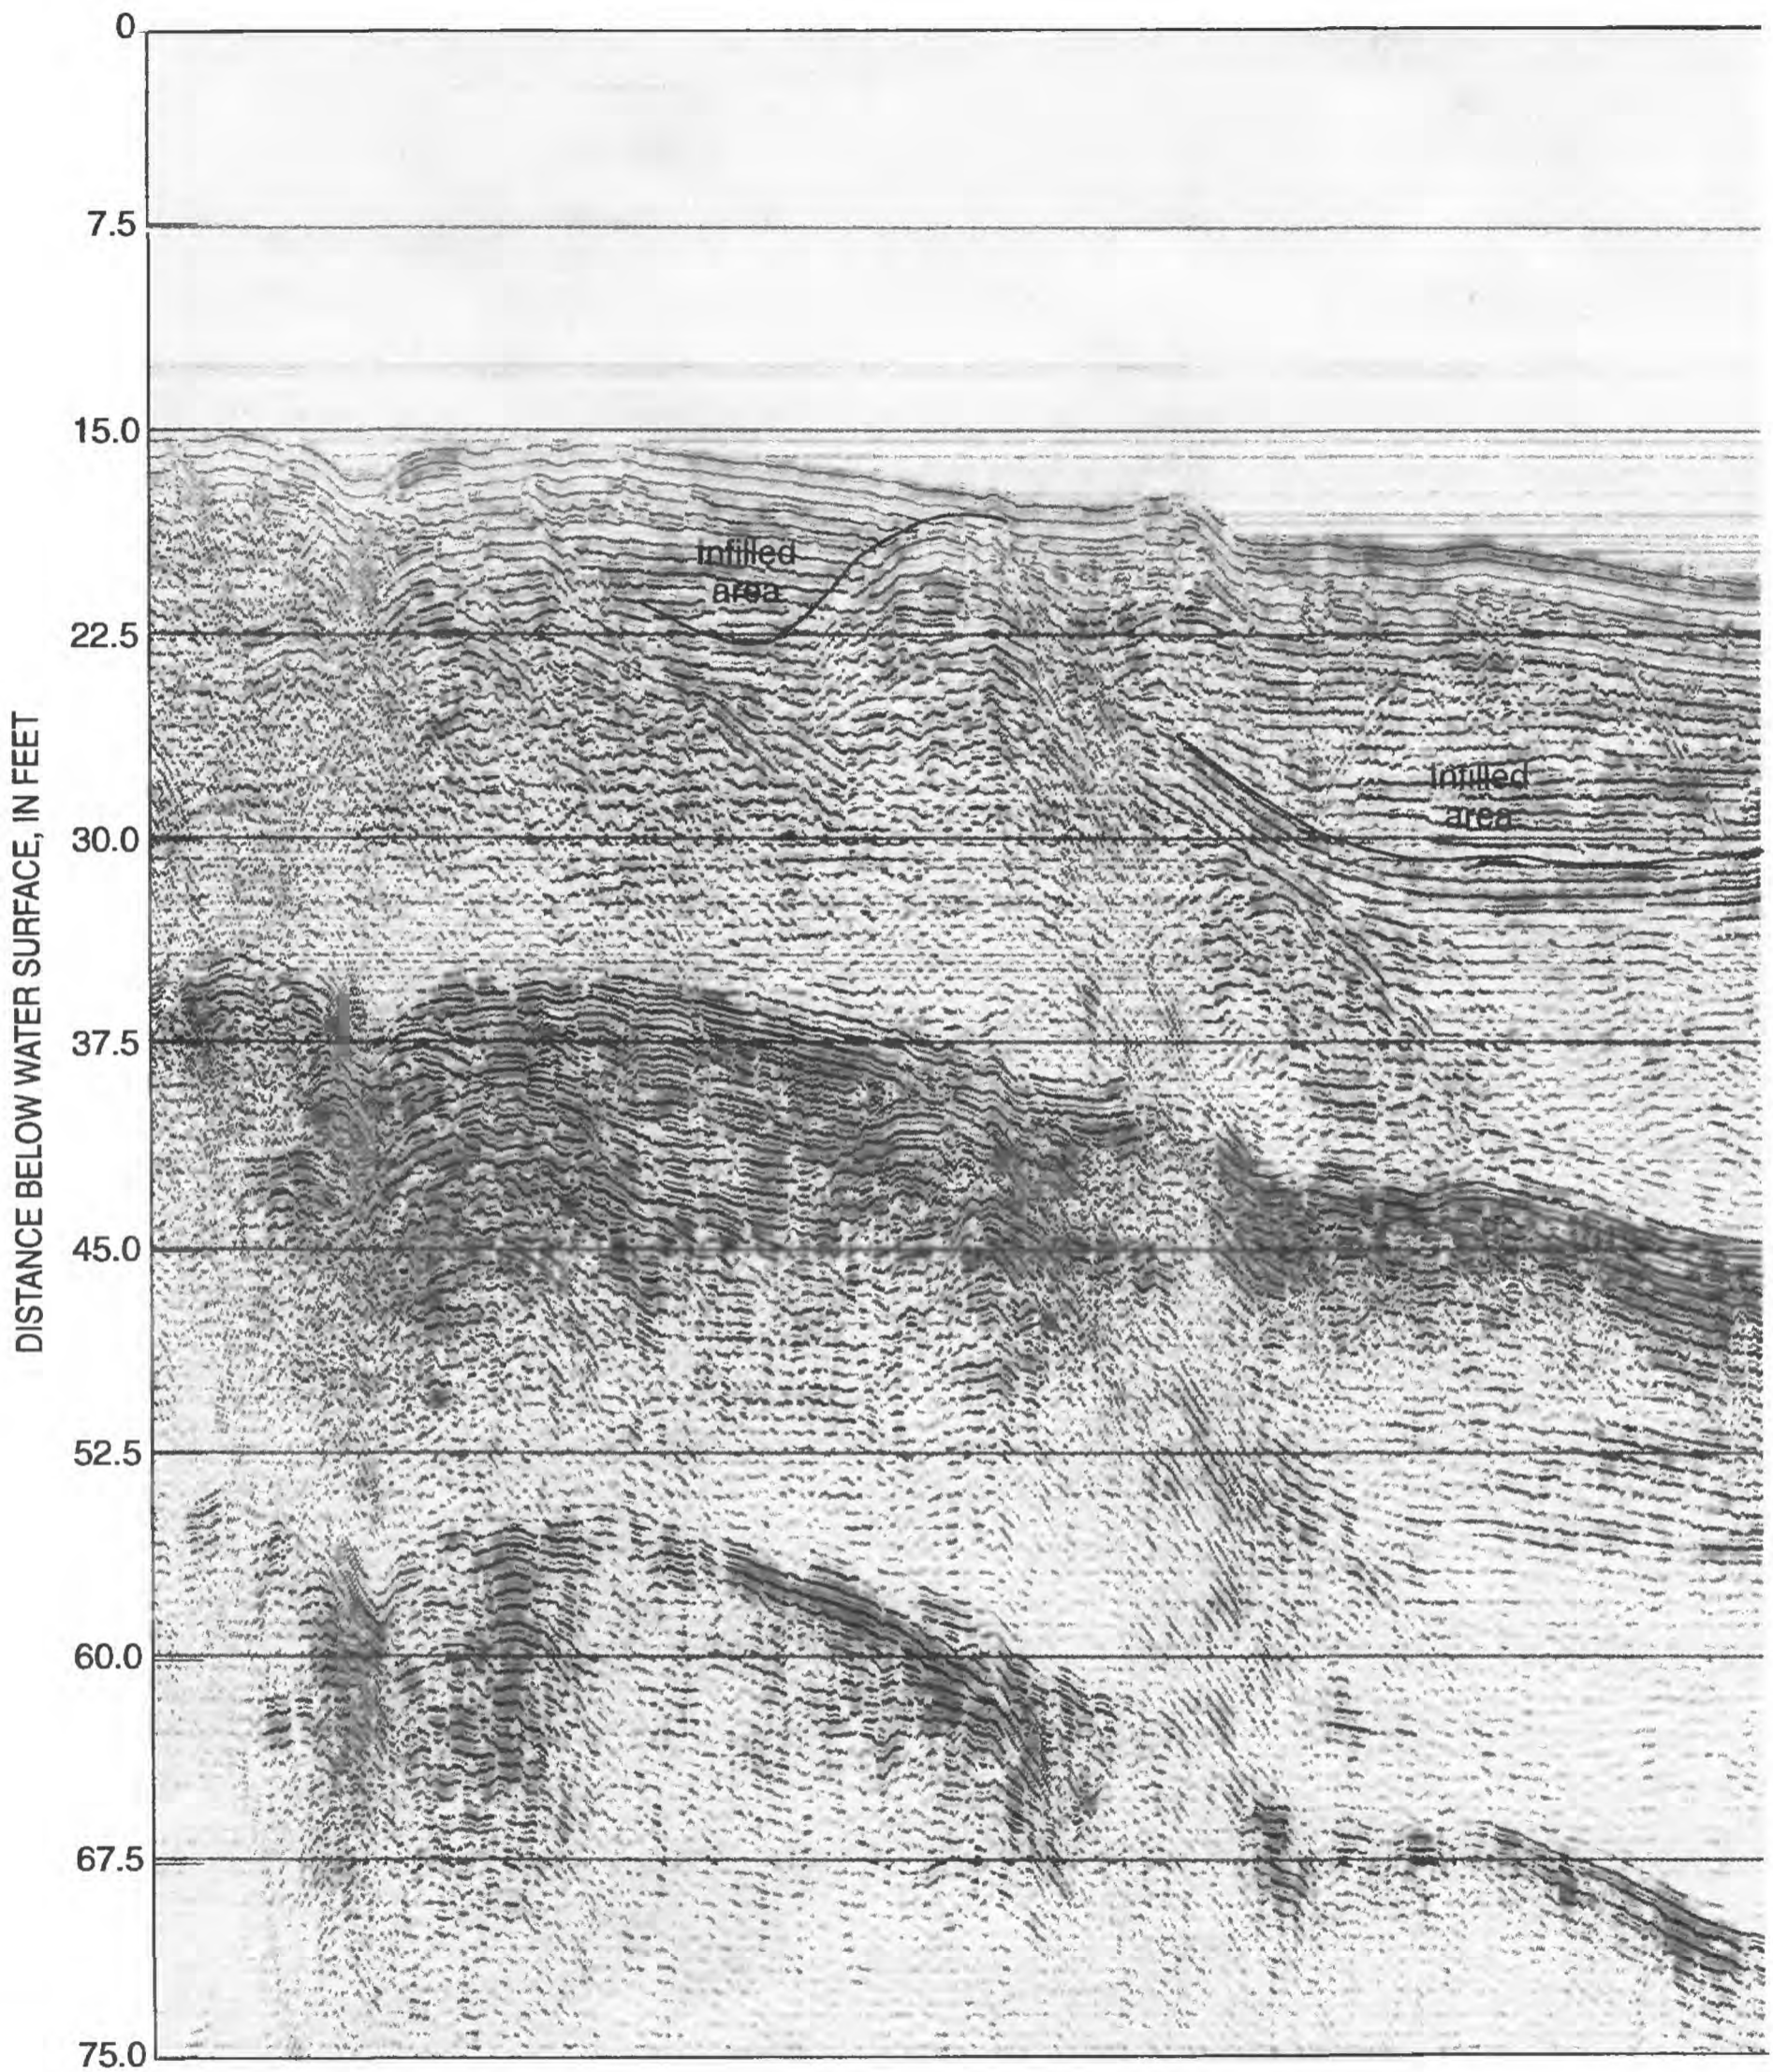
**Figure 33.** Record of 7.0-kHz continuous seismic reflection cross section from Profile 2 at Miles Lake.
