# INVESTIGATION OF BRIDGE SCOUR AT SELECTED SITES ON MISSOURI STREAMS

Water-Resources Investigations Report 94-4200

By LAWRENCE D. BECKER

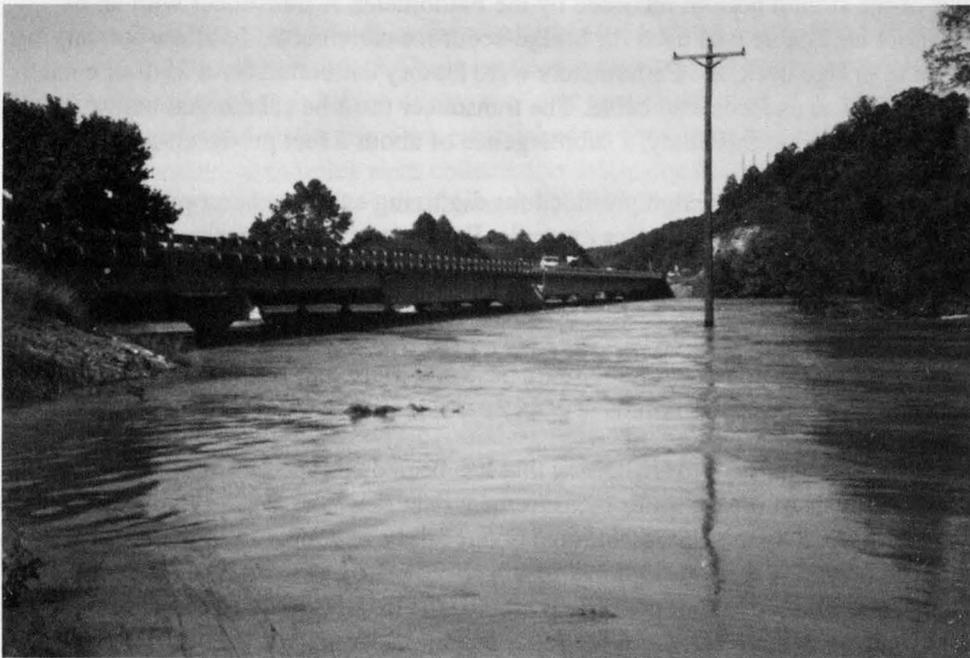
**Figure 2.** View of downstream side of bridge at time of scour measurement made during the flood of September 28, 1993, at the Gasconade River near Rich Fountain, Missouri (station number 06934000).

To investigate bridge scour at selected sites on Missouri streams, data were collected during floods (fig. 2) large enough to cause local scour at bridge piers. This local scour involves lowering of the streambed below a natural level in the vicinity of the bridge piers. Scour measurements are needed to determine how and to what depth the streambed scours around bridge piers because of factors, such as increased flow velocities, depths, and turbulence near the upstream side of the bridge and the bridge piers. Scour depths estimated from published scour equations are compared in this report with scour depths measured onsite.

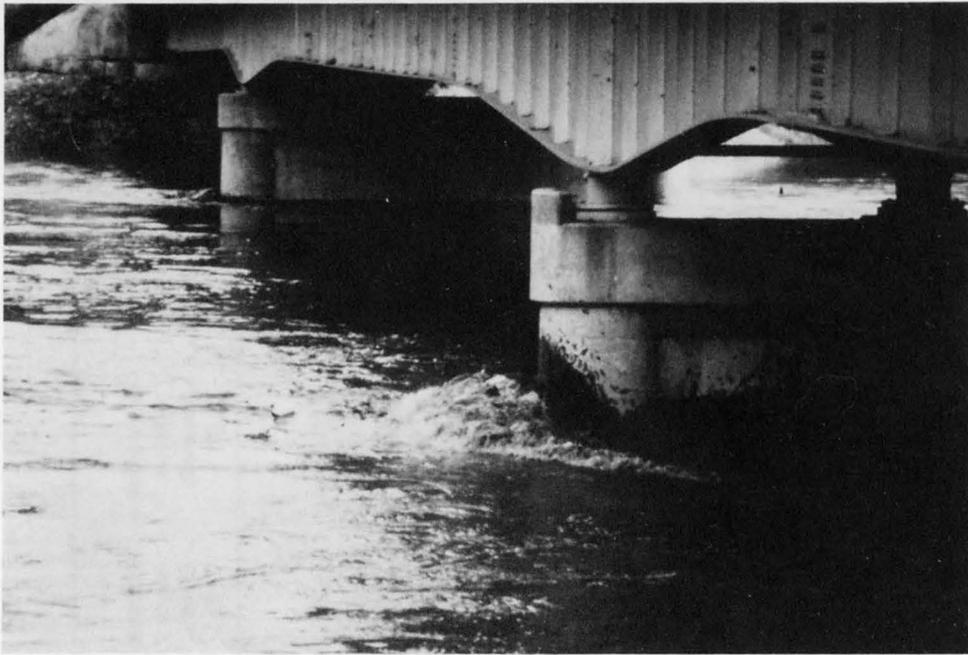
**Figure 3.** Pileup of water surface at upstream side of bridge pier during the flood of May 13, 1991, at Little Piney Creek at Newburg, Missouri (station number 06932000).

Scour measurements made during this study and review of historical discharge measurements at streamflow-gaging stations resulted in 54 sets of data collected during 24 floods (table 2). Measured scour holes at piers ranged from 0.5 to 7.1 feet deep. The deepest scour hole (7.1 feet) was determined from Fathometer soundings along the upstream side of the bridge at the Grand River near Sumner during the flood on March 16, 1990. Local scour depths presented in this report (table 2) are scour depths attributable to local scour only, at the time of and under conditions existing during the scour measurement. Flow disturbances at and near piers that cause local scour to occur are shown in figures 3 and 4.

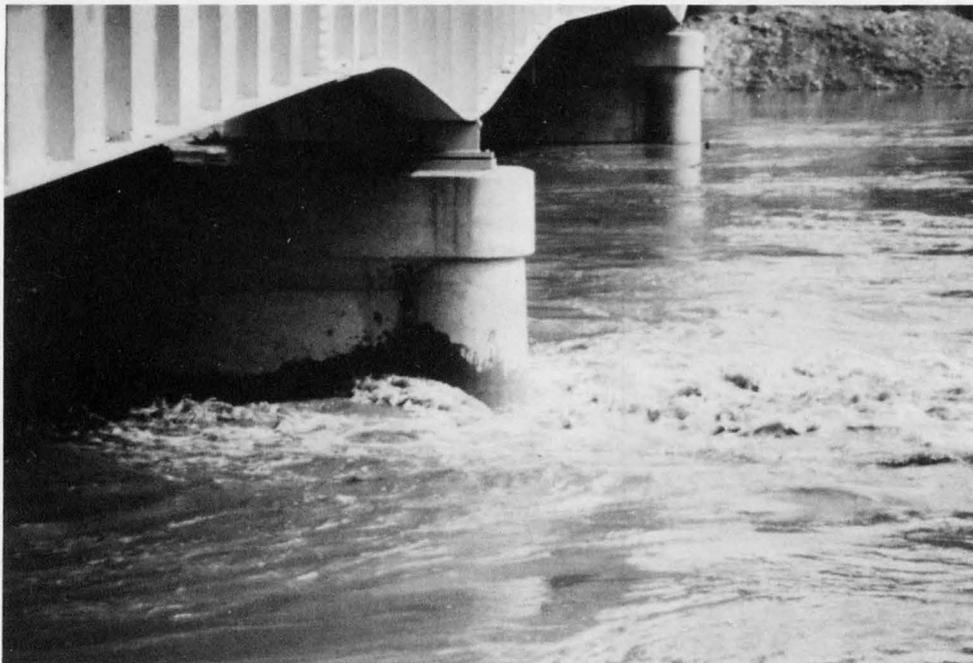
**Figure 4.** Turbulent flow at and downstream from bridge pier during the flood of May 13, 1991, at Little Piney Creek at Newburg, Missouri (station number 06932000).

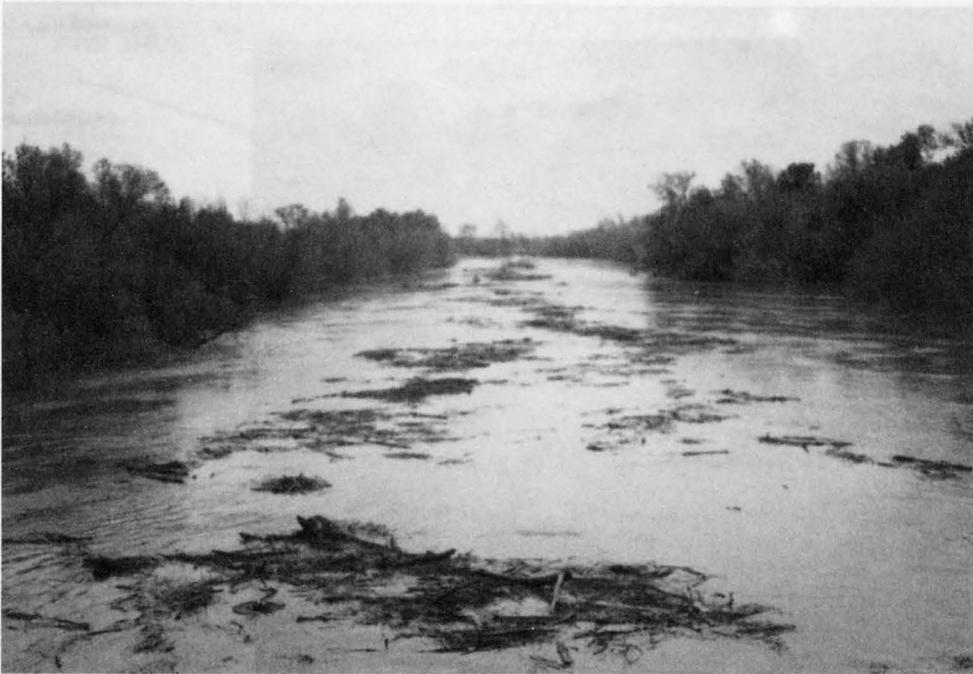
**Figure 5.** Floating woody debris during the flood crest on April 21, 1991, at the Grand River near Sumner, Missouri (station number 06902000; view downstream from bridge on State Highway 139).

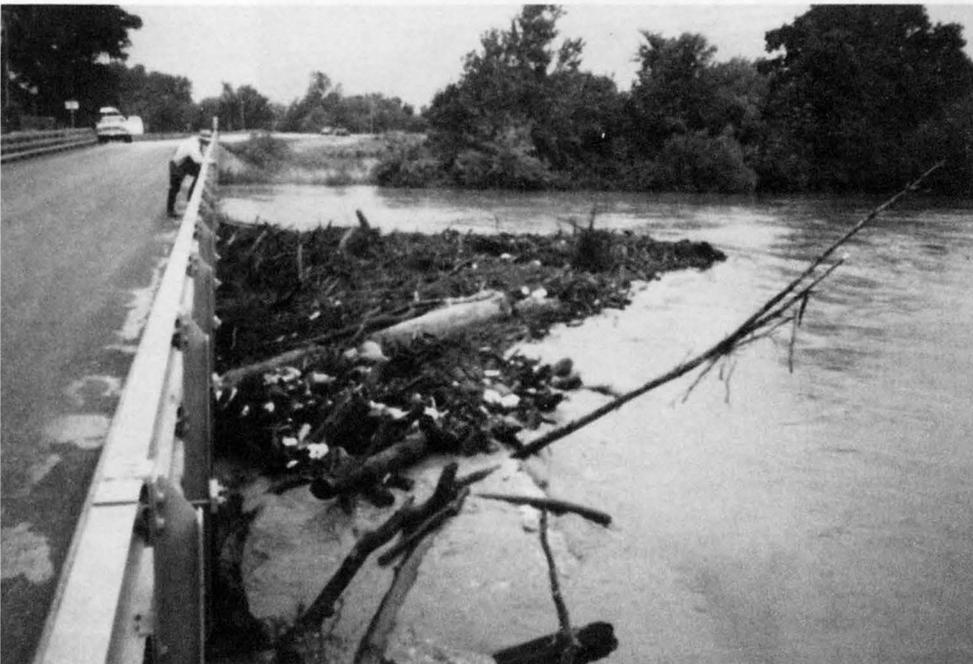
**Figure 6.** Woody debris accumulated against the center bridge pier partially blocking the bridge opening on the upstream side during the flood of July 8, 1993, at the Chariton River near Prairie Hill, Missouri (station number 06905500).

One effect of lodged debris, with respect to scour, is that it effectively increases pier width and decreases the bridge-opening area. At some bridges located on sand channel streams in northern Missouri, debris accumulated on the piers during larger floods to such an extent that the bridge opening was contracted to a degree that caused or increased scour remote from the piers. When such partial blockage of the bridge opening occurs, increased contraction scour can occur, resulting in scour depths that are much greater than would be attributable only to local scour.

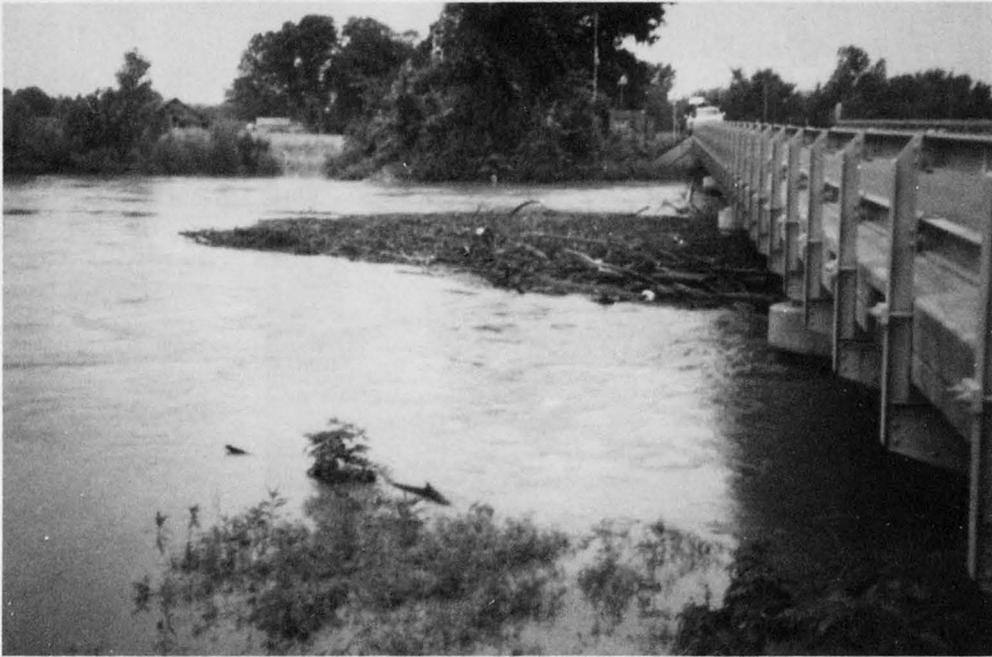
**Figure 7.** View of the downstream side of bridge and woody debris accumulated on the center pier extending completely through the bridge opening during the flood of July 8, 1993, at the Chariton River near Prairie Hill, Missouri (station number 06905500).

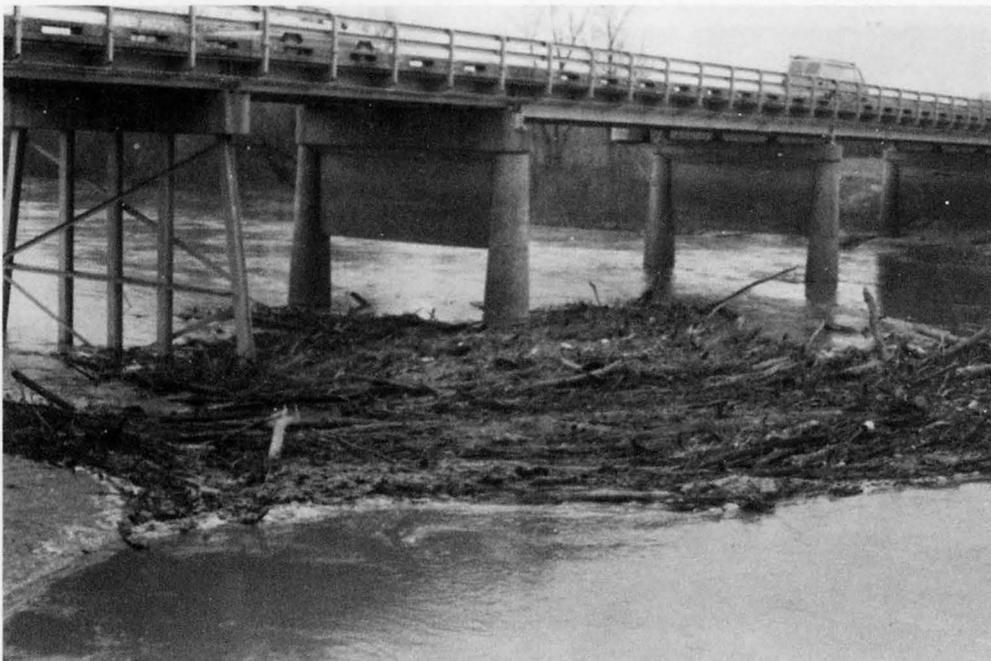
**Figure 8.** Woody debris accumulated on upstream side of bridge piers partially blocking the bridge opening following the flood of April 12, 1992, at the Chariton River at Novinger, Missouri (station number 06904500).

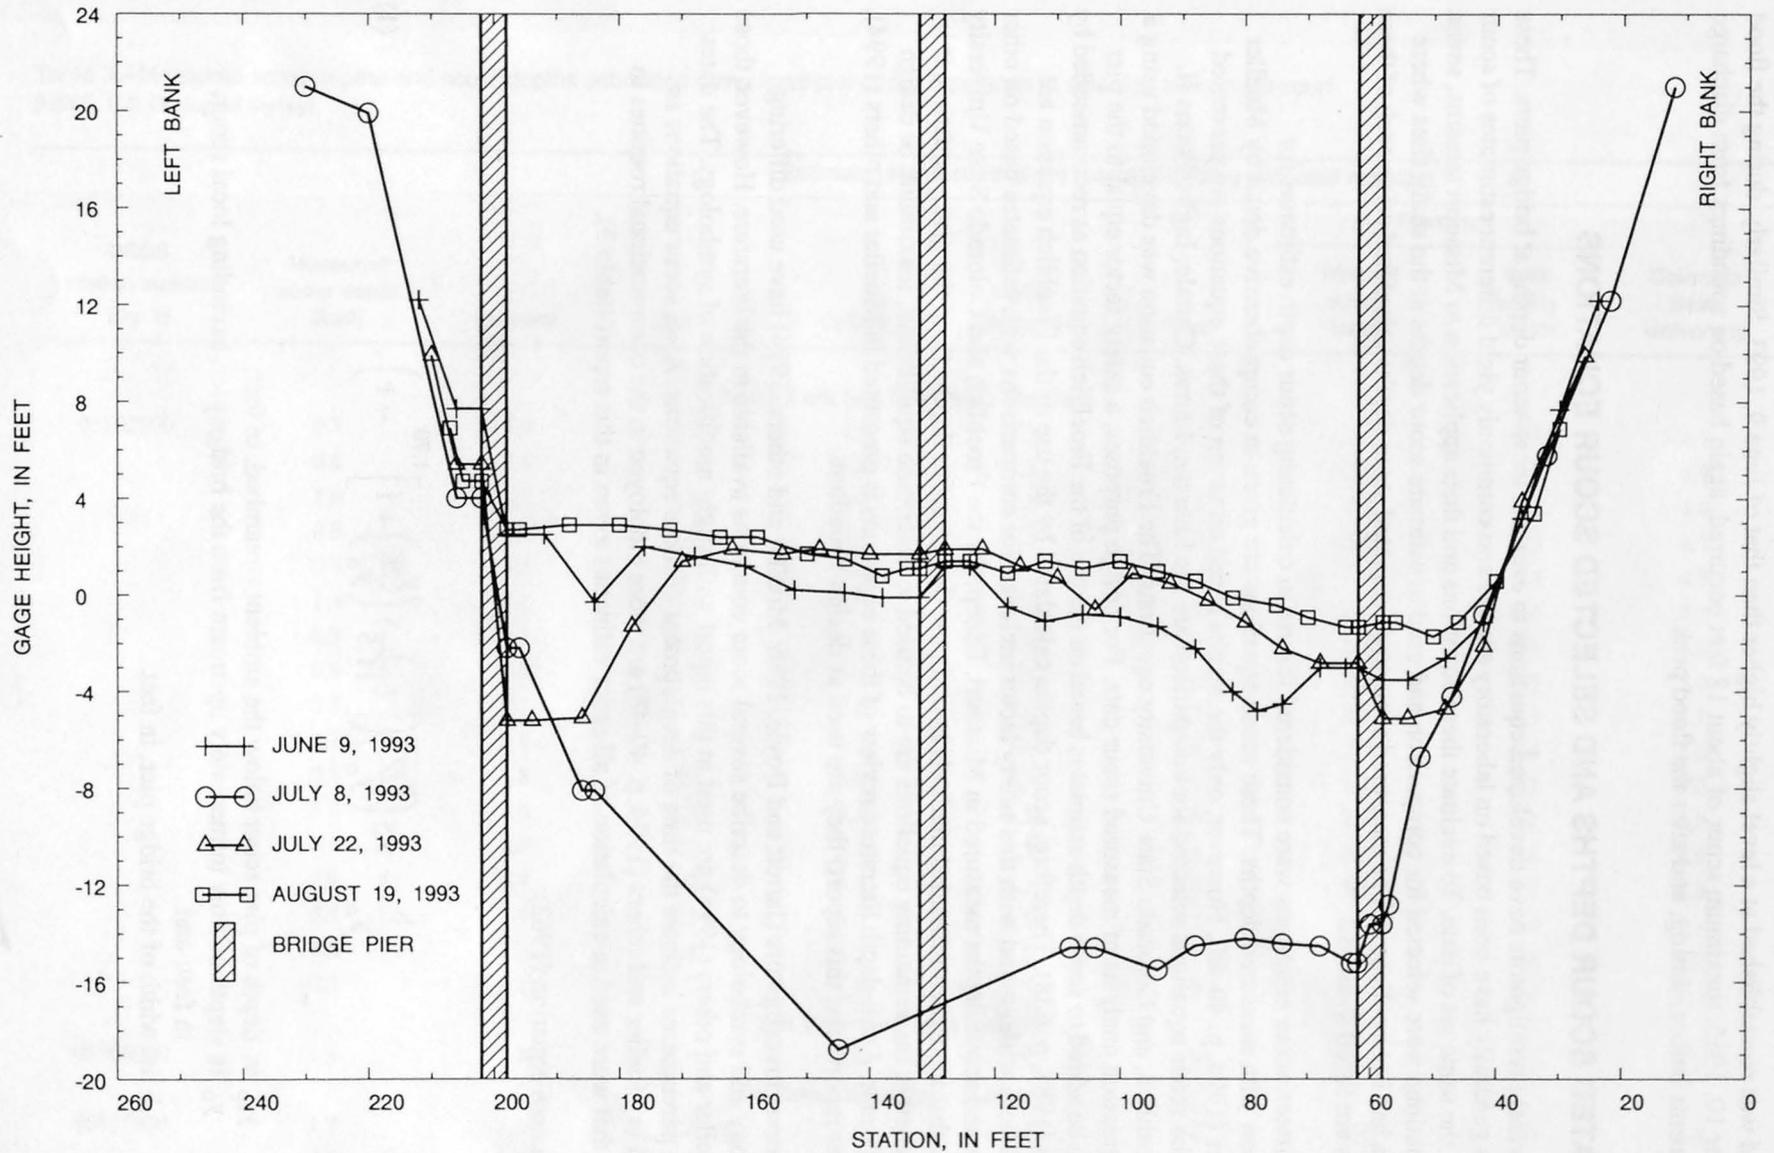
Figure 9. Streambed cross sections at the Chariton River near Prairie Hill, Missouri (station number 06905500; soundings along downstream side of bridge).

This phenomenon of increased scour has been shown to occur during extreme floods at the Chariton River near Prairie Hill site by comparison of cross-sectional data from discharge measurement soundings made before, during, and after flood peaks. For example, during the July 8, 1993, flood, the streambed was lowered, as shown in figure 9, by about 19 feet at the downstream side of the bridge in comparison to streambed levels recorded on June 9, 1993. This temporary degradation is attributable to combined effects of contracted flow at the bridge and partial blockage of the bridge opening by woody debris (figs. 6 and 7). A cross section obtained during a discharge measurement on August 19, 1993, indicated (fig. 9) that the

streambed was reestablished at a level slightly higher than that of June 9, 1993. Similarly, during the flood of October 10, 1985, maximum scour of about 18 feet occurred, again based on soundings from discharge measurements before, during, and after the flood peak.

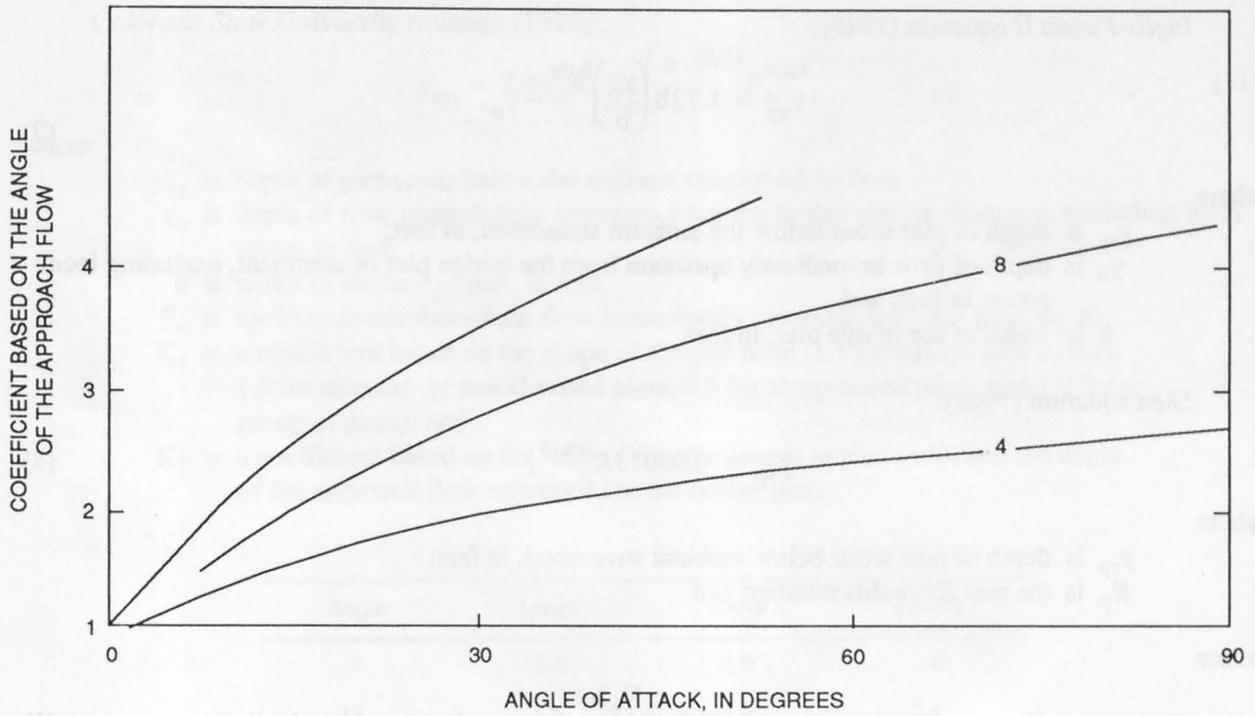
**Figure 10.** Effect of angle of attack on bridge pier (modified from Laursen, 1962, p. 177).

Laursen found that the most important aspect of the geometry of the pier was the angle of attack between the pier and the flow, coupled with the length-width ratio of the pier. The shape of the pier also is important if the pier is aligned with the flow. Therefore, the depth of scour from equation 1 must be corrected for pier shape if the pier is aligned with the flow

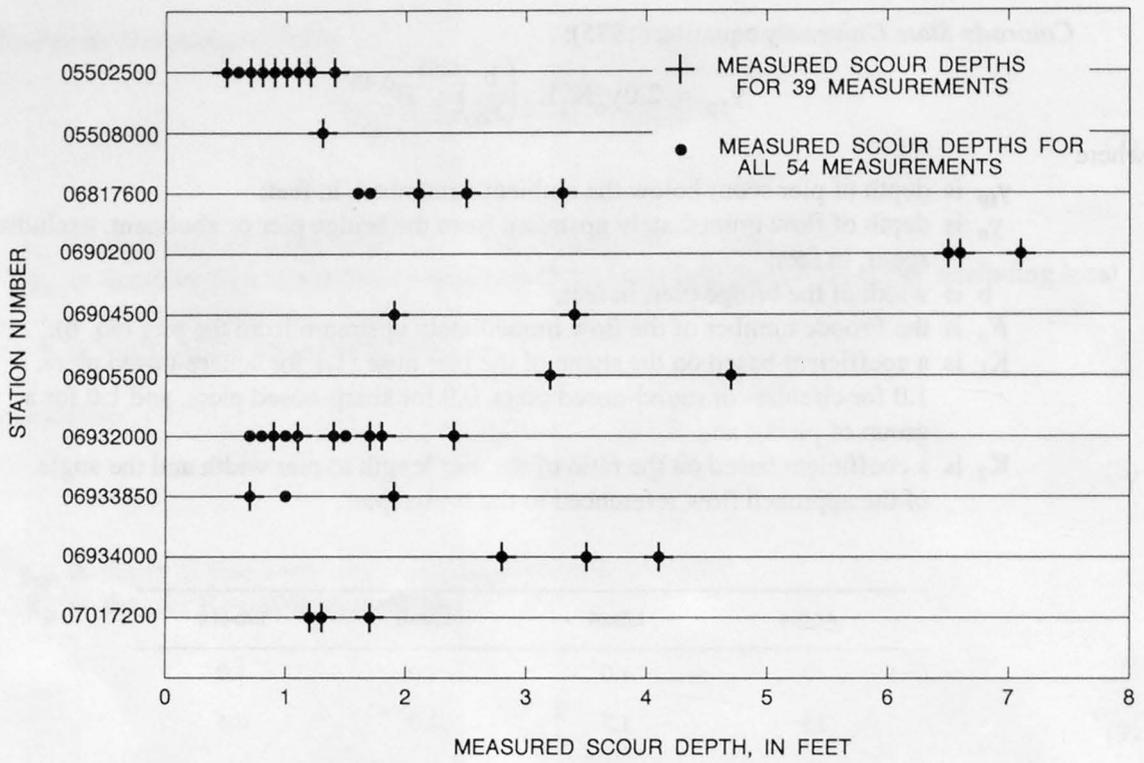
Figure 11. Measured scour depths for each of the selected sites in Missouri.

Scour parameters (equation variables) of pier width, mean bed-material diameter, flow depth, and flow velocity were used as ordinate values and the depth was used as the abscissa value for each scour measurement to indicate the relation the scour parameters have with scour depths (figs. 12-15; table 2). Because all piers were considered round-nosed and no appreciable flow angles of attack were experienced at these piers during scour measurements, neither pier shape nor angle of attack was a factor related to measured scour depths. The bed-material samples obtained during this study are assumed to be representative of the bed-material size at the time of the scour measurements. Some piers were tapered from top to bottom resulting in effective pier widths normal to flow that varied with flow depths. For the 10 sites in Missouri, these figures indicate that measured scour depths are not dependent on, nor can they be

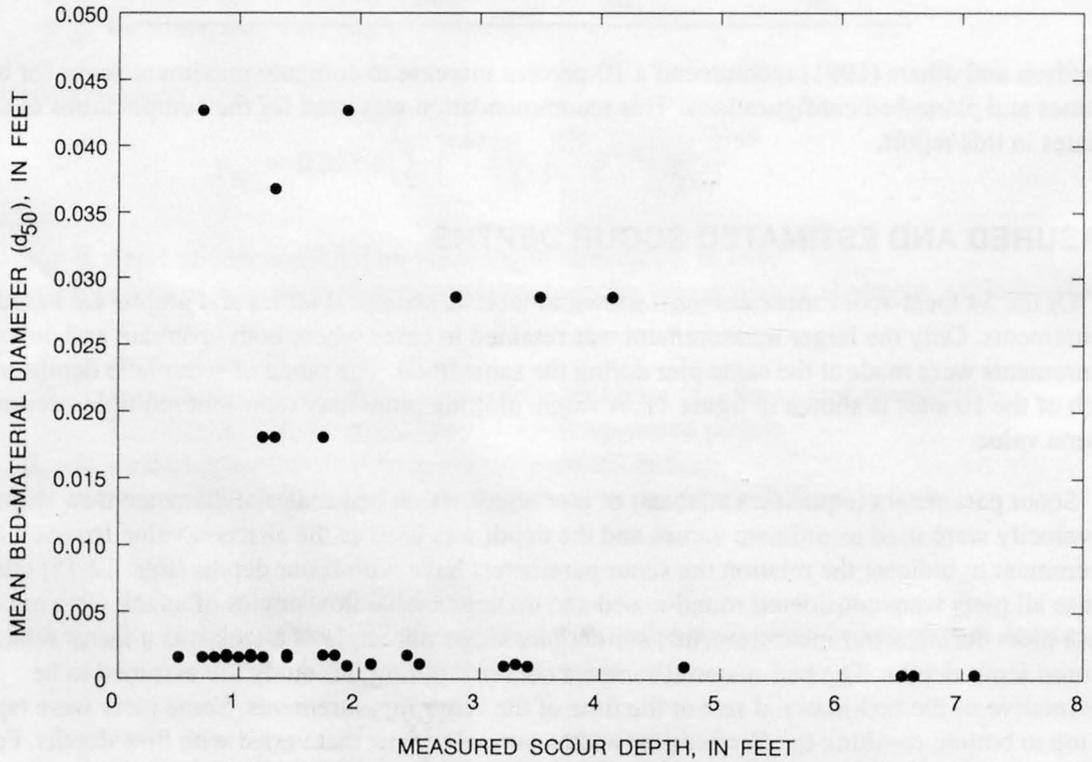
Figure 12. Relation between mean bed-material diameter and measured scour depth at selected sites in Missouri.

explained by, any one single variable because the plotted values in each graph do not describe definite, close fitting lines of relation with scour depth. However, flow depth indicated the most significant relation with depth of scour.

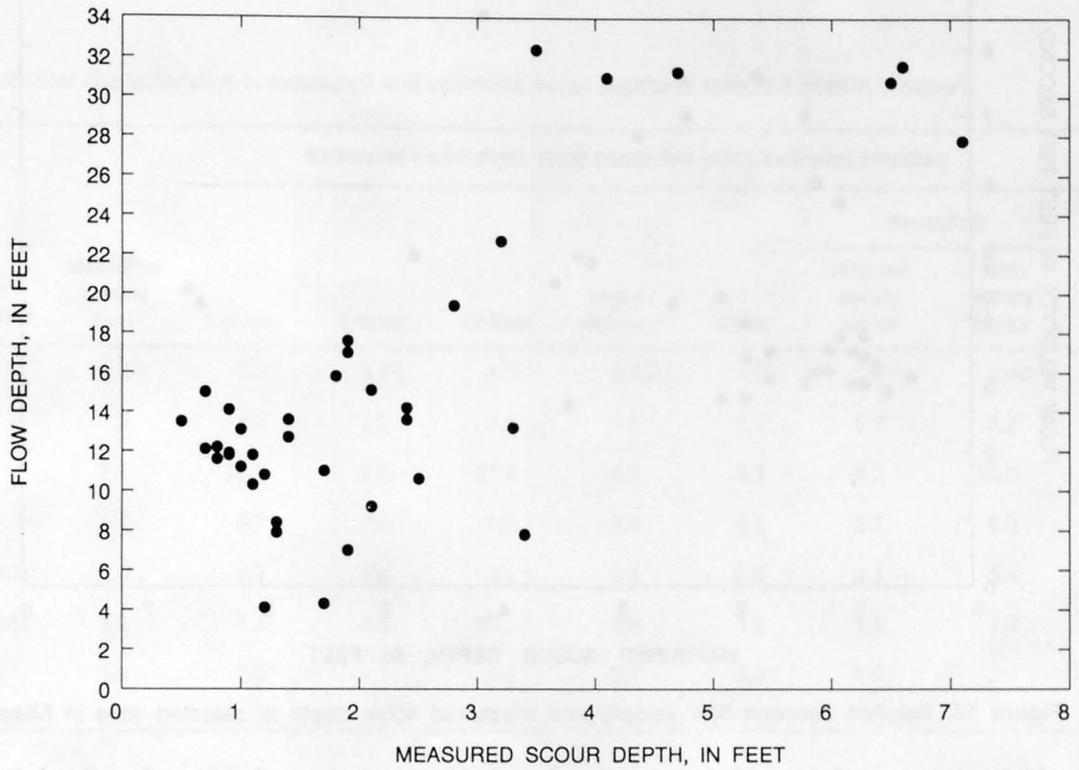
**Figure 13.** Relation between flow depth and measured scour depth at selected sites in Missouri.

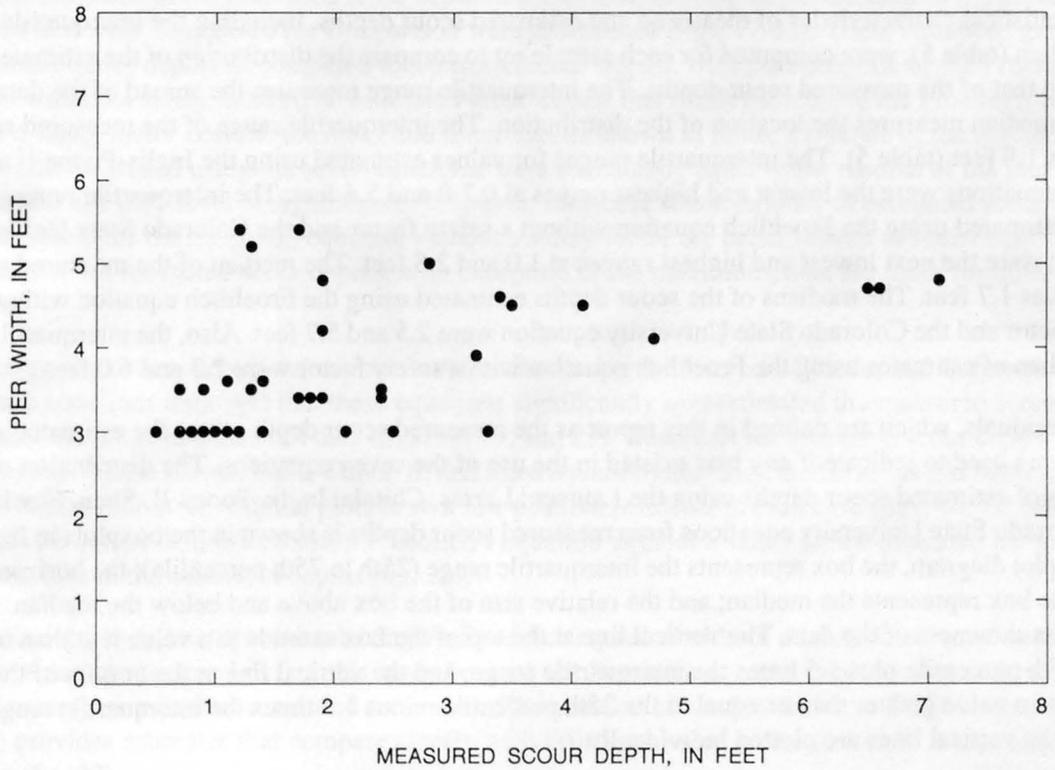
**Figure 14.** Relation between pier width and measured scour depth at selected sites in Missouri.

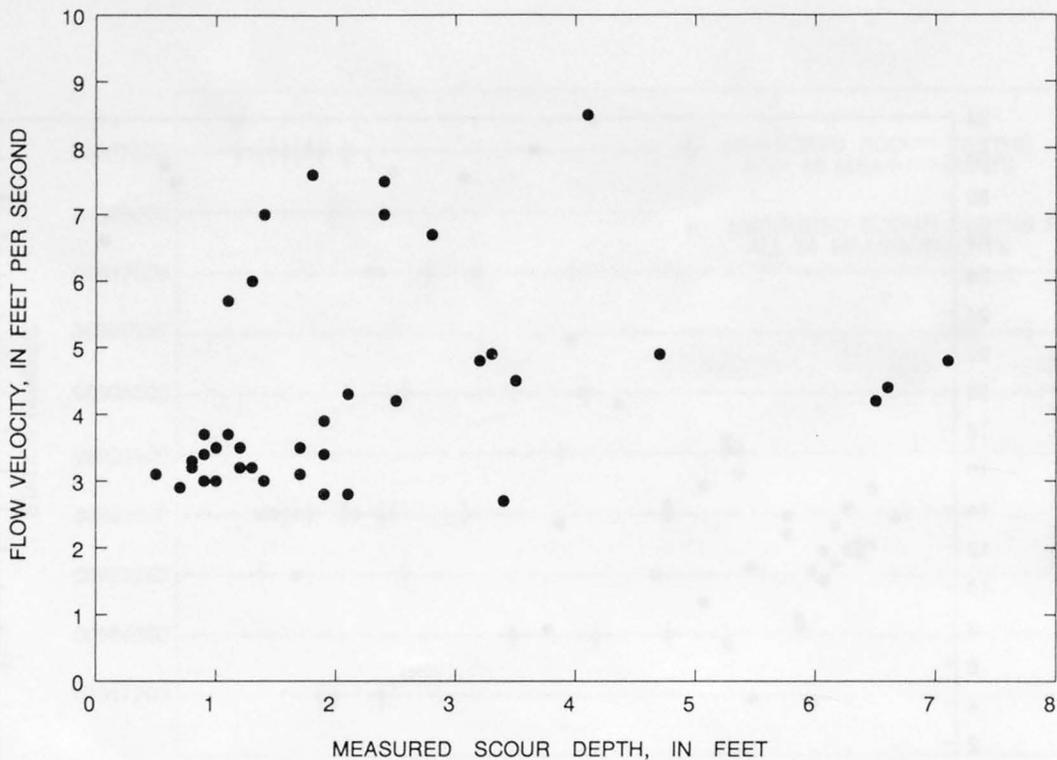
**Figure 15.** Relation between flow velocity and measured scour depth at selected sites in Missouri.

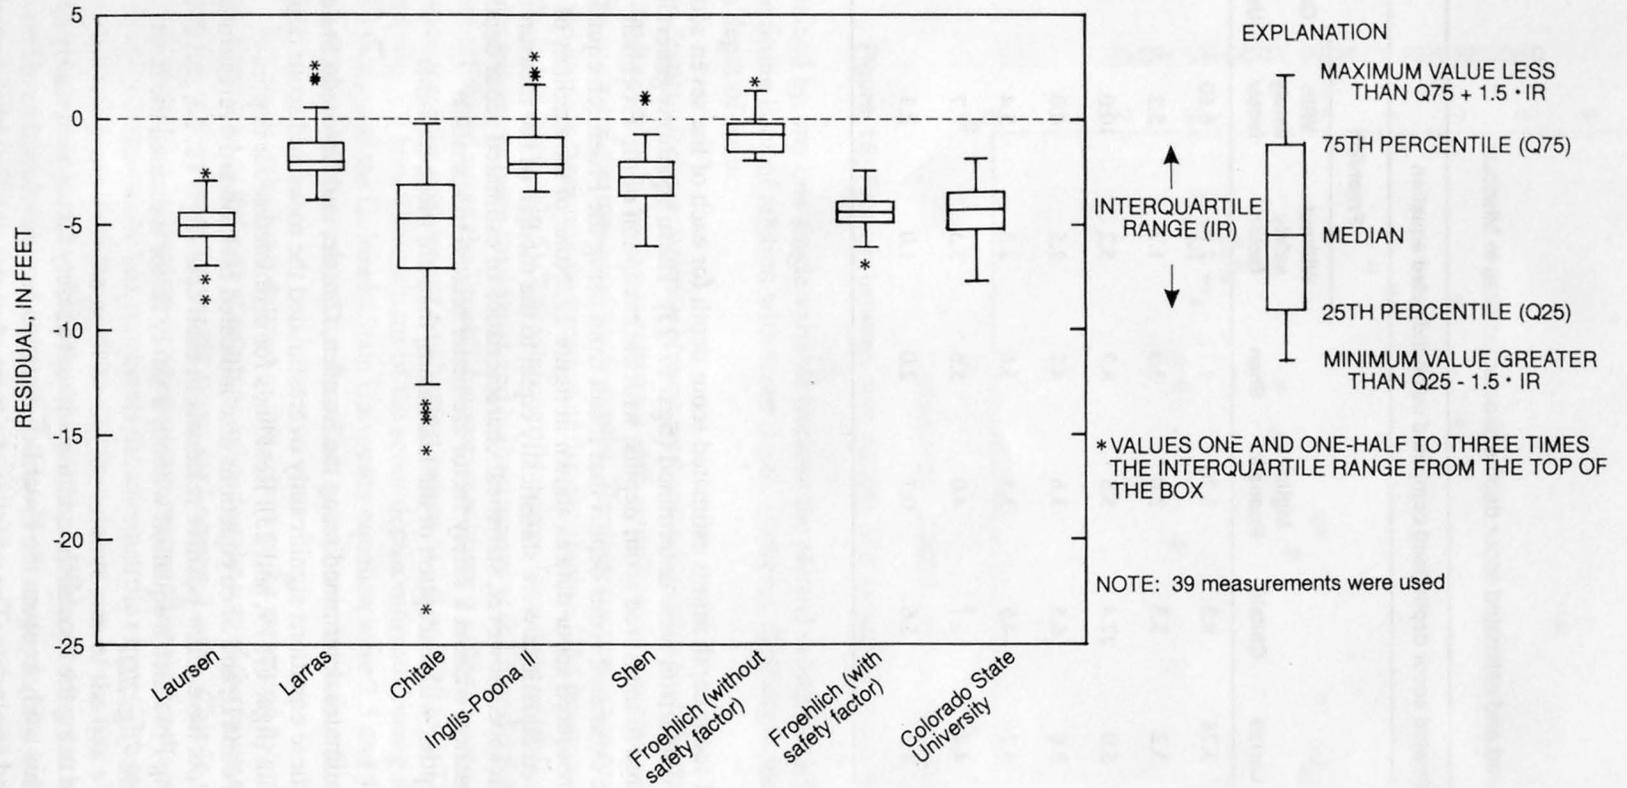
**Figure 16.** Distribution of residuals of estimated scour depths (using scour equations) from measured scour depths at selected sites in Missouri.

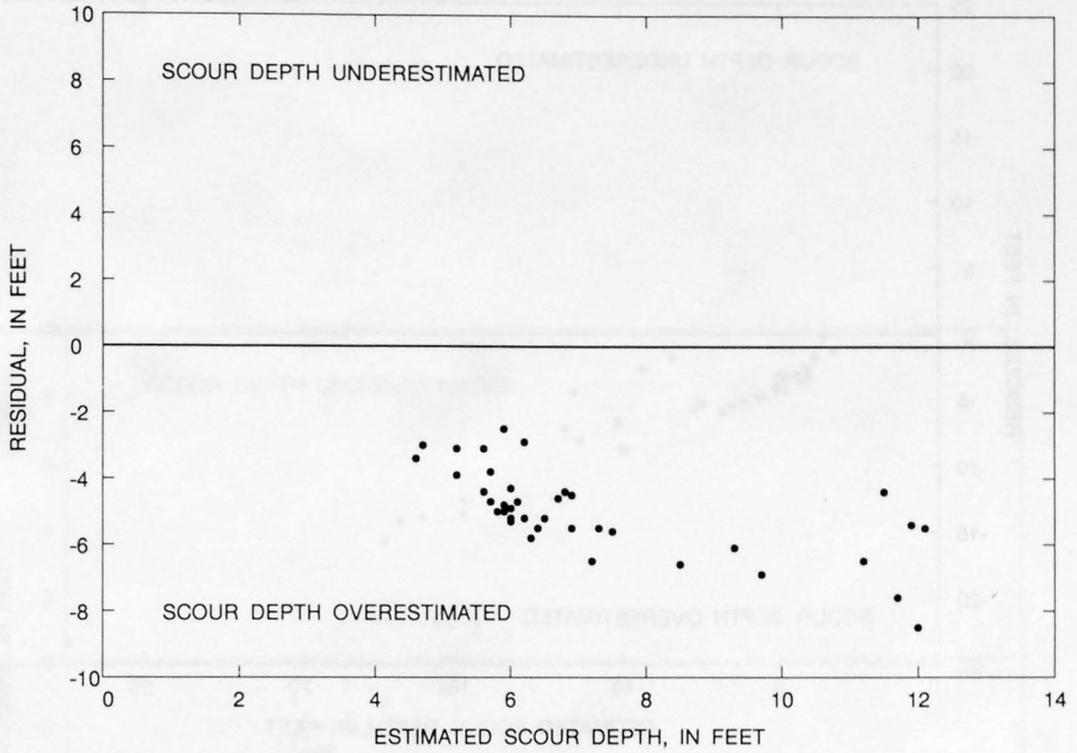
**Figure 17.** Relation between scour depth estimated using the Laursen equation and the residual (measured scour depth minus the estimated scour depth) at selected sites in Missouri.

Large negative residuals for estimates determined using the Laursen, Chitale, and Colorado State University equations indicated that these equations significantly overestimated the measured scour depths throughout the range of measured data (figs. 17, 19, and 23). Residuals for estimated scour depths determined using the Larras, Inglis-Poona II, and Shen equations also indicated bias toward overestimation of scour depths, but these residual plots have a few positive residuals in each case (figs. 18, 20, and 21). Residuals for values determined using Froehlich's equation without a safety factor indicated the least significant bias in the estimated depths (fig. 22).

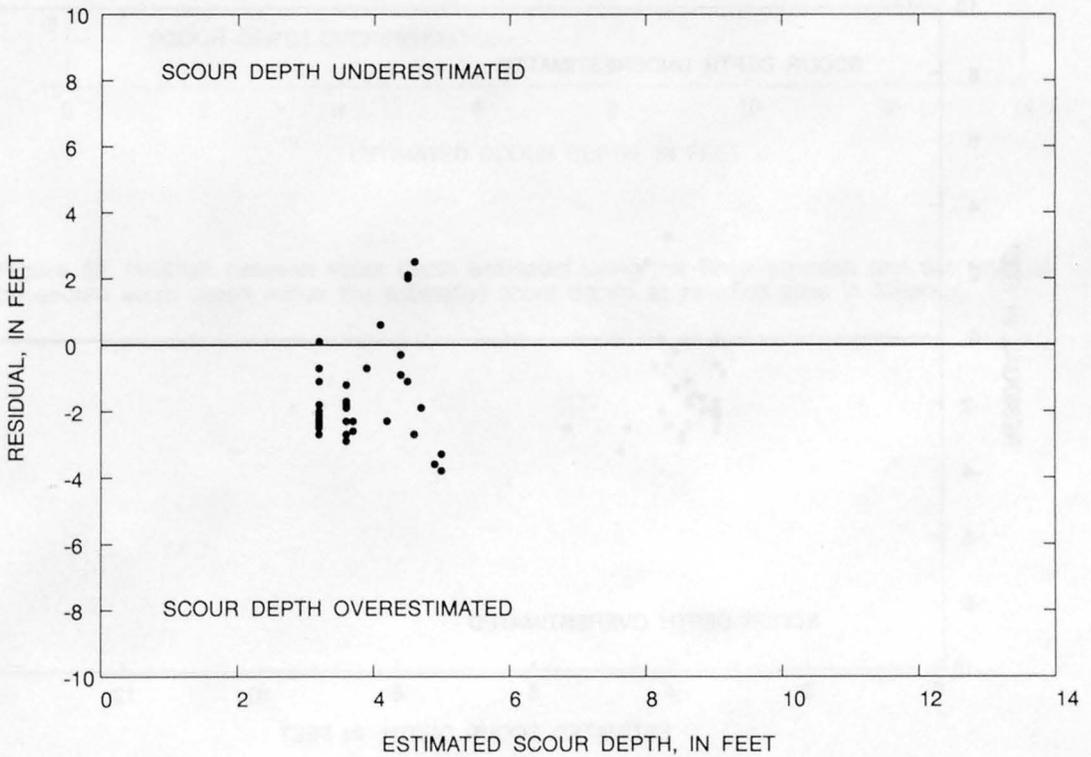
**Figure 18.** Relation between scour depth estimated using the Larras equation and the residual (measured scour depth minus the estimated scour depth) at selected sites in Missouri.

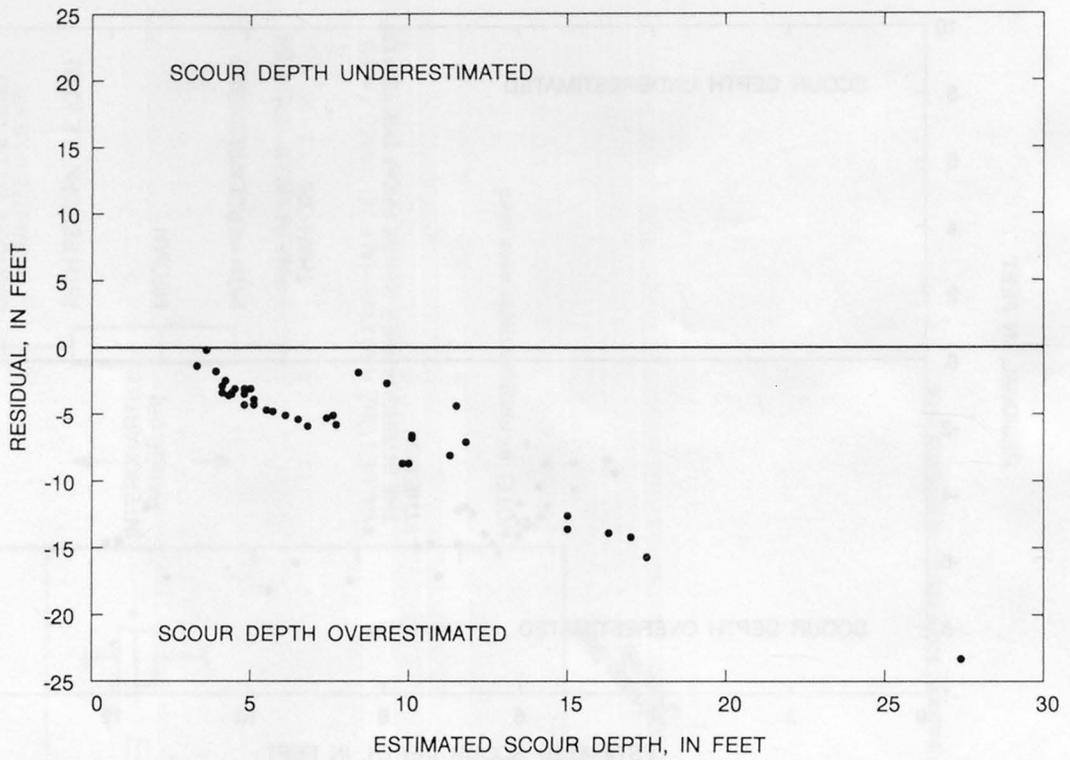
**Figure 19.** Relation between scour depth estimated using the Chitale equation and the residual (measured scour depth minus the estimated scour depth) at selected sites in Missouri.

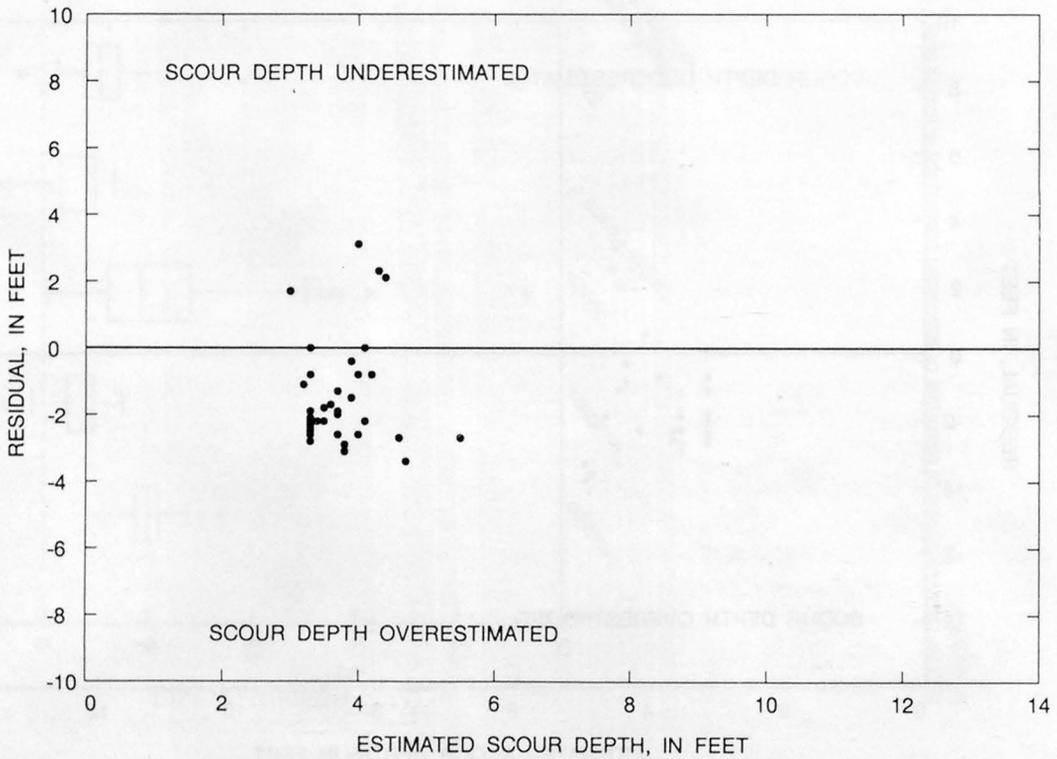
**Figure 20.** Relation between scour depth estimated using the Inglis-Poona II equation and the residual (measured scour depth minus the estimated scour depth) at selected sites in Missouri.

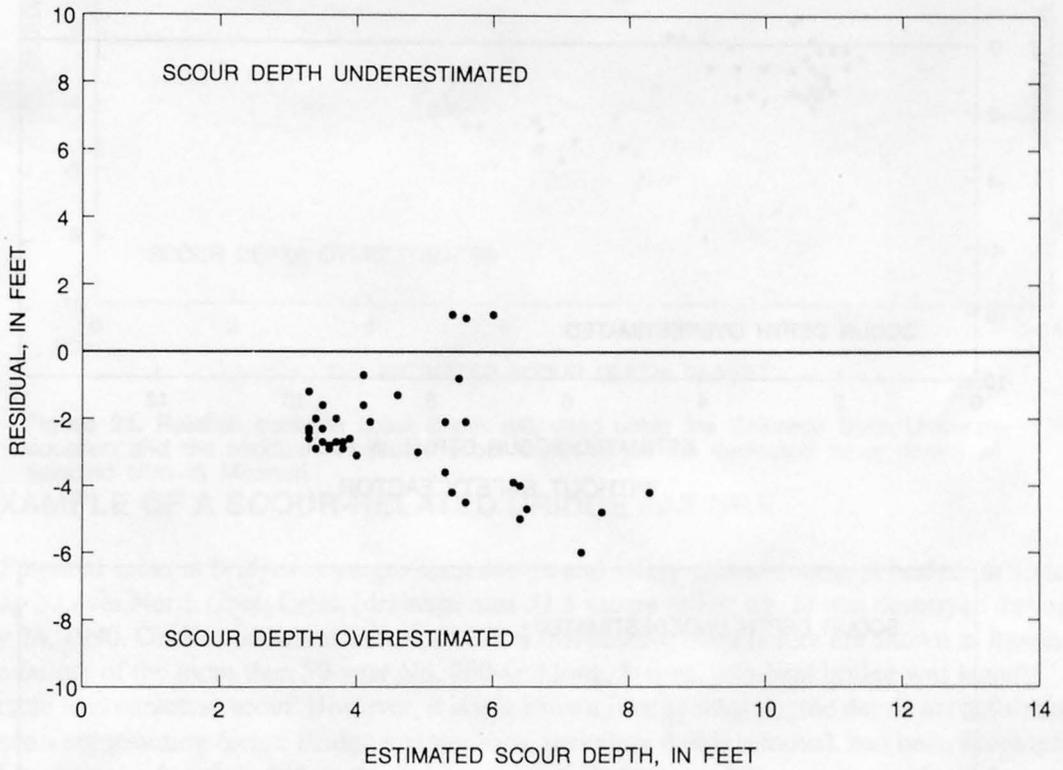
**Figure 21.** Relation between scour depth estimated using the Shen equation and the residual (measured scour depth minus the estimated scour depth) at selected sites in Missouri.

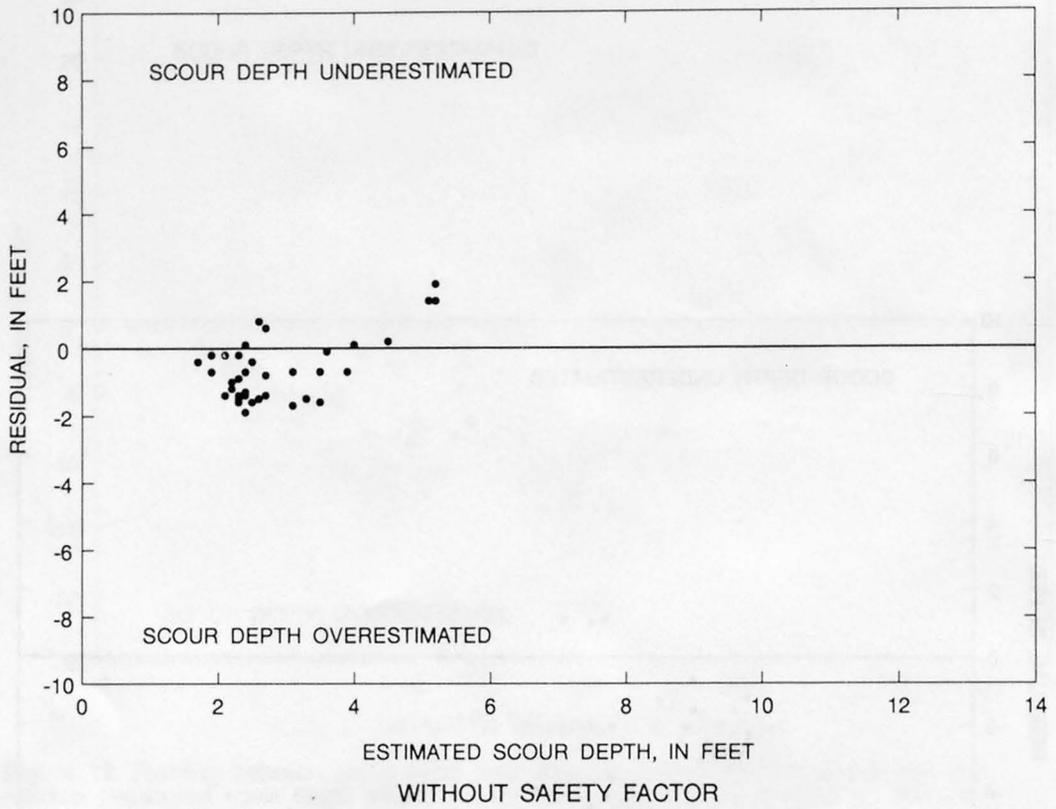
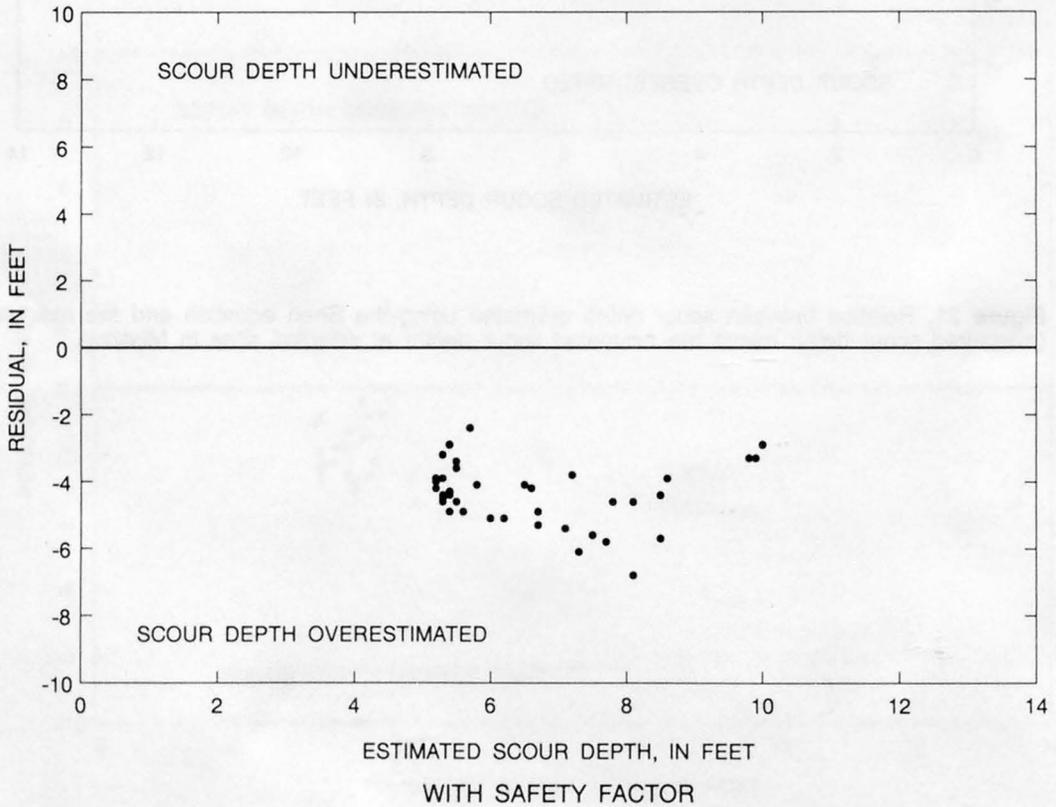
**Figure 22.** Relation between scour depth estimated using the Froehlich equation and the residual (measured scour depth minus the estimated scour depth) at selected sites in Missouri.

Scour-depth estimates obtained using the Froehlich equation without a safety factor most nearly agree with scour depths measured during this study because the Froehlich equation was developed based on regression analysis of actual measured scour data. The addition of a safety factor to the Froehlich equation (fig. 22) provides estimates that compare closely with estimates based on the Colorado State University equation (fig. 23).

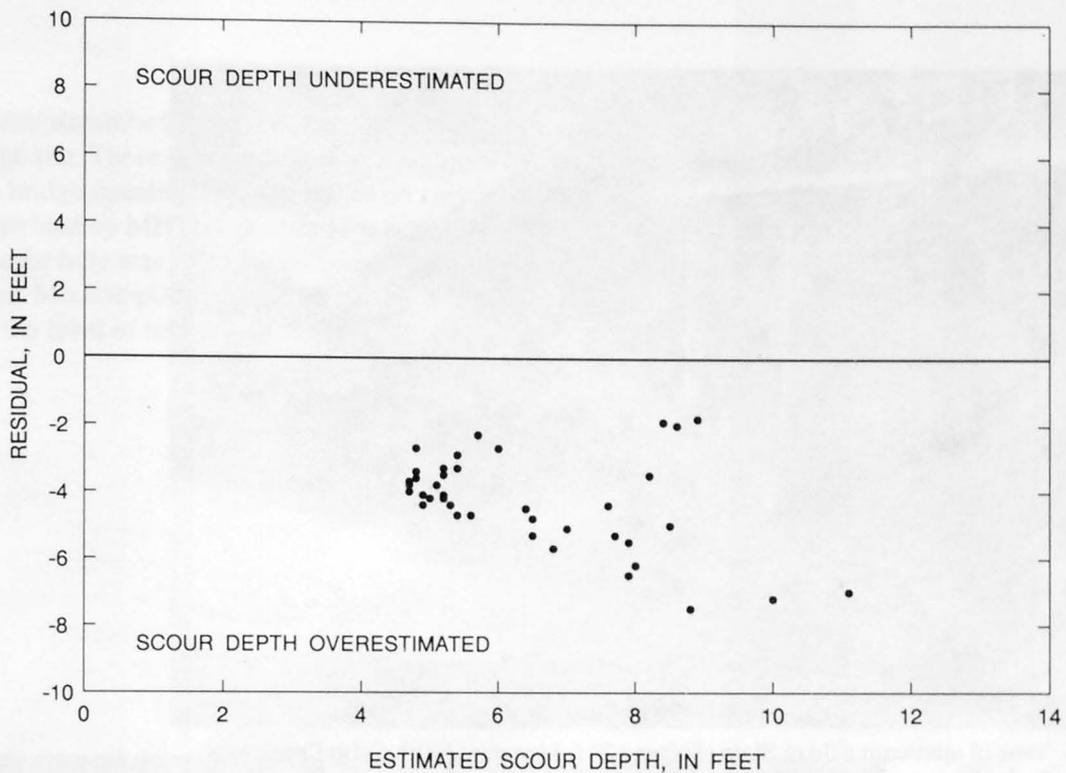
**Figure 23.** Relation between scour depth estimated using the Colorado State University equation and the residual (measured scour depth minus the estimated scour depth) at selected sites in Missouri.

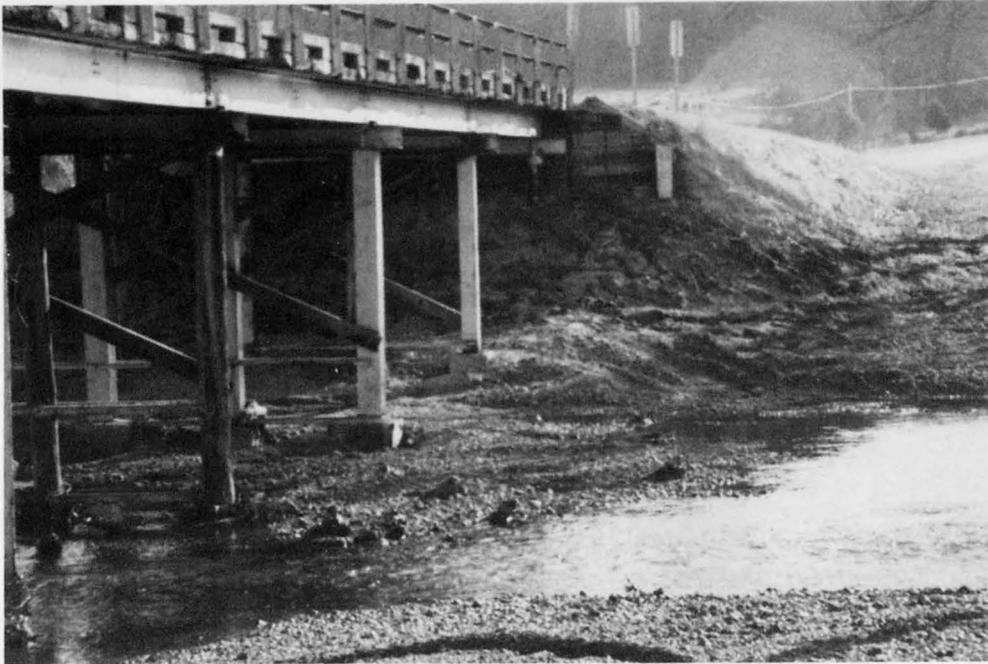
**Figure 24.** View of upstream side of State Highway 32 bridge over North Cobb Creek near Lebanon, Missouri (photograph of February 20, 1990, courtesy of the Missouri Highway and Transportation Department).

Potential scour at bridges is a significant design and safety consideration. A bridge on State Highway 32 over North Cobb Creek (drainage area 52.5 square miles; fig. 1) was destroyed during a flood on May 26, 1990. Onsite conditions before and after this scour-related failure are shown in figures 24 and 25. The failure of the more than 50-year old, 200-foot long, 8-span, pile-bent bridge was largely attributable to contraction scour. However, it is not known if or to what degree debris accumulation may have been a contributing factor. Bridge maintenance, including debris removal, had been accomplished by MHTD personnel a few days before the flood (Missouri Highway and Transportation Department, oral commun., 1990). Immediately after the failure, hydrologic, hydraulic, and geomorphic data were collected at the bridge site and adjacent areas.
