# INVESTIGATION OF BRIDGE SCOUR AT SELECTED SITES ON MISSOURI STREAMS

Water-Resources Investigations Report 94-4200

By LAWRENCE D. BECKER

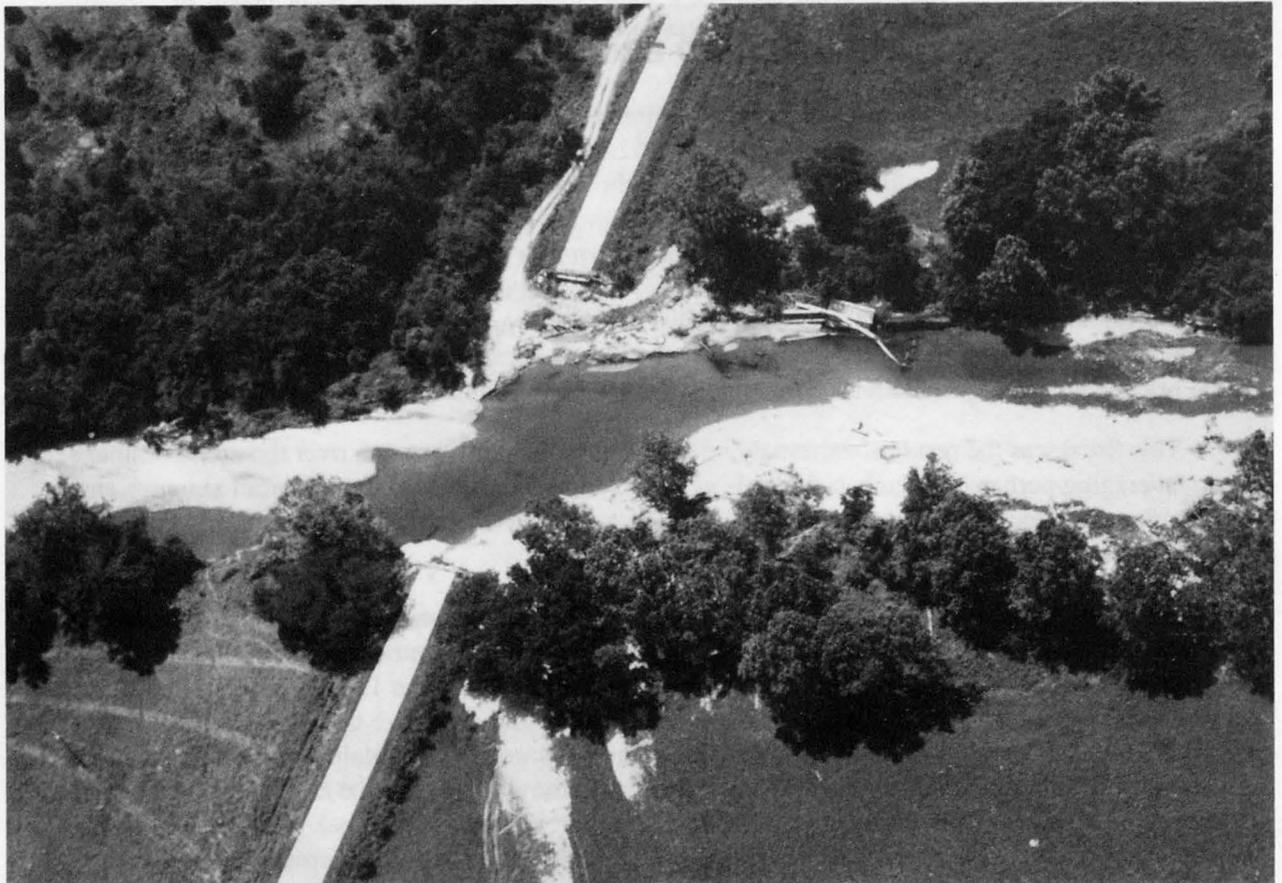
**Figure 25.** Aerial view of State Highway 32 crossing at North Cobb Creek, near Lebanon, Missouri, showing a scour-related bridge failure that occurred during the flood of May 26, 1990 [direction of streamflow is from left to right; note sand and gravel banks deposited by flood downstream from highway (middle and bottom center of view); photograph of June 20, 1990].

Many streambed cross sections were obtained upstream from, at, and downstream from the highway and bridge site. These surveyed cross sections showed an extremely large scour hole at and downstream from the bridge opening (fig. 26). Based on surveyed cross sections, bridge plans dated November 14, 1932 (provided by MHTD), post-failure boring logs (provided by MHTD), and photographs (figs. 24 and 26) the scour hole was at least 6 feet deep and may have been as deep as 9 feet near the downstream side of the bridge. More importantly, on-site evidence indicated that scour to bedrock had occurred and that scour down to the level of or below the bottom of some of the timber-pile bents had occurred.

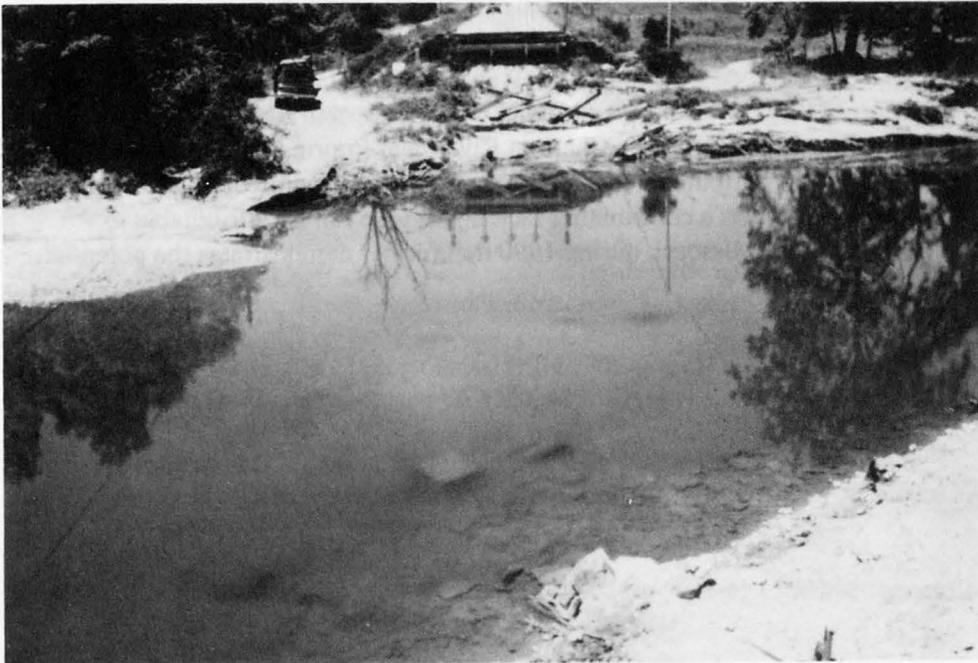
**Figure 26.** The large, deep scour hole formed during the flood of May 26, 1990, on North Cobb Creek near Lebanon, Missouri (photograph of June 14, 1990, is viewed from east abutment to west abutment of the destroyed bridge).
