# Magnitude and Frequency Data for Historic Debris Flows in Grand Canyon National Park and Vicinity, Arizona

By THEODORE S. MELIS, ROBERT H. WEBB,  
PETER G. GRIFFITHS, and THOMAS W. WISE

U.S. GEOLOGICAL SURVEY  
Water-Resources Investigations Report 94—4214

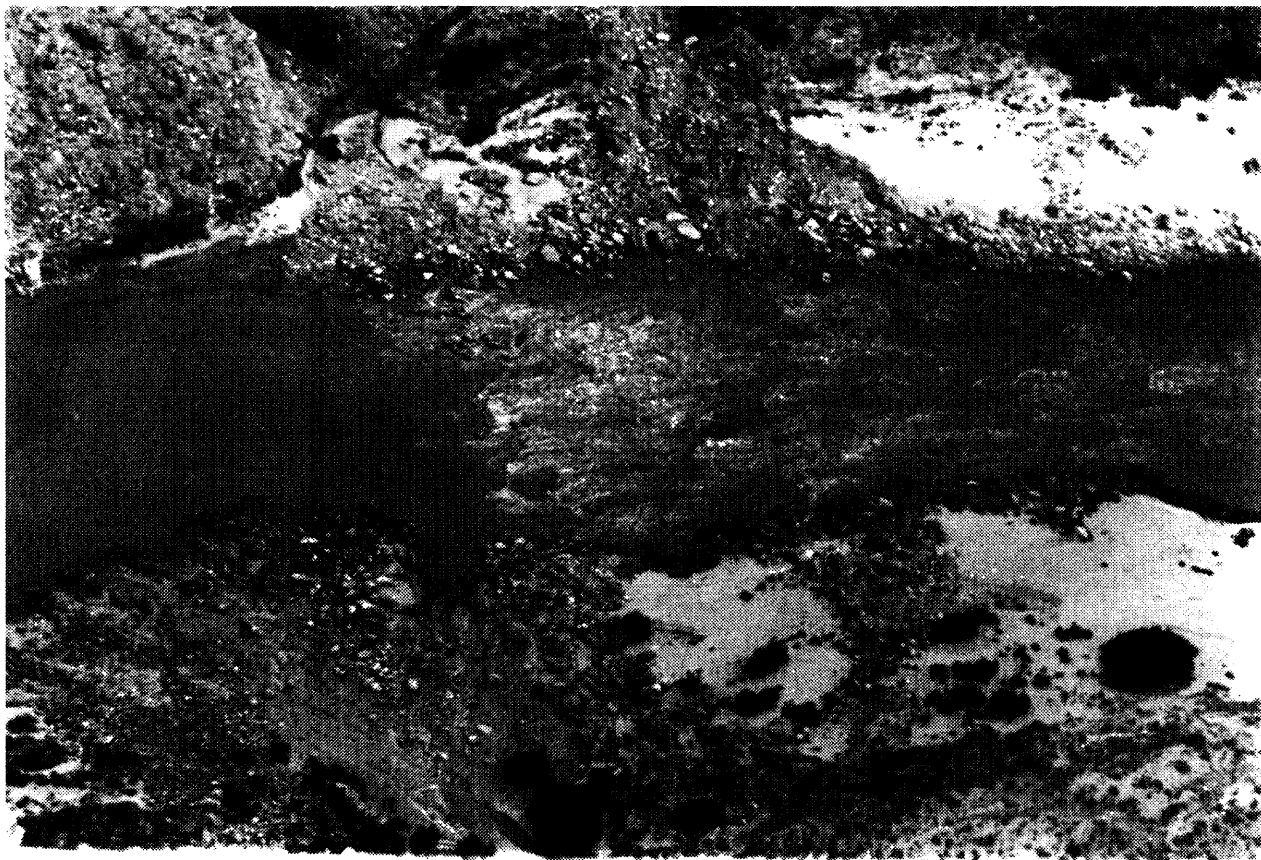
**Figure 5.** Oblique aerial photograph of Badger Creek Rapid (river mile 7.9) and the mouth of Jackass Creek (river mile 7.9-L) on October 4, 1958 (P.T. Reilly, Sun City, Arizona, photograph L42-17). View is east and discharge in the Colorado River is about  $162 \text{ m}^3/\text{s}$ . A debris flow that occurred between 1897 and 1909 caused extensive deposition on the Badger Canyon debris fan (left center); rocks that appear in the top center of the rapid were deposited by that debris flow. The direction of river flow is left to right.

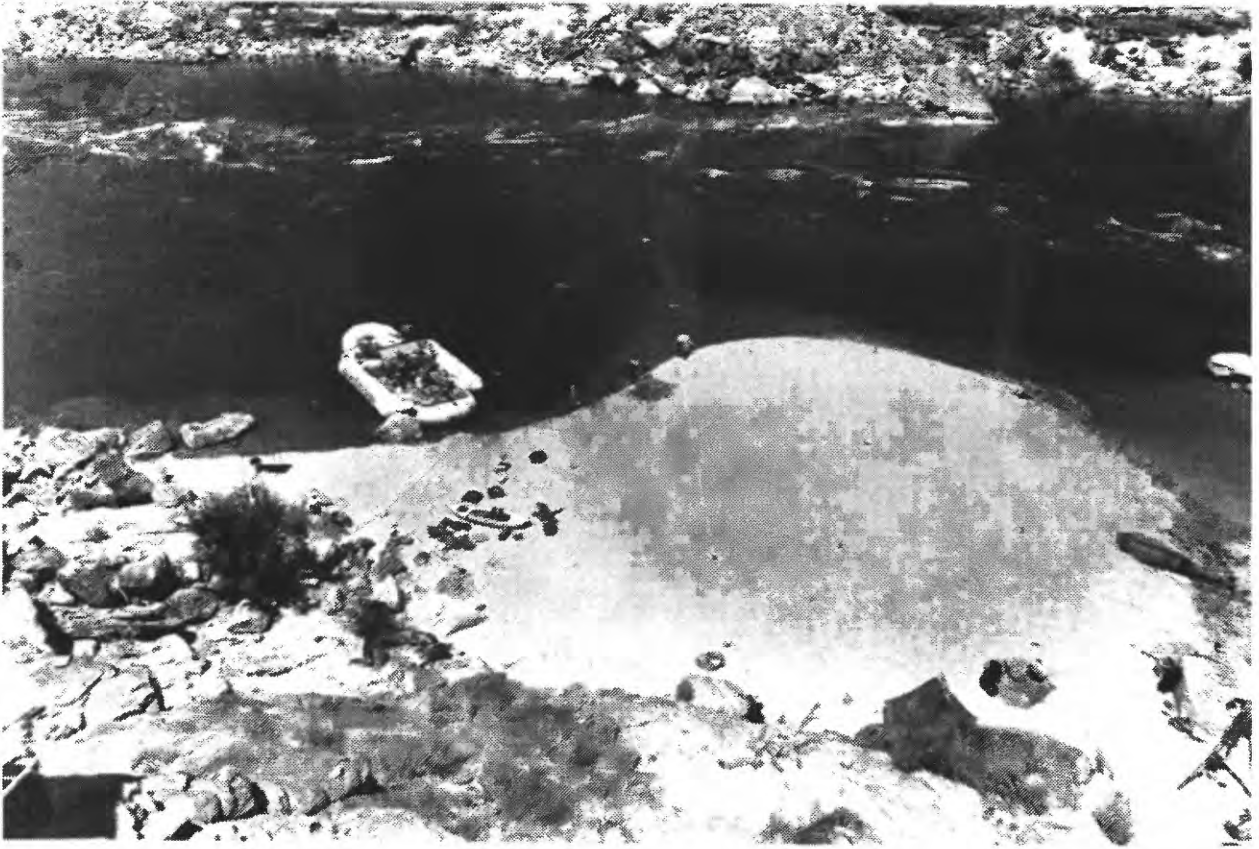
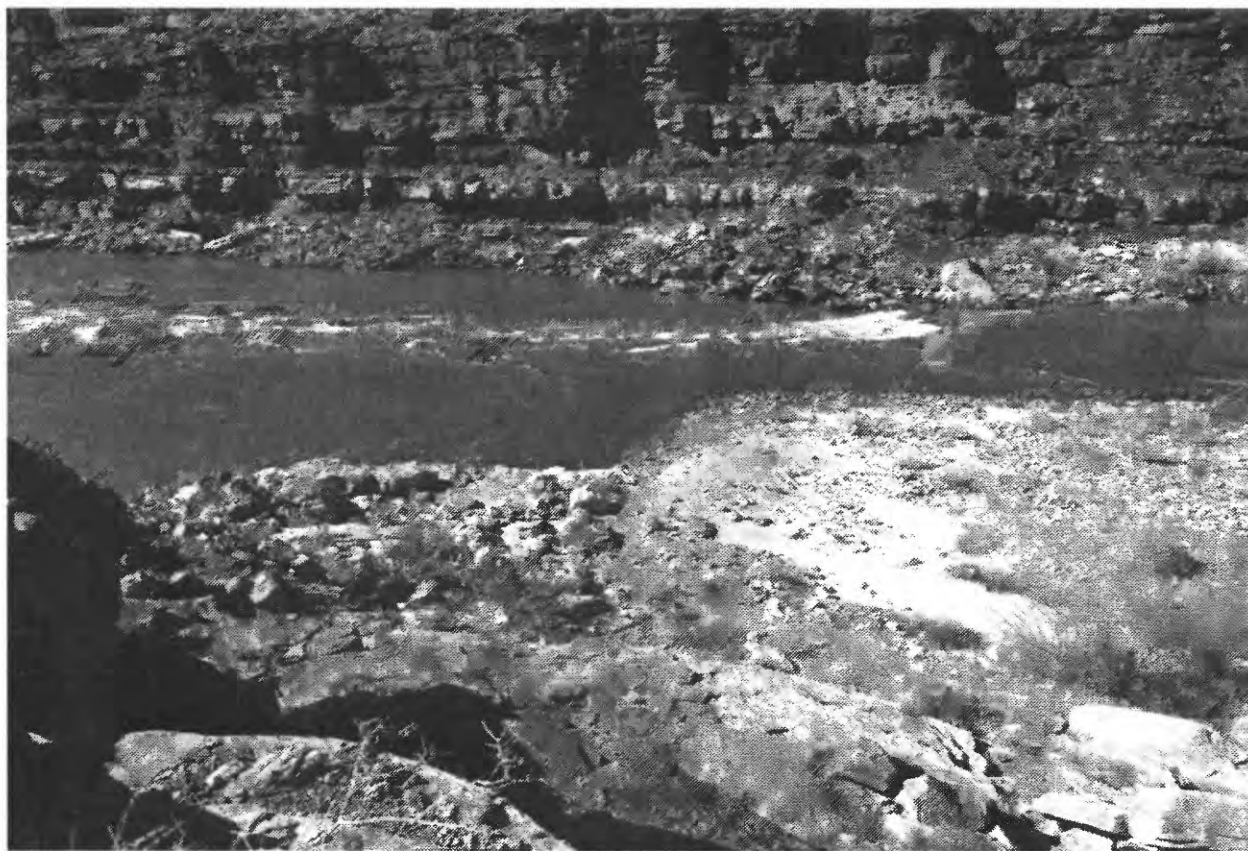
**Figure 7.** Replicate photographs' showing changes in the separation bar at "18-Mile Wash" (river mile 18.0-L) caused by the debris flow of August 1987. Photographs A and B were taken from approximately the same position. A. View of the separation bar at "18-Mile Wash" (J.C. Schmidt, U.S. Geological Survey, 1985) as it existed before the debris flow of 1987. Discharge in the Colorado River is about  $1,475 \text{ m}^3/\text{s}$ .

*B.* Replicate view of the aggraded debris fan at "18-Mile Wash" (Tom Wise, U.S. Geological Survey, February 1993) showing the effects of the debris flow of 1987. Discharge in the Colorado River is about 700 m<sup>3</sup>/s.

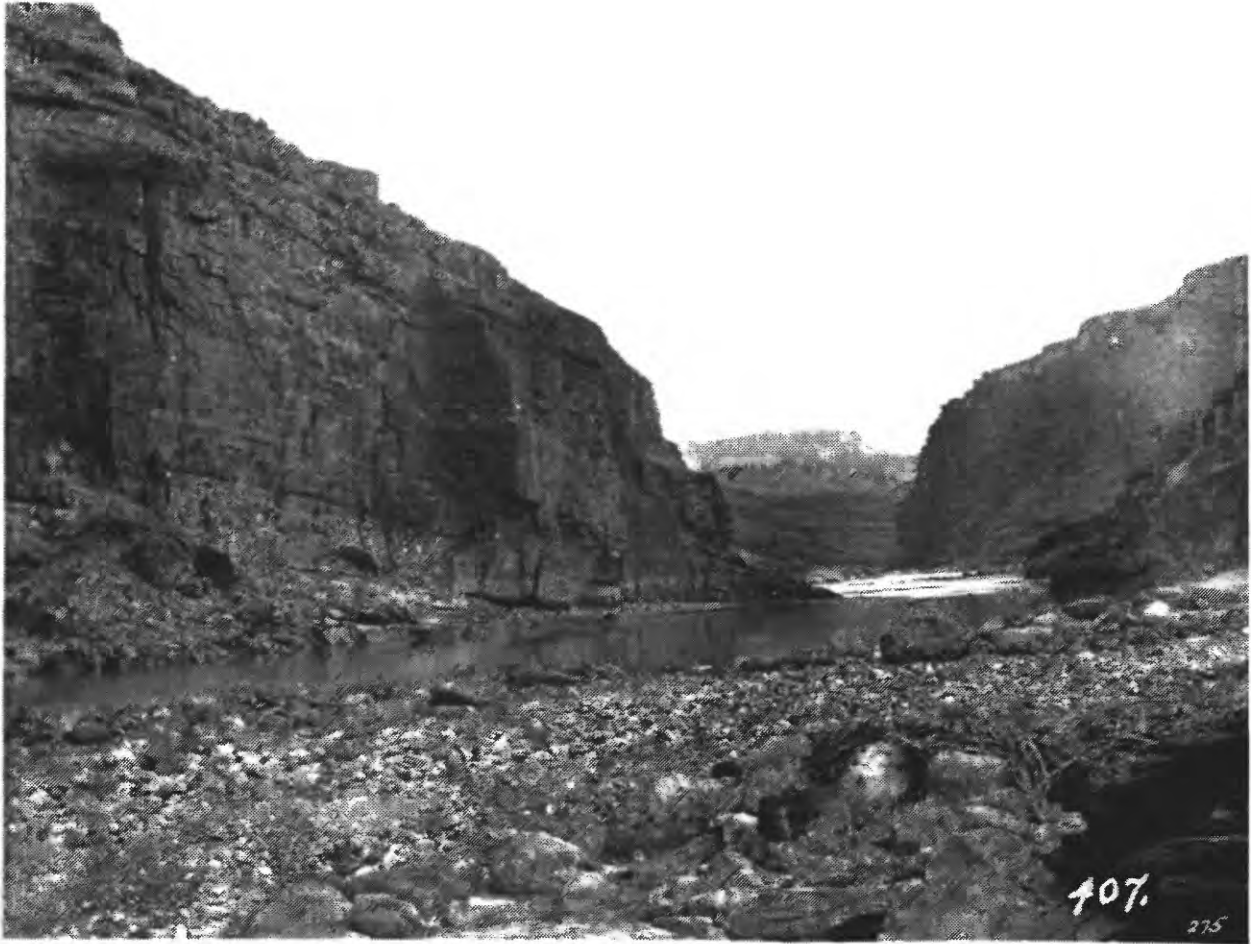
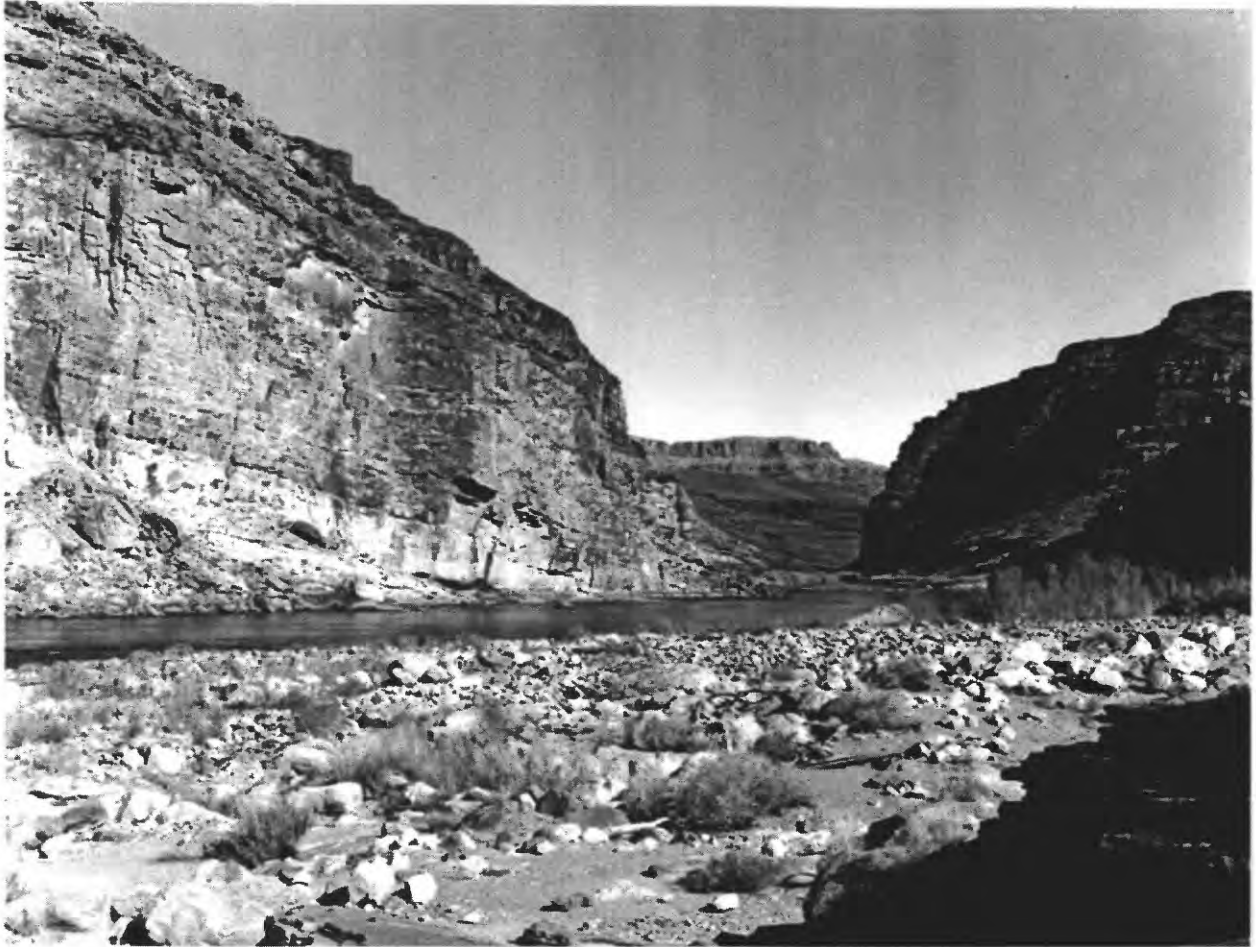
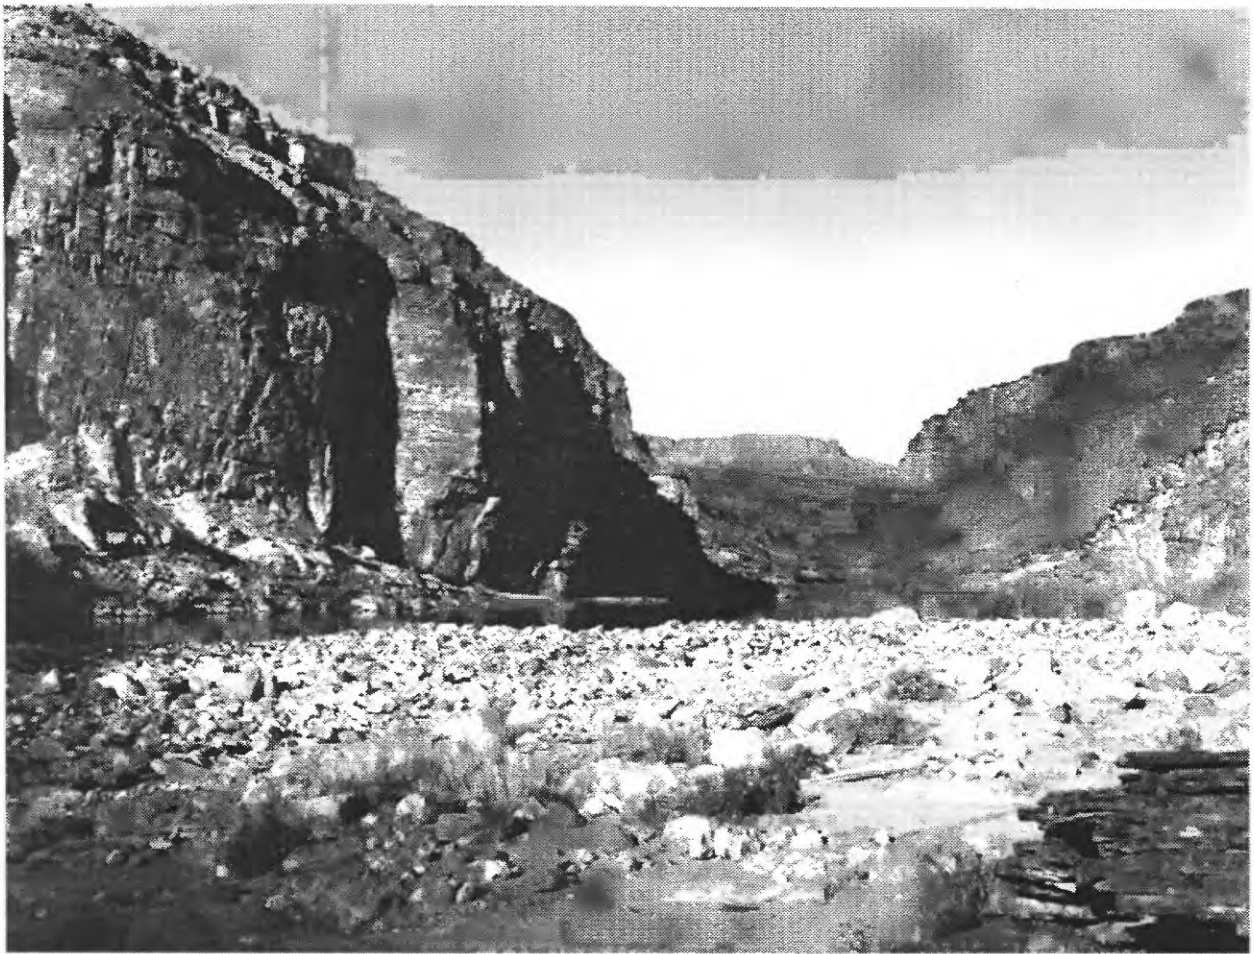
**Figure 31.** A time series of replicate photographs showing the debris fan at 75-Mile Canyon (river mile 75.5-L). A, The original view was taken on January 24, 1890 (Robert Brewster Stanton, number 407, National Archives). Gravel, cobbles, and lack of sand in foreground indicates that a debris flow occurred before this view was made, but probably no earlier than June 1884, when  $8,500 \text{ m}^3/\text{s}$  reportedly flowed in the Colorado River.

*B.* The first replicate view was taken on January 27, 1990 (Ralph Hopkins, U.S. Geological Survey, stake 1445). The debris flow of 1987 deposited on the mid-ground; note the deposition of debris around the base of the prominent boulder at right-center in the view. Changes to boulders in the extreme foreground occurred during a debris flow on an unknown date.

C. The second replicate view was taken on February 10, 1991 (T.S. Melis, stake 1445). The debris flow of 1990 deposited 12,000 m<sup>3</sup> of sediment on the debris fan. Deposition is particularly obvious around the prominent boulder at right center.

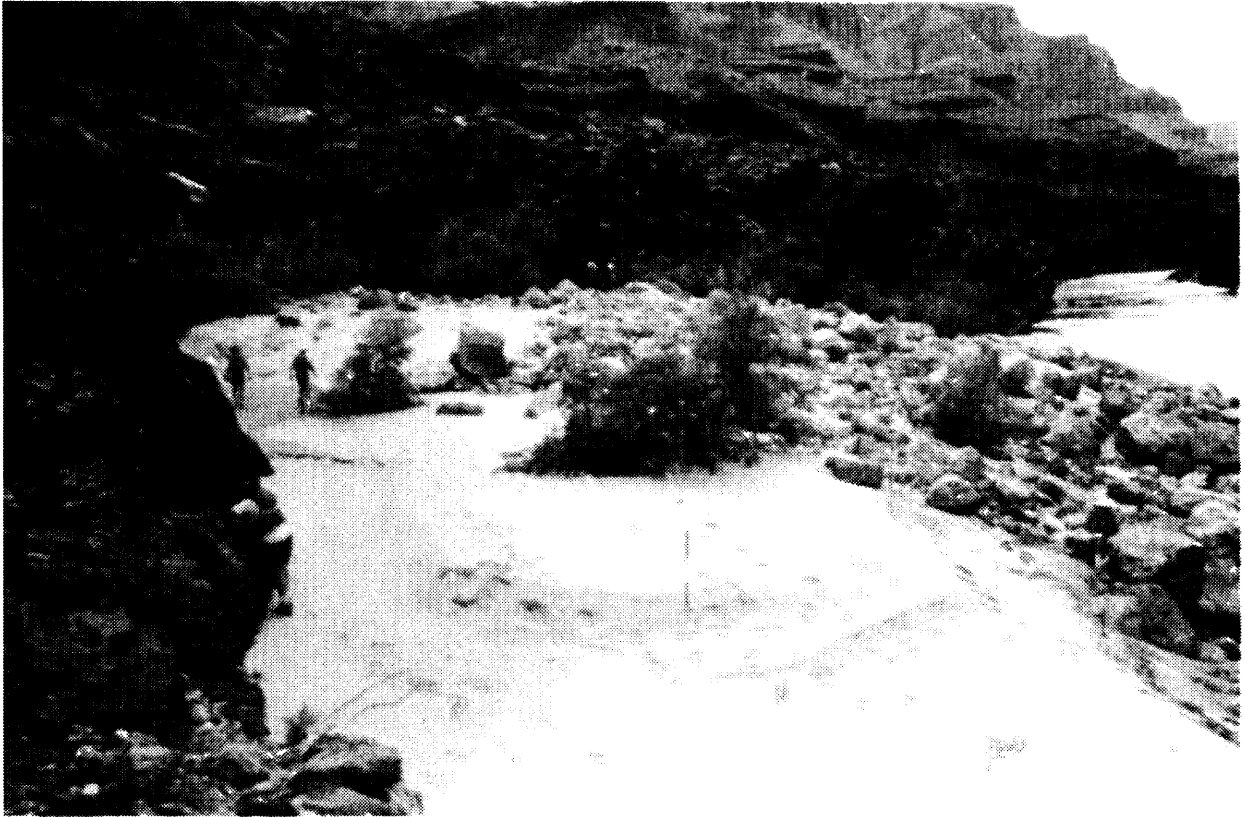
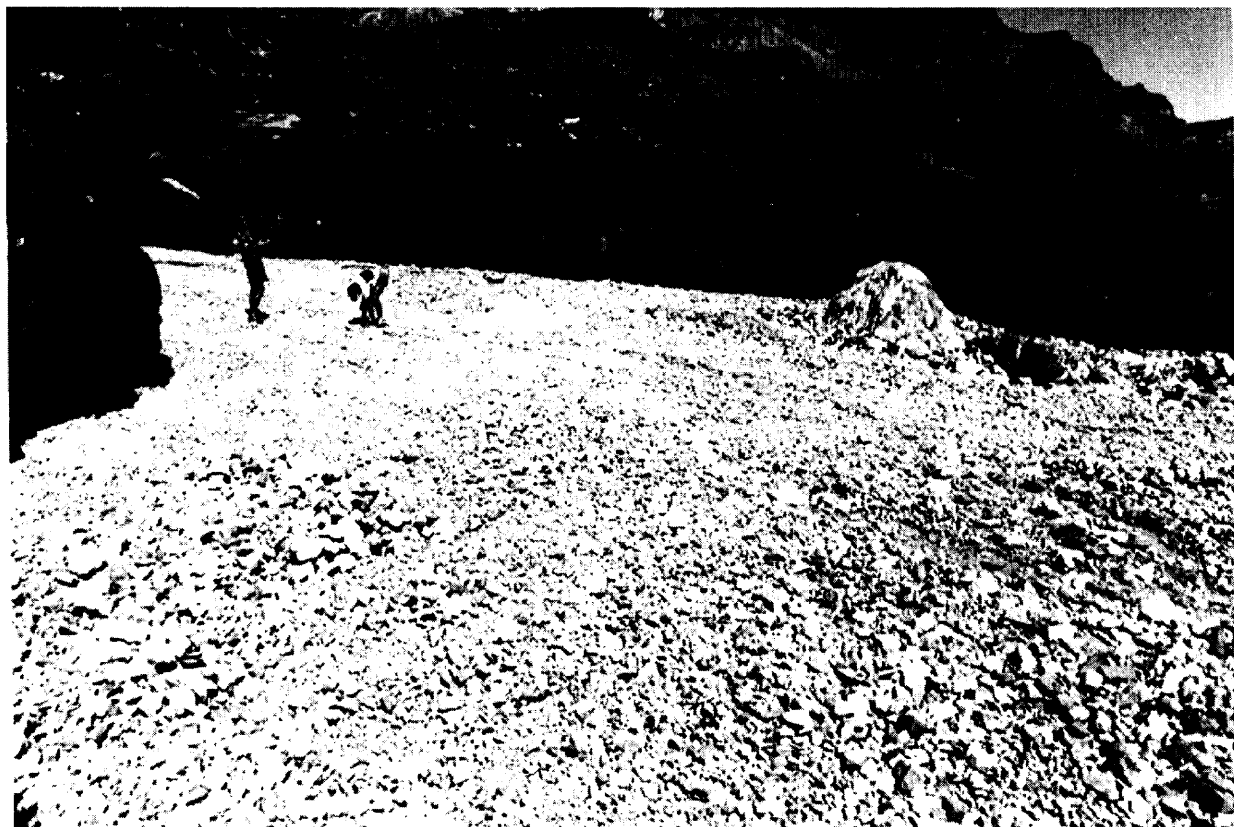
**Figure 43.** Replicate photographs of the debris fan at "127.6-Mile Canyon" (river mile 127.6-L). A, The original view, which is looking downstream, shows the debris fan at "127.6-Mile Canyon" as it appeared in the summer of 1973 (Harmer Weeden, Pennsylvania State University, Weeden slide III-3, Grand Canyon National Park).

*B*, The replicate view was taken on October 19, 1991 (Liz Hymans, U.S. Geological Survey, stake 2236). The debris flow of 1989 has buried the former sand bar and aggraded the debris fan by 2 m.

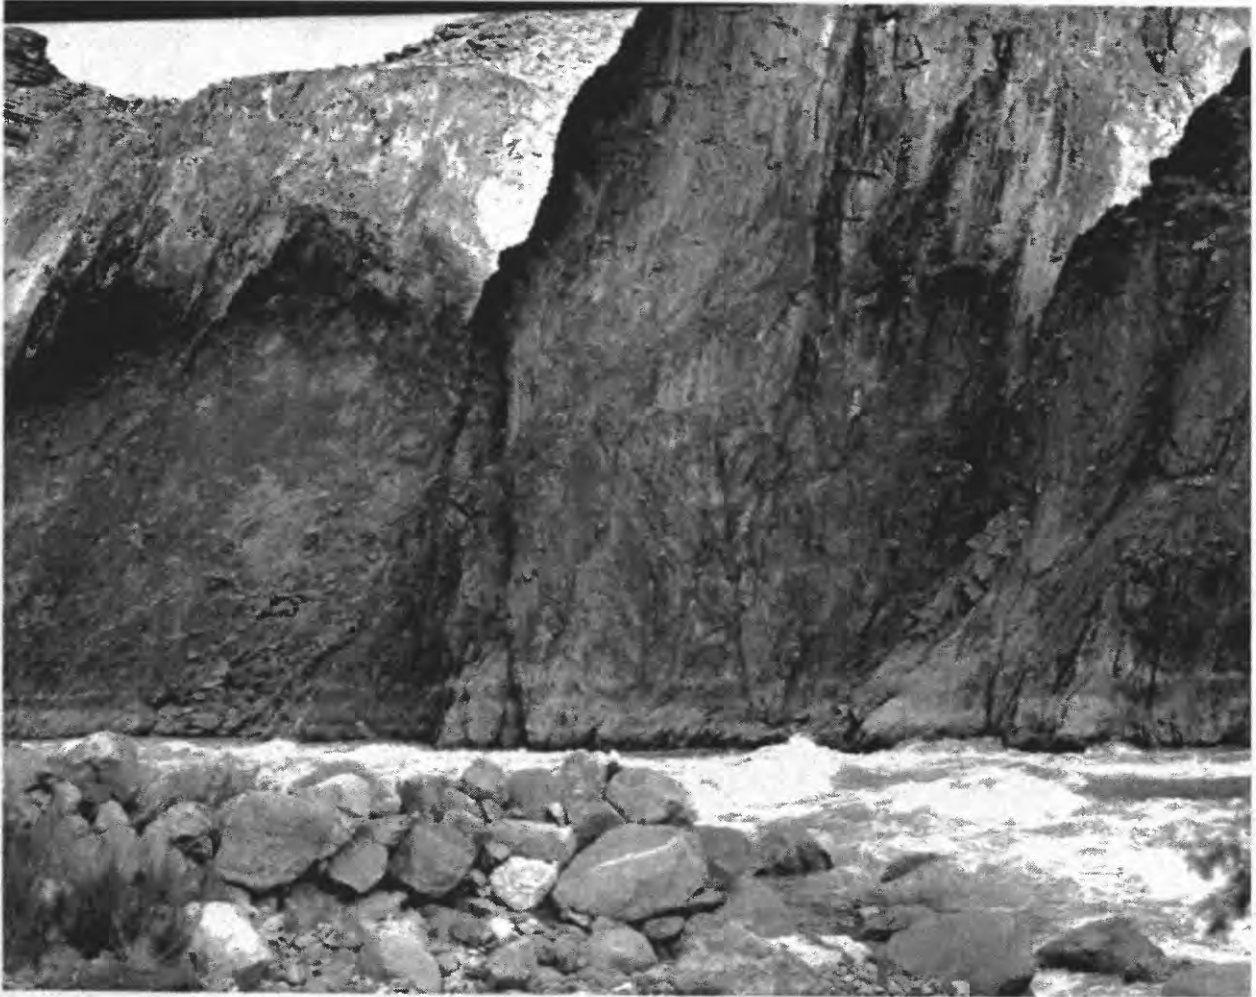
**Figure 44.** Replicate photographs of the debris fan at Specter Chasm (river mile 129.0-L), a tributary of the Colorado River. A, The original view, which is downstream and across the river, shows the debris fan and rapid at the mouth of Specter Chasm as it appeared on July 27, 1927 (Clyde Eddy, photograph 76, Huntington Library).

*B*, The replicate view was taken on September 25, 1993 (Ted Melis, U.S. Geological Survey, stake 2624). The debris flow of 1989 has deposited large boulders on the debris fan and in the rapid.

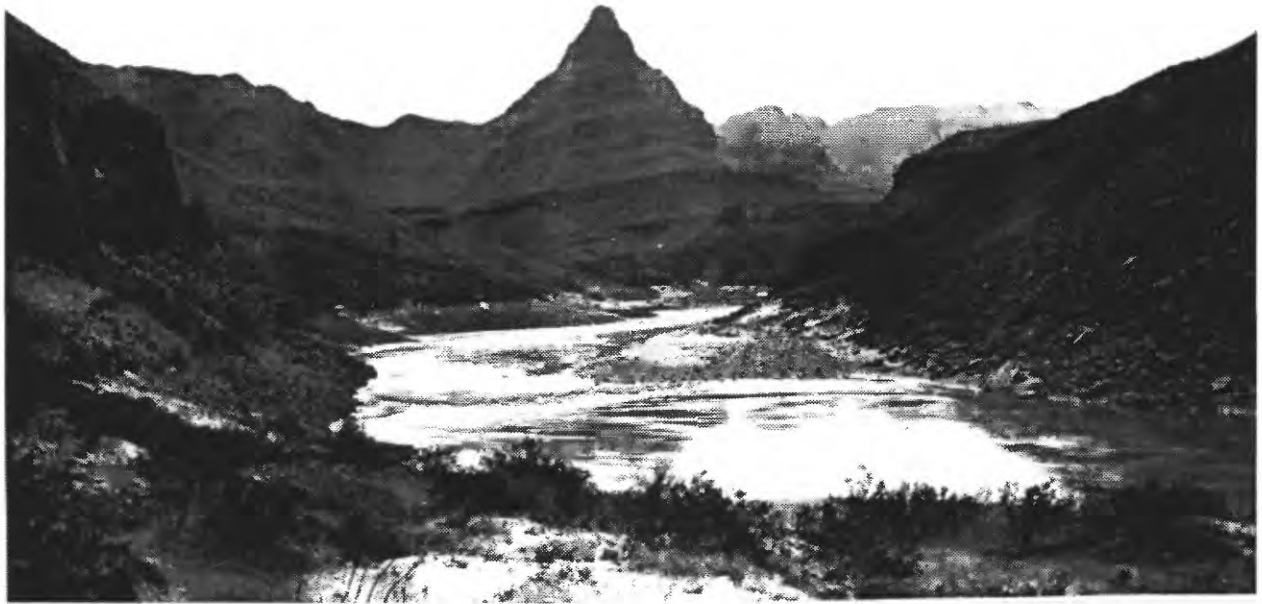
**Figure 60.** Replicate photographs of the debris fan of an unnamed tributary at river mile 222.6-L in Grand Canyon. A, The original view, looking downstream, was taken on March 1, 1890 (Robert Brewster Stanton, number 660, National Archives).

The frequency of debris flows in this drainage basin was determined using a combination of repeat photography and aerial photography. An 1890 photograph, replicated in 1991, documents the occurrence of one debris flow (fig. 60). The aggraded debris fan appears in a 1965 aerial photograph, and analyses of two samples of debris-flow matrix yielded no detectable activity of  $^{137}\text{Cs}$ . Therefore, the debris flow occurred between 1890 and 1952. Analysis of aerial photography indicates that the debris flow had occurred by 1965. No aerial photographs from 1935 are available.

Replication of the 1890 photograph revealed that the separation bar downstream from the debris fan at mile 222.6 increased in size after 1890 (fig. 60). The enlarged sand bar also appears in a 1965 aerial photograph. The changes in this sand bar are probably directly related to the altered geometry of the aggraded debris fan.

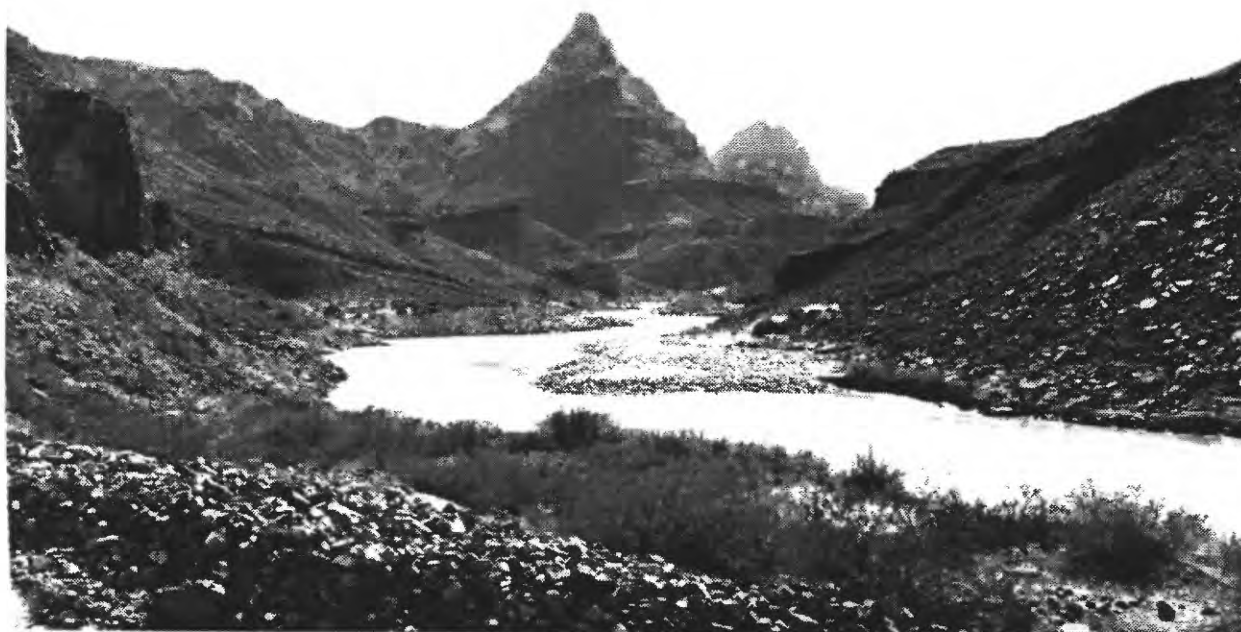
**Figure 60.** Continued.

*B*, The replicate view, taken on February 26, 1991 (Raymond M. Turner, U.S. Geological Survey, stake 1521b), shows a prominent debris-flow terrace that covers the foreground of the 1890 view. This debris flow occurred on an unknown date sometime between 1890 and 1965. The large separation bar that has been deposited downstream from the aggraded debris fan is probably an effect of the aggraded debris fan.

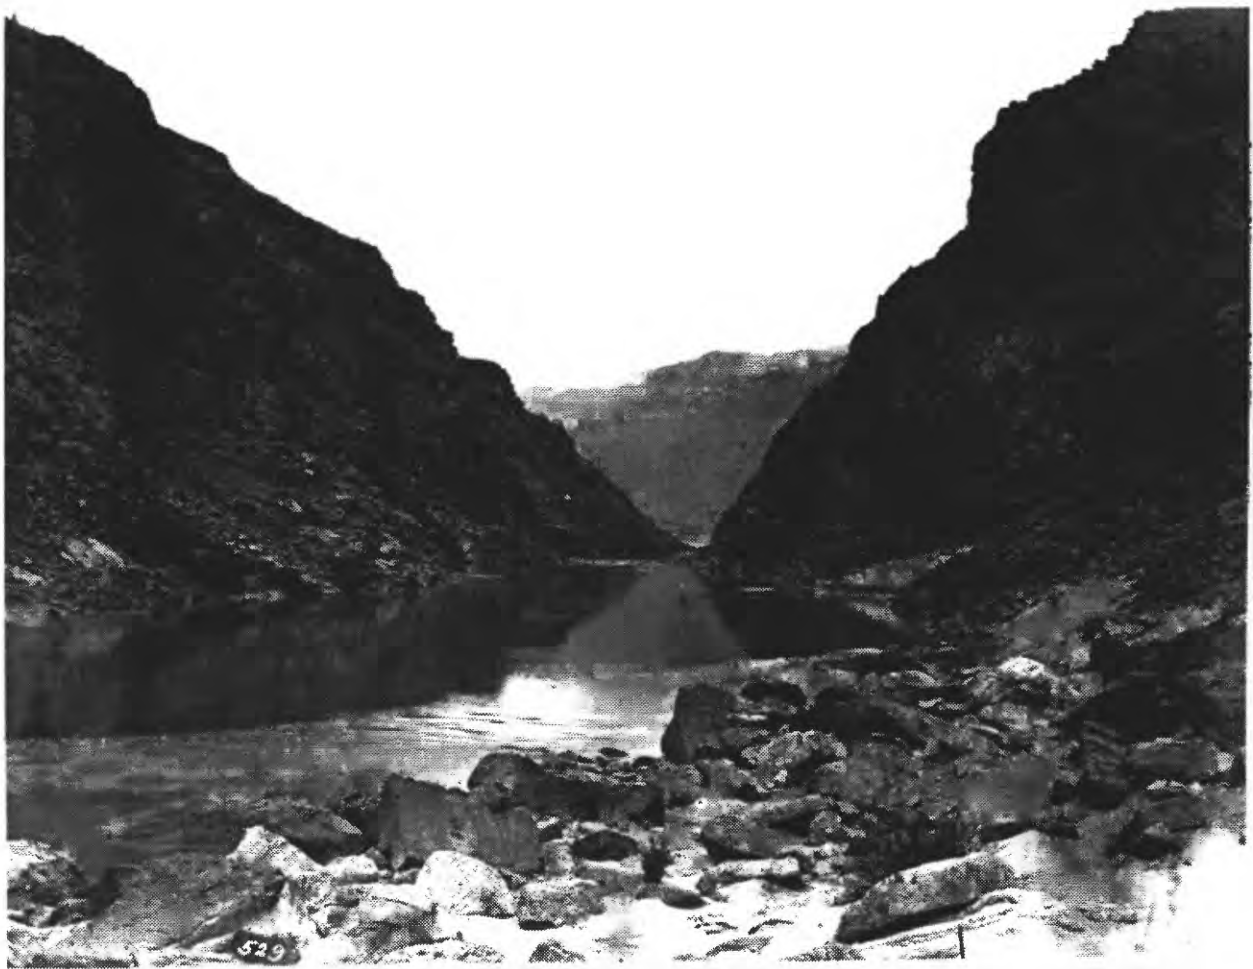
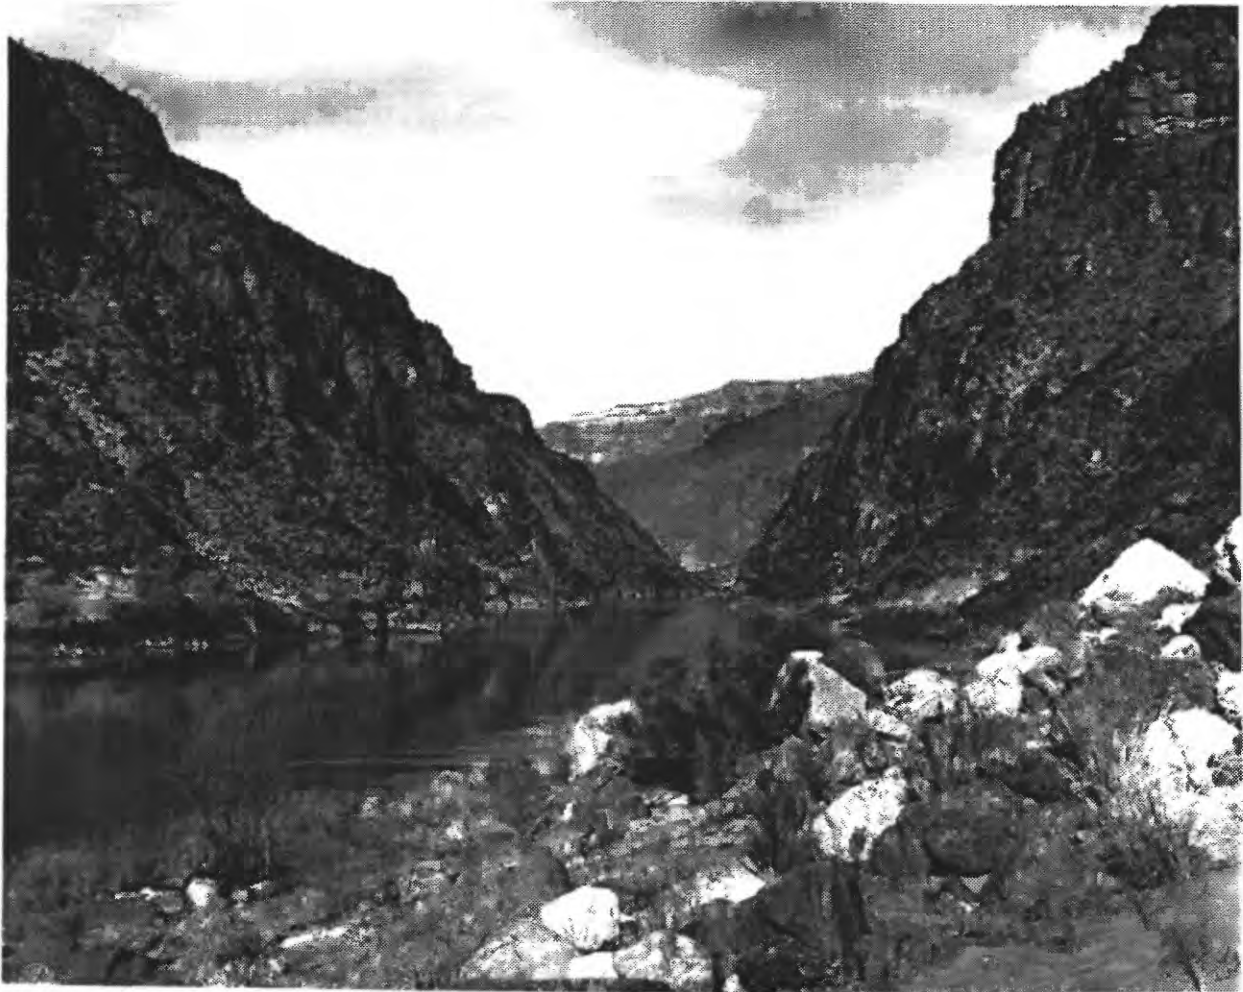
**Figure 62.** Replicate photographs showing the debris fan of an unnamed tributary of the Colorado River at river mile 224.5-L in Grand Canyon. A, The original view, looking upstream, was taken on March 1, 1890 (Robert Brewster Stanton, number 661, National Archives).

*B*, The replicate view, taken on February 26, 1991 (Dave Edwards, U.S. Geological Survey, stake 1522b), shows a levee at left-center that was deposited between 1890 and 1965. The deposition resulted from superelevation of a debris flow around a short bend in the channel through the debris fan.

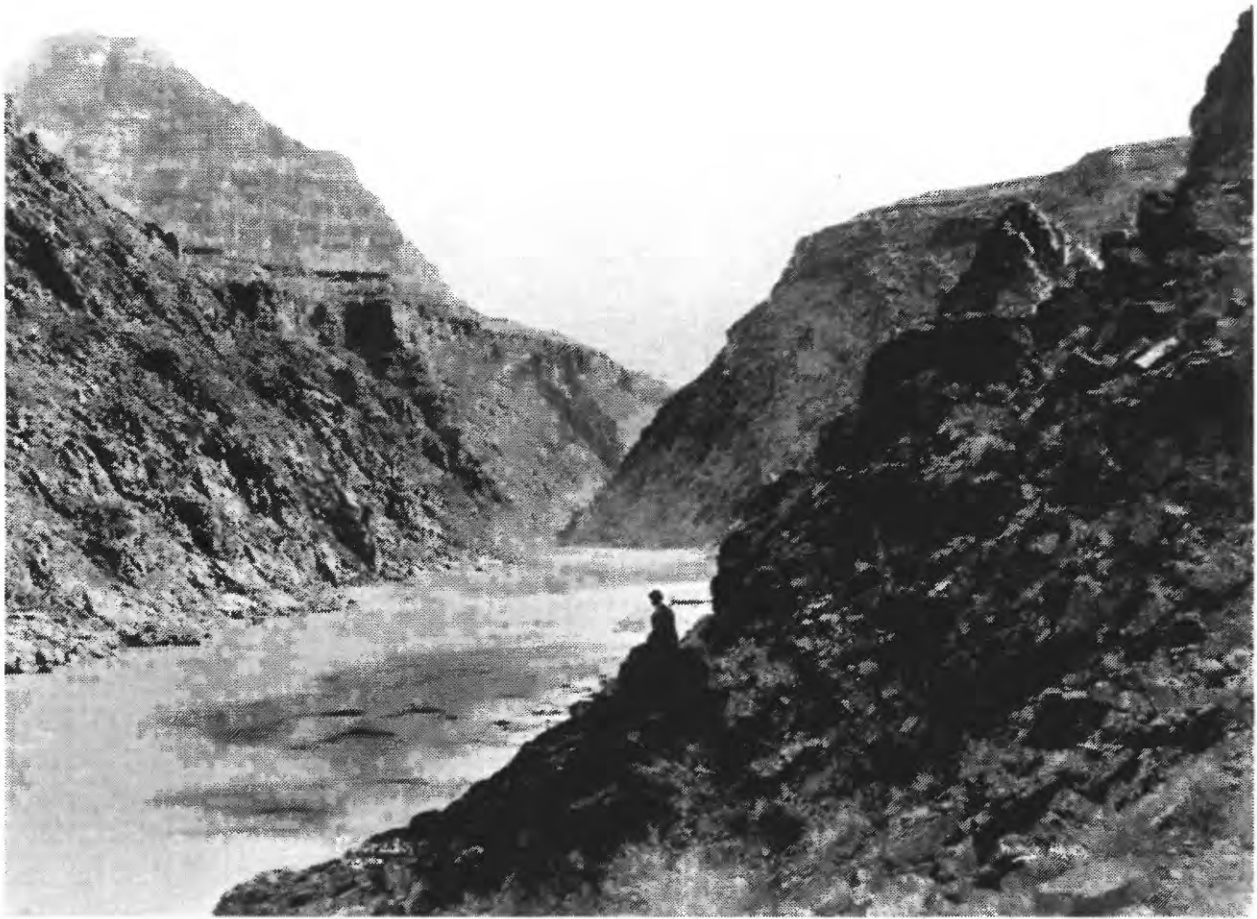
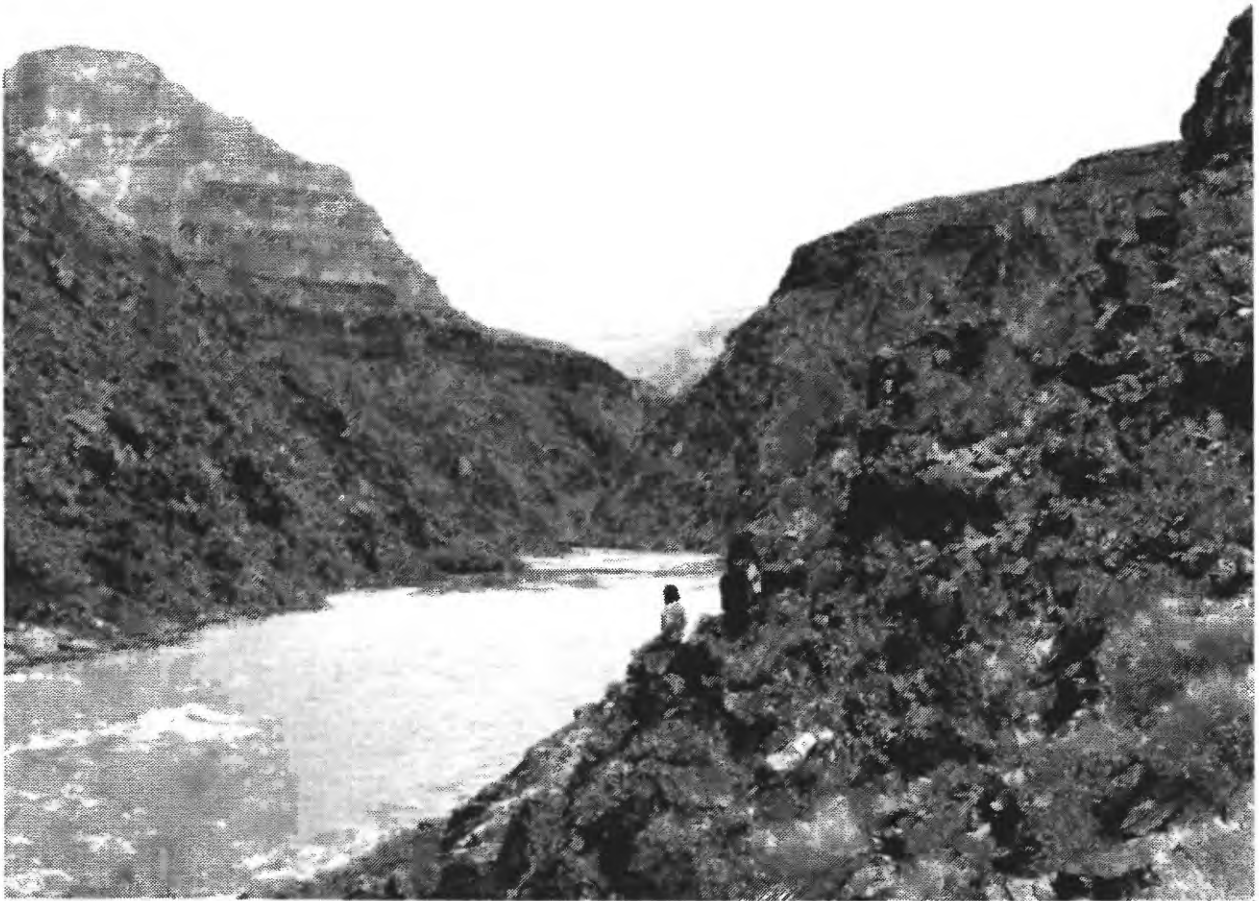
**Figure 64.** Replicate photographs showing the head of Diamond Creek Rapid near the confluence of Diamond Creek (river mile 225.8-L), a tributary of the Colorado in Grand Canyon. A, The original view, looking upstream toward the confluence of Diamond Creek, was taken in April 1883 (Ben Wittick, 15467, Museum of New Mexico). The prominent debris fan constricting the river channel at the head of the rapid is indicative of a recent debris flow..

*B*, The replicate view, taken on March 16, 1994 (T.S. Melis, stake 2776a,), shows that the debris fan shown in the 1883 photograph has been completely removed. The debris fan was probably eroded during the discharge of 8,500 m<sup>3</sup>/s on the Colorado River in the summer of 1884 or later.

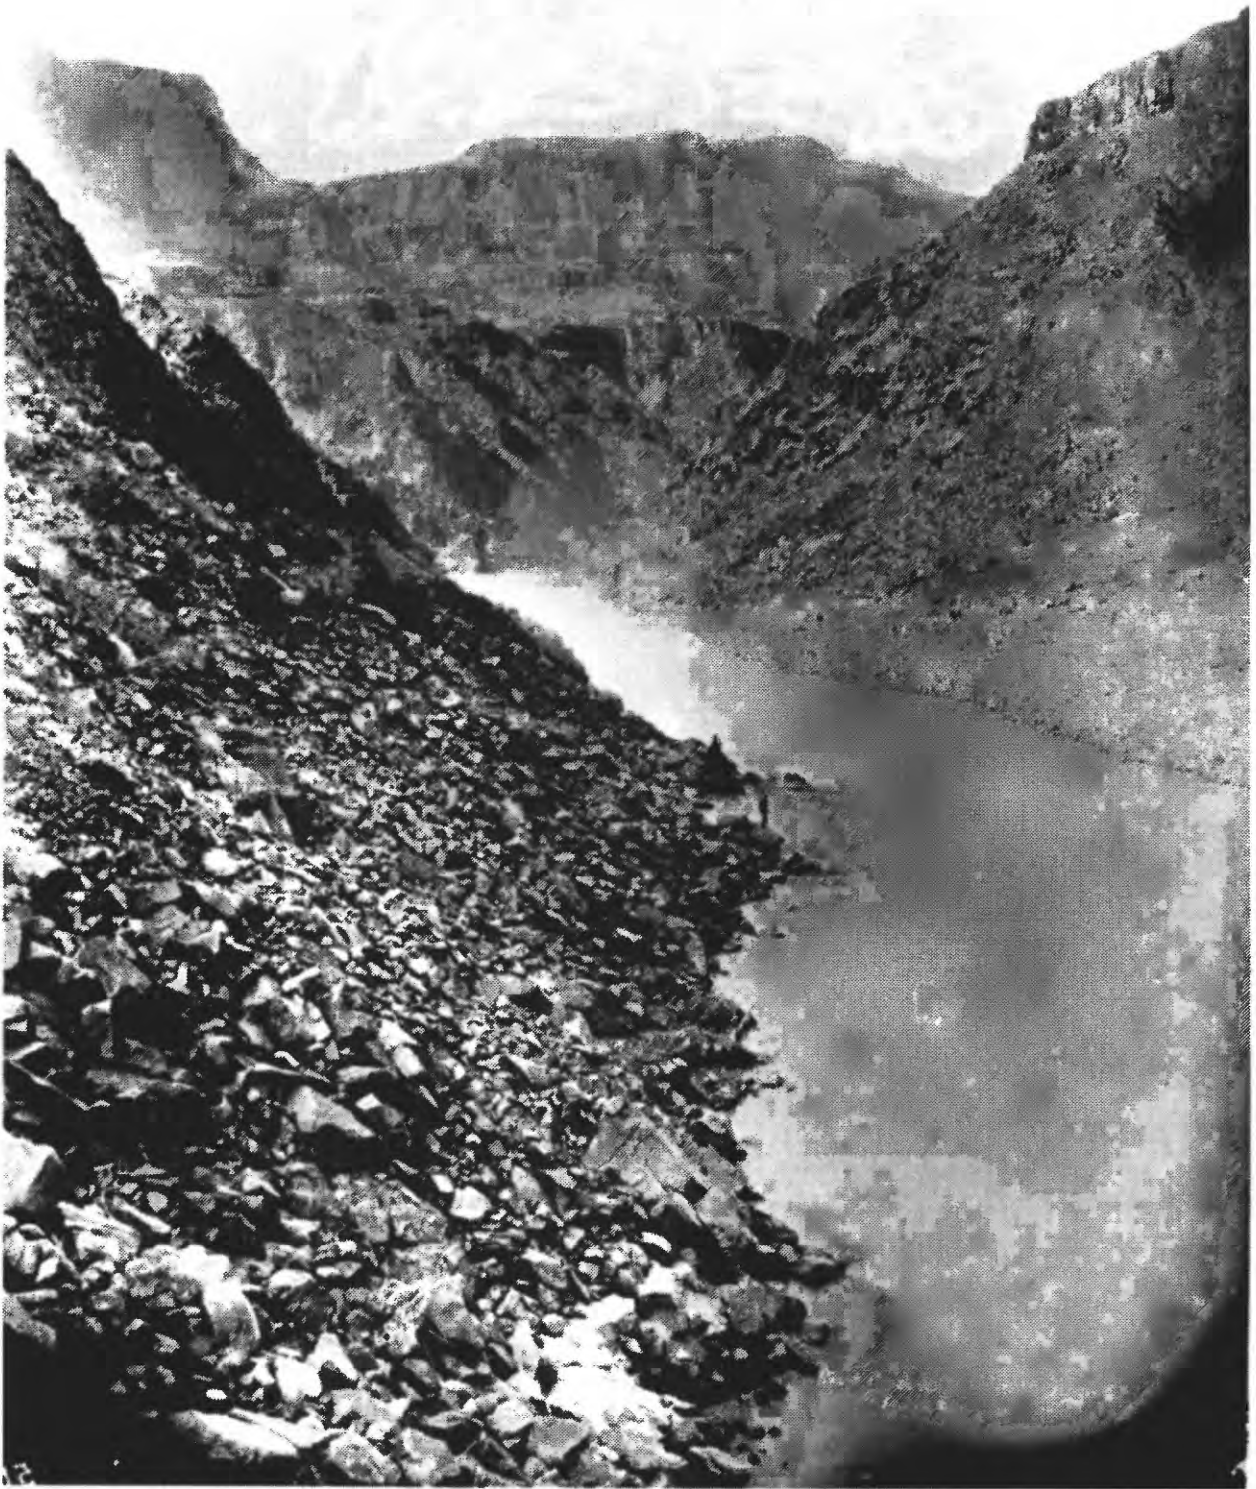
**Figure 65.** Replicate photographs of the Colorado River near the bottom of Diamond Creek Rapid (river mile 226.0). A, The original view, looking downstream, was taken in the spring of 1884 (Ben Wittick, 15468, Museum of New Mexico). The channel appears to be open and without a debris bar.

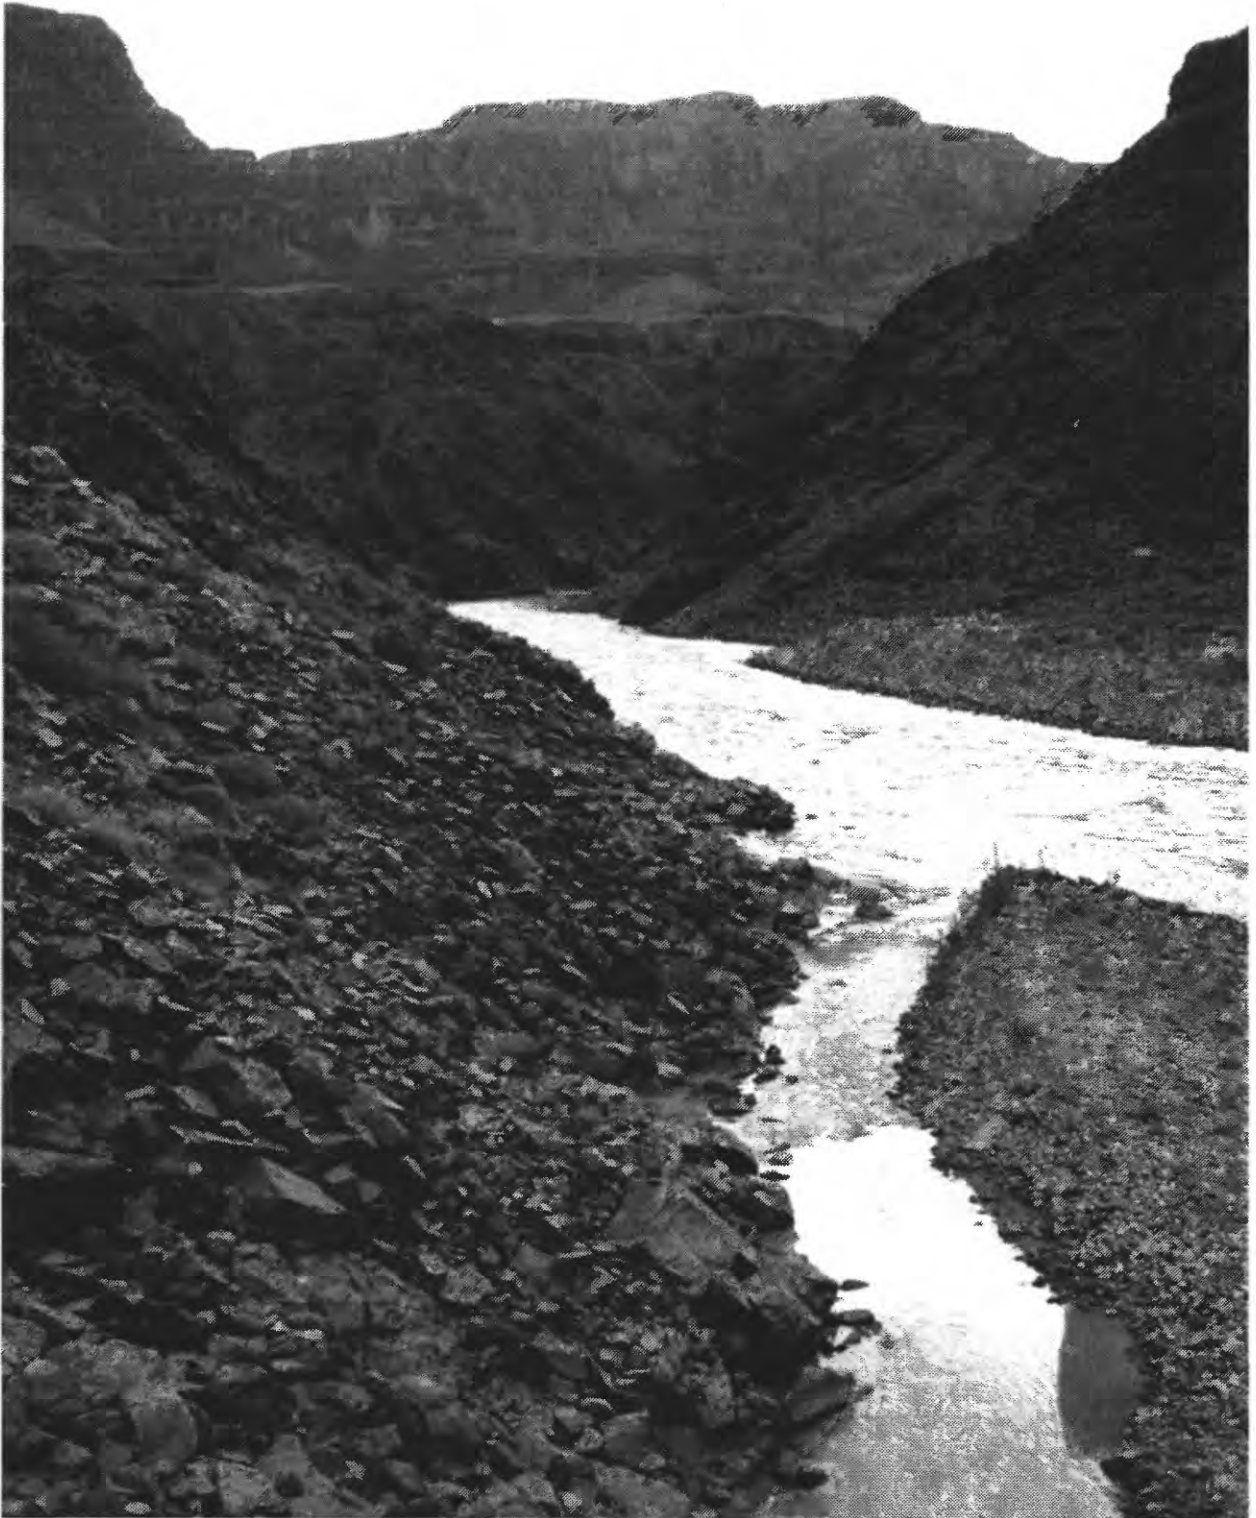
**Figure 65.** Continued.

*B*, The replicate view, taken on March 16, 1994 (T.S. Melis, stake 2777), documents the presence of a new debris bar at the bottom of Diamond Creek Rapid. This debris bar was formed by reworking and deposition of cobbles and boulders eroded from the 1984 debris fan at the mouth of Diamond Creek.

The 1984 debris flow was probably the largest to occur since before 1883 in Diamond Creek. On the basis of the two debris flows which we documented from historic photographs and the 1984 debris flow which was witnessed, we estimate a frequency of approximately one debris flow every 35 years. This is in accord with estimates of debris-flow frequency made elsewhere in western Grand Canyon. A replicate of an 1883 photograph of the bottom of Diamond Creek Rapid (appendix 6) reveals a new, mid-channel debris bar (fig. 65). On the basis of aerial photographs taken in 1935 and 1989 this debris bar was probably the result of reworking of the 1984 debris fan. The newly formed debris bar below Diamond Creek Rapid is one of the only two new debris bars we observed in the Colorado River (the other is at mile 62.5).
