EFFECTS OF WATER-CONTROL STRUCTURES ON HYDROLOGIC AND WATER-QUALITY CHARACTERISTICS IN SELECTED AGRICULTURAL DRAINAGE CANALS IN EASTERN NORTH CAROLINA

by M.W. Treece, Jr., and M.L. Jaynes

U.S. GEOLOGICAL SURVEY

Water-Resources Investigations Report 94-4226

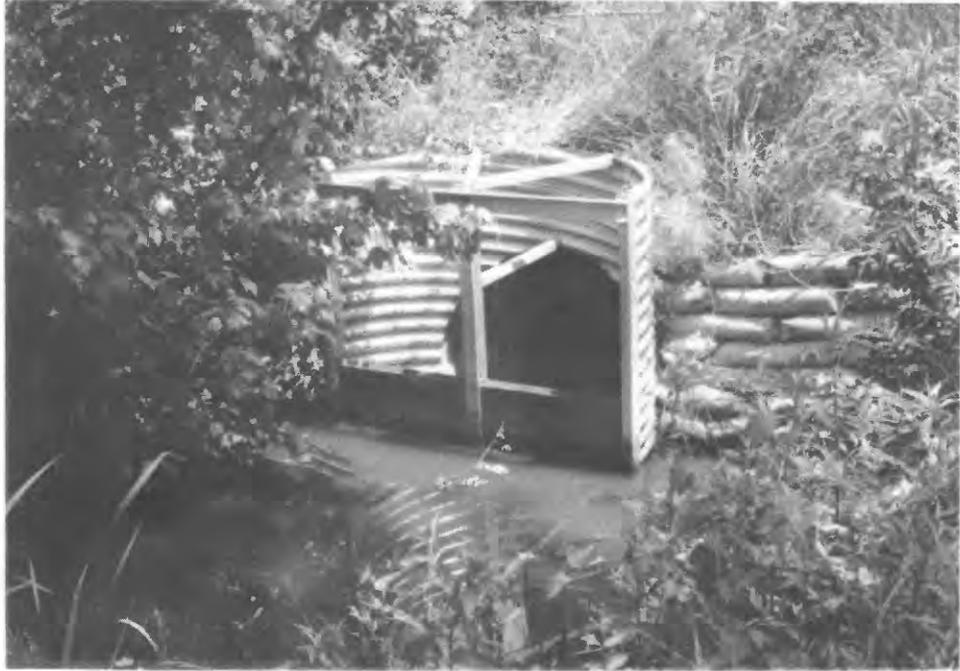
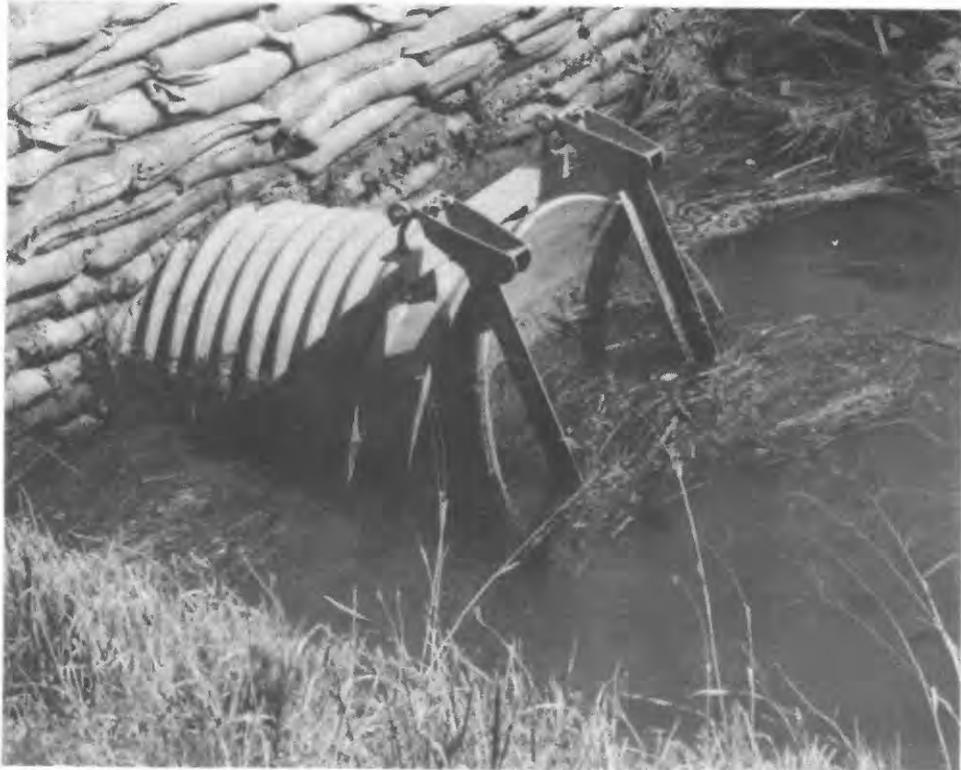
Figure 1. Photographs of a (A) flashboard riser and (B) tide gate at study sites in eastern North Carolina.

Water-control structures can help mitigate the adverse effects of agricultural drainage on sensitive estuarine waters (Gilliam, 1987) when used in draining cropland in the Coastal Plain of North Carolina. Water-control structures provide on-site benefits to the farmer; for example, flashboard risers allow the farmer to exert some control over field soil-moisture conditions. Also, water-control structures reduce the upstream movement of saline water onto fields, which can damage crops and jeopardize the productivity of the soil.
