METHODS FOR ASSESSING CHANNEL CONDITIONS RELATED TO SCOUR-CRITICAL CONDITIONS AT BRIDGES IN TENNESSEE

Water-Resources Investigations Report 94-4229

**Prepared in cooperation with the
TENNESSEE DEPARTMENT OF TRANSPORTATION and the,
U.S. DEPARTMENT OF TRANSPORTATION,
FEDERAL HIGHWAY ADMINISTRATION**

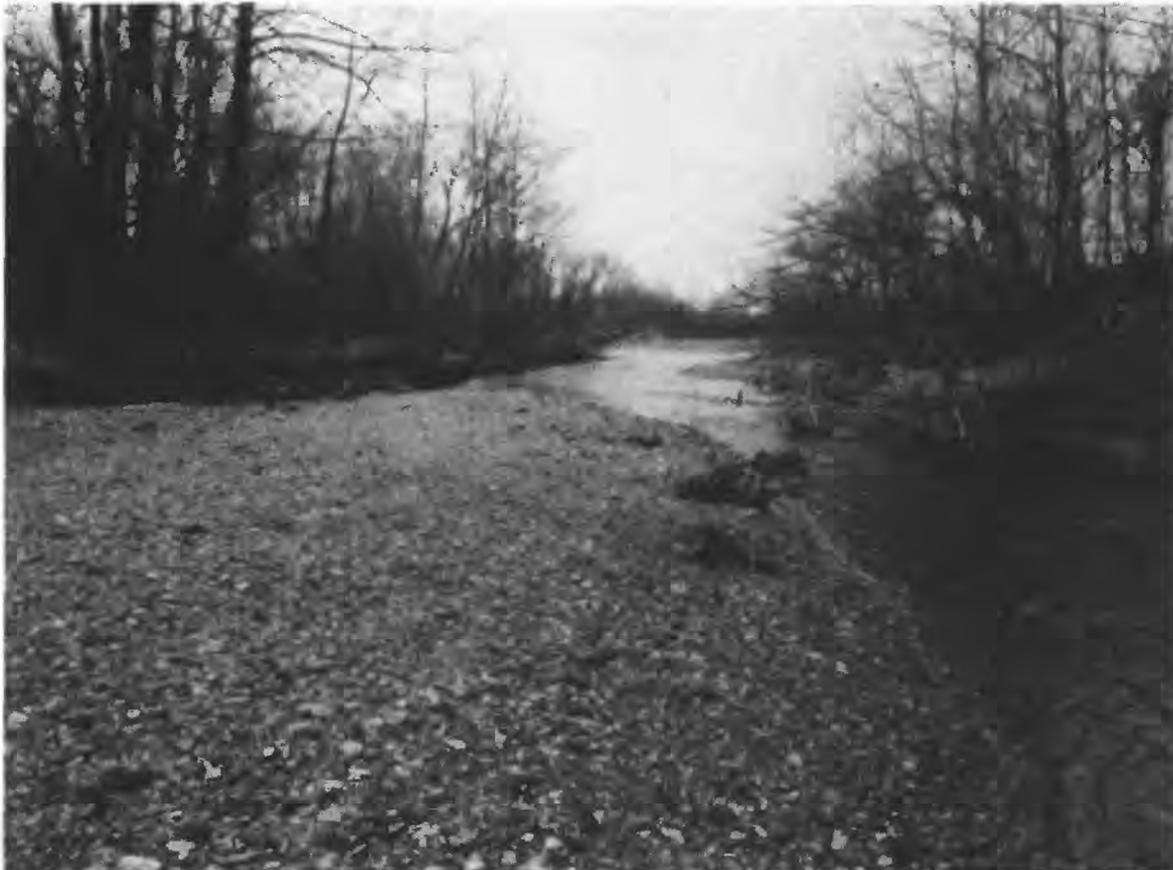
Figure 3. Western Highland Rim gravel-bed channel at Tumbling Creek, State Route 230, Humphreys County, Tennessee (photograph by Donald E. League, U.S. Geological Survey, 1993).

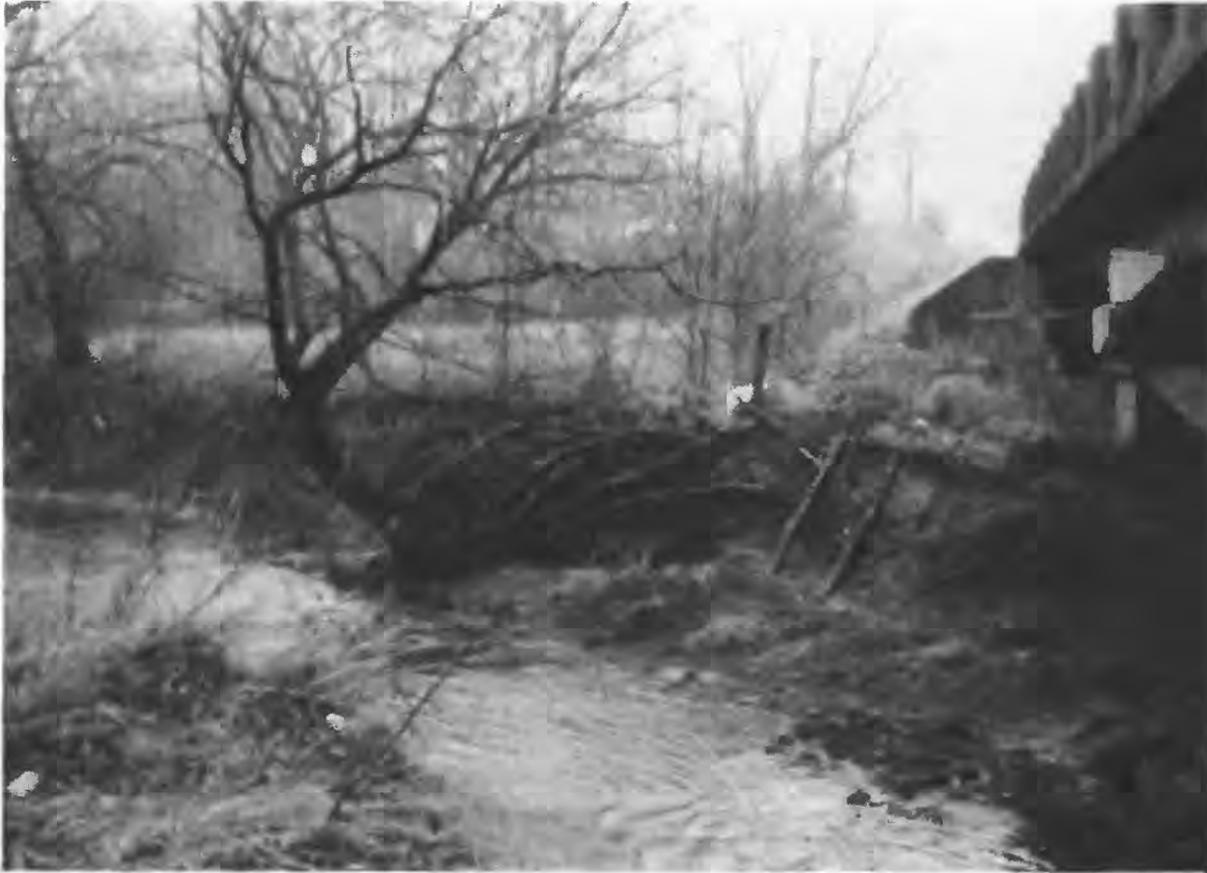
Figure 6. High-flow impact point at Little Swan Creek, State Route 15 bridge, Lincoln County, Tennessee (photograph by Donald E. League, U.S. Geological Survey, 1993).

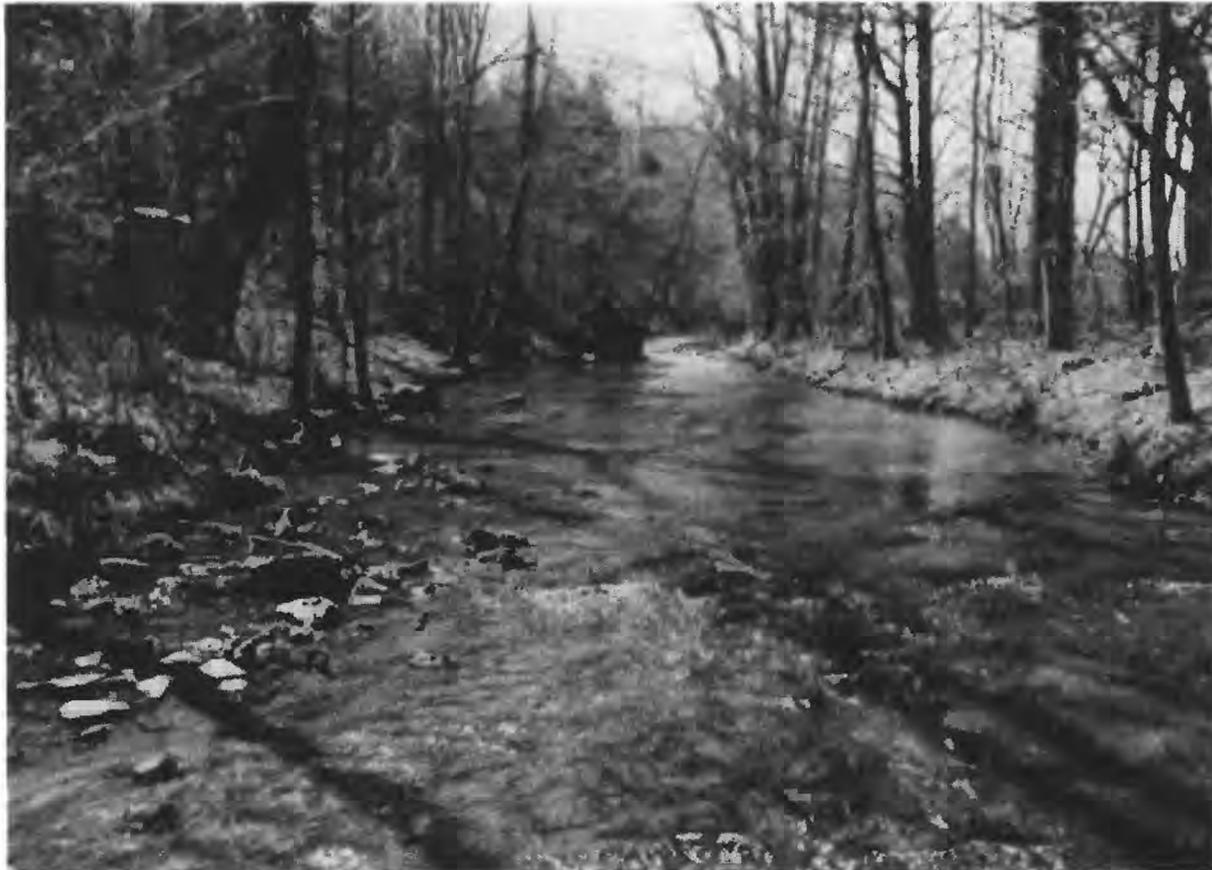
Figure 7. Stable banks along a bedrock channel at Johnson Creek, State Route 48, Dickson County, Tennessee (photograph by Donald E. League, U.S. Geological Survey, 1993).

downstream can indicate that problems at the crossing are site specific, and not related to system-wide response (for example, fig. 7). Certain bank conditions, such as high, steep banks, are more likely to fail by mass wasting and are generally indicative of rapidly occurring bank-forming processes.

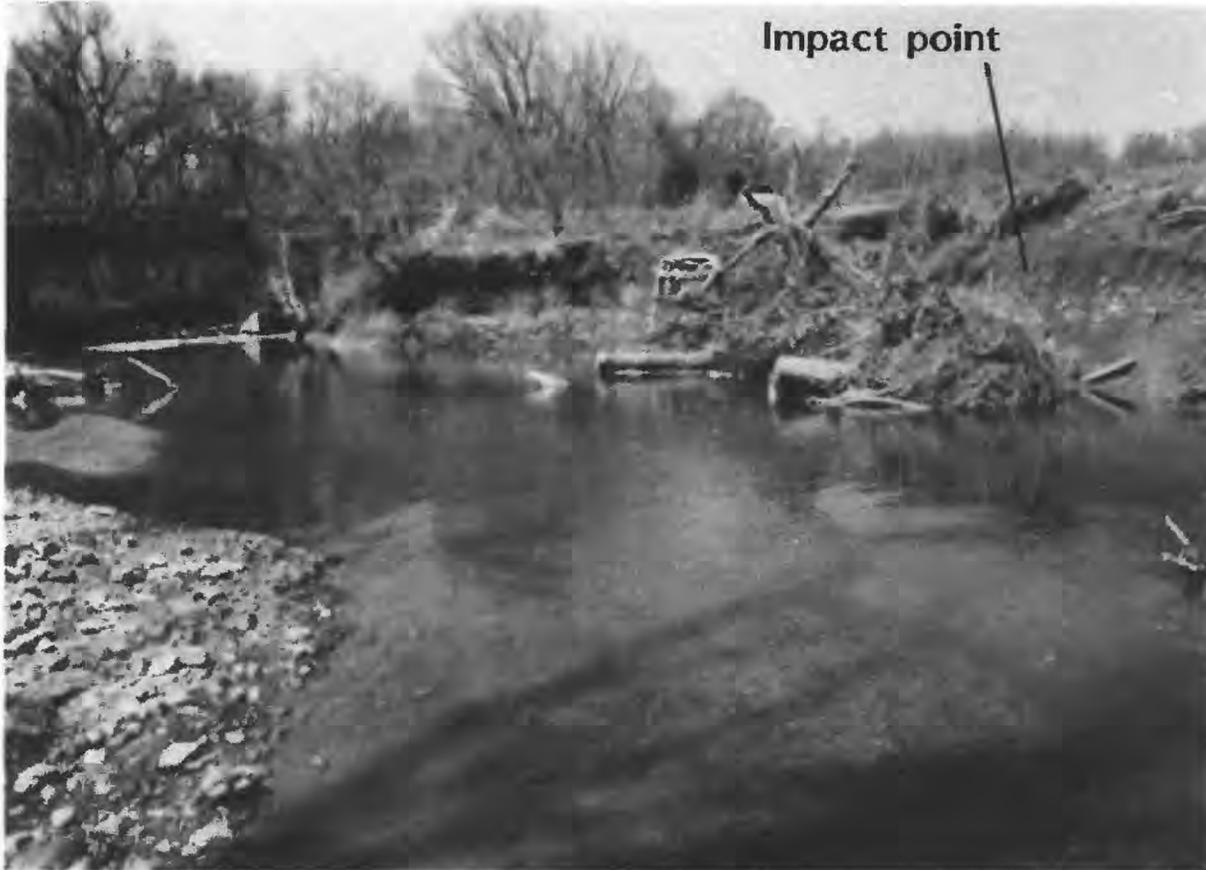
A.

Figure 11. Meander impact points: (A) Impact point is moving toward the bridge, and (B) impact point is undercutting a hillside (photographs by Donald E. League, U.S. Geological Survey, 1992).

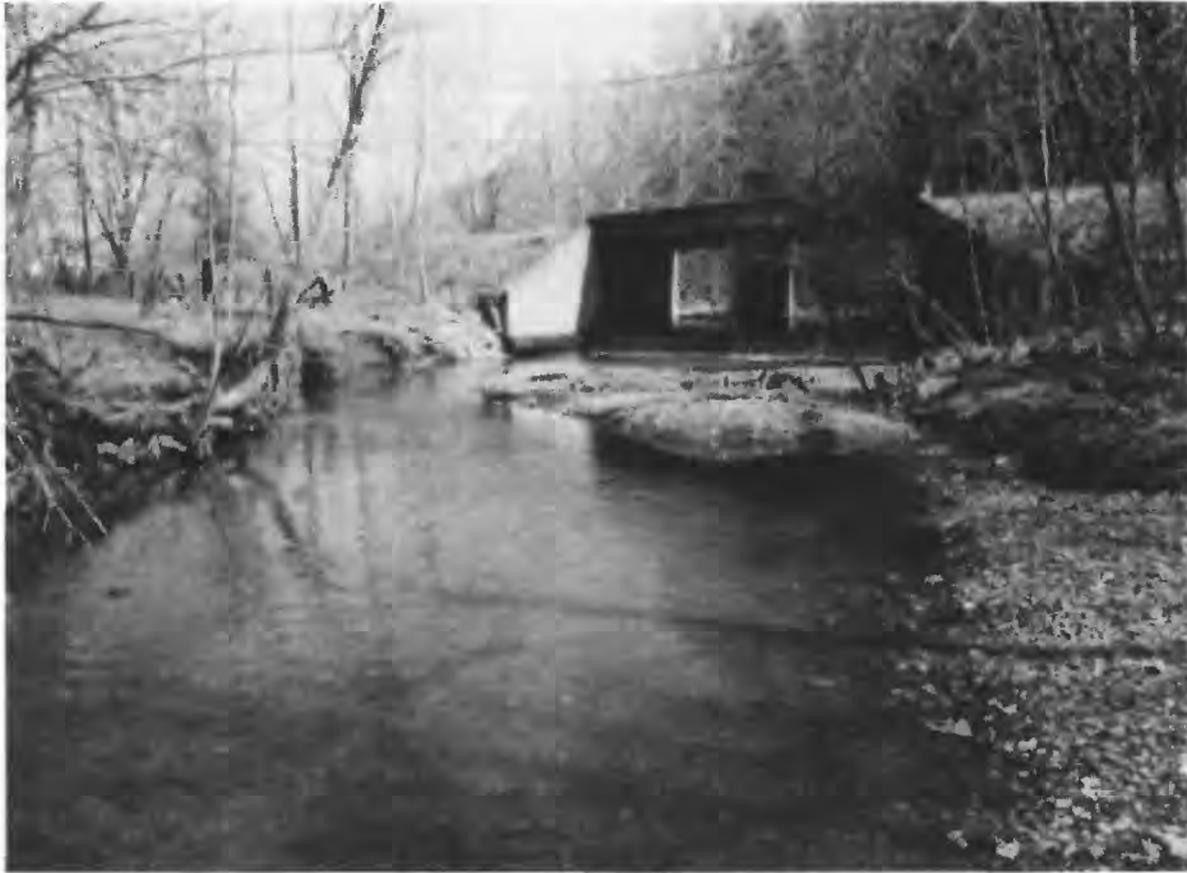
Figure 15. Example of downstream sill exposure due to flow expansion on downstream side of a floored culvert at Indian Creek, Route 1779, Humphreys County, Tennessee (photograph by Donald E. League, U.S. Geological Survey, 1992).

Percent of channel constriction (table 4) refers to differences in channel width, and therefore conveyance, upstream and at the bridge. Contraction scour occurs as a result of flow acceleration caused by the channel constriction; therefore, as constriction increases, the assigned value increases. Scour resulting from channel constriction at floored culverts often exposes the downstream sill and undermines the abutment wall or wing wall (fig. 15).

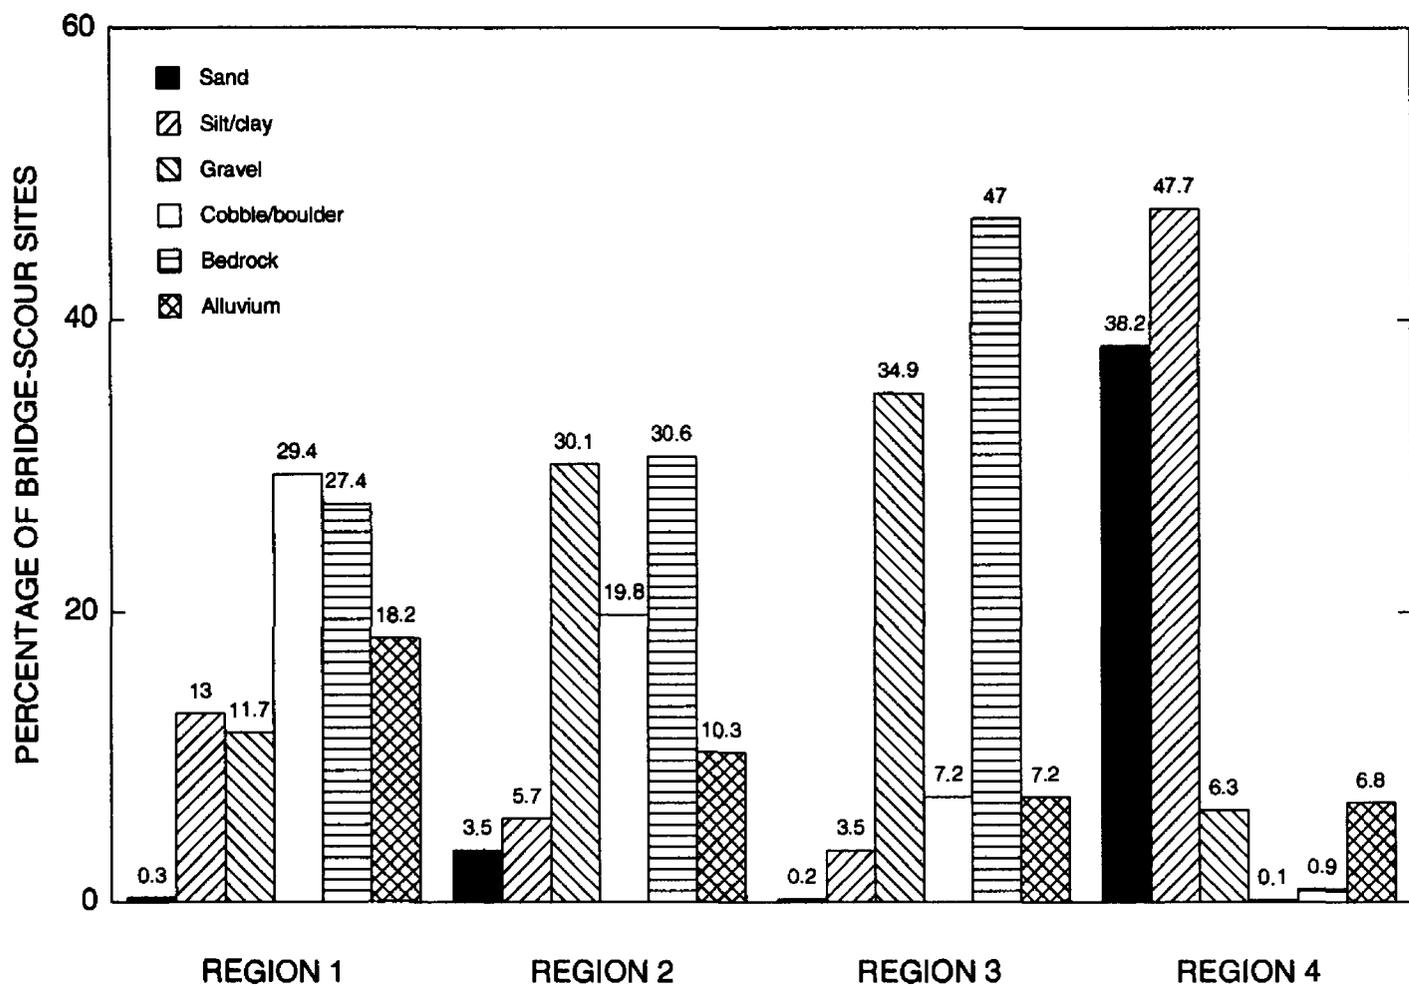
Figure 23. Percentage of bridge-scour sites with given bed-material characteristics in Tennessee Department of Transportation regions 1, 2, 3, and 4.
