Channel Change and Sediment Transport in Two Desert Streams in Central Arizona, 1991–92

By JOHN T.C. PARKER

U.S. GEOLOGICAL SURVEY
Water-Resources Investigations Report 95—4059

Prepared in cooperation with the
FLOOD CONTROL DISTRICT
OF MARICOPA COUNTY

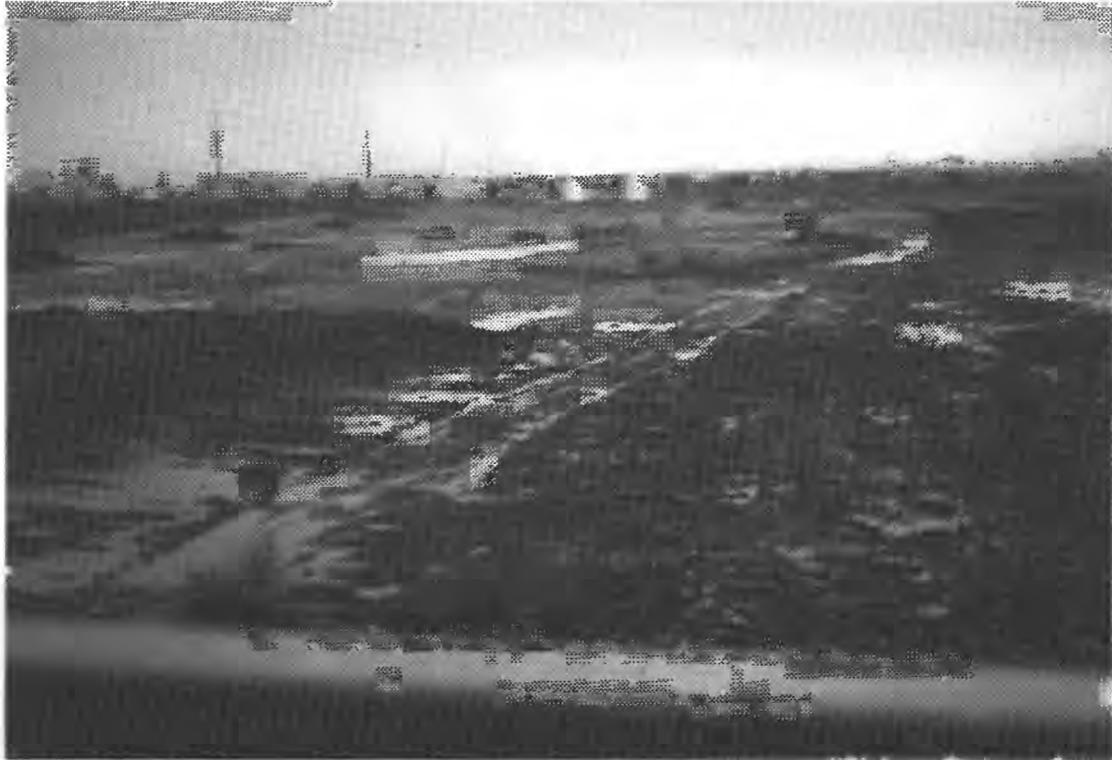
A, Looking upstream from the 24th Street bridge. Much of the channel bottom has been scraped, and gravel was pushed into piles shown at the left edge of the photograph.

Figure 3. Salt River before winter flows of 1992, Phoenix, Arizona.

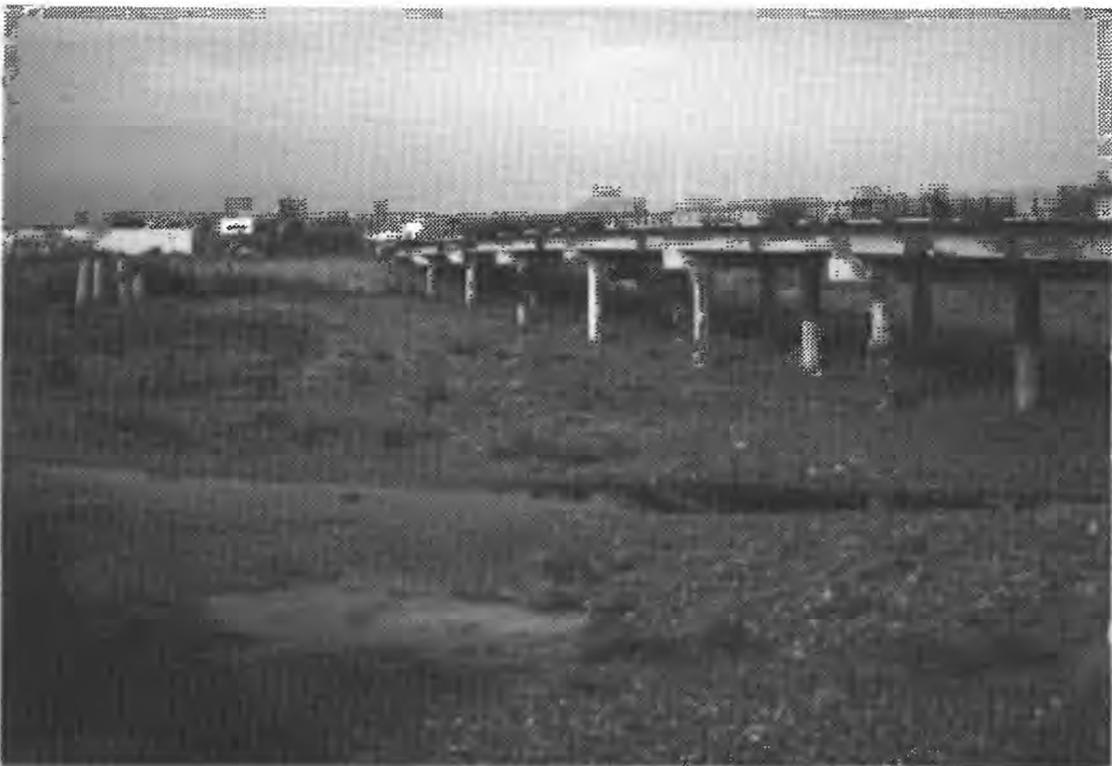
B, Looking across the channel from the left bank downstream from the 16th Street bridge.

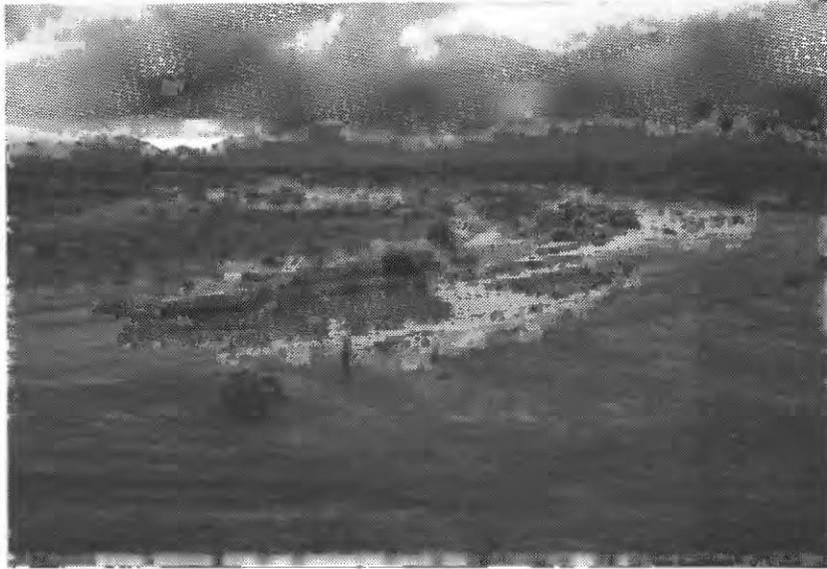
A, Looking downstream from the Southern Pacific Railroad bridge at the head of the study reach.

Figure 5. Hassayampa River before winter flows of 1992, Arlington, Arizona.

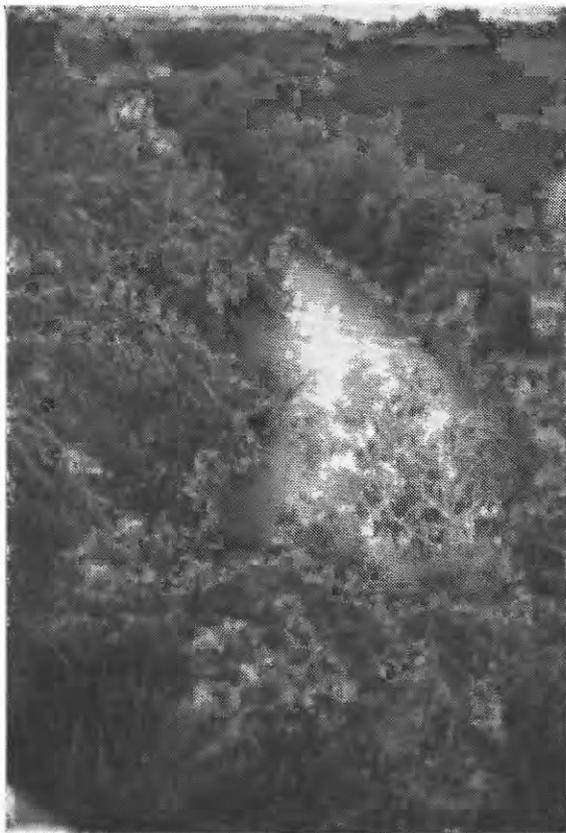
B, Looking upstream from the Old U.S. Highway 80 bridge.

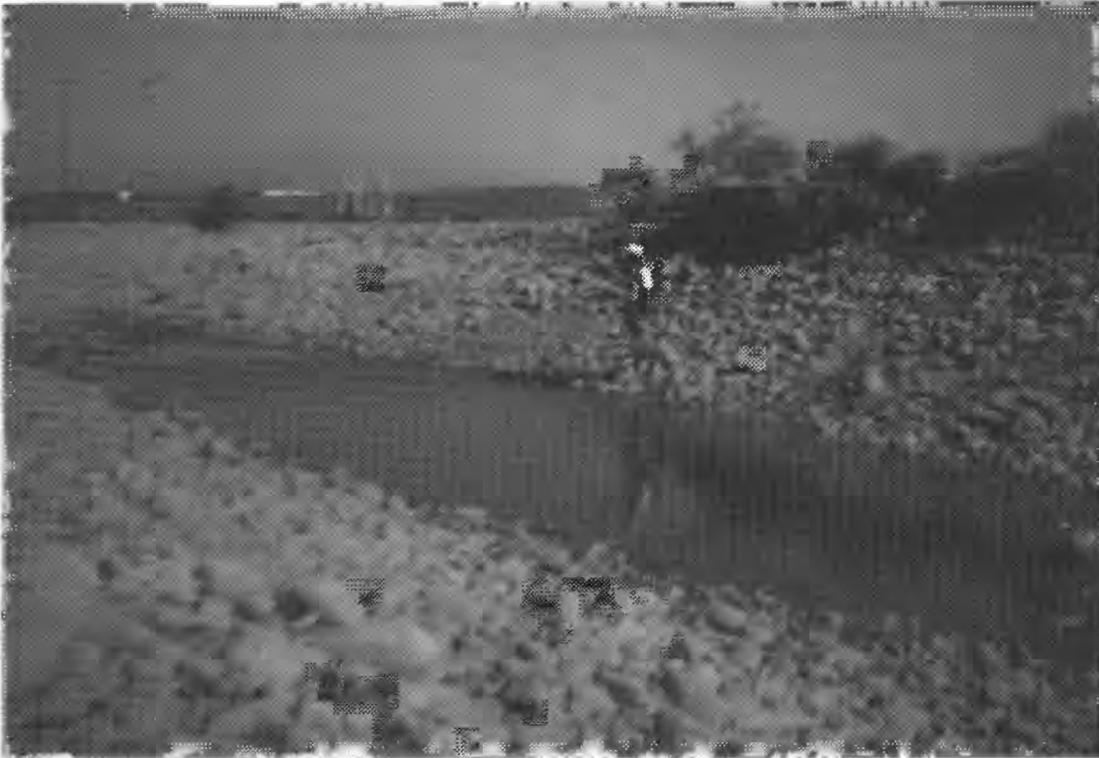
A, Incised channel below 16th Street near cross section 1; preflow gravel-paved channel bottom was 0.3 to 0.4 meters below vegetated surface (Top right of photograph).

Figure 12. Effects of flows on the Salt River, Phoenix, Arizona, 1992.

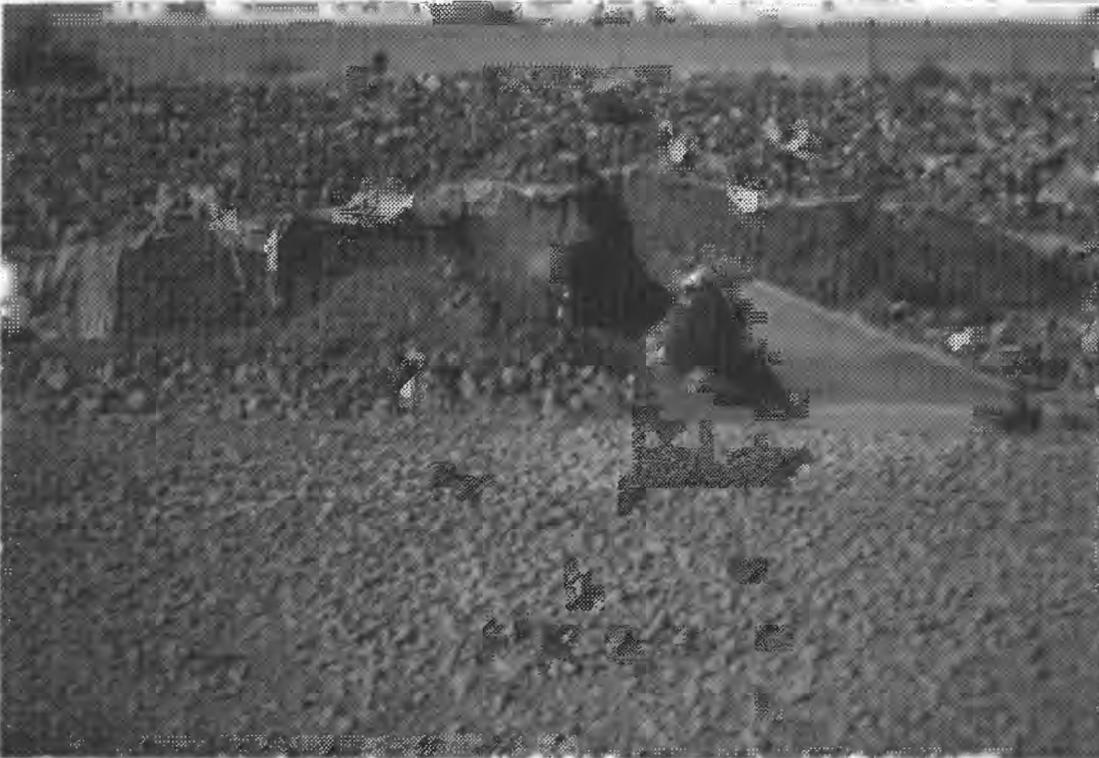
B, Erosion of boulder revetment and loss of structure at storm-drain outlet below 16th Street near cross section 2.

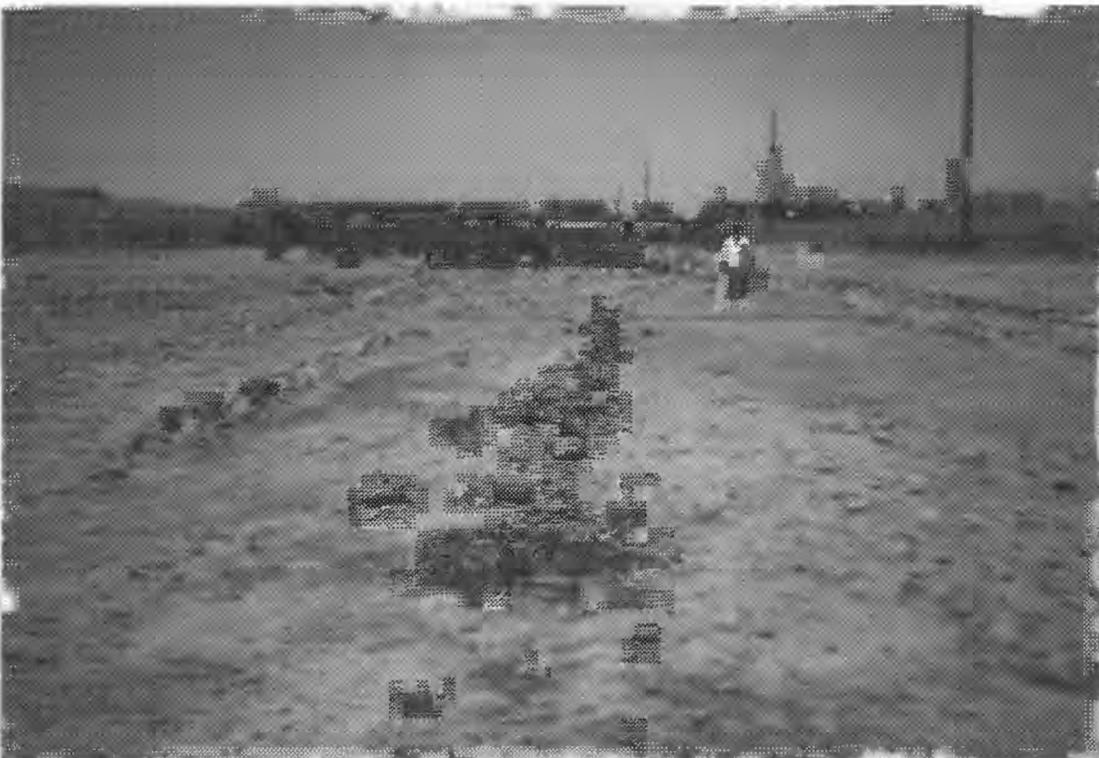
C, Gravel berms between cross sections 4 and 5 about 800 meters below 16th Street bridge showing little or no disturbance from winter flows.

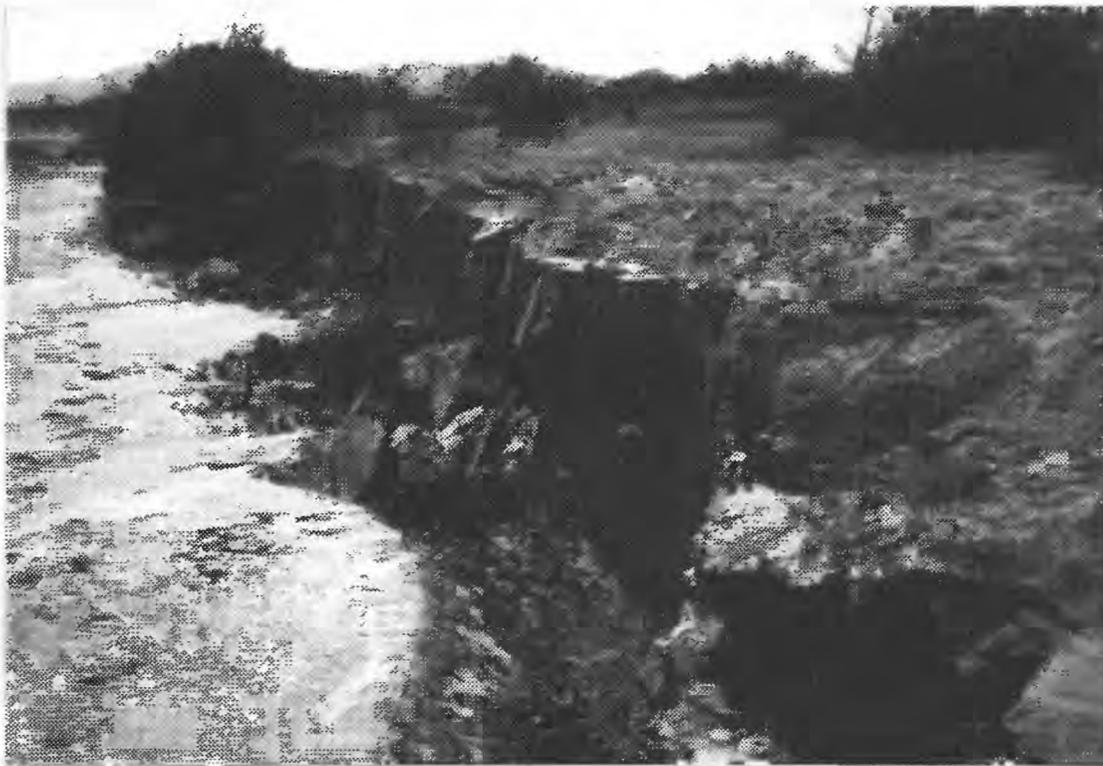
A, Looking downstream at streambank just below cross section 2 after the flow on January 6, 1992. Failure material at base of bank indicates some erosion occurred from the flow in January. (Photograph was taken on January 30, 1992.)

Figure 16. Effects of flows on the Hassayampa River, near Arlington, Arizona, 1992.

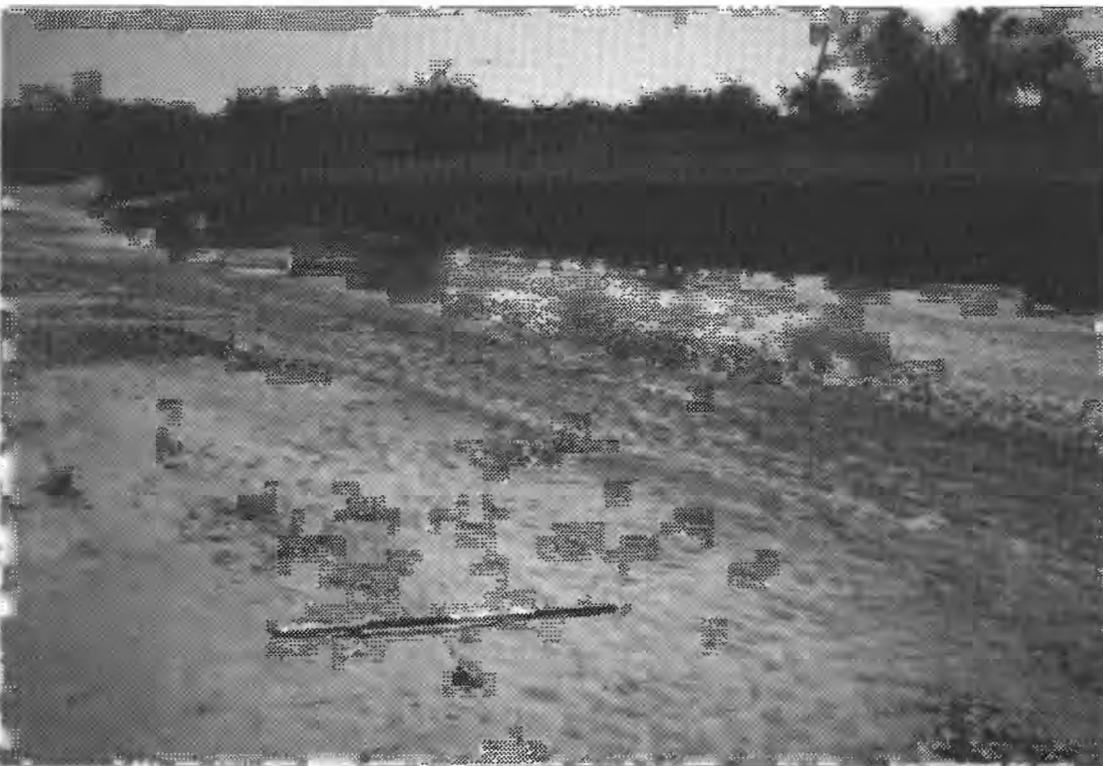
B, Bank erosion after the flow on February 7, 1992. (Photograph 16B is the same location as photograph 16A. Photograph was taken on April 10, 1992.)

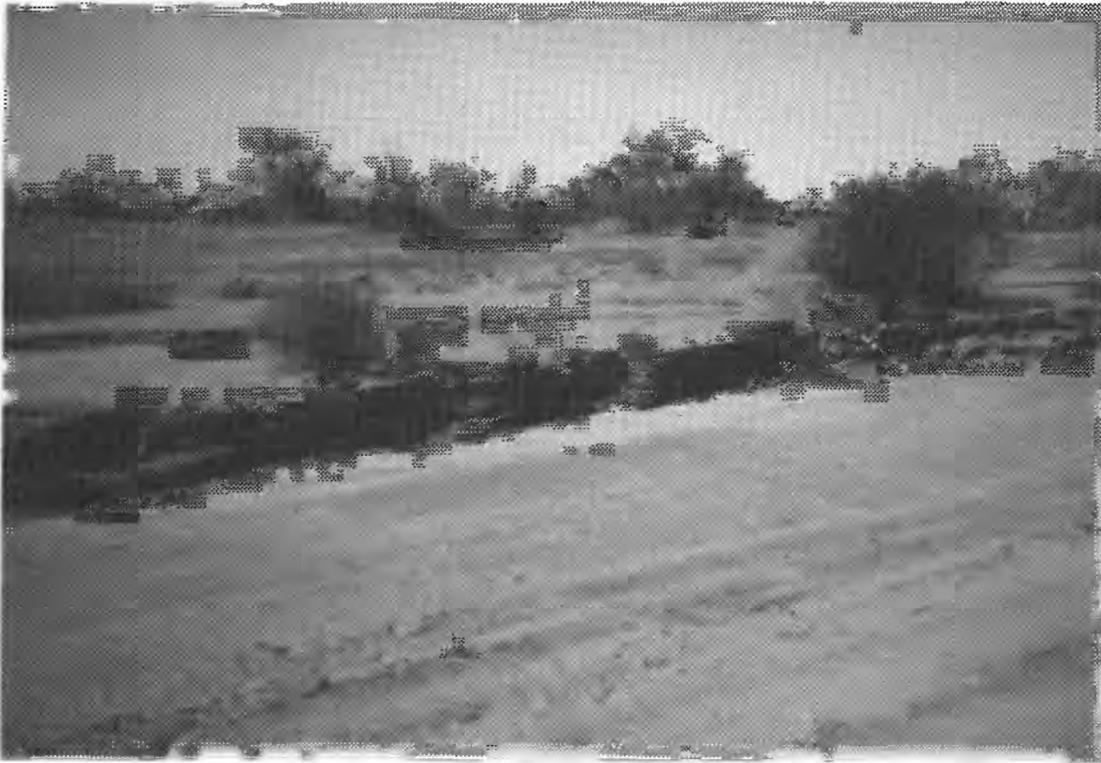
C, Looking upstream at low terrace near cross section 10 before flow on February 7, 1992. (Photograph was taken on January 30, 1992.)

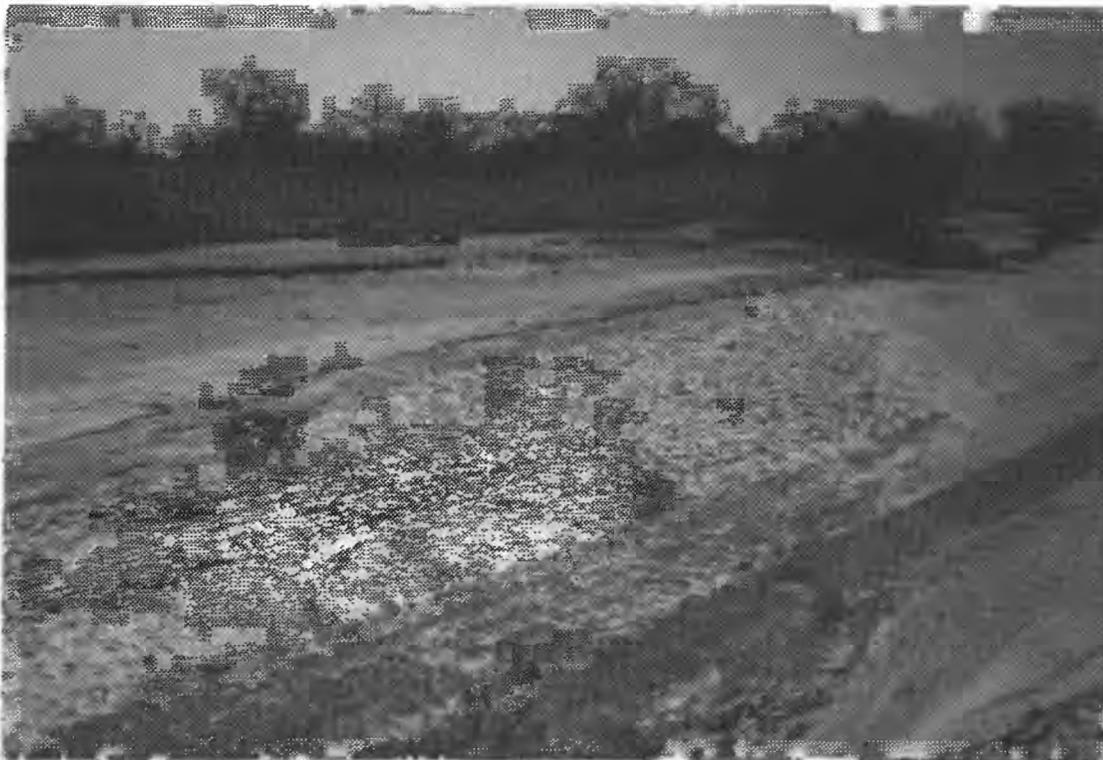
D, Low terrace along right side of channel after the flow on February 7, 1992. Deposition in channel nearly buried the terrace. (Photograph 16*D* is the same location as photograph 16*C*. Photograph was taken on April 10, 1992.)
