Hydraulic Characteristics Near Streamside Structures Along the Kenai River, Alaska

By Joseph M. Dorava

Water-Resources Investigations Report 95-4226

ALASKA DEPARTMENT OF FISH AND GAME

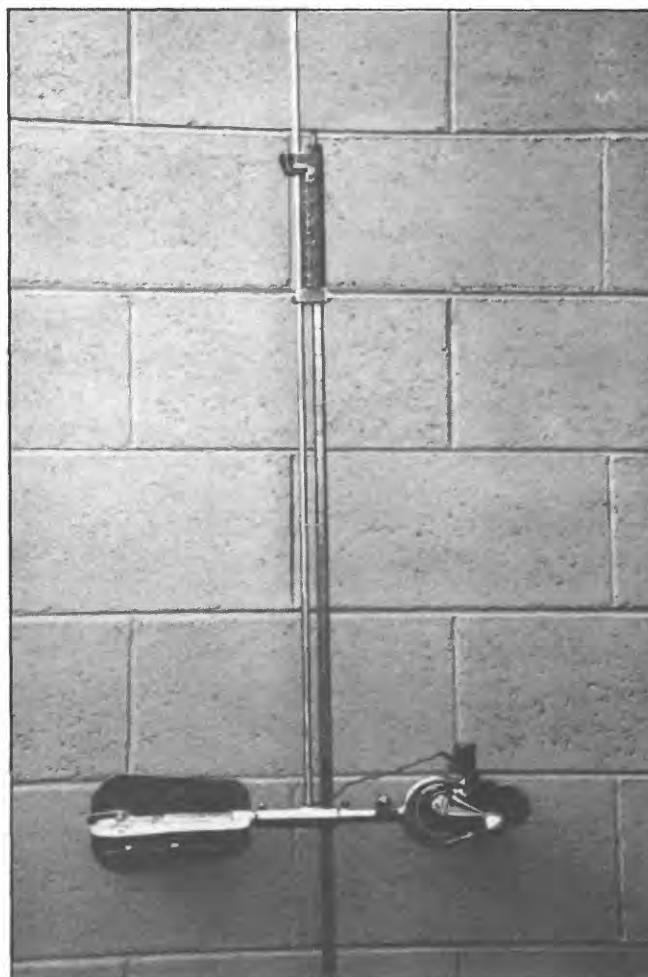
Figure 5. Price-AA velocity meter attached to a top-setting wading rod.

Velocity at each site was measured with a calibrated Price-AA meter. This type of meter is made of stainless steel and is formed into a circle of six cups that are mounted on a vertical axis and rotate in a horizontal plane (fig. 5). This is the standard velocity meter used by the USGS. The meter was mounted on a hand-held rod because all depths were wadable. The meter was lowered into the water and the number of rotations during a fixed interval of time were recorded. The rotation rate for the Price-AA meter is proportional to the water velocity.

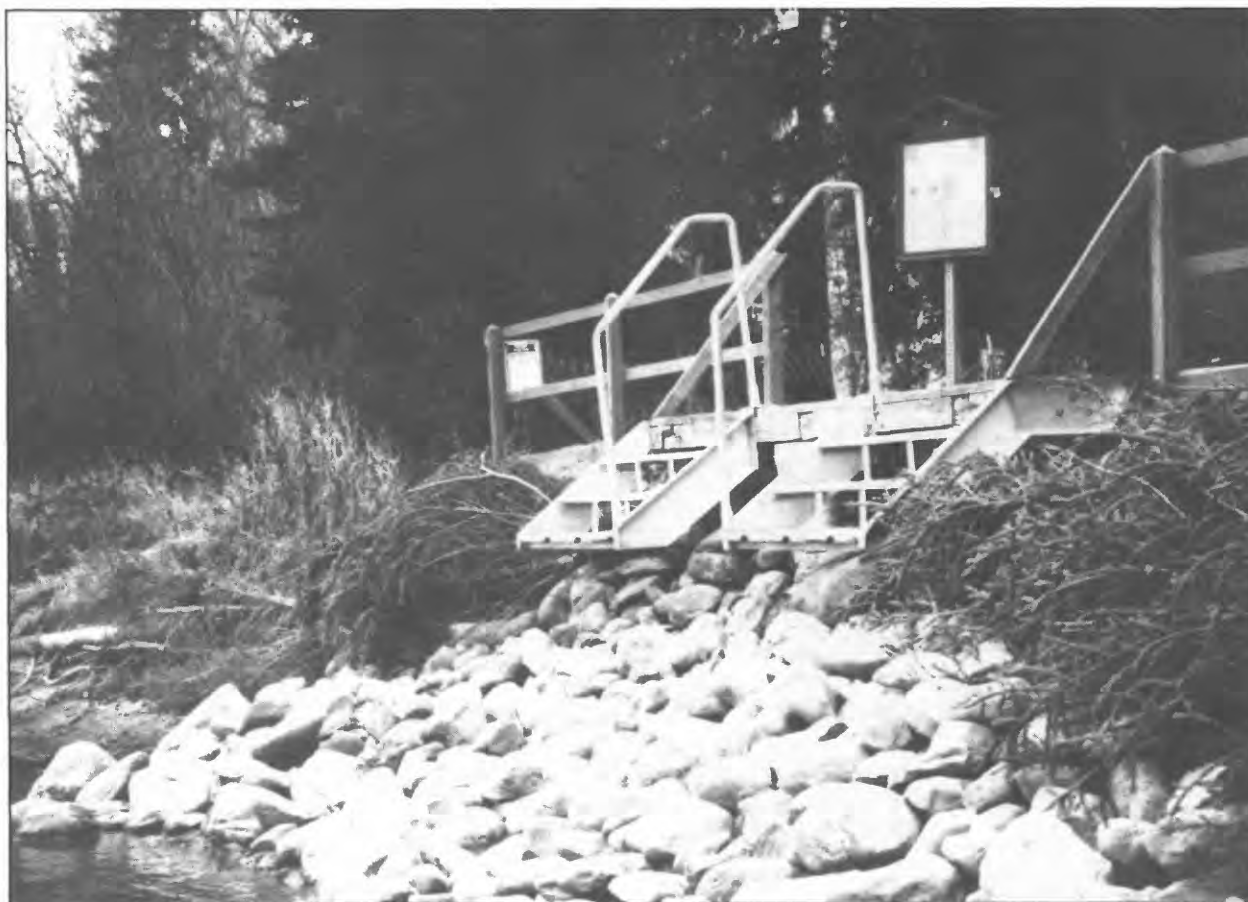
Figure 10. Floating dock area near river mile 16.6 along Kenai River. Riprap placed near dock attachment is in the small boulder size range (10-40 inches). View is looking downstream from right bank on May 9, 1995.

Measurements on May 9, 1995 at this site were made with the dock out of the water (table 5). Flow velocity and depth were nearly equal at points upstream from, at, and downstream from the dock's attachment point during these measurements.

Because the dock requires a specific height of water to float it at its attachment point, it can not be deployed until the high-water period that usually occurs in mid- to late June. The dock must be removed again when the water height declines in the fall. Although it was only in the water during high flow, measurements at the floating dock indicate no velocities that were unacceptable to juvenile salmon. The velocities measured were within the range commonly utilized by rearing salmon and the direction of streamflow was not altered in a manner that would likely increase bank erosion.

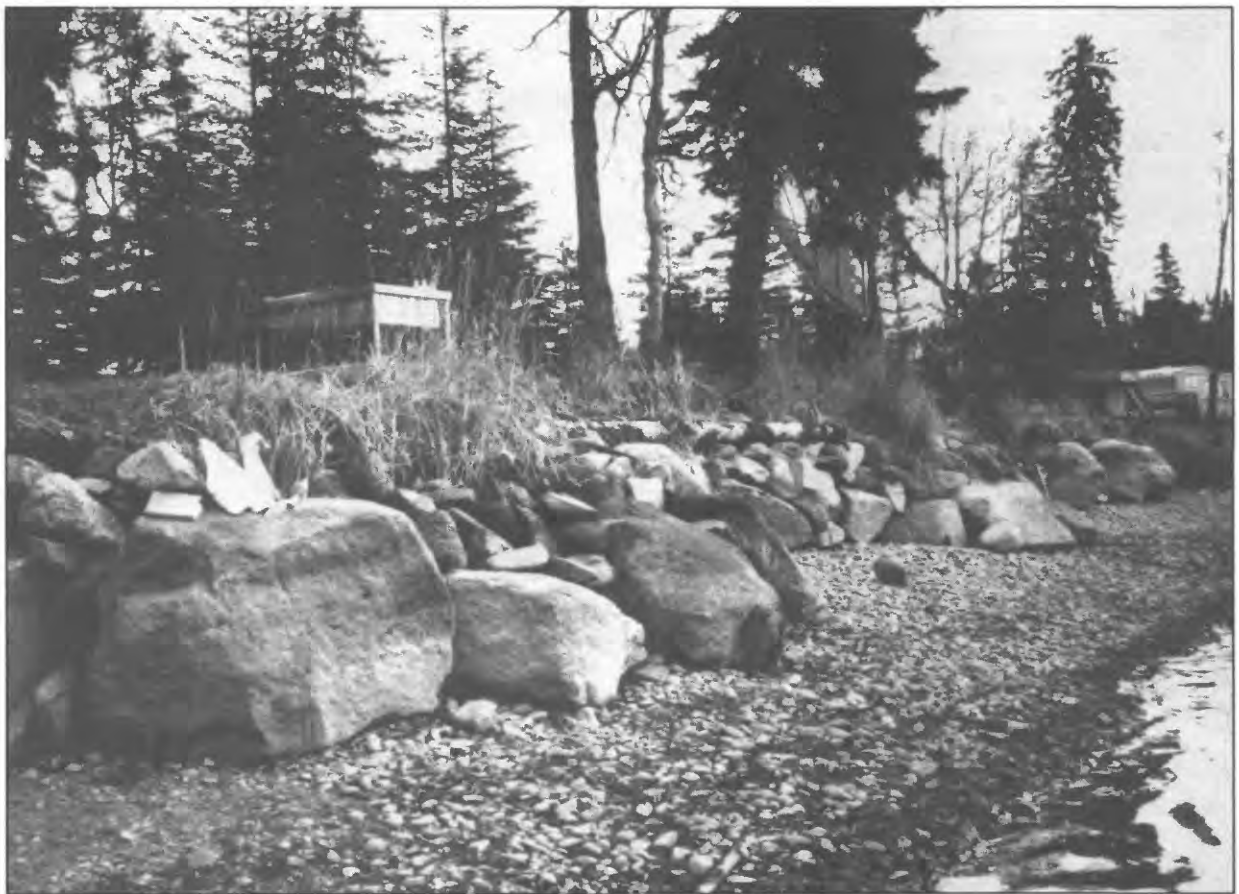
Figure 11. Rock retaining wall near river mile 16.8 along the Kenai River. Large boulders are 2 to 3 feet in diameter. The natural bed material at base of wall is in the cobble size range

For this investigation, a near-vertical, irregularly protruding rock wall built of 2-to 3-foot diameter boulders was selected for evaluation (fig. 11). It is located on the right bank near river mile 16.8 (C, on fig. 7) at lat 60°30'26"N and long 151°06'49"W. The wall was built to protect the streambank near a boat launch from erosion. The wall is about 40 ft long and has sections that project from 3 to 6 ft into the channel. The wall is near the downstream end and on the outside of a meander bend (fig. 7), an area of this reach that experiences naturally higher velocity.

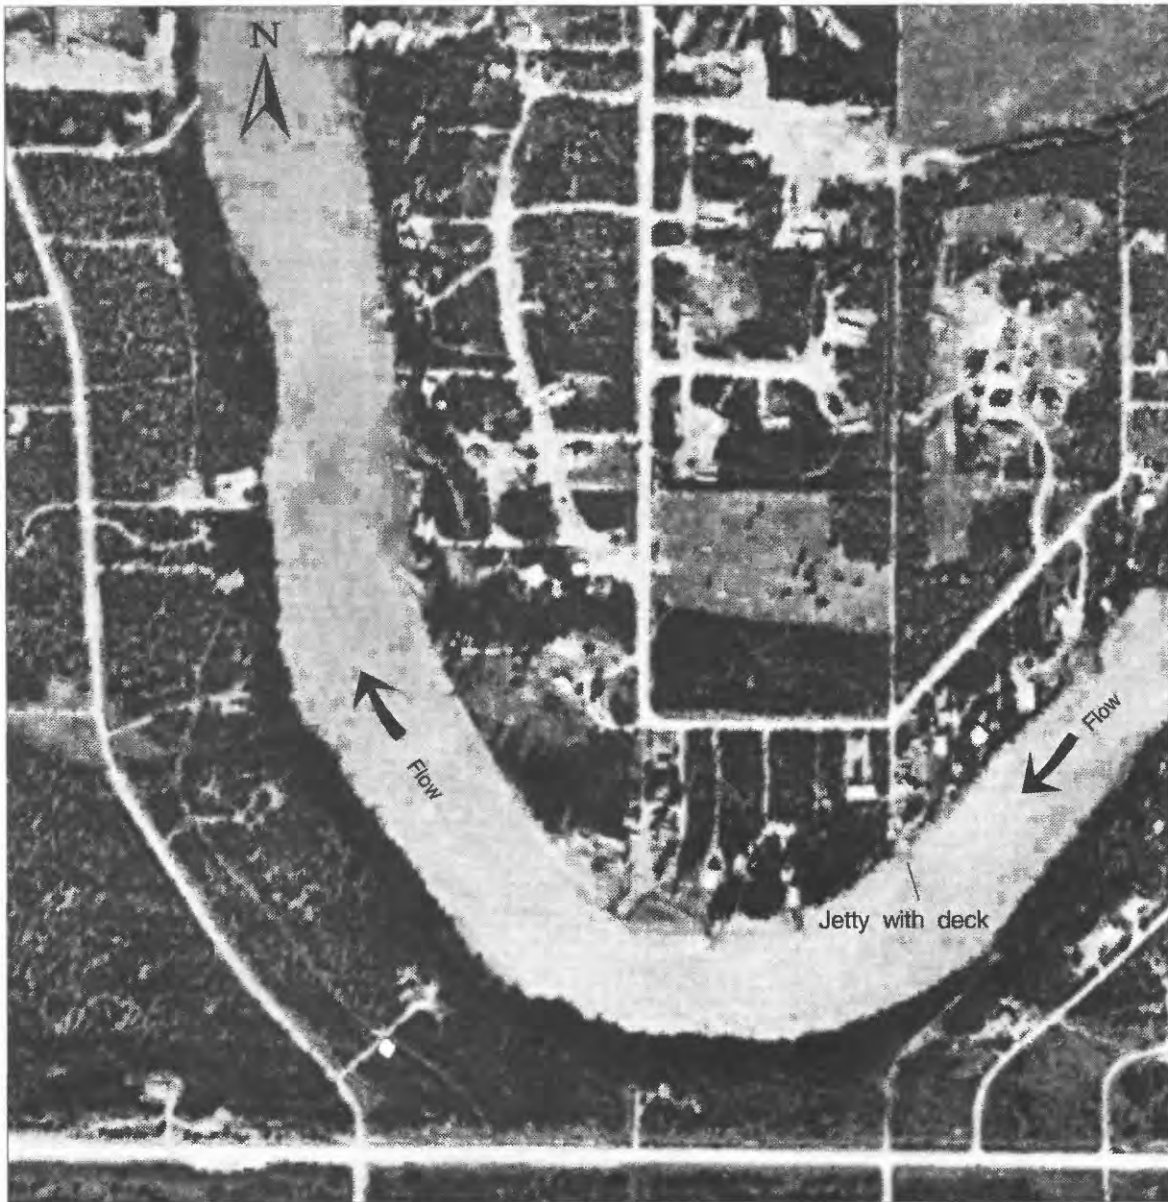
Figure 14. Location of jetty with deck near river mile 37.9 along the Kenai River. Area shown extends from approximately river mile 38.2 downstream to 37.0. Modified from aerial photograph, dated July 2, 1992, provided by Alaska Department of Fish and Game.

Eighty jetties were identified by ADF&G along the Kenai River (Liepitz, 1994). Thirteen of these, ranging in length from 15 to 75 ft, are along the inside edge of a large meander bend between river miles 37 and 38 (Scott, 1982) (fig. 14). These jetties are about 2 mi downstream from the upper anabranch reach of the river where numerous islands are slowing and diverting water around them. However, between these islands and the jetties is Naptowne Rapids, where the Kenai River is perhaps its fastest and steepest. Below these rapids, the river enters a series of long meanders where the river thalweg likely shifts between banks following the outside of the meanders. Near river mile 37.9, along the inside of the second meander about 1.5 mi downstream from Naptowne Rapids, a rock jetty (fig. 14) about 50 ft long was investigated for its influence on stream hydraulics. This jetty, at approximate lat 60°31'10"N., long 150°44'01"W., was selected because it is one of the larger jetties on the river. It also had easy roadside access and the downstream residents were experiencing some streambank loss, which they attributed to the jetty.

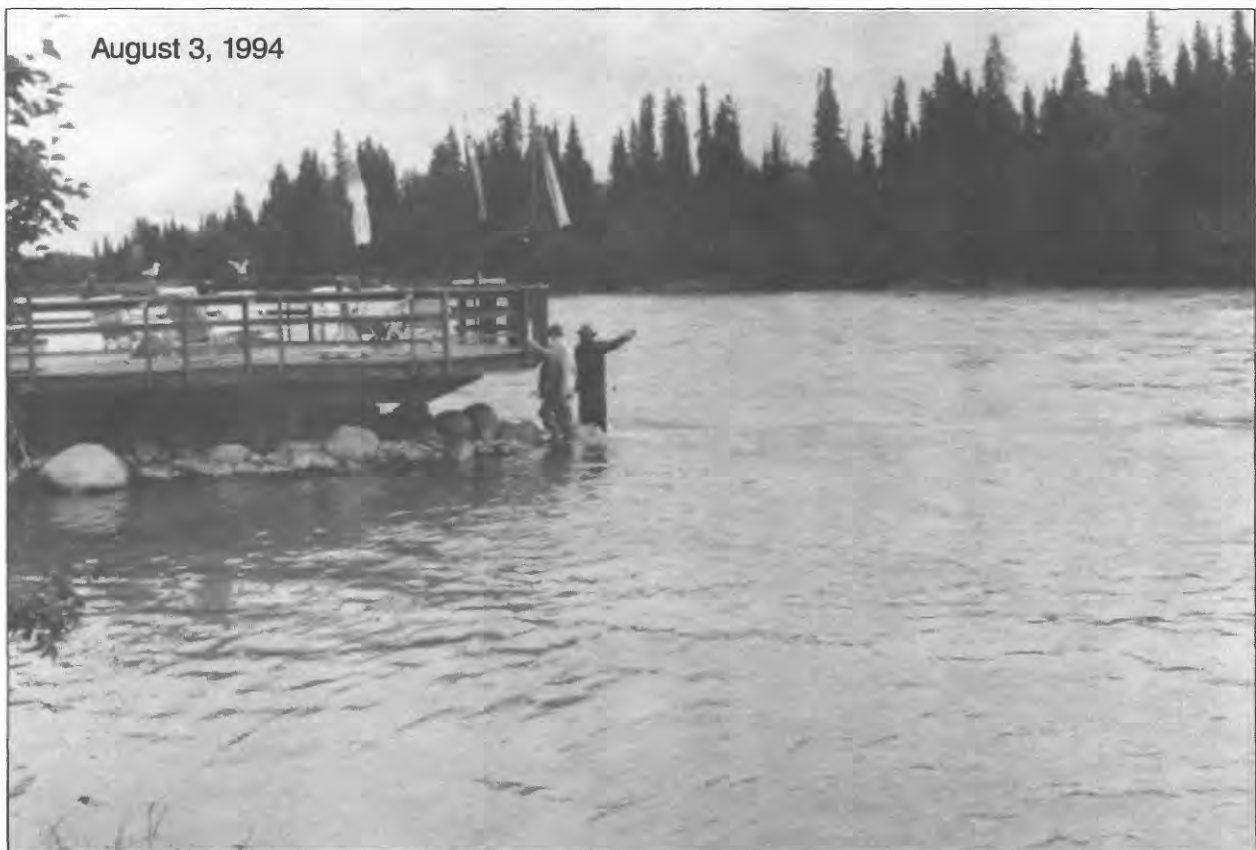
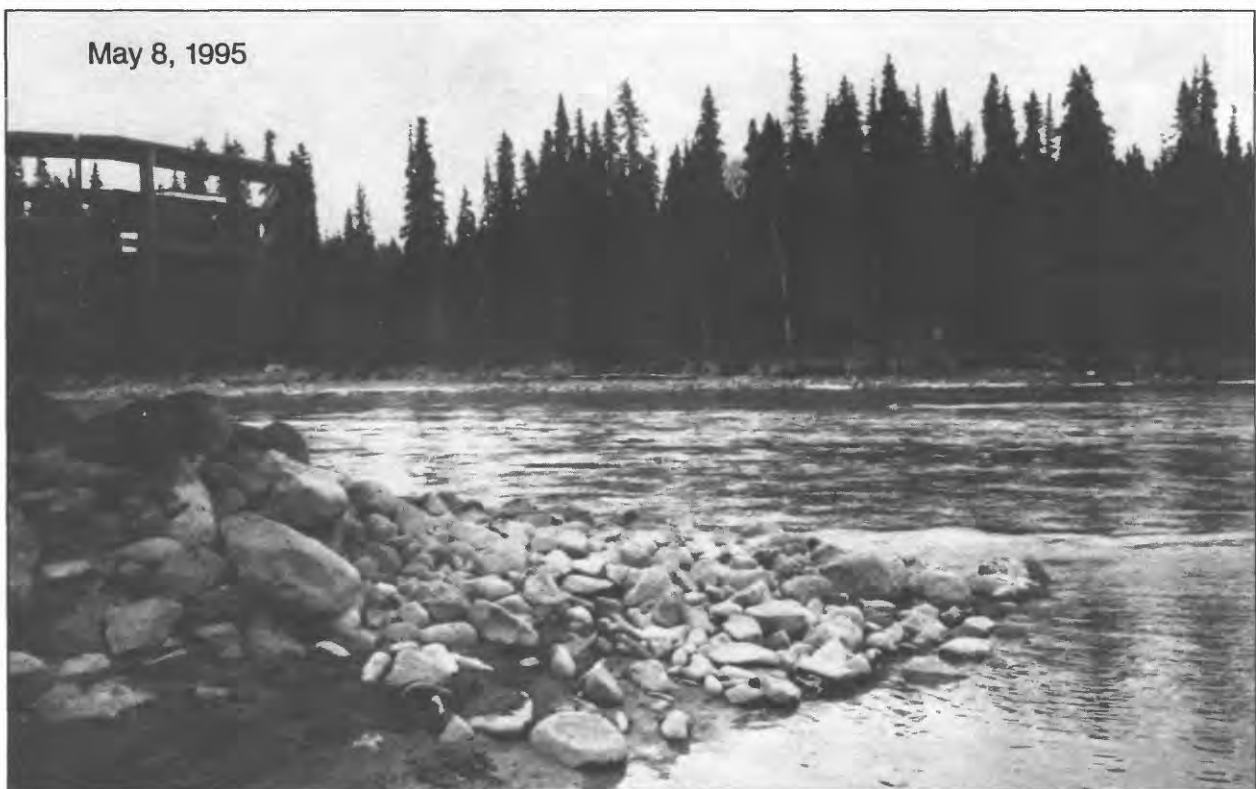
Figure 15. Jetty with deck near river mile 37.9 along the Kenai River. View is looking upstream from right bank.

The base or toe of this jetty is made of large 1-to-3-foot-diameter rocks (fig. 15). It is further reinforced with a poured concrete foundation in the center, which supports a large, approximately 20-foot-diameter screened gazebo and an extensive wooden deck (fig. 16). This wooden gazebo/deck combination rests on the rock jetty. Its floor was about 7 ft above the water surface on June 9, 1994. This jetty has been in place since sometime prior to 1972 (Scott, 1982). However, no indication of the date when the gazebo was constructed or when concrete reinforcement of the jetty was completed is available. In addition to supporting the gazebo, the jetty provides protection for a boat launch which enters the river at the jetty's downstream edge (fig. 16). Upstream from the jetty, the streambank is reinforced by a wood retaining wall approximately 30 ft long and more than 8 ft high. Having experienced some bank loss, the downstream landowner has also reinforced the bank utilizing natural vegetation along the upper bank and cabled spruce trees below the ordinary high water line (fig. 16).

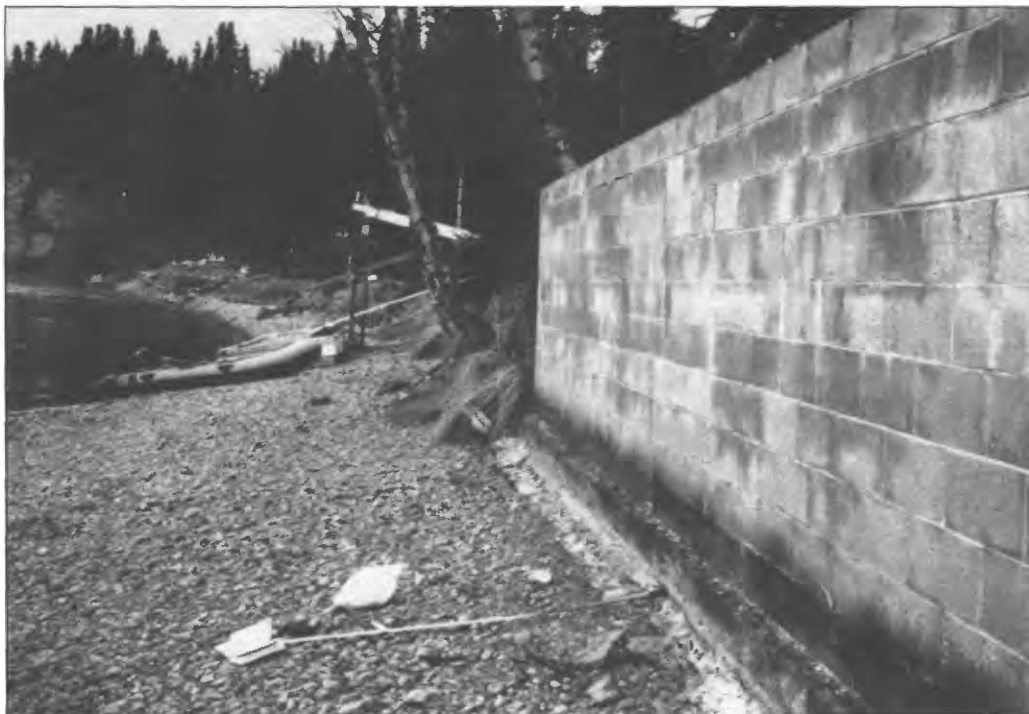
Figure 18. Concrete block retaining wall near river mile 42 along the Kenai River. View is looking downstream on right bank May 8, 1995.

On May 8, 1995, this wall was dry and was more than 25 ft from the edge of the water (fig. 18), so no measurements were made. At low-flow conditions a pattern of large circular eddies was present in the main channel flow.

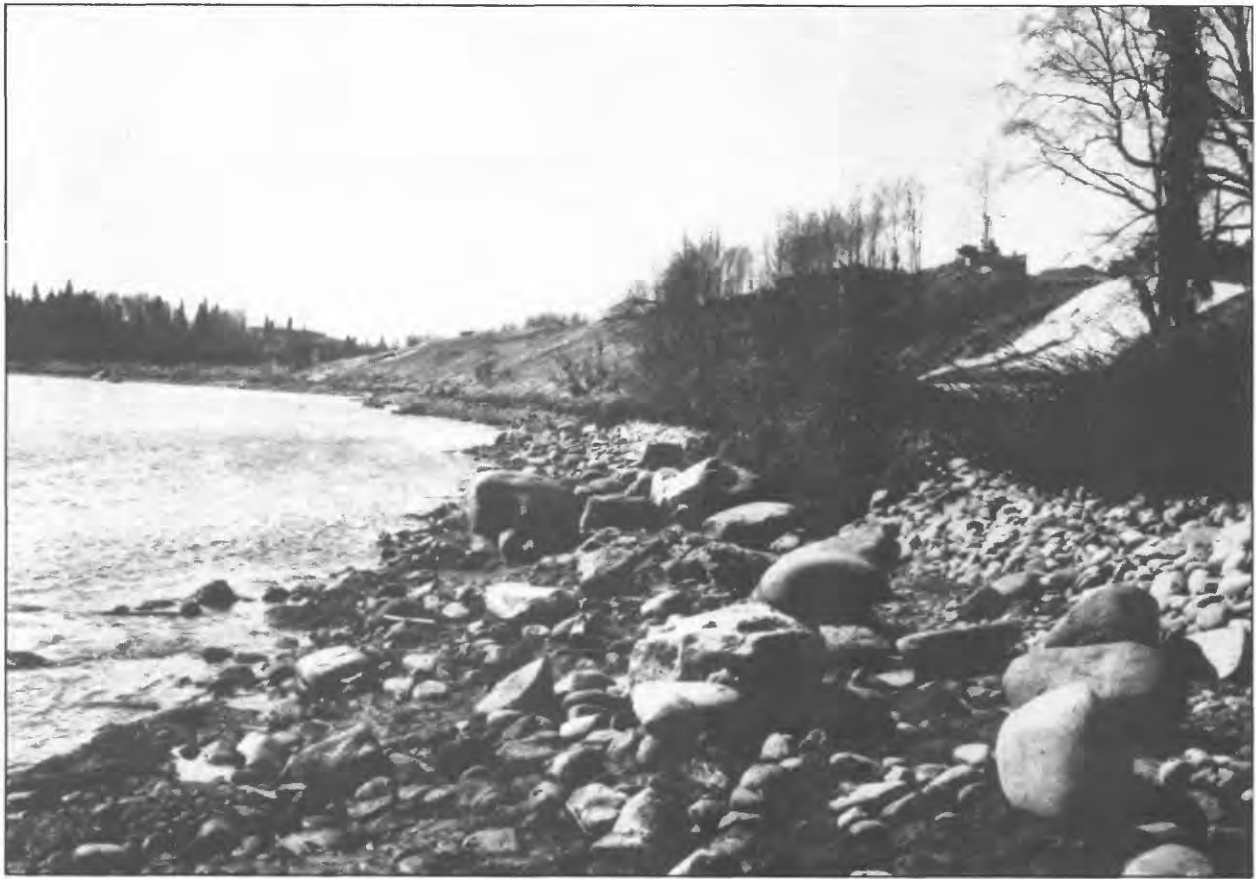
Figure 21. Soldotna Creek Bio-Engineering Project near river mile 21.9 along the Kenai River. View is looking downstream on right bank May 9, 1995.

The Soldotna Creek Bio-engineering Project is a pilot project near river mile 21.9, about 0.9 mi upstream from the Sterling Highway Bridge (fig. 2). This project utilizes a variety of natural living and non-living plant materials and unique installation techniques to help stabilize a 650-foot reach of the right bank of the Kenai River downstream from the mouth of Soldotna Creek (fig. 20). The biologically engineered bank stabilization techniques utilized at this site were designed to restore natural bank characteristics and protect the bank from future erosion caused by water action and foot traffic, while providing productive habitat for juvenile chinook salmon. Several different techniques using indigenous Alaskan willows and grasses in combination with boulders, root wads, and special walkways, are in place in a heavily used park area (fig. 20). With the exception of the root wads, boulders, and a downstream section of the vegetation, much of the bank stabilization and the walkway were installed at an elevation commonly higher than the ordinary water surface, and therefore have little influence on the flow velocity or direction of the river (fig. 21).
