# WHEN THE BLUE-GREEN WATERS TURN RED

Historical Flooding in Havasu Creek, Arizona

U.S. GEOLOGICAL SURVEY  
Water-Resources Investigations Report 96—4059

By THEODORE S. MELIS, WILLIAM M. PHILLIPS  
ROBERT H. WEBB, and DONALD J. BILLS

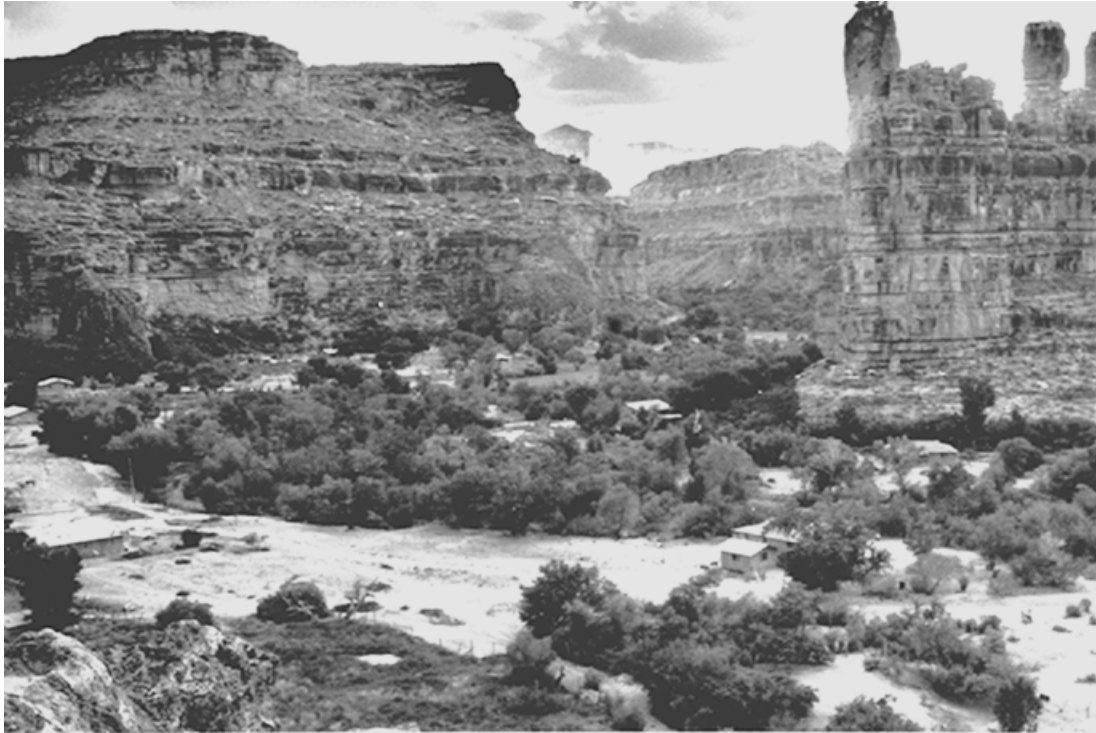
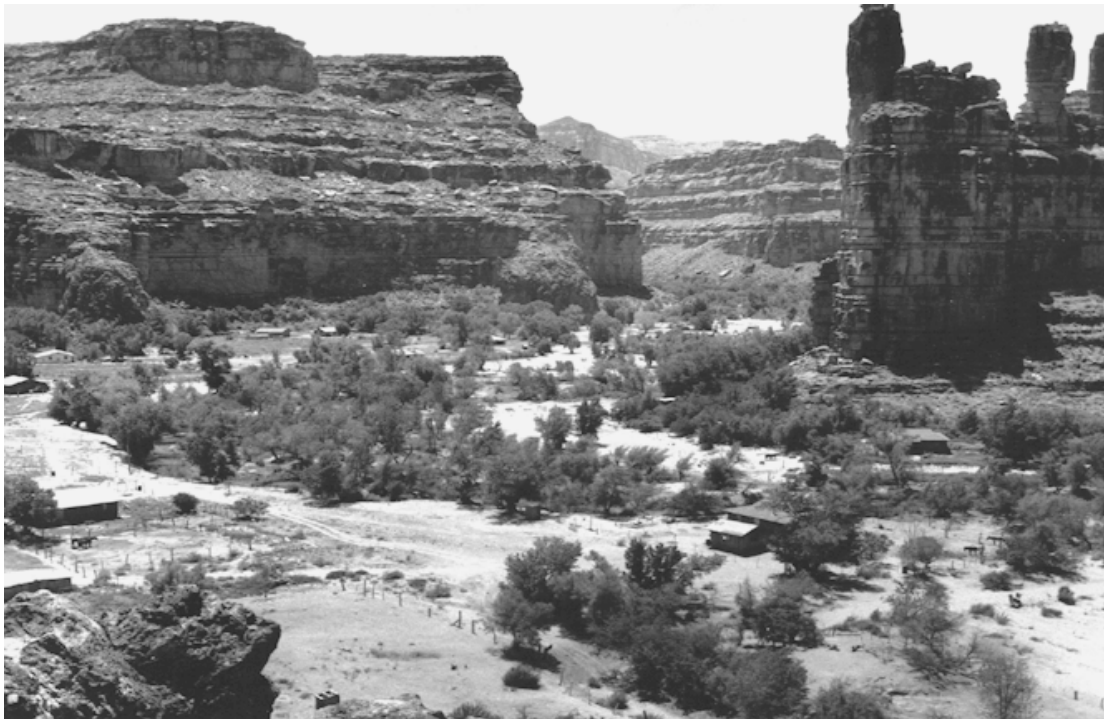
**Figure 19.** Replicate views of Havasu Canyon in the vicinity of Supai. A, (1988). View of Havasu Canyon near Supai before the 1990 flood (Brownold). B, (1991). Replicate view showing the effects of the 1990 flood on Havasu Canyon near Supai (Stake 2149).

Photographs taken before and after the 1990 flood (fig. 19) show some effects of the 1990 flood in this section of Havasu Canyon. In 1988, trees of approximately the same height as those present in 1941 lined the creek. In 1991, the channel appeared scoured, but most of the trees survived the 1990 flood. Comparison of the 1941 and 1988 views show that agricultural activities have decreased on the bottomlands near Supai. Interpreting channel changes from these five photographs is difficult, owing to human impacts following relocation of the village in 1910. The photographs taken around the turn of the century, however, stand in contrast with later views because mature trees are missing from the channel banks. The absence of large trees may reflect the damage caused by the large floods before 1899 or may be caused by some unknown activities of the Havasupai.

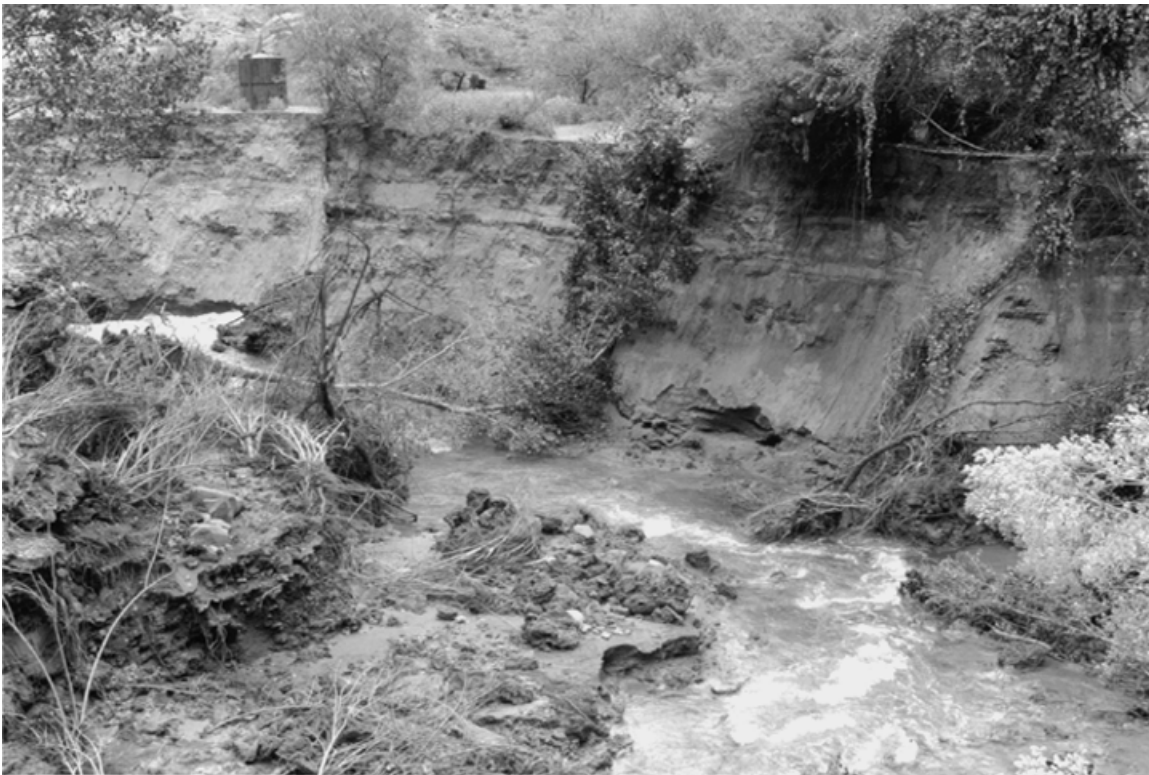
**Figure 20.** (1990). View of the arroyo formed between Havasu and Fiftyfoot Falls after 1910 (Crumbo, Stake 2197).

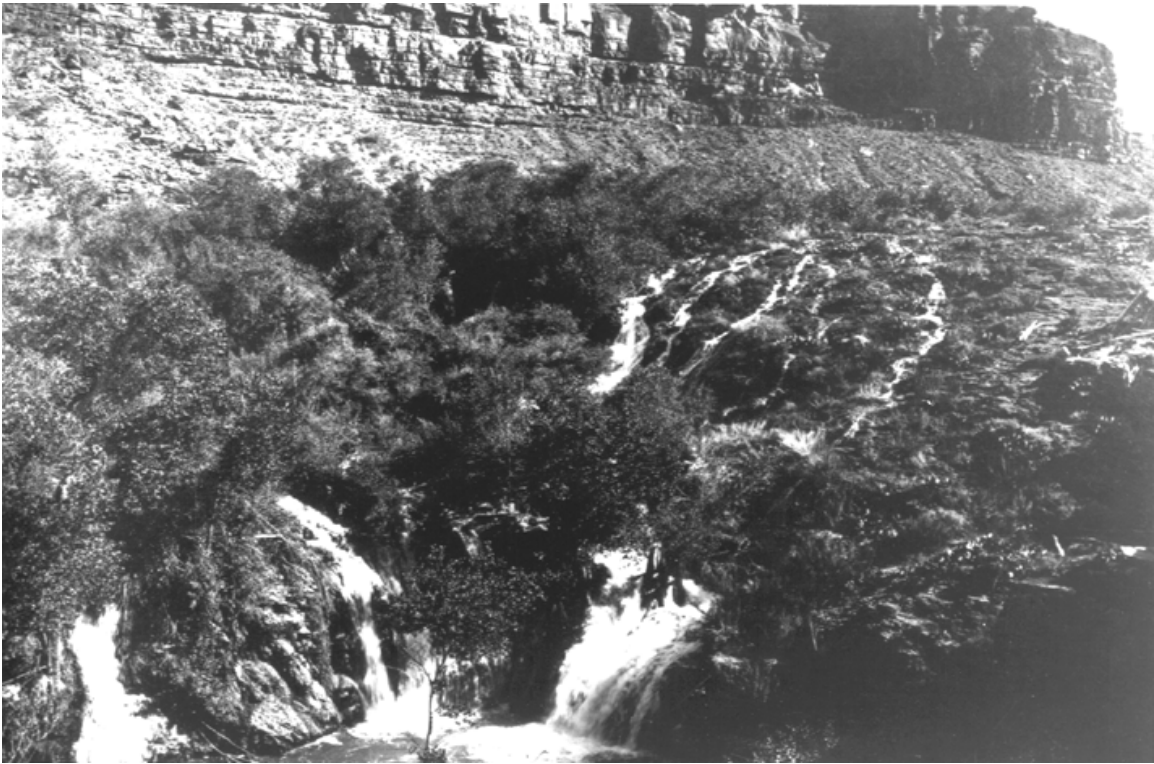
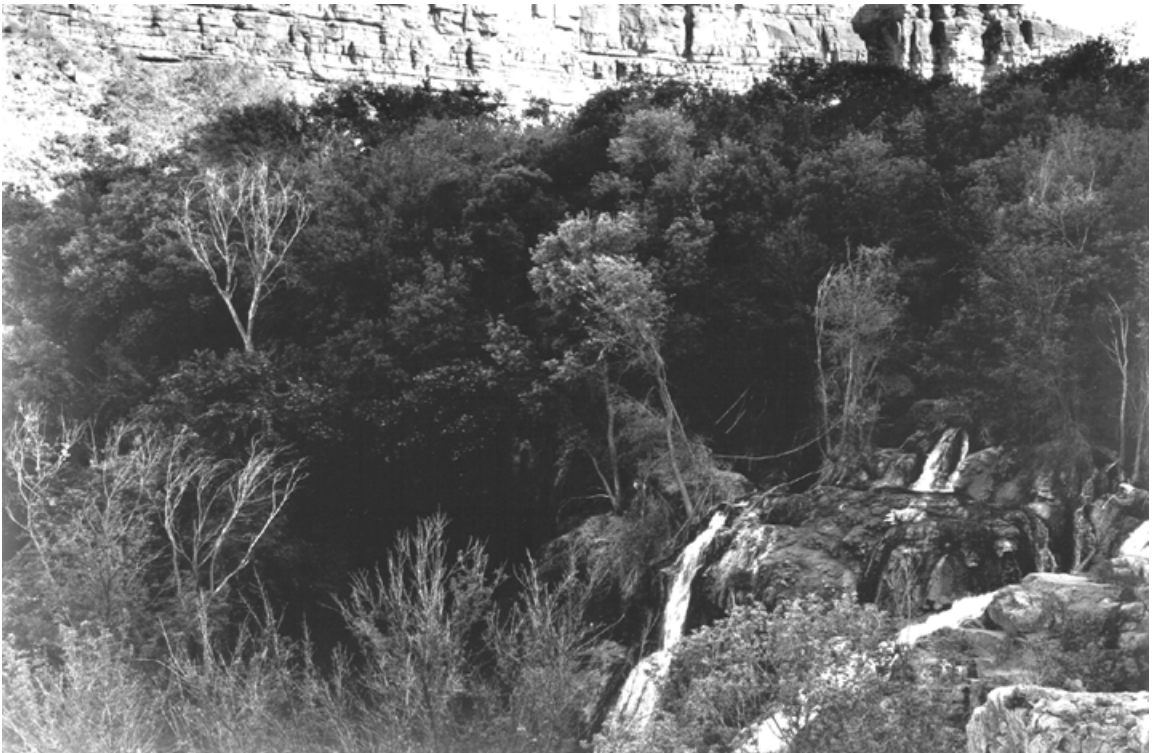
**Figure 21.** Replicate views of Navajo Falls. A, (ca. 1899). View of Navajo Falls and riparian vegetation along Havasu Creek before the 1910 flood (Peabody). B, (1991). Replicate view showing Navajo Falls and riparian vegetation along the creek after the 1990 flood (Stake 2156).

A photograph of Navajo Falls taken around 1899 (fig. 21a) shows small trees along the right side of the channel, whereas the left bank and center of the channel had little vegetation. The 1991 replicate (fig. 21b) shows an increase in both the density and height of riparian vegetation. A dense gallery of trees had become established sometime after the turn of the century and was prominent in 1991. A view of the top of Navajo Falls taken in late January, 1910 (fig. 22a) shows the reach upstream was mostly devoid of trees immediately after the 1910 flood, which contrasts greatly with the circa 1899 view (fig. 21a). The 1910 view also shows that significant incisional erosion occurred between about 1899 and 1910, probably a result of the 1910 flood. The 1994 match (fig. 22b) shows fewer and smaller trees at the top of the waterfall than in 1910; most trees in 1994 were 10 to 15 m tall.

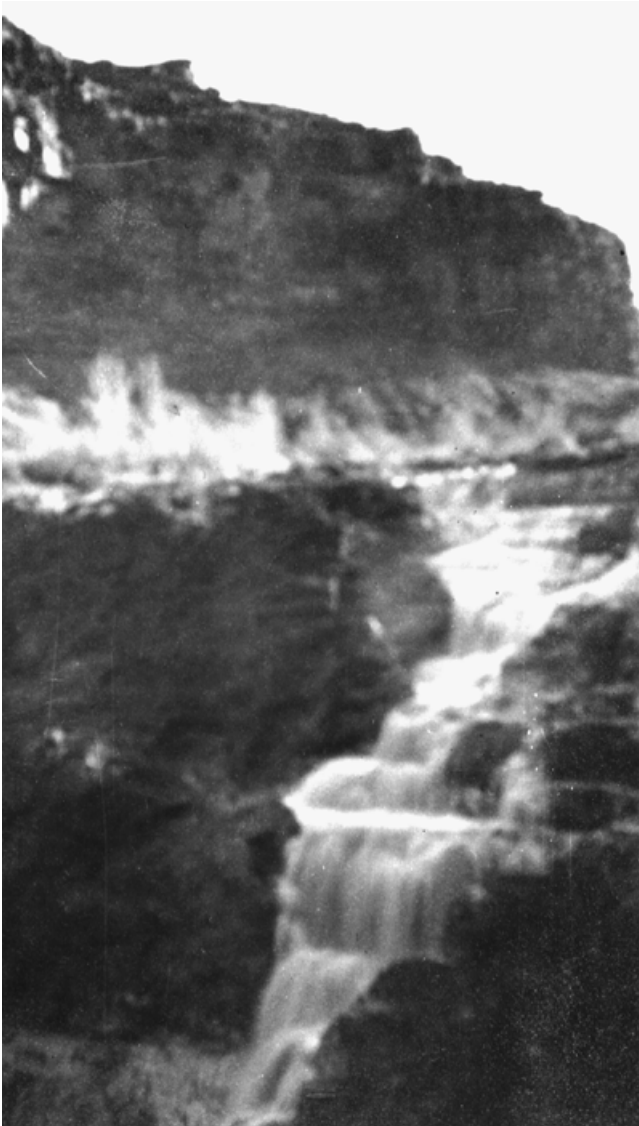
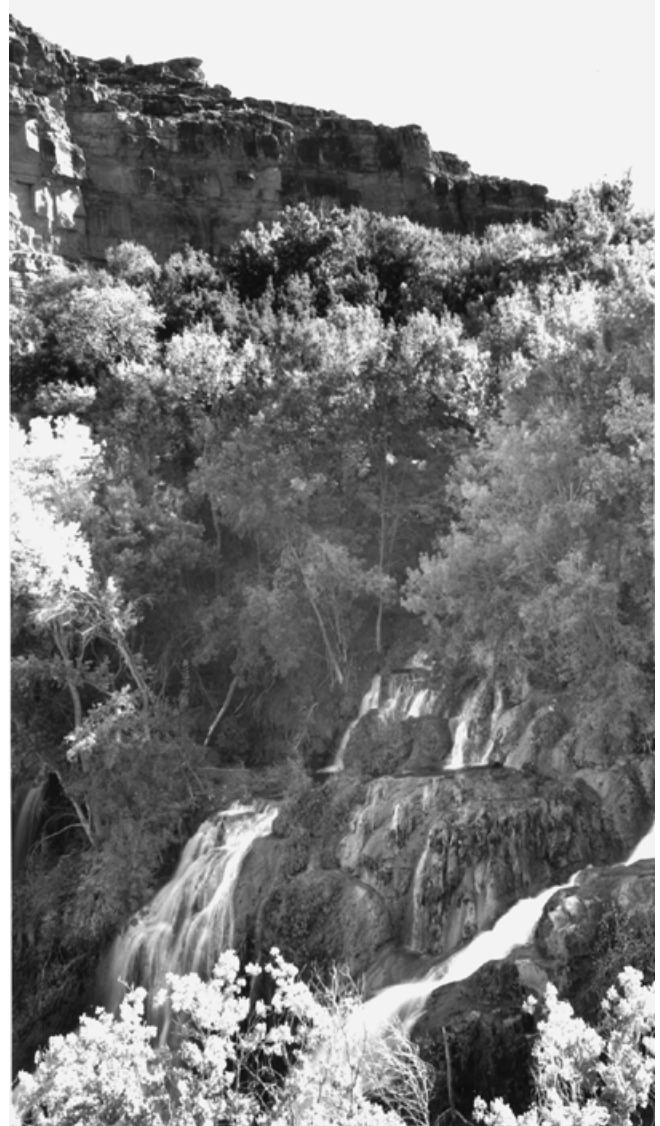
**Figure 22.** Replicate views of Navajo Falls. A, (1910). View of Navajo Falls and riparian vegetation along Havasu Creek immediately after the 1910 flood. The photograph is out of focus, but shows the scouring effects of the flood (Barnes). B, (1994). Replicate view showing Navajo Falls and riparian vegetation along Havasu Creek after the 1990s floods (Stake 2871)

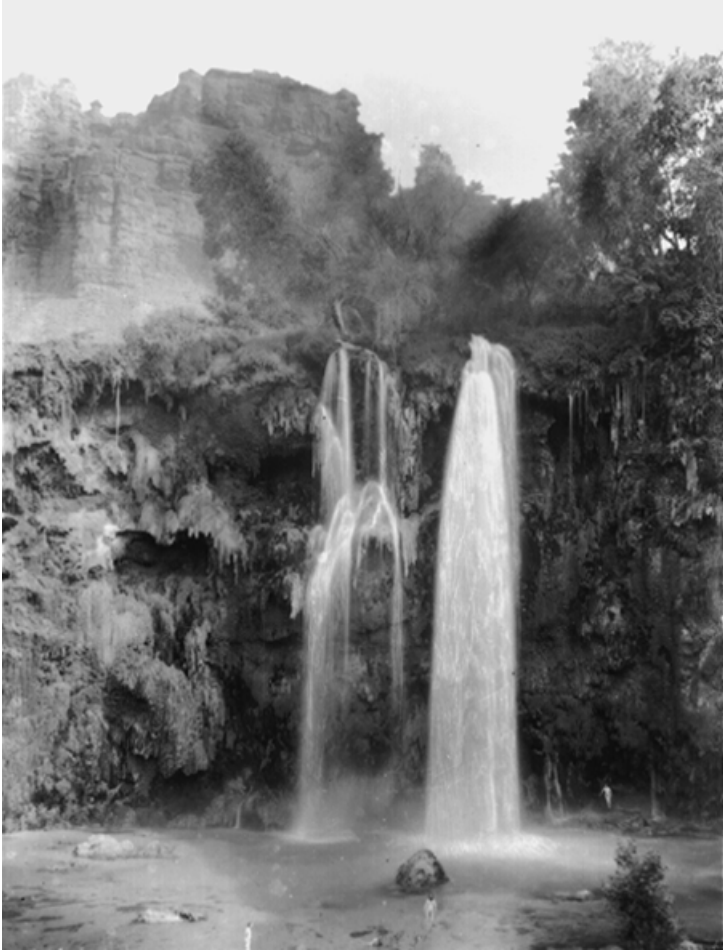
**Figure 23.** Replicate views of Havasu Falls. A, (1885). View showing Havasu Falls and its plunge pool before erosive historic floods (Wittick). B, (1994). Replicate view showing Havasu Falls, its plunge pool, and riparian vegetation after the 1990s floods (Stake 2875)

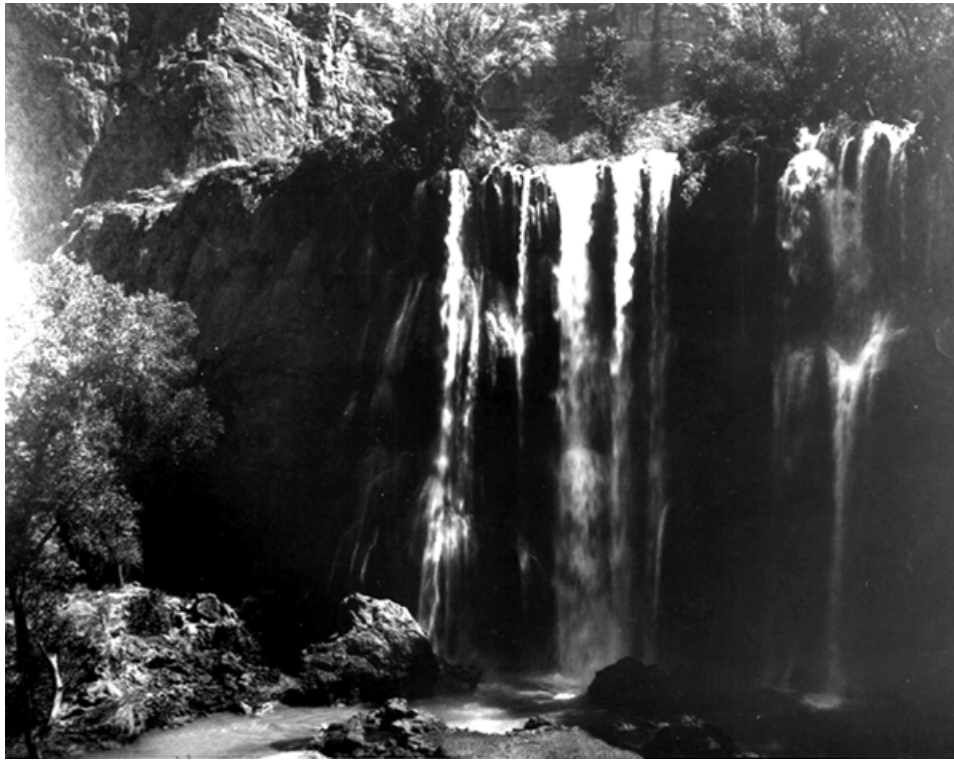
**Figure 24.** Replicate views of Havasu Falls. A, (ca. 1899). View showing Havasu Falls and its plunge pool before erosion of the top of the waterfall (Peabody). B, (1991). Replicate view showing the erosion of the top of Havasu Falls that occurred in 1910 and the dense growth of riparian vegetation that withstood the 1990 flood (Stake 2153).

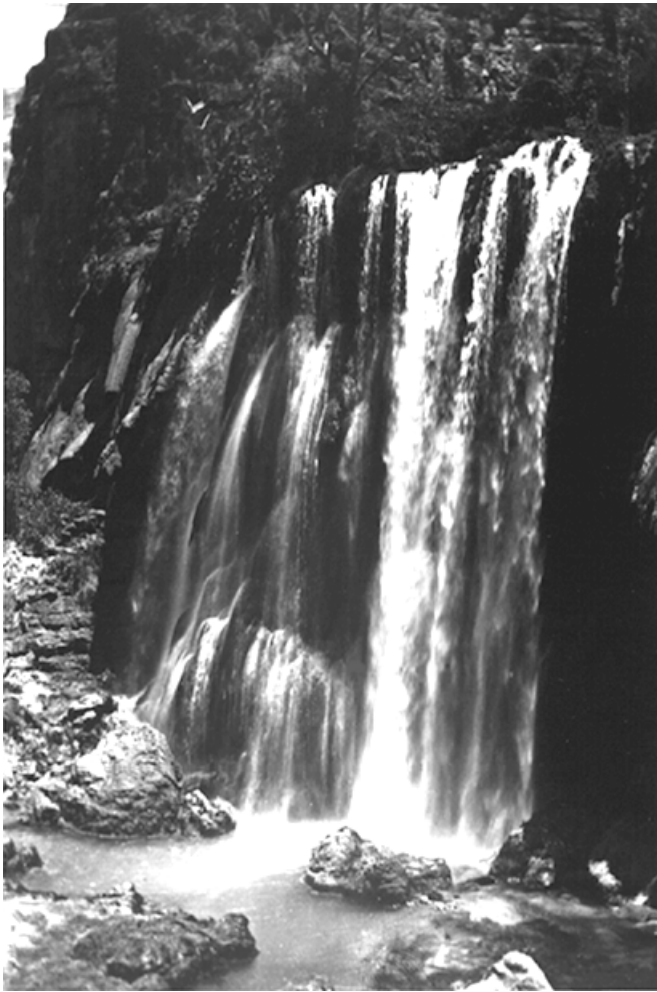
**Figure 25.** Replicate views of Havasu Falls. A, (1903). View showing Havasu Falls and its plunge pool before the 1910 flood (Marshall). B, (1991). Replicate view showing Havasu Falls, its plunge pool, and riparian vegetation that withstood the flood of September 1990 (Stake 2151).

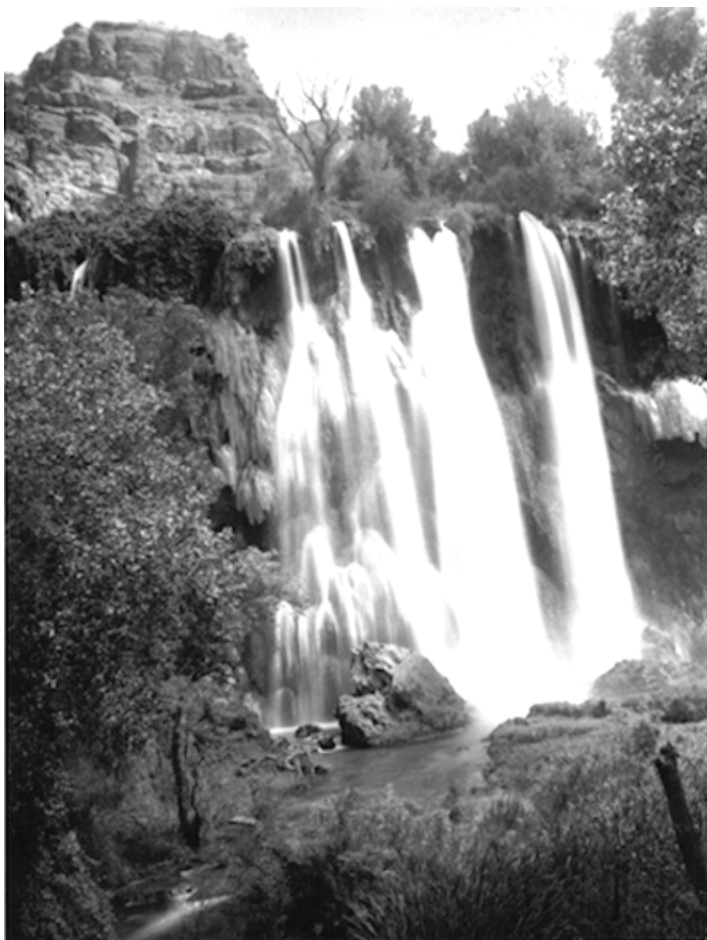
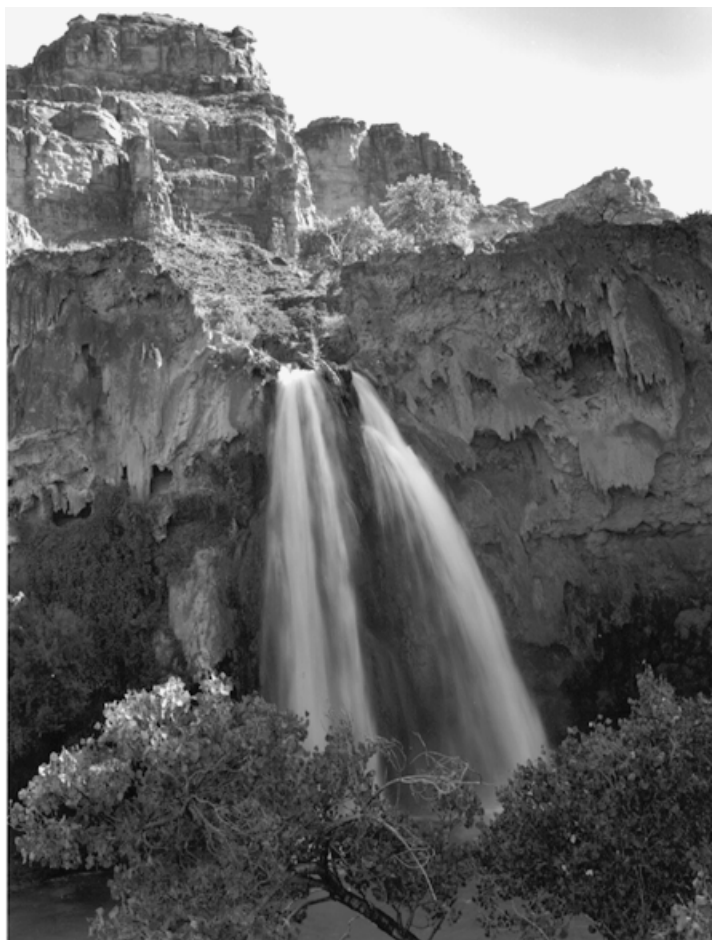
**Figure 26.** Replicate views of Havasu Falls. A, (1907). View showing Havasu Falls and its plunge pool just before the 1910 flood (Kolb). B, (1994). Replicate view showing Havasu Falls, its plunge pool, and riparian vegetation after the 1990s floods (Stake 2877).

A Kolb 1907 photograph of Havasu Falls is the last known to have been made before the 1910 flood occurred (fig. 26a). Its 1994 replicate (fig. 26b) again shows the deeply incised notch formed during that flood. Erosion of the notch in Havasu Falls in 1910 is best shown from near the top of the waterfall (fig. 27) looking downstream. Large cottonwood trees present below the waterfall occurred further downstream in 1907 than they did in 1994.

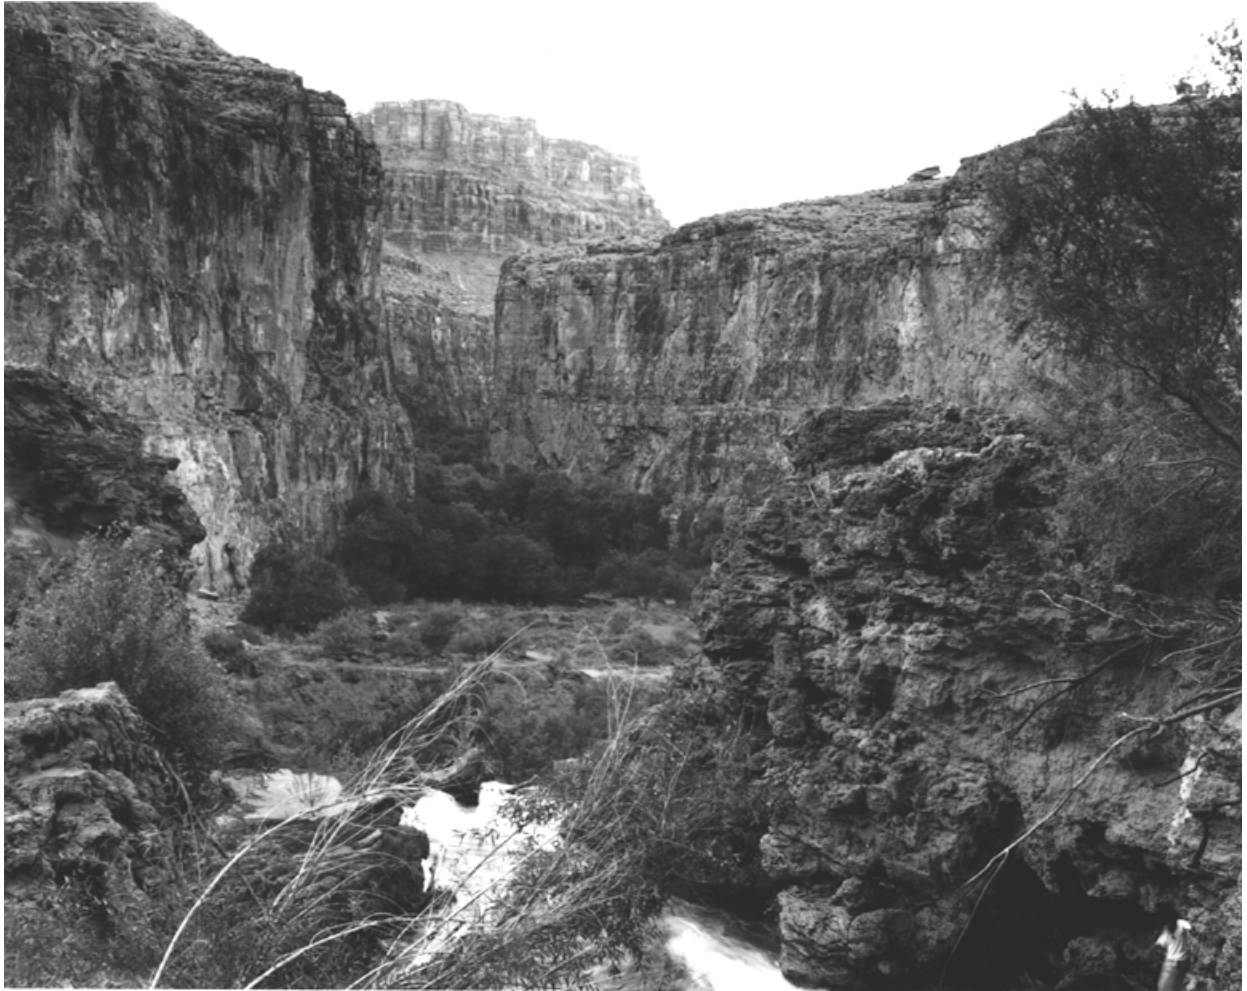
**Figure 27.** (1994). Downstream view showing the incised notch in Havasu Falls caused by the 1910 flood (Stake 2879). The channel incised about 9 m through travertine deposits.

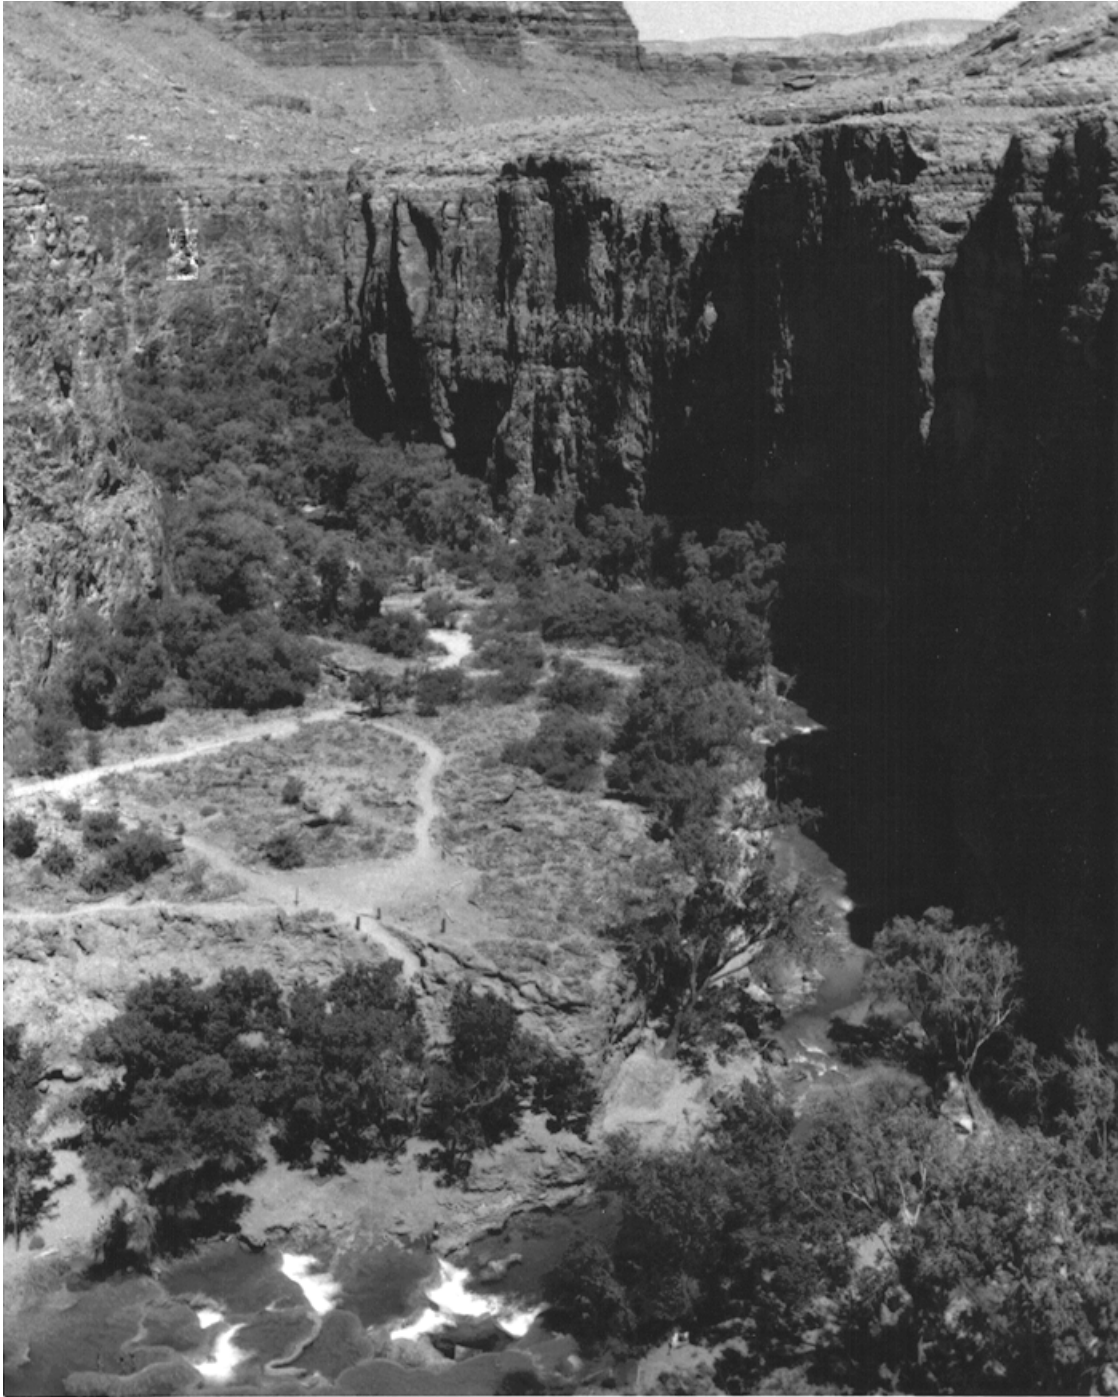
**Figure 30.** Replicate views of Havasu Canyon downstream from Havasu Falls. A, (1988). View showing Havasu Creek and riparian vegetation immediately downstream from Havasu Falls before the 1990 flood (Brownold).

B, (1991). Replicate view showing Havasu Creek and damaged riparian vegetation immediately downstream of Havasu Falls after the 1990 flood (Stake 2148).

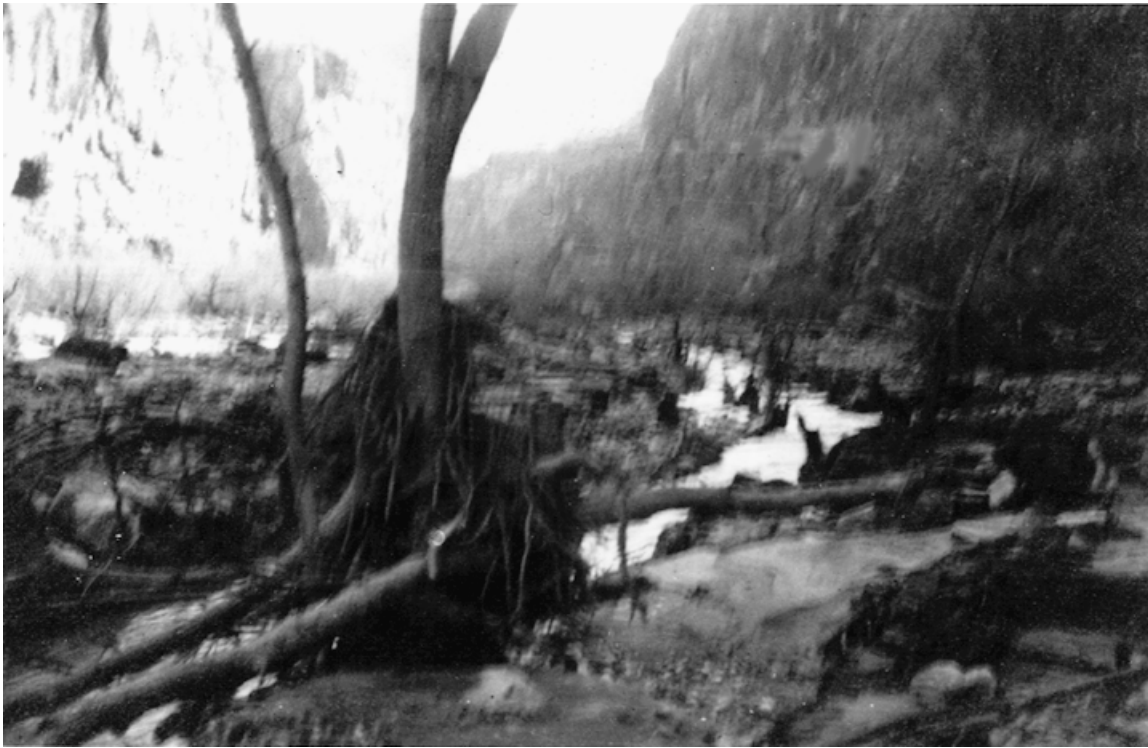
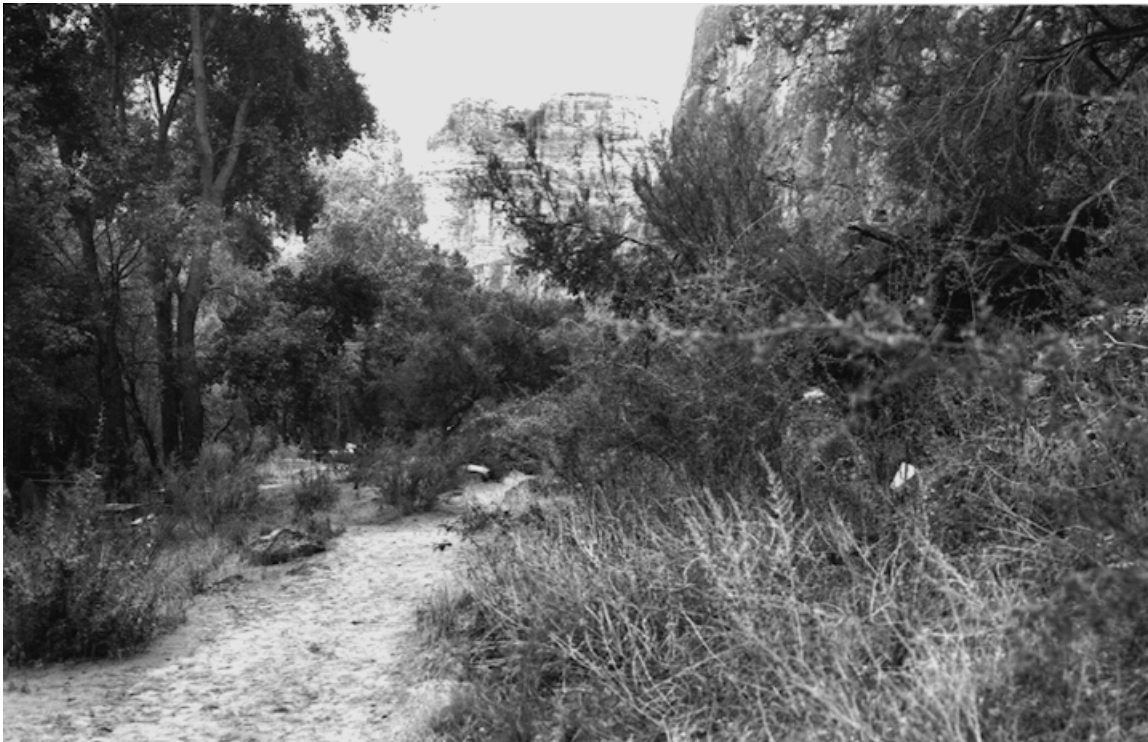
**Figure 31.** Replicate views of Havasu Canyon in the Havasupai campground. A, (1910). View showing Havasu Creek in the Havasupai campground immediately after the 1910 flood. The photograph is out of focus, but shows the scoured condition of the channel (Barnes). B, (1994). Replicate view showing Havasu Creek in the Havasupai campground after the 1990s floods (Stake 2883).

Eight original and replicate photographs showing the reach between Havasu and Mooney Falls, referred to here as the “Havasupai campground,” were examined for flood-related change (fig. 18; appendix 2). The original images were made in 1903, 1910, and 1988 and were replicated from 1991 through 1994 (appendix 2). The time series represented by these photographs suggests that the Havasupai campground had only slightly less vegetation in 1903 compared to 1994. However, comparison of the 1903 and 1910 views with the 1994 replicates (figs. 31 and 32) indicates that most of the vegetation uprooted from the canyon bottom in 1910 had recovered by 1994 and persisted despite the 1990 and 1993 floods.

In contrast to the erosion apparent in the 1910 view, a replicate pair of 1988 and 1991 views, made about 200 m upstream (fig. 33), showed little vegetation damage or channel change caused by the September 1990 flood. The damaging effects of the 1910 flood (fig. 31), in comparison with minor changes caused by the 1990s floods in the

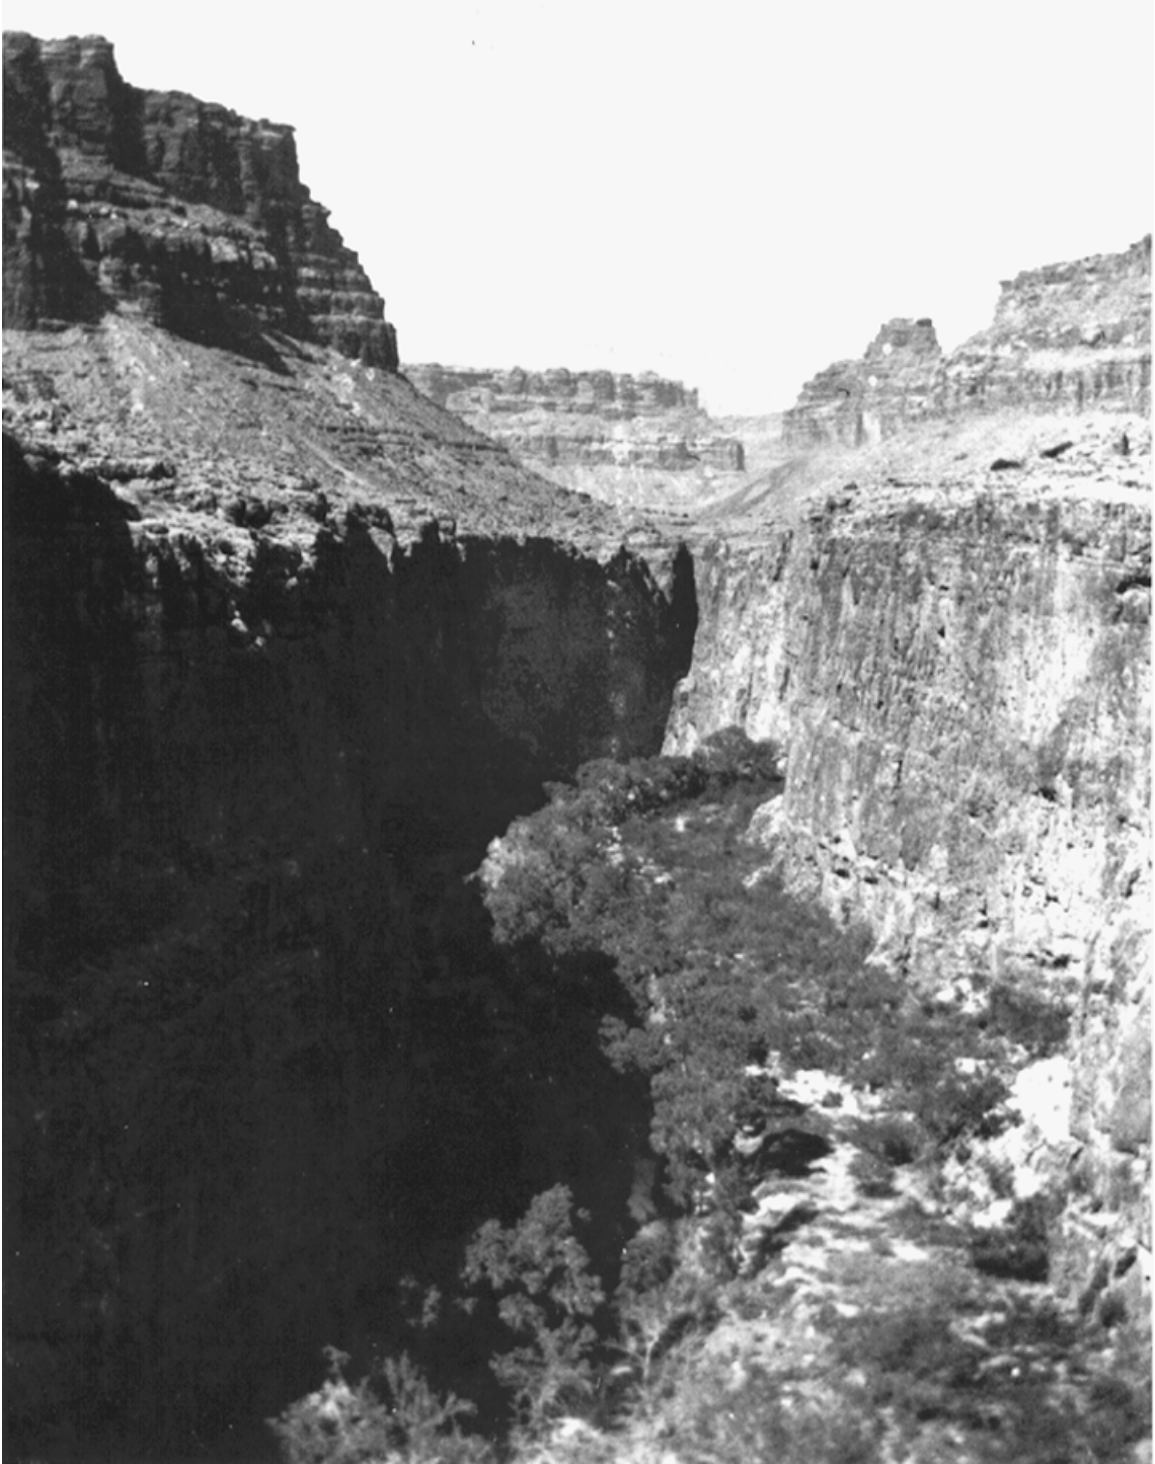
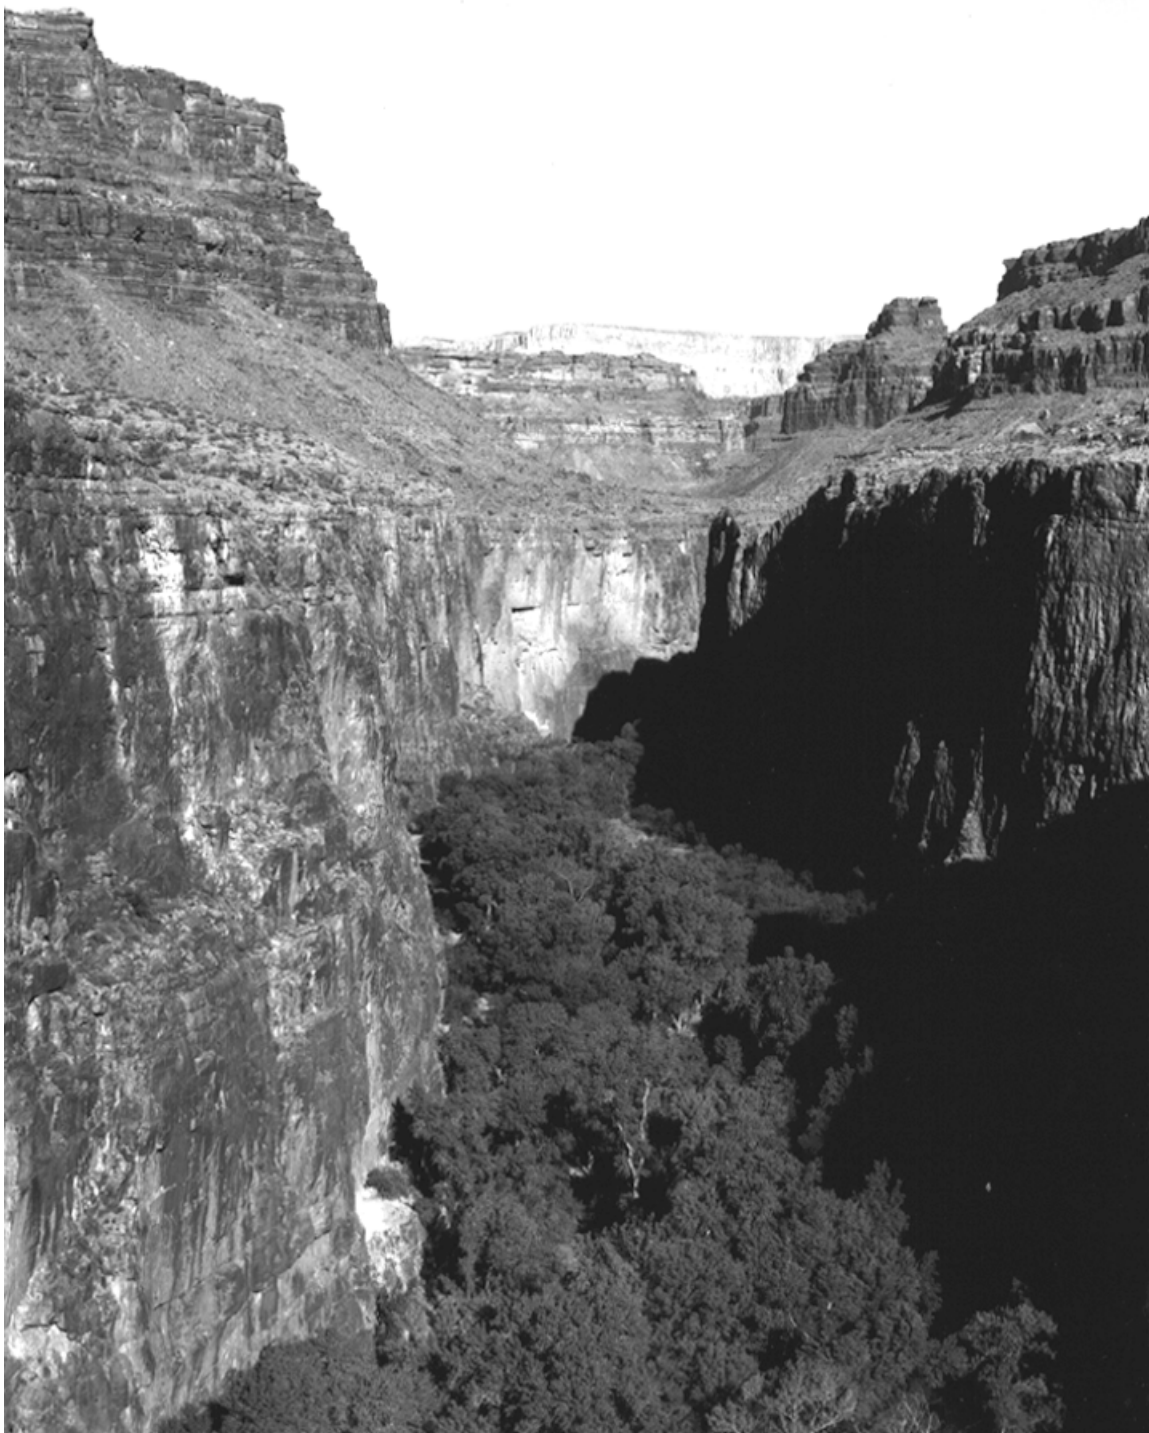
**Figure 32.** Replicate views of Havasu Creek in the Havasupai campground. A, (1903). View showing Havasu Canyon in the Havasupai campground after the 1899 flood (Marshall).

B, (1994). Replicate view showing Havasu Creek in the Havasupai campground after the 1990s floods (Stake 2880)

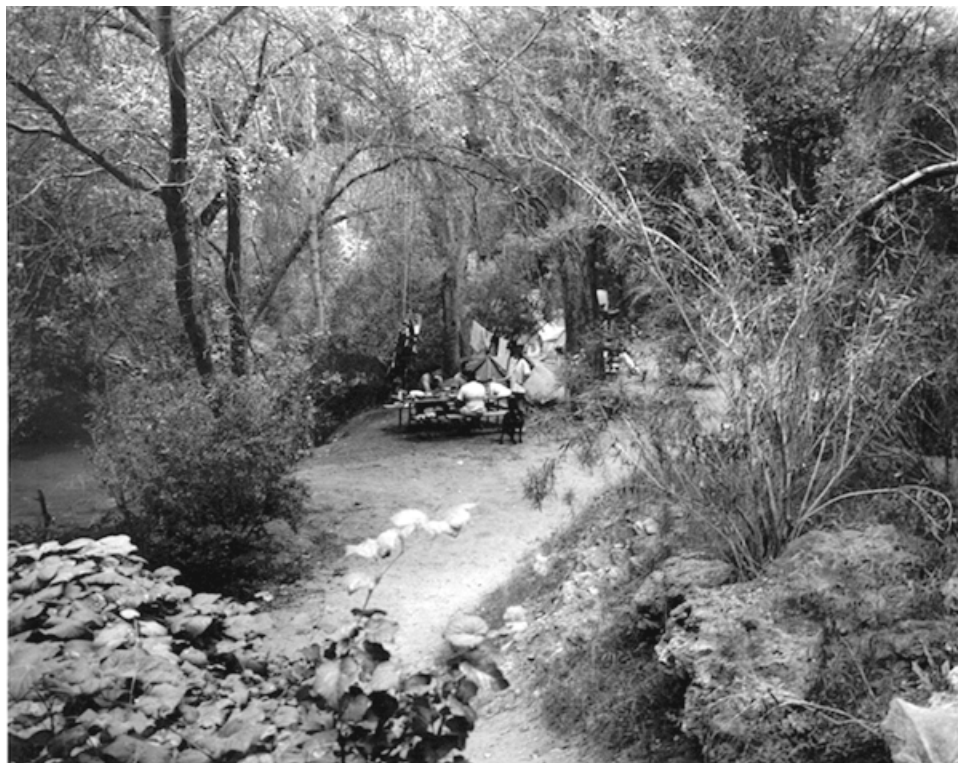
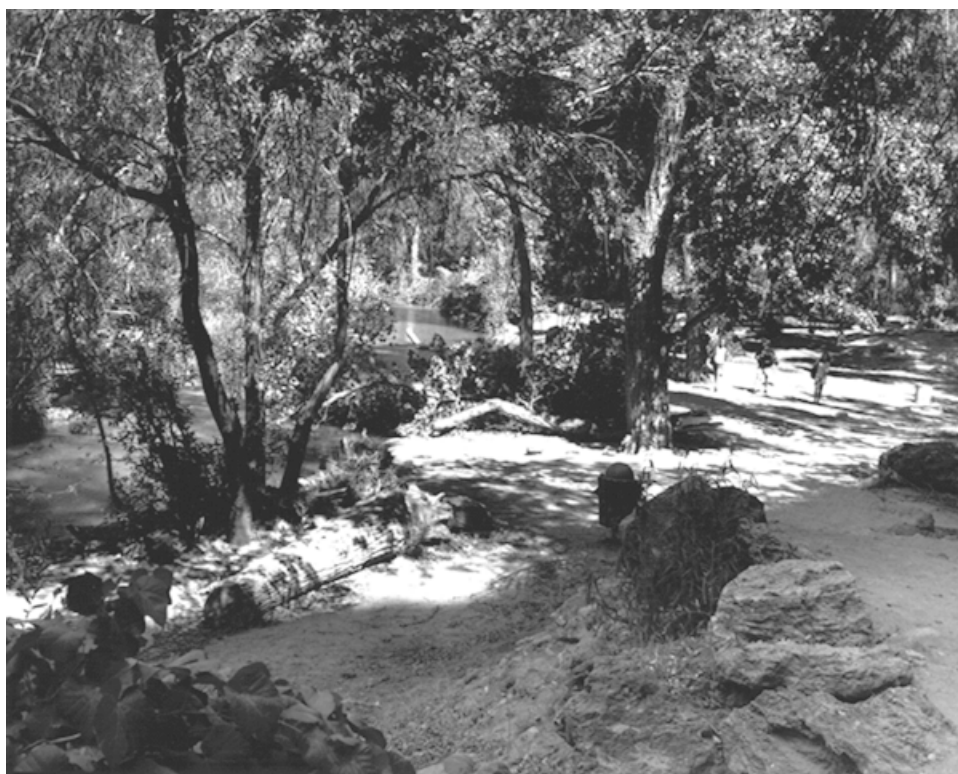
**Figure 33.** Replicate views of Havasu Canyon in the Havasupai campground. A, (1988). View showing riparian vegetation along Havasu Creek in the Havasupai campground before the 1990 flood (Brownold). B, (1991). Replicate view showing the damaged riparian vegetation along Havasu Creek in the Havasupai campground after the 1990 flood (Stake 2145).

Havasupai campground reach (fig. 33), supports the conclusion that the 1990 flood was less destructive, and presumably smaller than the 1910 flood.
