# WHEN THE BLUE-GREEN WATERS TURN RED

Historical Flooding in Havasu Creek, Arizona

U.S. GEOLOGICAL SURVEY  
Water-Resources Investigations Report 96—4059

By THEODORE S. MELIS, WILLIAM M. PHILLIPS  
ROBERT H. WEBB, and DONALD J. BILLS

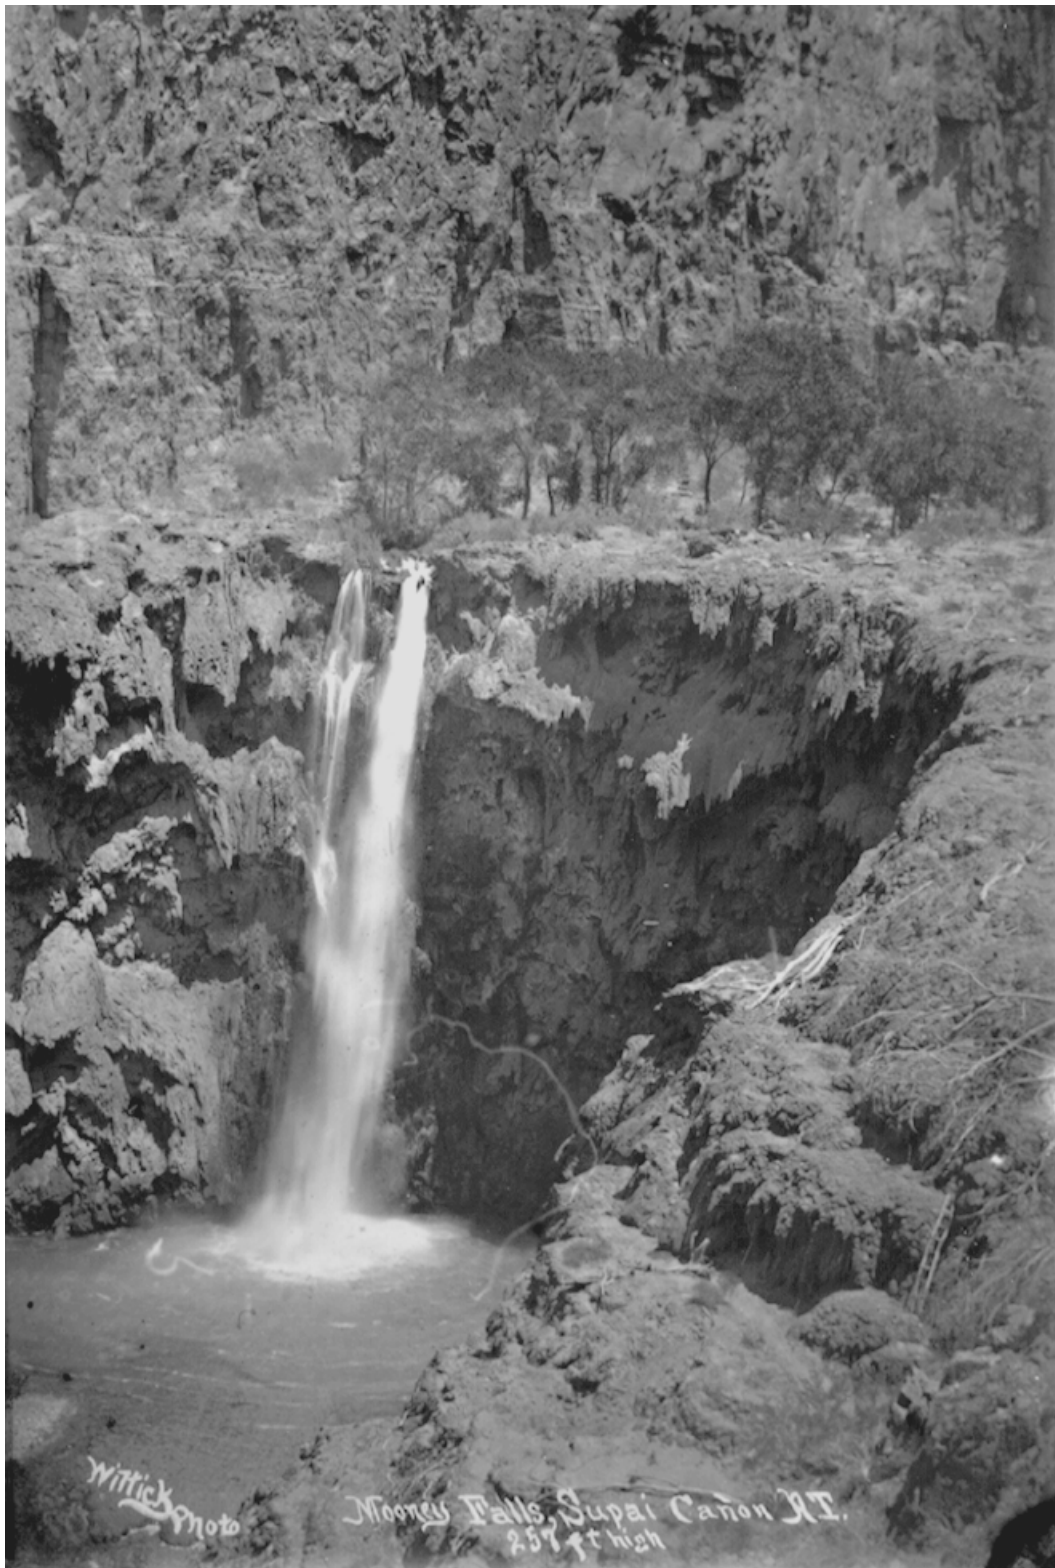
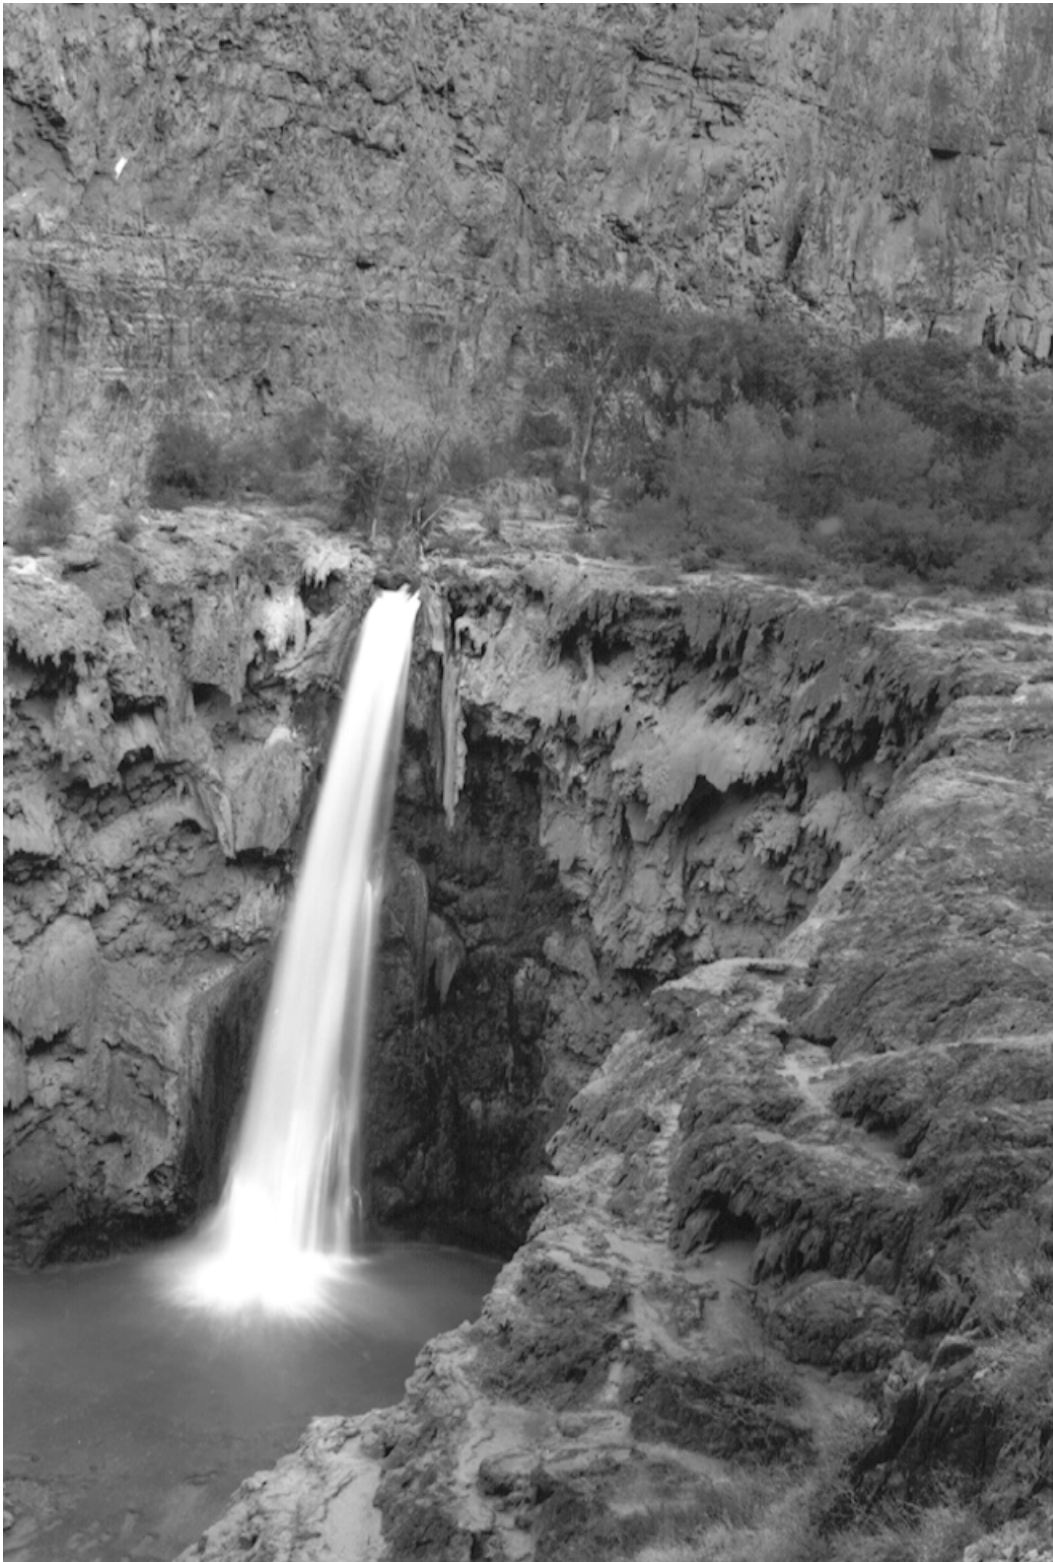
**Figure 34.** Replicate views of Mooney Falls. A, (1885). View showing Mooney Falls and its plunge pool before the onset of historical floods (Wittick).

B, (1994). Replicate view showing Mooney Falls and its plunge pool after the 1990s floods (Stake 2882).

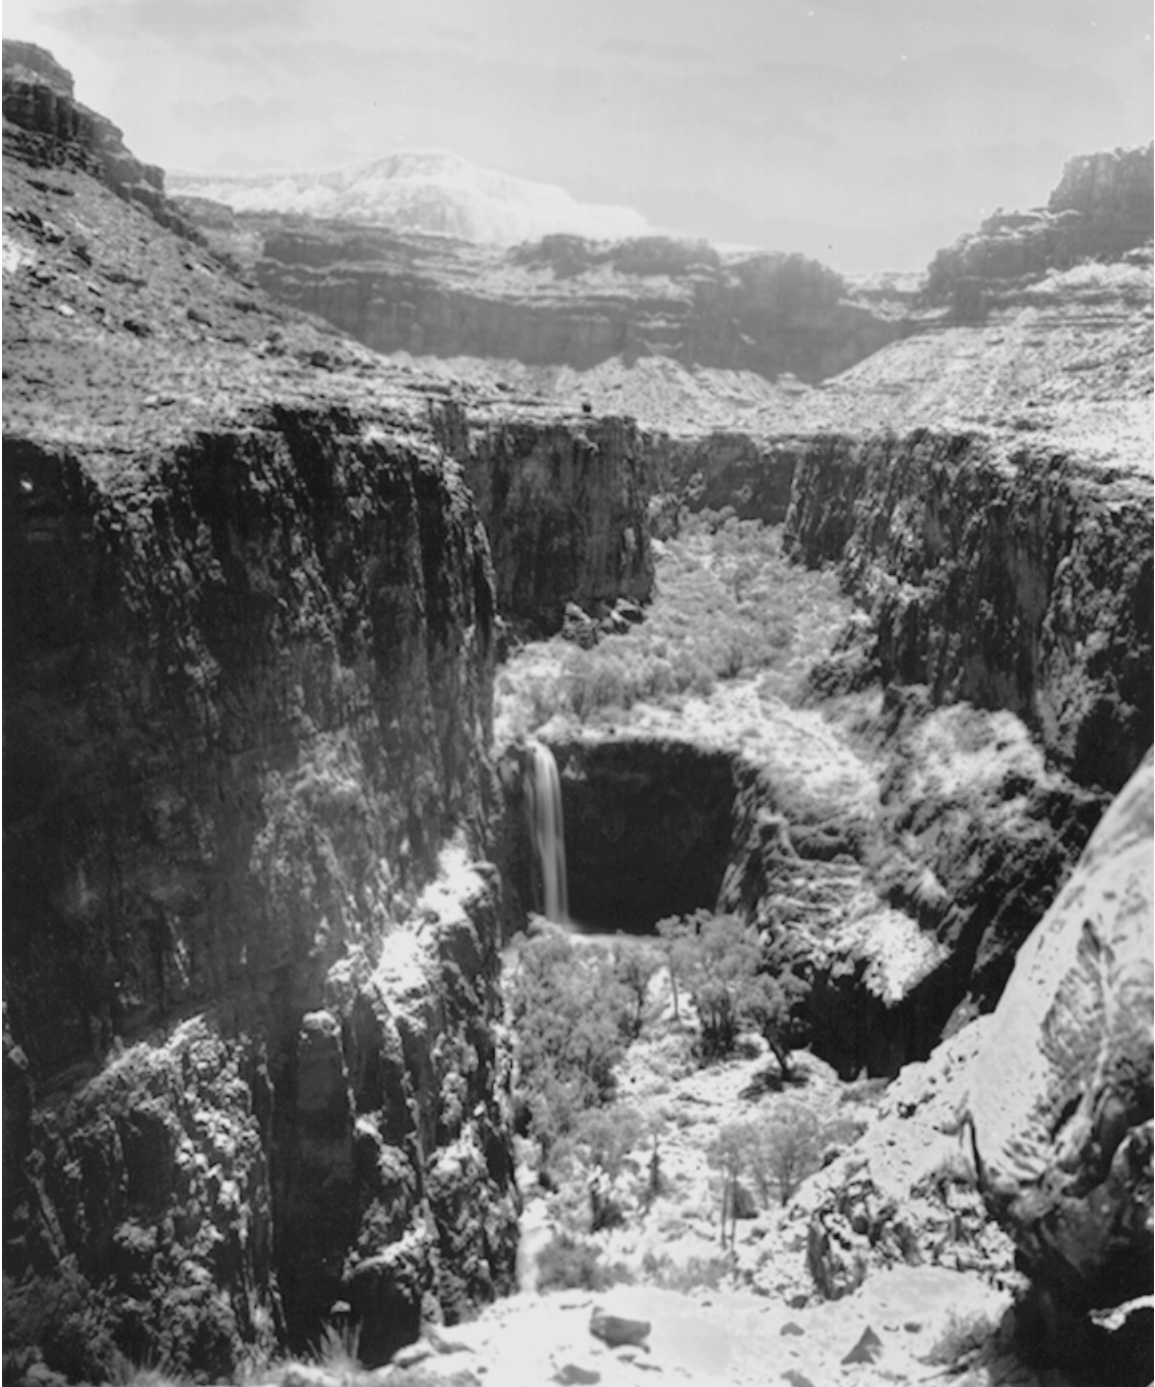
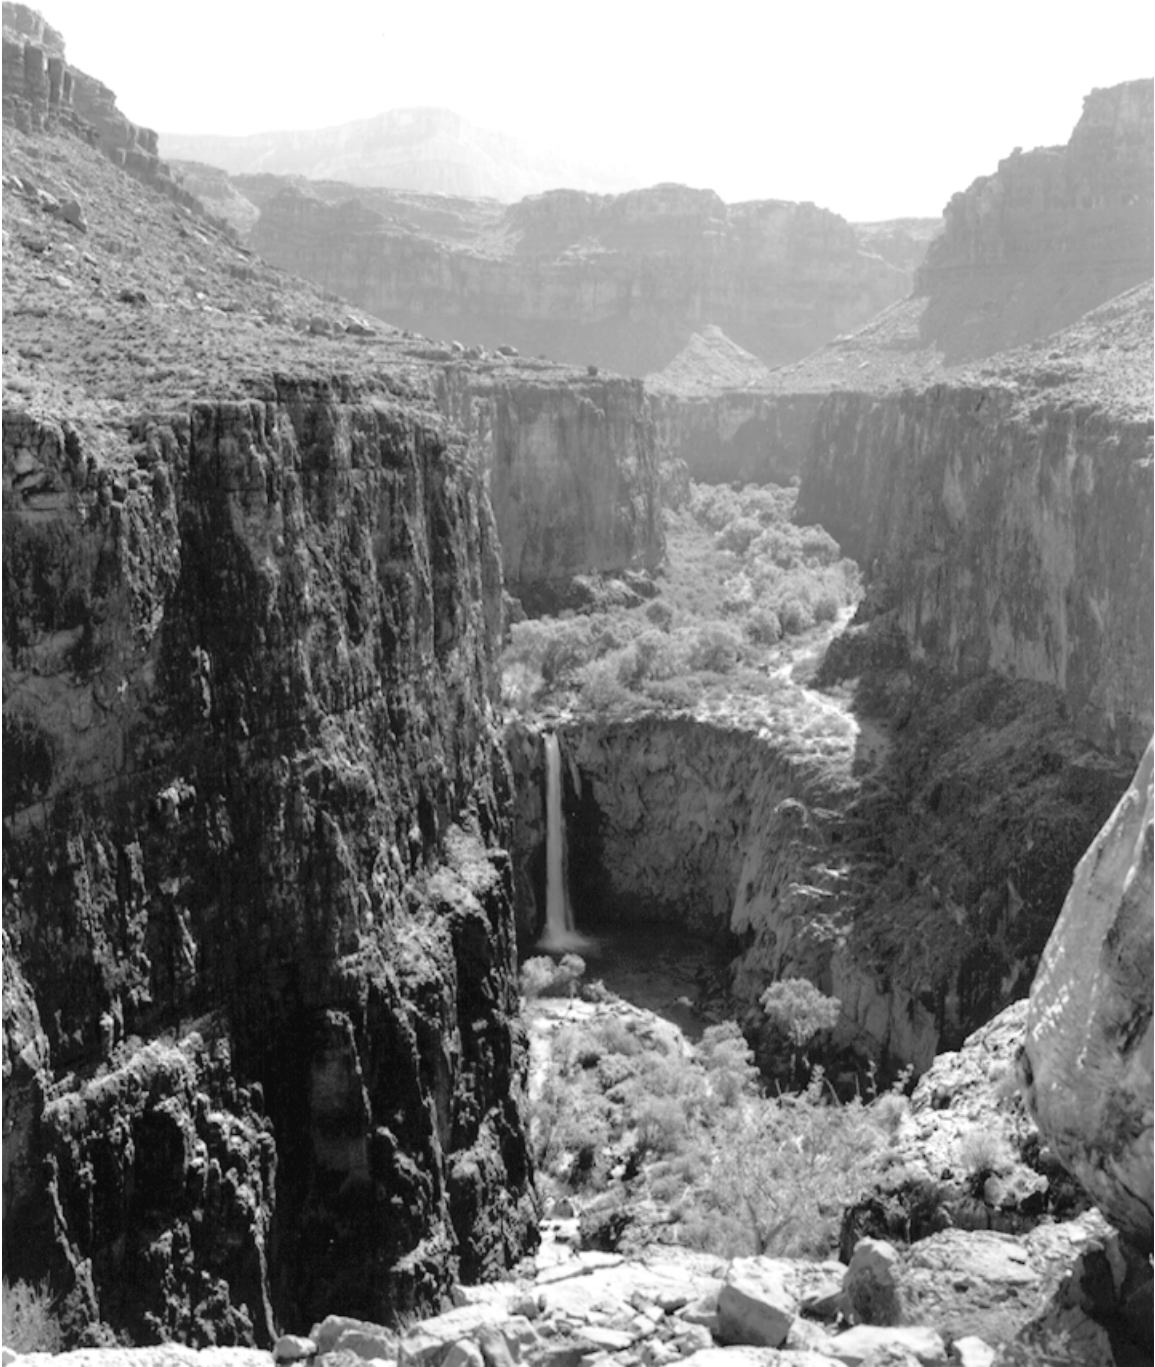
**Figure 35.** Replicate views of Mooney Falls. A, (1907). View showing Mooney Falls, its plunge pool, and riparian vegetation upstream before the 1910 flood (Kolb).

B, (1994). Replicate view showing Mooney Falls, its plunge pool, and riparian vegetation upstream after the 1990s floods (Stake 2881).

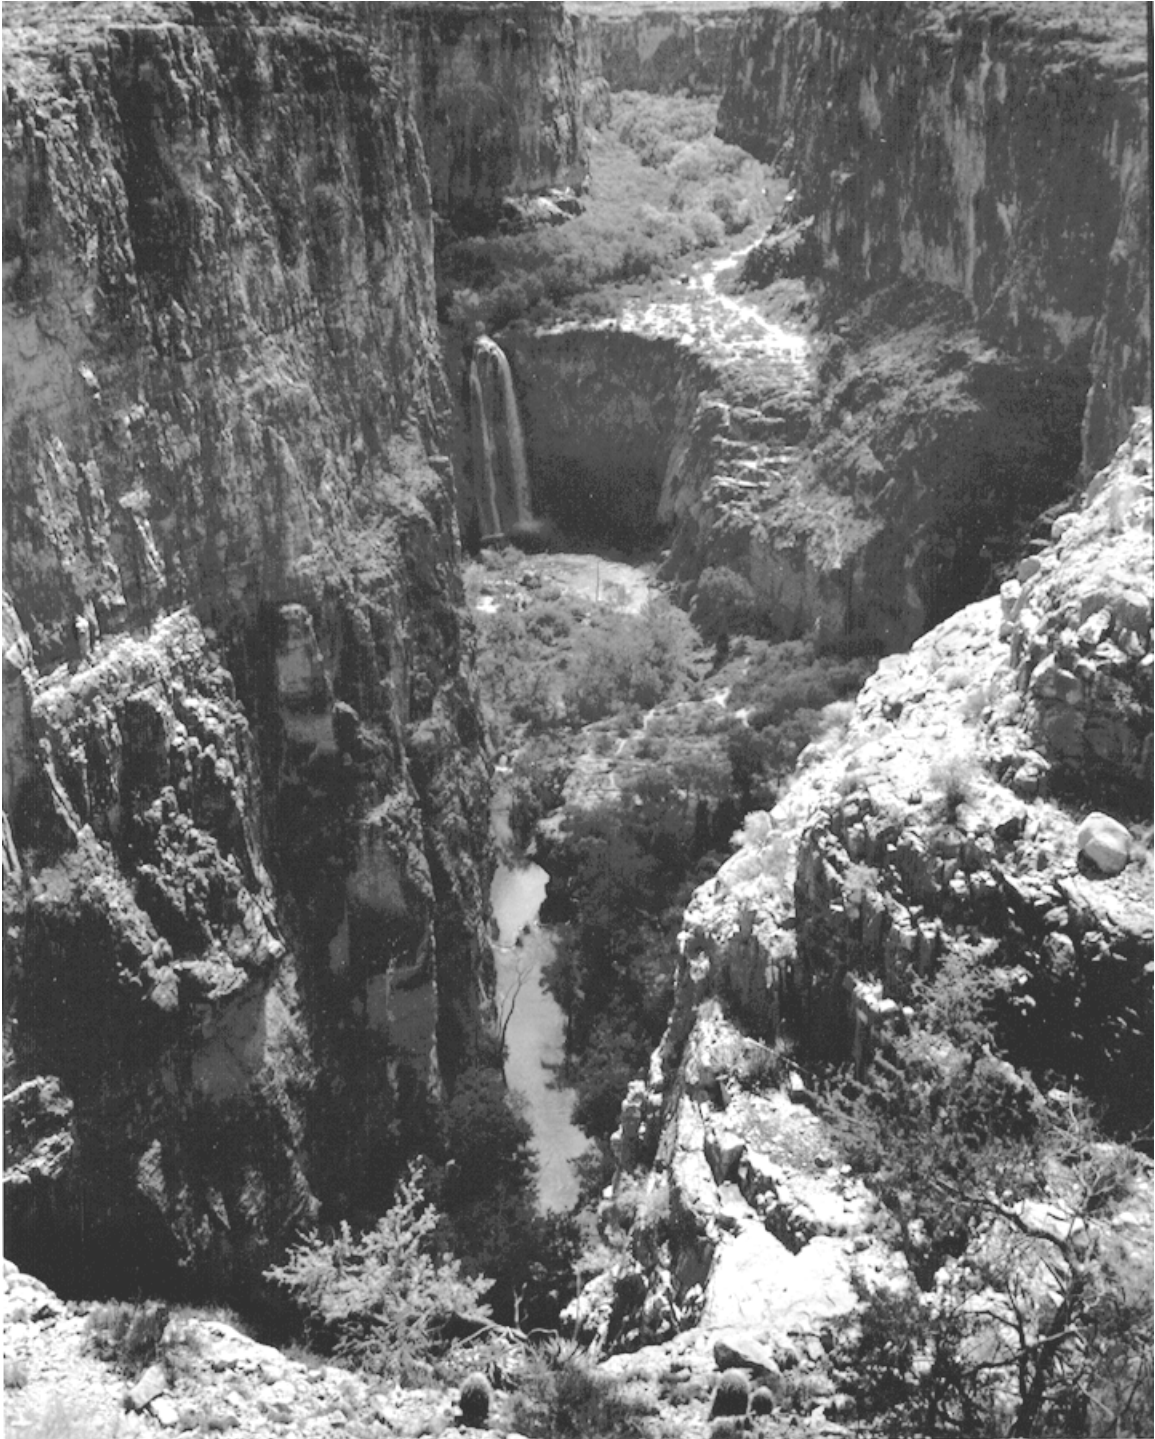
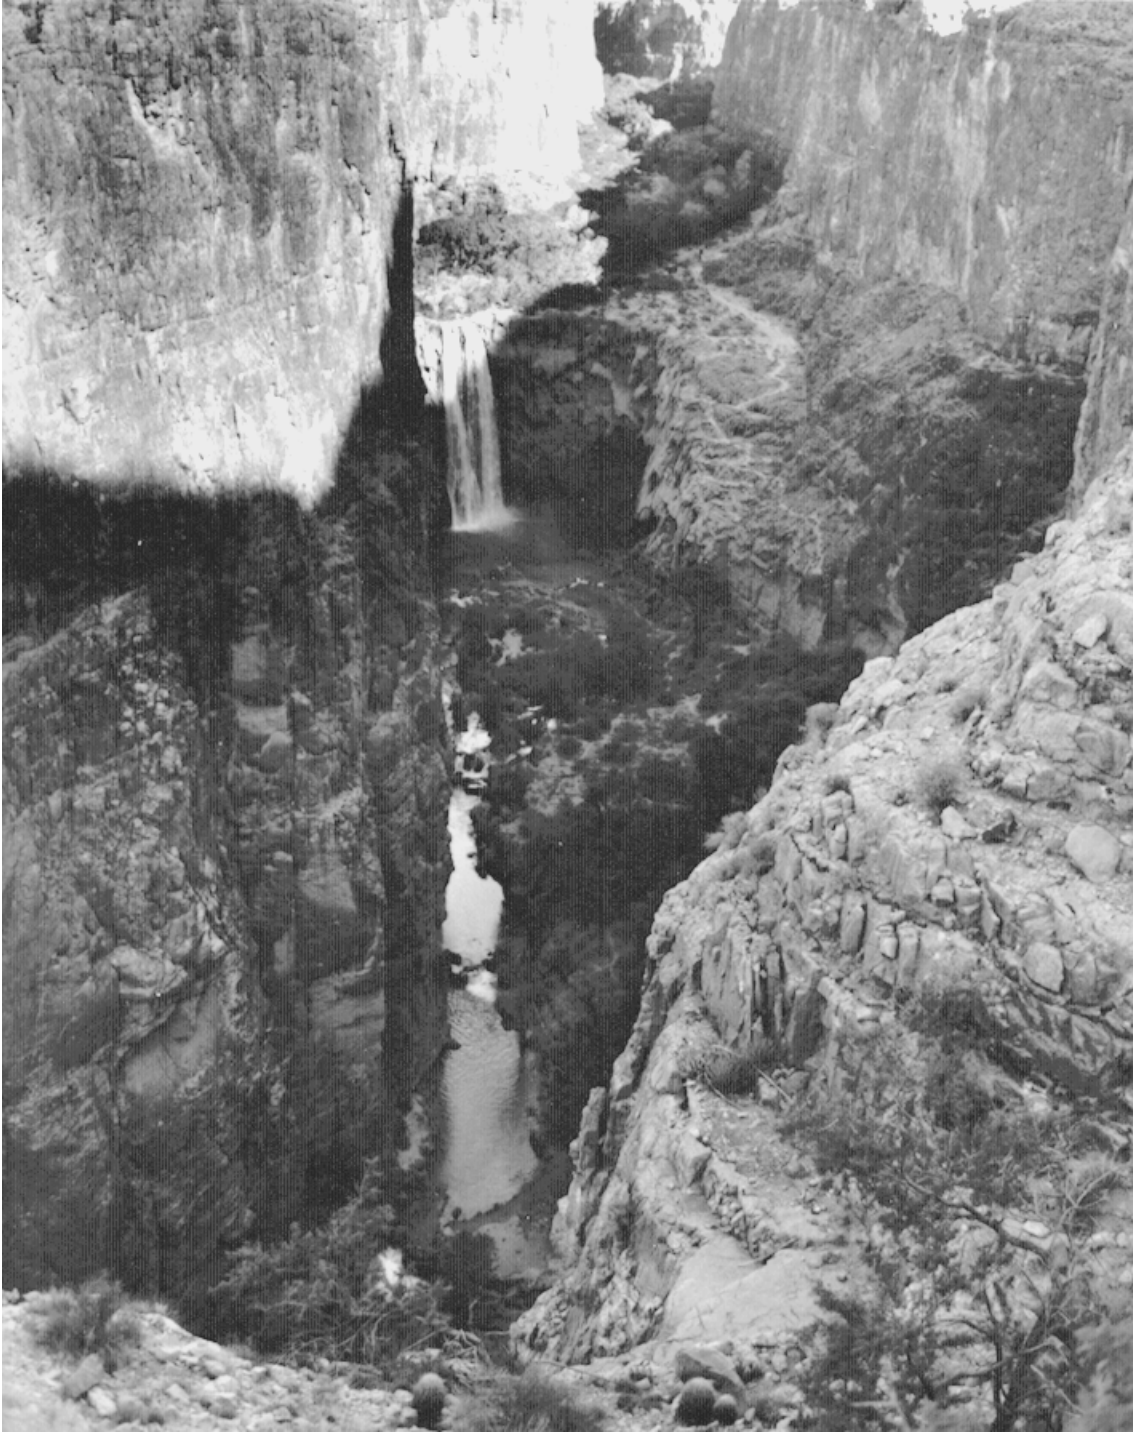
**Figure 36.** Replicate views of Mooney Falls. A, (1988). View showing Mooney Falls and its plunge pool before the 1990 flood (Brownold).

B, (1991). Replicate view showing Mooney Falls and its plunge pool after the 1990 flood (Stake 2147).

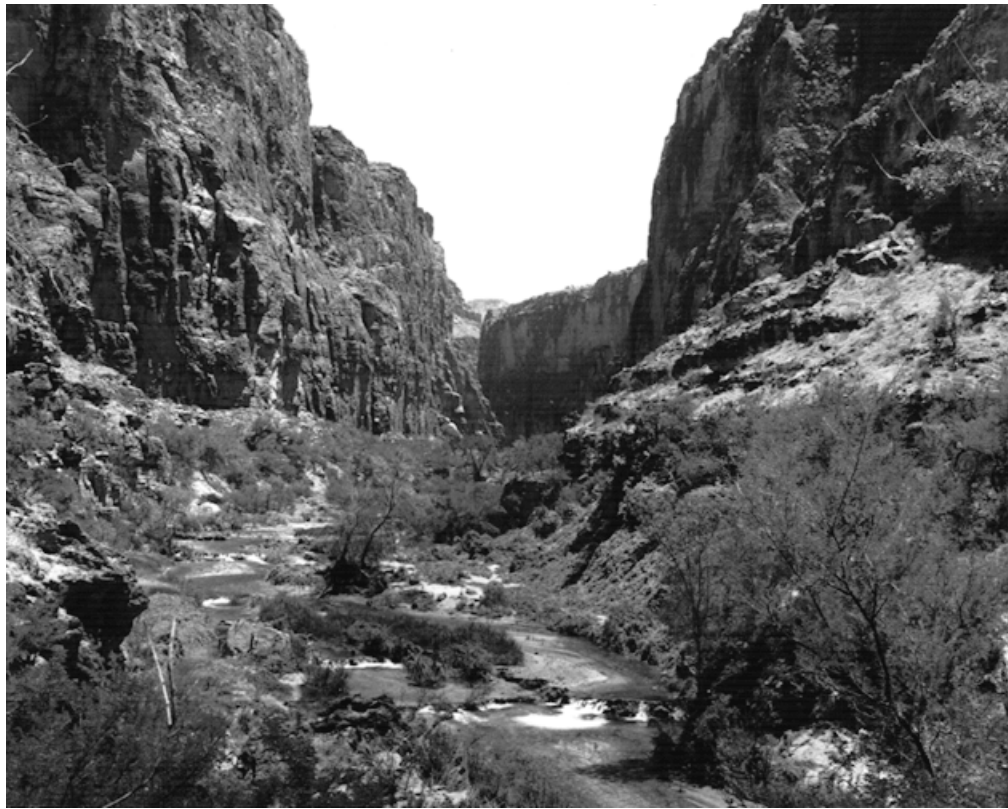
**Figure 38.** Replicate views showing riparian vegetation between Mooney and Beaver Falls. A, (1988). View showing riparian vegetation along Havasu Creek between Mooney and Beaver Falls before the 1990 flood (Brownold). B, (1991). Replicate view showing damage to riparian vegetation along Havasu Creek between Mooney and Beaver Falls after the 1990 flood (Stake 2142).

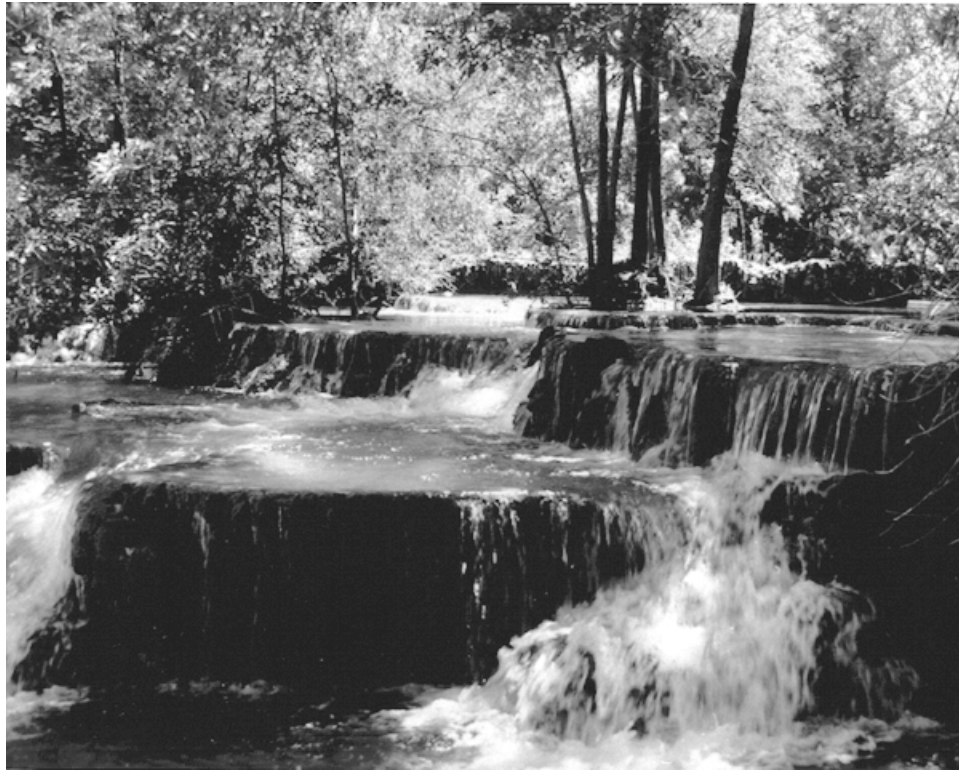
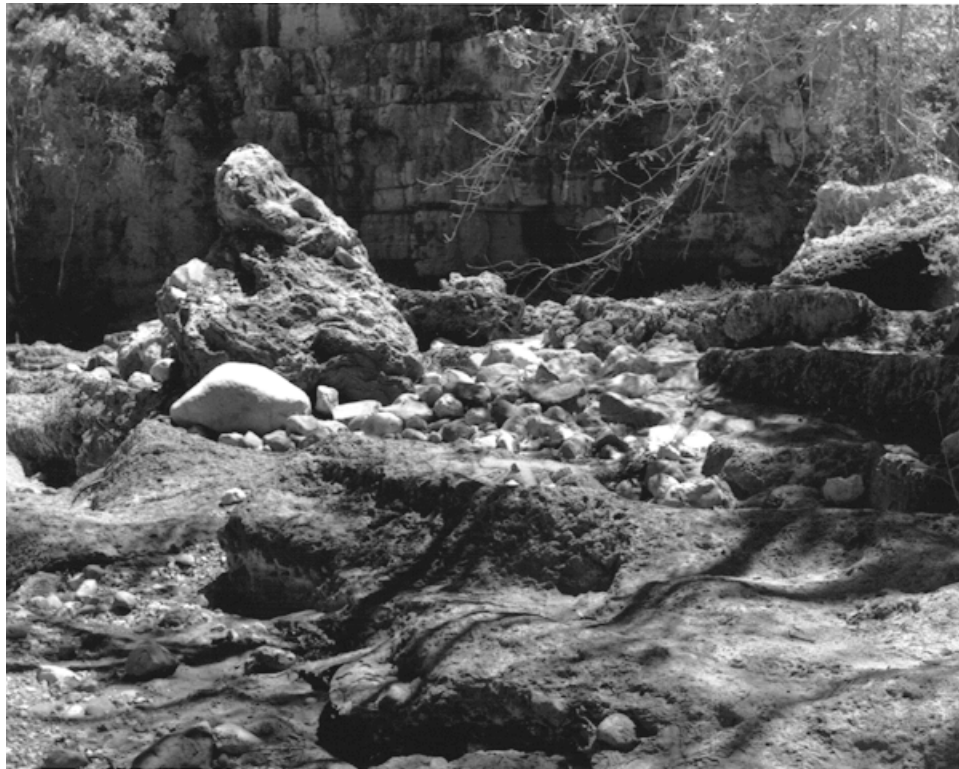
**Figure 39.** Replicate views near the confluence of Havasu Creek and Beaver Canyon. A, (1988). Downstream view showing travertine deposits near the confluence of Havasu Creek and Beaver Canyon before the 1990 flood (Brownold). B, (1991). Replicate view showing the severely eroded condition of travertine deposits near the confluence of Havasu Creek and Beaver Canyon after the 1990 flood (Stake 2139).

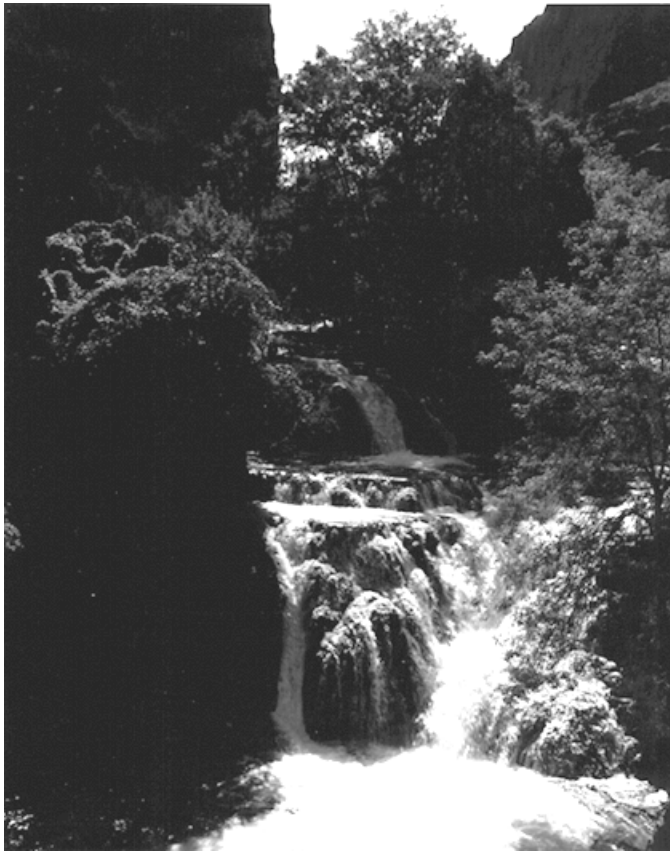
**Figure 40.** Replicate views of Beaver Falls. A, (1988). Upstream view showing Beaver Falls, its plunge pools, and riparian vegetation along the Havasu Creek channel before the 1990 flood (Brownold). B, (1991). Replicate view showing the scoured condition of Beaver Falls, its plunge pools, and riparian vegetation along Havasu Creek after the 1990 flood (Stake 2141).

A 1988 photograph of the waterfall shows it as it looked before the September 1990 flood (fig. 40a). The 1991 replicate shows changes that occurred during the 1990 flood (fig. 40b). The main impact of the 1990 flood in the vicinity of Beaver Falls was severe damage to riparian vegetation, whereas little change occurred in the travertine waterfall or its plunge pool.

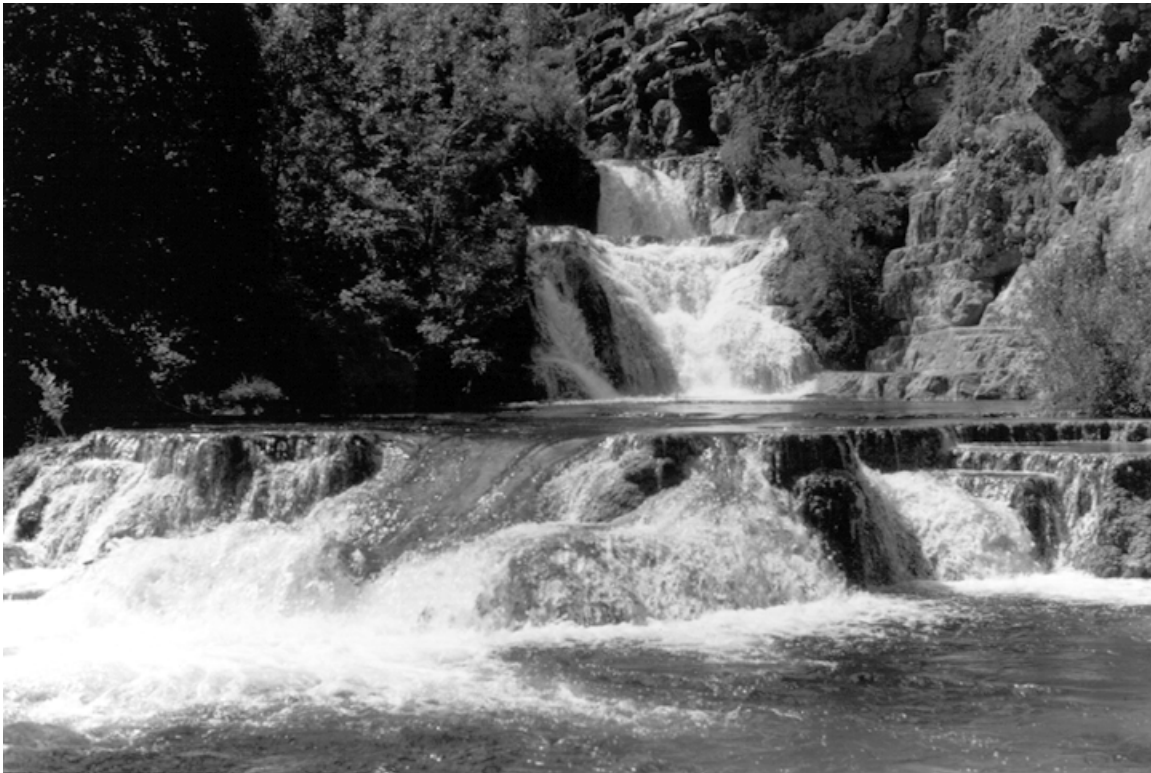
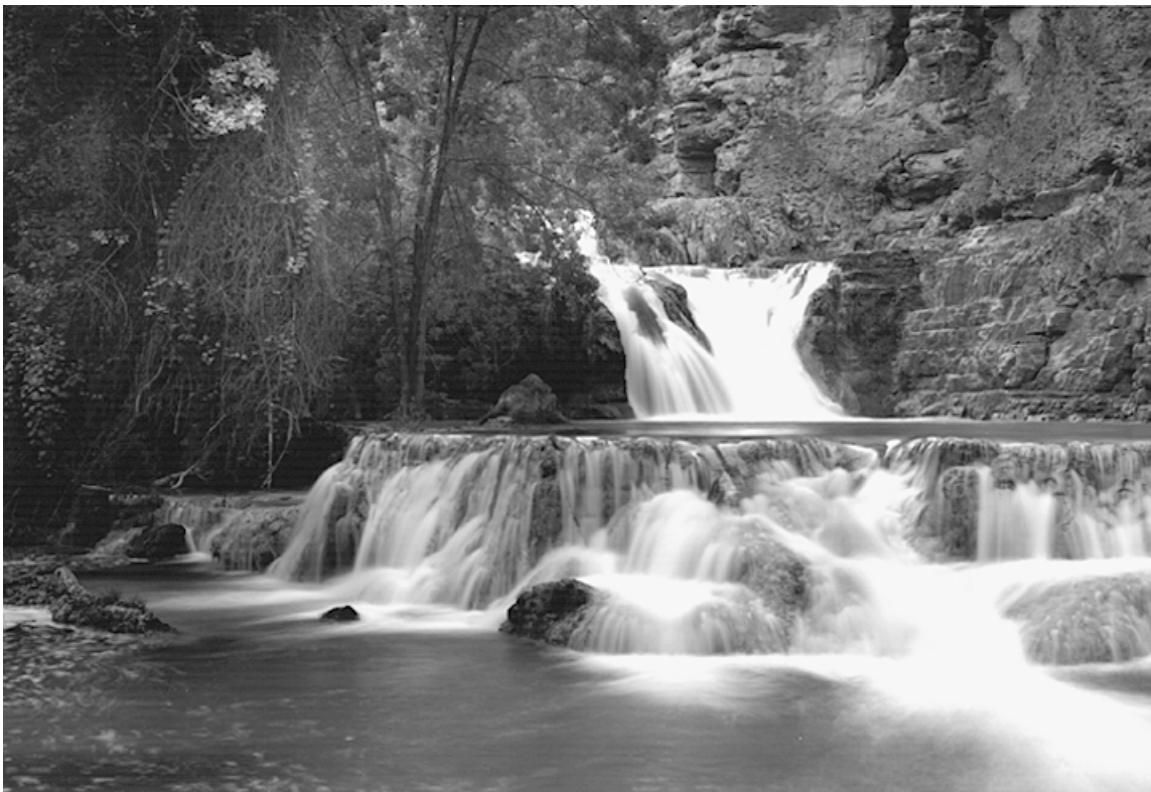
**Figure 41.** Replicate views of Beaver Falls. A, (1970). Upstream view showing Beaver Falls, its plunge pools, and riparian vegetation along Havasu Creek before the 1990s floods (Billingsley). B, (1994). Replicate view showing Beaver Falls, its plunge pools, and riparian vegetation along Havasu Creek after the 1990s floods (Stake 2887).

A 1970 view of Upper Beaver Falls (fig. 41a) appeared nearly identical to its 1994 replicate (fig. 41b); showing very little change caused by flooding between 1970 and 1994. A 1937 photograph

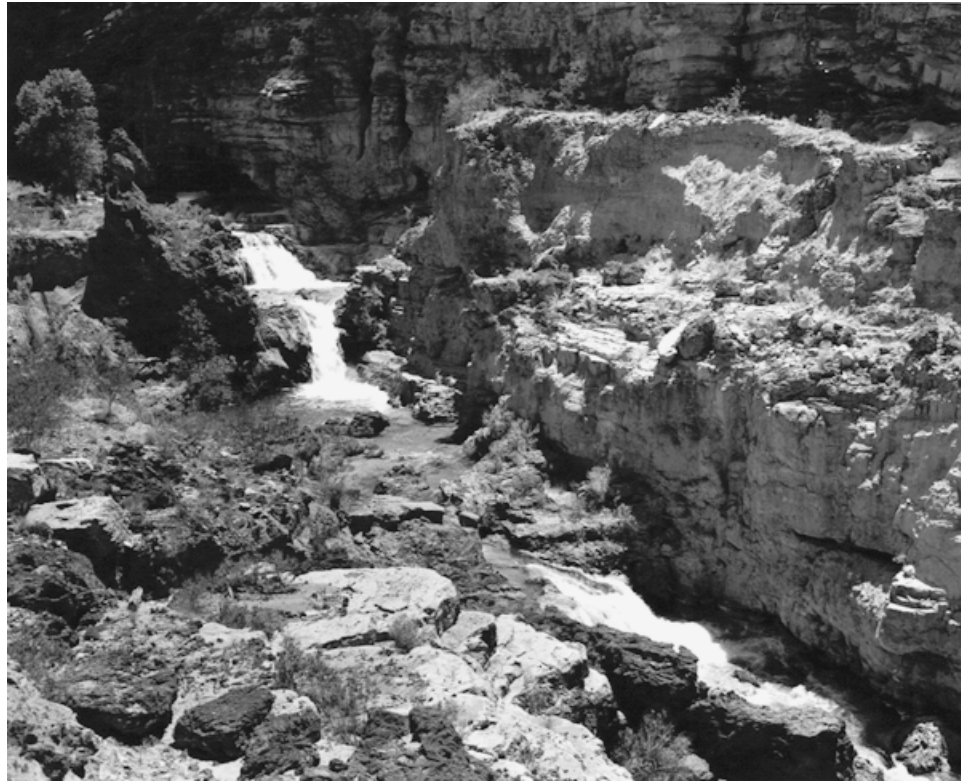
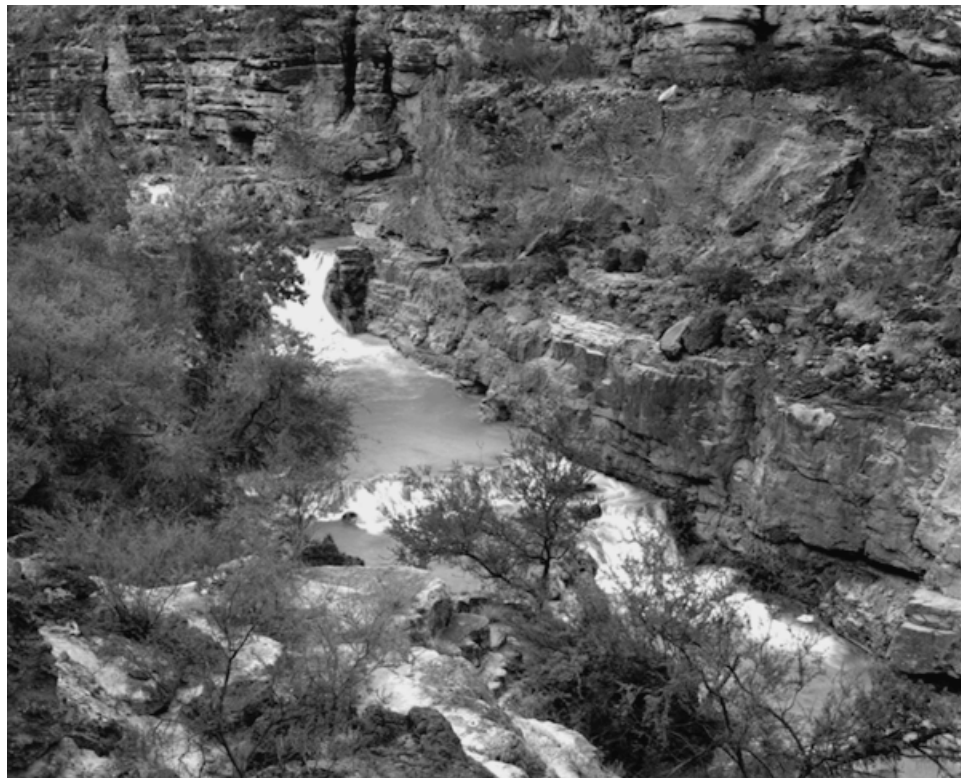
**Figure 42.** Replicate views of Beaver Falls. A, (1937). Upstream view showing Beaver Falls and riparian vegetation along Havasu Creek (Muench). B, (1994). Replicate view showing Beaver Falls and riparian vegetation along Havasu Creek after the 1990s floods (Stake 2888).

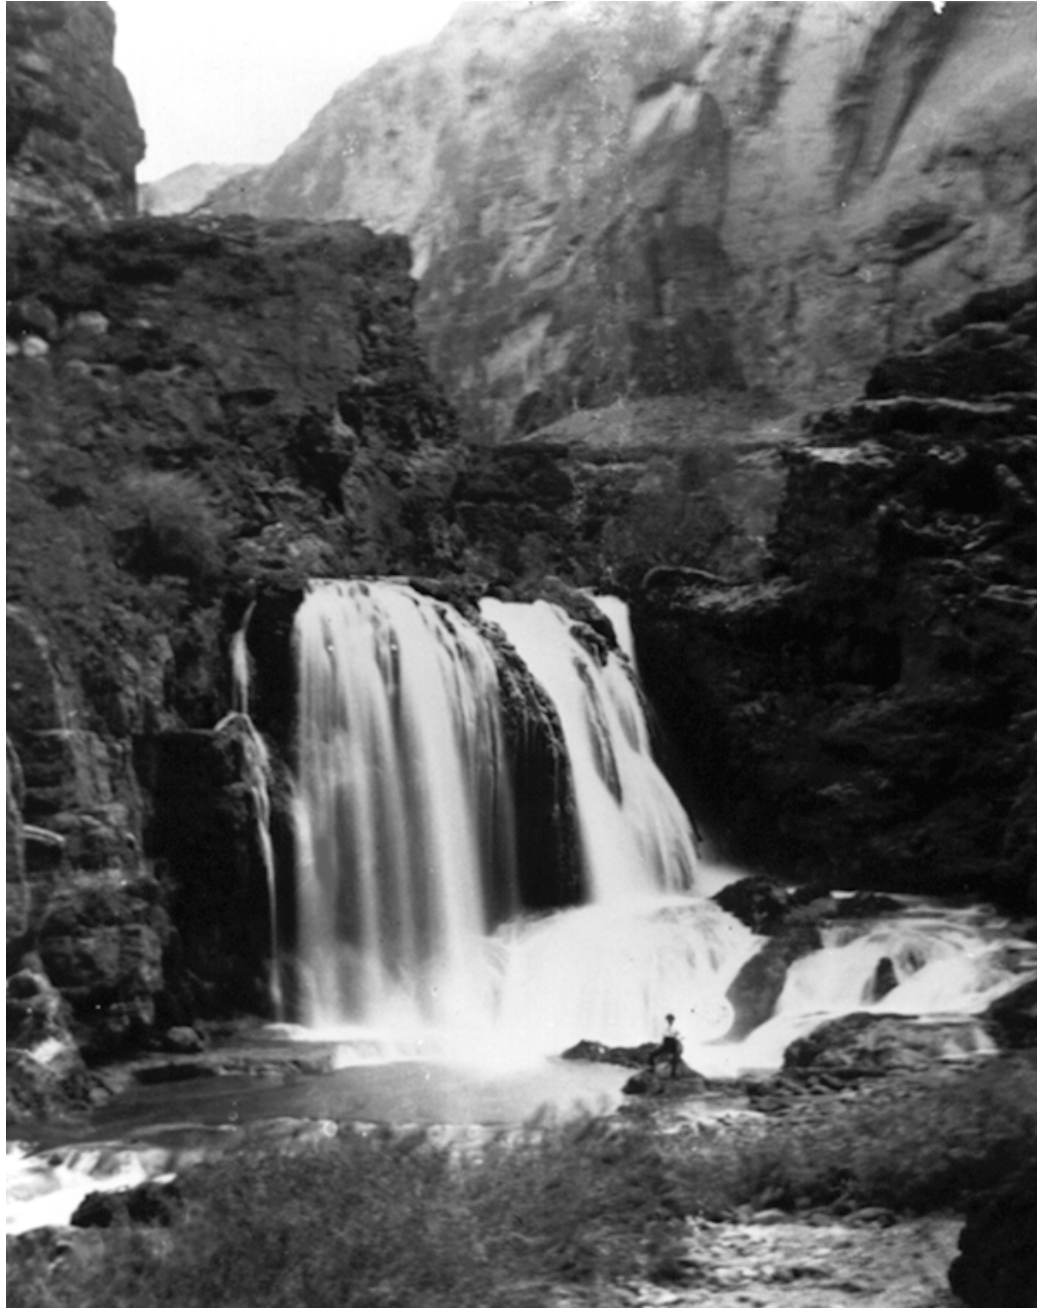
**Figure 43.** (1903). Upstream view showing Beaver Falls before the 1910 flood (Marshall, Stake 2190).

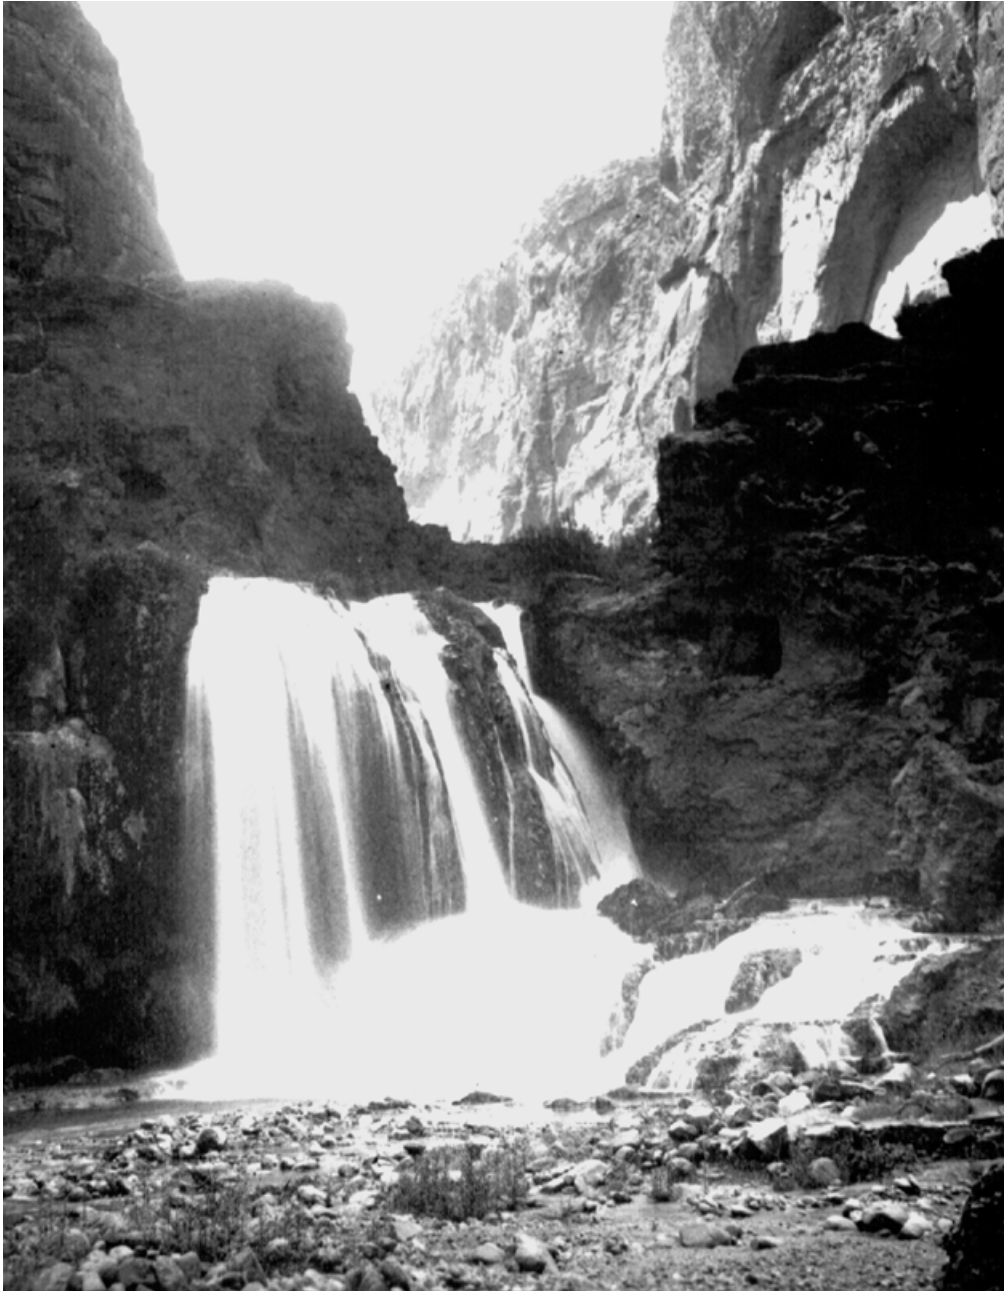
**Figure 44.** (1907). Upstream view showing Beaver Falls before the 1910 flood (Kolb; Stake 2192).

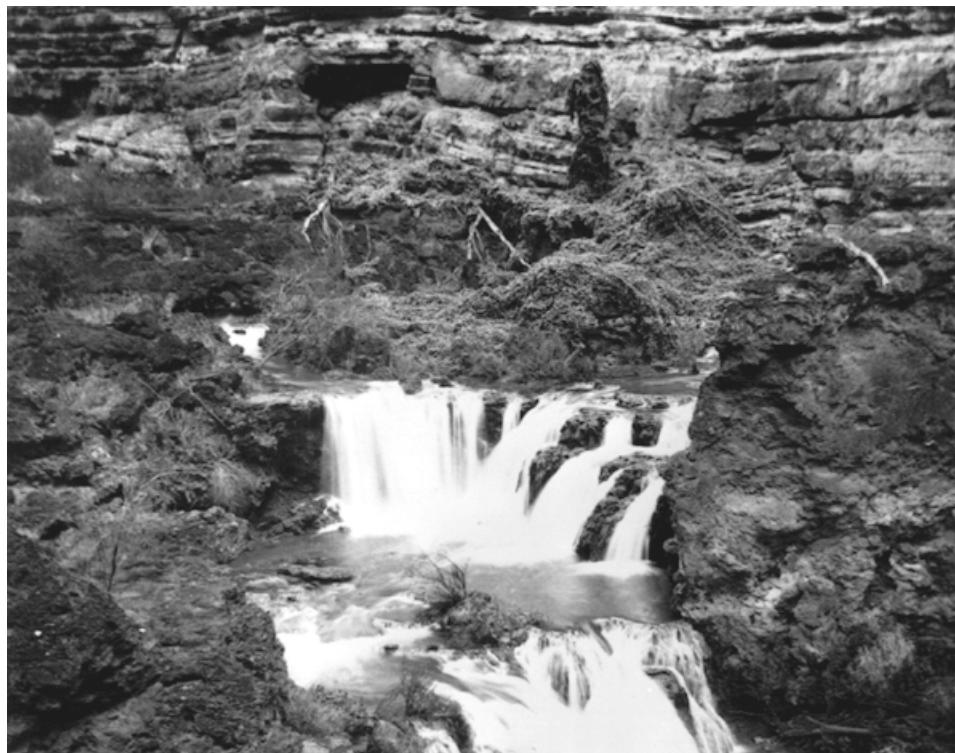
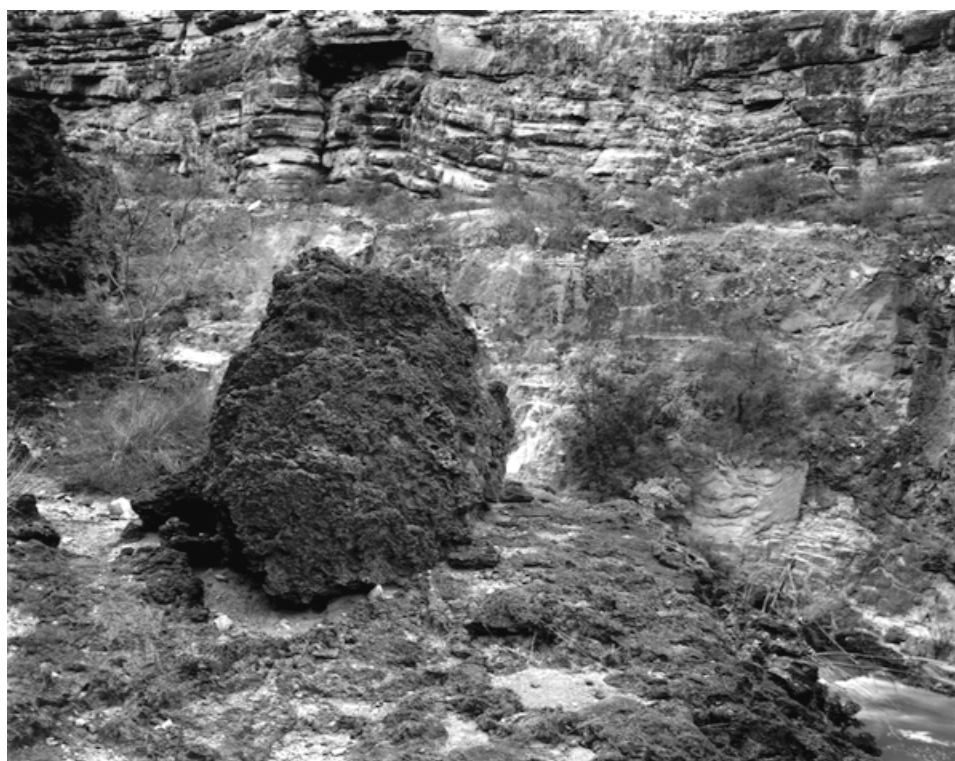
**Figure 45.** Replicate views of channel erosion of Havasu Creek downstream from Beaver Falls. A, (1903). Upstream view showing Havasu Creek immediately downstream from Beaver Falls before the 1910 flood (Marshall). B, (1994). Replicate view showing severe channel erosion in Havasu Creek immediately downstream from Beaver Falls after the 1990s floods (Stake 2889).
