# WHEN THE BLUE-GREEN WATERS TURN RED

Historical Flooding in Havasu Creek, Arizona

U.S. GEOLOGICAL SURVEY  
Water-Resources Investigations Report 96—4059

By THEODORE S. MELIS, WILLIAM M. PHILLIPS  
ROBERT H. WEBB, and DONALD J. BILLS

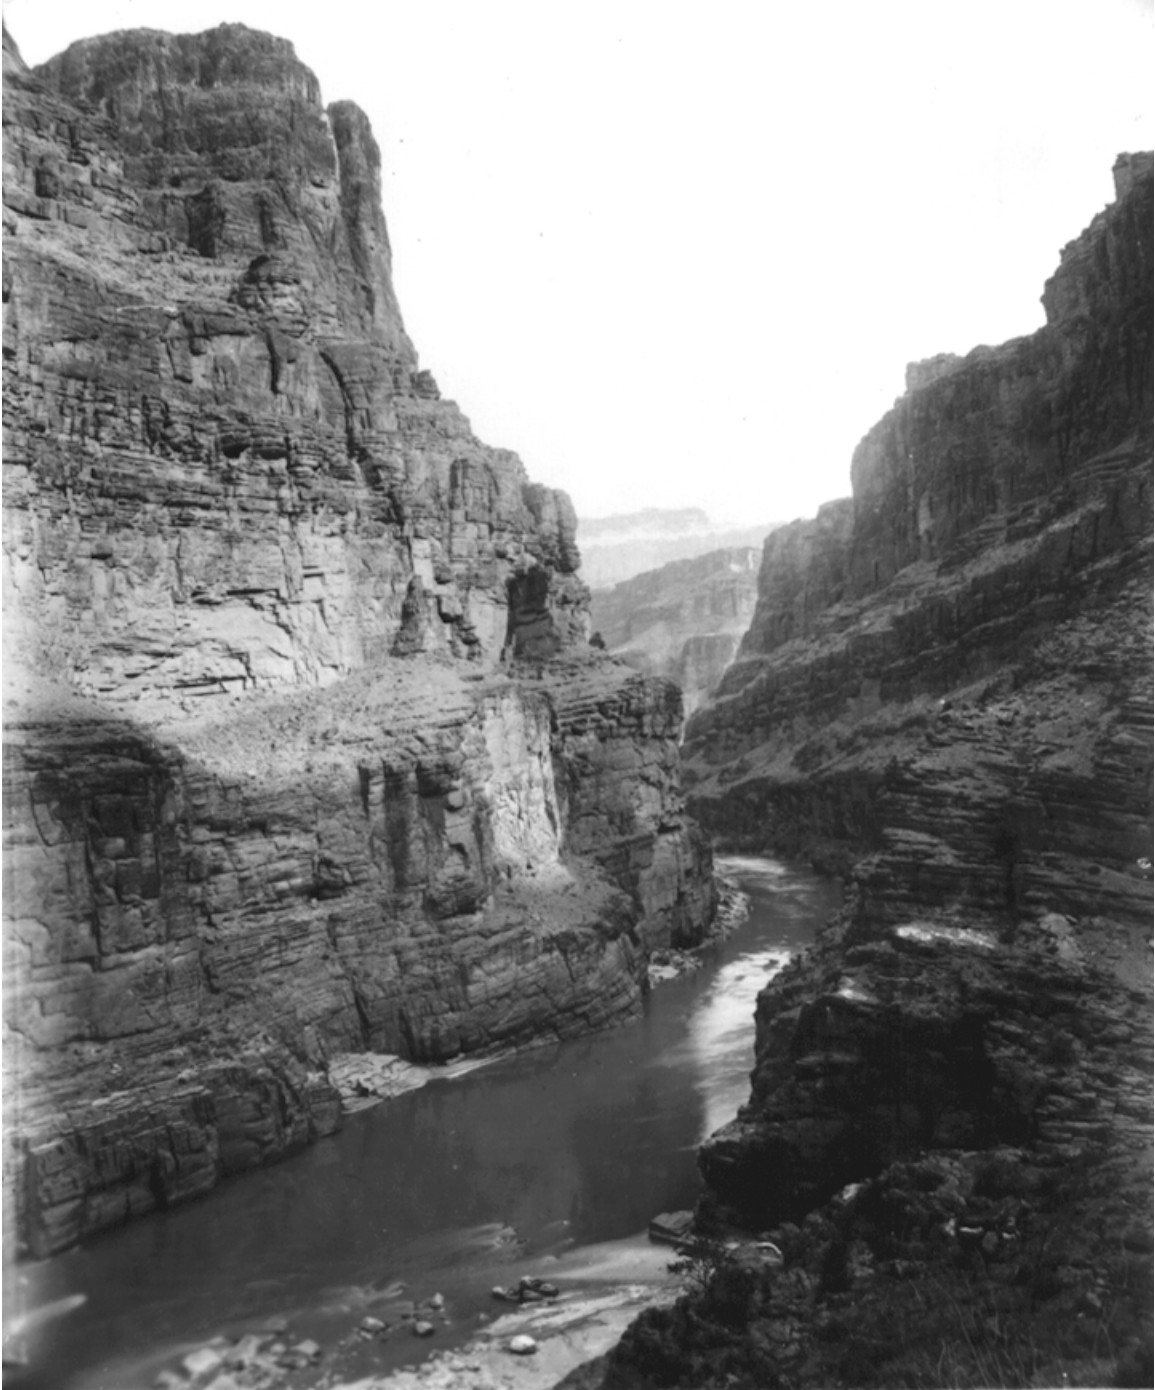
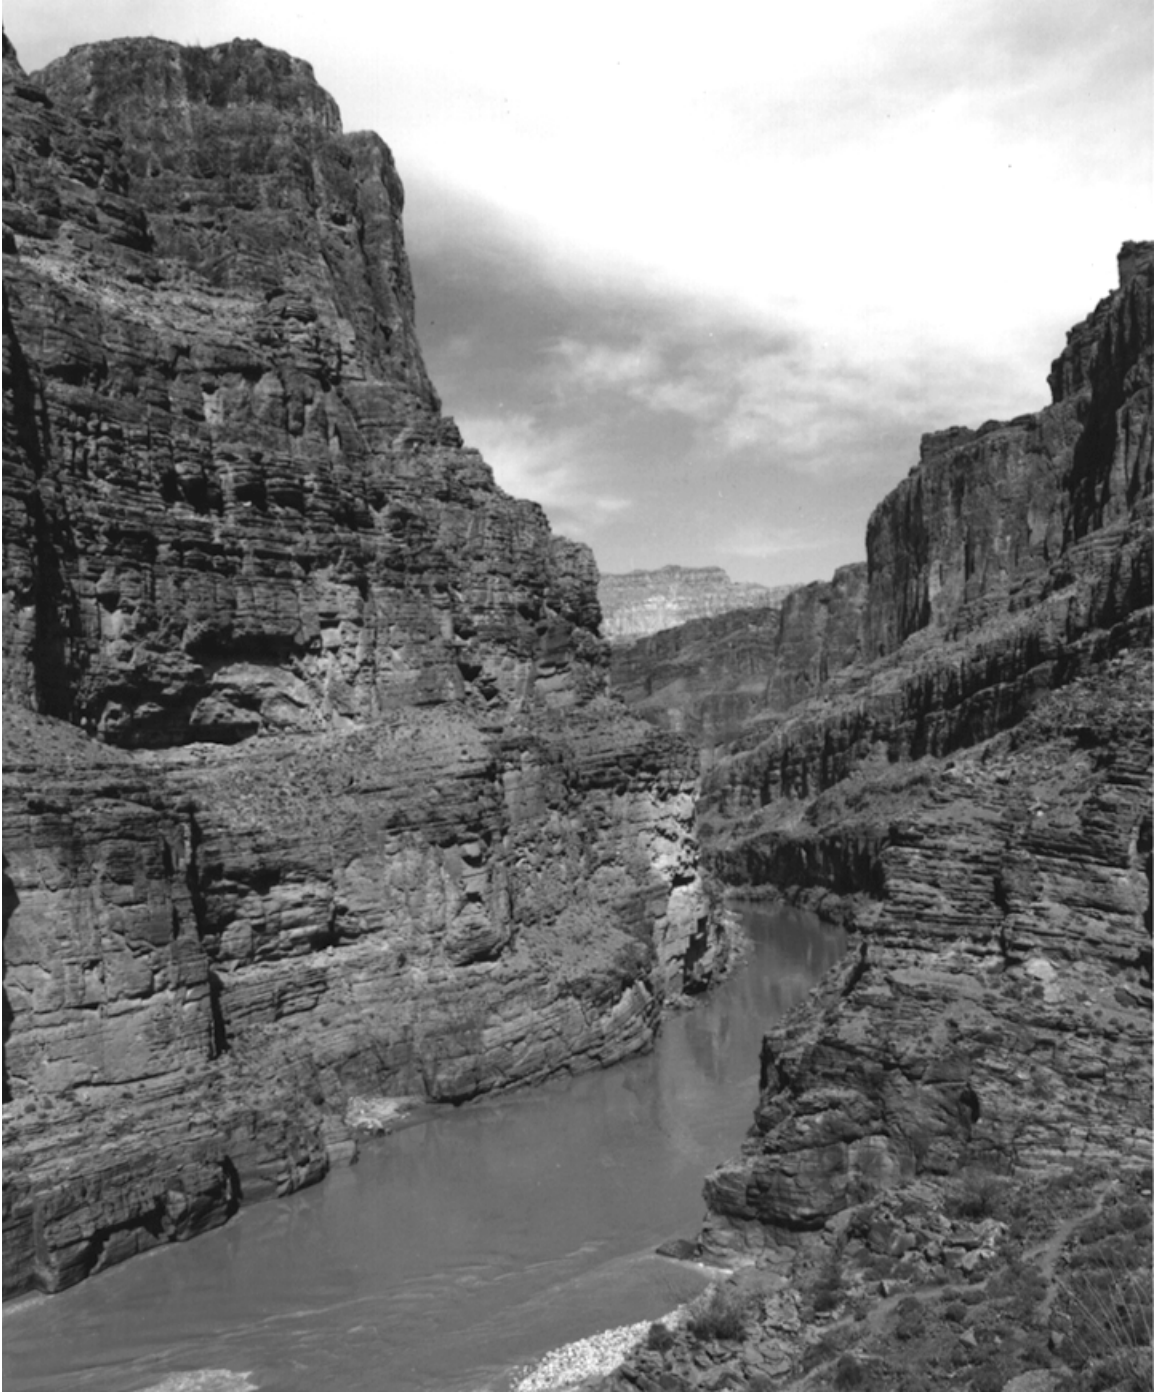
**Figure 47.** Replicate views of the confluence of Havasu Creek and the Colorado River. A, (1911). Upstream view from the left bank of the Colorado River showing the mouth of Havasu Creek immediately after the 1910 flood (Kolb).

B, (1993). Replicate view showing the mouth of Havasu Creek and the head of Havasu Rapid (Stake 2655). The new debris fan was deposited by the 1992 and 1993 floods.

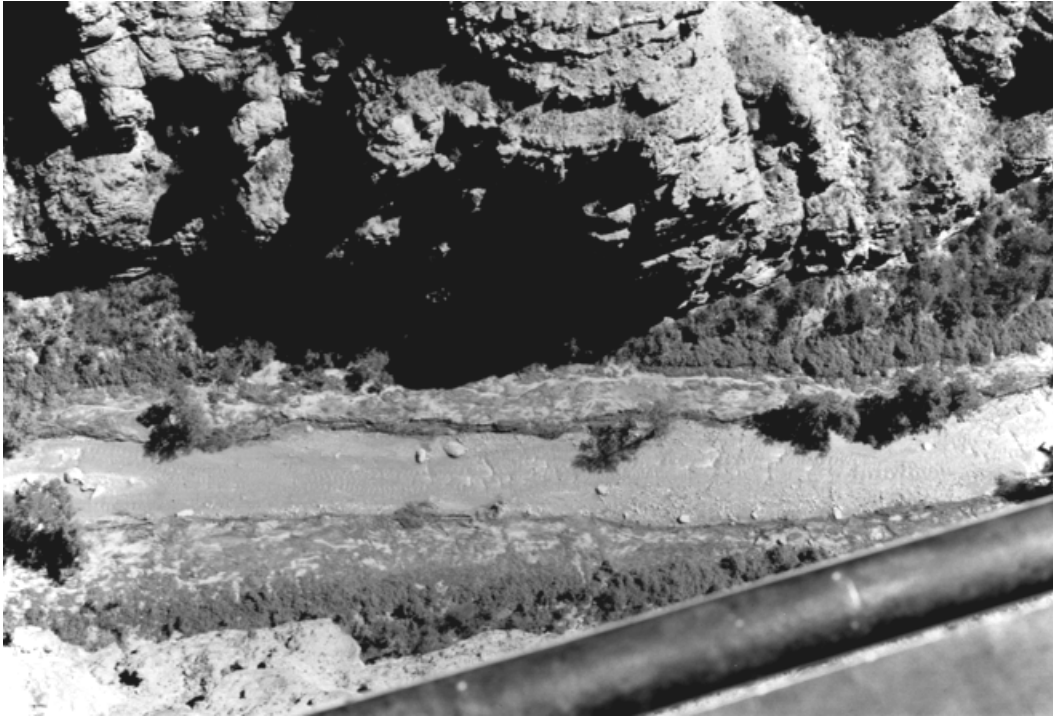
**Figure 48.** Oblique aerial view of the scour zone of Havasu Creek in lower Havasu Canyon between Beaver Falls and the Colorado River caused by the 1990 flood (Crumbo, Stake 2198).
