Estimates of Bridge Scour at Two Sites on the Virgin River, Southeastern Nevada, Using a Sediment-Transport Model and Historical Geomorphic Data

Water-Resources Investigations Report 97-4073

Prepared in cooperation with the
NEVADA DEPARTMENT OF TRANSPORTATION

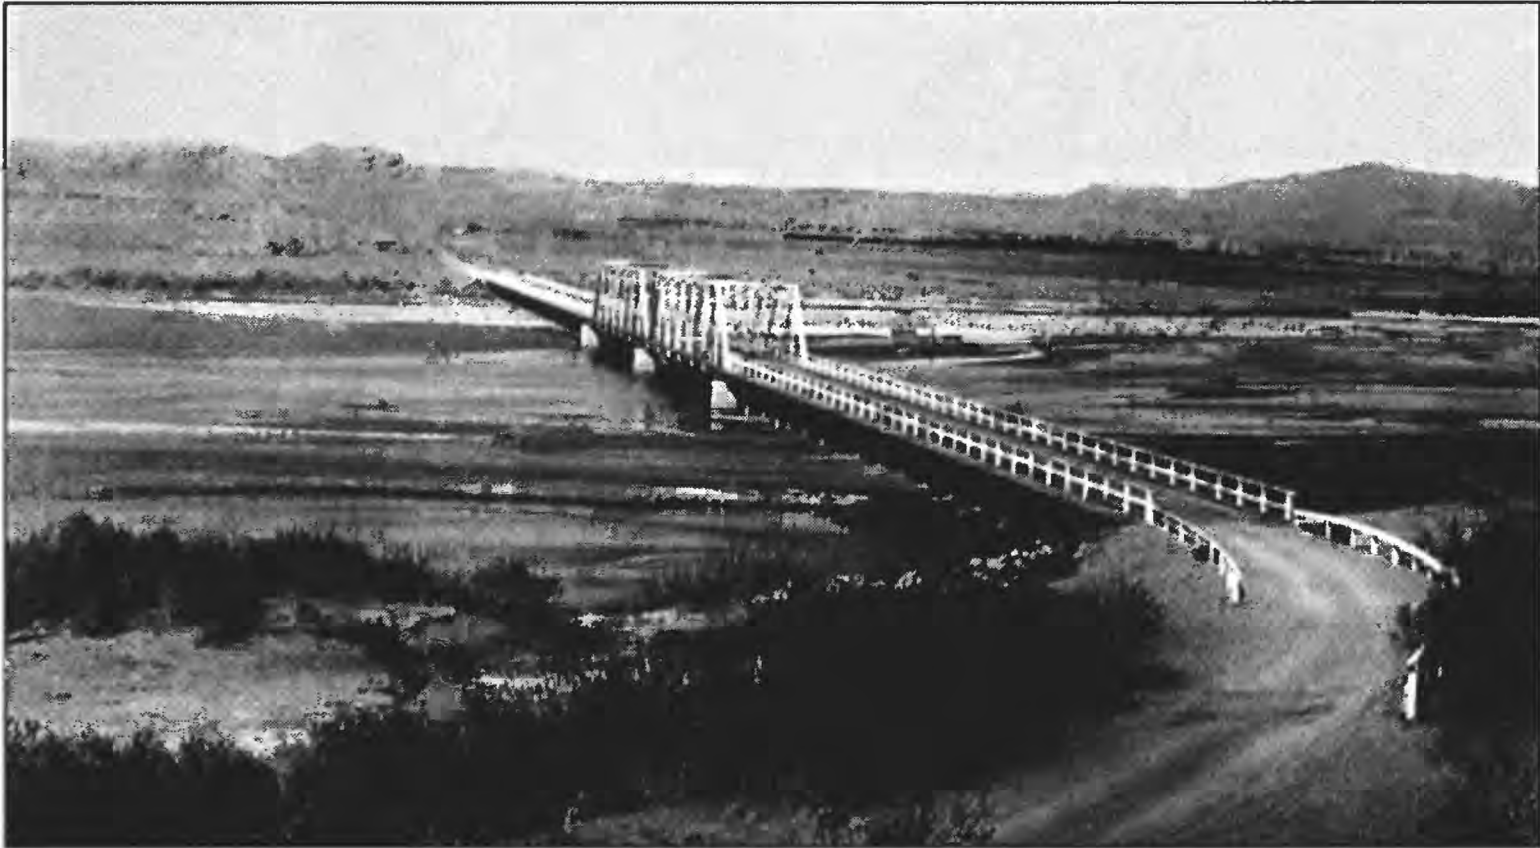
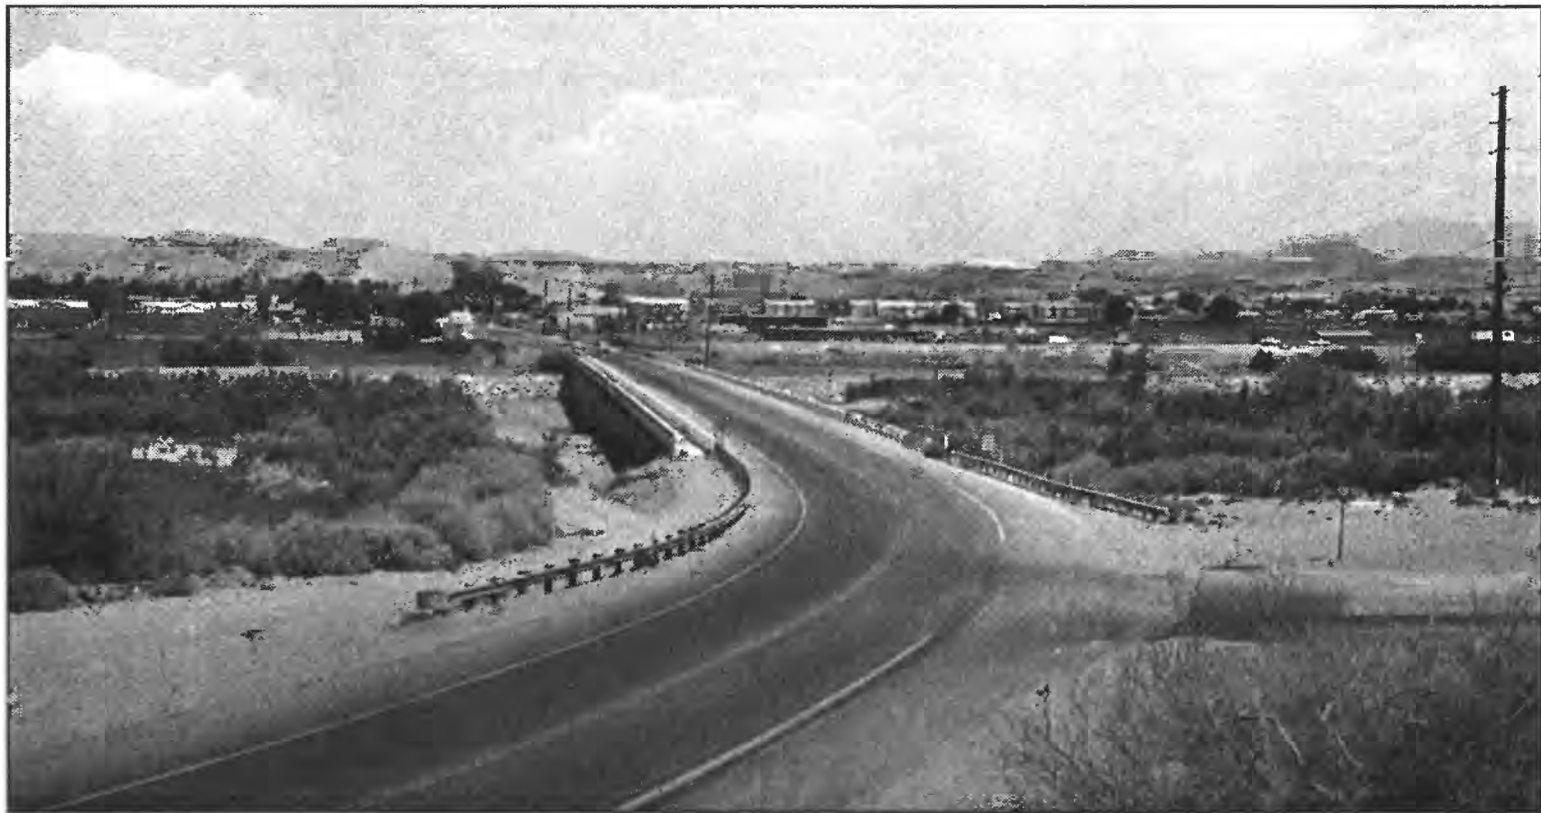
Figure 6. Views of Mesquite, Nev., bridge in (A) 1924 (photograph courtesy of Nevada Historical Society, Clark County photograph 7) and (B) 1996. View is from left bank looking northeast toward town of Mesquite. Streamflow is from right to left.

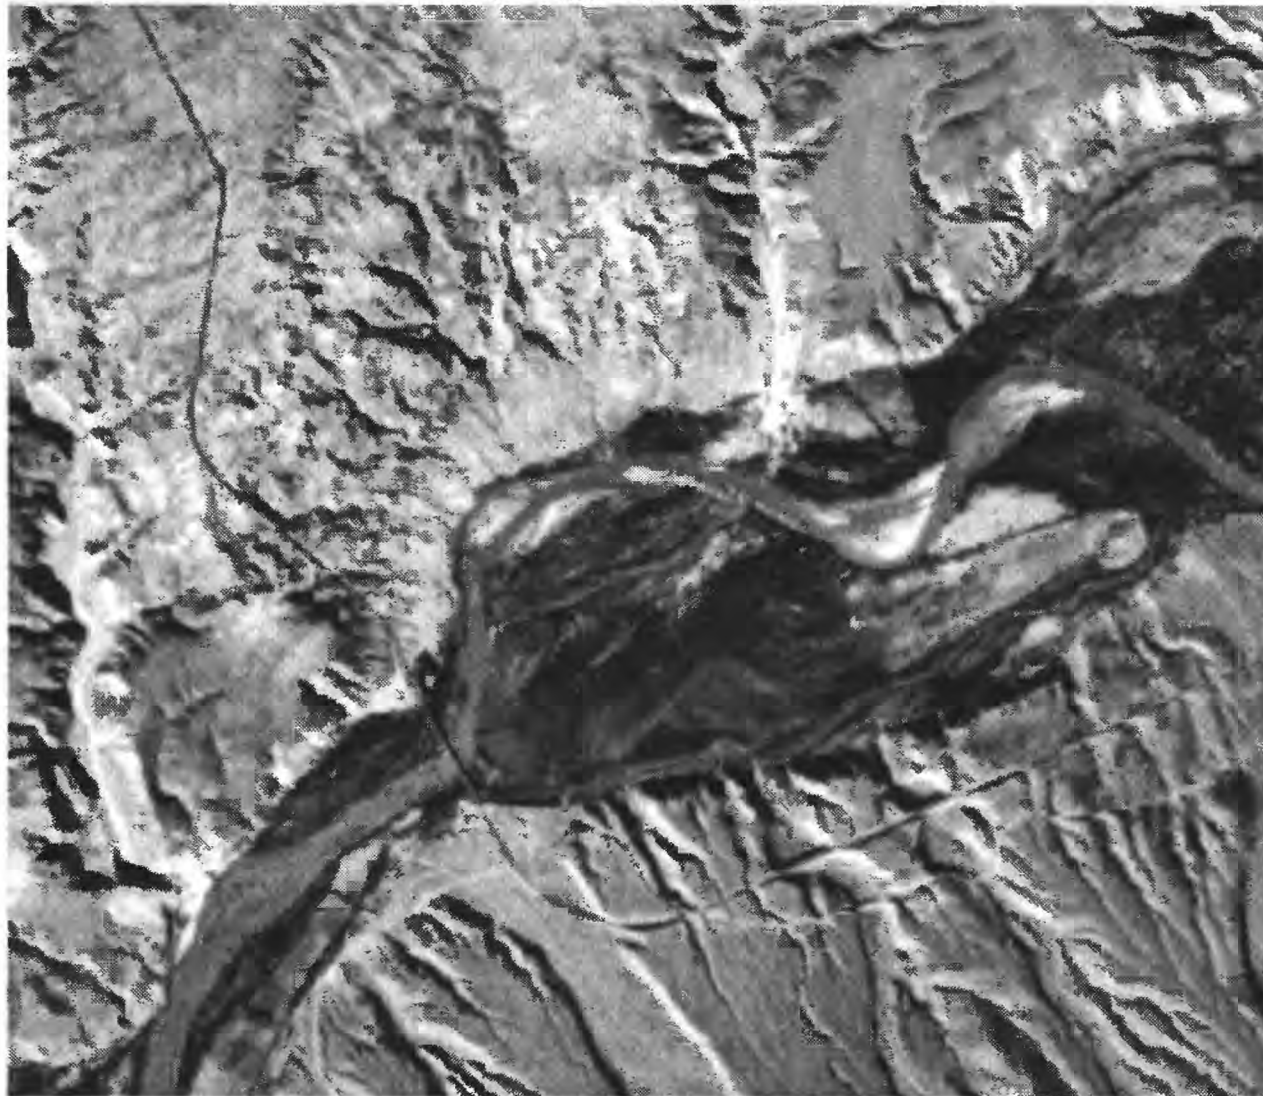
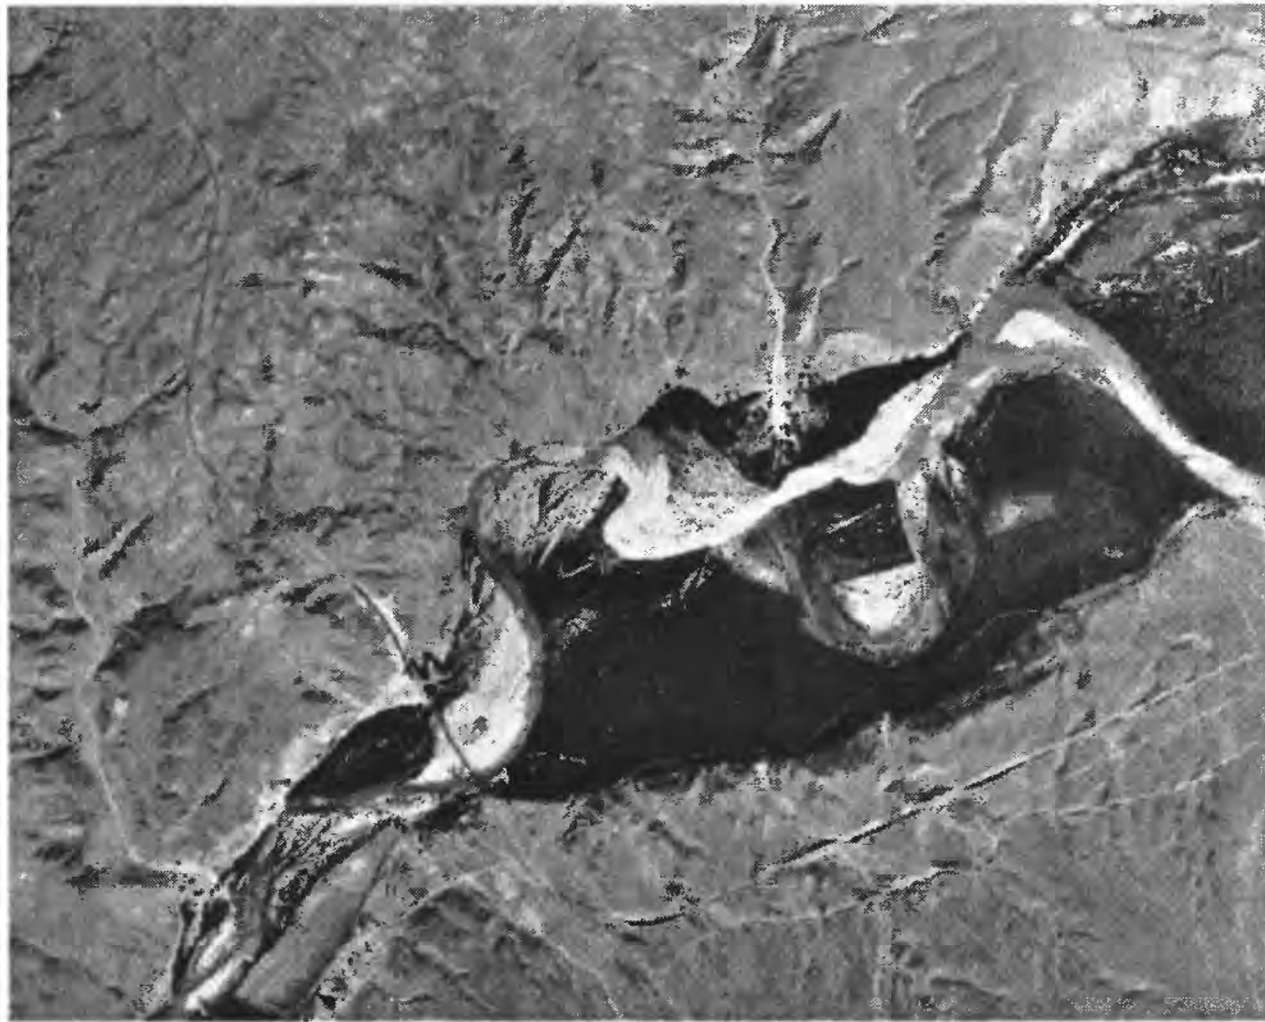
Figure 9. Aerial photographs of Riverside, Nev., bridge area (A) November 13, 1938 (Soil Conservation Service), (B) November 16, 1953 (Army Mapping Service), (C) September 22, 1978 (U.S. Air Force), and (D) August 8, 1995 (U.S. Geological Survey). Photographs are oriented with north at top and streamflow is from right to left.
