# Flood of March 1997 in Southern Ohio

U.S. GEOLOGICAL SURVEY  
Water-Resources Investigations Report 97-4149

Prepared in cooperation with the  
Ohio Department of Natural Resources

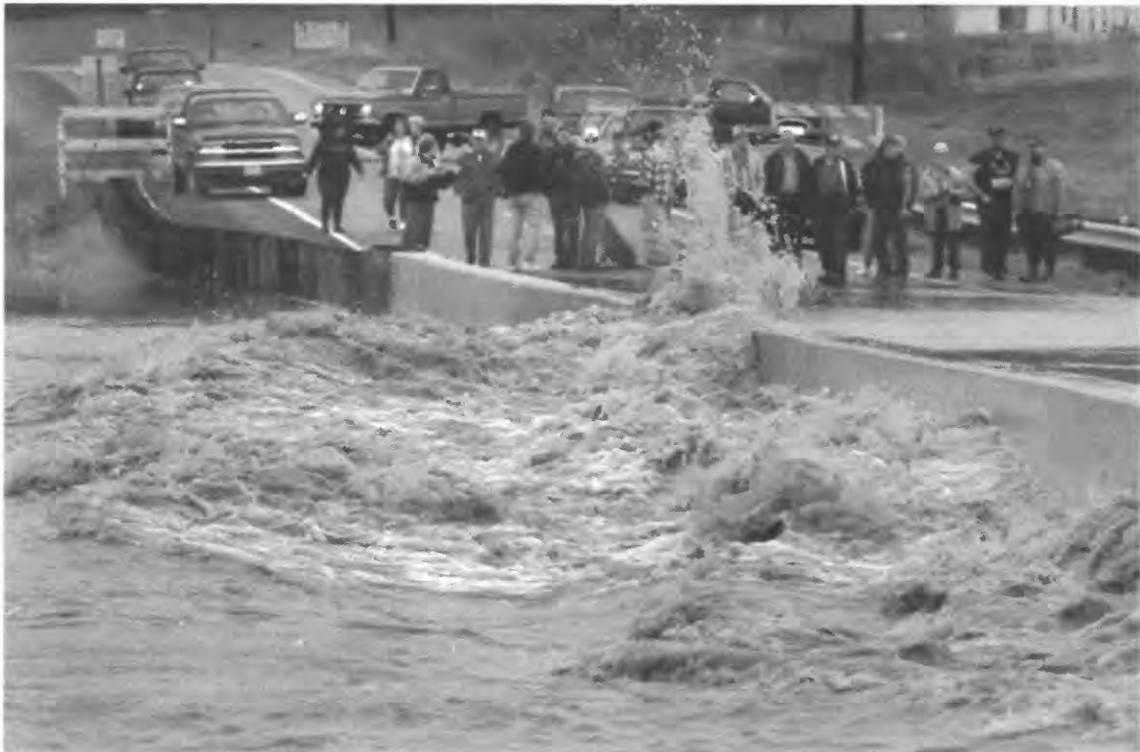
**Figure 6.** Floodwater of Ohio Brush Creek (Adams County, Ohio) splashing onto the State Route 125 bridge during the morning of March 2, 1997, looking downstream to the south.

On Sunday morning, March 2, 1997, the water level was high enough that highway officials closed the State Route 125 bridge over Ohio Brush Creek (about 6 miles east of West Union) because of concerns about the structural integrity of the bridge (fig. 6). By the afternoon, the water level had dropped, and officials reopened the highway. USGS field personnel were able to obtain a direct measurement of the streamflow from the State Route 125 bridge (fig. 7).

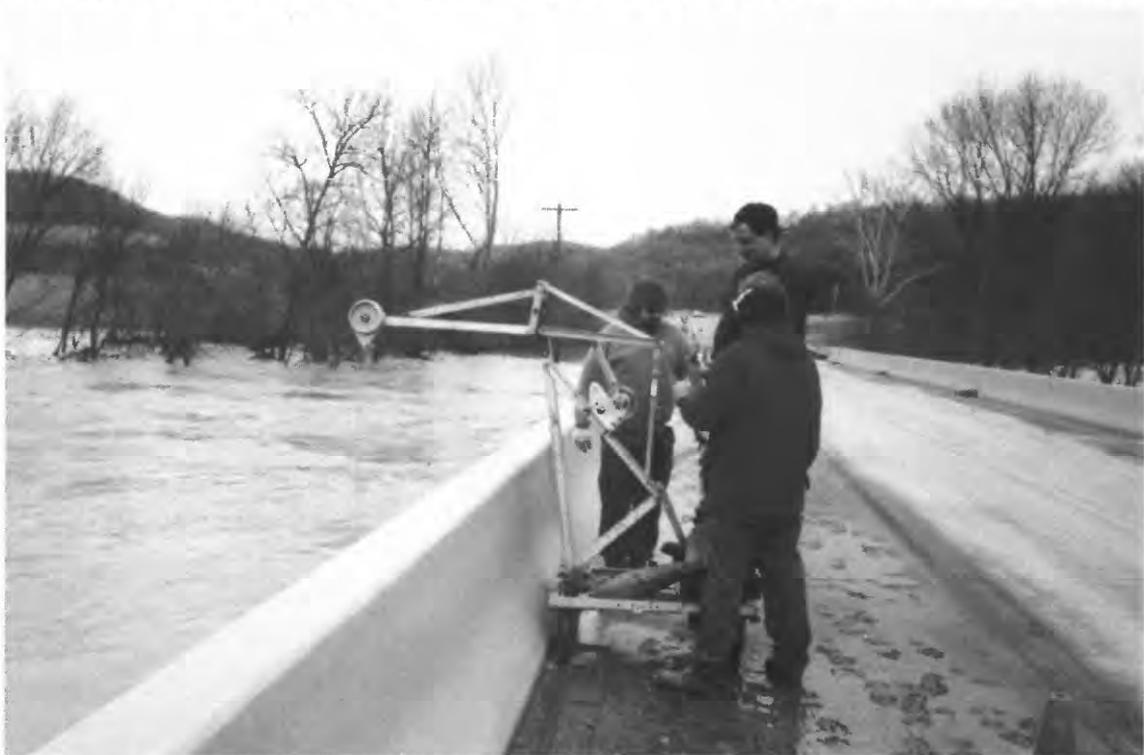
**Figure 7.** U.S. Geological field crew making a streamflow measurement on the State Route 125 bridge over Ohio Brush Creek (Adams County, Ohio) during the afternoon of March 2, 1997, looking to the southeast.

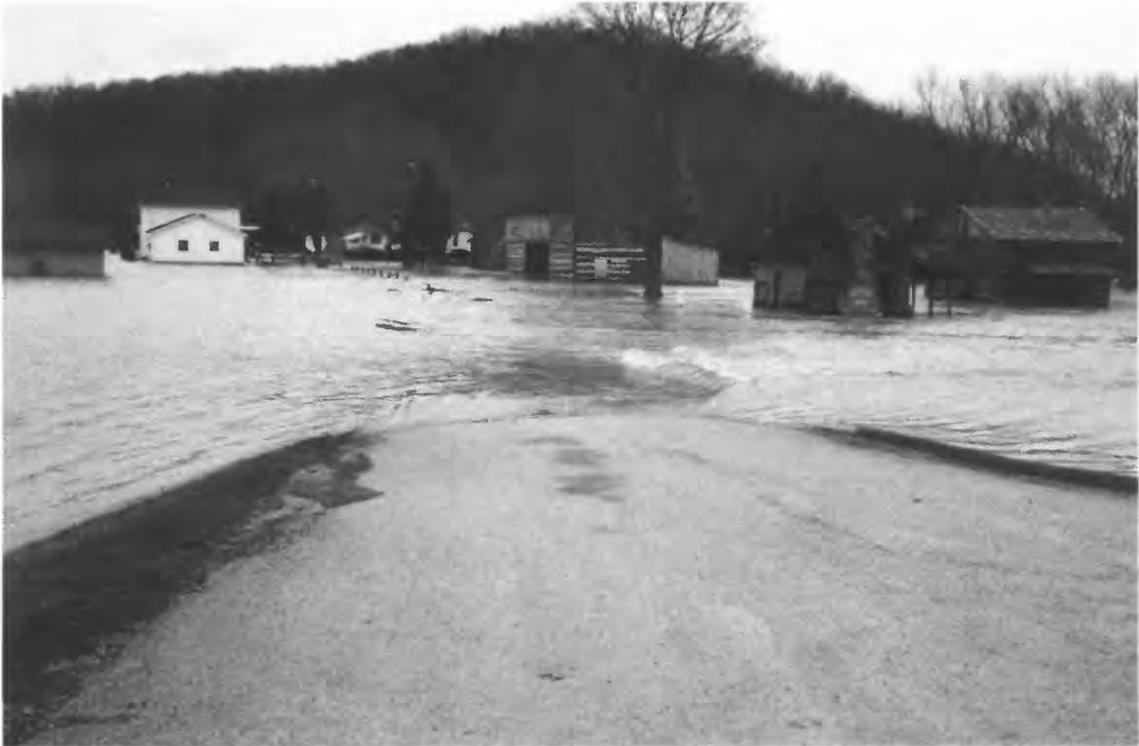
**Figure 8.** Floodwaters of Raccoon Creek, prior to the peak streamflow, surrounding historic log cabins at The Bob Evans Farm in Adamsville, Ohio, March 2, 1997, looking to the northeast, flow direction from the left to right.

**Raccoon Creek at Adamsville** (03202000, Gallia County) — The March 1997 peak streamflow of 16,500 ft<sup>3</sup>/s on Raccoon Creek at the USGS streamflow-gaging station was the largest streamflow since May 1968. The recurrence interval corresponding to the March 1997 peak streamflow is estimated to be greater than 25 years but less than 50 years. Historic log cabins at the recreated 1800's village along the bank of Raccoon Creek at The Bob Evans Farms property in Adamsville were damaged by the floodwaters (figs. 8 and 9).

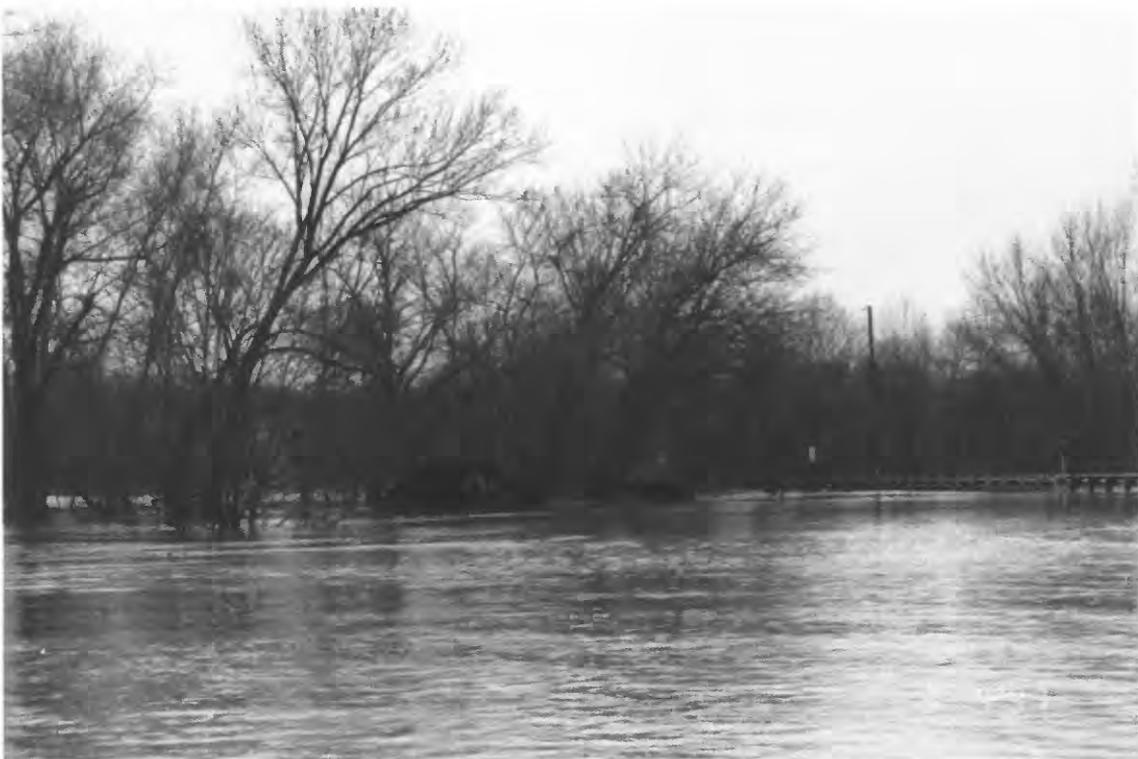
**Figure 9.** The Wickline and Post Office log cabins being swept off their foundations by Raccoon Creek floodwaters at The Bob Evans Farm in Adamsville, Ohio, March 4, 1997, looking downstream to the southwest.

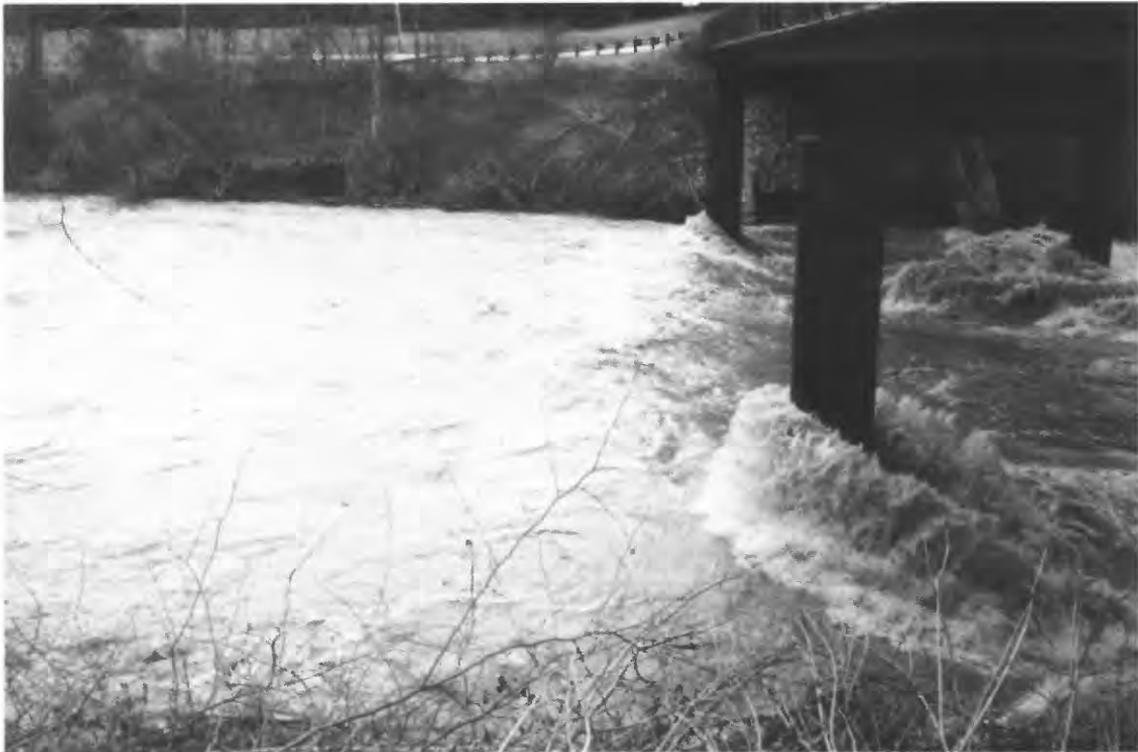
**Figure 10.** White Oak Creek floodwaters piling up on the piers at the State Route 221 bridge near Georgetown, Ohio, March 2, 1997, looking to the northeast.

**White Oak Creek near Georgetown** (03238500, Brown County) — The March 1997 streamflow of 17,900 ft<sup>3</sup>/s at the USGS streamflow-gaging station White Oak Creek near Georgetown (fig. 10) was the largest streamflow since July 1980 (19,500 ft<sup>3</sup>/s). The March 1997 flood was the second largest streamflow

recorded at this location since the peak streamflow of 22,400 ft<sup>3</sup>/s in March 1964. The recurrence interval for the March 1997 peak streamflow is estimated to be greater than 10 years but less than 25 years.

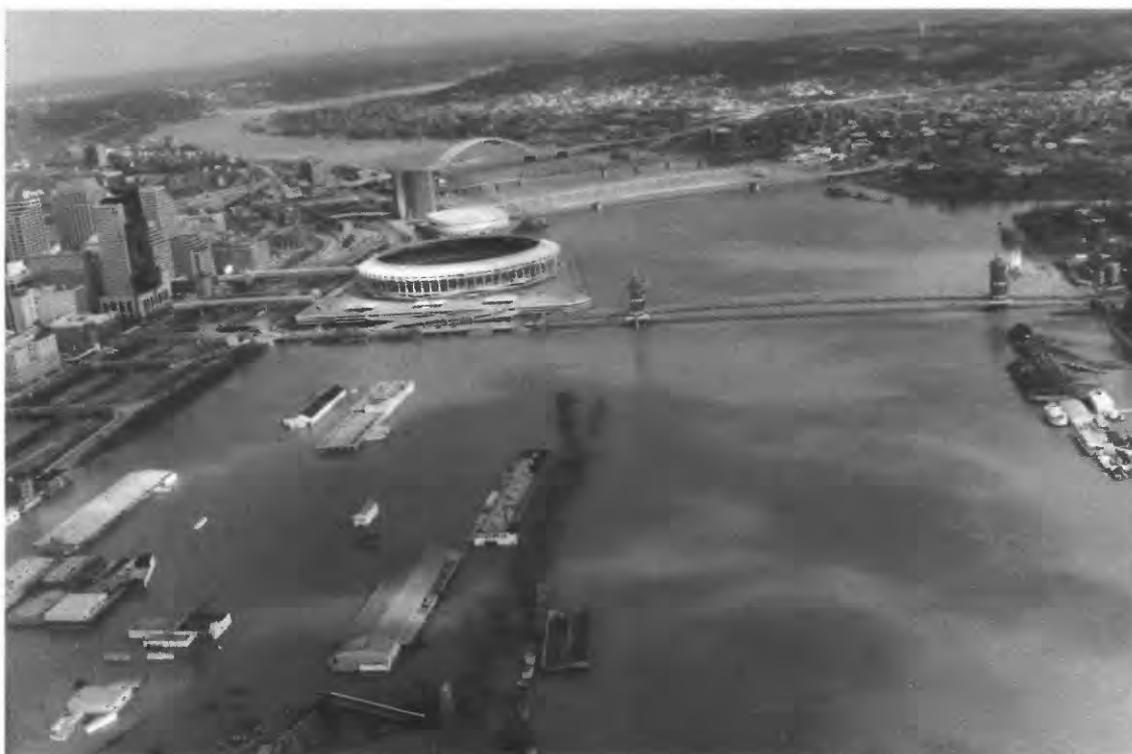
**Figure 11.** Flooding of the Ohio River at Cincinnati, Ohio, March 5, 1997, looking upstream to the east.

**Ohio River at Cincinnati** (03255000, Hamilton County) — The March 1997 peak streamflow of 625,000 ft<sup>3</sup>/s was the largest streamflow at the Ohio River at Cincinnati USGS streamflow-gaging station since March 1964. The recurrence interval corresponding to the March 1997 peak streamflow is estimated to be greater than 10 years but less than 25 years. Many low-lying areas along the Ohio River in the Cincinnati area — the most densely populated part of southern Ohio — were inundated during the March 1997 flood (fig. 11).
