CHARACTERIZATION AND EVALUATION OF CHANNEL AND HILLSLOPE EROSION ON THE ZUNI INDIAN RESERVATION, NEW MEXICO, 1992-95

Water-Resources Investigations Report 97-4281

Prepared in cooperation with the

PUEBLO OF ZUNI

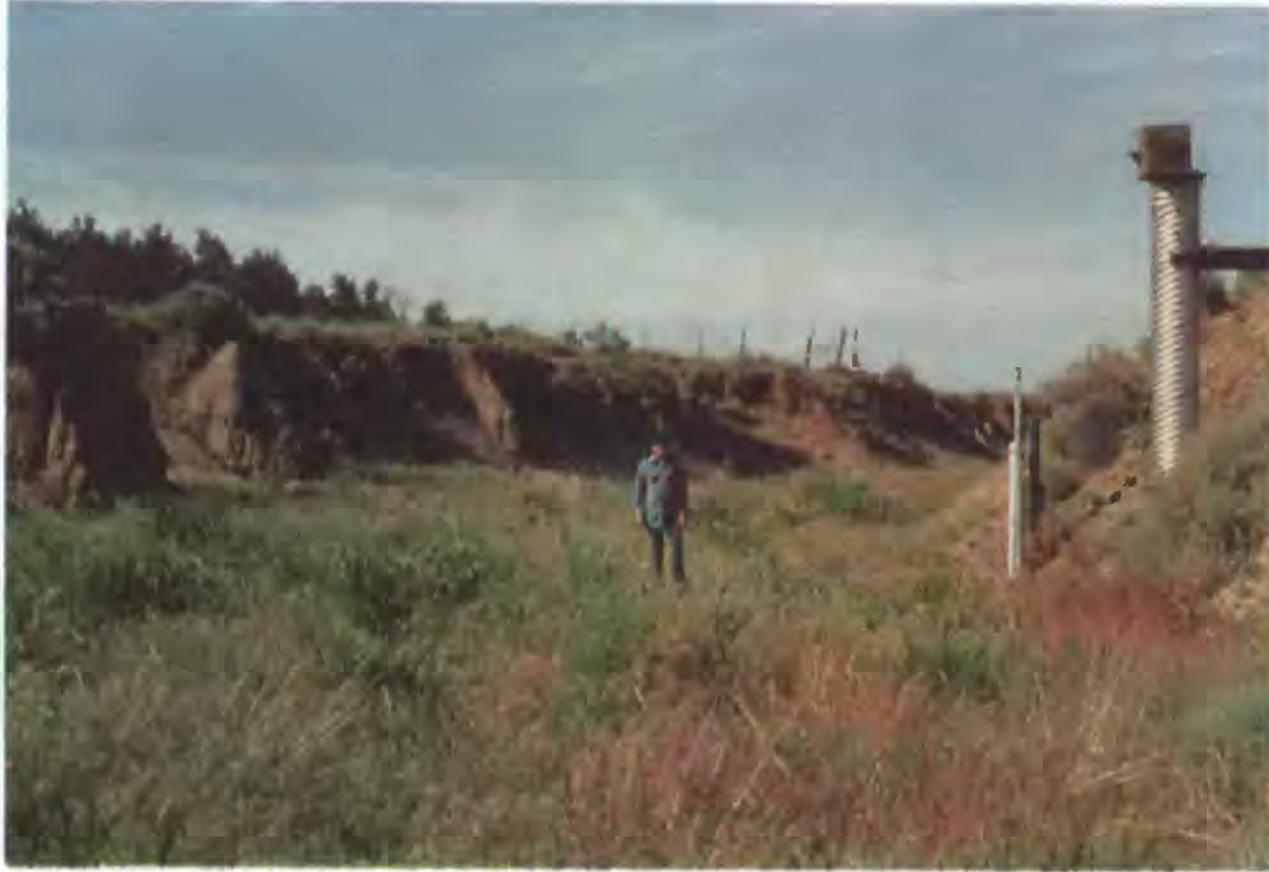
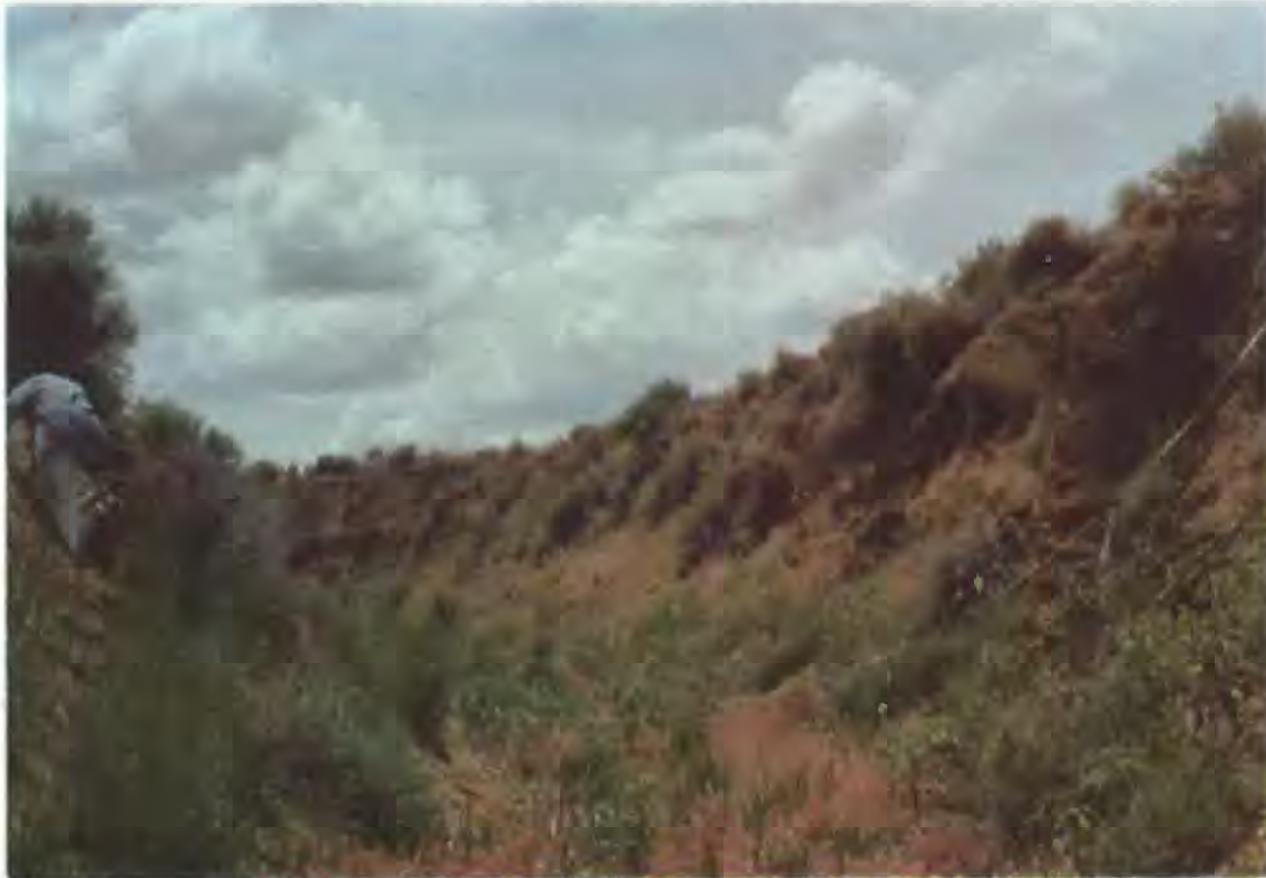
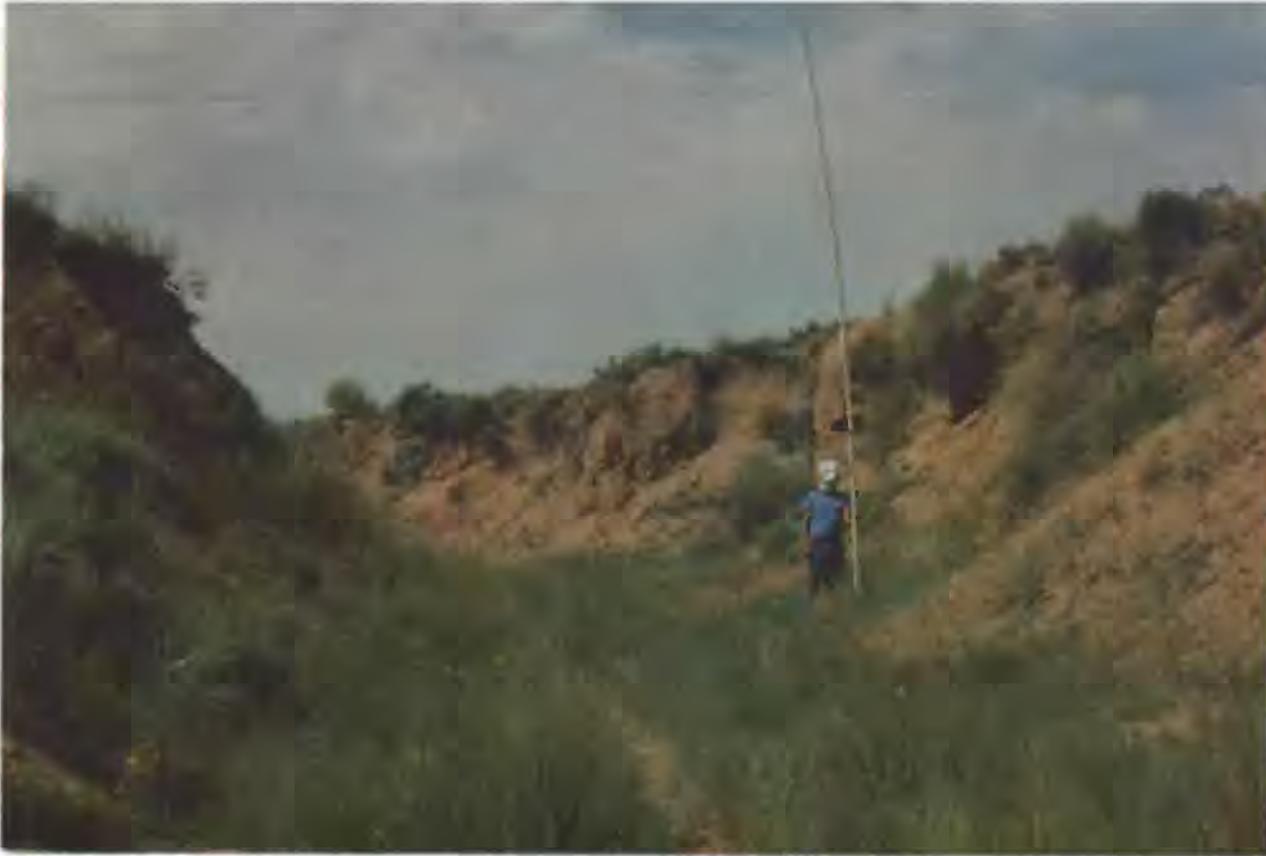
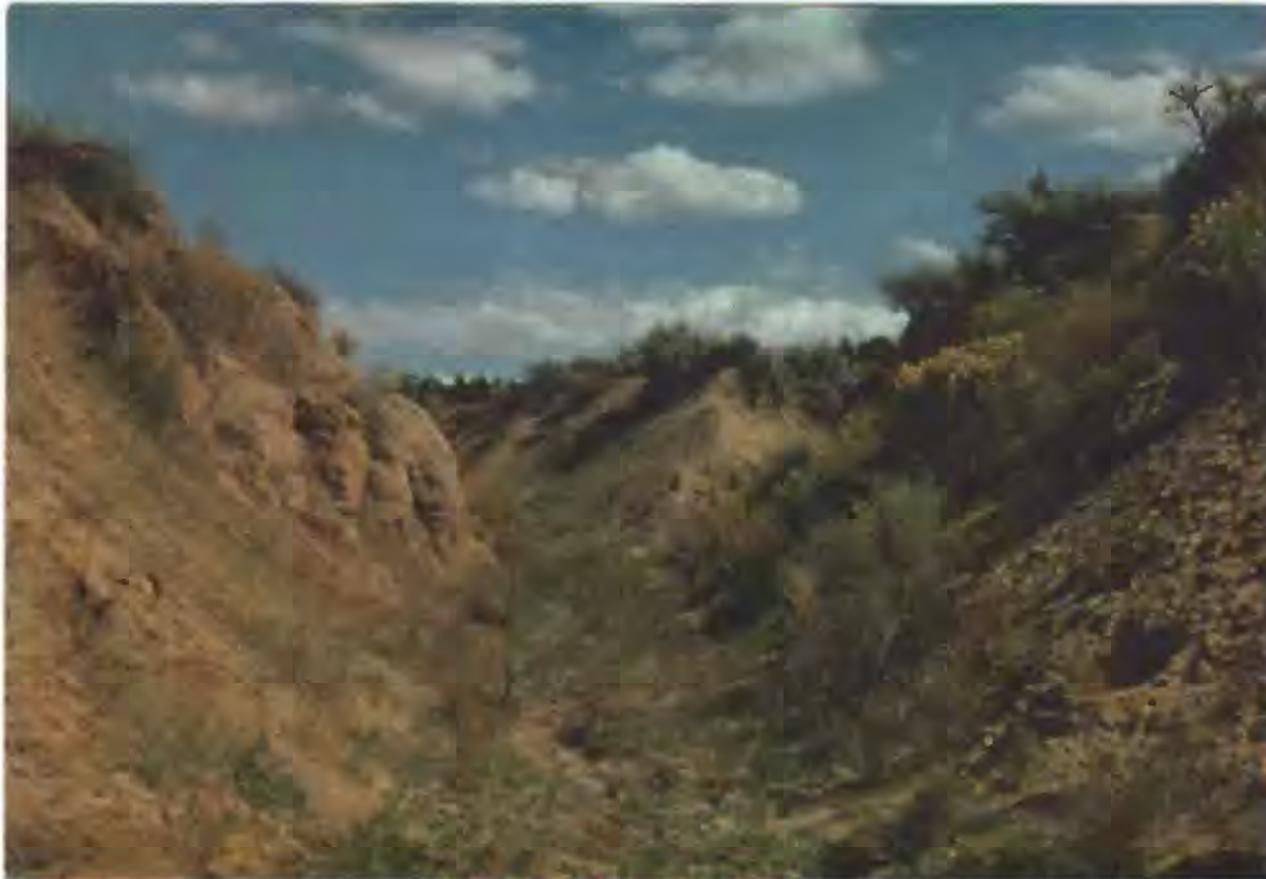
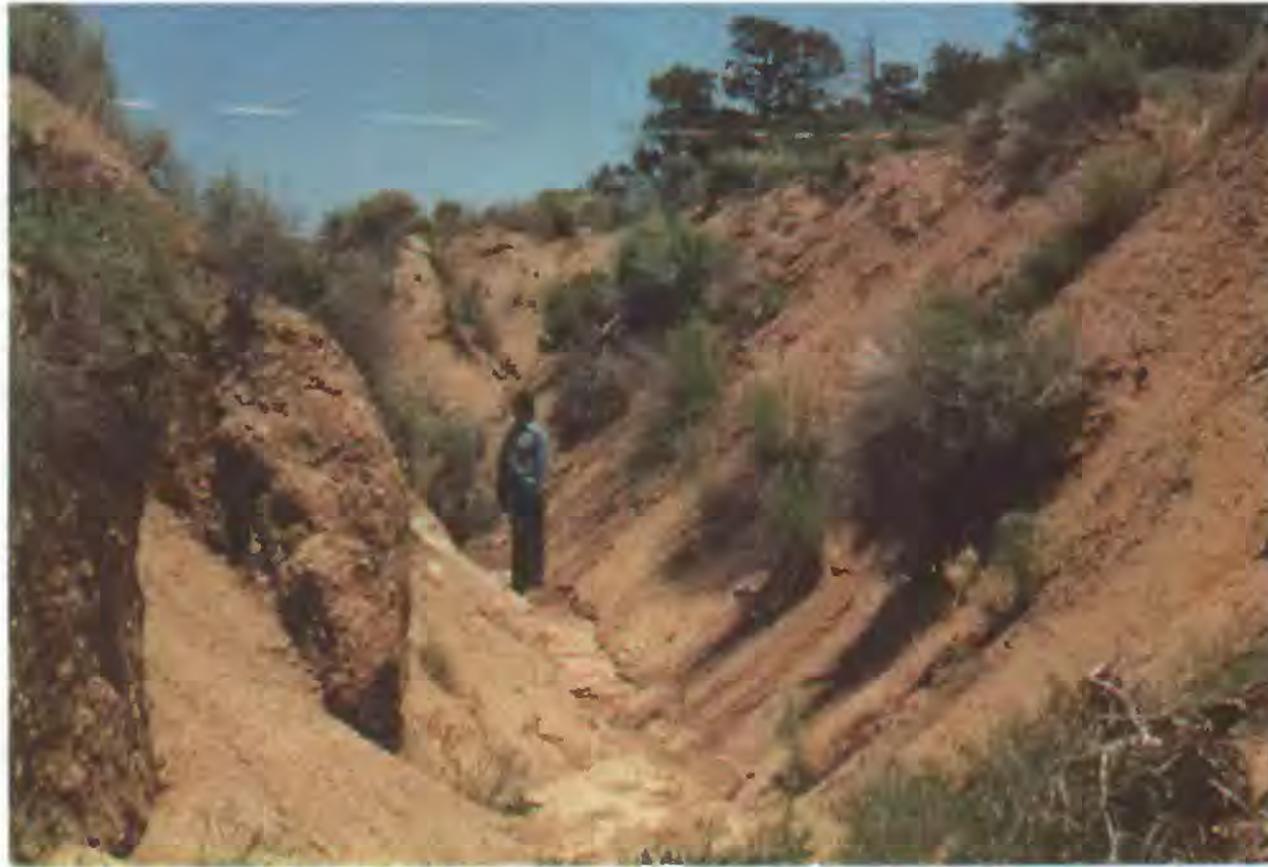
Figure 12.--Changes in the main-channel geometry of Conservation Draw in an upstream direction and in tributary CDT3: (A) CD1, (B) CD5, (C) CD9, (D) CD12, and (E) CDT3.

Number of surveyed cross sections = 5
Average top width = 50 meters
Average depth = 3.89 meters
Coefficient of geometry = 0.54

Number of surveyed cross sections = 2
Average top width = 16.6 meters
Average depth = 7.49 meters
Coefficient of geometry = 0.23

Number of surveyed cross sections = 2
Average top width = 23.7 meters
Average depth = 5.88 meters
Coefficient of geometry = 0.27

Number of surveyed cross sections = 2
Average top width = 17.3 meters
Average depth = 5.54 meters
Coefficient of geometry = 0.25
