TOPOGRAPHY, SURFACE FEATURES, AND FLOODING OF ROGERS LAKE PLAYA, CALIFORNIA

U.S. GEOLOGICAL SURVEY
Water-Resources Investigations
Report 98-4093

Prepared in cooperation with the
U.S. DEPARTMENT OF THE AIR FORCE

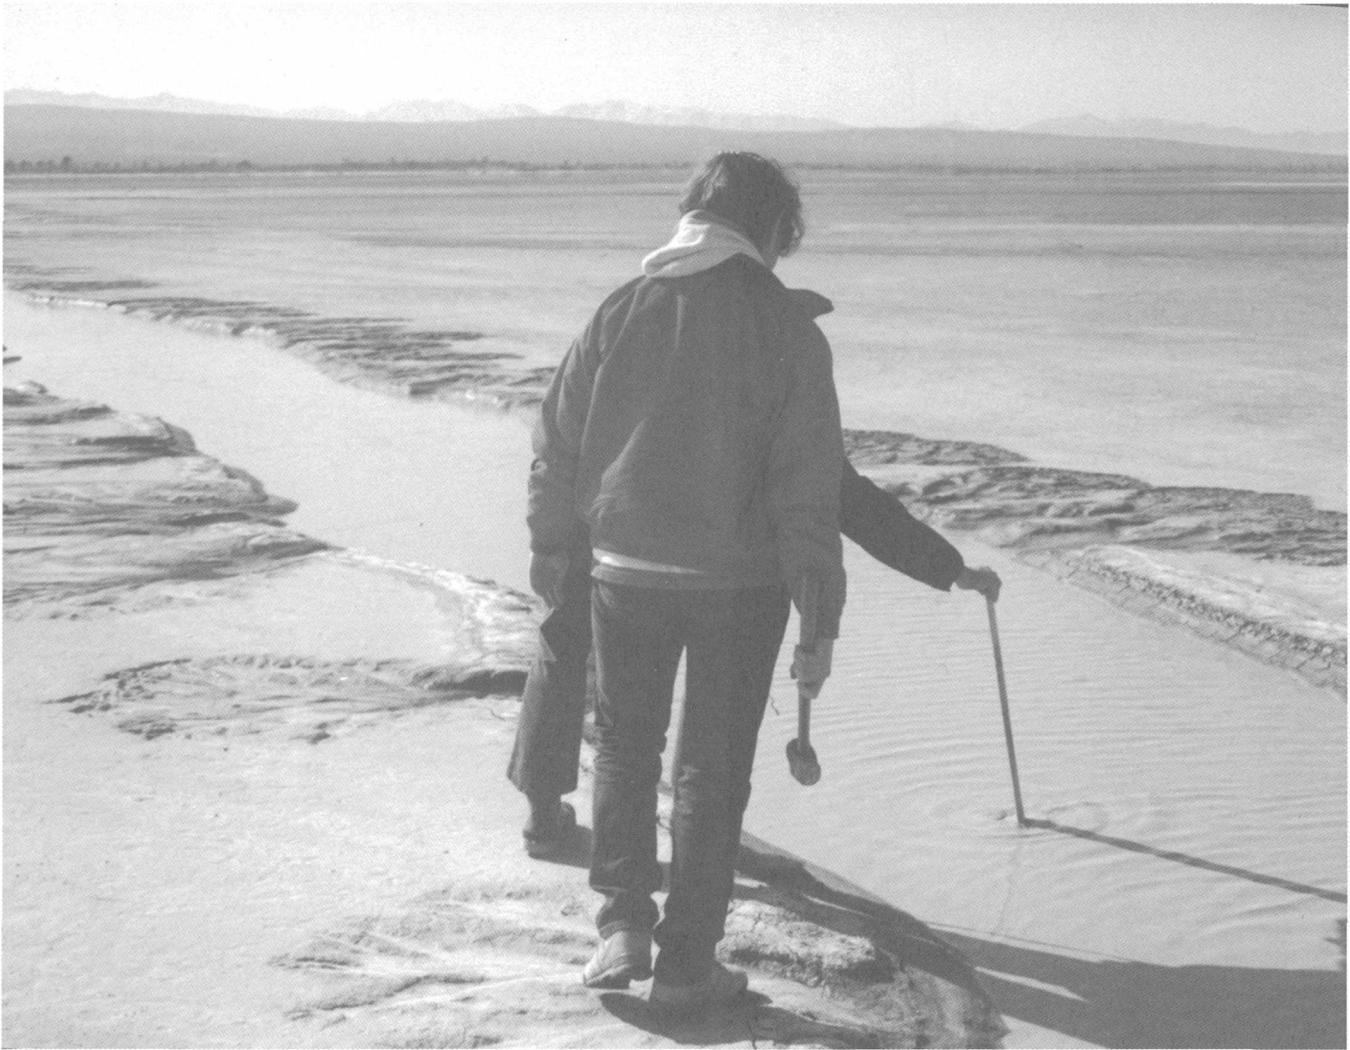
Figure 3. Erosional fissure located near runway 25 on the east side of Rogers Lake playa, Edwards Air Force Base, California. View toward the southeast. Cracks can attain widths of several feet and lengths of several hundred feet. (Photographed in 1992)

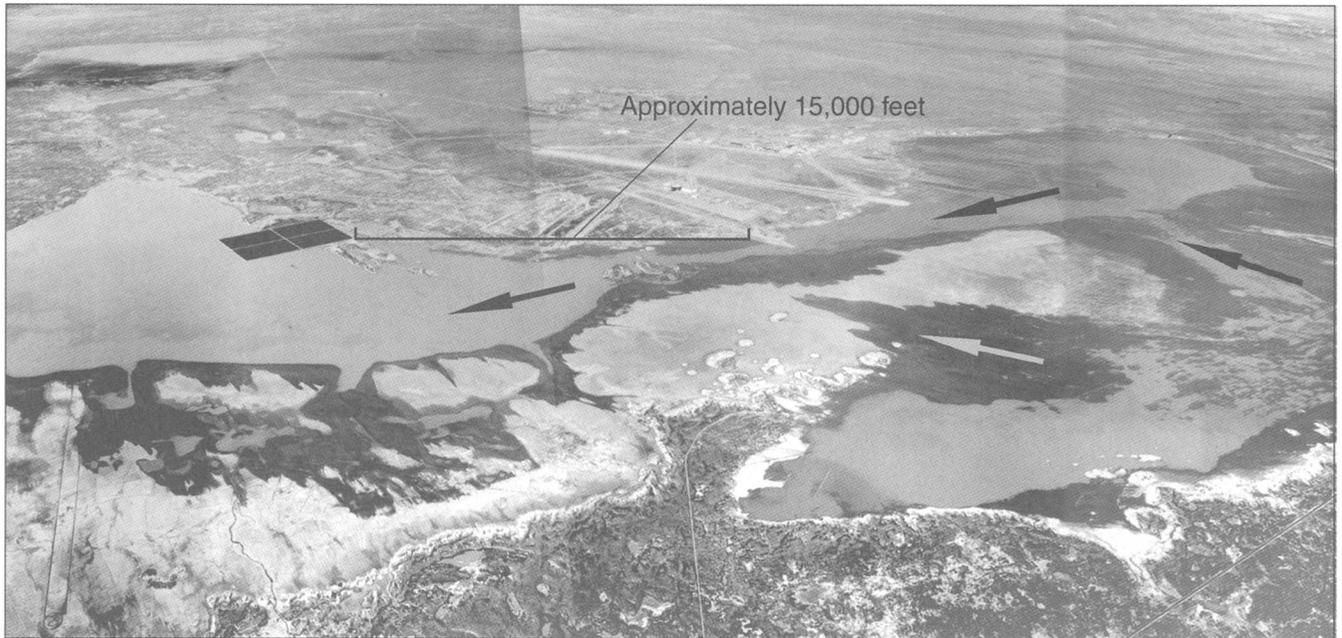
Figure 12. Aerial view of playa inundation, Rogers Lake, Edwards Air Force Base, California. *A*, March 1992. *B*, January 1995. View is to the west. Arrows indicate direction of flow. (Photographs courtesy of U.S. Department of the Air Force, 1995.)

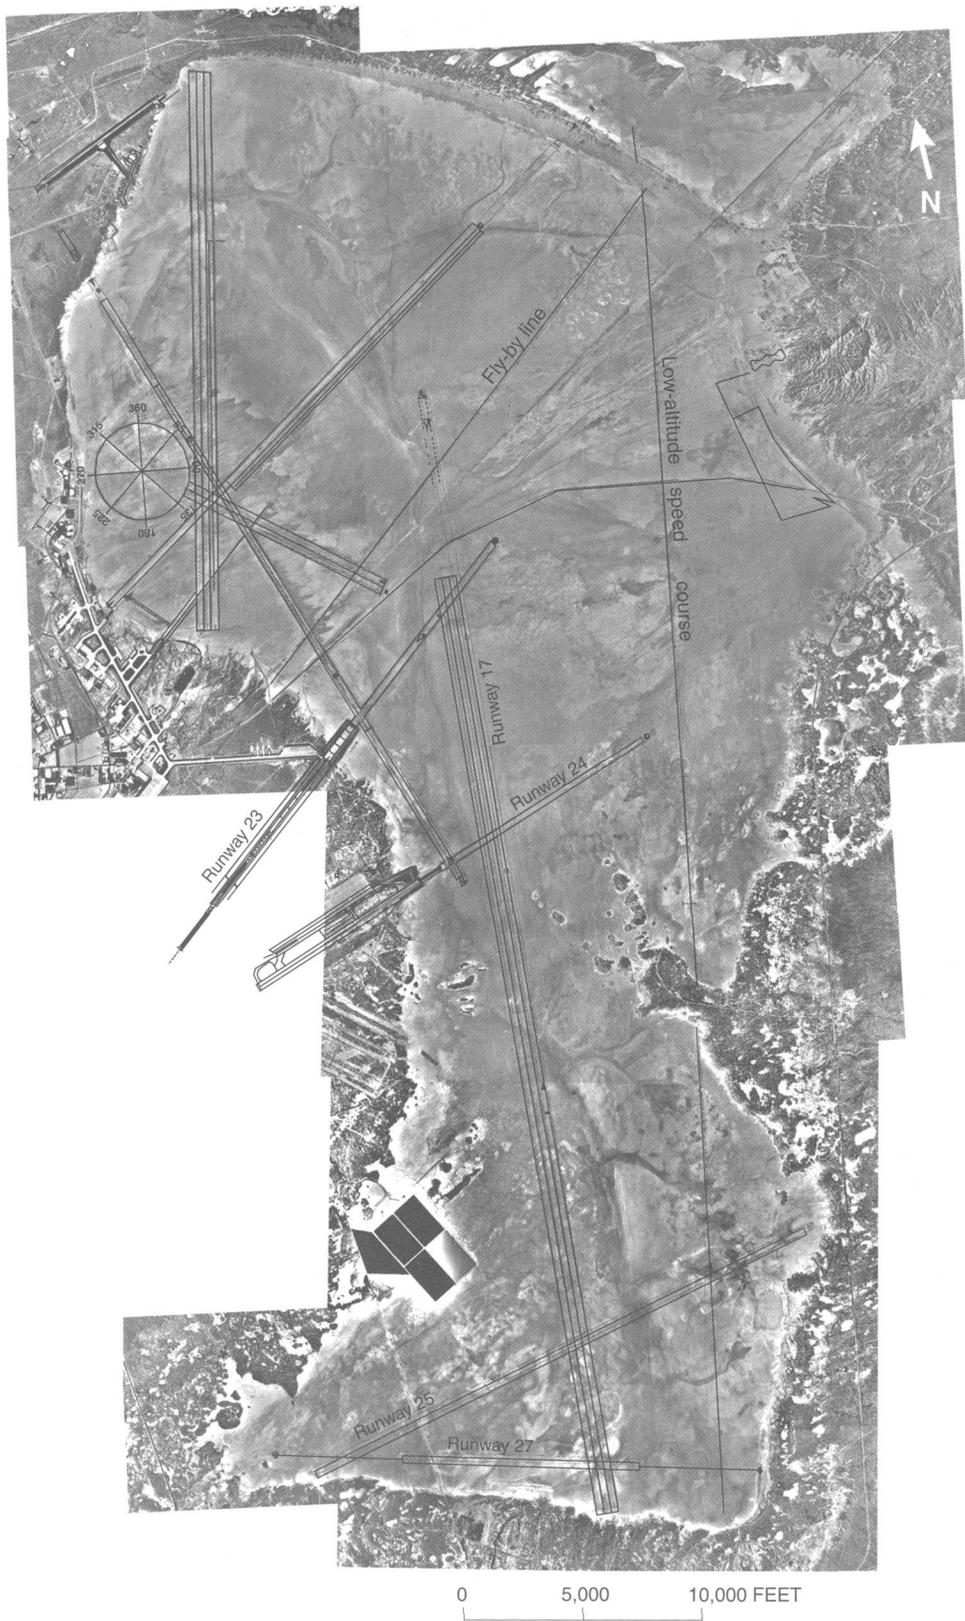
Figure 13. Dry conditions on Rogers Lake playa, Edwards Air Force Base, California. Fine lines indicate location of runways on playa. (From aerial photographs taken in 1990)

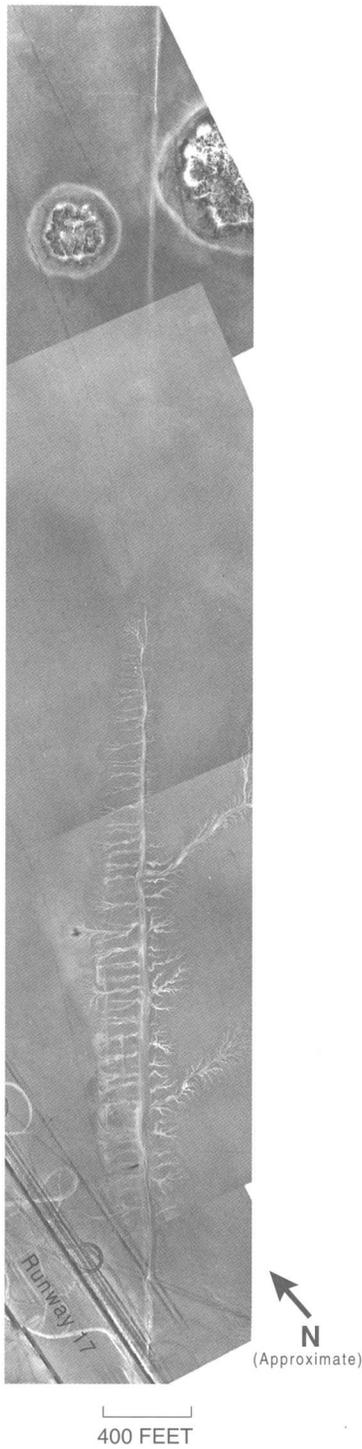
Figure 17. Headcut fissure at runway 17 on Rogers Lake playa, Edwards Air Force Base, California. (From aerial photographs taken in 1990)

A simple dendritic pattern of shallow headcuts joins along a fissure that extends northeast from runway 17 (fig. 17). The line of the existing fissure is nearly perpendicular to the elevation contour lines at that region of the playa. Slope along the fissure is 0.002, which is steeper than slope for other areas in the central part of Rogers Lake playa. As water flows down the steepest gradient, it enters the fissure which is oriented to continue the flow path in the same direction. At the entrance to the fissure, water flows more rapidly and causes local erosion at the confluence. Lowering of the channel bottom at the entrance causes erosion of the sediment to continue upstream in a process that resembles gullying of steeper lands.

The northeast end of the fissure continues as a straight, uneroded lineament (light marking) through rocky outcroppings (fig. 17). Although the origin of this lineament is not known, gullying has occurred along this feature, rather than creating the eroded feature spontaneously. As water transports sediment along the existing lineament, it has induced meanders that are typical of alluvial streams. Stream meandering involves a hydraulic reaction to sporadic deposits of sediment along a stream course. The meanders in this fissure often coincide with confluences of minor gullies where transported sediment deposits and redirects flow in the main channel. Meanders also can form in the straight lines of desiccation cracks.

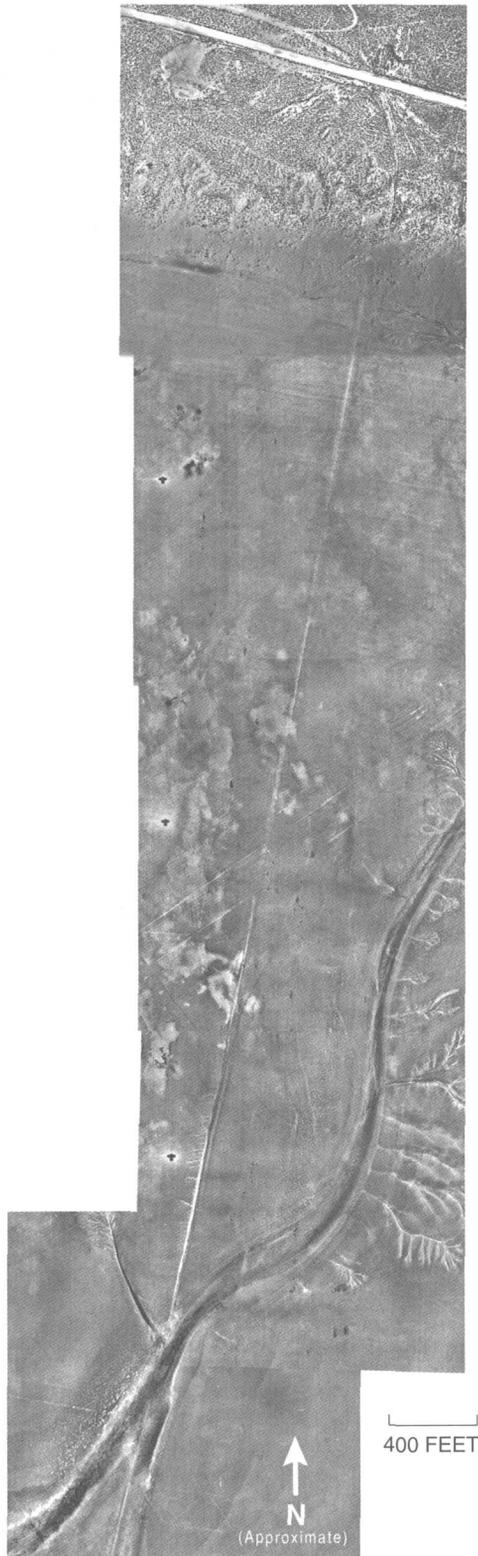
Figure 18. Lineament (light marking) and headcut at north end of Rogers Lake playa, Edwards Air Force Base, California. The lineament is diffuse and uneroded to the north. Small headcuts extend laterally from the lineament where it enters the main flow channel. (From aerial photographs taken in 1990)

Another lineament is evident at the north end of Rogers Lake playa (light marking, fig. 18). Erosion in the middle part of this feature has been incorporated into the north-south flow channel. The north and south ends of the lineament are uneroded in the photographs, and the middle part is eroded with short headcuts along both sides. More elaborate dendritic patterns occur along larger flow channels from the northeast and northwest that converge with this straight feature. The origin of the lineament is unknown. The lineament begins faintly at the northern playa margin and continues until diffusing into the wide, flat area near the navigation compass (see fig 5). The lineament probably represents an artificial disturbance to the playa and indicates that such disturbances can become sites of

future erosion. Like the fissure at runway 17, this lineament is oriented nearly perpendicular to the elevation contours.

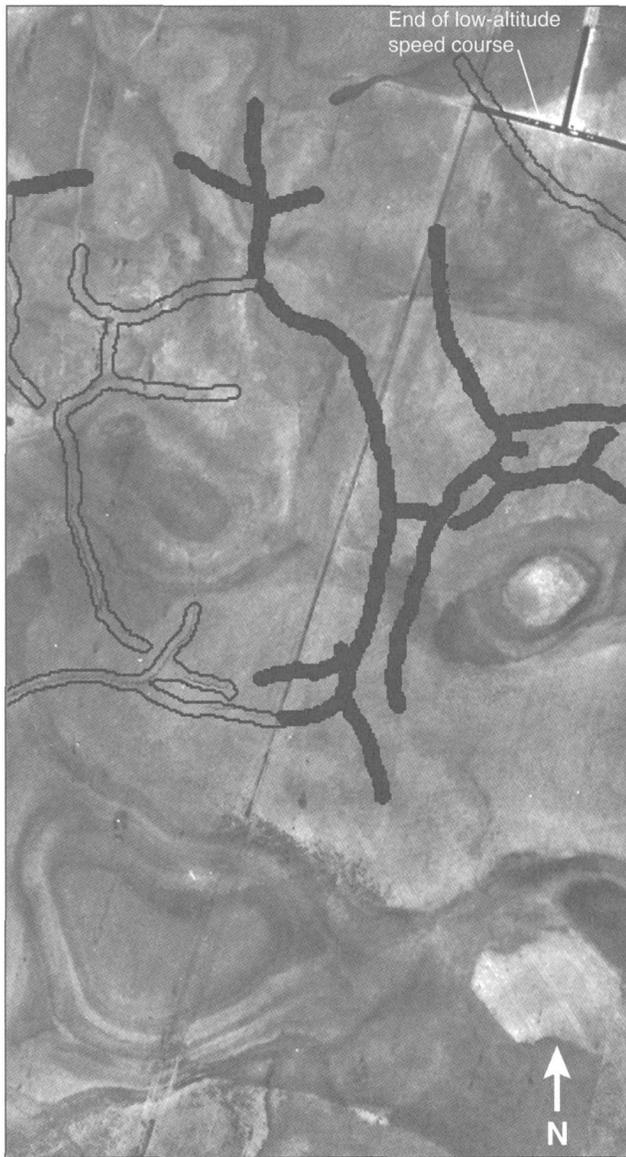
Figure 22. Detail of figure 21 near south end of low-altitude speed course and small ponded areas on Rogers Lake playa, Edwards Air Force Base, California, overlain with lines from crack surveys. Results of crack surveys are indicated by a hollow line. Darkened sections of the lines represent surveyed cracks that have no correlated marks on the aerial photographs of the playa. See figure 21 for location. (From aerial photographs taken in 1990)

In some cases, the terminus of an open-ended crack did not change detectably between 1990 and 1995 (fig. 22). More often, the open-ended cracks

playa (fig. 22). The correspondence could indicate sedimentation in a ponded area or erosion of local flow paths toward low areas.

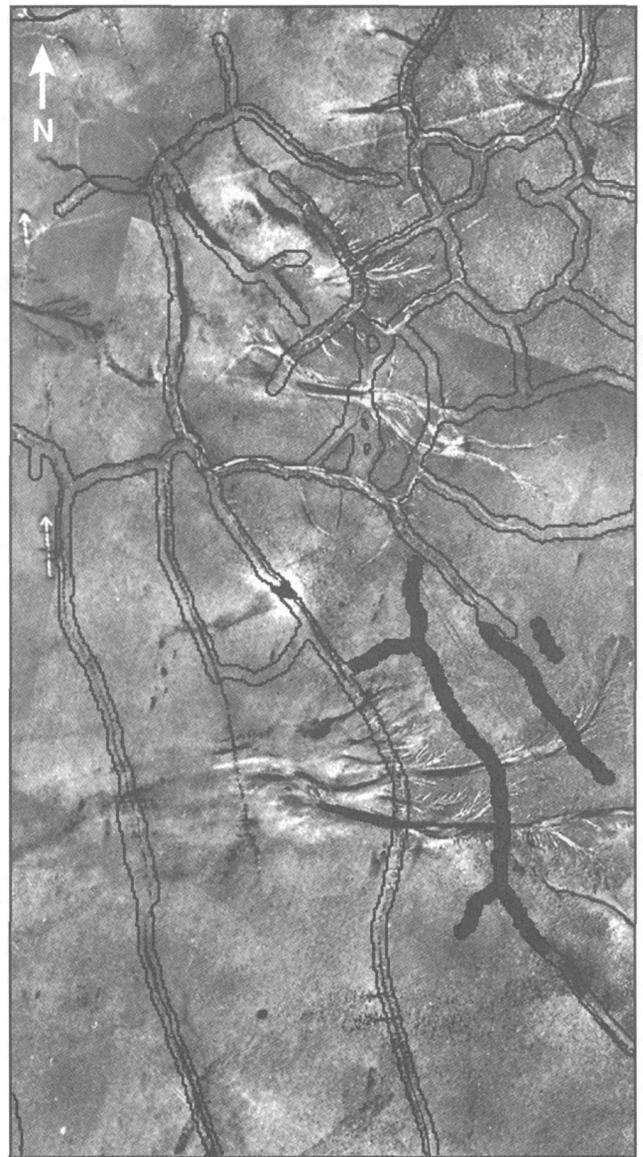
Figure 23. Detail of figure 21 in area of long fissures on Rogers Lake playa, Edwards Air Force Base, California, overlain with lines from crack surveys. Results of crack surveys are indicated by a hollow line. Darkened sections of the lines represent surveyed cracks that have no correlated marks on the aerial photographs of the playa. See figure 21 for location. (From aerial photographs taken in 1990)

extended farther in the same direction and branched (fig. 23). The terminus of an open-ended crack occasionally corresponded to a dark stain on the wetted

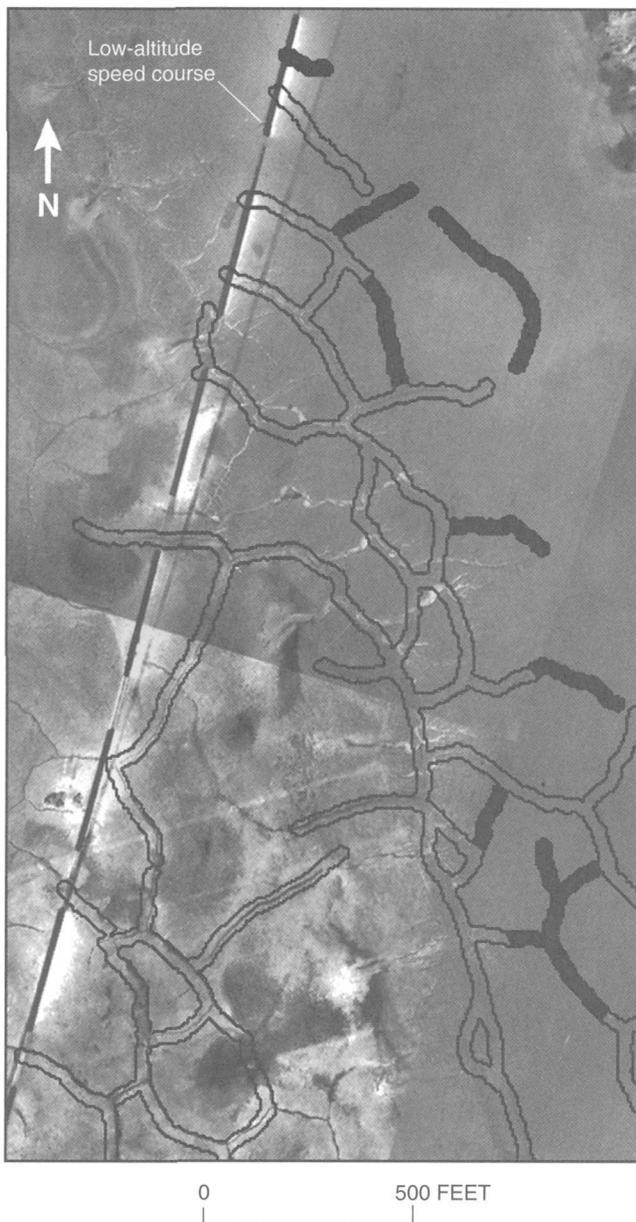
Figure 24. Detail of figure 21 near north end of low-altitude speed course and margin of Rogers Lake playa, Edwards Air Force Base, California, overlain with lines from crack surveys. Results of crack surveys are indicated by a hollow line. Darkened sections of the lines represent surveyed cracks that have no correlated marks on the aerial photographs of the playa. See figure 21 for location. (From aerial photographs taken in 1990)

However, cracks mapped in regions where photographs show no cracks can be taken as evidence of the appearance of new cracks. In most crack networks, the ground surveys showed cracks in 1995 that were imperceptible in the 1990 photographs (fig. 24).
