Analysis of Vegetation Controls on Bank Erosion Rates, Clark Fork of the Columbia River, Deer Lodge Valley, Montana

—Eleanor R. Griffin and J. Dungan Smith

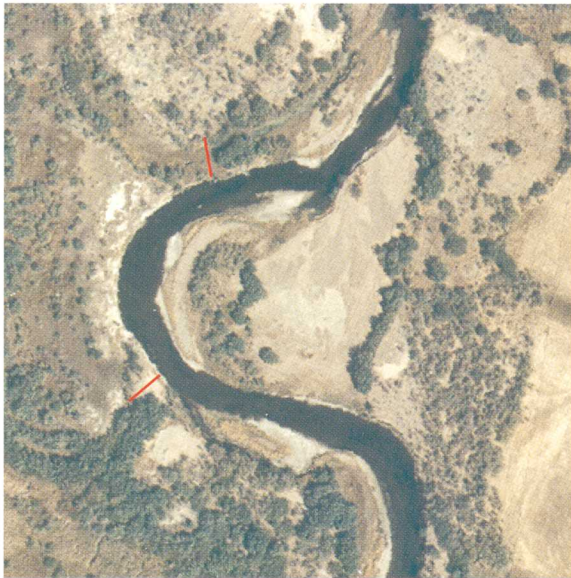
Vegetation class 0—bare slickens

Figure 7. Examples of the seven classes of vegetation density and type. The arrows indicate flow direction. The area of the bank between the two red lines in each image is the portion of the bank examined to classify vegetation. The bend shown with bare slickens along the outside bank (class 0) is located at River Mile 23.0, where the average erosion rate from 1989 to 1997 was 1.67 feet per year. The edge of the cut-bank in vegetation class 6 was completely hidden by shrub canopy, and the amount of bank retreat (if any) could not be determined from the aerial photographs.

tion density and type immediately adjacent to the eroding cut-banks in the meander bends. The seven classes were based on types of vegetation present and, where there were shrubs, the relative distance between adjacent shrub canopies, as shown in figure 7. In vegetation classes 5 and 6, the shrubs were close enough that their canopies were in contact. Shrub canopies

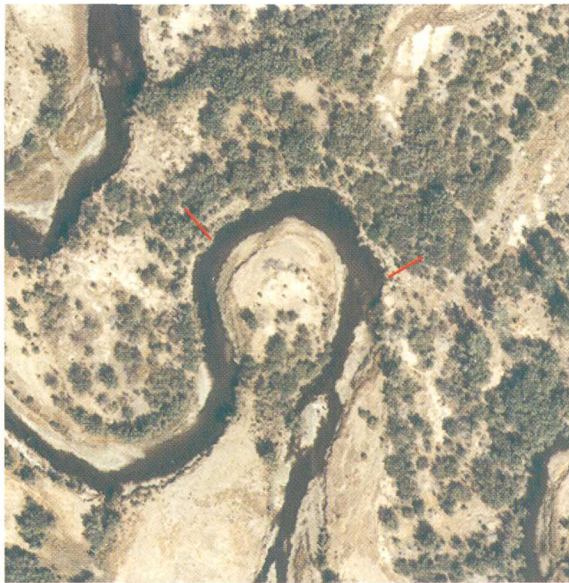
Vegetation class 4—shrubs within one channel width apart all around the bend

Figure 7. Examples of the seven classes of vegetation density and type. The arrows indicate flow direction. The area of the bank between the two red lines in each image is the portion of the bank examined to classify vegetation. The bend shown with bare slickens along the outside bank (class 0) is located at River Mile 23.0, where the average erosion rate from 1989 to 1997 was 1.67 feet per year. The edge of the cutbank in vegetation class 6 was completely hidden by shrub canopy, and the amount of bank retreat (if any) could not be determined from the aerial photographs—Continued.

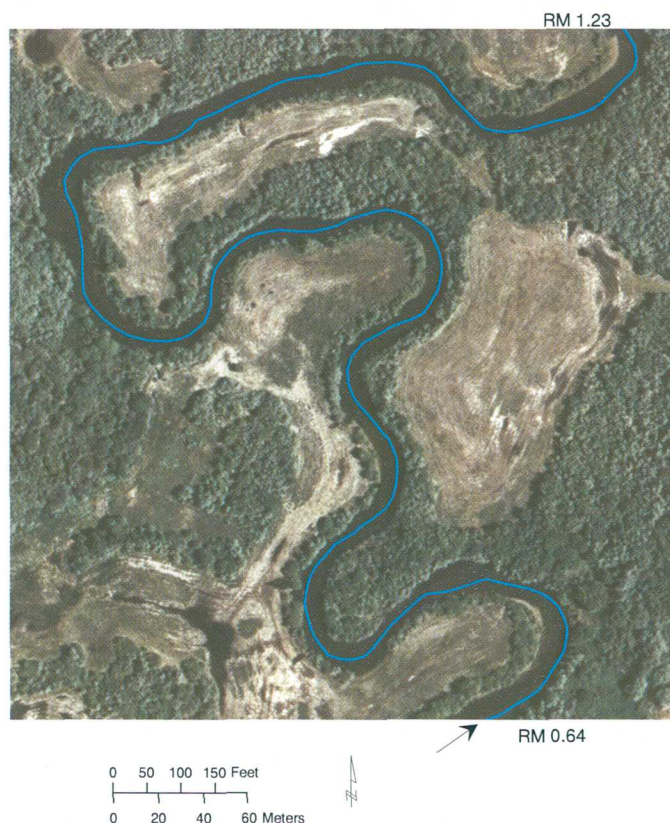
Figure 10. A 0.6-mile (0.9-kilometer) reach in July 1997 where dense woody vegetation and shrub canopies obscured both banks through much of the reach.

shrub canopies. The class 5 bends typically had 90 percent of the cutbank hidden by shrub canopies. In order to make accurate measurements of erosion on cutbanks, most of the bank must be visible in both aerial photographs (fig. 10). Therefore, the amount of bank retreat at the 35 bends in these two vegetation classes could not be measured from the aerial photographs, and a lower limit on cutbank erosion rate could not be determined. The hypothesis that the lowest possible erosion rate is zero cannot be disproved with the available data.
