HURRICANE MITCH: Peak Discharge for Selected River Reaches in Honduras

—By Mark E. Smith, Jeffrey V. Phillips, and Norman E. Spahr

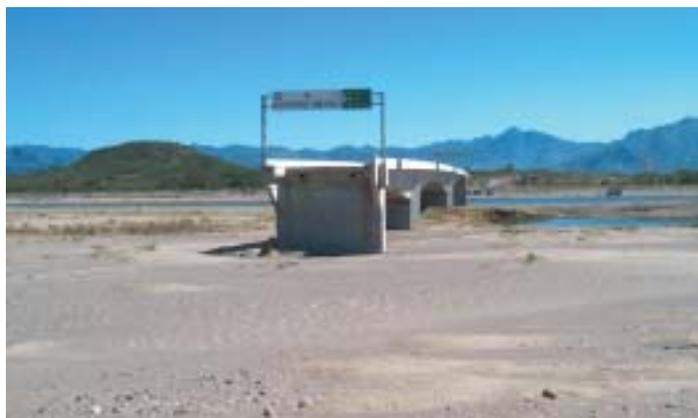
Post-Hurricane Mitch remnants of a newly constructed highway bridge across the Río Choluteca north of Choluteca. The bridge was designed to convey floodflows through the main span.

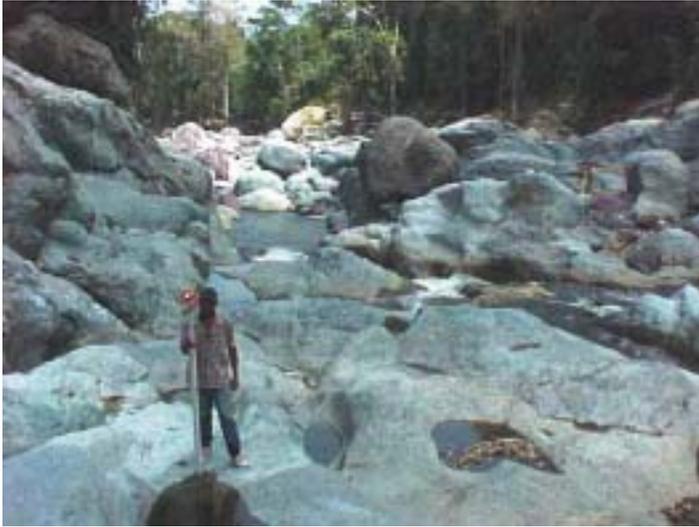
Looking downstream at the bedrock and large boulders that compose the channel of the Río Bonito (Site 3).

channel is composed of a series of steep pool-and-riffle reaches confined by steep rock walls. The bed consists of bedrock and large boulders 1.5 to more than 9 meters (4.9 to more than 30 feet) in diameter. The reach apparently was not affected by deposition of smaller material (sand and gravel).

The computed peak discharge of 3,710 cubic meters per second (m^3/s) (131,000 cubic feet per second, ft^3/s) is subject to rather large uncertainty (more than 25 percent) because of the steep, non-uniform channel conditions. Computed flow velocities ranged from 4.33 to 7.65 meters per second (14.2 to 25.1 feet per second). Top width of the flood channel ranged from 56.4 to 93.6 meters (185 to 307 feet), and the hydraulic slope (based on surveyed high-water marks) was 0.0408 meter/meter.

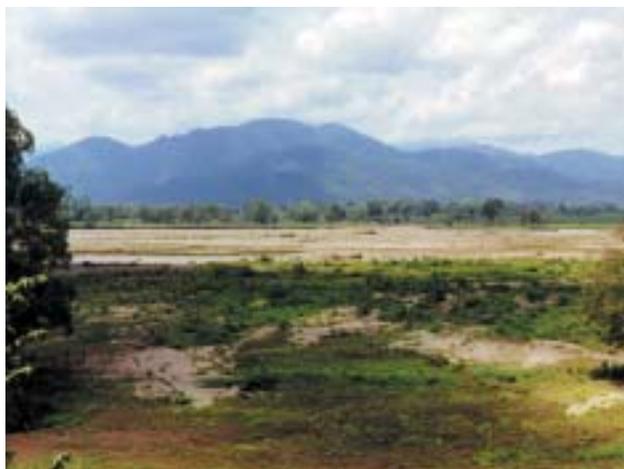
Looking left to right at the upstream cross section of the study reach of the Río Aguán (Site 1). Width of flow at this cross section was 1,800 meters (5,900 feet).

Because of the wide, unconfined valley, few suitable reaches for measurement were available. The flood was confined to a width of about 1.7 kilometers in the vicinity of Clifton, upstream from the town of Sabá and just downstream from the confluence with the Río Jaguaca. Three cross sections were surveyed in the confined reach (just less than a 1.3 kilometers in length) and peak flow was computed by using the slope-area method (Site 1). The peak discharge of $19,700 \text{ m}^3/\text{s}$ ($696,000 \text{ ft}^3/\text{s}$) was the largest flow measured in Honduras by the USGS. Top width of the flood channel averaged 1,660 meters (5,460 feet), and the hydraulic slope was 0.0017 meter/meter.

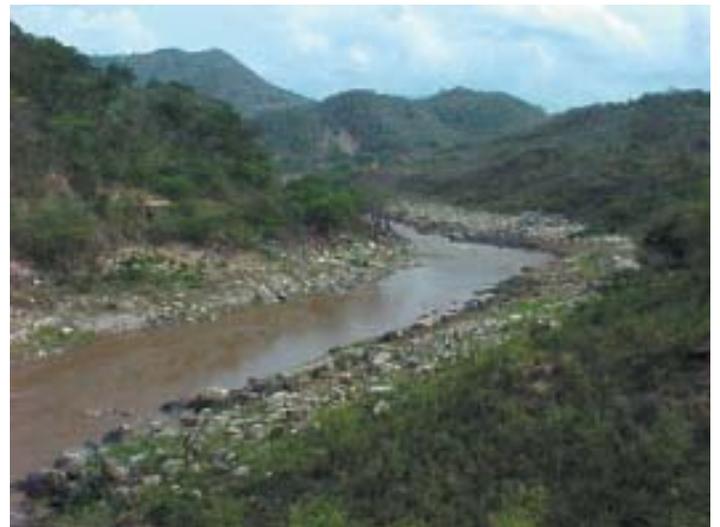
Looking downstream at the study reach of the Río Ulúa near Chinda (Site 6). Note the scour on each bank, indicating the extent of the flood.

Measurement of flooding of the Río Ulúa was made near the town of Chinda (Site 6). The site is located in the mountainous terrain upstream from the Sula Valley where the river is confined to an incised, fairly uniform channel; the photograph shows the measurement reach and the scoured banks left by the flood. Drainage area at the site ($8,510 \text{ km}^2$; $3,280 \text{ mi}^2$) is less than half the drainage area of the lower river basin ($20,600 \text{ km}^2$; $7,950 \text{ mi}^2$, at the streamflow-monitoring station Río Ulúa at Guanacastales), but measurement of flow in the valley itself was impossible because of the expanse of the inundated area. Computed peak discharge near Chinda was $11,000 \text{ m}^3/\text{s}$ ($388,000 \text{ ft}^3/\text{s}$), by the slope-area method; peak discharge of combined flows in the lower valley was much larger. Top width of the flood channel near Chinda averaged 159 meters

(522 feet), and the hydraulic slope was 0.0035 meter/meter. The straight reach was well suited for slope-area measurement. The channel generally was uniform through the reach and was not substantially affected by erosion/sedimentation during the flood.

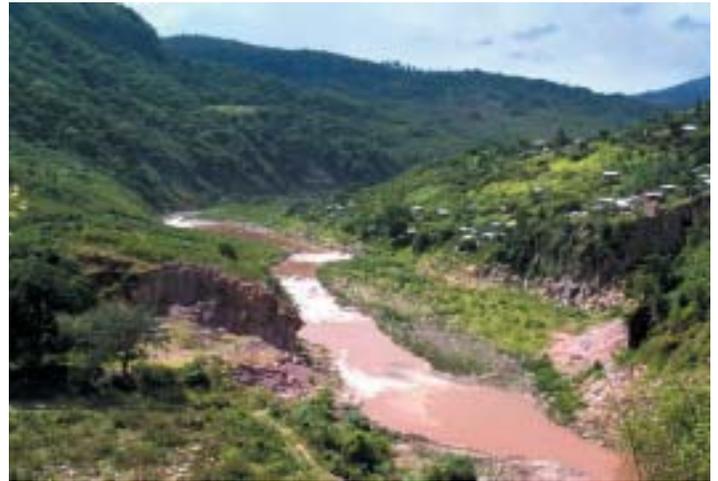
Looking downstream at the study reach of the Río Choluteca near Tegucigalpa (Site 14).

The Río Choluteca is formed by the confluence of the Río Guacerique with the Río Grande in Tegucigalpa. A measurement of peak discharge of the Río Choluteca was made just downstream from Tegucigalpa (Site 14); the computed peak was $4,360 \text{ m}^3/\text{s}$ ($154,000 \text{ ft}^3/\text{s}$). Peak discharge probably was affected by reservoir storage upstream on both the Río Grande (Concepción Reservoir) and the Río Guacerique (Los Laureles Reservoir). The channel in the study reach generally was straight and uniform, and flow was confined to the main channel. Top width averaged 105 meters (343 feet), and the hydraulic slope was 0.0097 meter/meter.

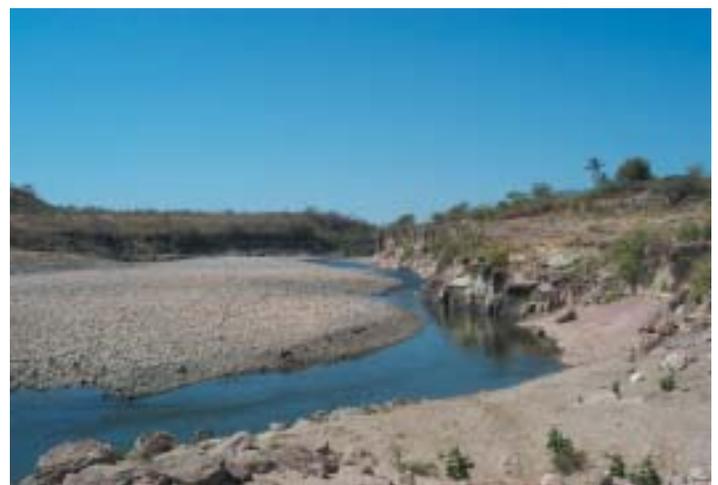
Looking downstream at the study reach of the Río Choluteca at Colonia Apacilagua (Site 15). The depth of the flood water nearly reached the top of 15-meter cliff (center of the photograph).

Peak flow of the lower Río Choluteca was measured at Colonia Apacilagua (Site 15), upstream from the city of Choluteca. Choluteca, an important population center of 80,000, is situated on the left bank of the Río Choluteca. The city suffered extensive flood damage during Hurricane Mitch. The peak-flow measurement site at Apacilagua is about 25 river kilometers (16 river miles) upstream from Choluteca and was selected because the flood waters were confined to a width of less than 183 meters (600 feet) between two vertical rock cliffs. Several houses upstream from Apacilagua were destroyed, but the town itself, perched atop the 15-meter (49-foot) cliff on the right bank of the river (looking downstream), was not flooded.

The computed peak flow of $14,300 \text{ m}^3/\text{s}$ ($506,000 \text{ ft}^3/\text{s}$) was measured using a three-section slope-area computation. Average top width of the channel was 235 meters (772 feet); the hydraulic slope of measured high-water marks was 0.0051 meter/meter. According to local residents, the peak occurred late Friday night, 30 October. This information indicates that peak flow at Apacilagua was the result of rainfall-runoff in the lower basin, rather than downstream progression of the flood wave that affected Tegucigalpa. Peak flooding in Tegucigalpa occurred early Saturday morning, 31 October.
