Environmental Effects of the Big Rapids Dam Remnant Removal, Big Rapids, Michigan, 2000-02

Water-Resources Investigations Report 03-4136

By Denis F. Healy, Stephen J. Rheaume, and J. Alan Simpson

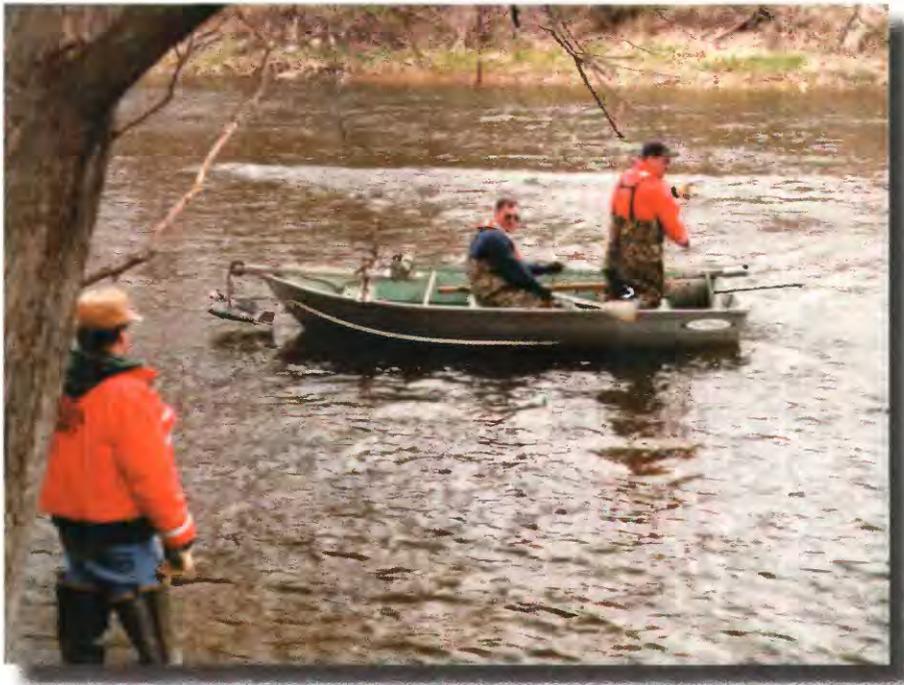
COVER PHOTO: U.S. Geological Survey scientists extending a steel cable tagline across transect 28 on April 19, 2002. The cable is used to keep the boat on the transect during streamflow measurements and streambed-elevation profiles. Photo by D. Healy.

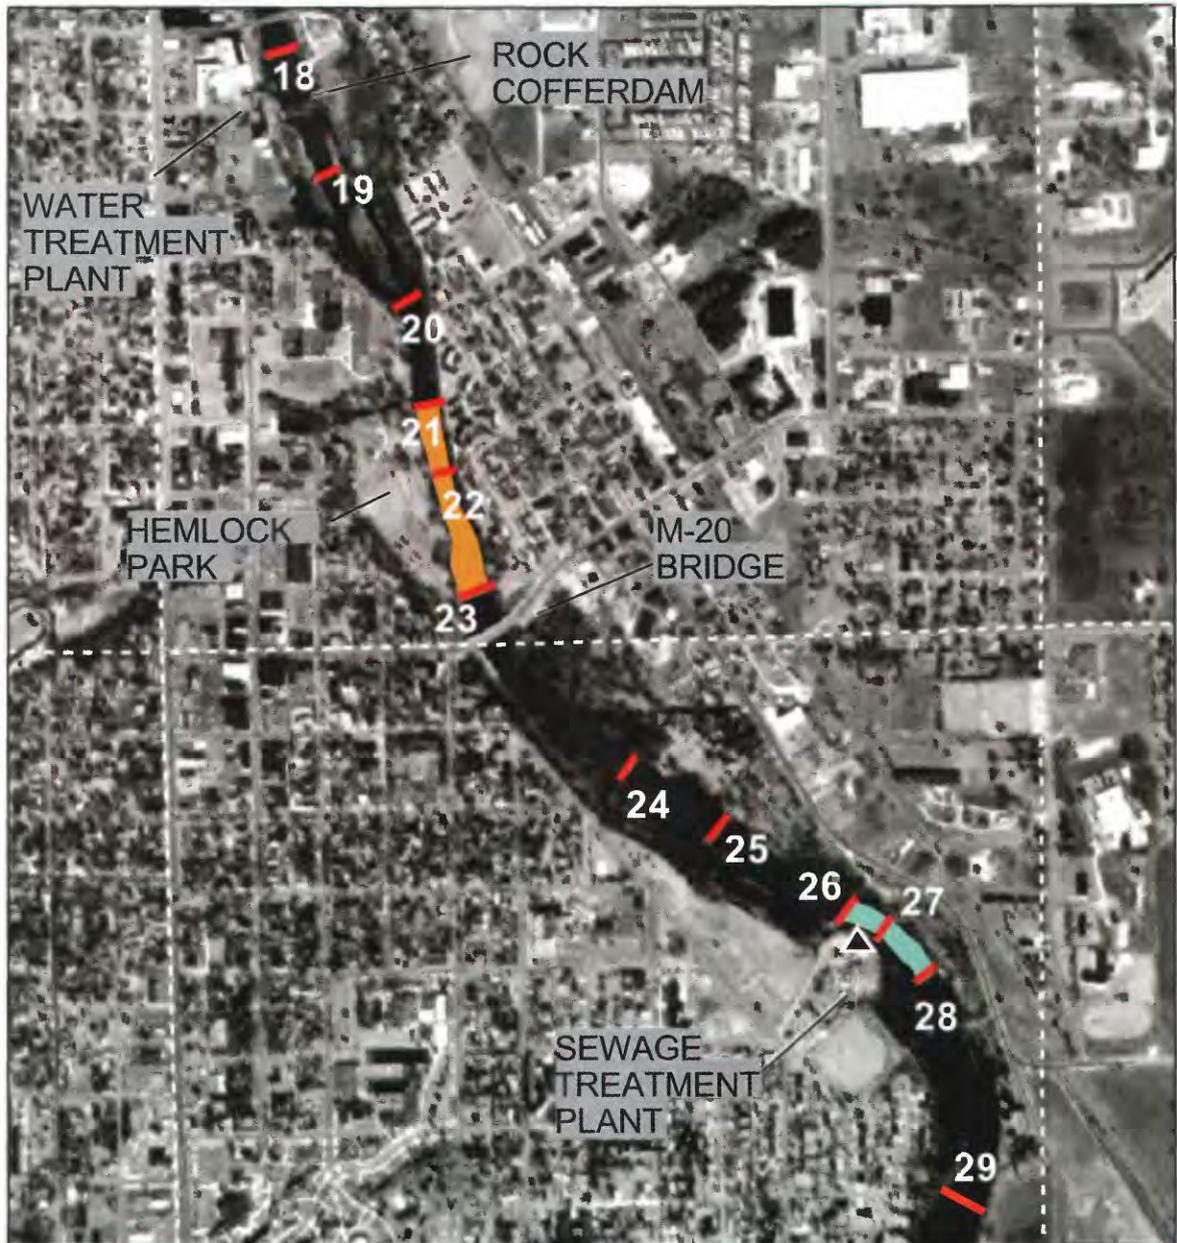
Figure 2b. Detail of the central section of the study area showing transects 18–29 and the rock cofferdam prior to removal, Big Rapids, Michigan.

Reach C is between transects 21 and 23 in Hemlock Park (fig. 2b). Reach C underwent slight habitat degradation after the dam was removed, but habitat scores remained good. Stream-habitat GLEAS Procedure 51 scores rated good (88) for the pre-removal assessment, good (84) for the removal assessment, and good (79) for the post-removal assessment (table 9).

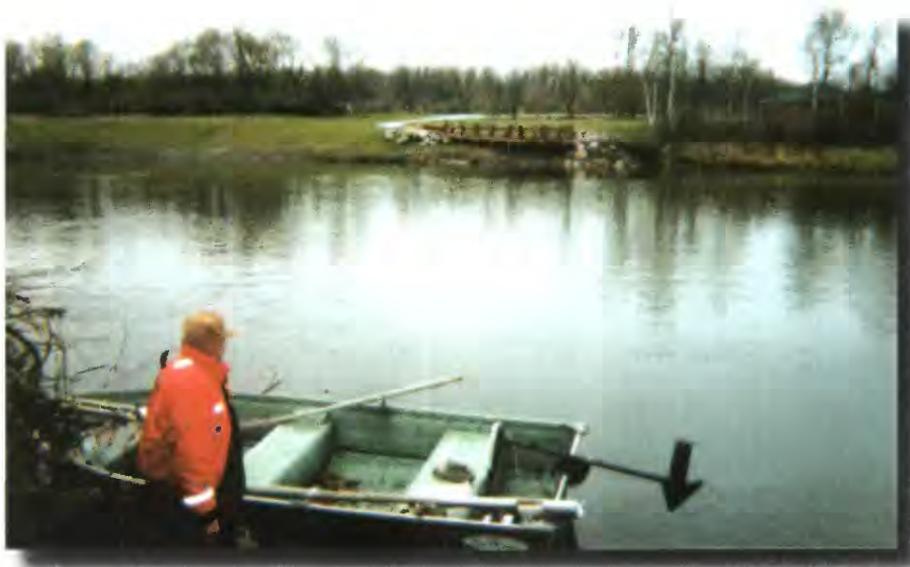
Figure 12. Impoundment reach (Reach B) at North End Riverside Park before dam removal looking east from right downstream bank, transect 9, April 4, 2000. *Photo by D.L. Hubbell.*

fair (69) for the pre-removal assessment, to good (106) for the removal assessment, to excellent (112) for the post-removal assessment (table 8). The reach went from a reduced-velocity impoundment with average depths of 3.5 ft, to a series of riffles, runs and pools of various depths and velocities (figs. 12 and 13).

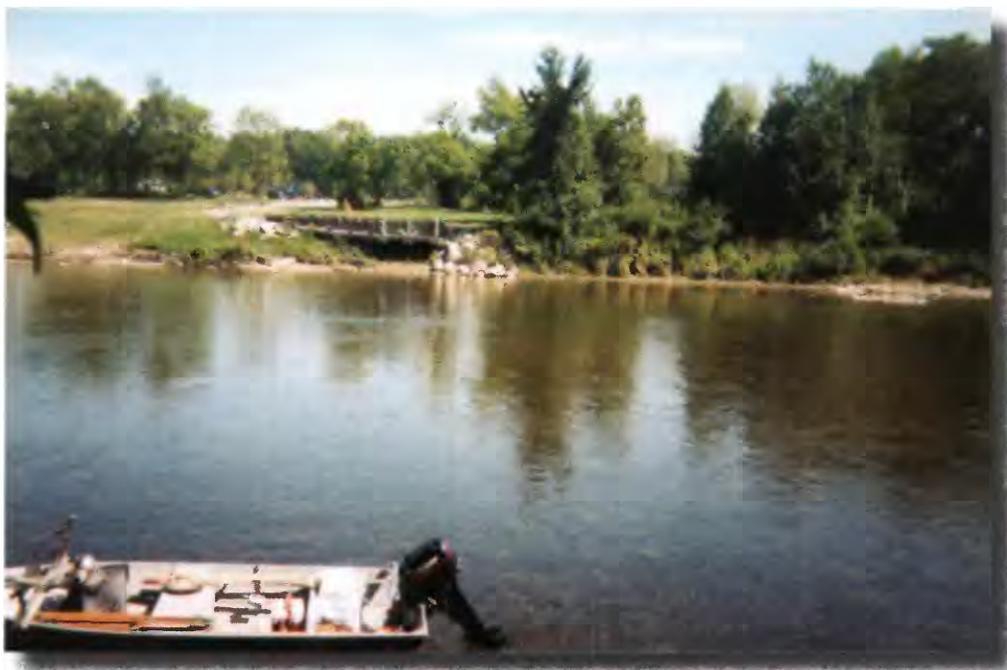
Figure 13. Impoundment reach (Reach B) at North End Riverside Park after dam removal, looking east from right downstream bank, transect 9. *Photo by D.L. Hubbell.*

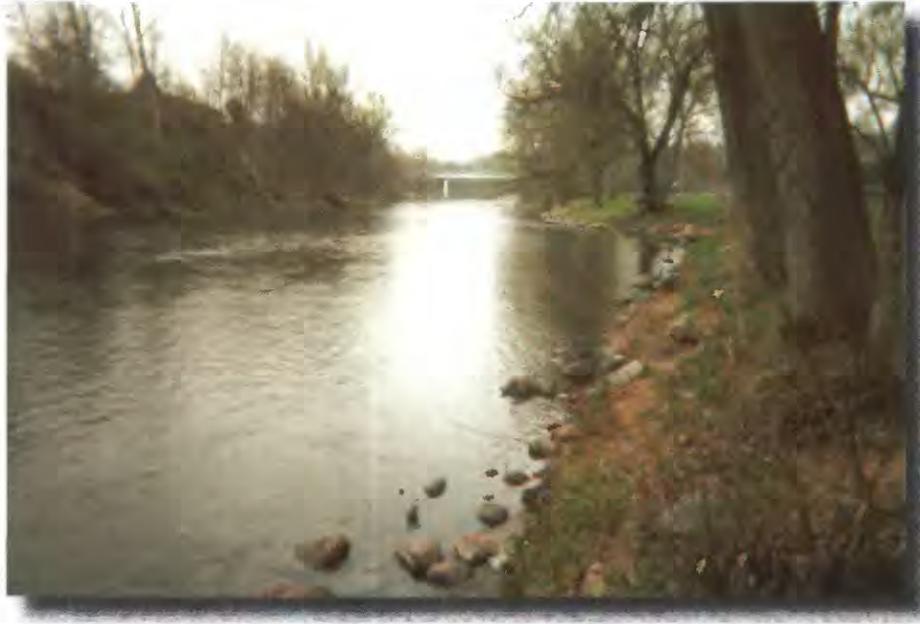
Figure 14. First downstream reach (Reach C) at Hemlock Park looking south from right downstream bank, transect 21, April 17, 2000.
Photo by D.L. Hubbell.

The reach was dominated by deep runs and pools and few riffles, resulting in a less than excellent habitat score even before the dam removal. The most noticeable habitat change during and after dam removal was an increase in siltation and embeddedness in the runs and pools. Gravel, cobbles, boulders, and logs that had been only 25-percent covered with sand and silt became as much as 70-percent embedded. Some of the deeper pools were beginning to fill with sand; however, higher velocities (greater than (>) 2.0 ft/s) kept most of the sand and silt moving downstream. Streambanks which were fairly steep and moderately unstable, remained unchanged. Bank vegetation was and still is predominantly grasses (fig. 14).

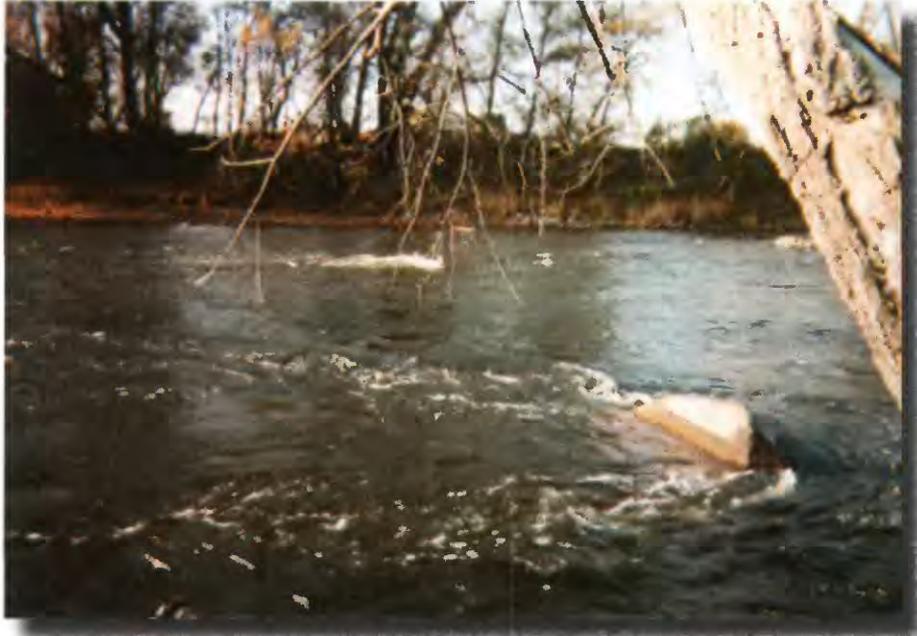
Figure 15. Second downstream reach (Reach D) at the USGS streamflow-gaging station looking east from right downstream bank, transect 26, October 17, 2000. *Photo by D.L. Hubbell.*

Reach D underwent slight habitat degradation after the dam was removed. The most noticeable habitat change was a measurable increase in siltation and embeddedness. Gravel, cobbles, boulders, and logs that had been 25-percent covered with sand and silt were found to be 50-percent embedded; however, in most places, velocities of 3-4 ft/s were capable of transporting most of the suspended sediment further downstream.

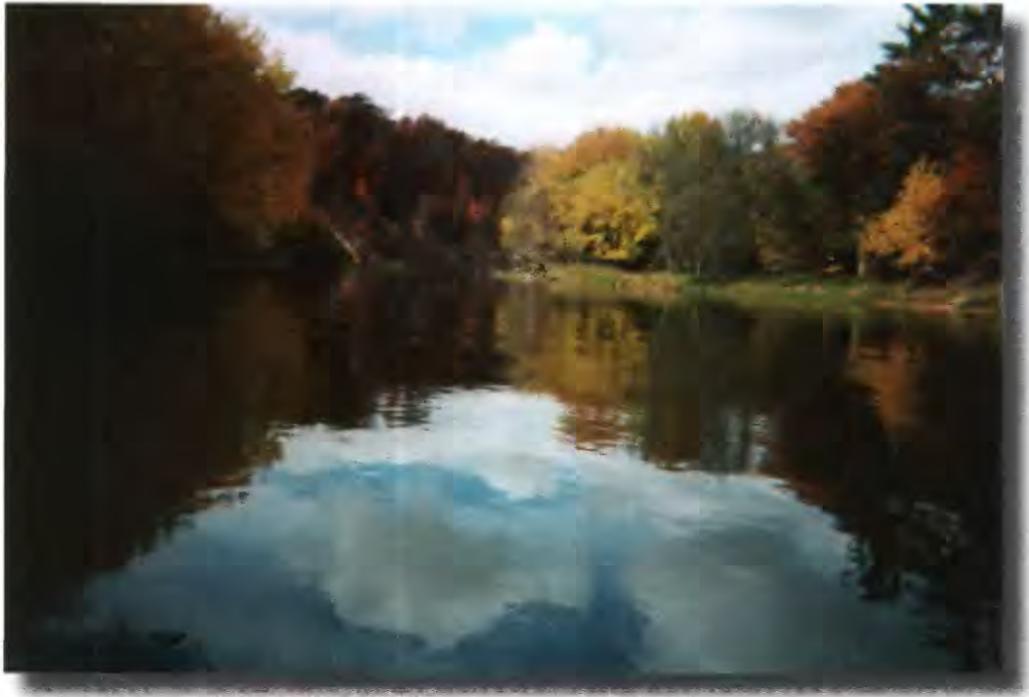
Figure 16. Third downstream reach (Reach E) at High Banks Park looking east from left downstream bank, transect 36. *Photo by D.L. Hubbell.*

Reach E is between transects 35 and 37 and is 7,750 ft downstream from reach D. The entire reach at High Banks Park is in backwater from Rogers Pond Dam. The streambanks are sloped and moderately unstable. Bank vegetation is predominantly grasses (fig. 16).
