# EFFECTS OF CHANNEL CHANGES ON GEOMORPHIC AND HYDRAULIC CHARACTERISTICS OF THE CANADIAN RIVER NEAR RATON, NEW MEXICO, 1965-2000

Water-Resources Investigations Report 03-4221

*By Anne Marie Matherne and Nathan C. Myers*

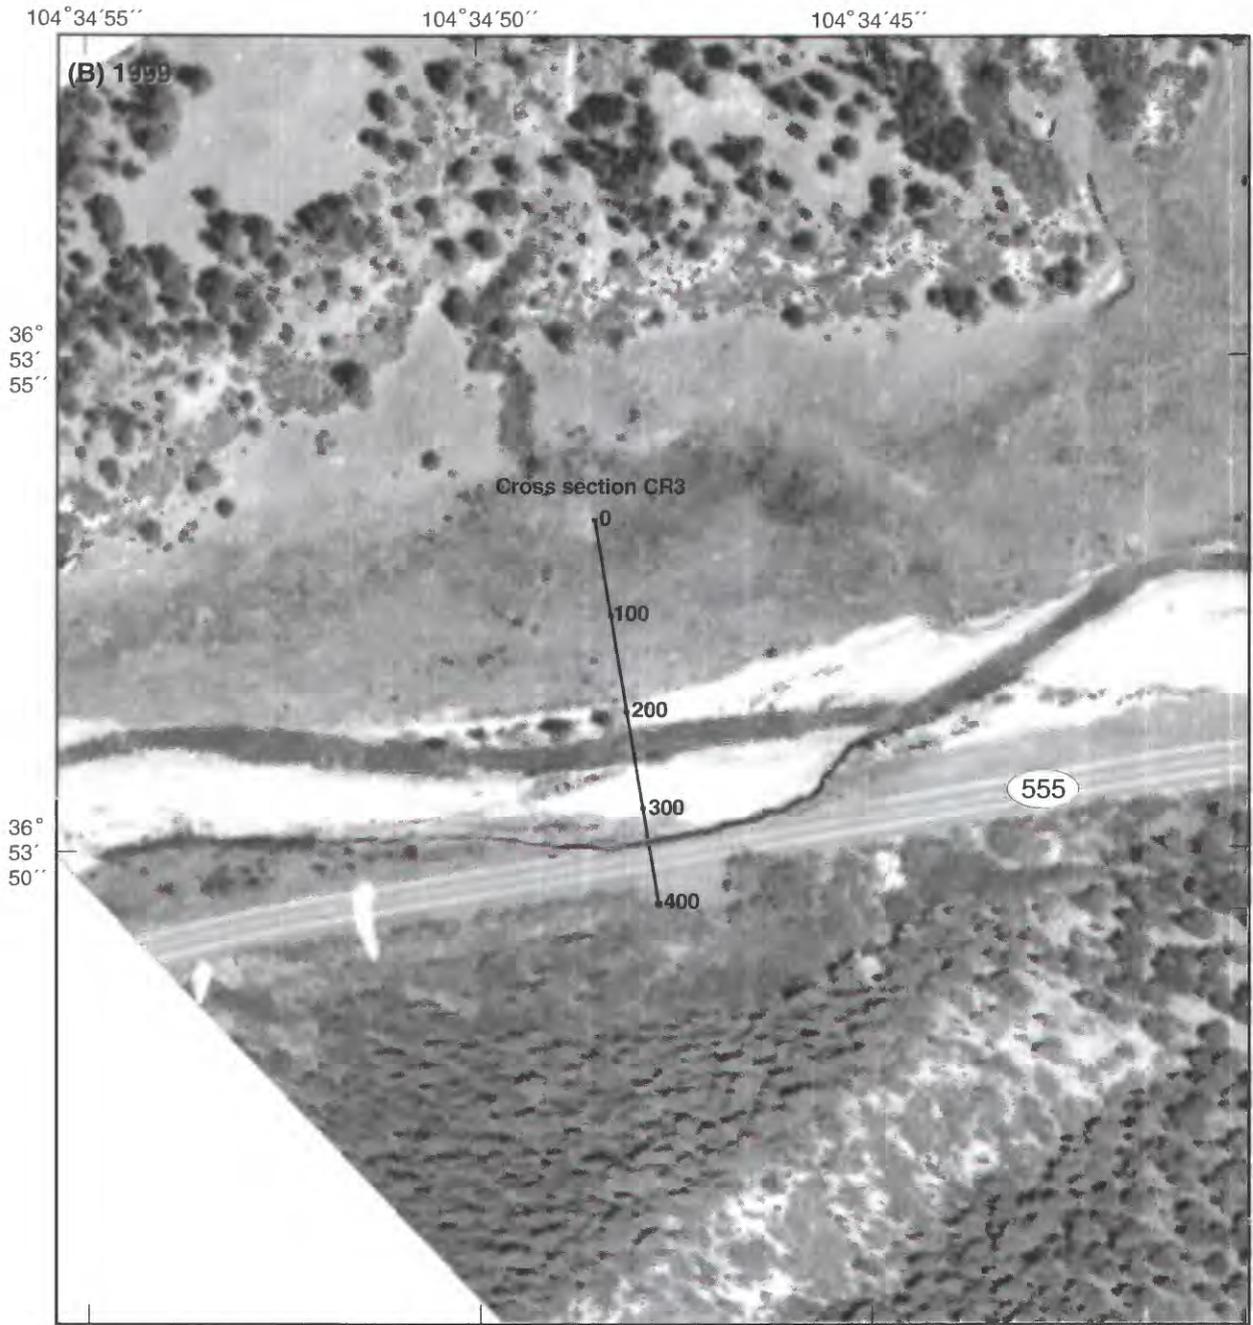
**Figure 6B.** Aerial photographs and location of cross section CR3 for (A) 1965 and (B) 1999, and (C) schematic showing 1965 and 1999 channels.

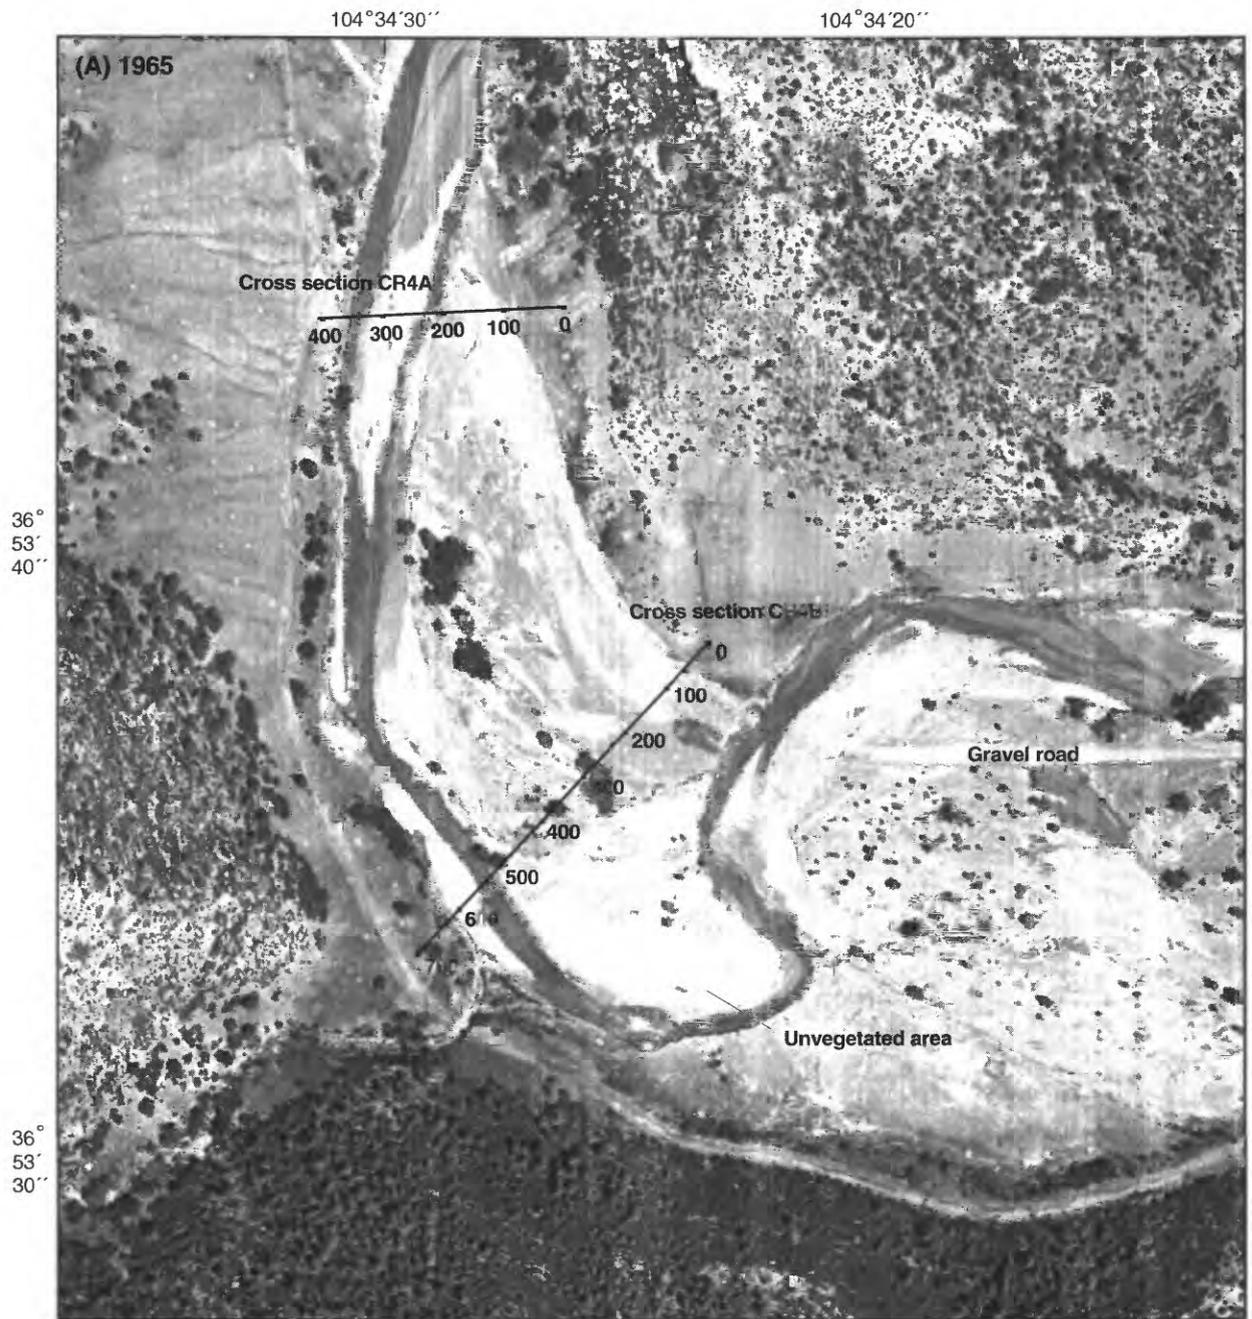
**Figure 7A.** Aerial photographs and location of cross sections CR4A and CR4B for (A) 1965 and (B) 1999, and (C) schematic showing 1965 and 1999 channels.

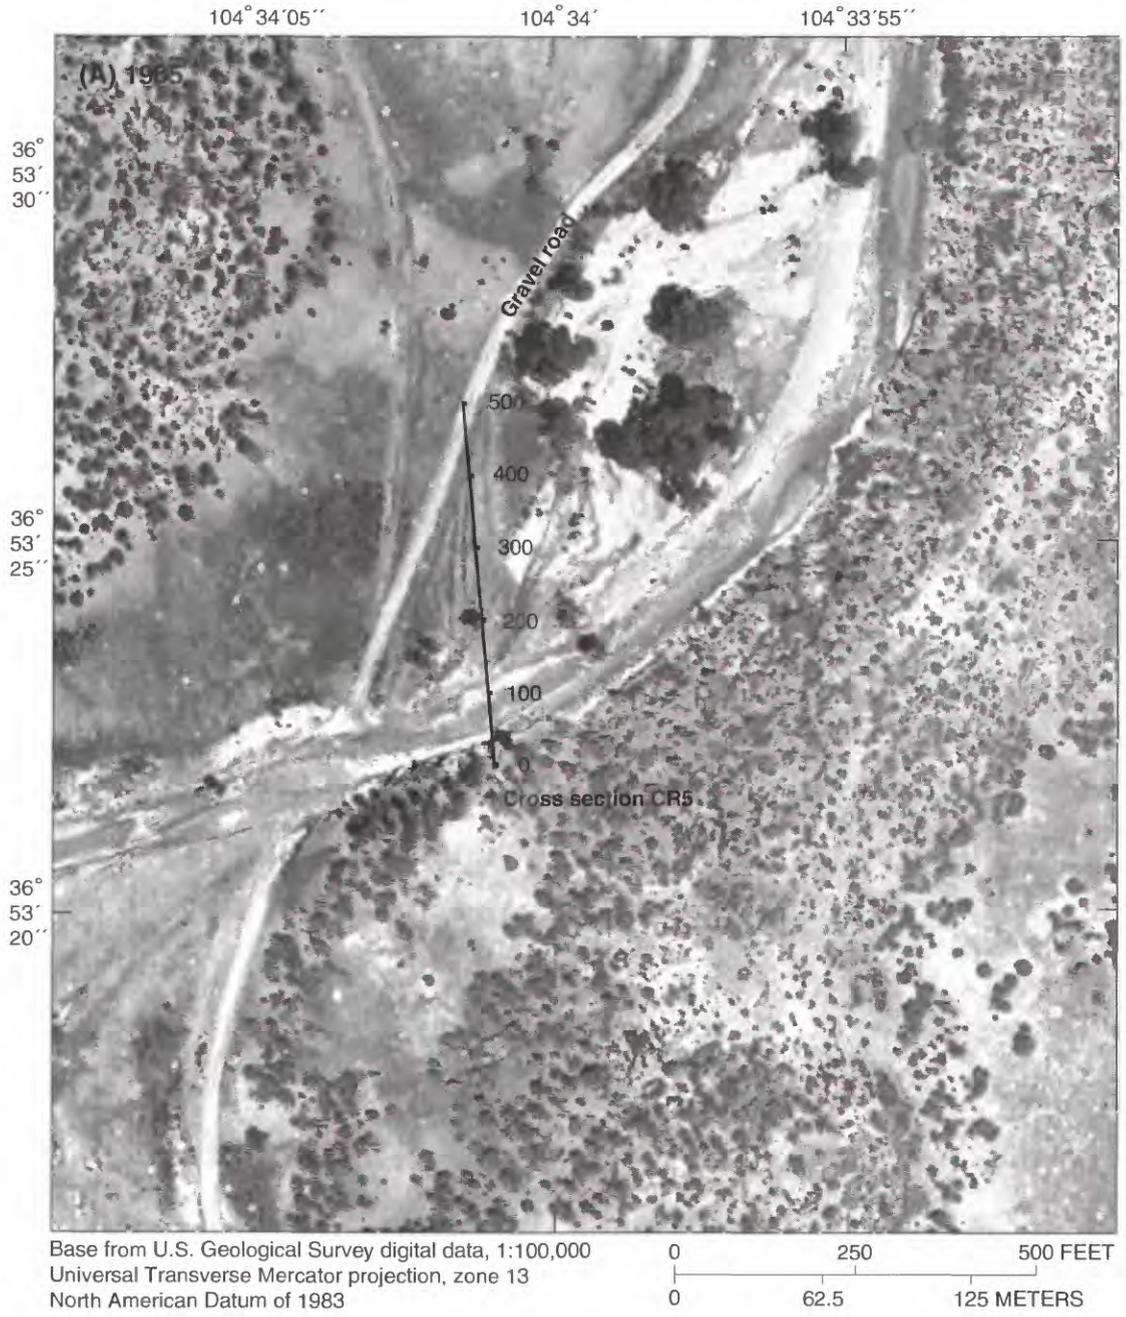
**Figure 8A.** Aerial photographs and location of cross section CR5 for (A) 1965 and (B) 1999, and (C) schematic showing 1965 and 1999 channels.

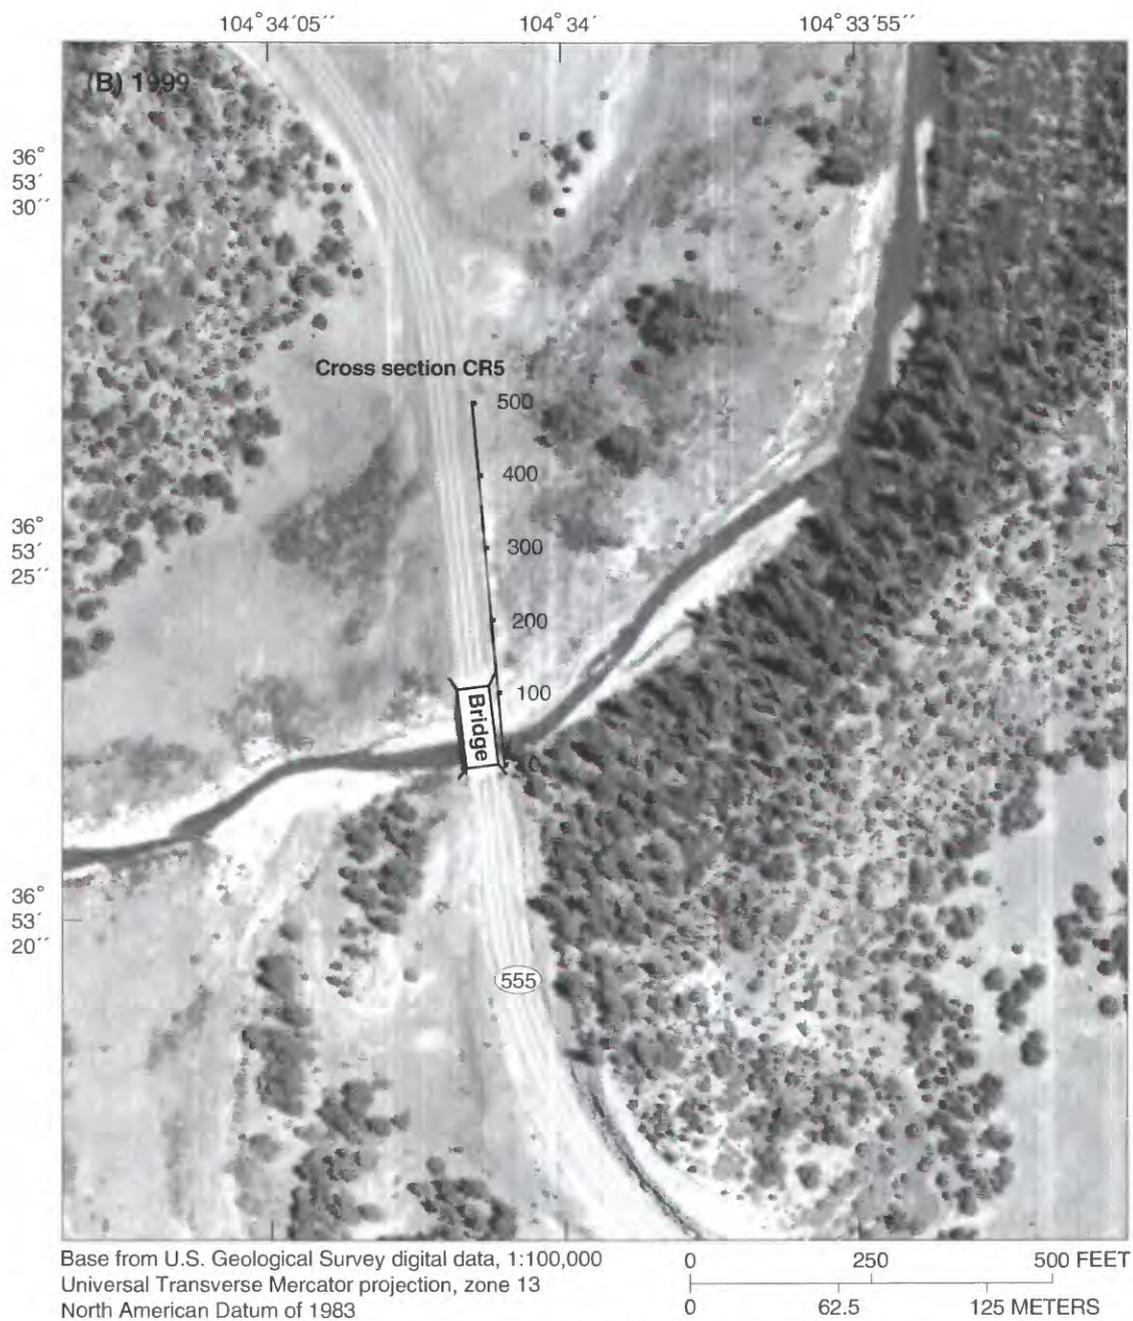
**Figure 8B.** Aerial photographs and location of cross section CR5 for (A) 1965 and (B) 1999, and (C) schematic showing 1965 and 1999 channels.

At cross section CR5, located just upstream from the NM 555 bridge, the river channel is tightly confined in the channelized approach to the bridge (figs. 8B and 13F). The bankfull W:D ratio (6.9) is small compared with those of other cross-section reaches, but the channel is not entrenched (table 1). The estimated basal shear stress at cross section CR5 is the largest of all cross sections for bankfull discharge (1.75 lb/ft<sup>2</sup>) and second largest for flood-prone discharge conditions (2.95 lb/ft<sup>2</sup>) (table 2).

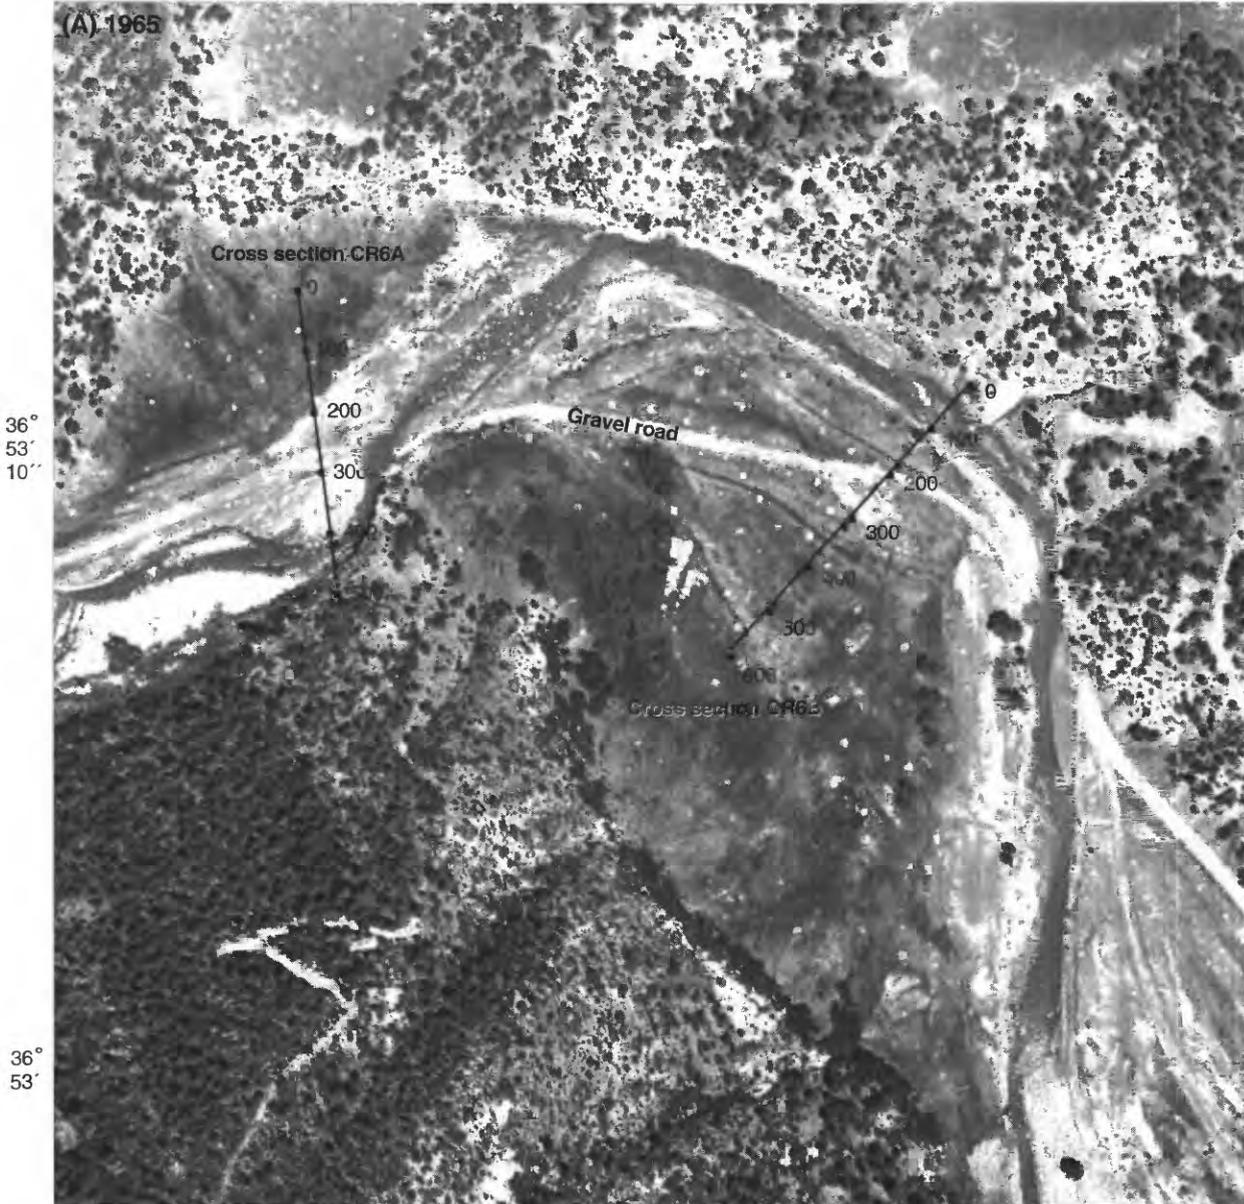
**Figure 9A.** Aerial photographs and location of cross sections CR6A and CR6B for (A) 1965 and (B) 1999, and (C) schematic showing 1965 and 1999 channels.

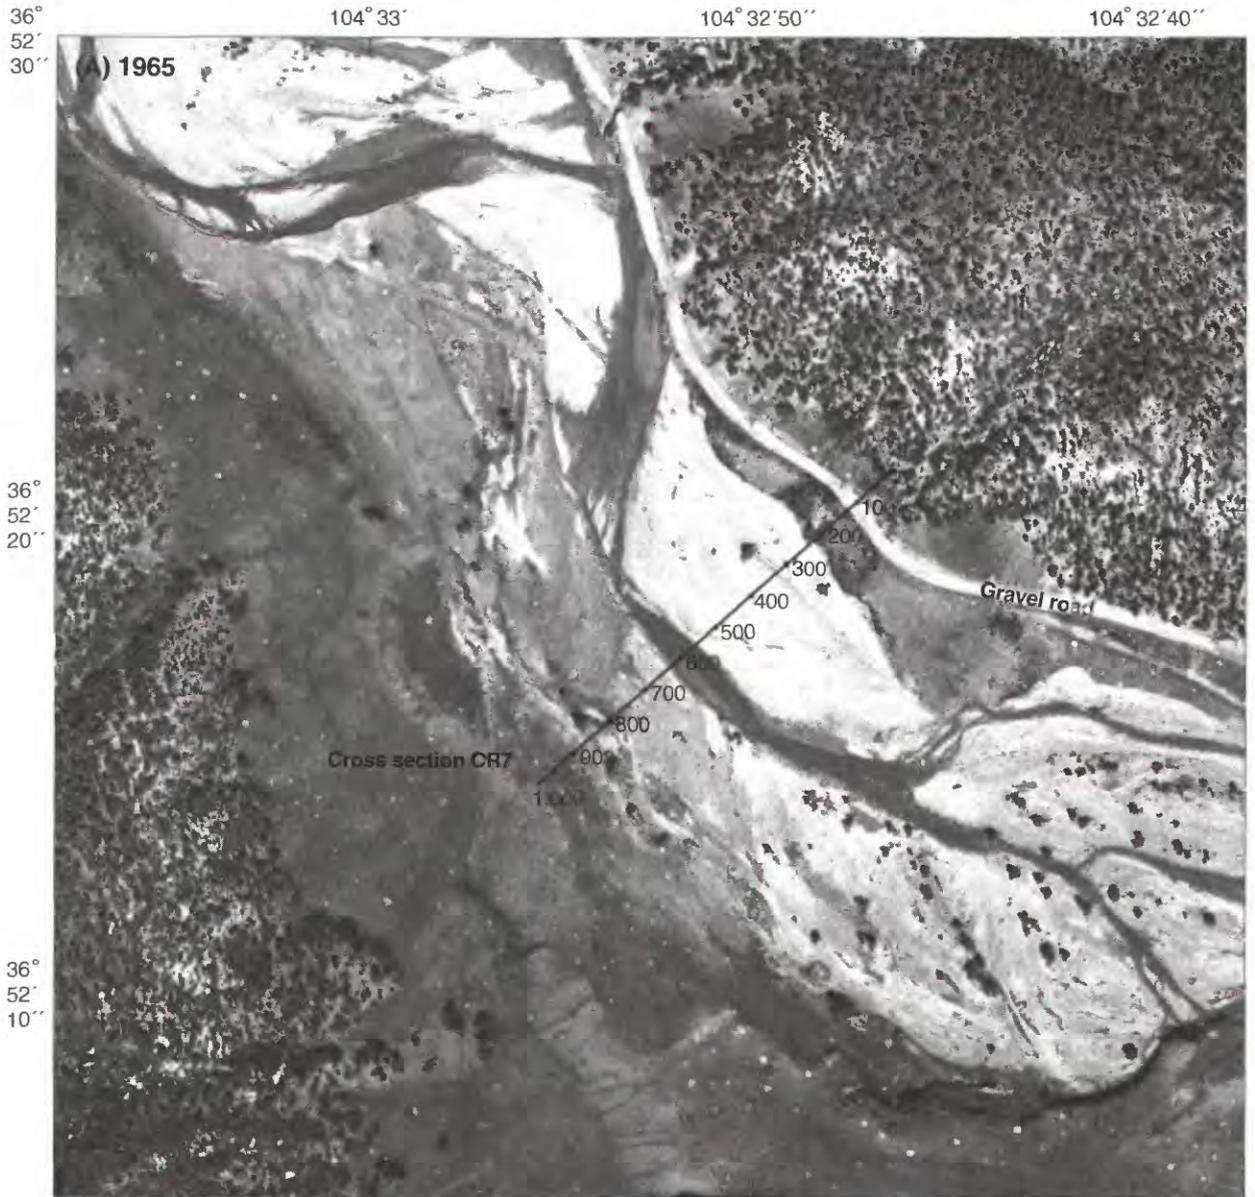
**Figure 10A.** Aerial photographs and location of cross section CR7 for (A) 1965 and (B) 1999, and (C) schematic showing 1965 and 1999 channels.

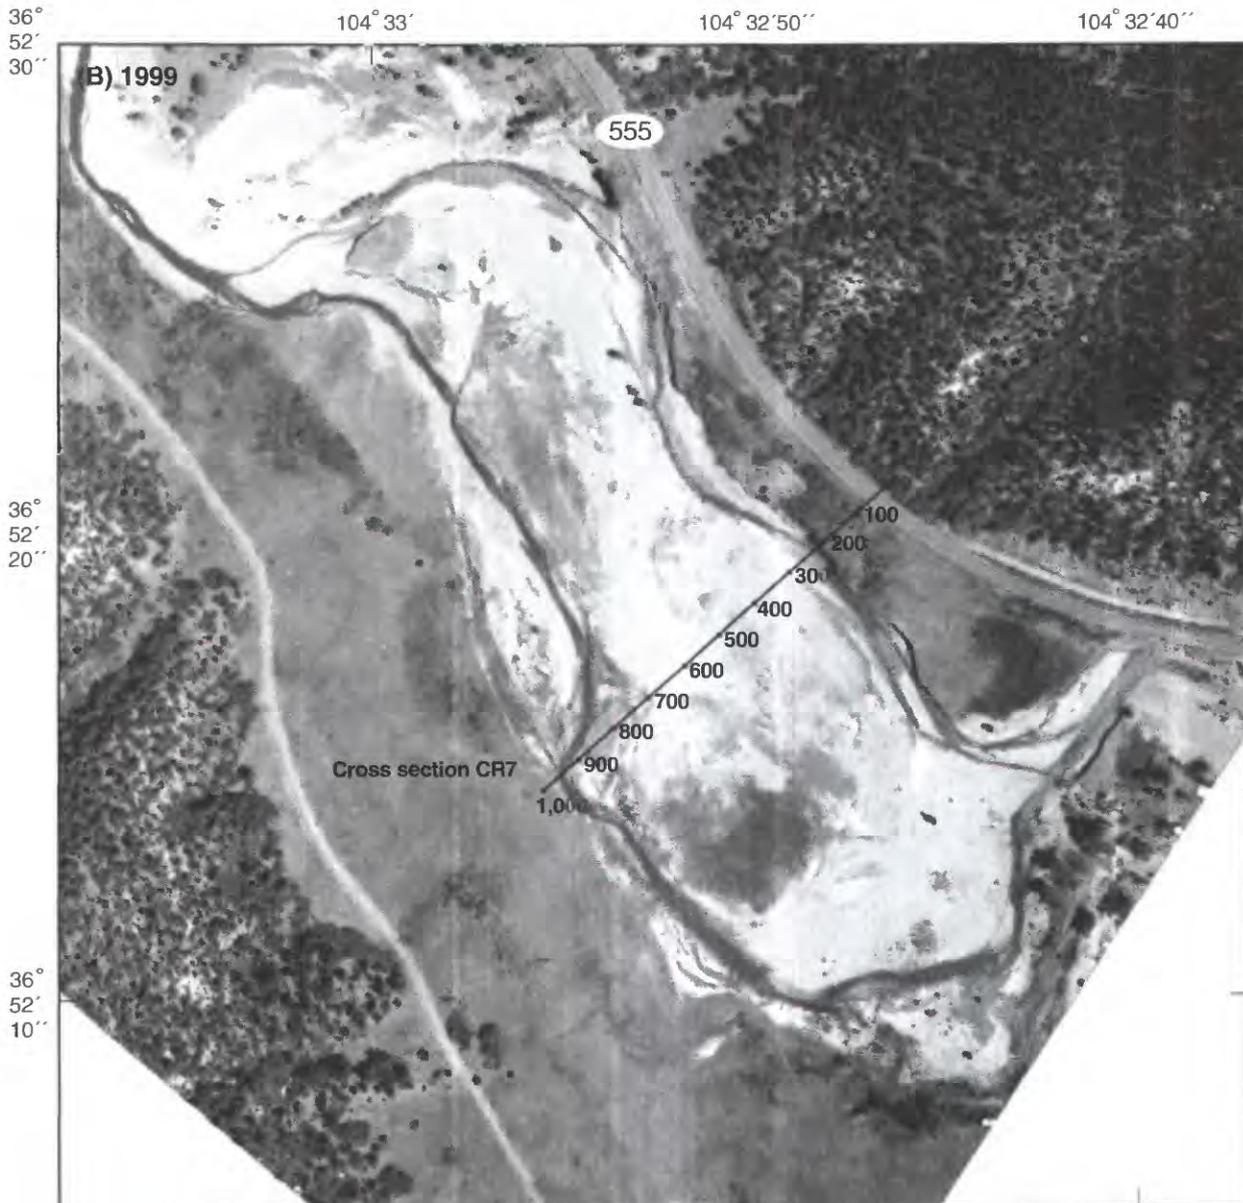
**Figure 10B.** Aerial photographs and location of cross section CR7 for (A) 1965 and (B) 1999, and (C) schematic showing 1965 and 1999 channels.
