In cooperation with the  
West Tennessee River Basin Authority

# Shoals and Valley Plugs in the Hatchie River Watershed

By Timothy H. Diehl

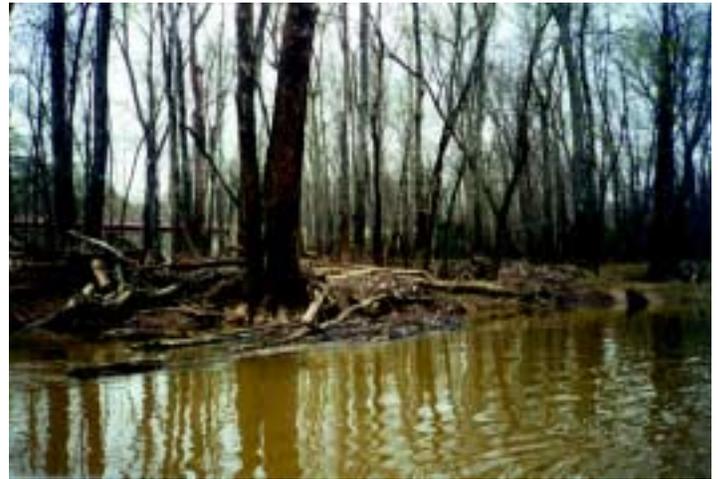
Woody debris piled against tree during low overbank flood on the Hatchie River at Pocahontas, Tennessee.

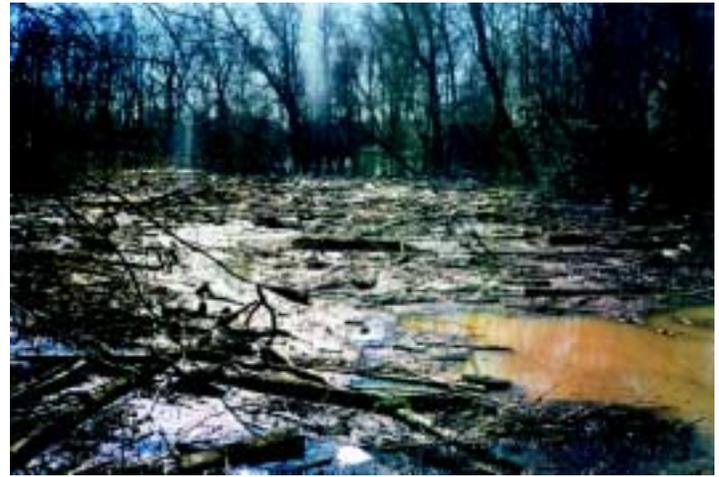
Floating debris forms a raft across the Hatchie River main channel near Serles, Tenn.

one-sixth of the upstream depth and by more than 2 feet. Smaller depths of shoaling are difficult to distinguish from the background of constantly changing river depth. At the upstream end of a shoal, the slope of the water surface increases. Despite the shallower depth, flow is faster. The irregular shallow bed traps large floating debris such as logs and branches in rafts and jams.

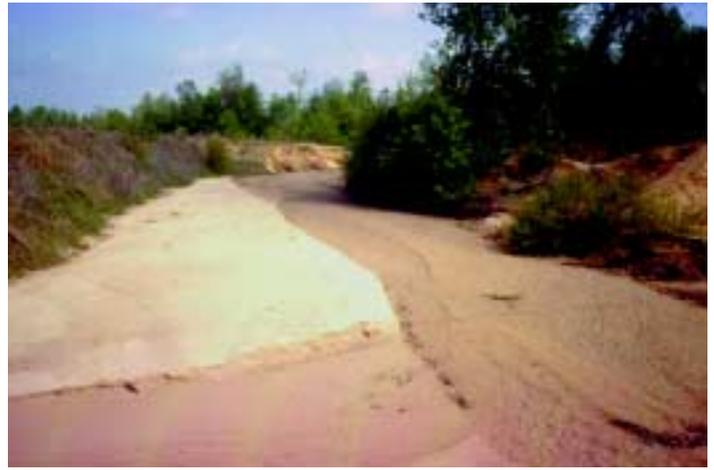
Sand-laden tributary, Muddy Creek, near Hatchie Station, Tennessee.

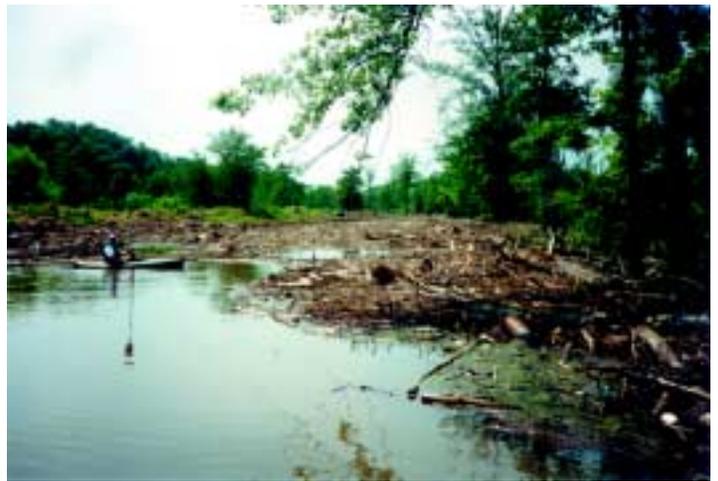
Upstream end of the valley plug on the Tuscumbia River at the Mississippi-Tennessee State line.

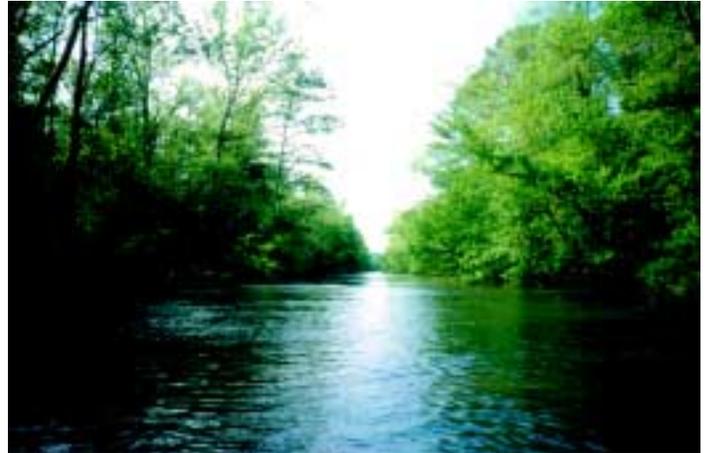
A section of the Hatchie River near Hatchie Station, Tennessee, which has been straightened.

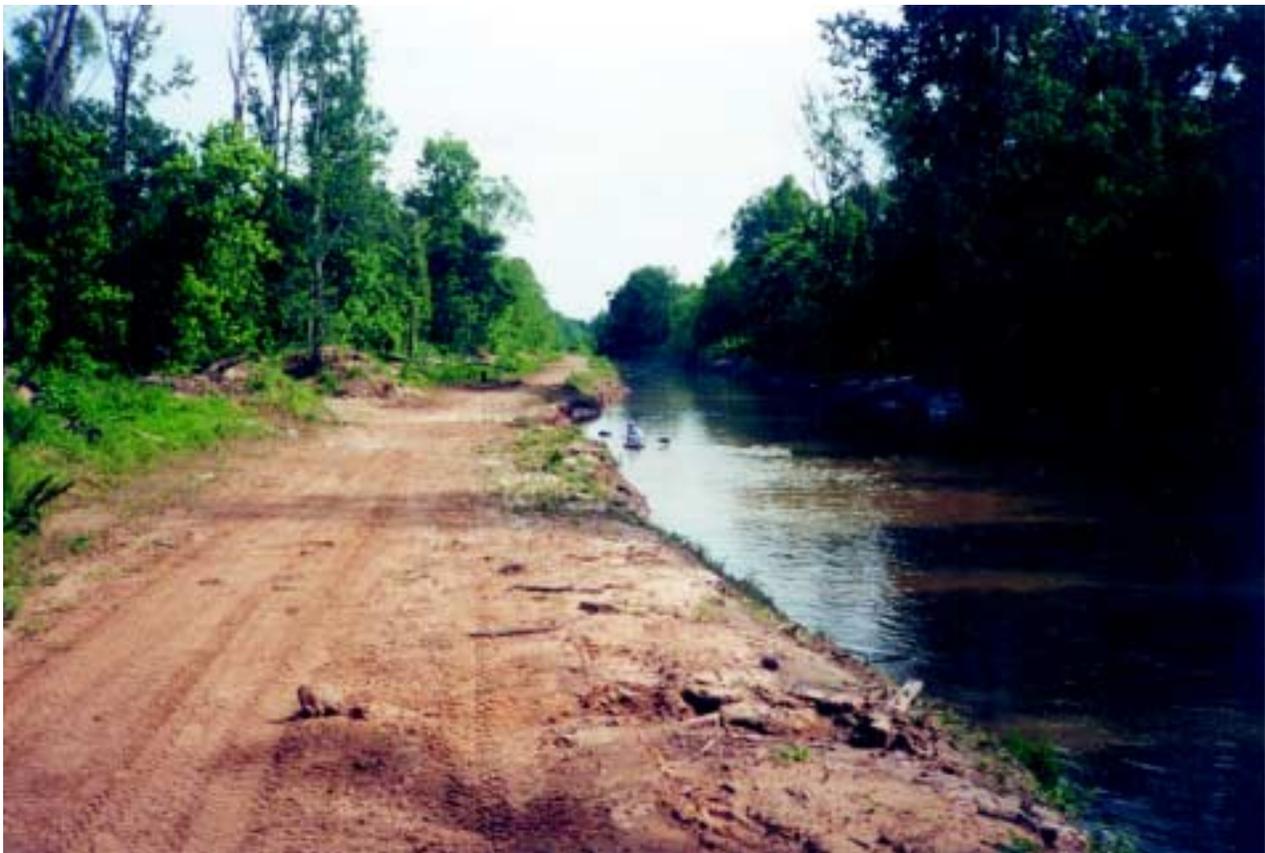
Re-dredged drainage canal, Hatchie River at the mouth of Brush Creek, Mississippi.

Some tributary channels have been reopened after being blocked by valley plugs—either by dredging along their original alignment, or by replacing with another maintained channel. The three deepest tributary-mouth shoals in the Hatchie River main stem are located at the mouths of such channels. In contrast to channelization of meandering tributaries, which has nearly ceased in recent years, dredging canals through valley plugs has continued through the period of this study. For example, in 1999 the Hatchie River drainage canal was re-dredged through a valley plug that blocked the canal upstream from the mouth of Brush Creek.

Upstream from Brush Creek, clearing, snagging, and dredging along a plugged canal reach in 1999 enabled excess sand from about 225 square miles of the upper Hatchie River watershed to travel downstream. Sand bars and woody debris produced a narrow, fast, irregular, shallow reach just downstream from the end of the dredged canal section. This sand will either accumulate into a new valley plug just below the downstream end of the main-

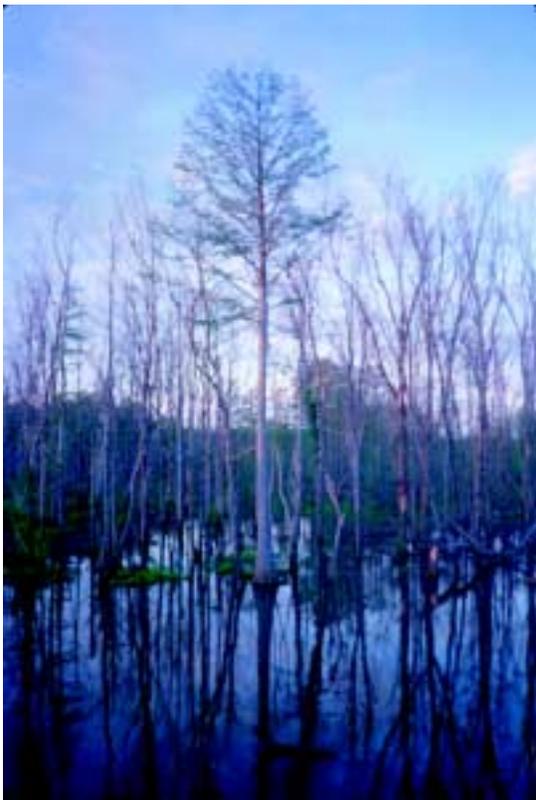
Ponded swamp with dead hardwoods and live cypress.
