Flood of September 22, 1998, in Arecibo and Utuado, Puerto Rico

WATER-RESOURCES INVESTIGATIONS REPORT 01-4247

By Heriberto Torres-Sierra

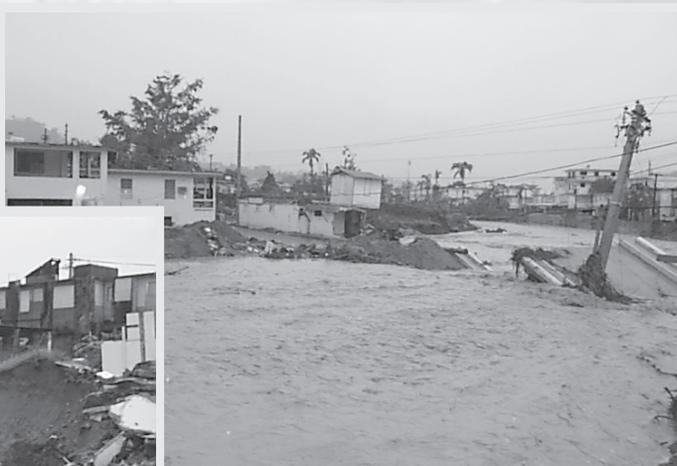
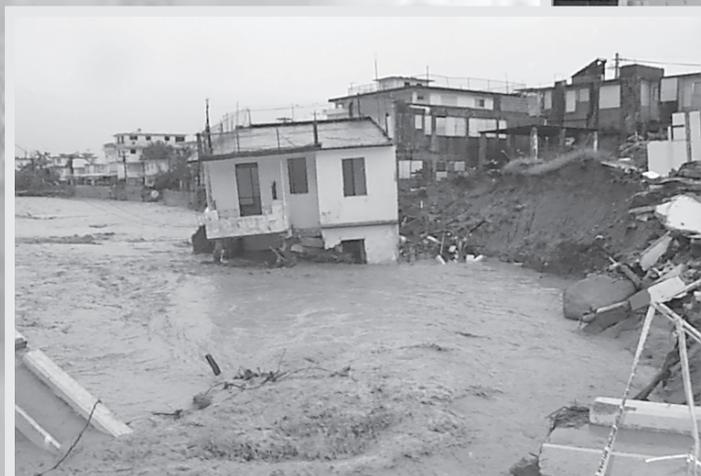
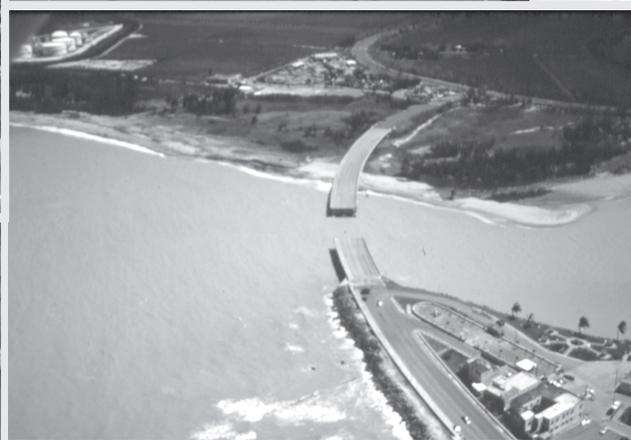
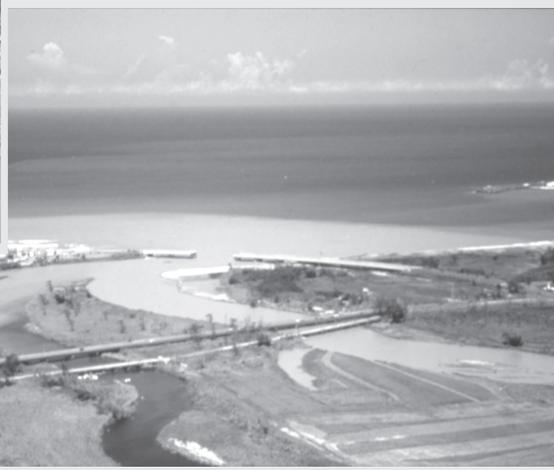
1. House damaged by floodwaters from the Río Viví in downtown Utuado, Puerto Rico. Photograph by Heriberto Torres-Sierra, September 1998, USGS.
2. High concentration of debris near the spillway of the Dos Bocas Dam, Arecibo, Puerto Rico. Note the container stuck on dam piers. Photograph by Heriberto Torres-Sierra, September 1998, USGS.
3. Road damaged from flooding in downtown Utuado, Puerto Rico. Photograph by Heriberto Torres-Sierra, September 1998, USGS.
4. Victor Rojas Avenue bridge destroyed by floodwaters from the Río Grande de Arecibo near downtown Arecibo, Puerto Rico. Photograph by Richard M.T. Webb, September 1998, USGS.
5. Aerial view of low-lying areas of downtown Arecibo inundated by floodwaters from the Río Grande de Arecibo, Arecibo, Puerto Rico. Photograph by Richard M.T. Webb, September 1998, USGS.
