Streamflow and Erosion Response to Prolonged Intense Rainfall of November 1–2, 2000, Island of Hawaii, Hawaii

Water-Resources Investigations Report 02-4117

By Richard A. Fontaine and Barry R. Hill

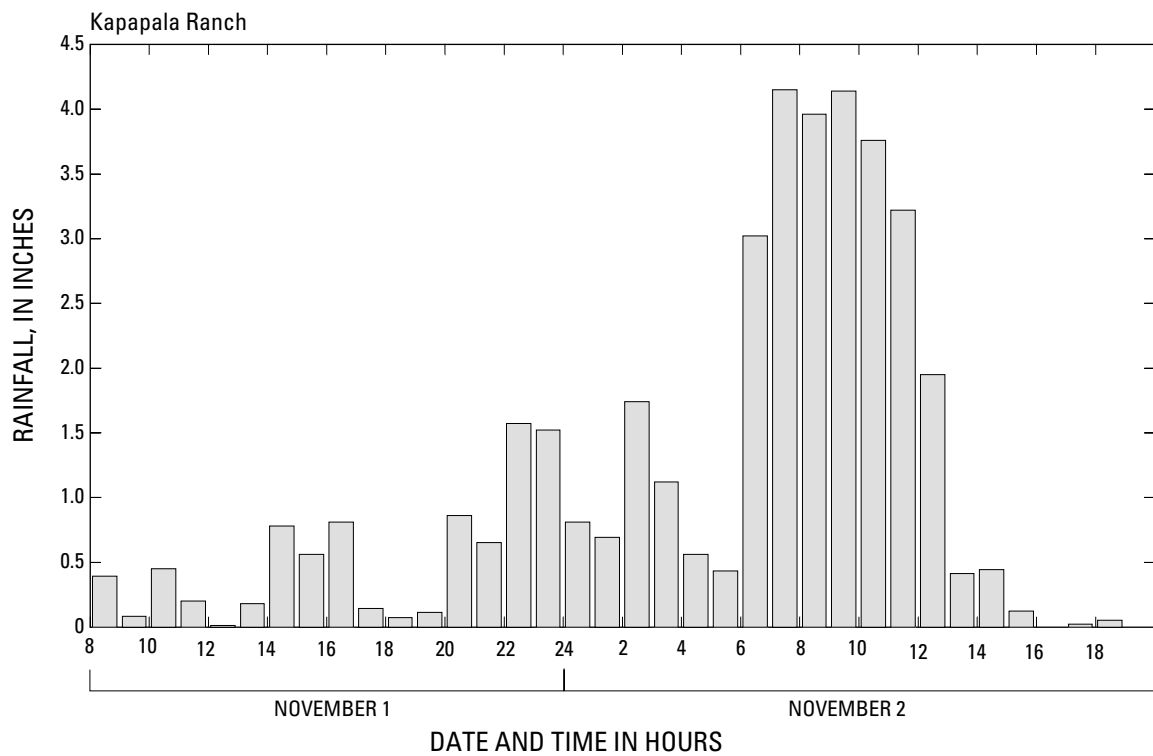
Figure 4. Graph showing hourly rainfall totals for November 1–2, 2000 at Waiakea Uka and Kapapala Ranch, island of Hawaii, Hawaii. (Provisional data from the National Weather Service)

The temporal distribution of storm rainfall was distinctly different in the Waiakea and Kapapala high-rainfall areas. Peak-rainfall intensities occurred much later in the Kapapala high-rainfall area. As a result, the amount of rain that fell prior to the period of maximum intensity was much greater there. In the Waiakea high-rainfall area, as represented by the data for the Waiakea Uka station (fig. 4), the 4-hour period of most intense rainfall occurred 14 hours after the beginning of the storm. A total of 6.65 in., or 21 percent of the total-storm rainfall of 30.89 in., fell prior to the period of most intense rainfall. A total of 12.83 in., or 42 percent of the total-storm rainfall, fell after the period of most intense rainfall. In the Kapapala high-rainfall area, as represented by the data for the Kapapala Ranch station (fig. 4), the 6-hour period of most intense rainfall occurred 22 hours after the storm began. A total of 13.73 in., or 35 percent of the total-storm rainfall of 38.97 in., fell prior to the period of most intense rainfall. A total of 2.99 in., or 8 percent of the total-storm rainfall, fell after the period of most intense rainfall.

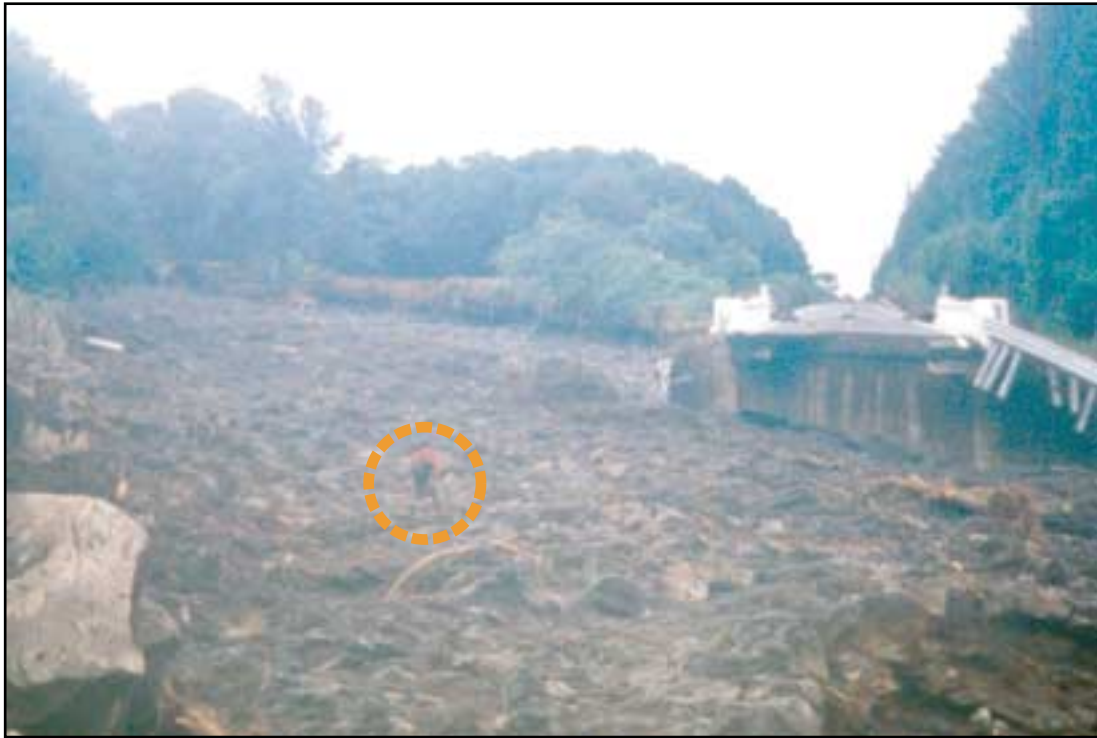
Figure 5. Photograph showing site of destroyed Highway 11 bridge over Keaiwa Stream near Pahala, Hawaii, November 3, 2000, island of Hawaii, Hawaii. Note person (circled) for scale.

Total flood damages associated with the November 1–2, 2000 storm were estimated to be in excess of 70 million dollars (Paul Haraguchi, consulting meteorologist, written commun., 2001). Travel in and around the Waiakea and Kapapala high-rainfall areas was brought to a standstill as numerous bridges and stream crossings were destroyed. Most notable among the damaged crossings were the four bridges along Highway 11 near Pahala and the Komohana Street Bridge over Alenaio Stream. Figure 5 is a picture taken at the site of the former Highway 11 Bridge over Keaiwa Stream, just north of Pahala, on November 3, 2000.

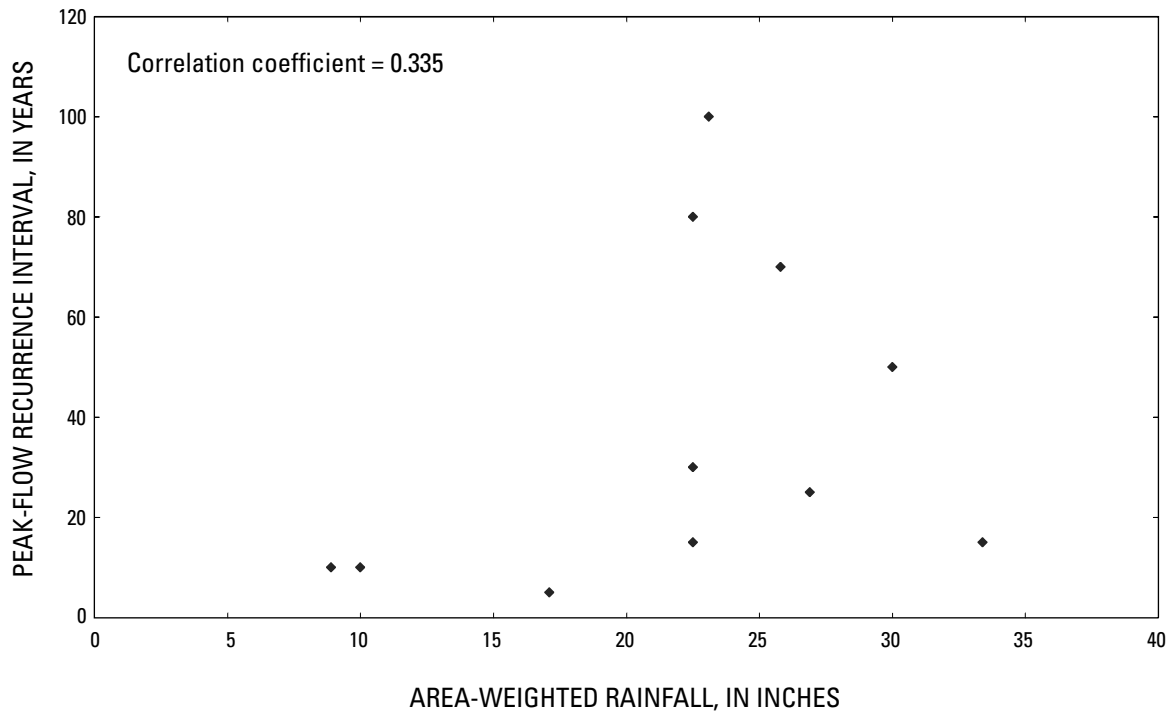
Figure 8. Scatterplot of peak-flow recurrence interval and area-weighted storm rainfall, November 1–2, 2000 flood, island of Hawaii, Hawaii.

To explore the relationship between peak flows and rainfall data, a scatterplot of peak-flow recurrence interval (table 3) compared with area-weighted storm rainfall (table 4) was prepared (fig. 8). As can be seen in figure 8, peak-flow recurrence intervals show little correlation with storm-total area-weighted rainfall (correlation coefficient is 0.335). For example, the four sites with area-weighted storm rainfall totals of between 20

and 25 in. have recurrence intervals that range between 15 and greater than 100 years. The lack of a correlation between peak-flow recurrence intervals and storm-total rainfall indicates that peak flows are more strongly influenced by shorter-duration rainfall totals.

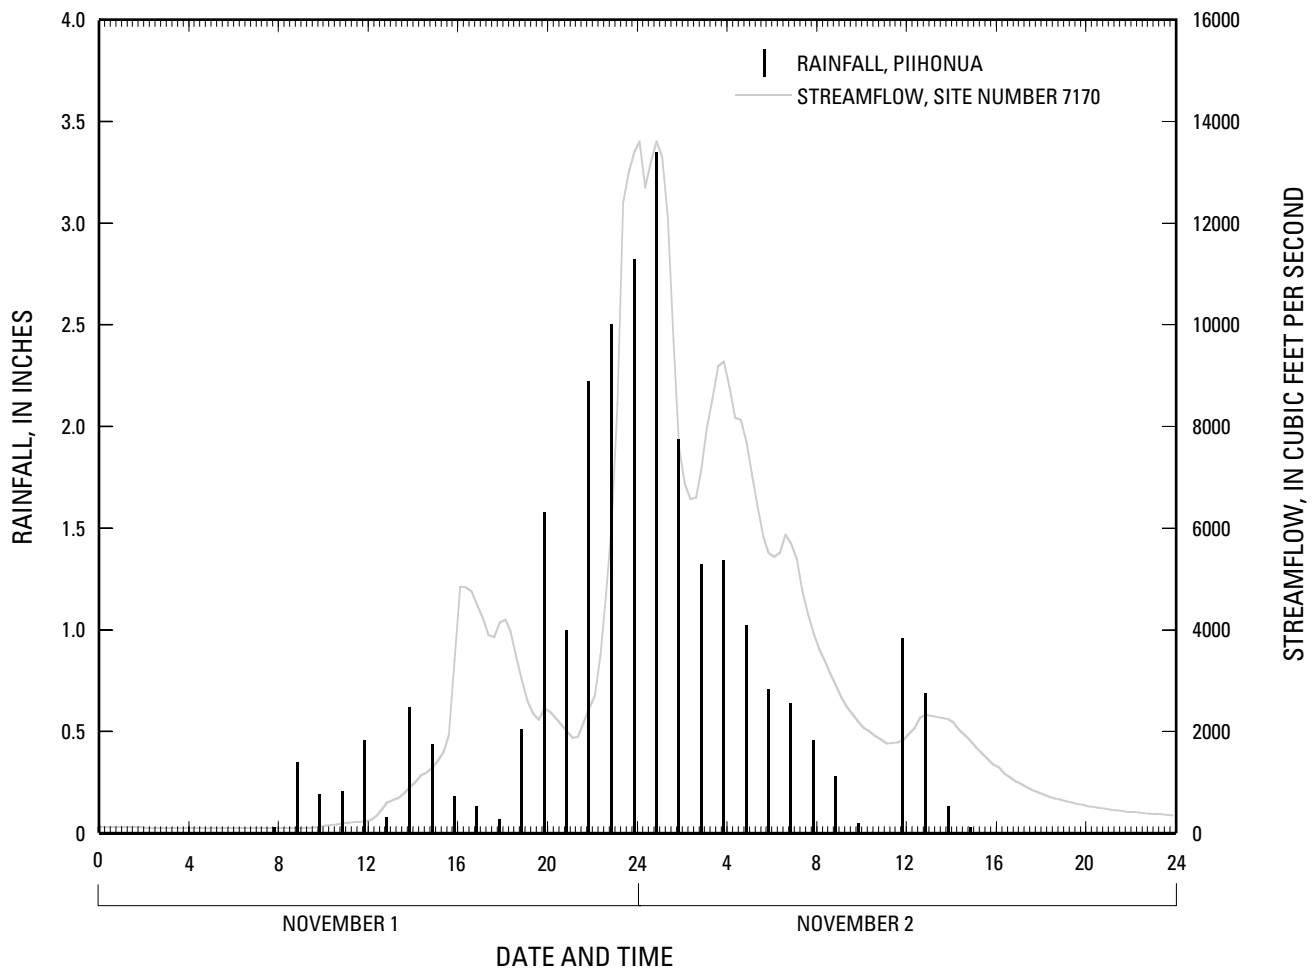
Figure 9. Piihonua hourly rainfall totals and Honolii streamflow data, November 1–2, 2000 flood, island of Hawaii, Hawaii.

Four sites have rainfall-runoff data for watersheds on the slopes of Mauna Kea (sites 7170, 7174, 7176, and 7176.5). Peak unit-runoff values for the four sites range from 950 to $2,620 \text{ ft}^3/\text{s}/\text{mi}^2$ and average $1,635 \text{ ft}^3/\text{s}/\text{mi}^2$. The peak-runoff ratio for site number 7176 (Alia Stream near Hilo) was computed to be greater than 100 percent, which implies that the maximum runoff rate from the watershed was greater than the maximum rainfall rate that fell on it. With the exception of unusual circumstances, such as dam failures, this is not a physical possibility and implies that one or more of the computations for this watershed were in error. The Piihonua hourly rain gage, while located a significant

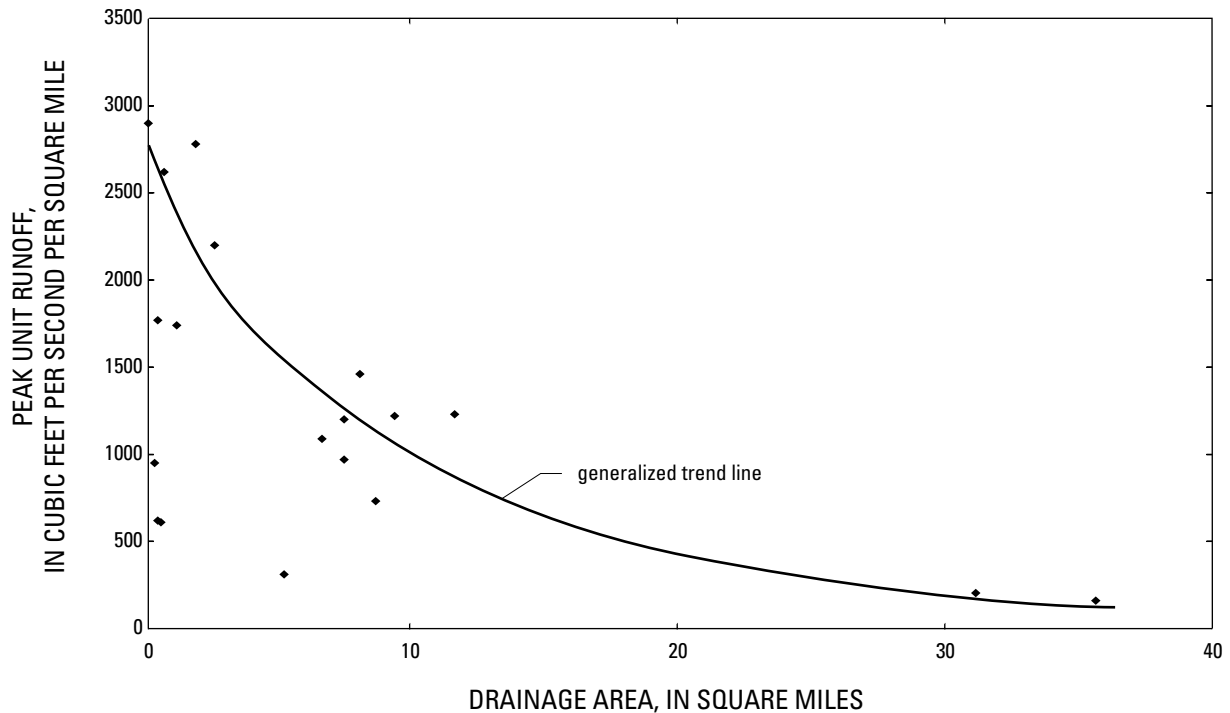
Figure 10. Relation between peak unit runoff and drainage area, November 1–2, 2000 flood, island of Hawaii, Hawaii.

To compare peak-flow rates at a variety of sites with differing drainage areas, it is best to use the peak unit-runoff rate (the peak flow rate divided by the drainage area, table 4). A scatterplot of peak unit-runoff rate compared with drainage area is shown in figure 10. Data for sites 34 and 36 were not included in figure 10 because of uncertainties in their computed drainage areas. Data for sites 7040 and 7130, although consistent with the generalized trend line shown, were not included in figure 10 because their drainage areas were an order of magnitude greater than those for the remaining sites. Data in figure 10 indicate that the peak unit-runoff rates generally decline with increasing drainage area. High-intensity rainfall is more likely to extend over entire watersheds when those watersheds are small. In larger drainages, the timing and spatial distribution of high rainfall intensities are more likely to vary throughout the watersheds, therefore leading to peak runoff rates that are not synchronized. Although the trend of declining peak unit-runoff rates is clear, the relation is not strong enough (correlation coefficient is -0.444) to allow use of the data in figure 10 to make estimates of peak unit-runoff rates at sites where peak-flow calculations were not made for the November 1–2, 2000 flood.
