Ground-Water Contamination from Lead Shot at Prime Hook National Wildlife Refuge, Sussex County, Delaware

Water-Resources Investigations Report 02-4282

by Daniel J. Soeder and Cherie V. Miller

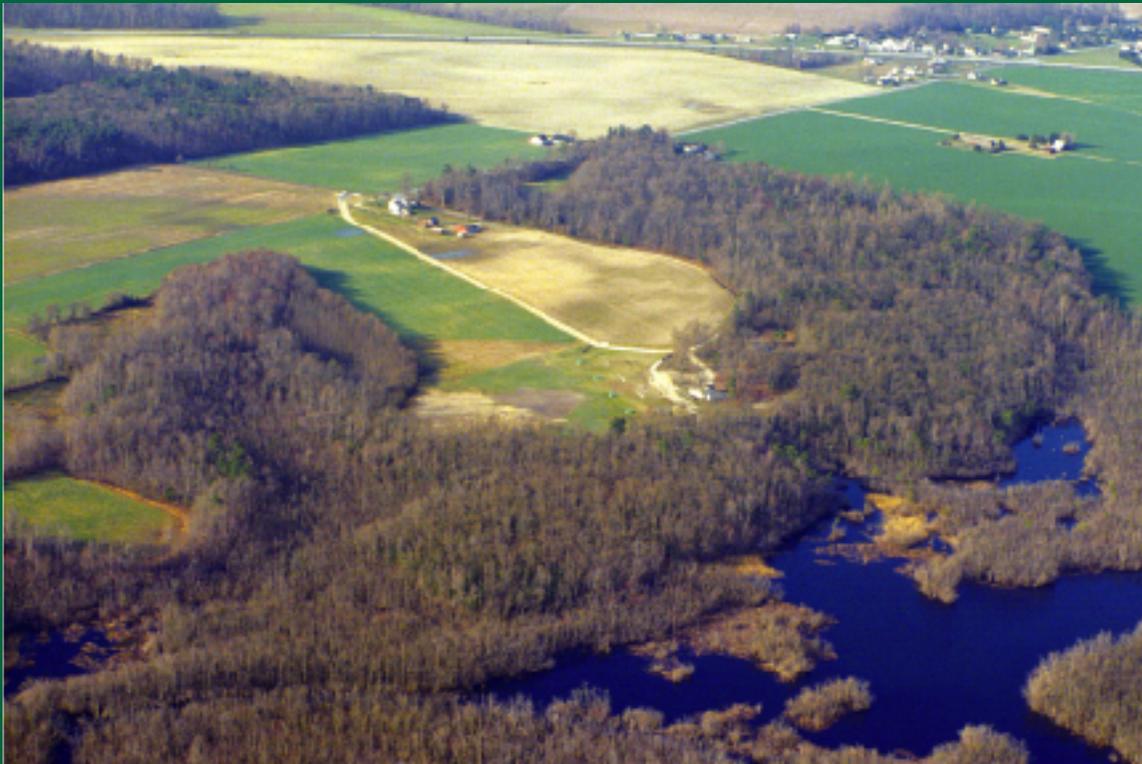
Cover. Oblique aerial photograph showing Broadkilm Sportsman's Club (center of photo) and Prime Hook National Wildlife Refuge, looking southwest (Refer to figure 3.)

The part of Prime Hook NWR bordering the club downrange from the trap-shooting area consists of a forested wetland along a small, unnamed tributary or slough to Primehook Creek shown in figure 3 as the wooded area to the left of the club facility. The slough consists of a series of small, shallow ponds or pools, a few to possibly a dozen feet wide, and only a few feet deep, separated by saturated hummocks of mud, fallen trees, and organic matter. The water is nearly stagnant with very slow drainage to Primehook Creek. The size and shape of the slough varies greatly with the seasonal rise and fall of the water table, and it dries up completely on occasion. The slough is heavily forested, and is not used much by migratory fowl, which prefer open water. There are numerous small mammals, birds, amphibians, and insects that are common in and around the slough, however, and use it as a water supply. Reference to the "unnamed tributary" or "slough" in this report denotes only the Primehook Creek tributary east of the club, in the area downrange from the trap houses. No work in the western tributary, indicated on figure 3 by the wooded area to the right of the club facility, was performed by the USGS as part of this study.

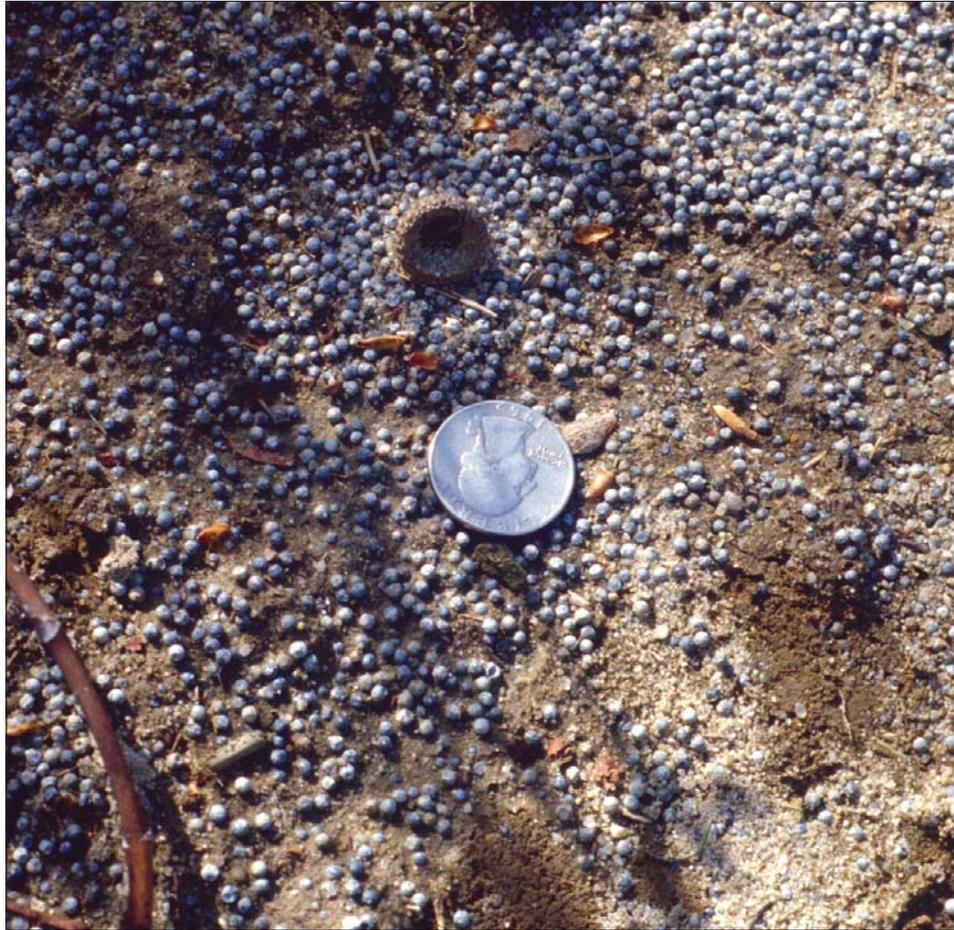
Figure 5. Close-up photograph of lead shot in the drop zone at the Broadkilm Sportsman's Club with white oxide or carbonate coatings on surface pellets. (24-millimeter-diameter coin is shown for scale.)

In April 2000, the USGS performed an initial field reconnaissance of the site to assess possible lead contamination in the ground water. Observations of lead pellets on the surface of the drop zone showed that many were coated with a

white oxide or carbonate layer (fig. 5), while those a few centimeters down into the upper soil horizon were shiny and metallic. The absence of the coating was interpreted as evidence of corrosion, and indicated that significant amounts of lead could be dissolving from the shot. The dissolved lead might then be transported into the shallow ground water. USFWS asked the USGS to carry out ground-water sampling and metals analysis as part of the site characterization work. Water samples were collected and analyzed by the USGS in May 2000 and again in April 2001.

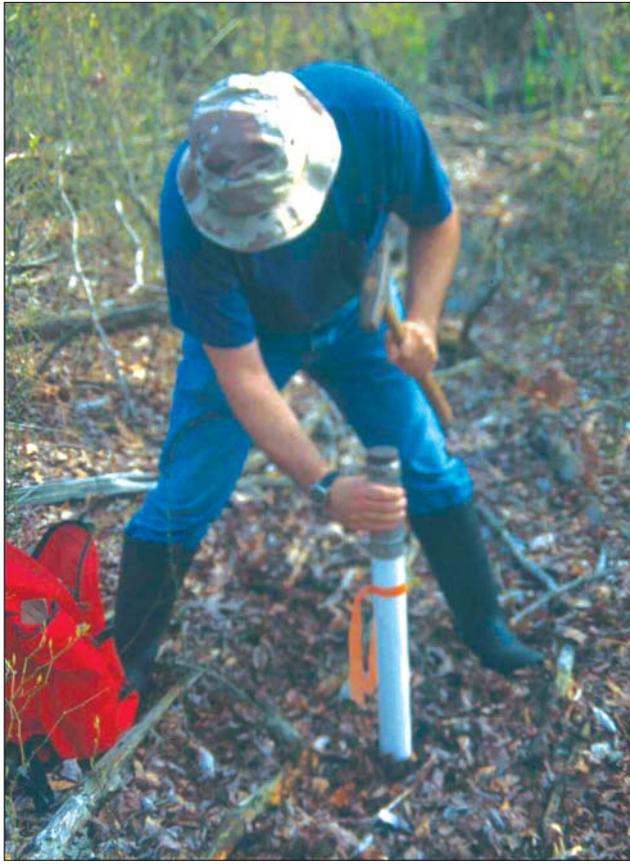
Figure 6. Seating a plastic well casing into a pre-dug hole at Prime Hook National Wildlife Refuge.

Seven drive-point well casings, each consisting of a Schedule 40 plastic (PVC) pipe, 1.5 in. in diameter and 3 ft in length, screened the entire length and fitted with a solid PVC point, were installed at Prime Hook NWR in April 2000 for initial shallow ground-water sampling. The casings were put in place using hand tools, by first clearing the ground surface of leaves, rubble, and lead shot with a shovel, and then manually digging a hole approximately a foot deep and a foot in diameter. After carefully checking the bottom of the hole to ensure that it was free of any remnant lead shot, a 2-in.-diameter, hand-operated soil auger was used to dig a round hole approximately 2 to 4 ft deep. Each casing was inserted into the hole, and a threaded steel cap on the upper end was hit several times with a sledgehammer to seat the point (fig. 6). Clean building supply sand was then placed into the annulus of the hole around the outside of the casing. Because the casings are screened over their entire 3-ft length, no attempt was made to pack off zones within the shallow soil profile penetrated by the emplacement hole. Finally, clean soil from the hand auger excavation was used to fill in the top of the hole and make it level with the ground surface. Great care was taken at every step of the installation process to ensure that no lead pellets were introduced into the hole or into the casing that might affect the results of the water sampling and metals analysis.

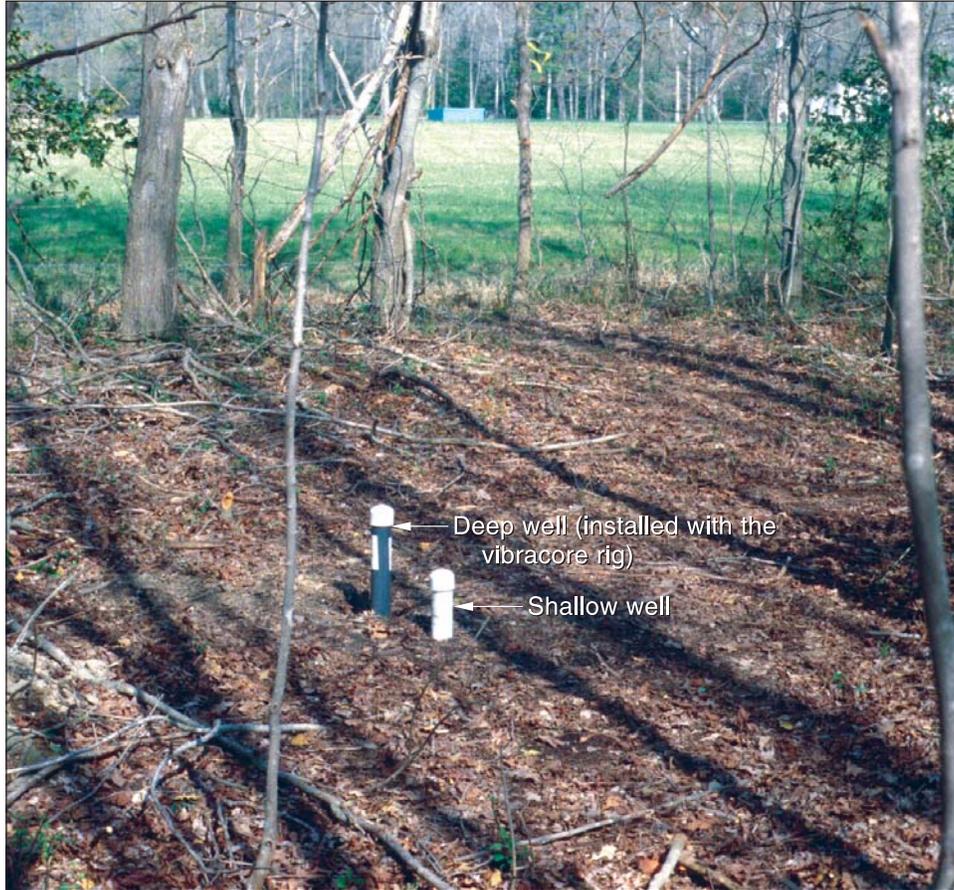
Figure 7. Shallow/deep well pair at upgradient location, Prime Hook National Wildlife Refuge.

Year 2000: The first well was placed upgradient and to the south of the main drop zone, in an area of the refuge that was free of visible lead pellets on the ground surface. This location was chosen as a control point to sample background levels of lead in the ground water. A second well was emplaced within the drop zone itself. This location was selected to sample the ground water directly beneath the highest concentrations of lead pellets to check for contamination. Five additional wells were then placed in various locations downgradient of the drop zone near the banks of the slough. These were intended to capture samples of any lead moving toward this surface-water body through the shallow ground water.

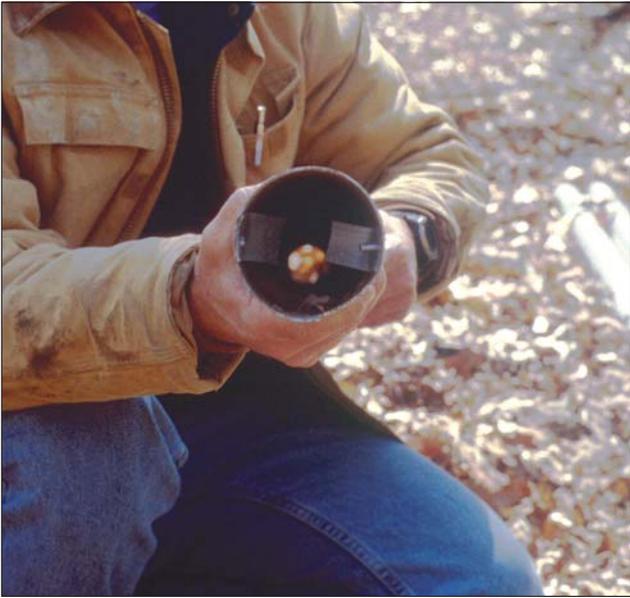
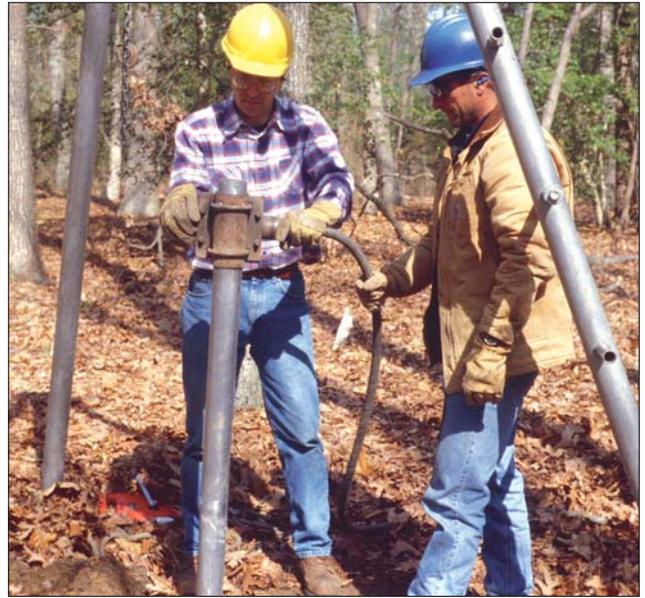
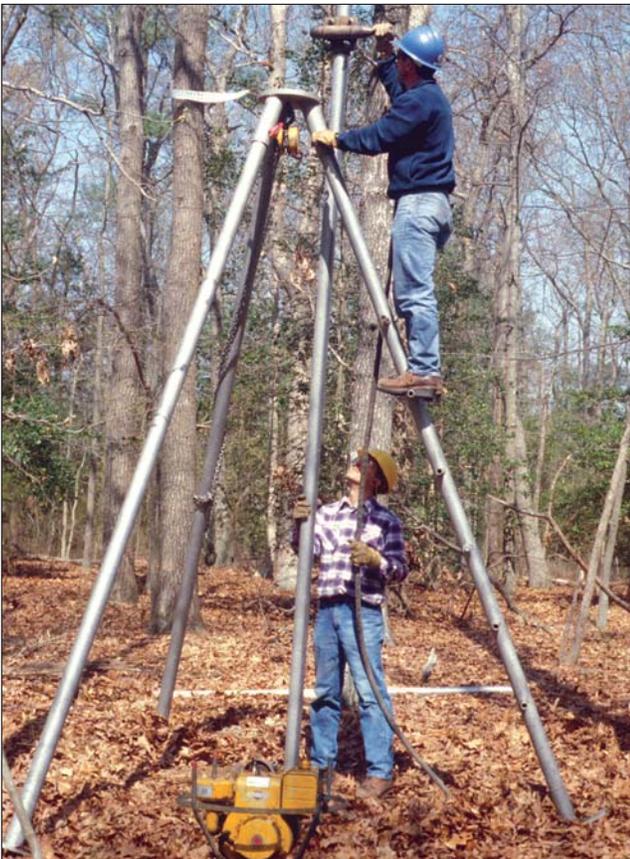
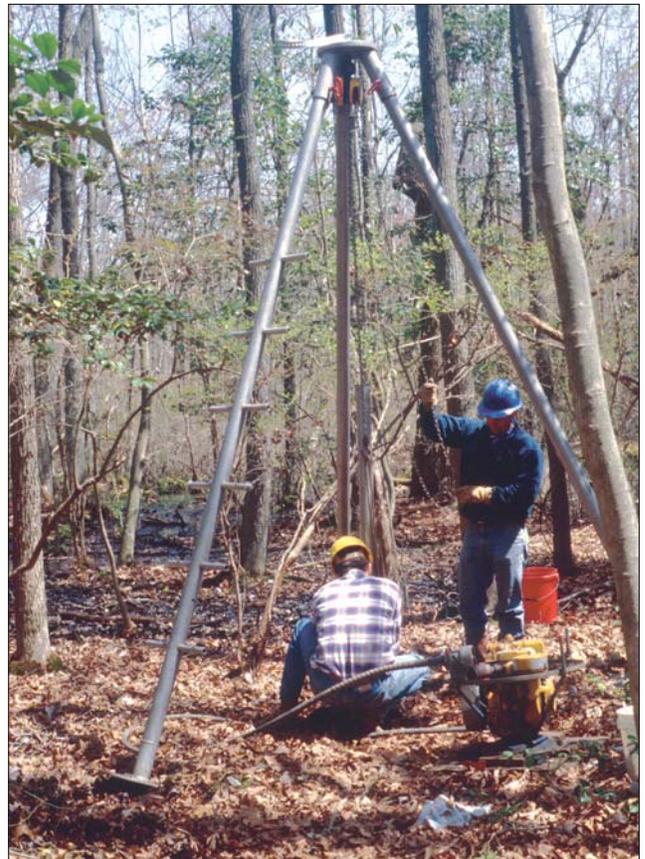
Figure 9. Vibracore rig used at Prime Hook National Wildlife Refuge.

Flanges inside bottom of pipe to retain soft sediment core.

Core pipe was vibrated approximately 8 feet into the ground.

Tripod used to support aluminum pipe with vibrator on upper end.

Extracting the core barrel from the ground using an automobile engine winch.

Soil and sediment core samples were obtained from 7 of the 12 well holes installed at Prime Hook NWR in April and May 2001. The core was collected using a “vibracore” rig on loan from the University of Delaware. This soft-sediment coring rig used 4-in.-diameter thin-walled aluminum irrigation tubing as drill pipe. The tubing, which can be up to 15 ft long, was mounted vertically under a tripod-like drilling support. A vibrator designed for de-aerating concrete was attached to the upper end of the tubing using u-bolts. The intense vibration caused the tubing to cut into the ground, and a core of soft sediment was captured inside the pipe. When the pipe penetrated to sufficient depth, the vibrator was removed, and an automotive engine winch was then used to pull the pipe and core up out of the ground.

Small metal flanges riveted to the inside of the bottom end of the pipe helped keep the core inside. Details of the coring apparatus are shown in figure 9. Cores were measured, capped, and labeled before being transported to the USGS office in Dover, Delaware.
