# **Channel Stability and Water Quality of the Alagnak River, Southwestern Alaska**

**Water-Resources Investigations Report 02-4184**

**Prepared in cooperation with the  
NATIONAL PARK SERVICE**

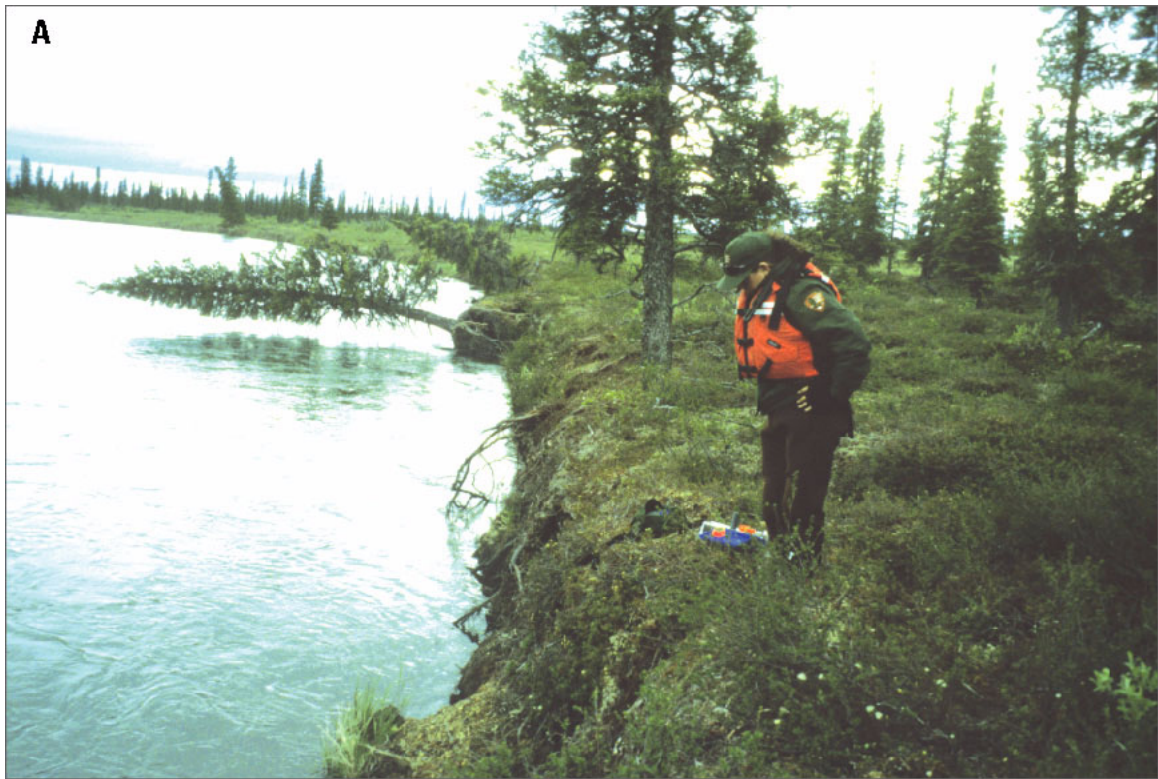
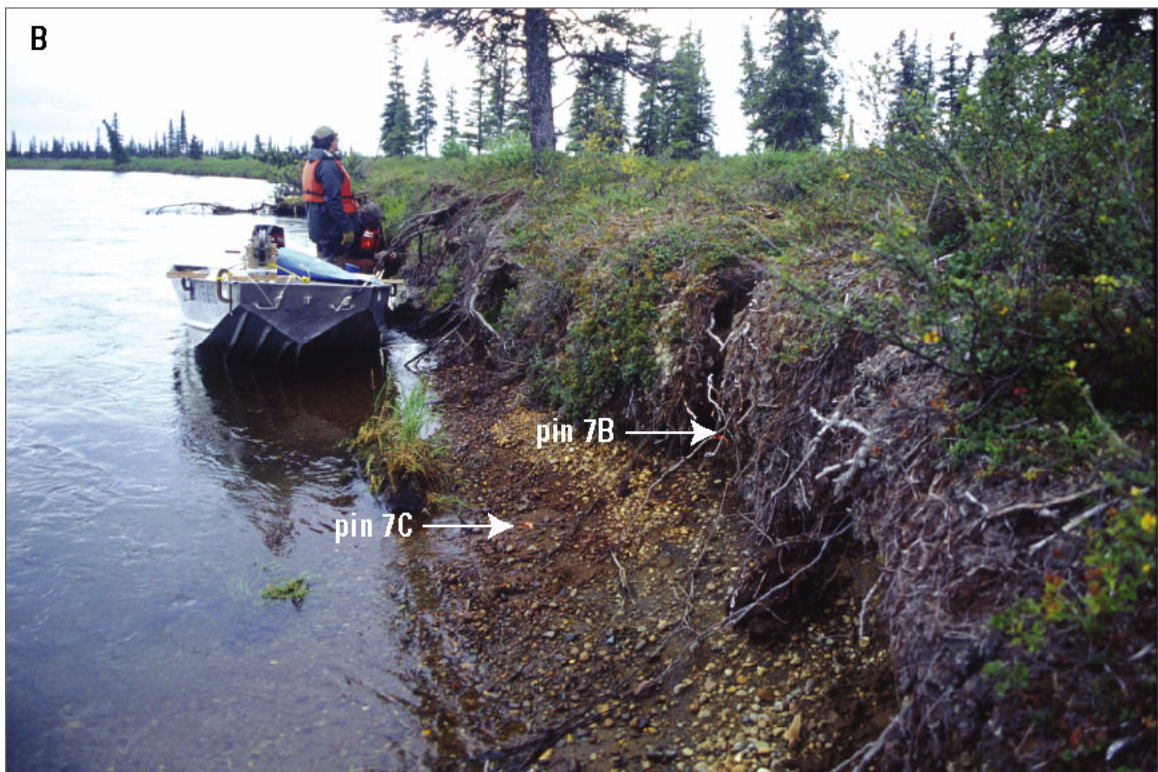
**Figure 6.** Vegetation mat draped over bank at erosion monitoring site 7 on the Alagnak River.

(A) High stage. Person is standing in line with erosion pins. Photograph by author, June 12, 2000.

(B) Low stage. Leaning tree visible in (A) has fallen into river and is collecting debris. Photograph by author, August 8, 2000.

Vegetation on terraces and other higher flood plain surfaces along the Alagnak River forms an interwoven mat that retains its integrity for weeks to years as it drapes over eroding banks. The strength of this root mat is typically sufficient to support trees in a leaning position (fig. 6) for several years, even as erosion removes the underlying bank. The mat is not attached to the bank face, such that the bank face is unvegetated. Eroding banks where a draped mat is not present are also unvegetated. High eroded banks with exposed faces revegetate once the bank toe is no longer subjected to active erosion.

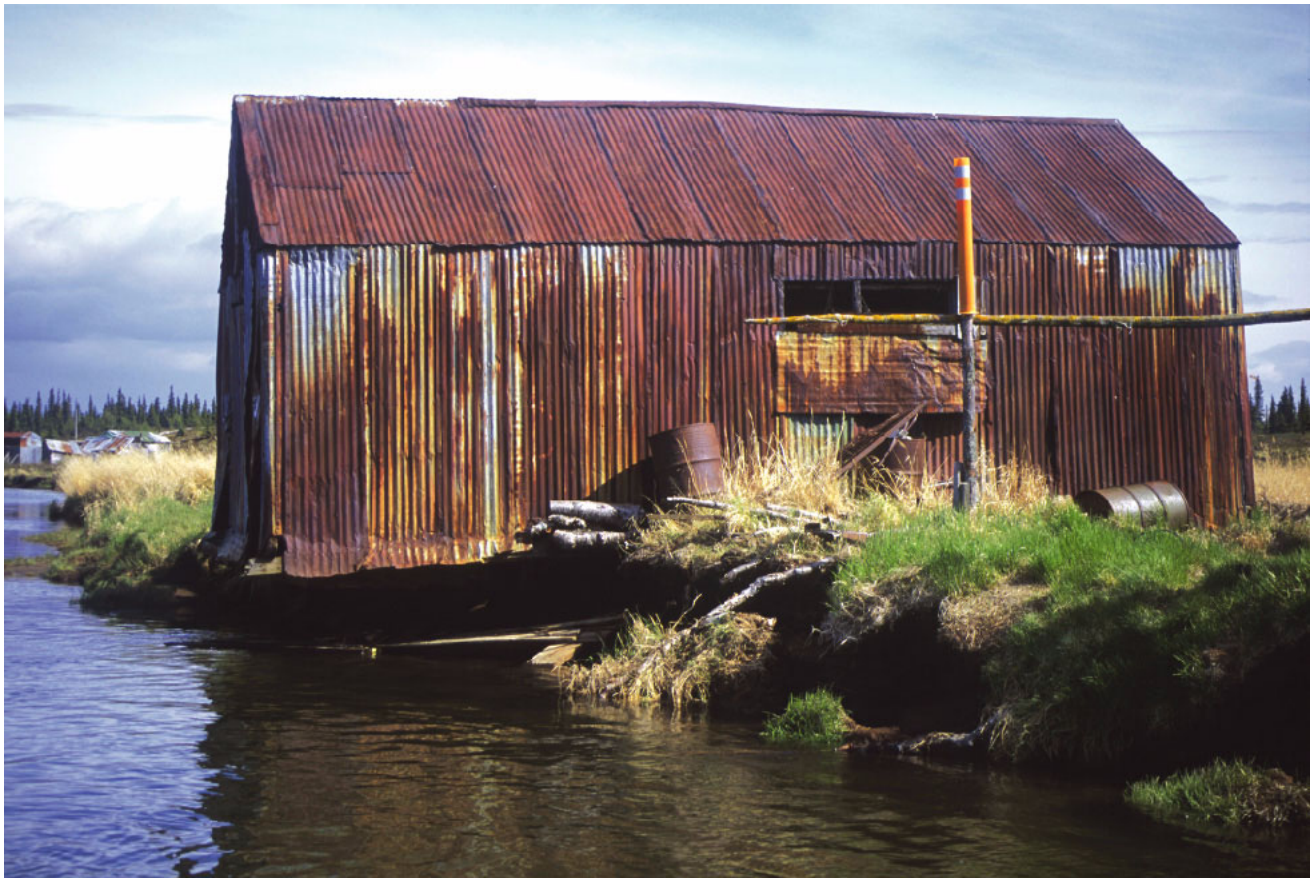
**Figure 21.** Bank erosion beneath bankside structure, Alagnak River river kilometer 17. Photograph by author, June 5, 2001.

Within the study area, human contributions or impediments to bank erosion are generated by foot traffic on banks, by bank protection and riverine structures at developed sites, and by motorboat traffic. Travel by foot was, at the time of this study, relatively minor, such that the contribution of human foot traffic is difficult to separate from the considerable bear traffic along the banks of the Alagnak River. Although foot traffic is responsible for the development of informal trails along the top edge of the riverbanks, which can contribute to bank failure by adding weight to unstable banks (Selby, 1993), mass failure is a minor issue for the non-cohesive banks of the Alagnak. Foot traffic has not resulted in the devegetation of bank faces except locally where campsites have been heavily used.

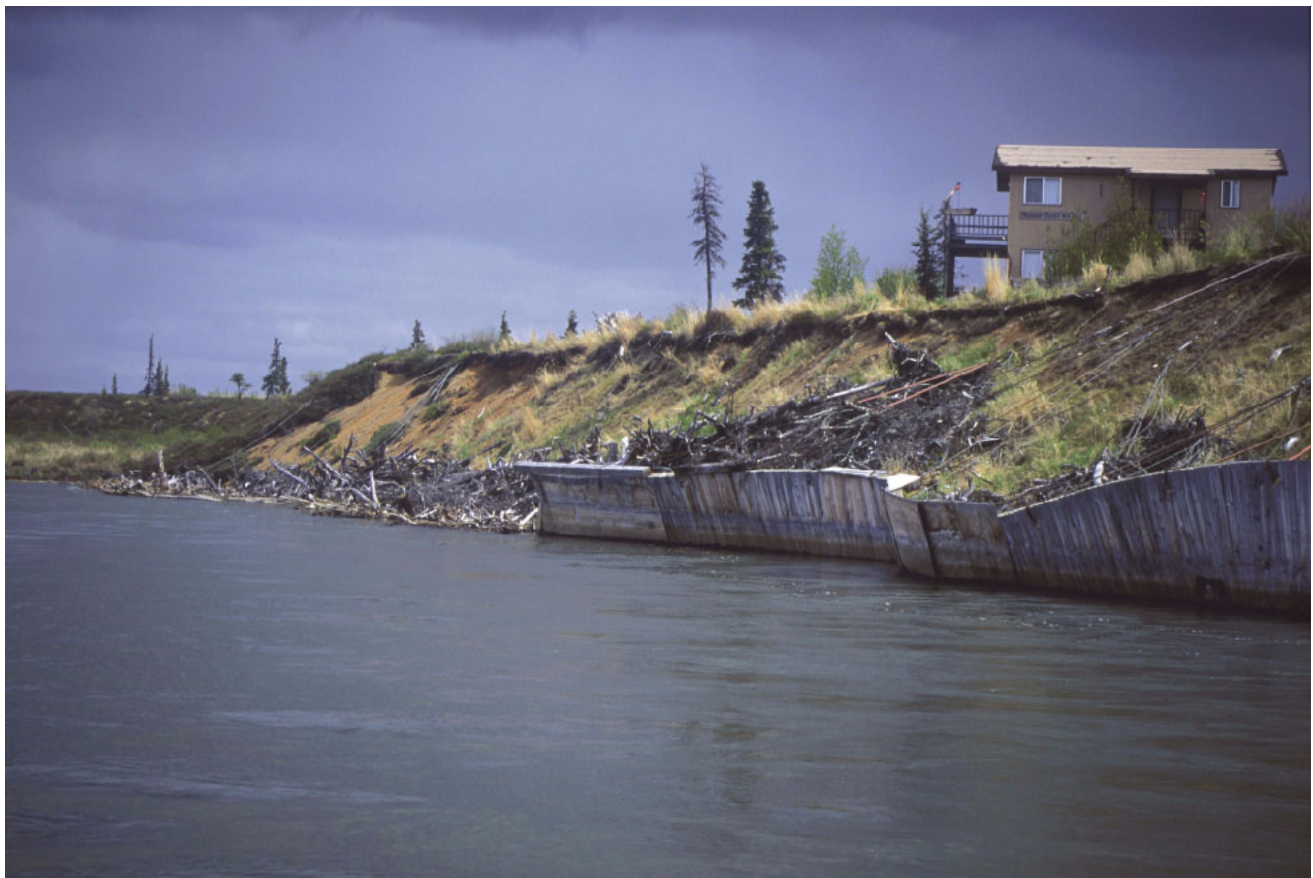
**Figure 28.** Trees and a revetment as erosion control, Alagnak River river kilometer 38. Photograph by author, June 7, 2001.
