DESTRUCTIVE FLOODS IN THE UNITED
STATES IN 1904

EDWARD CHARLES MURPHY
AND OTHERS

WASHINGTON
GOVERNMENT PRINTING OFFICE
1905

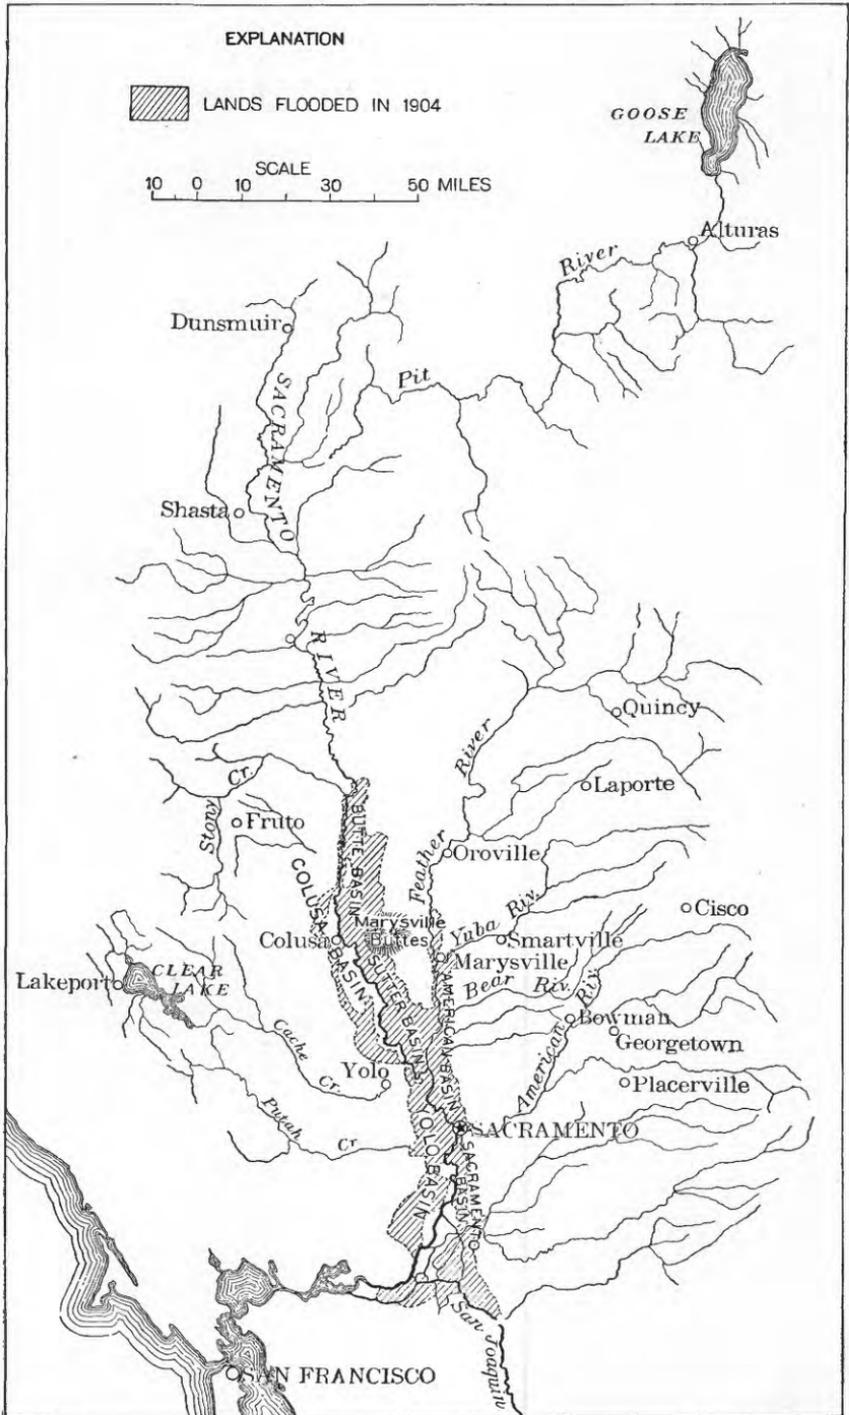
DRAINAGE BASIN OF SACRAMENTO RIVER.

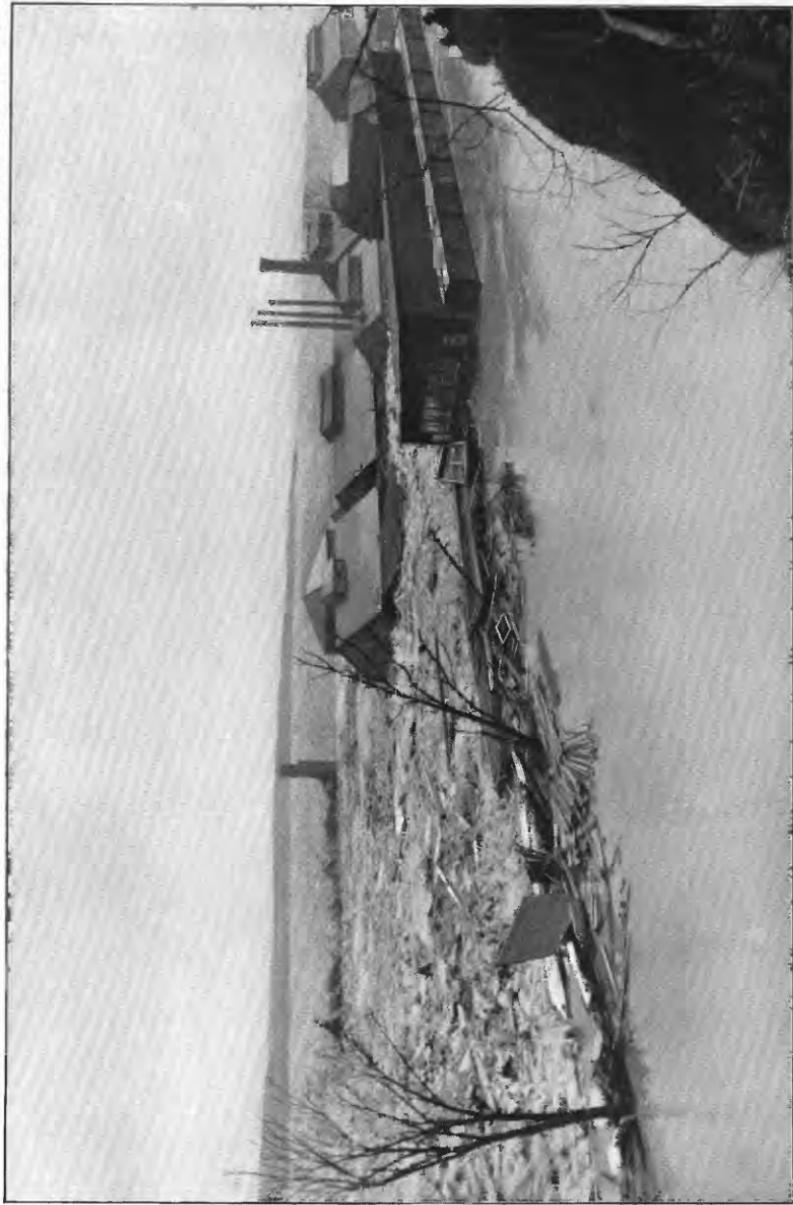
FLOOD OF MARCH 8, 1904, ON SUSQUEHANNA RIVER AT YORKHAVEN, PA., AT ITS HEIGHT.

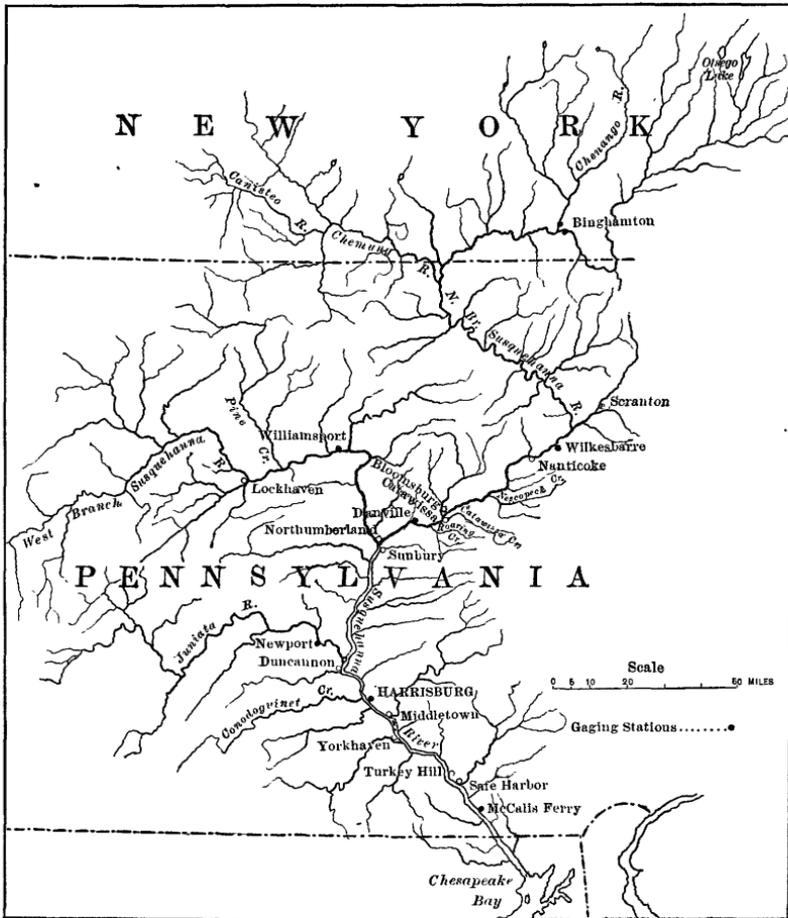
FIG. 1.—Drainage basin of Susquehanna River.

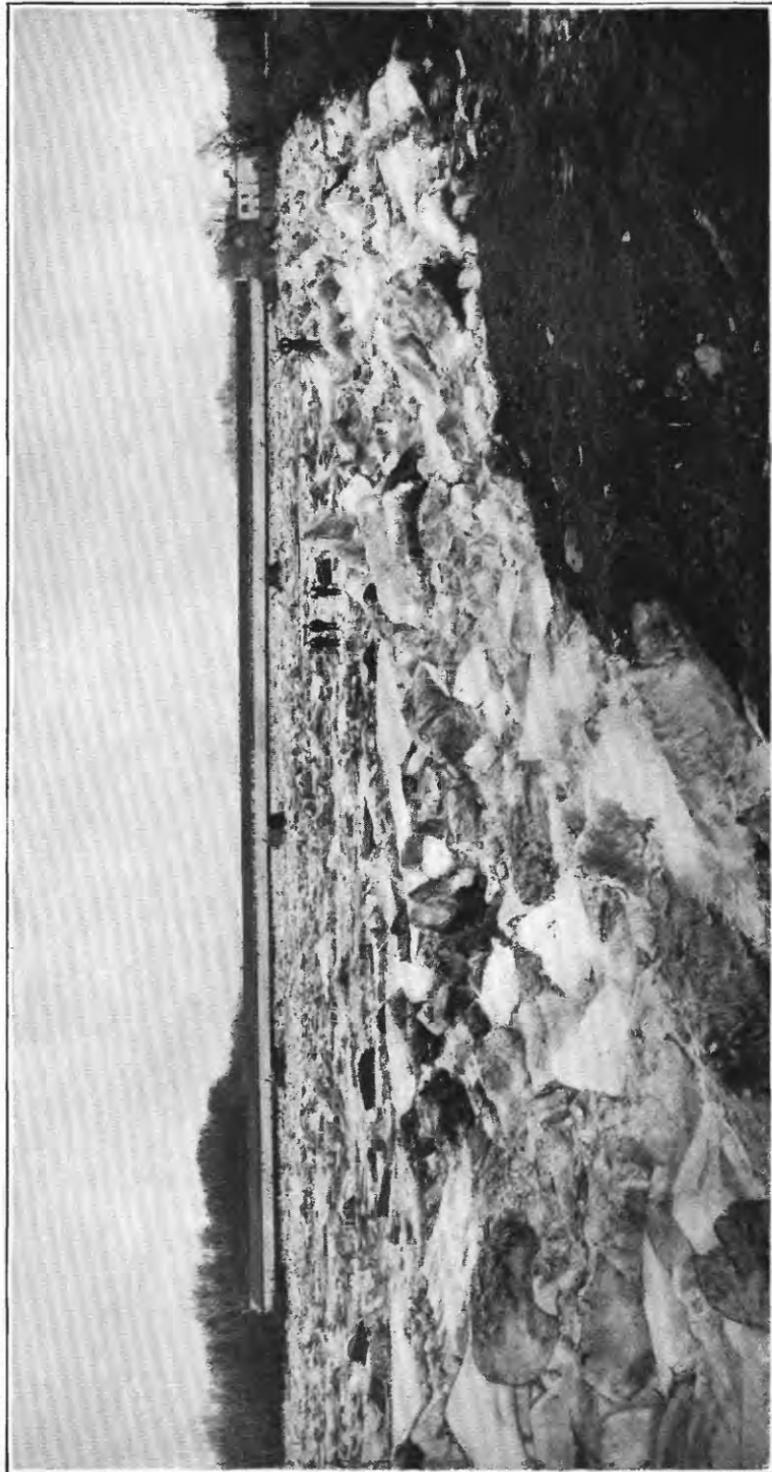
ICE GORGE OF 1875 ON SUSQUEHANNA RIVER AT WILKESBARRE, PA.

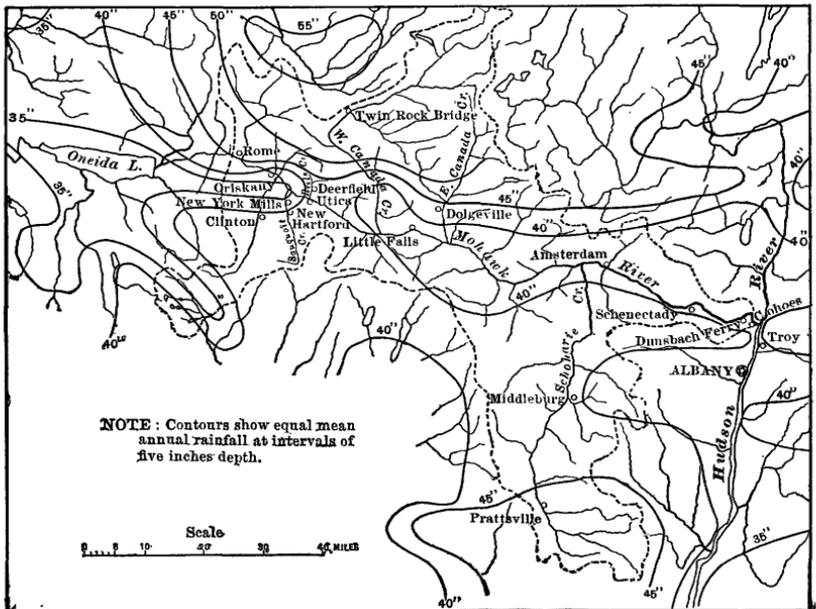
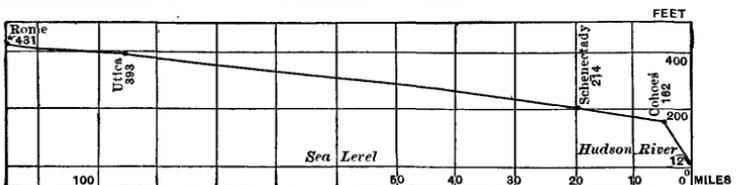
FIG. 2.—Drainage basin and profile of Mohawk River.

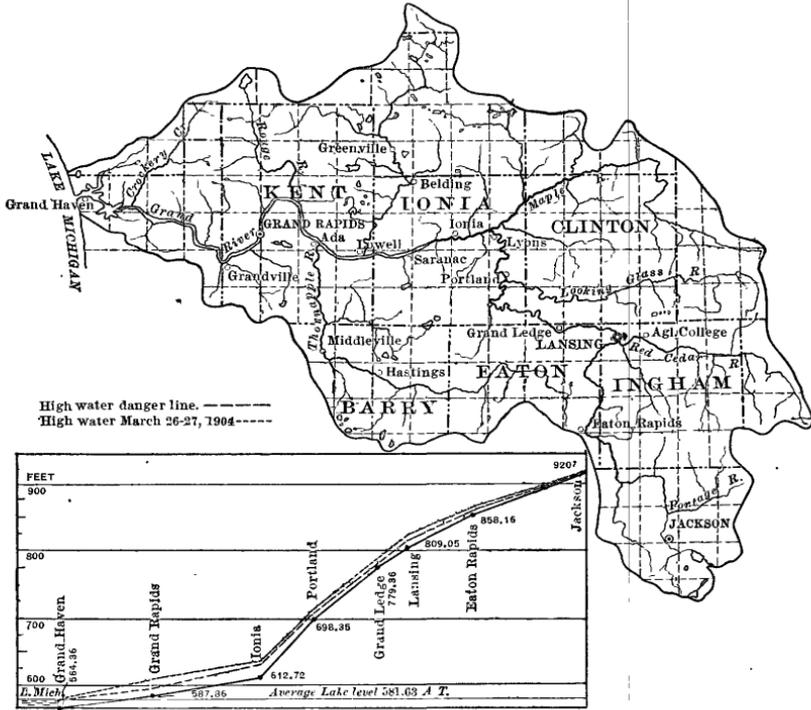
FIG. 3.—Drainage basin and profile of Grand River, Michigan.

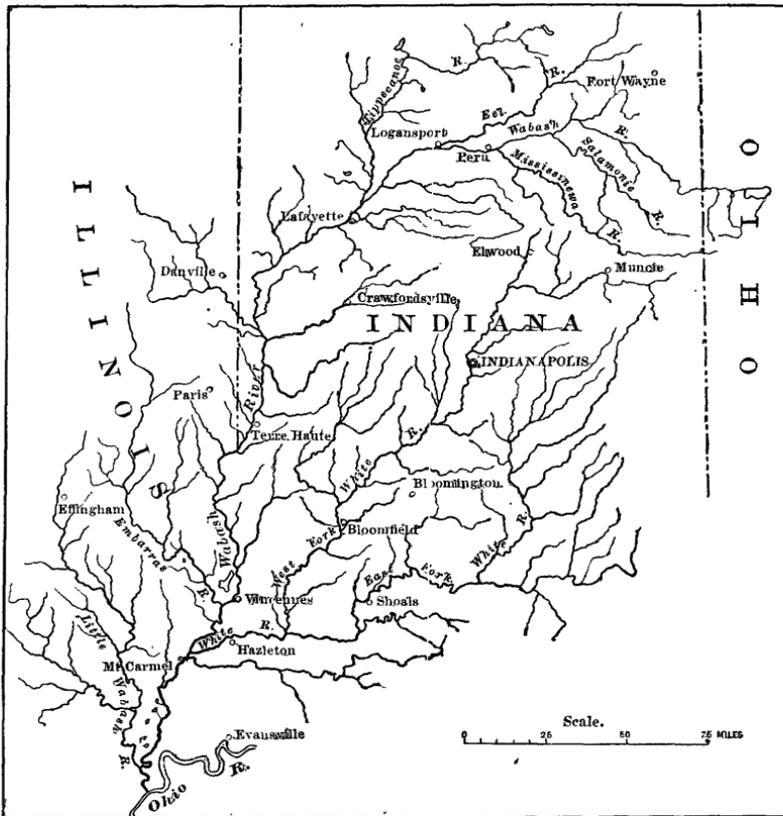
FIG. 4.—Drainage basin of Wabash River.

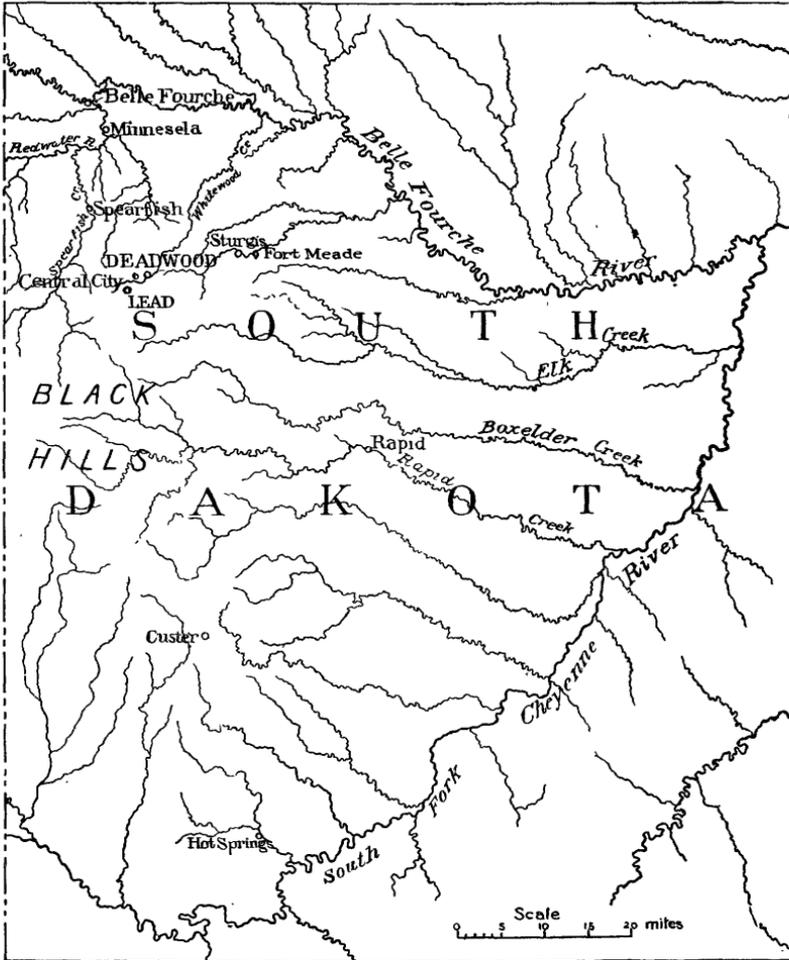
FIG. 5.—Part of Black Hills drainage.

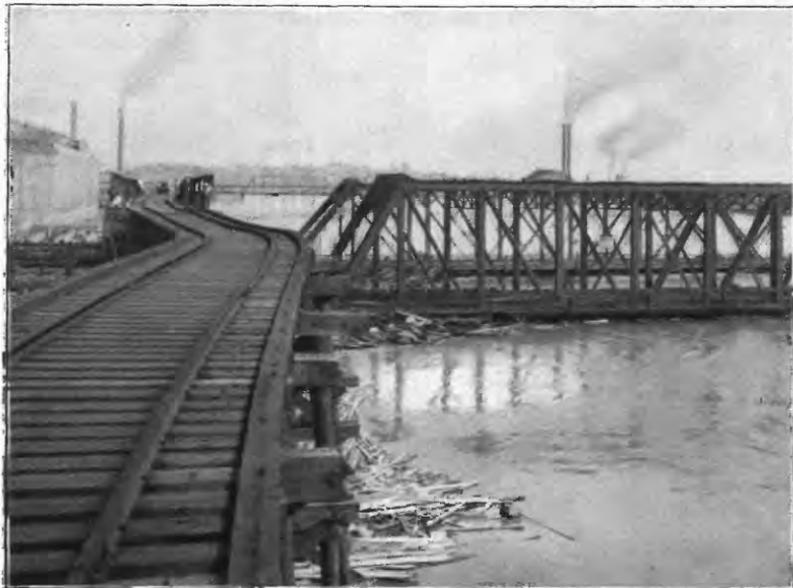
A. MISSOURI PACIFIC AND UNION PACIFIC RAILWAY BRIDGES OVER KANSAS RIVER AT KANSAS CITY DURING FLOOD OF 1904.

Pl. IV, A, shows the Missouri Pacific and Union Pacific railway bridges across Kansas River in Kansas City when the flood of July 7, 1904, had begun to recede. The Missouri Pacific bridge shown was the only one across the Kansas River at Kansas City that escaped destruction in 1903. The new Union Pacific bridge is at the same elevation above low water as the old one, and the channel under it has not been widened; in fact, the only effort made in Kansas City to prevent loss due to floods between the dates of these floods was the construction of a few of the new bridges at a few feet greater elevation

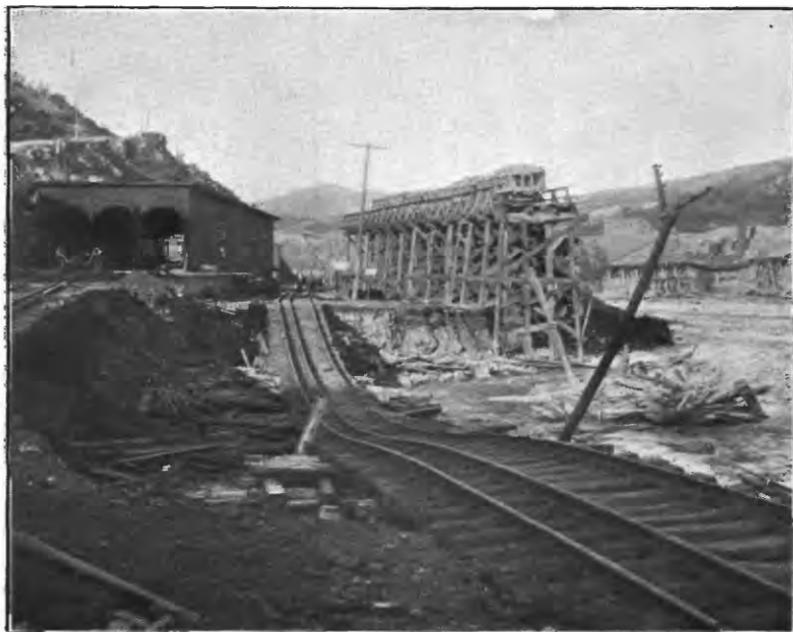
B. DAMAGE TO CHICAGO AND NORTHWESTERN RAILWAY ALONG WHITEWOOD CREEK, SOUTH DAKOTA.

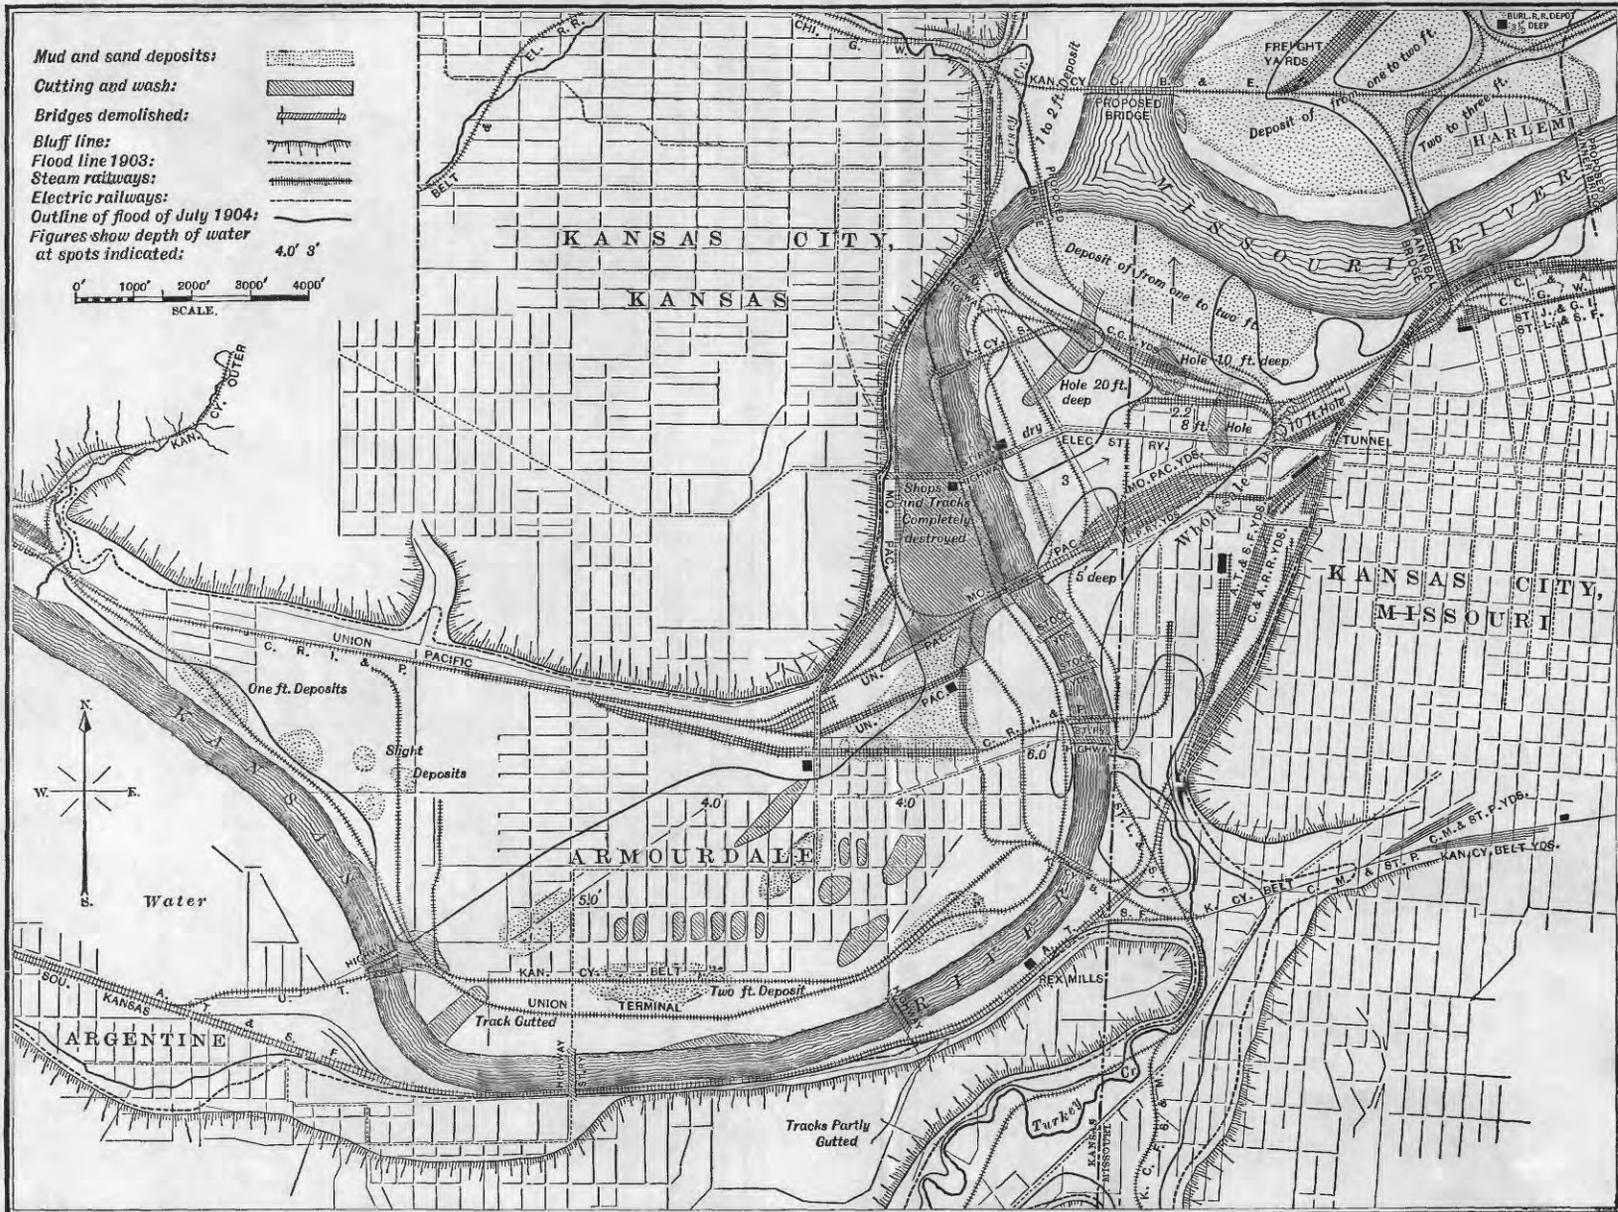
KANSAS CITY, SHOWING AREA FLOODED IN 1903 AND 1904.

than the old ones which were destroyed. The channel has not been widened, although at one place it is less than 450 feet in width. The spans of the bridges have not been lengthened, the channel has not been cleared of wreckage nor deepened, nor have levees been constructed to prevent overflow. The 1904 flood, although it did not reach within several feet of the height of the 1903 flood, nevertheless overflowed many acres of bottom land, drove a large number of people from their homes, and destroyed many thousand dollars' worth of property. Pl. V shows the areas submerged during the flood of 1903 and during that of 1904.

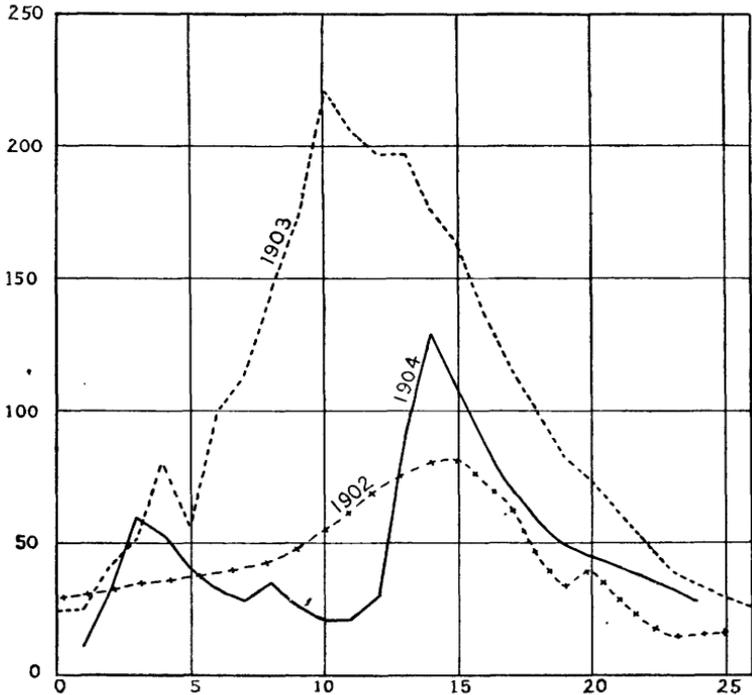
FIG. 6.—Flood discharge of Kansas River at Lecompton, Kans., in 1902, 1903, and 1904.

Necessary waterway.—The width of the channel between the abutments of the bridge at Lecompton is 800 feet. When the flood of June, 1903, was at its maximum stage the left bank was overflowed for a distance of at least one-half mile, but most of this overflow had very little velocity, and the discharge through the overflow part of the cross section was not more than 5 per cent of the total discharge. The right bank, along which are the Santa Fe Railway tracks, was submerged for a distance of about 110 feet.

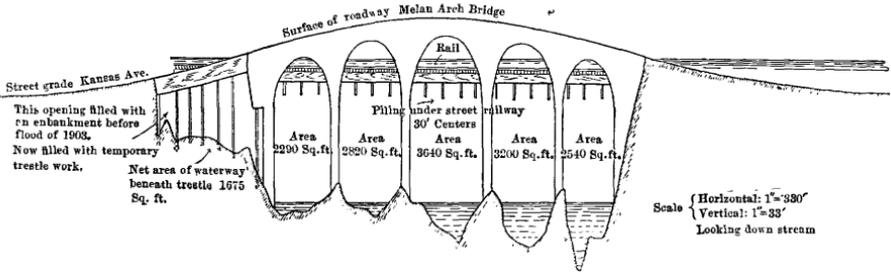
FIG. 7.—Cross section of Kansas River at Melan arch bridge, Topeka, Kans.

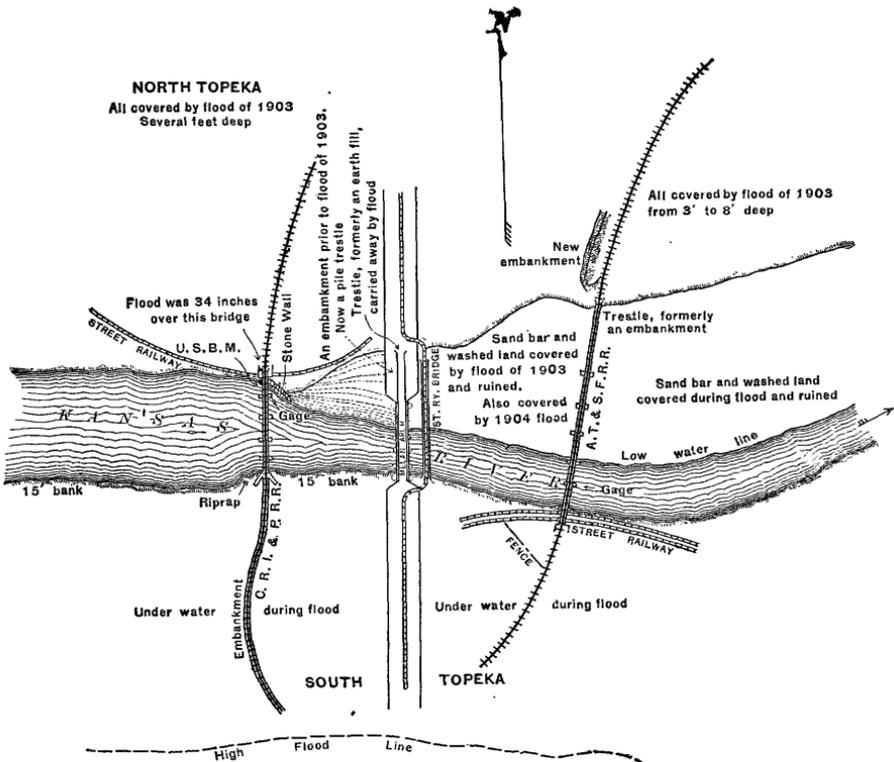
FIG. 8.—Kansas River and flooded area in vicinity of Melan arch bridge, Topeka, Kans.

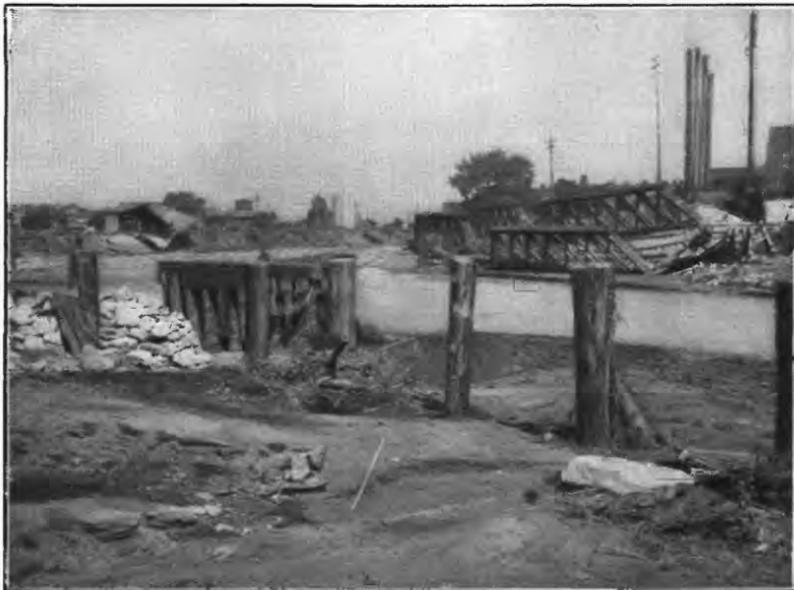
B. RUINS OF DENVER AND RIO GRANDE RAILWAY BRIDGE, TRINIDAD, COLO.

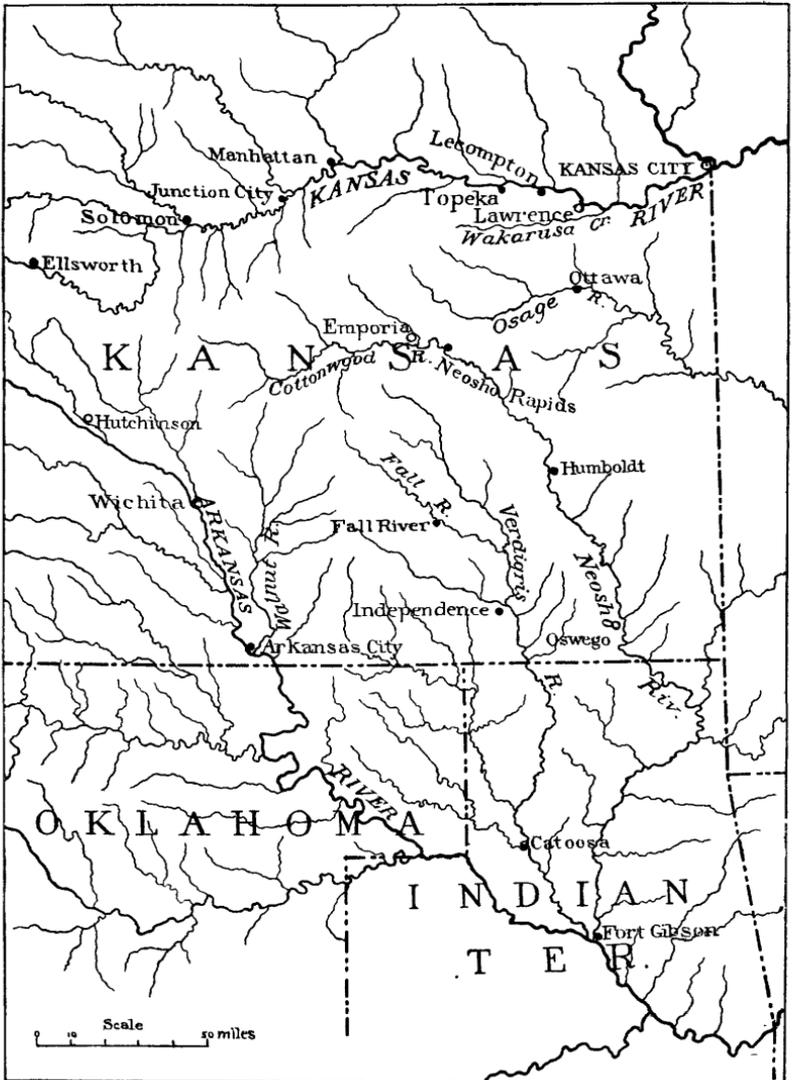
FIG. 9.—Drainage basins of southeastern Kansas.

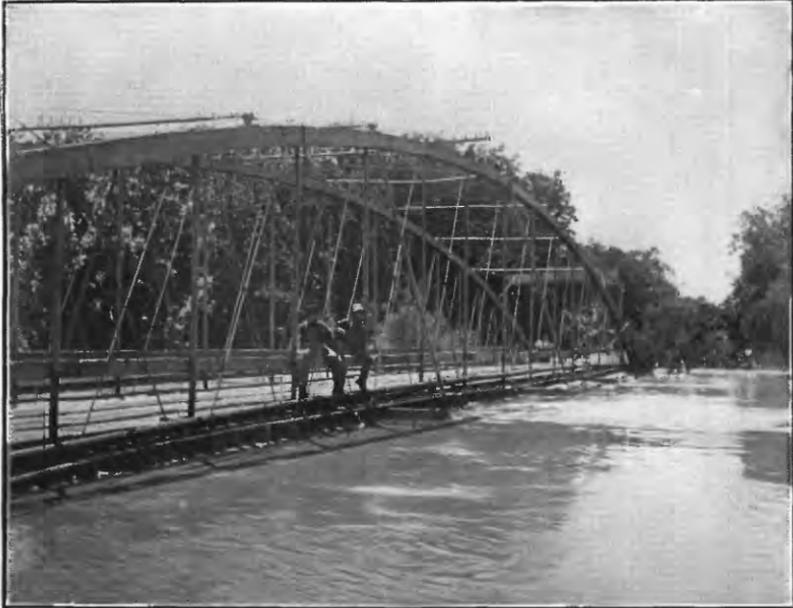
A. FLOOD IN NEOSHO RIVER AT HIGHWAY BRIDGE AT HUMBOLDT, KANS.

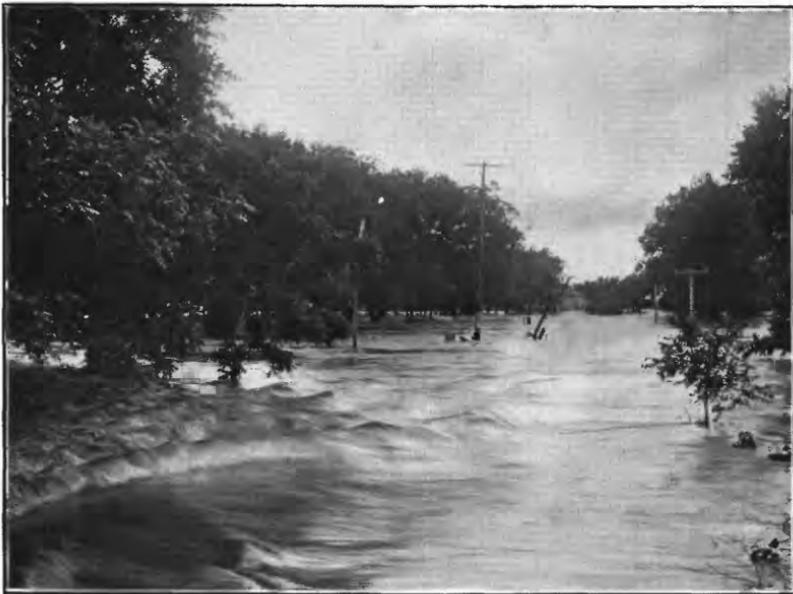
B. OVERFLOW OF RIGHT BANK OF NEOSHO RIVER AT HIGHWAY BRIDGE AT HUMBOLDT, KANS.

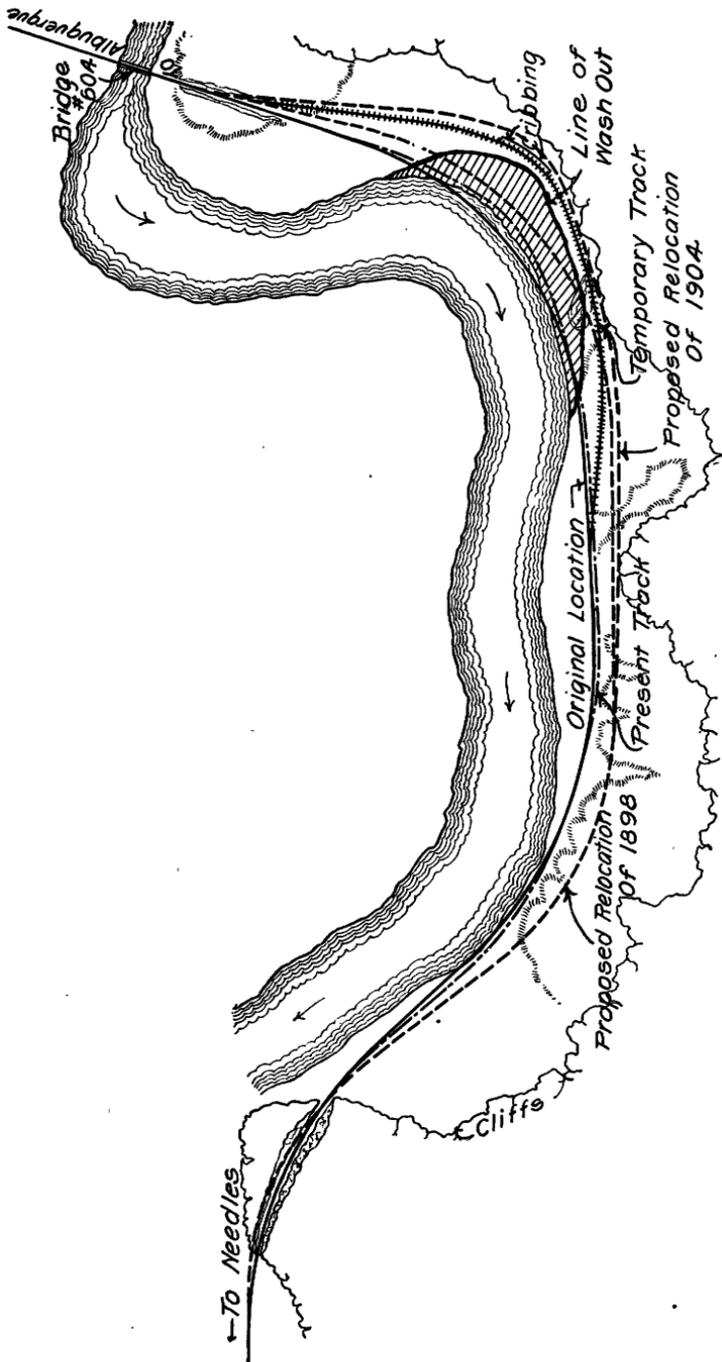
FIG. 10.—Erosion of bank of Big Sandy Creek and relocation of Santa Fe Railway, Troxton Canyon, Arizona. From Railway Age.

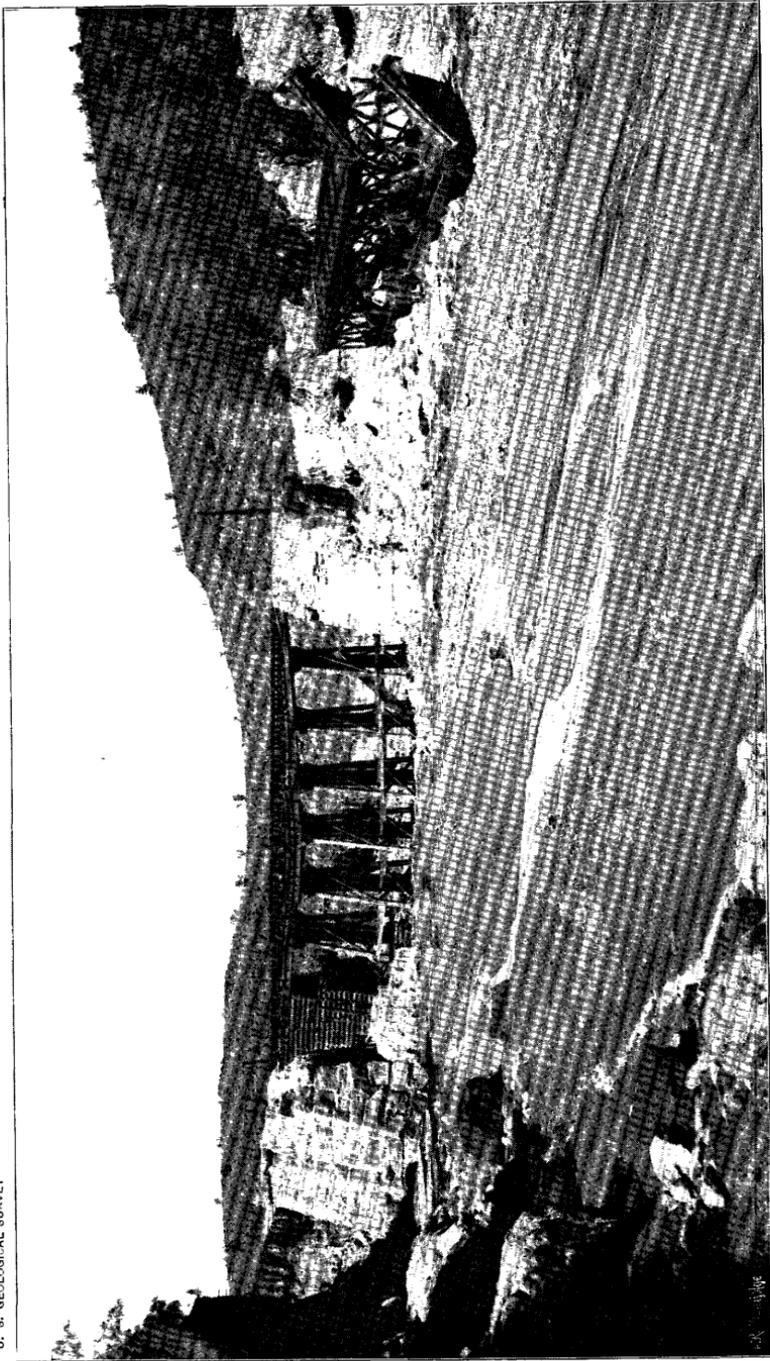
VIEW SHOWING EFFECT OF FLOOD ON ABUTMENTS AND BRIDGE NO. 604, SANTA FE RAILWAY, TROXTON CANYON.
From Railway Age.

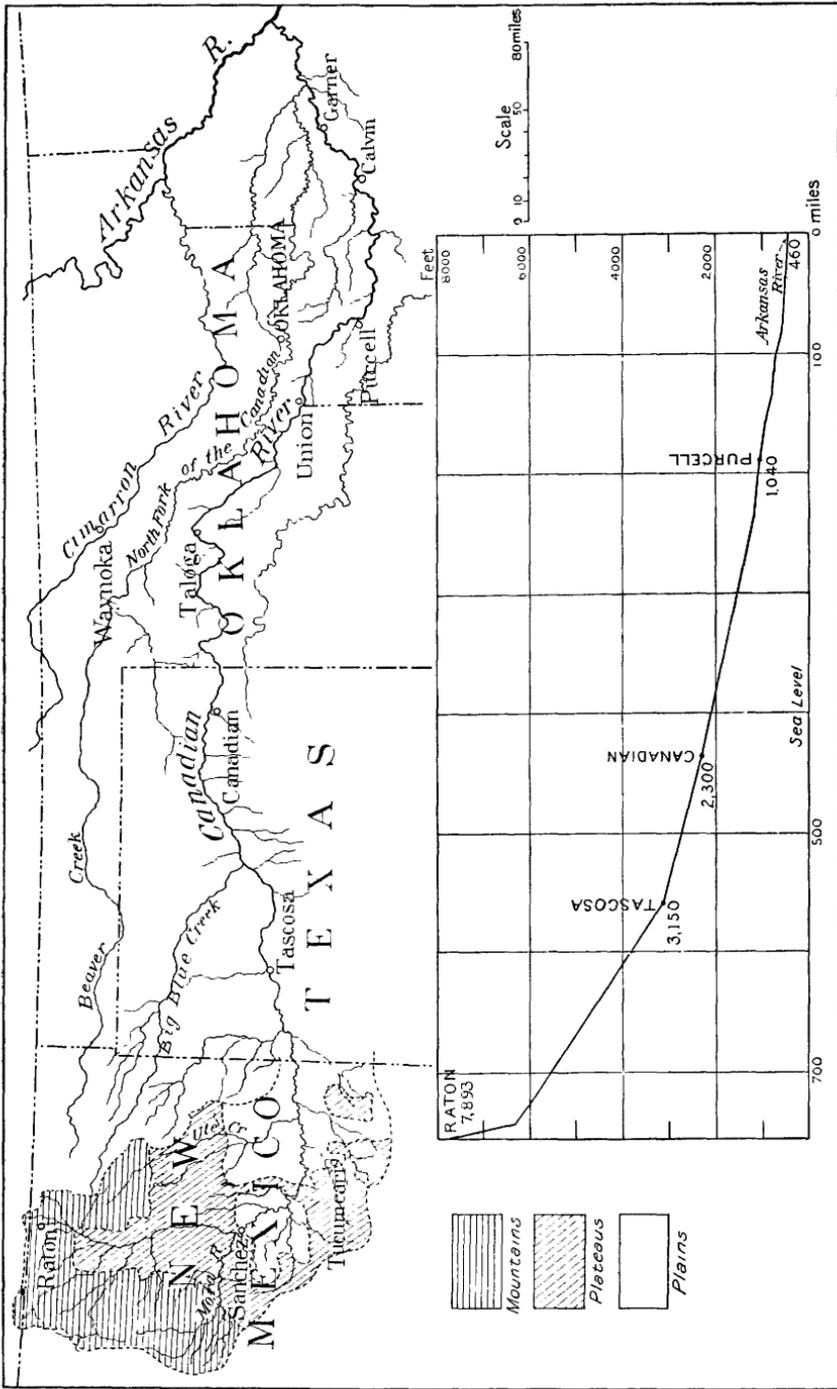
DRAINAGE BASIN AND PROFILE OF CANADIAN RIVER.

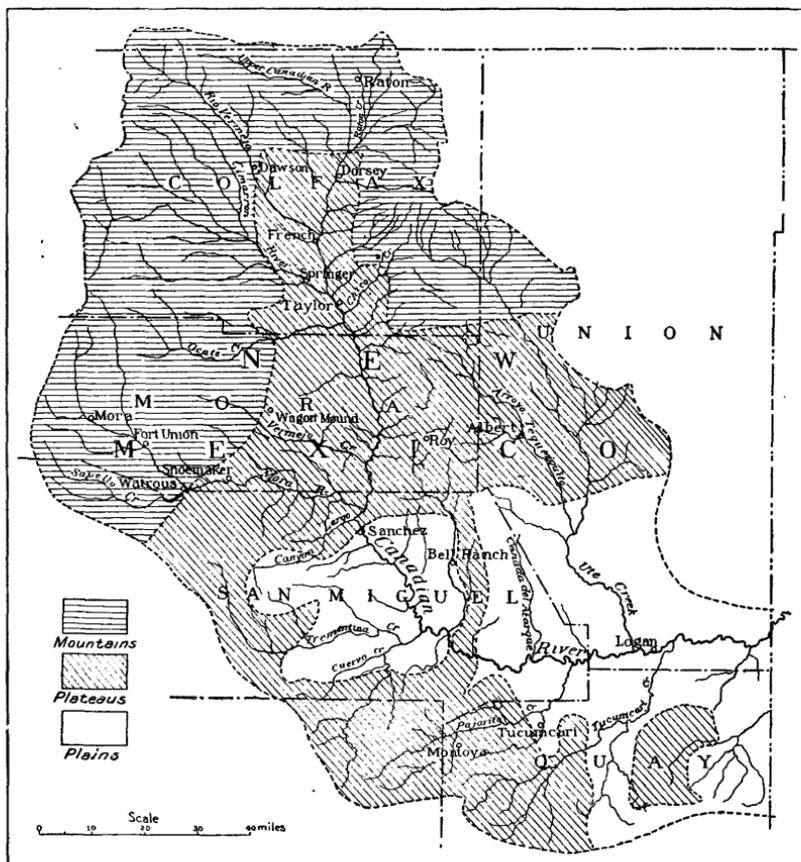
FIG. 12.—Upper portion of drainage basin of Canadian River.

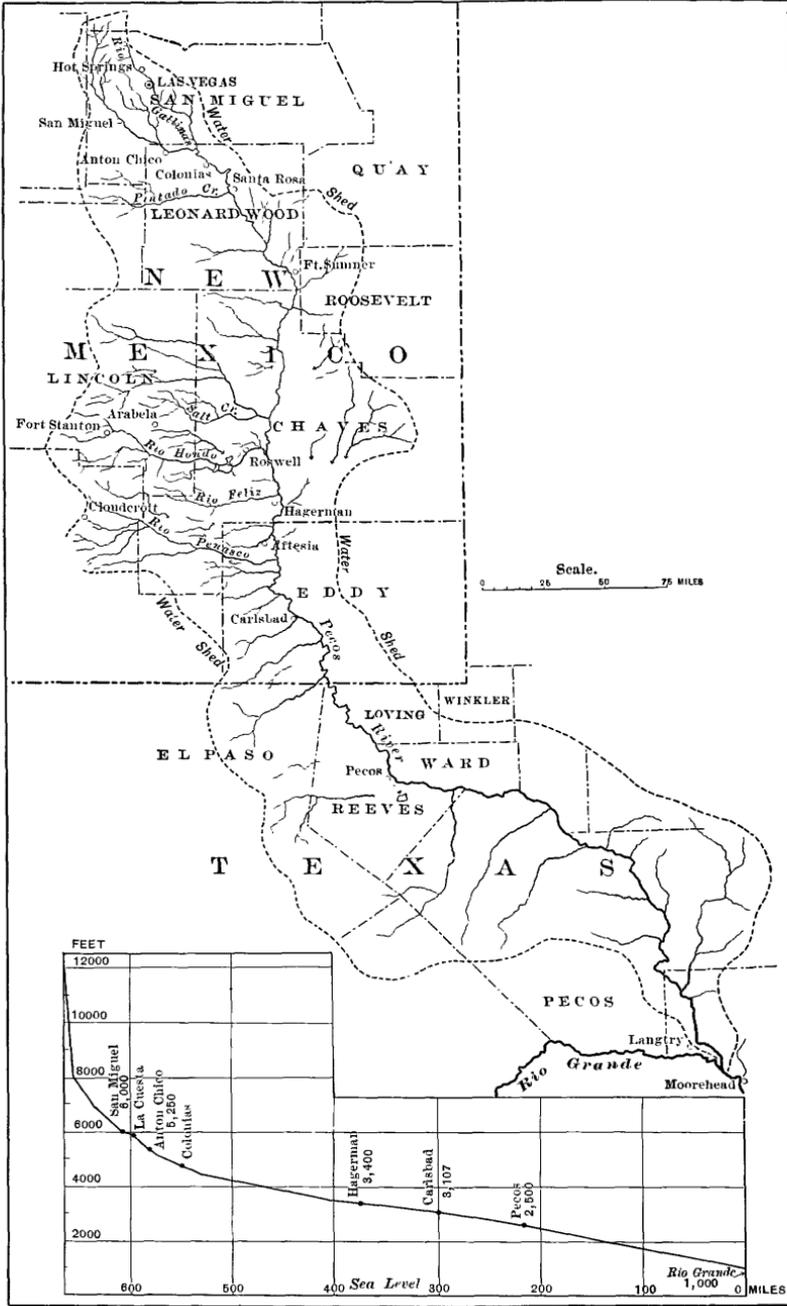
DRAINAGE BASIN AND PROFILE OF PECOS RIVER.

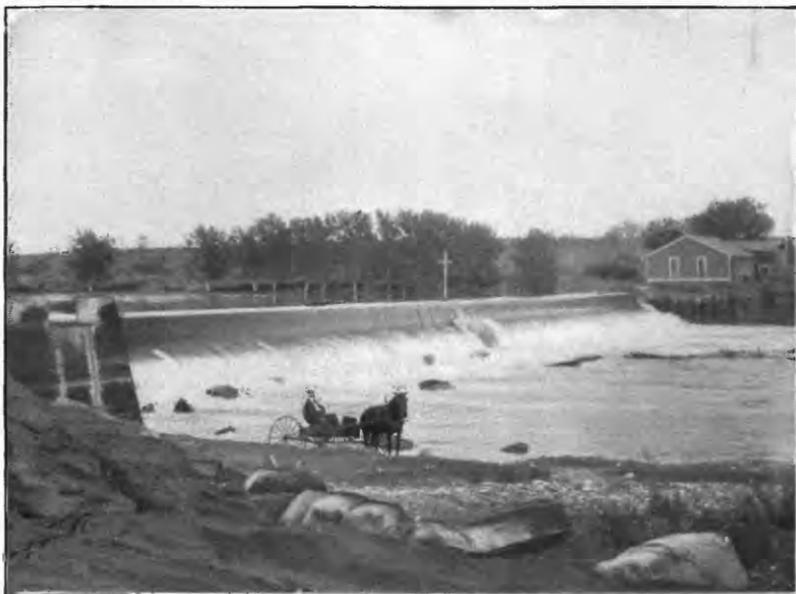
A. DAM ON PECOS RIVER AT CARLSBAD, N. MEX., BEFORE THE FLOOD OF OCTOBER, 1904.

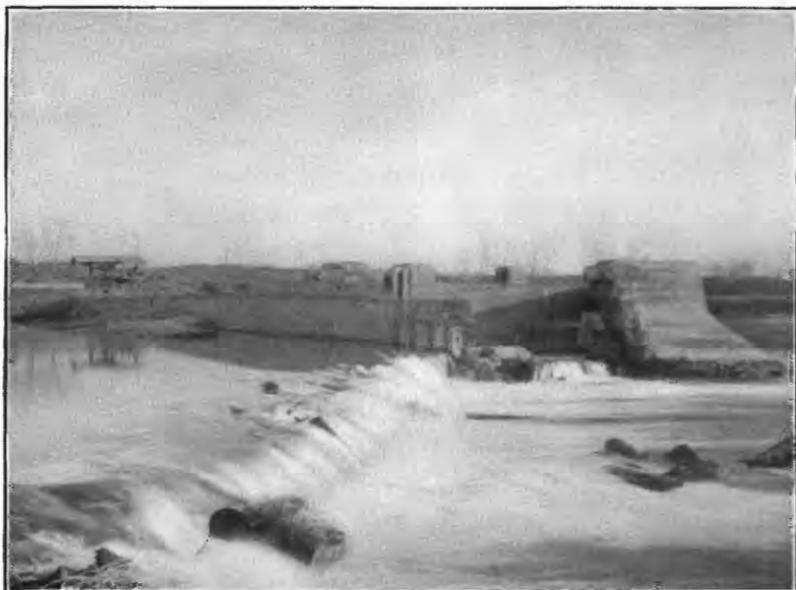
B. DAM AT CARLSBAD, N. MEX., AFTER THE FLOOD OF OCTOBER, 1904.

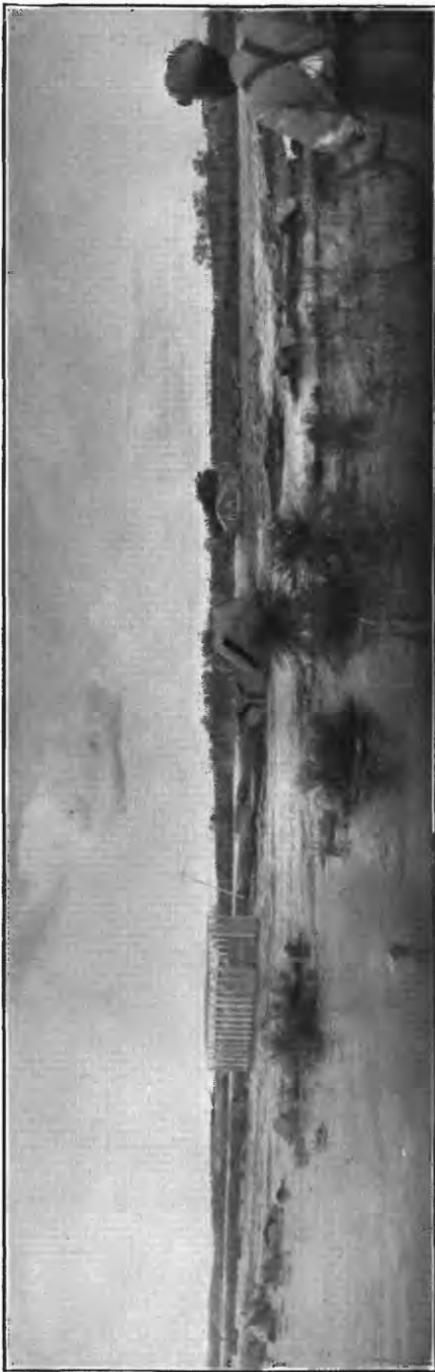
FLOOD AT DAM ON PECOS RIVER AT CARLSBAD, N. MEX., OCTOBER, 1904.

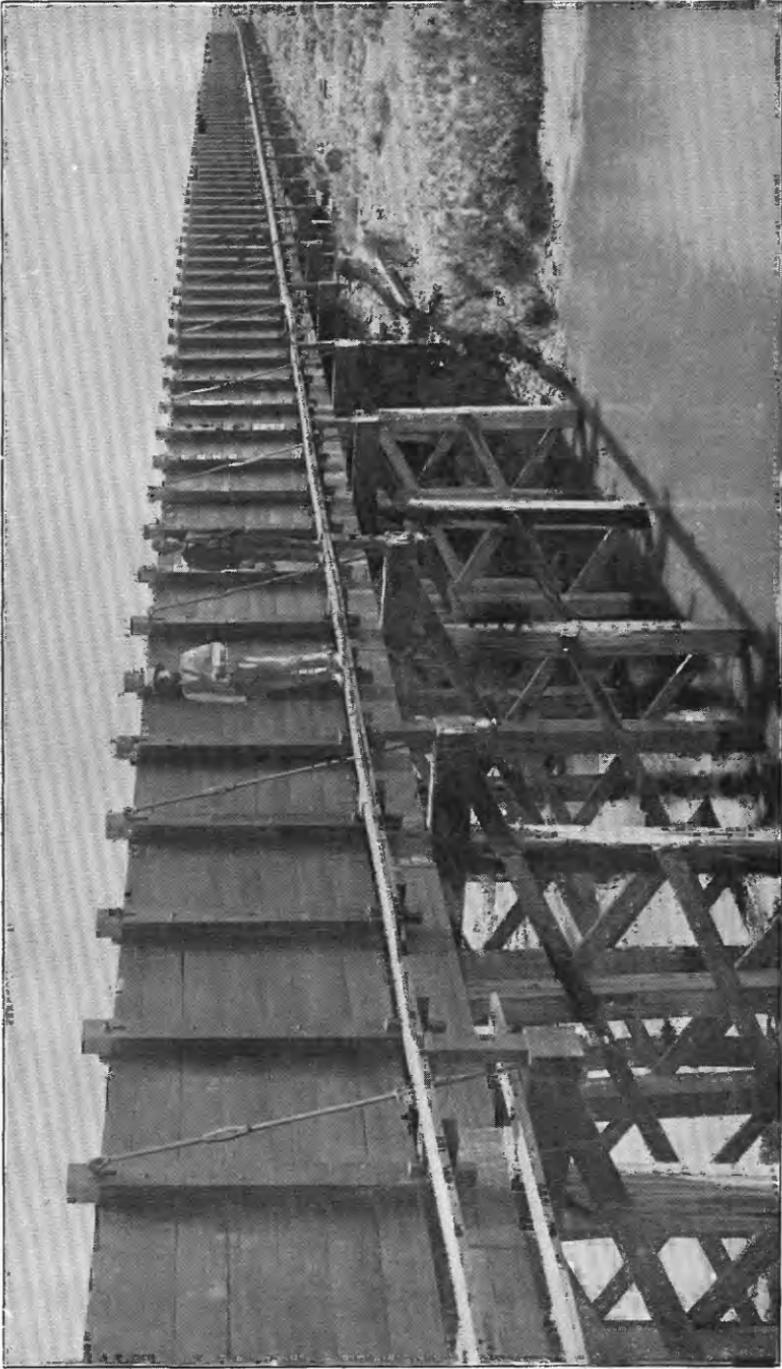
FLUME OF BARSTOW IRRIGATION COMPANY, PECOS RIVER, TEXAS, CARRIED AWAY BY FLOOD OF OCTOBER 5, 1904.

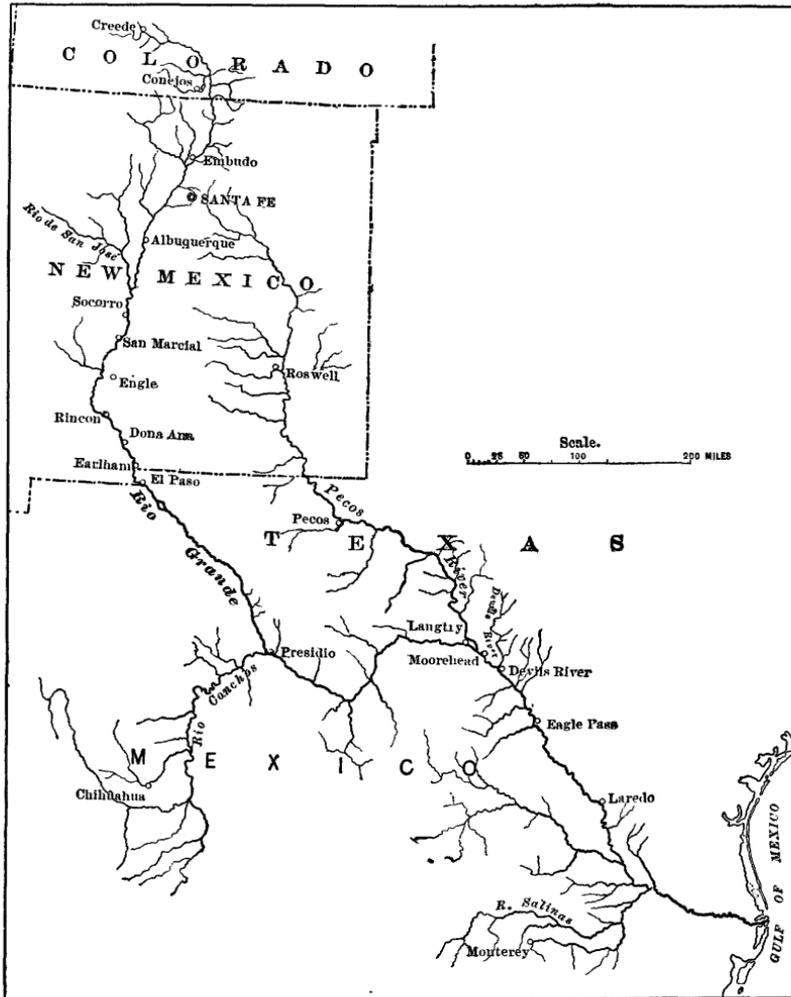
FIG. 13.—Drainage basin of the Rio Grande.

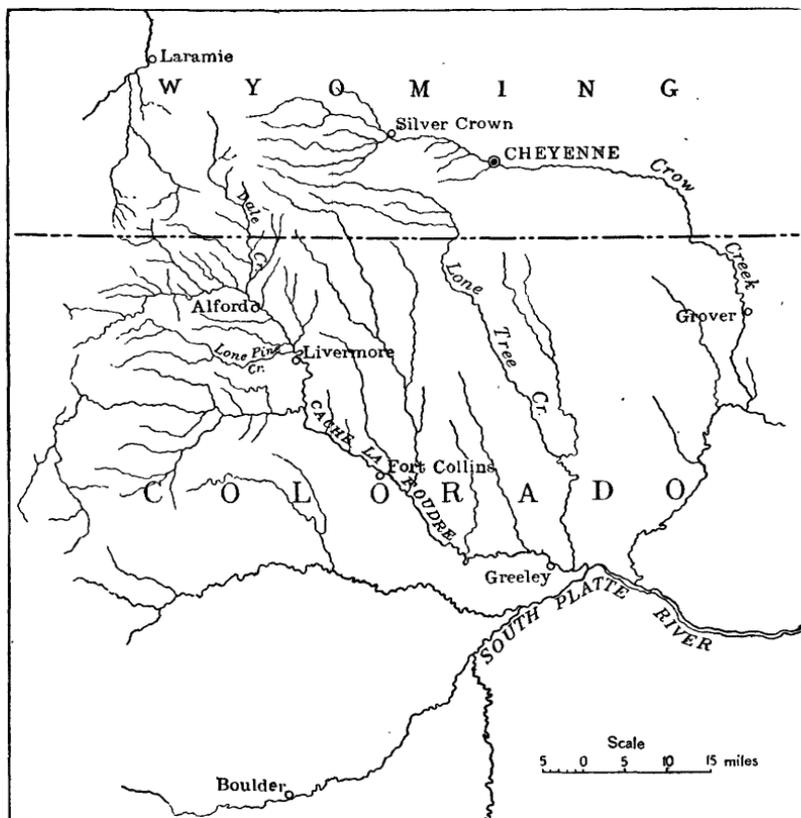
FIG. 14.—Drainage basins of Cache la Poudre River and Crow Creek.
